# **The Duchy Palace, Lostwithiel, Cornwall**

## **Historic building record and archaeological watching brief**

<b>Client</b>	<b>Cornwall Buildings Preservation Trust</b>
<b>Report Number</b>	<b>2012R060</b>
<b>Date</b>	<b>May 2013</b>
<b>Status</b>	<b>Final</b>
<b>Report author(s)</b>	<b>Jo Sturgess and Nigel Thomas</b>
<b>Checked by</b>	<b>Jacky Nowakowski</b>
<b>Approved by</b>

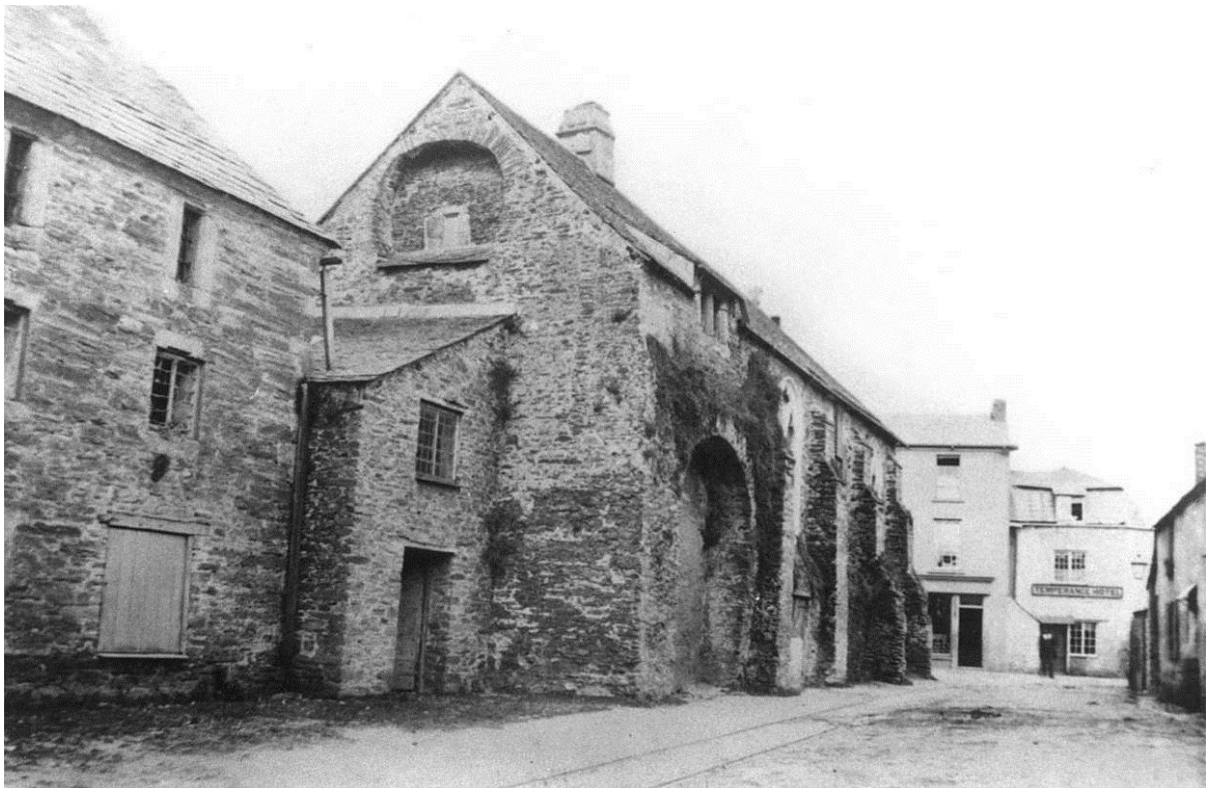
Fig 8 Photograph of the Convocation Hall looking north-east taken in 1860s/1870s

At this stage of its history the building was in use as the Duchy of Cornwall's county office. As the old entrance arch was blocked, the entrance to the office was through the lean-to building

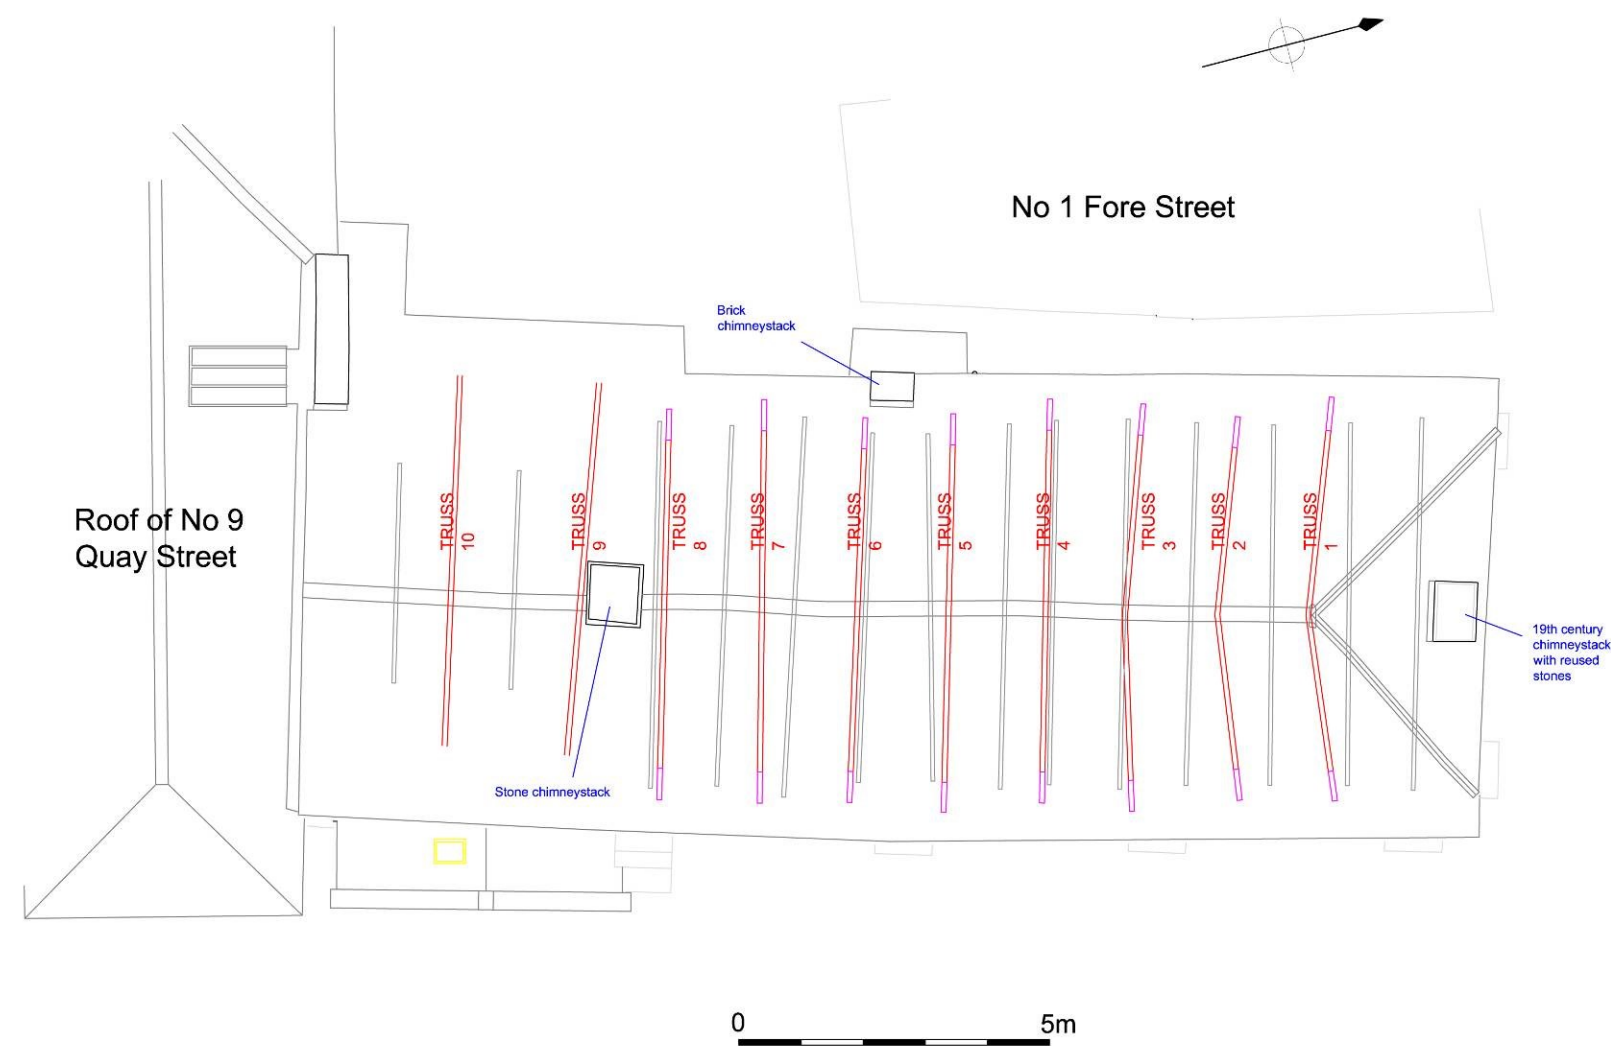
Fig 16 Plan at roof level  
Based upon measured survey supplied by Purcell UK; annotation by HEP

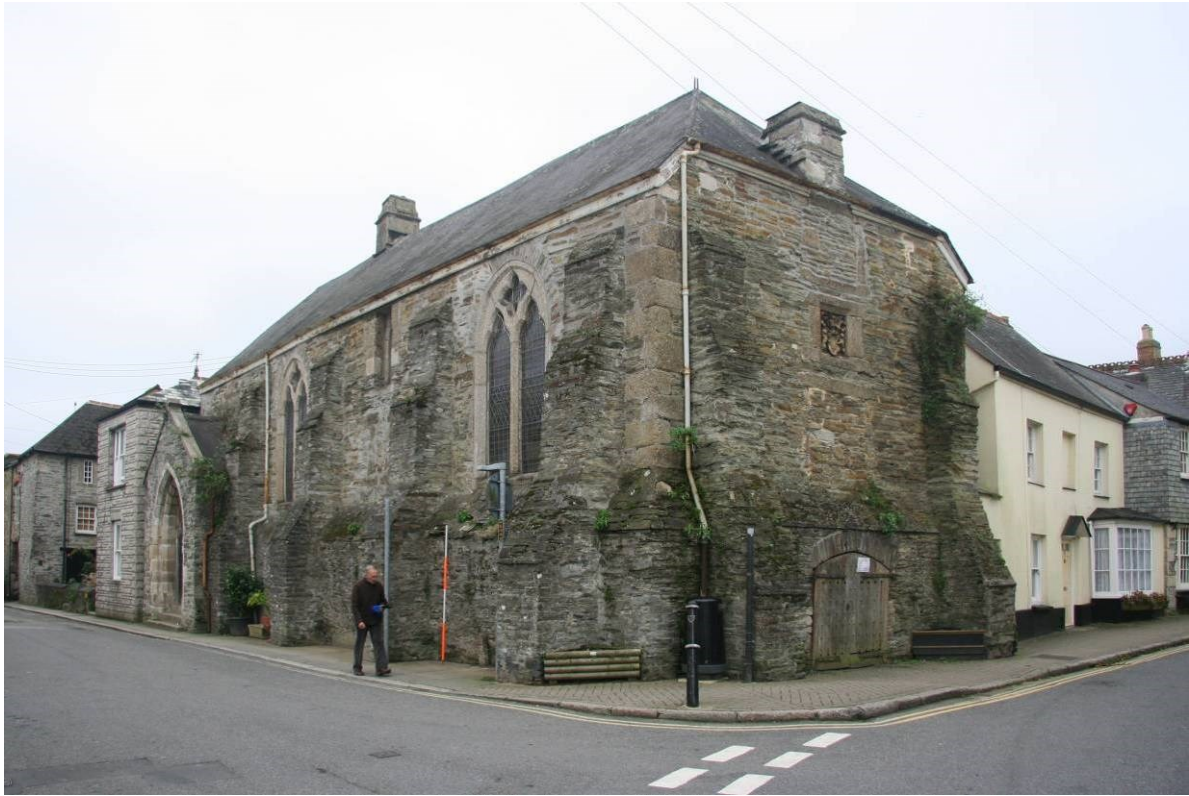
*Fig 27 The Duchy Palace photographed in late 2011 before renovation work commenced*

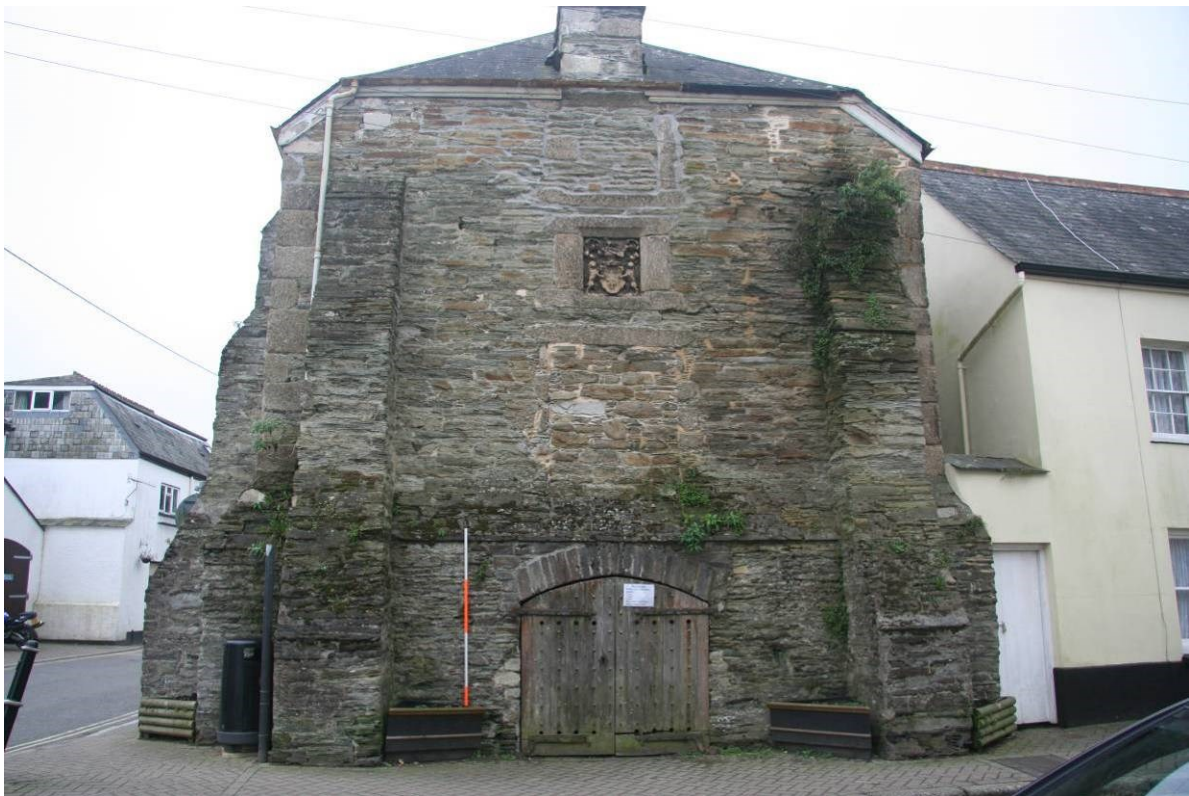
*Fig 28 The north elevation of the building (facing Fore Street) shows many alterations including blocked windows in the original two upper floors*

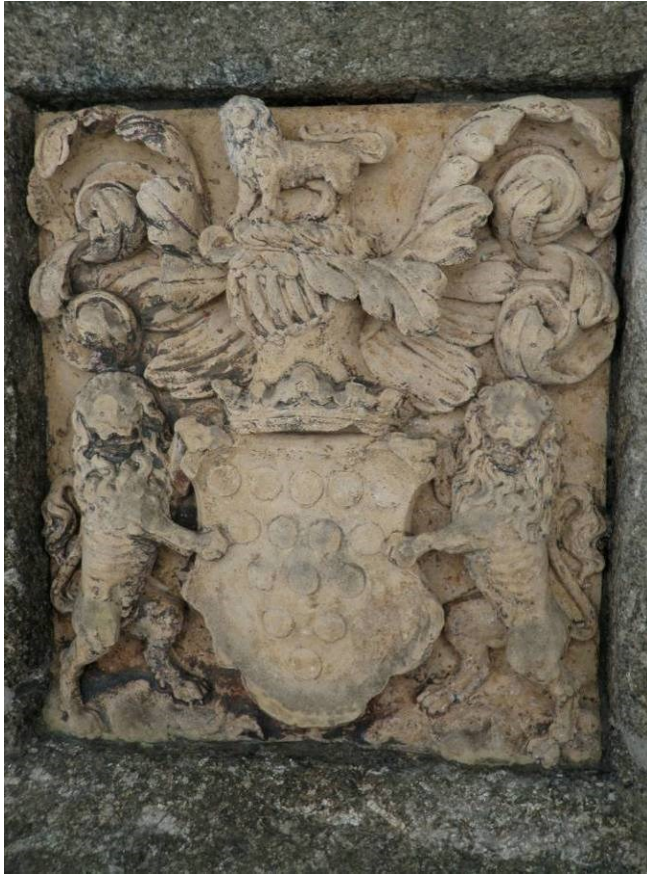
*Fig 29 Granite panel in the north wall containing the Duchy of Cornwall emblem (shown after initial stonework cleaning)*

A distinctive feature of the building is a panel in the north wall containing the heraldic arms of the Duchy of Cornwall. The granite frame surrounding the panel is coeval with the construction of the surrounding walling and therefore an original feature of the building. The decorative panel itself is most likely to be a post-Restoration replacement, assuming that the original medieval version was damaged or destroyed through the Parliamentary occupation of Lostwithiel during the Civil War.

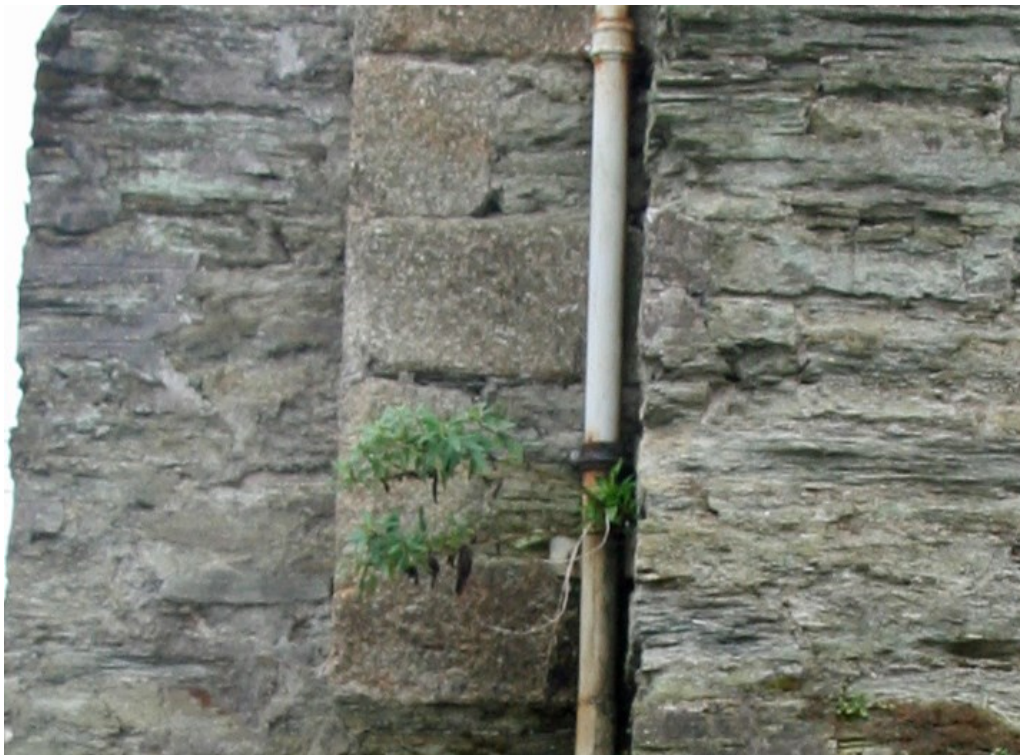
*Fig 30 Chamfered detail on the granite quoins at the junction of Fore Street and Quay Street*

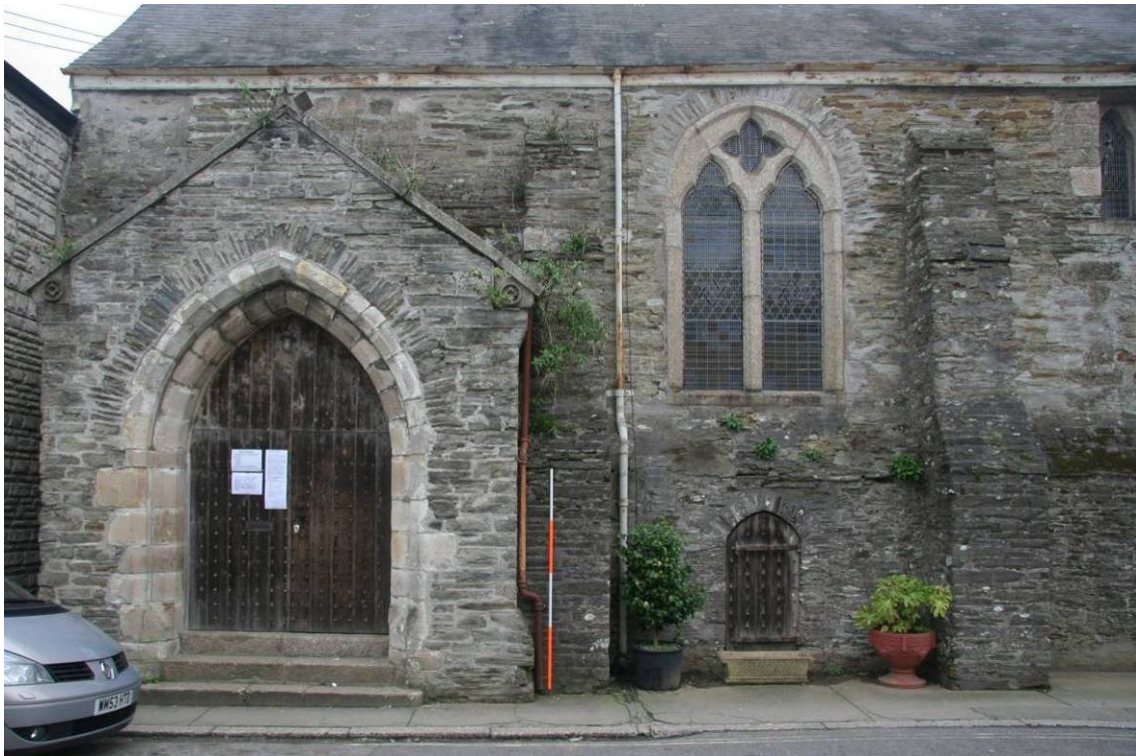
*Fig 31 Southern end of the Quay Street elevation*

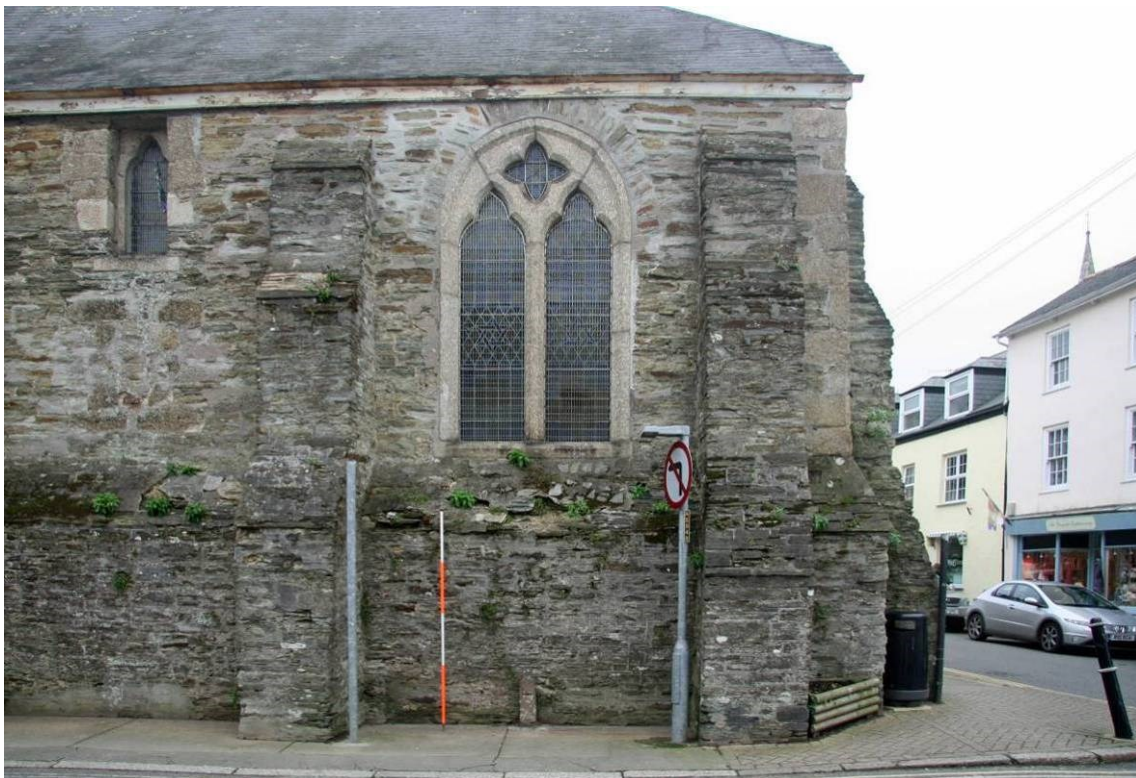
*Fig 32 Northern end of the principal elevation*

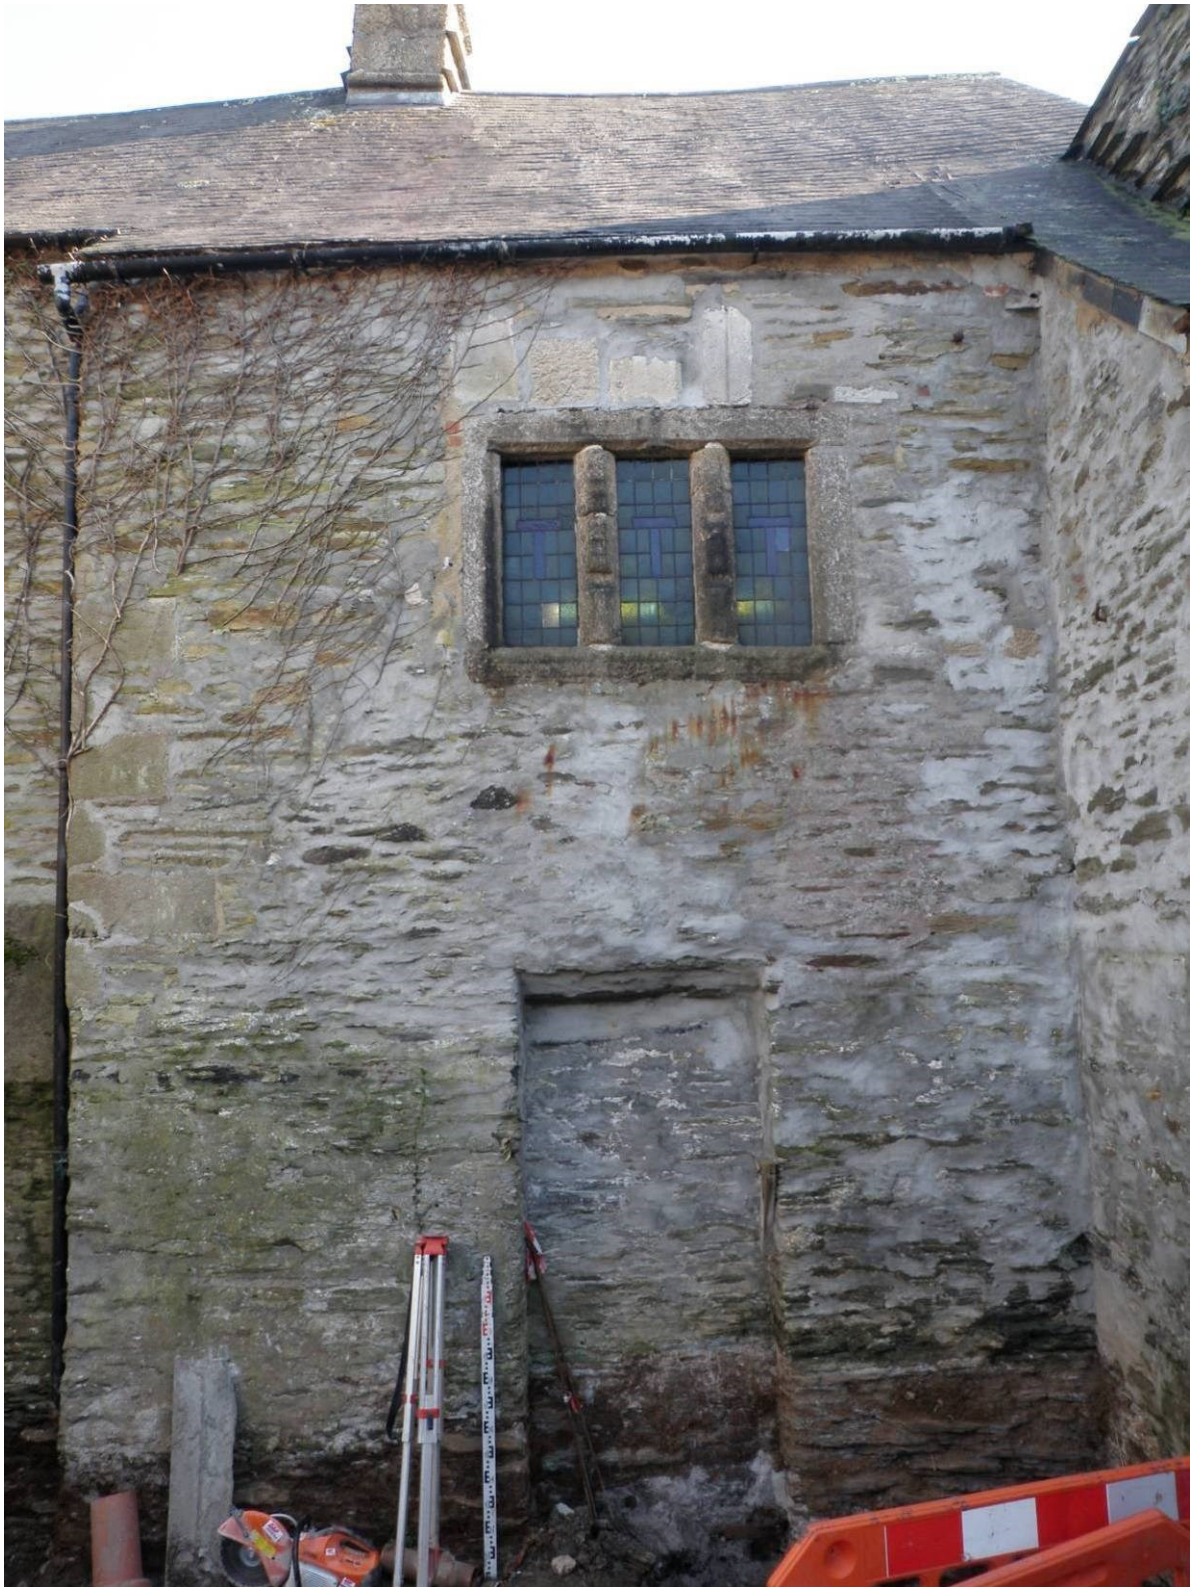
*Fig 33 West wall of the Convocation Hall with part of the gable of the former Great Hall to the right*

*Photographed before masonry conservation had begun, this side of the building had been heavily repaired with cement-based mortar. The window is a post-1878 addition, created from the frame of a former 2-light window (stub of central mullion is visible at the top). The tall recessed feature has not been completely explained during the study, but a later drain exits through the wall at its base*

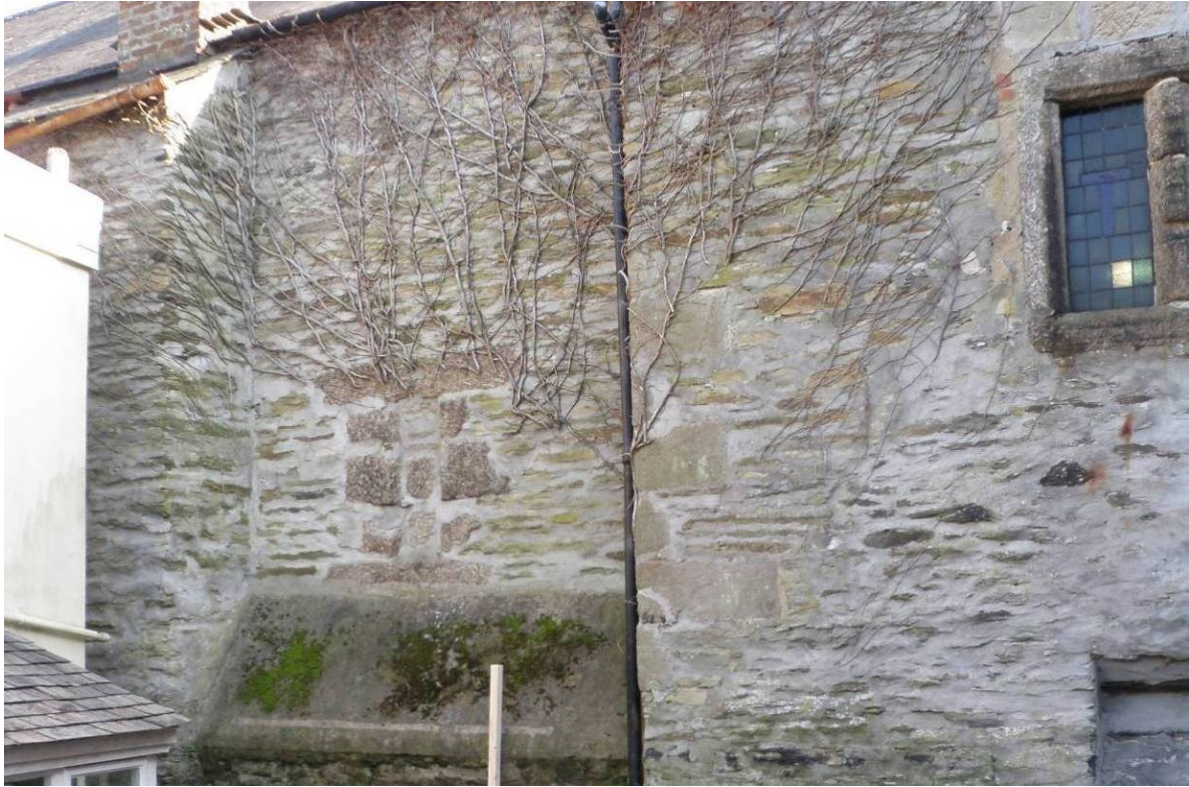
*Fig 34 A blocked original granite-framed slit window in the west wall, and the original lateral chimney forming a buttress to the left.*

*Sloping masonry beneath the window is part of a continuous buttress built to support the vaulted stone roof of the undercroft*

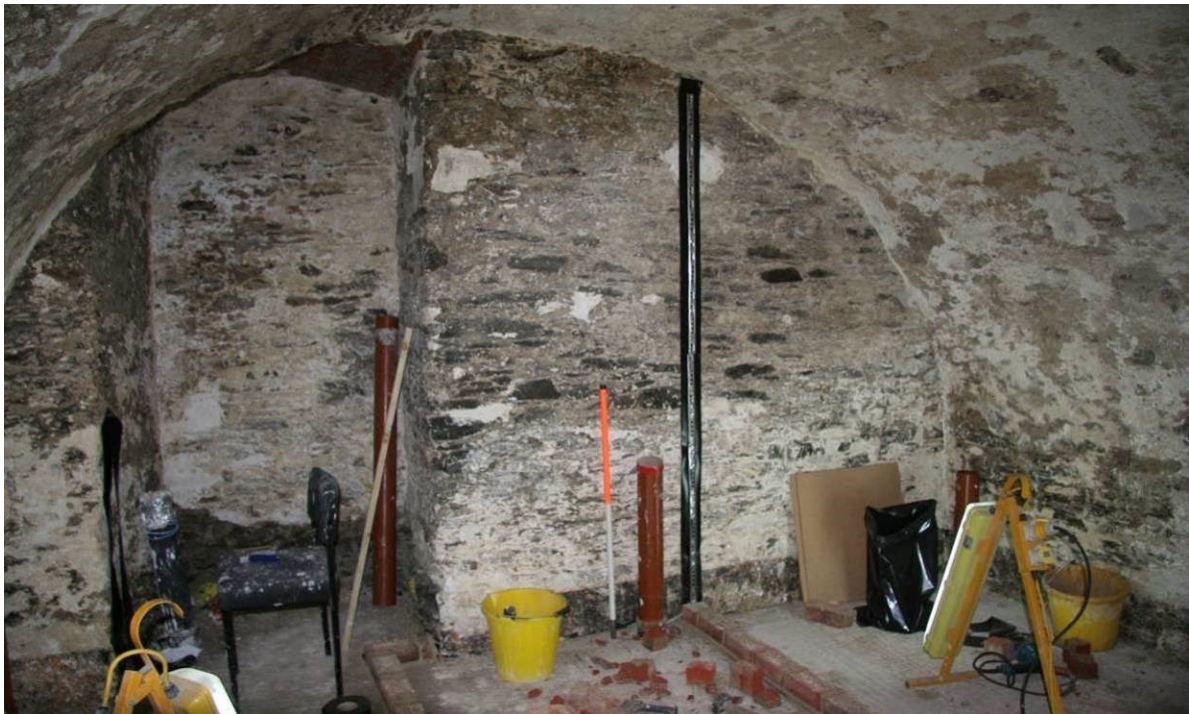
*Fig 35 The undercroft 'kitchen' beneath the anteroom*

*A doorway with a shallow arch of brickwork has been cut through the masonry of the former Great Hall*

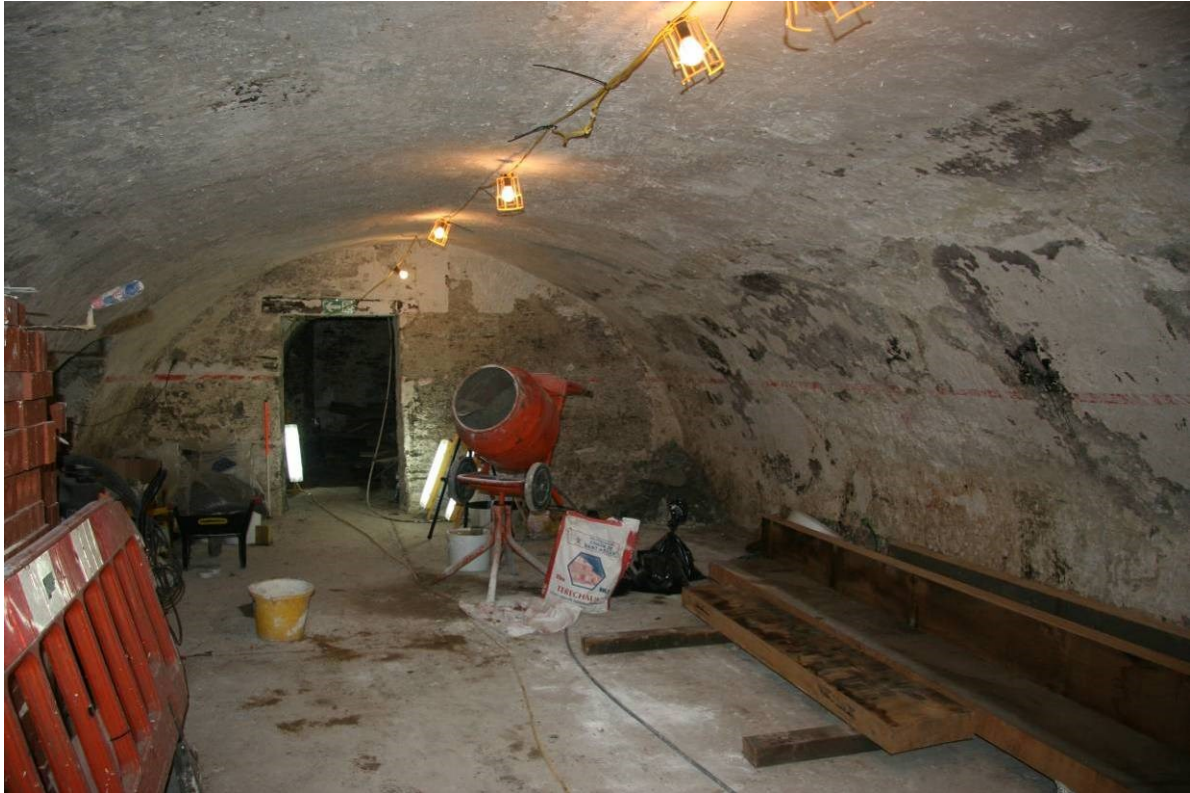
*Fig 36 General view of the main room within the undercroft, looking S*

*The red painted horizontal stripe was found beneath modern paint and may relate to wartime use*

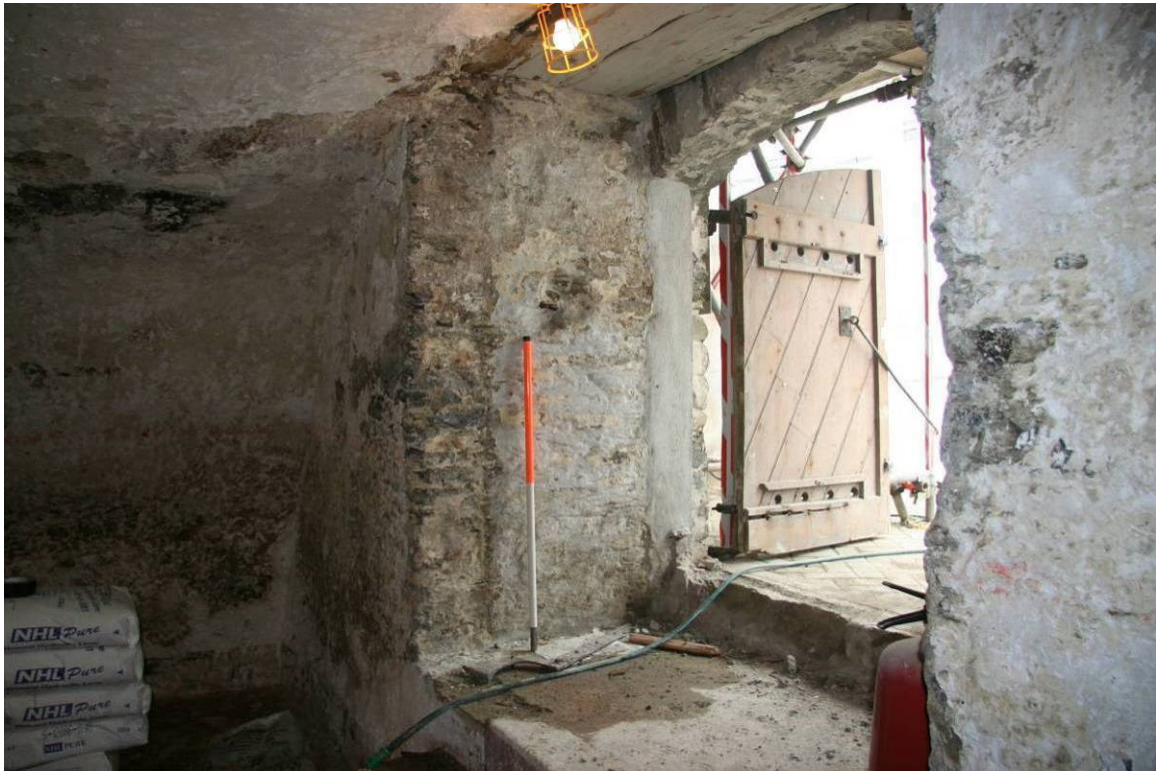
*Fig 37 Original north entrance to the undercroft; the arch headed outer doorway was added post-1878*

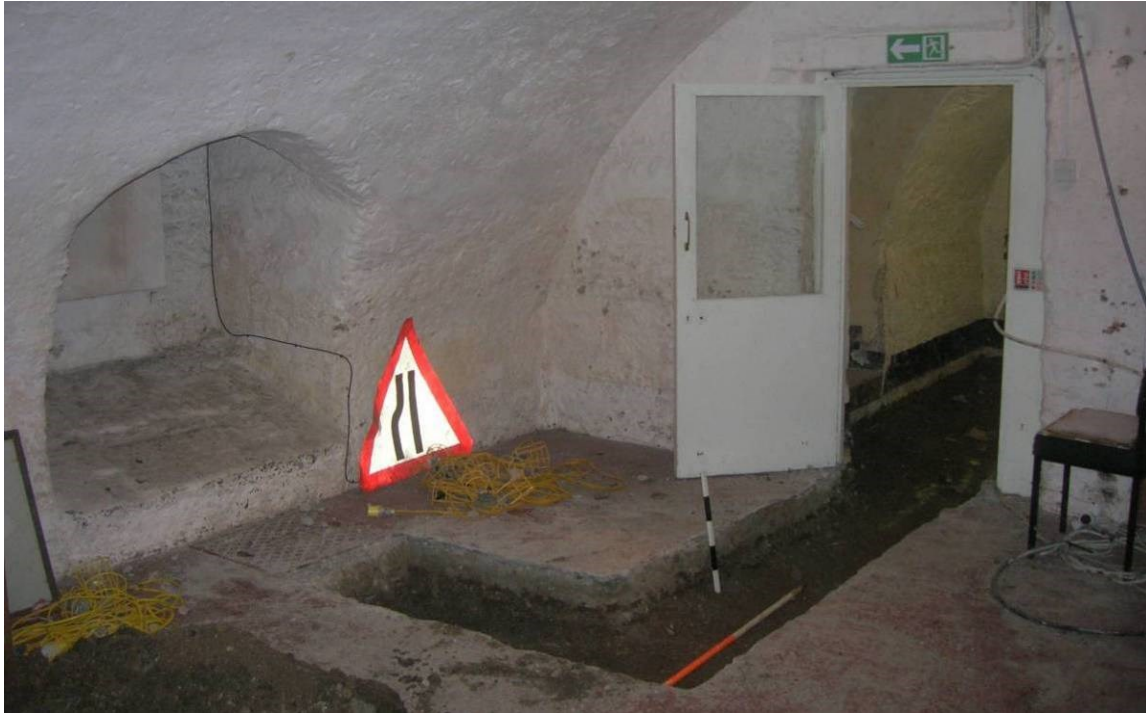
*Fig 38 Excavation for new drains in the undercroft revealed a pitched slate rubble structure seen following the line of the far edge of the trench from the door opening in the partition wall and dog-legging to the front wall of the building to the jamb of the recess opening*

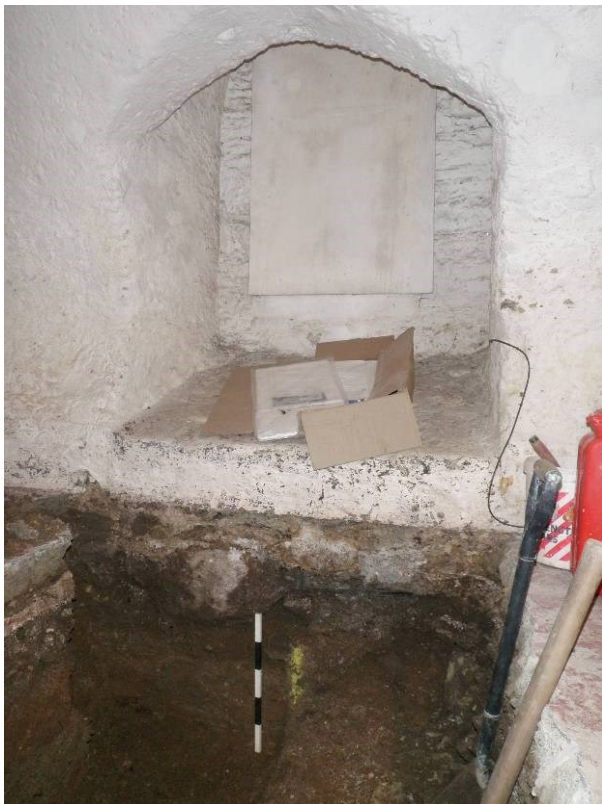
*Fig 39 A small arched doorway in the E wall of the undercroft has been inserted through to a partially infilled recess, the internal jambs of the original recess can be seen to extend below the ledge of the lower infill walling by 0.8m. The inserted external opening had a new arched head added post-1878*

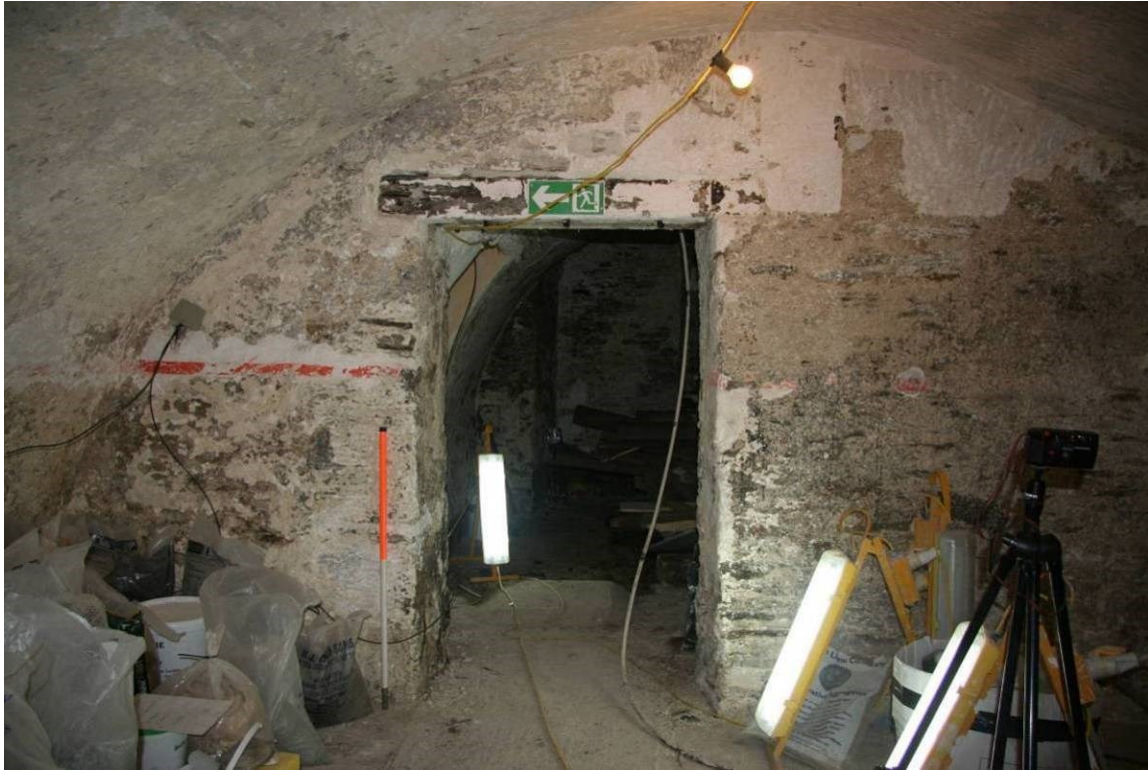
*Fig 40 This internal doorway linking the two parts of the undercroft was altered to suit raised floor levels, by being widened (to the RH side) and a lintel inserted higher up. The original doorway set at a lower level was probably arched*

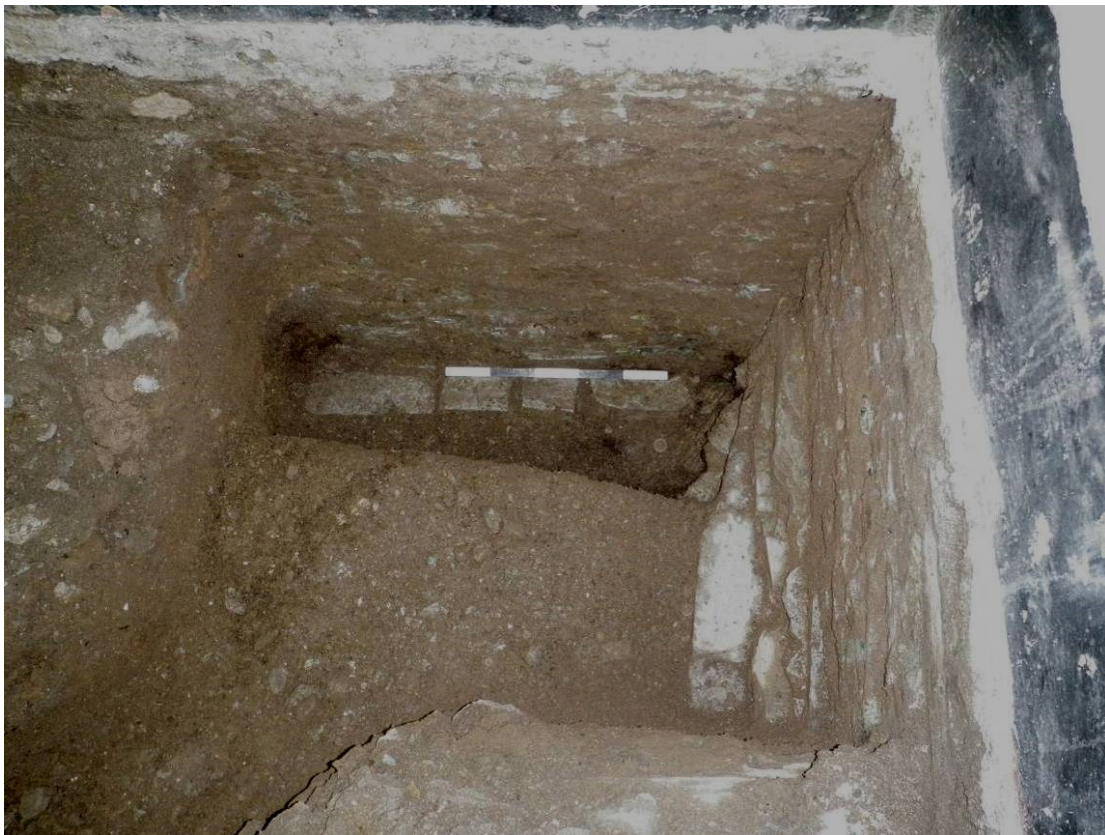
*Fig 41 Excavation in the SW corner of the undercroft clearly reveals the foundation level of the Great Hall gable (centre), wall (26). The Convocation Hall foundations (27) (right) abut this wall and are set at a higher level*

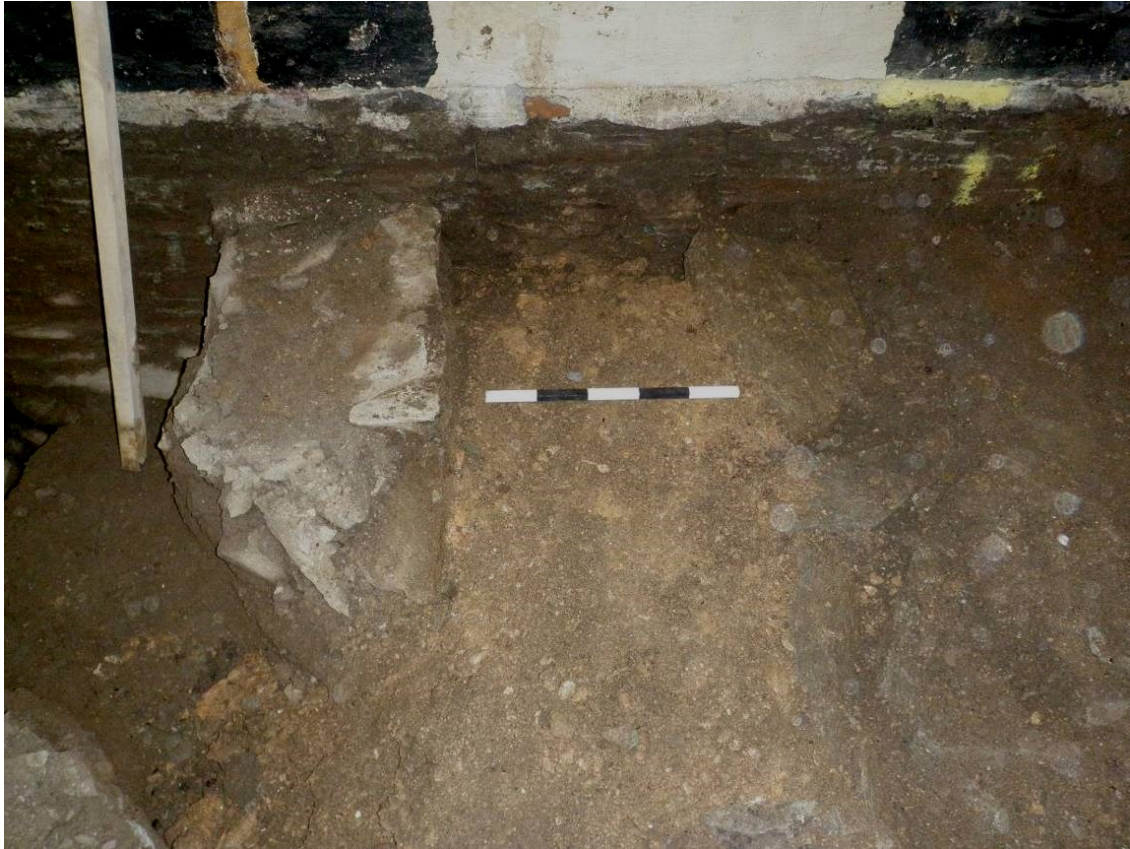
*Fig 42 Part of an infilled drain [6] revealed within the kitchen*

There has also been at least a metre of build up of material over the medieval ground surface. Within the base of the southern end of the wall is a narrow recessed area of masonry. Although this feature superficially resembles a tall doorway it has no lintel and is in fact a built recess, with sloped masonry above. It has been pierced at lower level to create a drain, and the area subsequently patched with crude brickwork. It is likely that the drain opening relates to a short length of stone-sided drain [6] found beneath the floor inside.

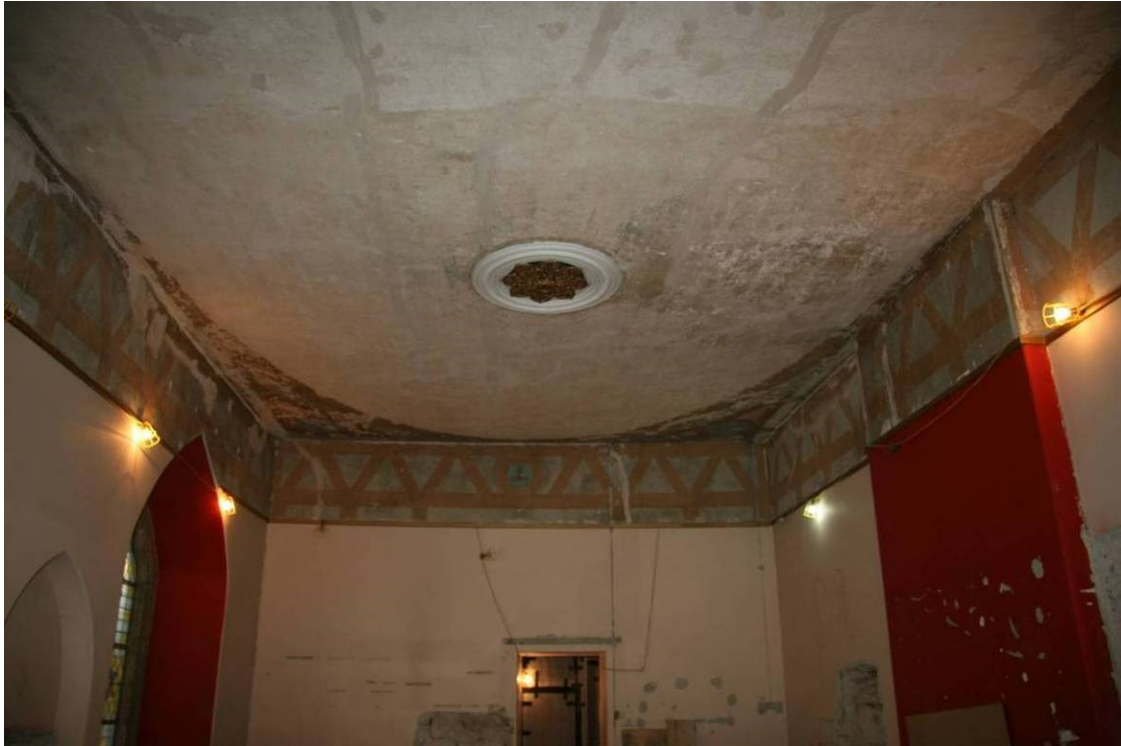
*Fig 44 The S end of the principal room, which was formerly used as a Masonic Lodge  
The extent of the painted frieze and ceiling was revealed after removal of modern finishes*

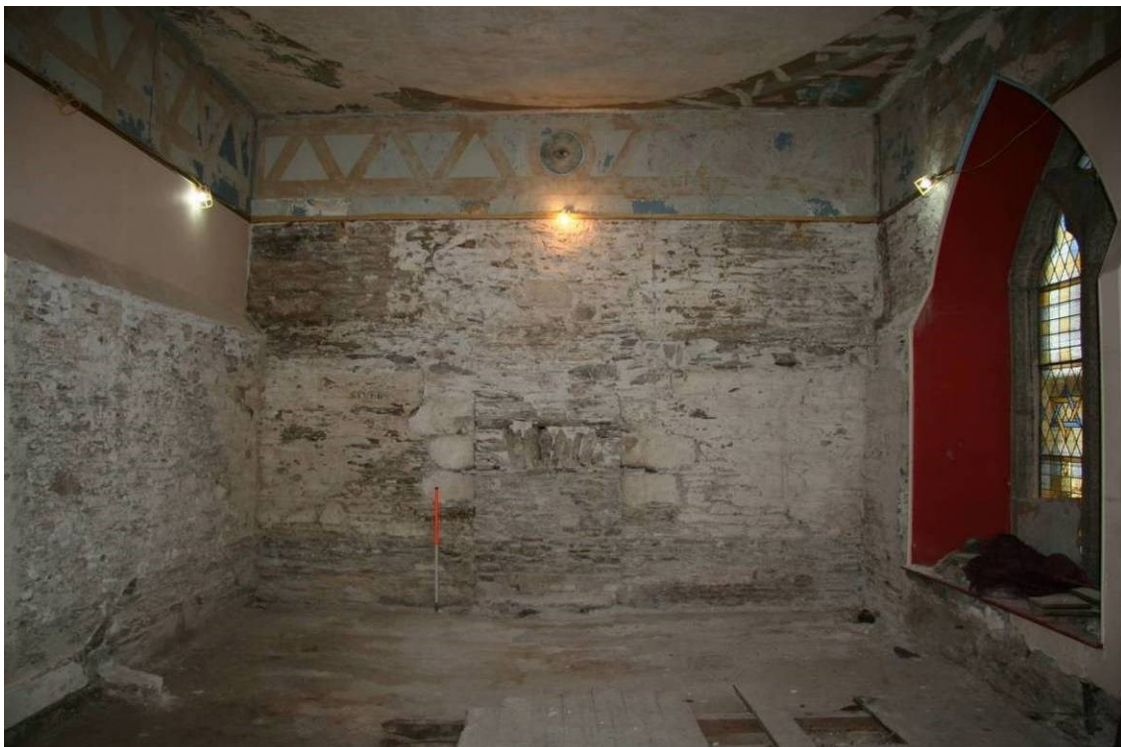
*Fig 45 Removal of plaster at the north end of the same room has revealed the stone  
jambs of the original window, subsequently deepened to convert the opening to a  
fireplace*

*Ledges in the side walls surviving at this end of the room are evidence of the original upper floor. Walling above the blocked central window has been removed and rebuilt to accommodate a flue ( what phase?)*

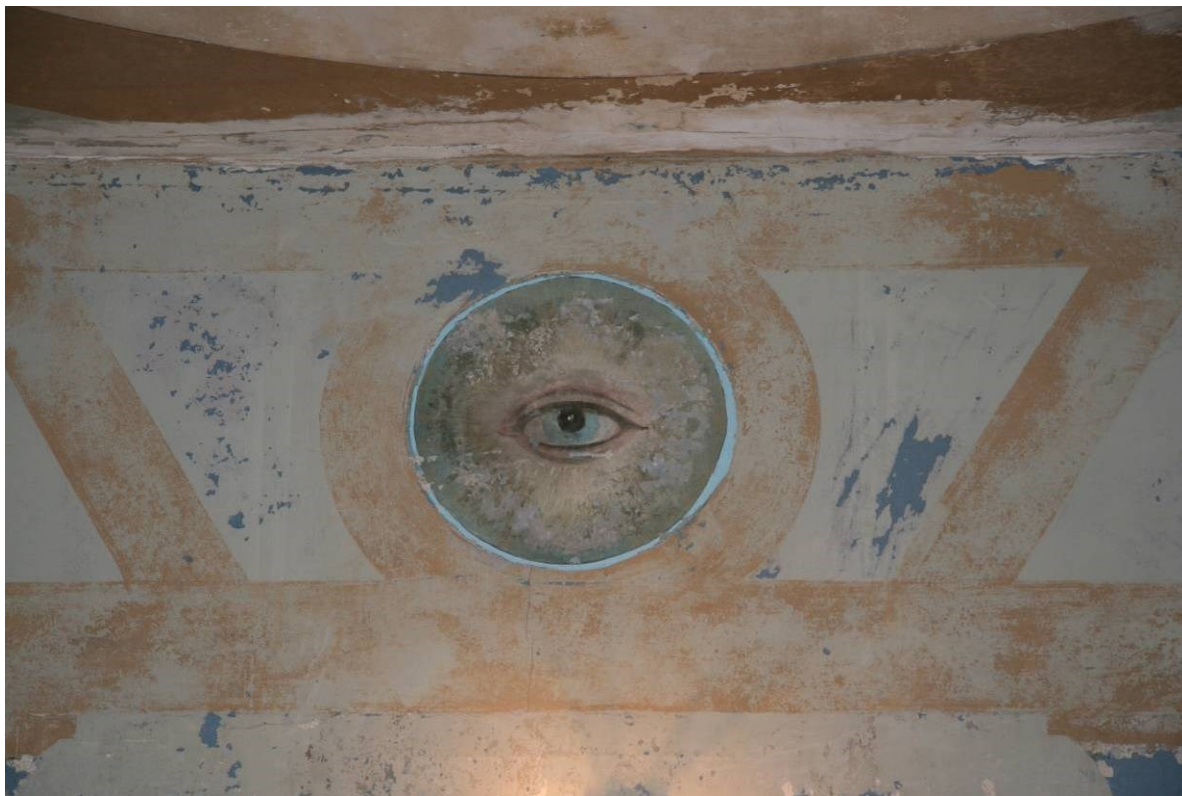
*Fig 46 A Masonic 'all-seeing eye' painted on the N wall of the principal room*

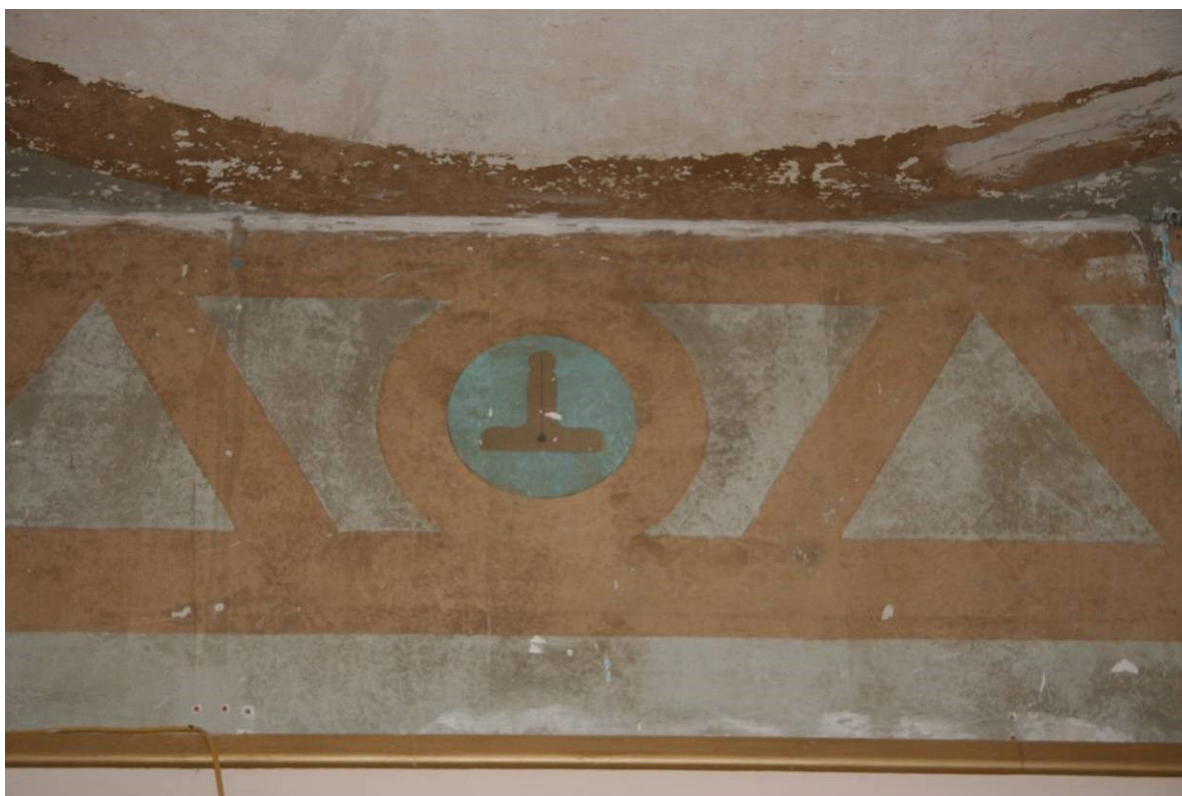
*Fig 47 Masonic symbol within the frieze at the S end of the room*
