# **The Duchy Palace, Lostwithiel, Cornwall**

## **Historic building record and archaeological watching brief**

<b>Client</b>	<b>Cornwall Buildings Preservation Trust</b>
<b>Report Number</b>	<b>2012R060</b>
<b>Date</b>	<b>May 2013</b>
<b>Status</b>	<b>Final</b>
<b>Report author(s)</b>	<b>Jo Sturgess and Nigel Thomas</b>
<b>Checked by</b>	<b>Jacky Nowakowski</b>
<b>Approved by</b>

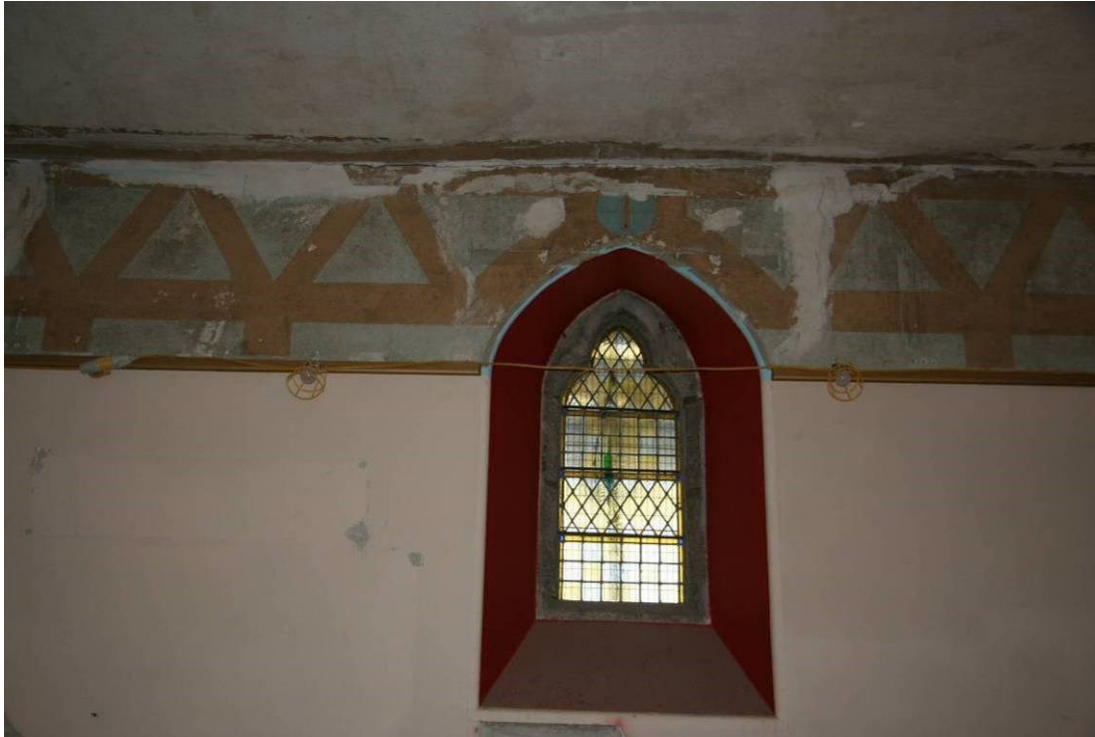
*Fig 48 A cusp-headed window was added during the time of the Duchy ownership in the mid 19<sup>th</sup> century*

*Addition of this window required removal of a partition between two room spaces. A new partition slightly to the N was built to replace it. Note also how the Masonic decoration scheme has incorporated this window by addition of a symbol above it*

Above the remaining slit window is another inserted granite framed and cusp headed window. This has jambs constructed of a mix of granite and Pentewan stones, and a shallow granite sill beneath. As the 1850s Duchy conversion plan shows an interior partition wall central to the main room space, this window does not appear to be part of that design. Evidence inside the room indicates the partition was an addition and was later removed and replaced by another wall c2m further north. The window is shown in 1860s/70s photographs (Figs 8 and 9), so clearly this interior alteration had occurred before then.

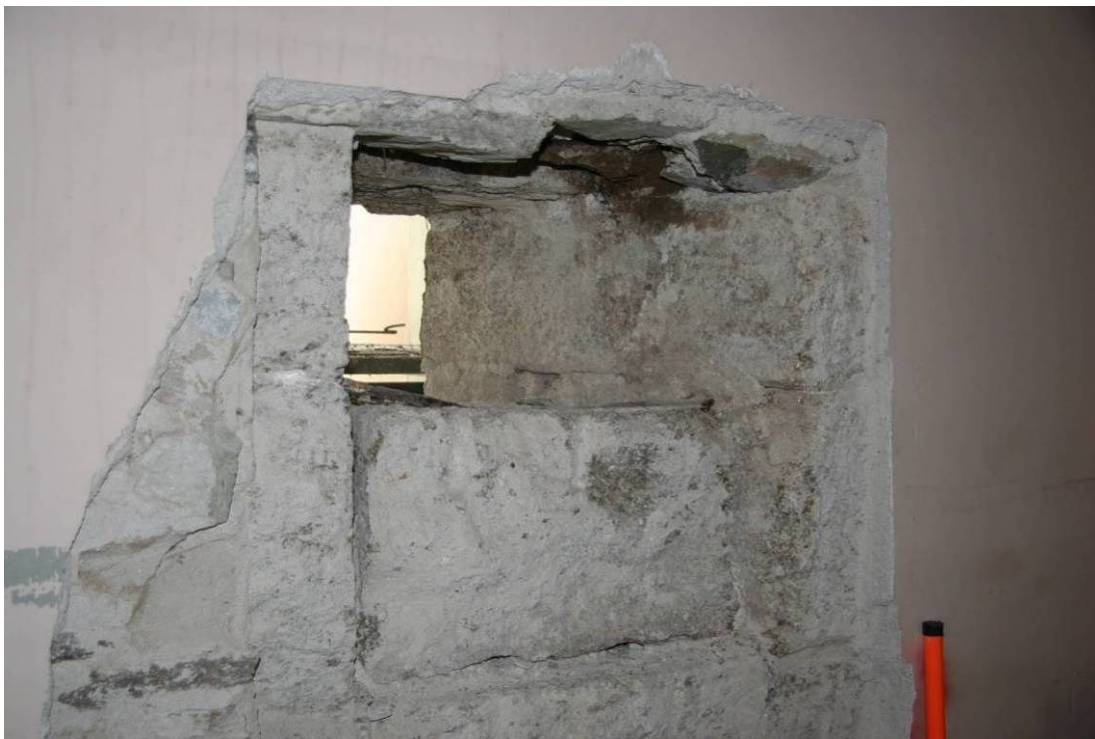
*Fig 49 An original slit window near the SW corner of the principal room*

*This was later infilled with wedge-shaped granite blocks retained in place with leaded iron straps*

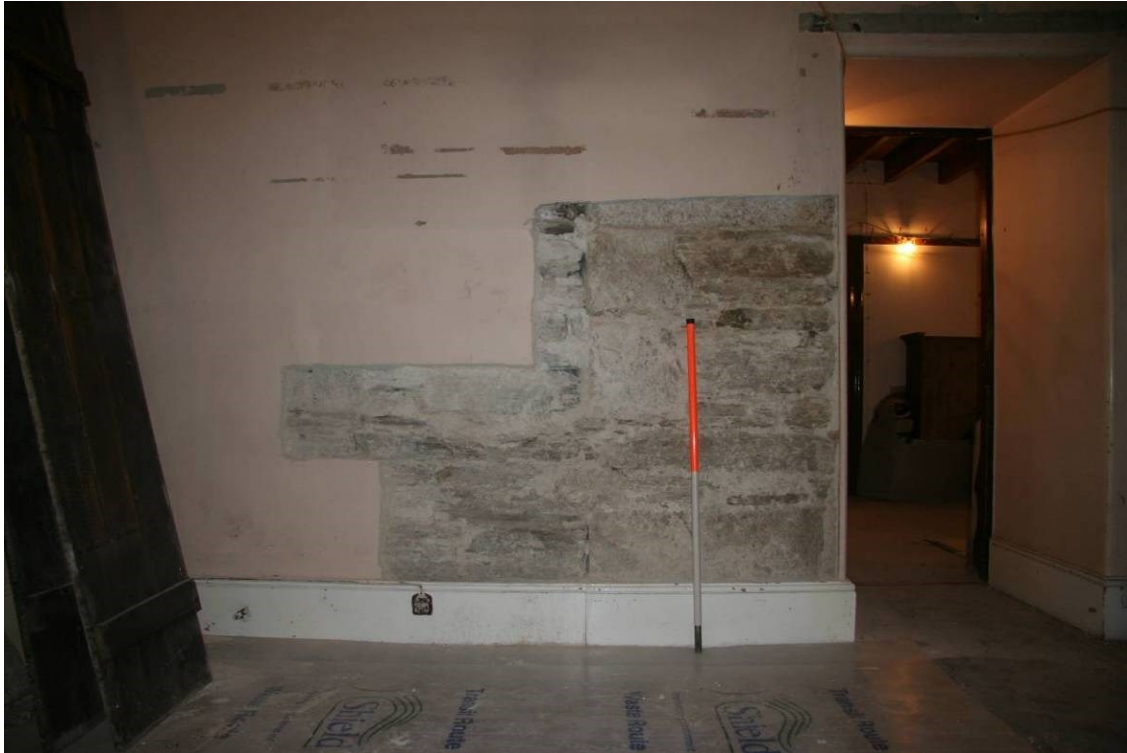
*Fig 50 The right-hand jamb and base of a slit window in the S wall of the principal room  
This window, plus another higher up, are evidence that the space beyond was originally unroofed. The present roof structure was added after 1620, according to tree-ring analysis (Tyers 2010)*

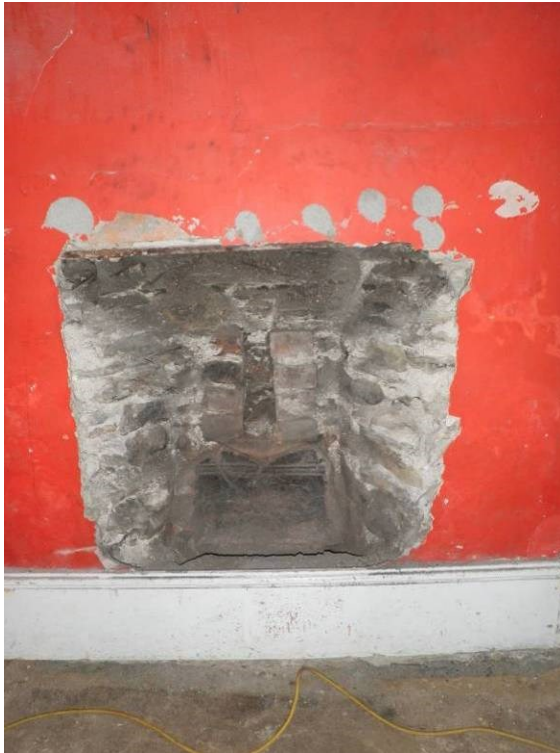
*Fig 52 The original lateral hearth, since infilled with a Victorian fireplace*

Although the chimney now breaks forward of the walls beside it, this is a result of the wall faces in this room having been cut back at the time of removal of the upper floor. The purpose of this extensive work is not entirely clear, but may be associated with removal of prison cell structures that were likely to have existed here

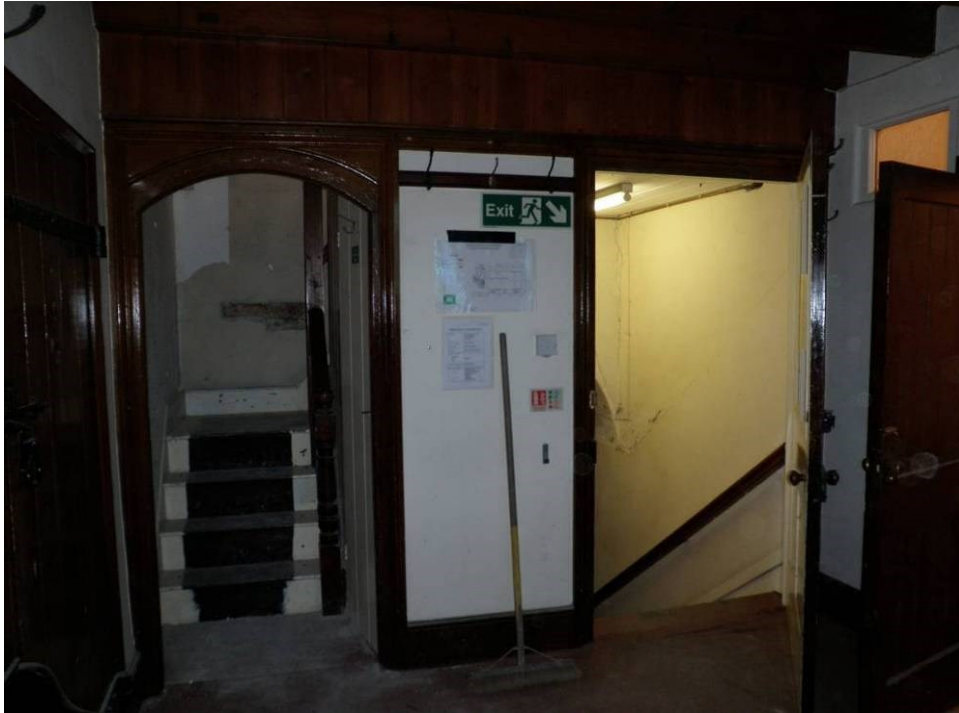
*Fig 53 Stairways from the Anteroom to the porch and upper room*

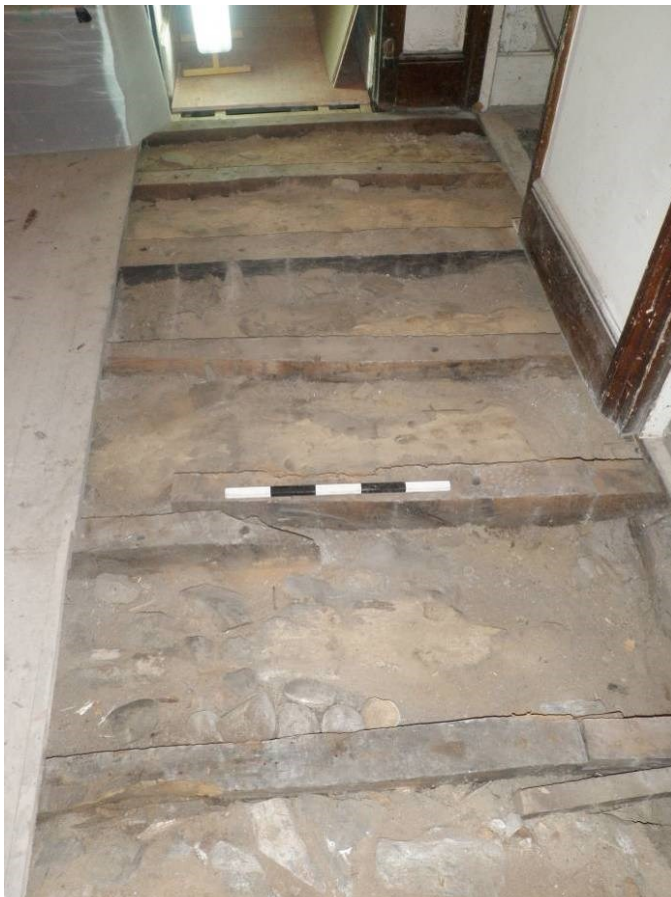
*Fig 54 Remains of cobbled flooring revealed beneath the timber floor in the anteroom (former courtyard)*

This is further strong evidence of this space formerly being unroofed, forming a small raised entrance courtyard built above a vault. The inserted timber joists are reused purlins, most likely put here after the roof structure was remodelled in the 1850s

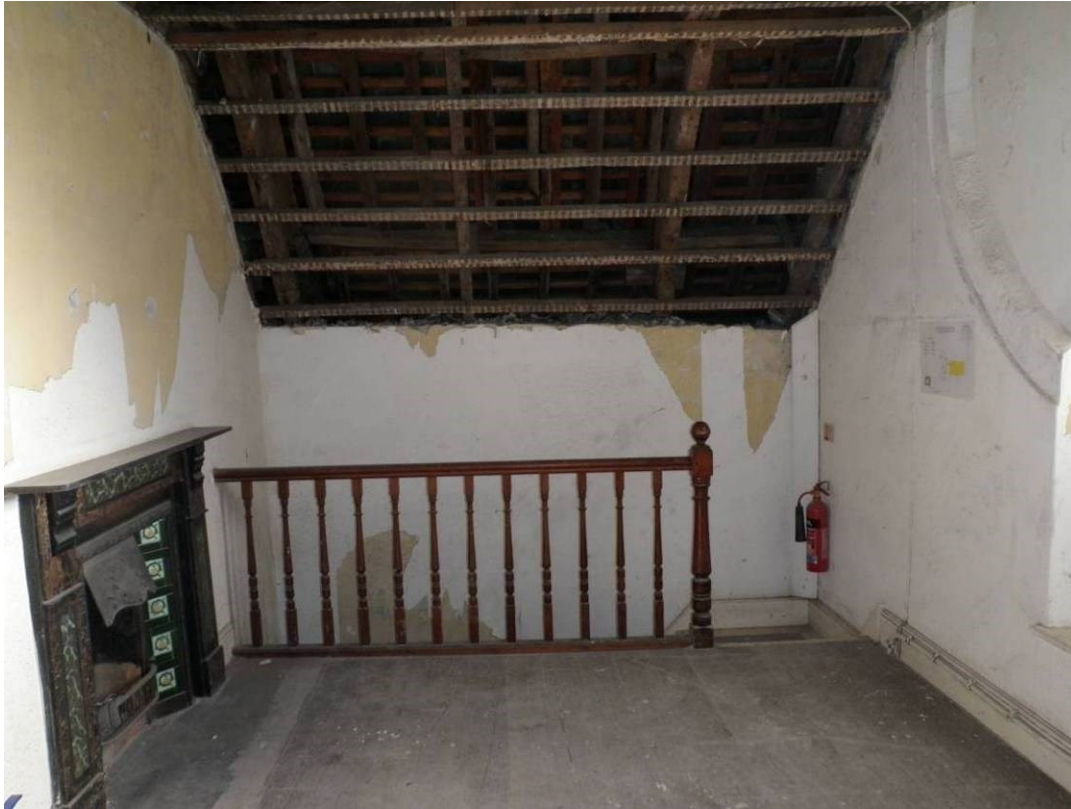
*Fig 55 The upper floor room, showing a late 19<sup>th</sup> century fireplace feeding into a flue cut into the face of the cross wall*

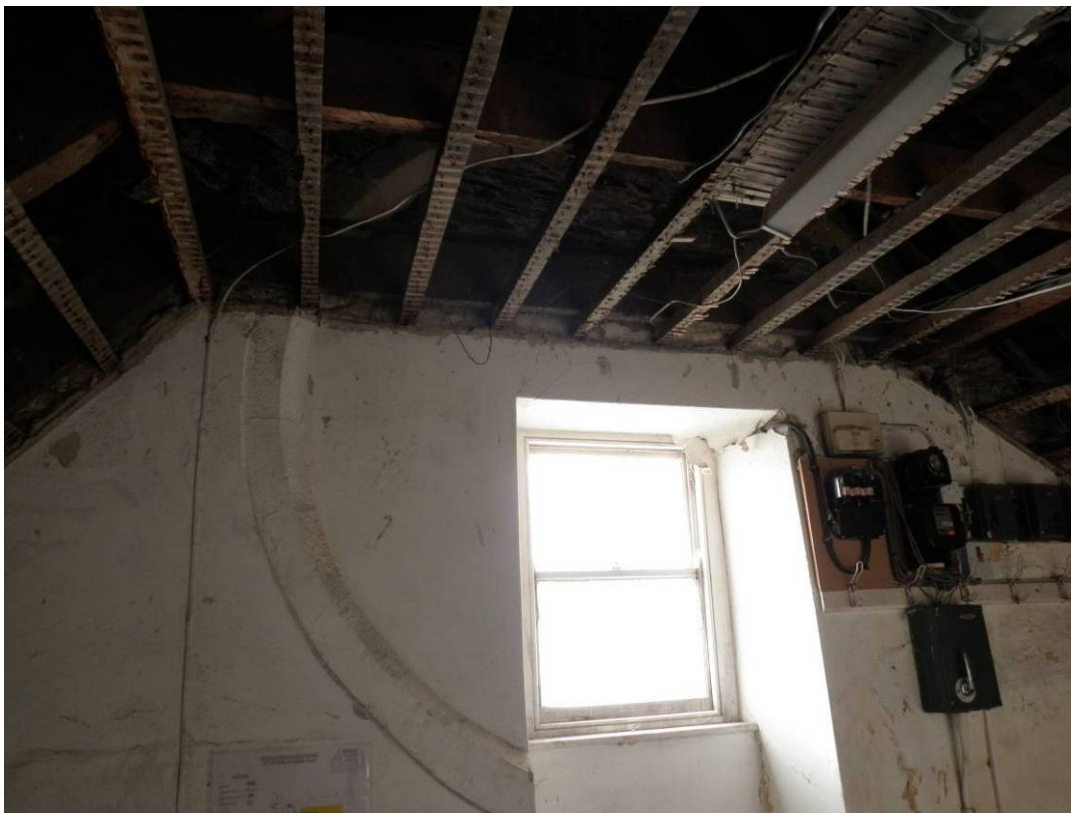
*Fig 56 Before the renovation work commenced only part of the lower arc of the Great Hall rose window could be seen within the upper floor room*

*The wooden window is a late 19<sup>th</sup> century insertion*

The reveal of the rose window can be seen clearly in mid 19<sup>th</sup> century photographs of the building (see Fig 8). The reveal is shown infilled with slate masonry and with a small stone framed window incorporated in the blocking. This window was replaced by a slightly larger wooden framed example in the later 19<sup>th</sup> century. The remains of the medieval rose window itself can be seen from inside the building (see section 8.3.3 and Figs 56-58).

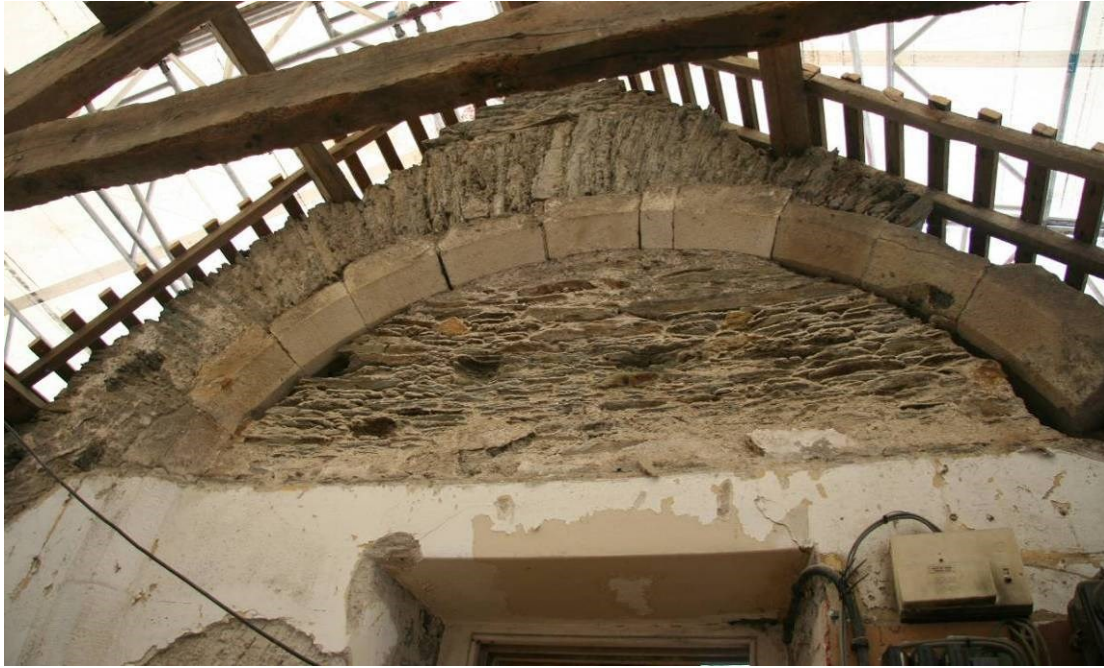
*Fig 57 The upper arc of the Great Hall rose window, shown after temporary removal of the roof during 2012*

*The blocking of the window is likely to date to the 1620s when the present roof was added and dormers incorporated above the east wall. Note the way the gable has been reduced, particularly to the right where the slate surround to the dressed Pentewan masonry has been removed. Truncation of the gable is likely to have occurred when a new prison building was constructed to the south in the 18<sup>th</sup> century*

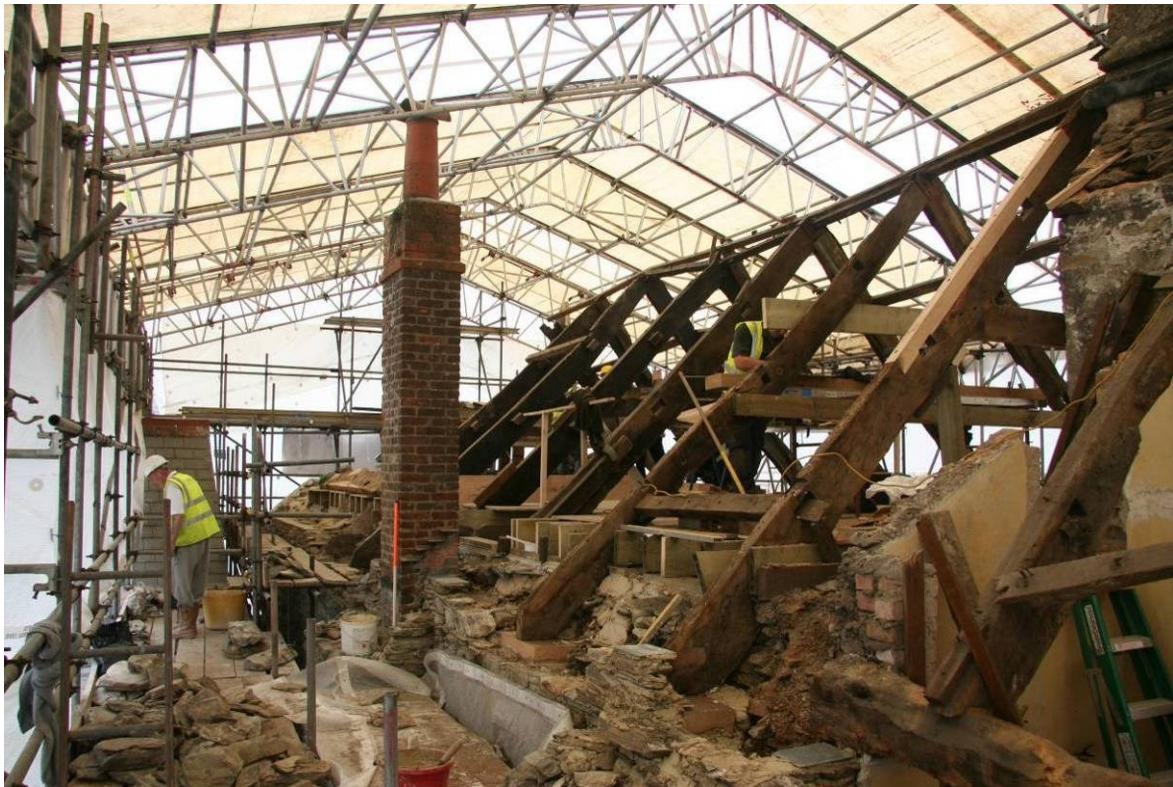
*Fig 59 Roof timber repair work in 2012, viewed from the SW*

*The brick chimney is a mid-19<sup>th</sup> century addition to the original medieval flue*

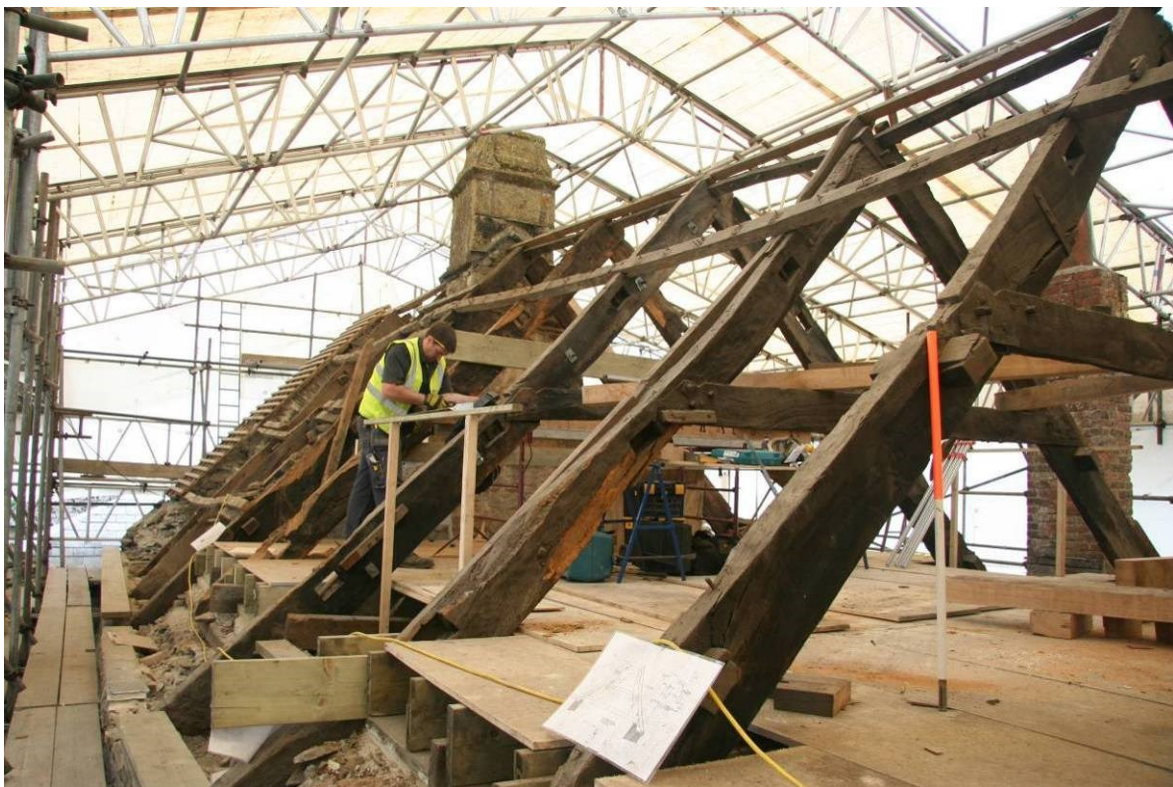
*Fig 60 Roof repair work in 2012, viewed from the NE*

*Note the sockets for former threaded purlins; the roof timberwork appears to have been mostly reassembled in the mid 19<sup>th</sup> century when the wall plates were rebuilt and a hipped roof alteration made at the north end*

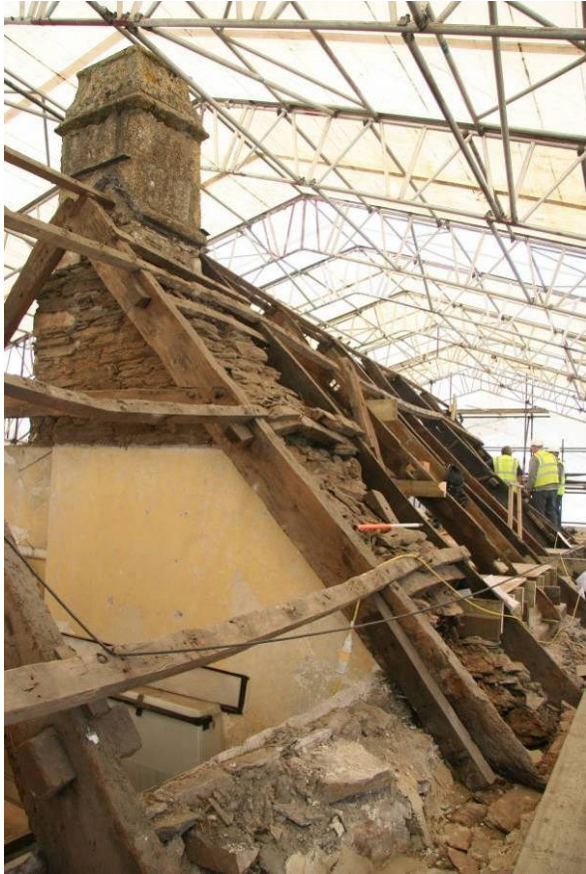
*Fig 61 The cross wall is the only location where threaded purlins remain*

*The wall in the lower foreground was raised when this area was roofed over in the 17<sup>th</sup> century*

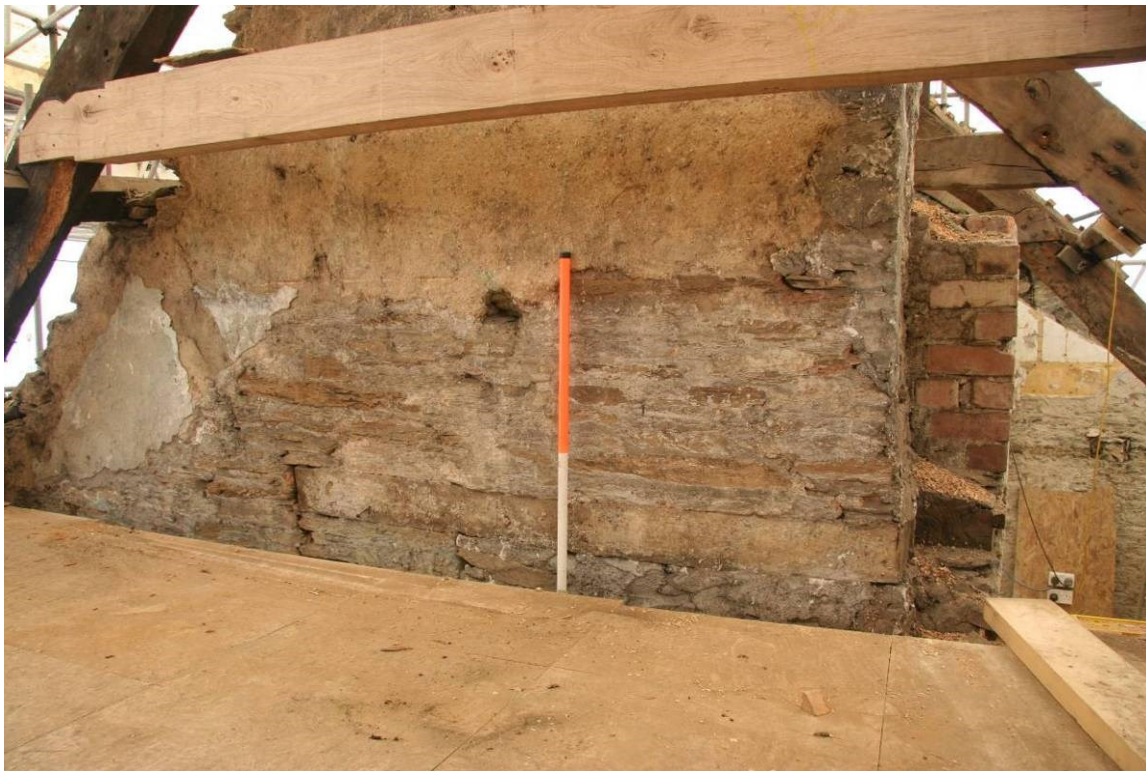
*Fig 62 Early plaster survives on the north side of the cross wall; note also the wooden lintels of a former window*

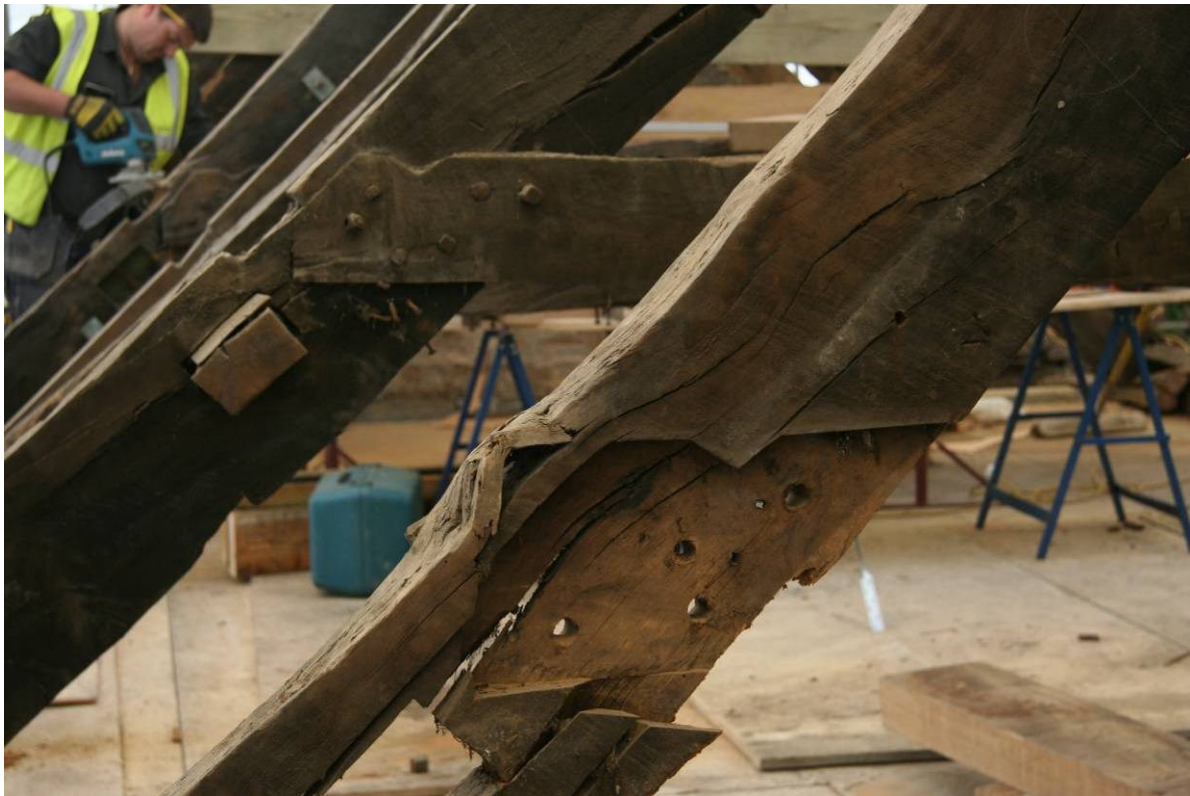
*Fig 63 Example of a pegged collar joint on the 17<sup>th</sup> century roof*

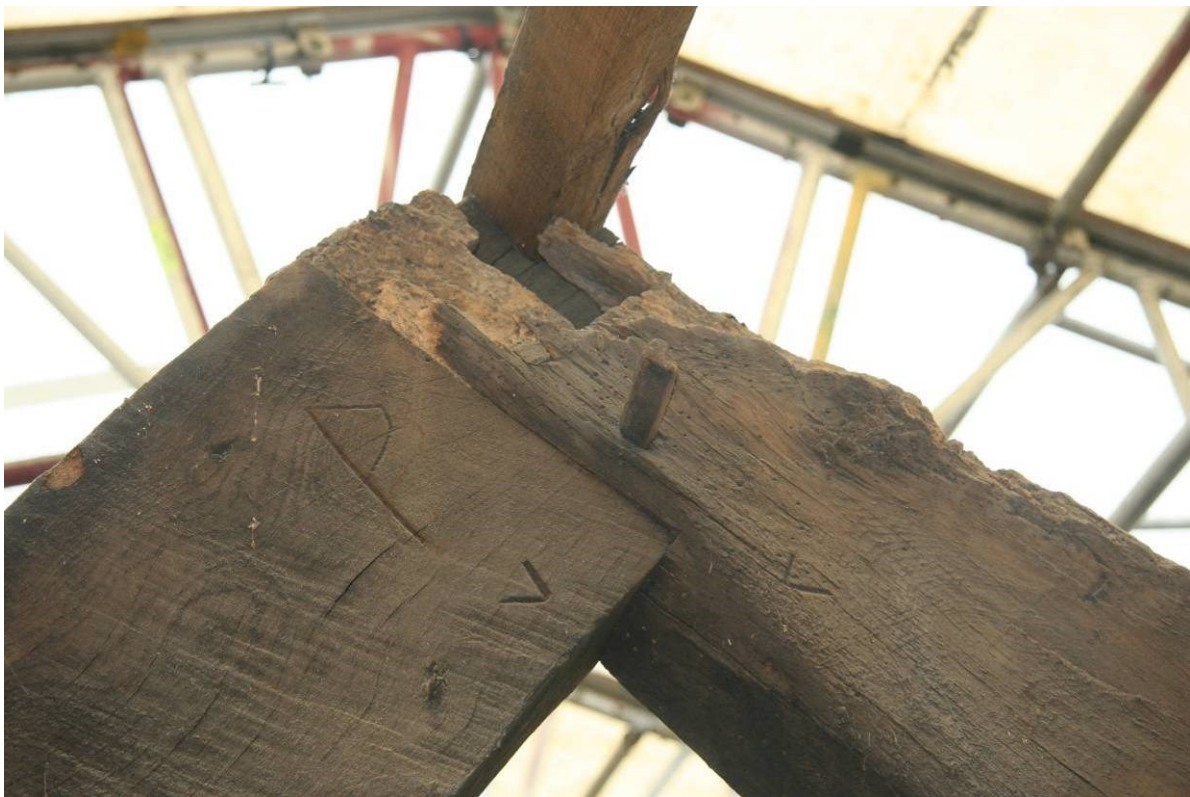
*Fig 64 Example of a pegged apex joint on the 17<sup>th</sup> century roof  
Carpenters marks are also clearly visible*

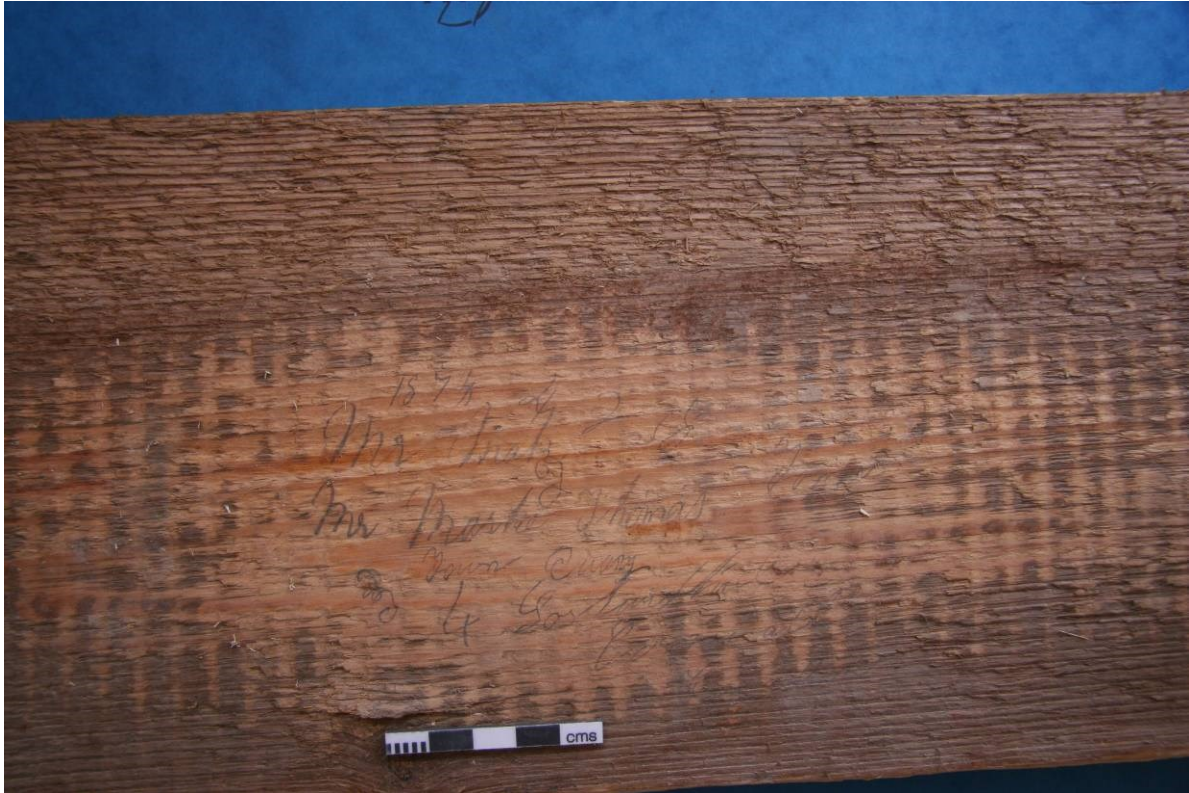
*Fig 65 Mark Thomas's name on a floorboard from the principal room dated 1874*

- Dump of later 19<sup>th</sup> century stoneware ink bottles in garden to west (Figs 66 and 67)
- Repair of wooden floor close to the windows in the principal room (dated 1874; see Fig 65)

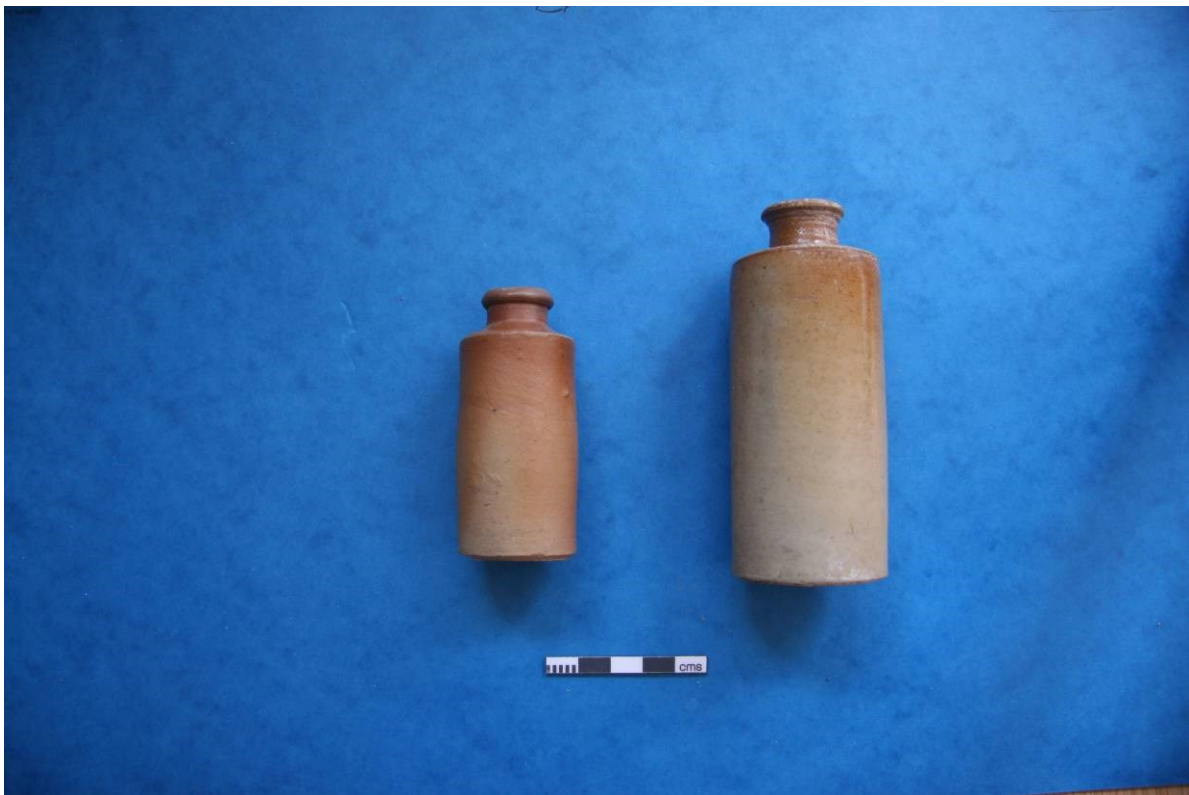
*Fig 66 Unstratified late 19<sup>th</sup> century stoneware ink bottles from the rear yard of 1 Fore Street*

Many late 19<sup>th</sup> and 20<sup>th</sup> century finds were recovered from the rear yard but unfortunately they were all unstratified so a selection were retained (Figs 66 and 67).

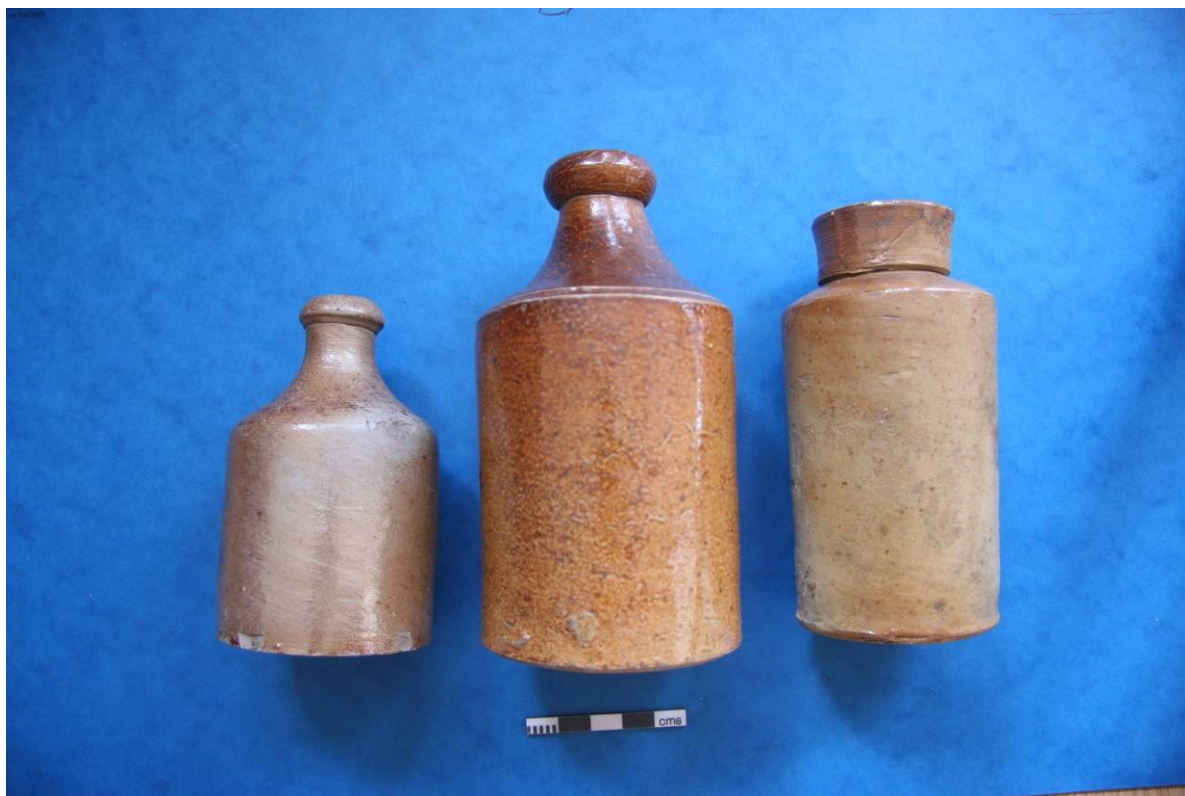
*Fig 67 Unstratified late 19<sup>th</sup> century stoneware ink bottles from the rear yard of 1 Fore Street*

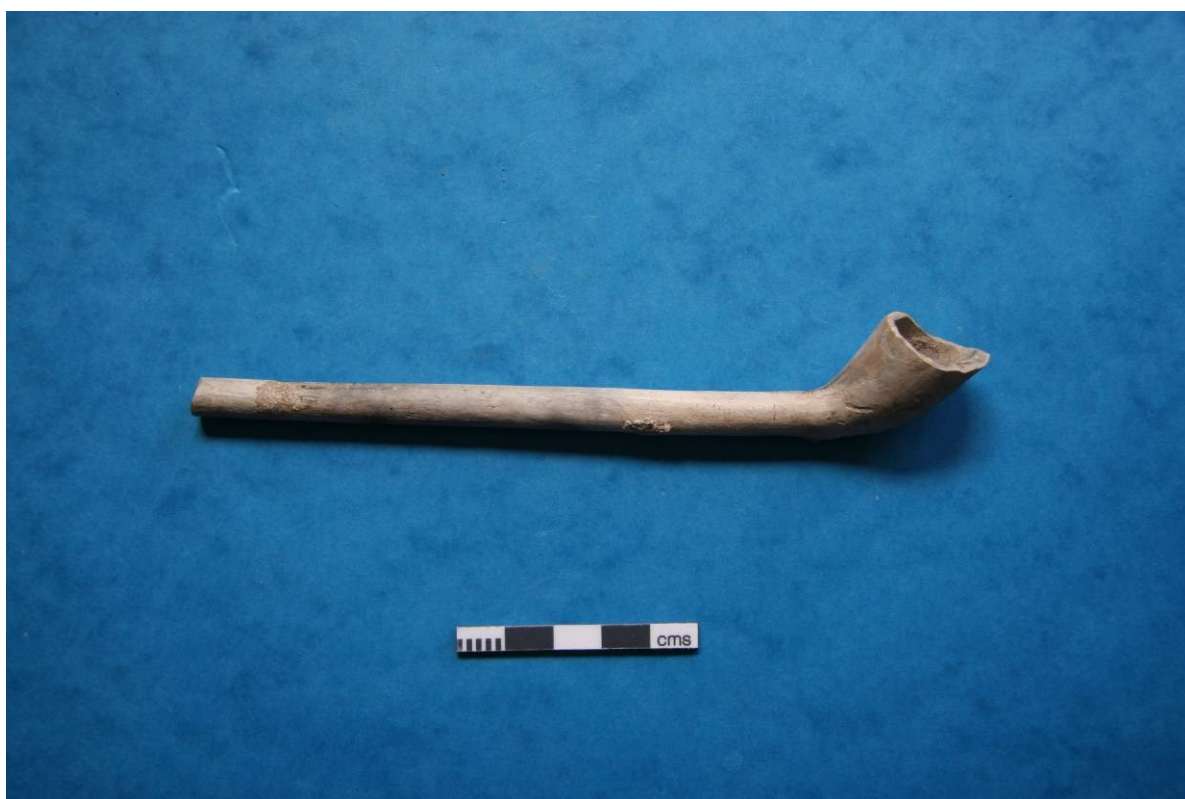
*Fig 68 17<sup>th</sup> century clay pipe stem and bowl from layer (3) beneath the floor of the kitchen in the undercroft*

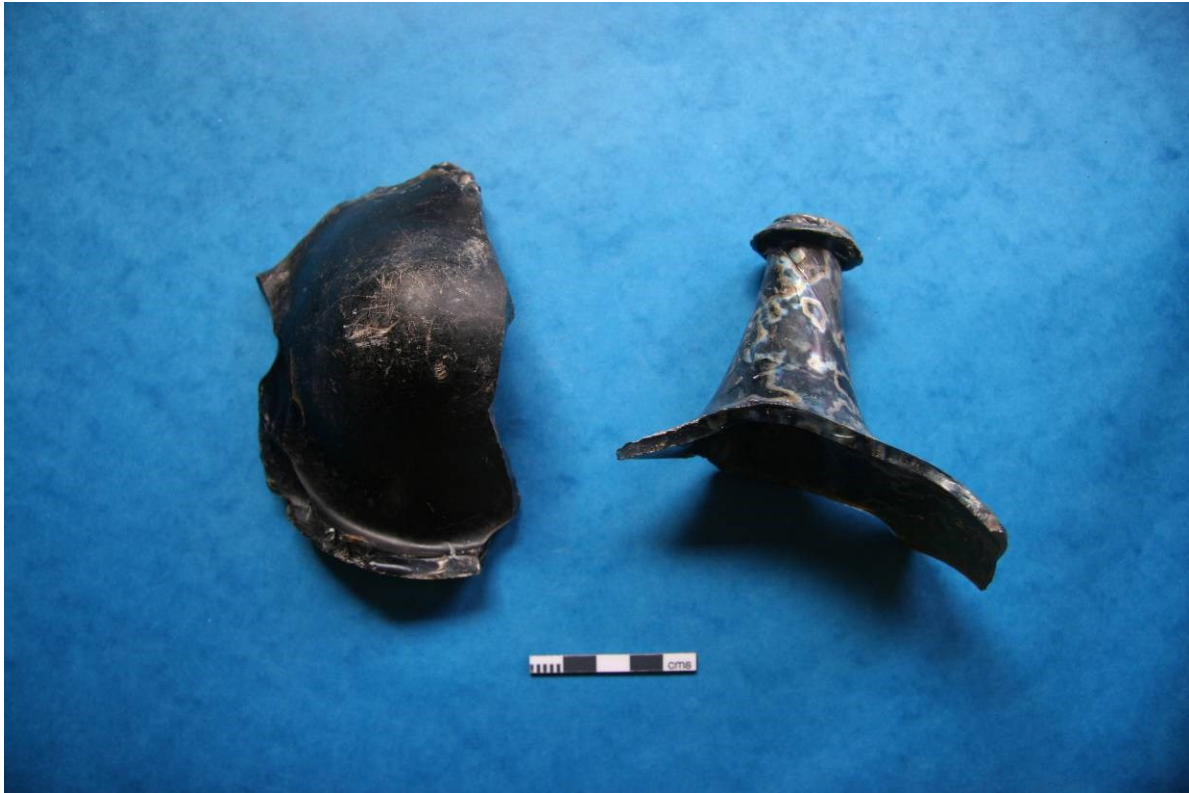
*Fig 69 17<sup>th</sup> to 18<sup>th</sup> century onion bottle fragments from layer (3) beneath the floor of the kitchen in the undercroft*

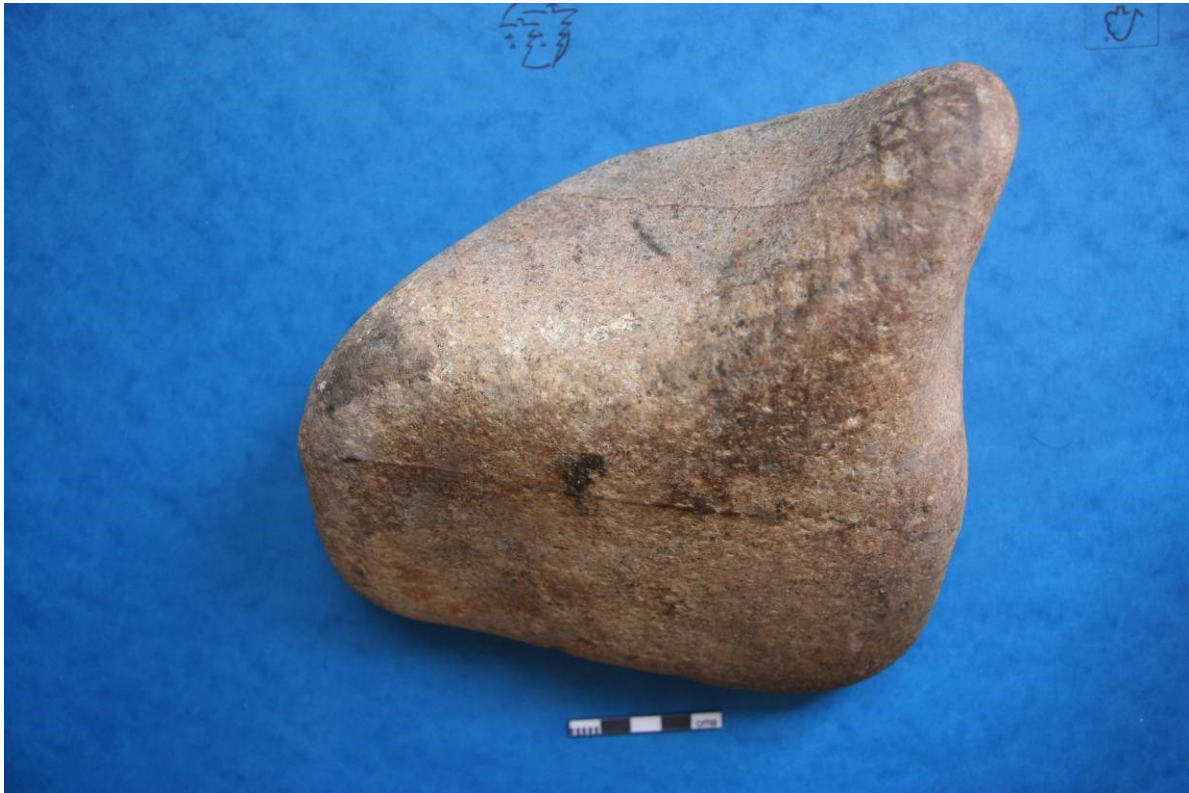
*Fig 70 Painted (cross design) river pebble reused in walling at the top of the southern part of the west wall*

the Masonic conversion after 1878. Earlier there had been a mullioned window in a blocking of the original entrance archway in the east wall. Loss of a window on this side would have necessitated construction of another to light the antechamber. It appears likely therefore that the window was simply moved from the east wall to the west. The upper part of the walling in this section abuts both the Great Hall gable and the Convocation Hall; this heightening is associated with the 1620s re-roofing. A large river worn stone bearing a painted(?) pattern has been incorporated into the top of the wall (Fig 70).

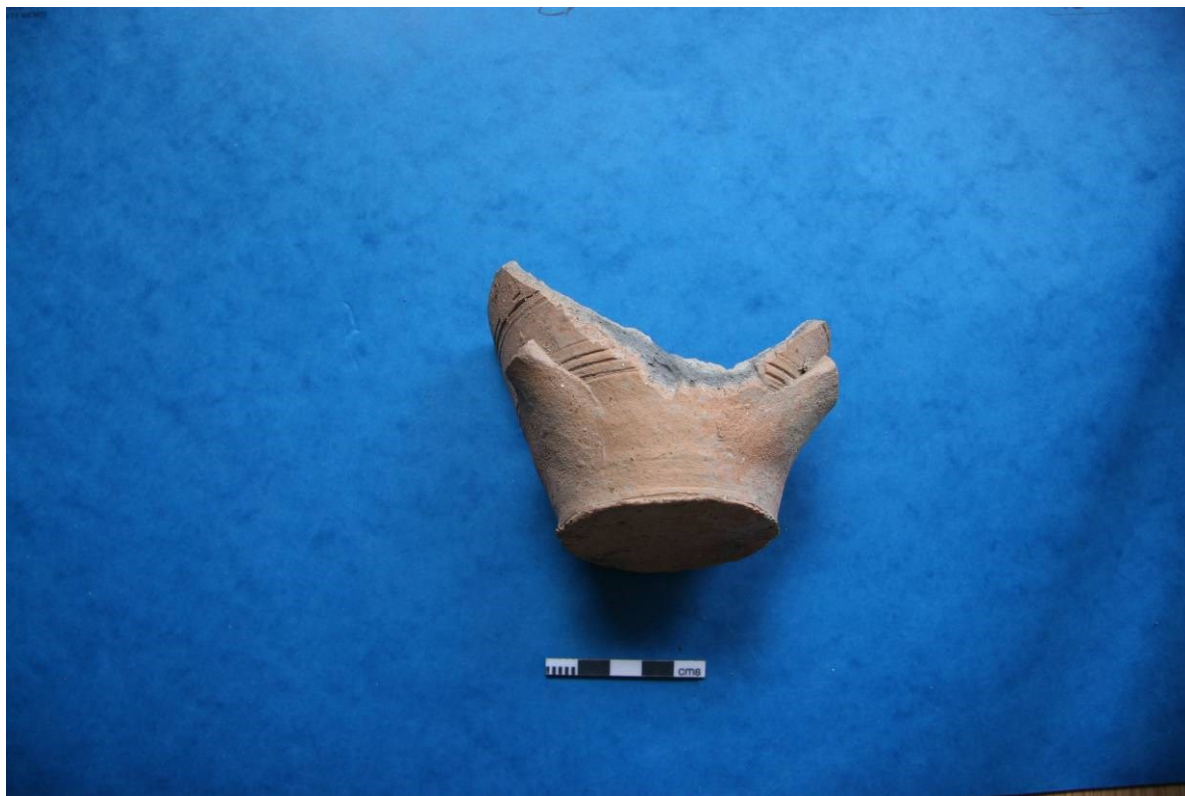
*Fig 71 15<sup>th</sup> to 16<sup>th</sup> century three handled mug or tyg from layer (3) beneath the floor of the kitchen in the undercroft*

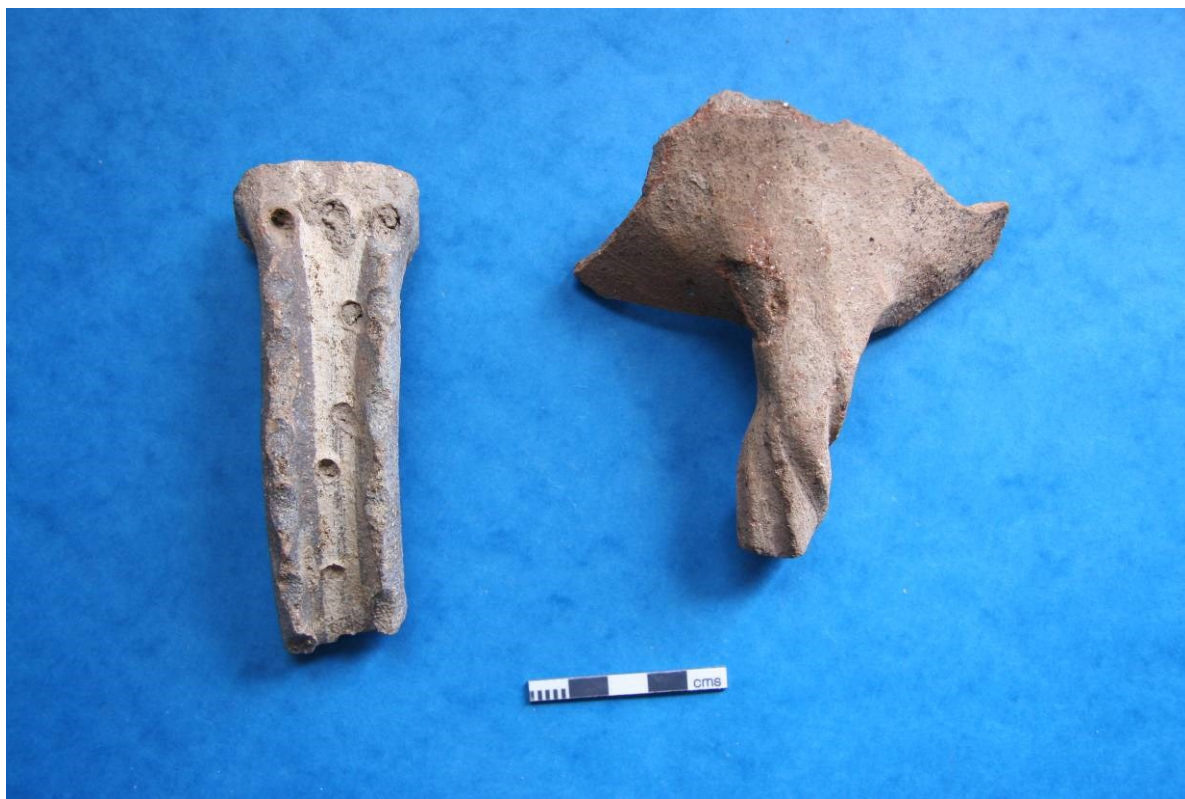
*Fig 72 Two 15<sup>th</sup> to early 16<sup>th</sup> century decorated pottery handles from layer (24) beneath the floor of the kitchen in the undercroft*

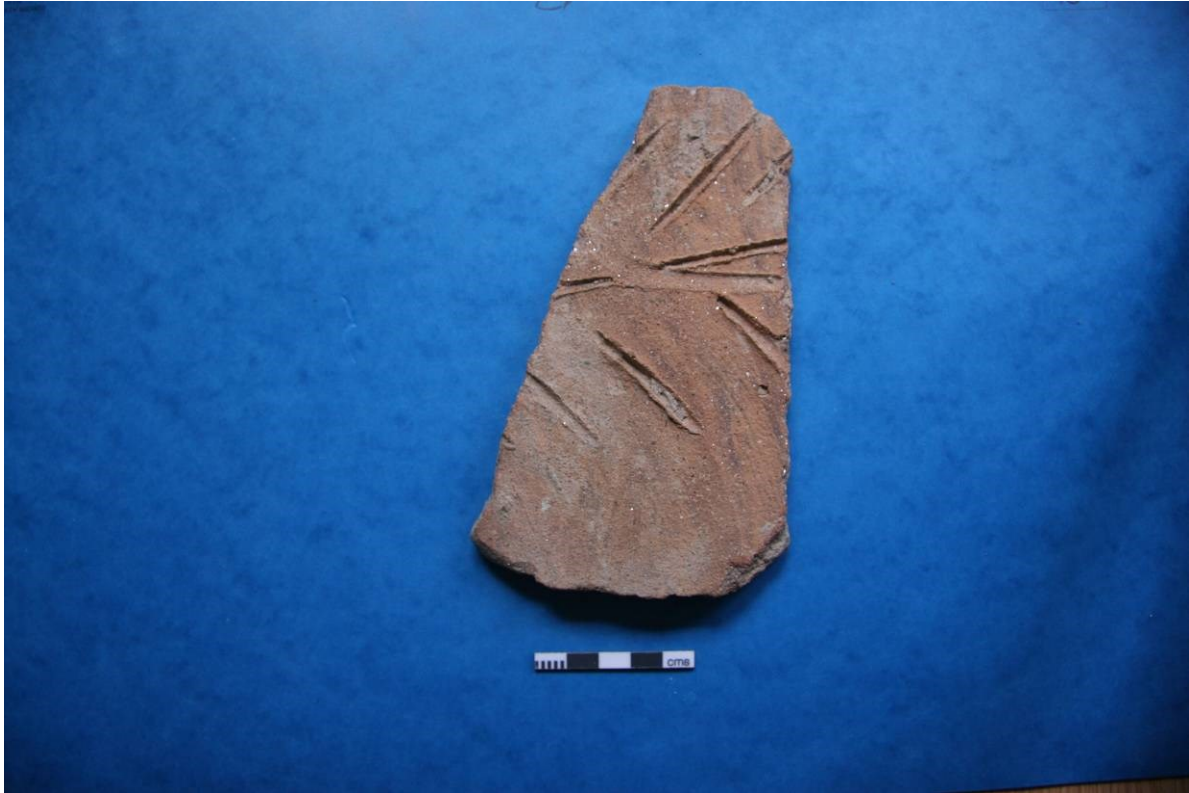
*Fig 73 Decorated face of 15<sup>th</sup> or 16<sup>th</sup> century ridge tile from layer (24) beneath the floor of the kitchen in the undercroft*
