An Archaeological Survey of
Rectory Wood and Field,
Church Stretton,
Shropshire

Archaeology Service Report Number 235
© Shropshire County Council
December 2004

A Report for
The Rectory Wood and Field Interest Group

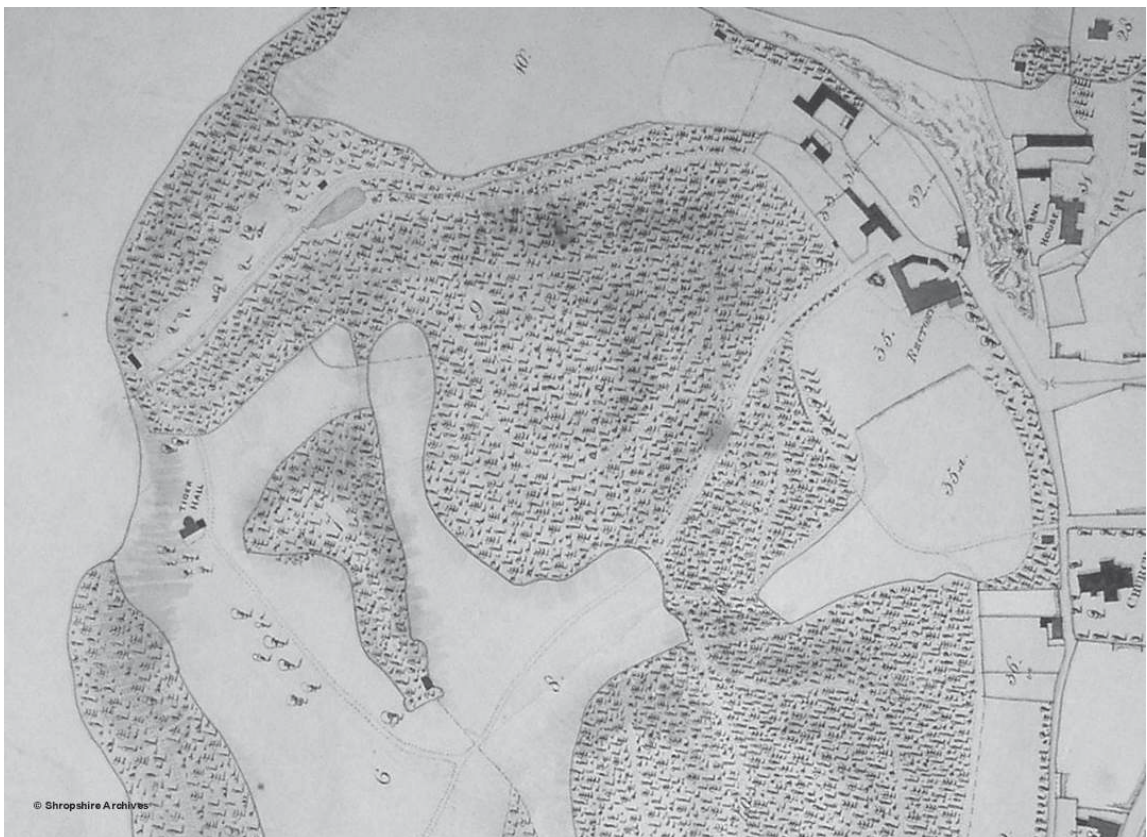
Figure 3: Extract from 1834 map showing the study area (SA P67/F/1/1)

Site 39 SO 44885 93670 Building (site of). A small building is shown in Rectory Field on an 1834 plan of Pemberton's estate (SA P67/F/1/1), possibly the temple building shown on a sketch of 1824 (SA 6009/272). No trace of this building survives above ground.

The 1767 plan however does appear to show most of the Rectory Wood area as open ground, and it is likely that Mainwairing had not yet begun planting his specimen trees. Just 50 years later however, the woodland on the estate was extensive and mature: a sketch of 1824 shows a temple building set on the edge of mature woodland, and the extent of this woodland is shown on the 1834 plan.

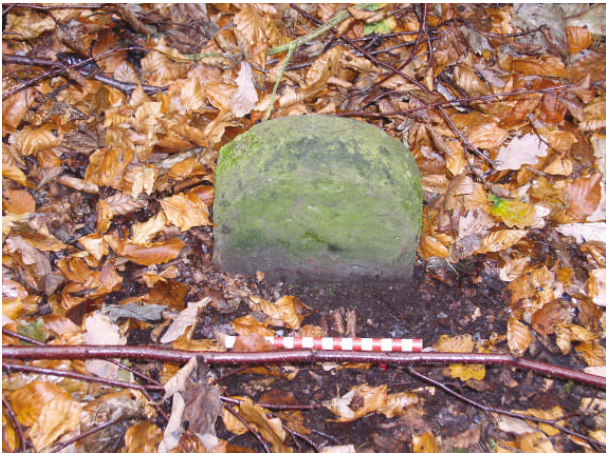
Site 1: boundary stone

Site 1 SO 44867 93823 Boundary stone. A boundary stone on the western boundary of Rectory Wood. The stone is plain and of grey sandstone, with a rounded top. The stone is 17cms wide by 8cms thick and stands 21cms above the ground surface. An inscribed character - a G or 6 – is discernible on the face of the stone. Condition: Good

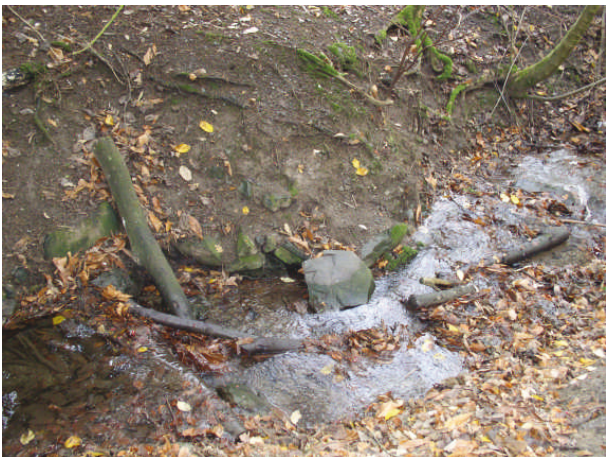
Site 6: footbridge abutment in the Townbrook

- Site 6** SO 44950 93928 Footbridge (remains of). The eastern abutment of a footbridge shown on the OS 25" 2nd ed. survives in the side of the Townbrook stream. The abutment comprises a semicircular stone wall about 2.5m long by 1.5m wide, and survives to a height of 1.25m. The western abutment has been entirely removed. Condition: Poor

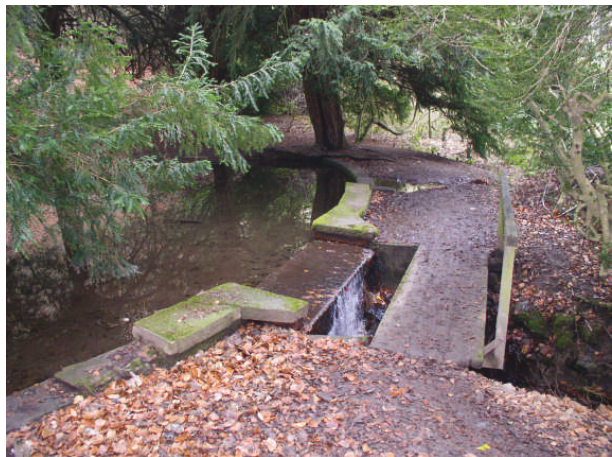
Sites 8 & 9: the pool dam and footbridge

- Sites 8** SO 44878 93934 Pool dam wall. A curved wall of red sandstone blocks has been built across the Town Brook to dam a pool (site 13). A single sandstone block has been detached from the northern end of the wall and now lies in the edge of the pool. The dam wall has a weir in its centre. The weir comprises a stone slab over a stone wall built onto a deposit of grey clay (which is probably the main component of the dam). The side walls of the weir are of brick. Condition: Fair

- Site 9** SO 44880 93939 Footbridge. A timber footbridge with a handrail crosses the Town Brook beside the dam wall (site 8). The footbridge rests on drystone wall abutments and is 4m long by 1m wide. Condition: Good

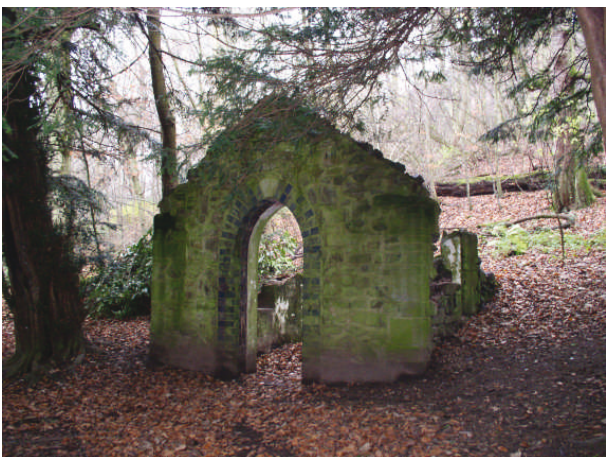
Site 10: the pumphouse

- Site 10** SO 44856 93942 Building. The remains of a former pump-house lie 6m to the northwest of the pool. The building is of stone rubble bonded in cement, with details of blue engineering brick. The roof has been removed, but the ends of iron pipes remain in the concrete floor. The building is approximately 4.5m long by 3.5m wide and stands to a height of 3m. Condition: Fair

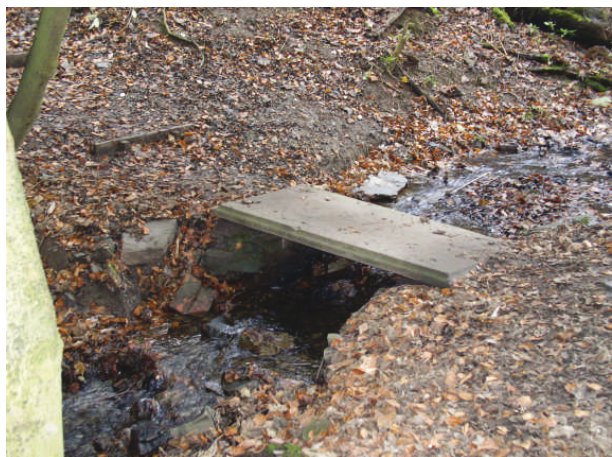
Site 17: footbridge

- Site 17** SO 44747 93855 Footbridge. A footbridge across the Town Brook in the northwestern corner of Rectory Wood. The bridge comprises a stone deck of a re-used grave slab, resting on drystone abutments. Condition: Good
