**BUILDING RECORDING OF  
THE CULROSS BUILDINGS  
KING'S CROSS CENTRAL  
LONDON BOROUGH OF  
CAMDEN**

**SITE CODE: KXG08**

**JANUARY 2010**

**Historic Building Recording of the Culross Buildings, King's Cross Central, London Borough of Camden**

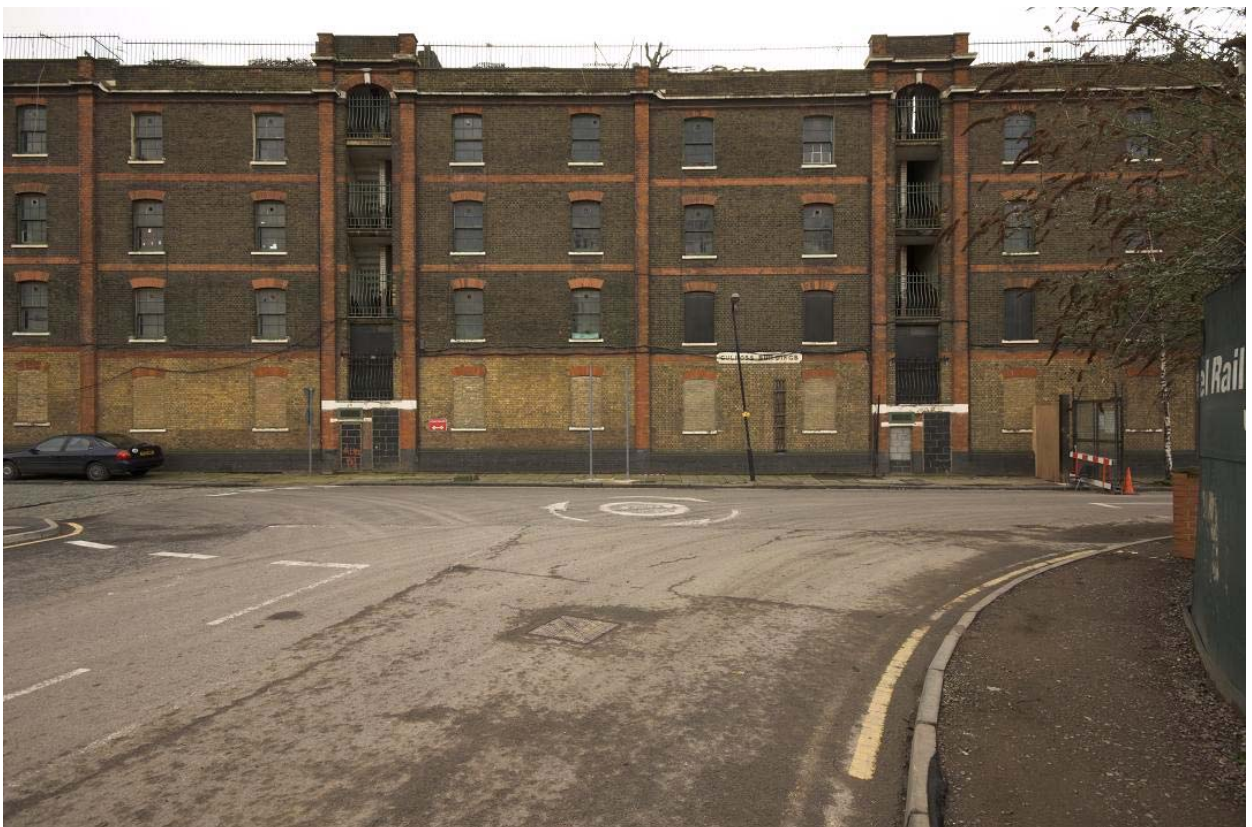
**Plate 1:** Front (north-west and south-west) elevations of the Culross Buildings with Culross Hall to the north-east (far left), Culross Building (left) and No. 41 Battle Bridge Road to the south-west (right)

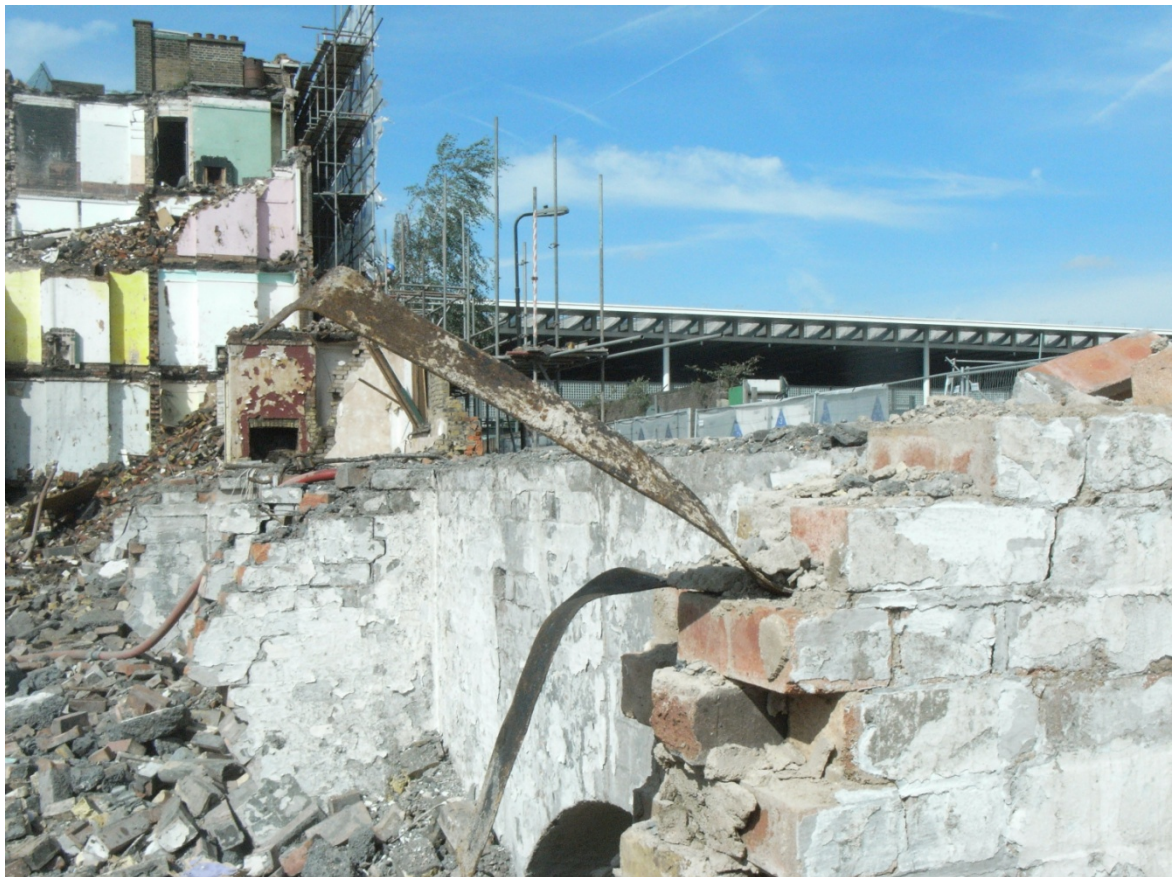
**Plate 6:** Hoop iron in a mortar joint within the brickwork of a basement dividing wall under the Culross Building, viewed from the east

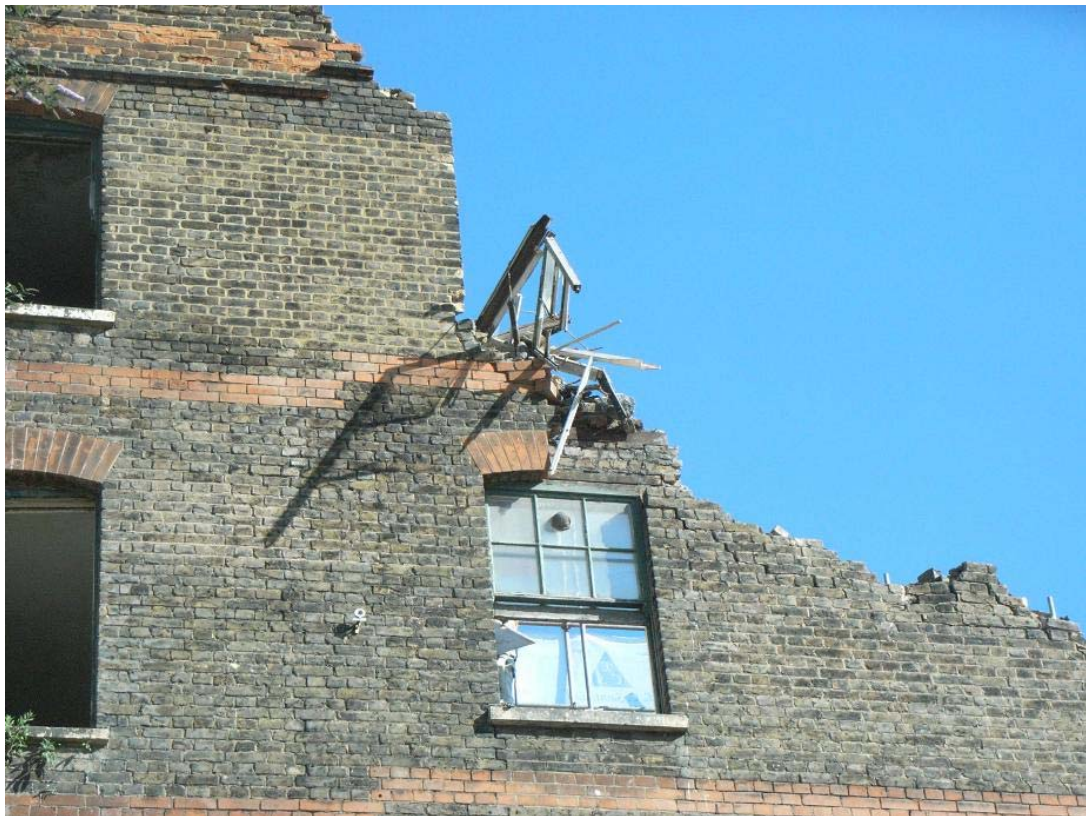
**Plate 13:** Iron lintel behind window arch in rear (south-east) elevation of Culross Building exposed during demolition

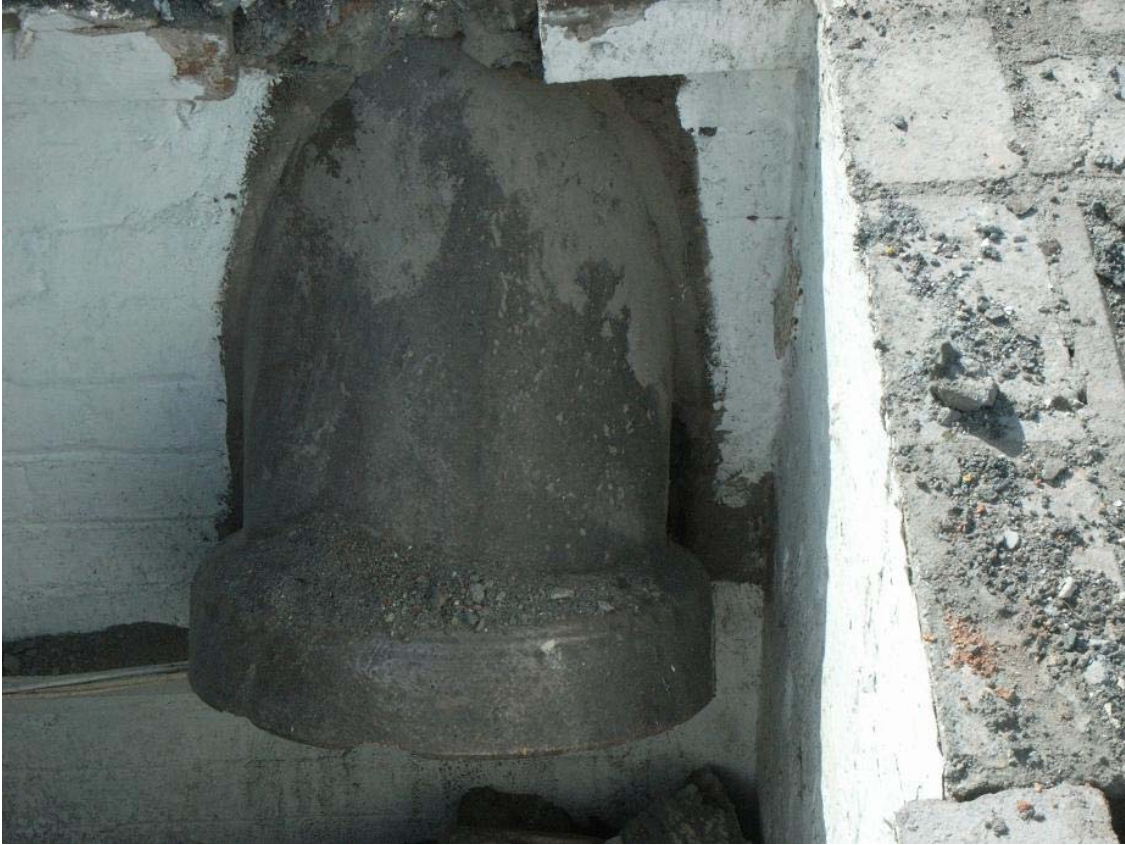
**Plate 26:** Blocked windows and ash chute in stairwell between Flats 5 and 6 (Figure 16) of Culross Building

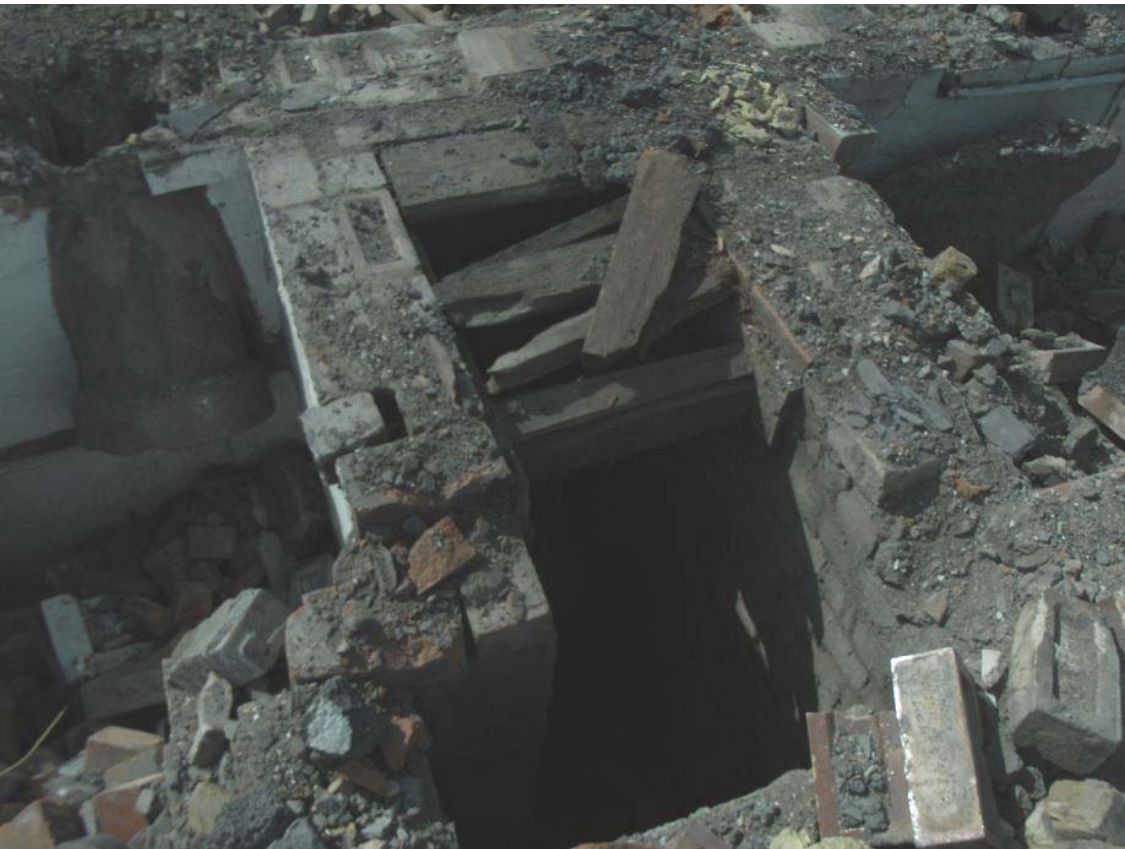
**Plate 27:** Foot of ash chute in Culross Building

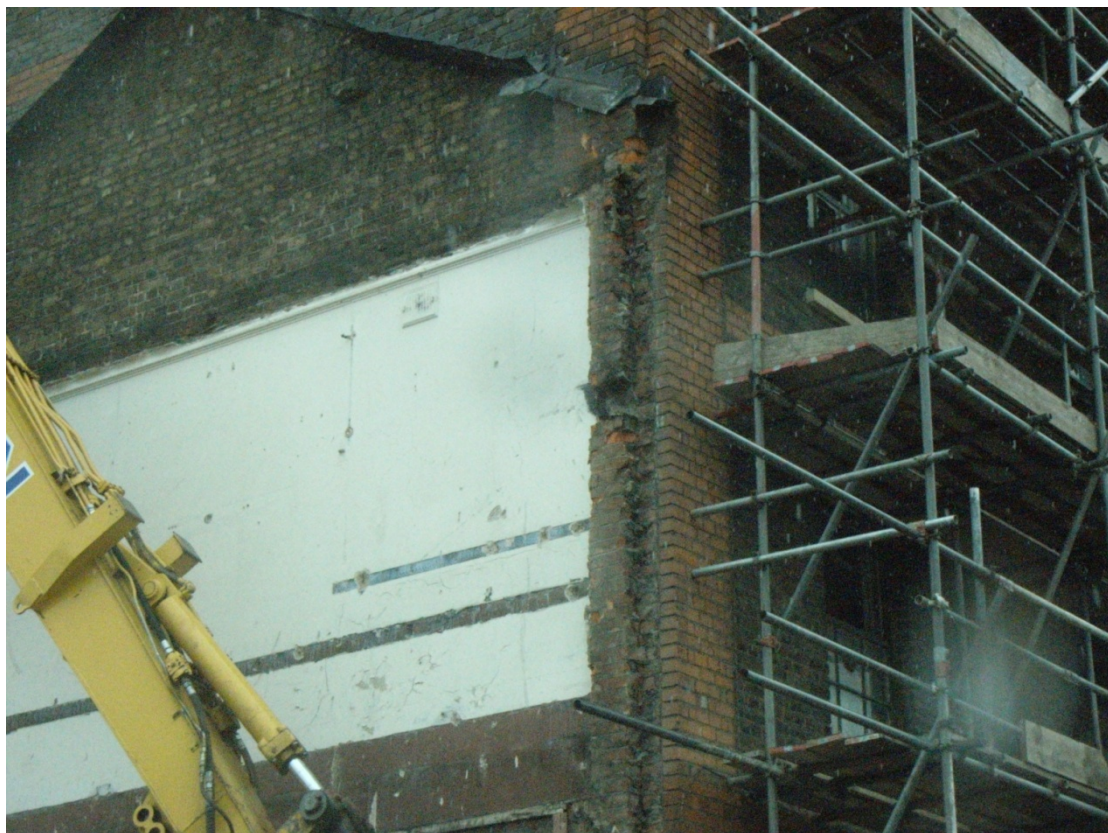
**Plate 43:** Straight joint between Culross Hall (right) and Culross Building (left) on the rear (south-east) side of the buildings during demolition

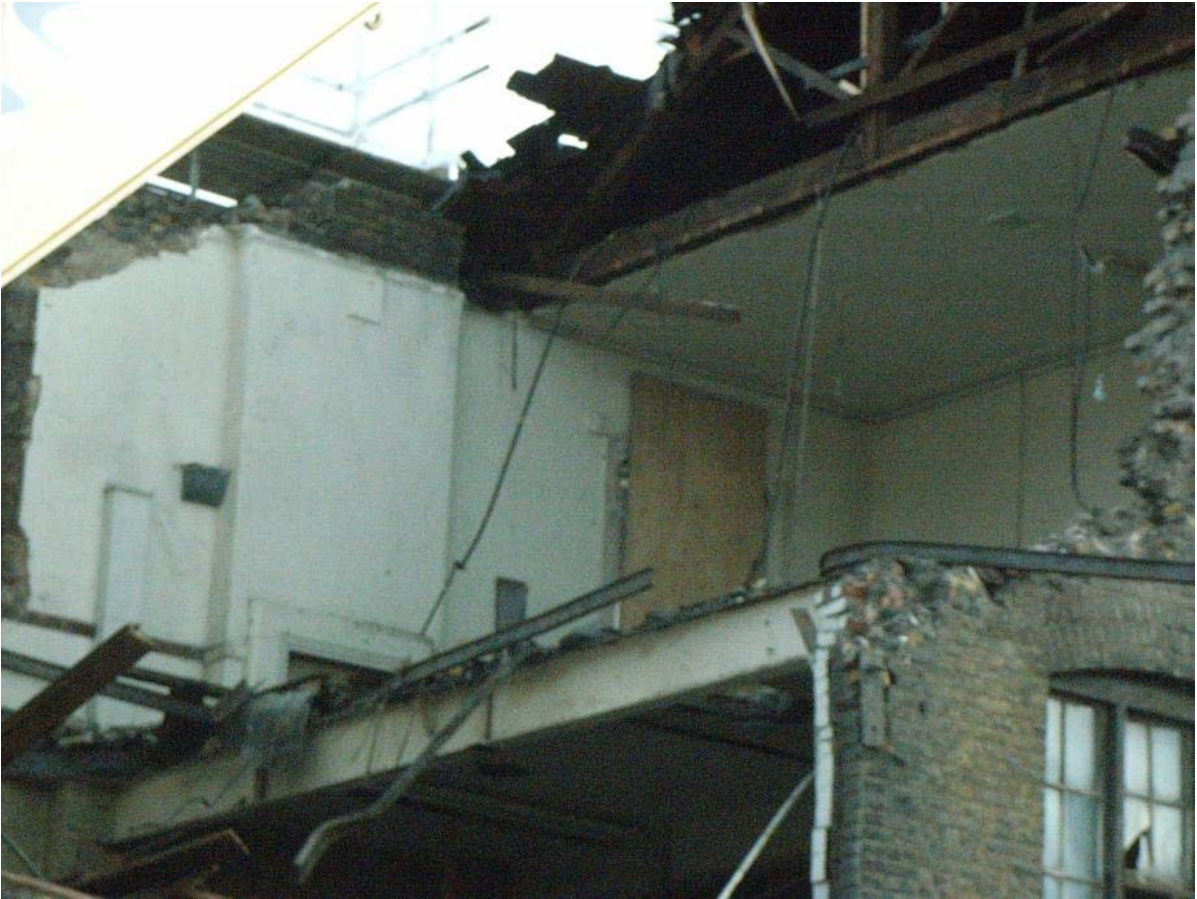
**Plate 54:** An RSJ supporting the first floor in Room CHGG (Figure 14) in Culross Hall

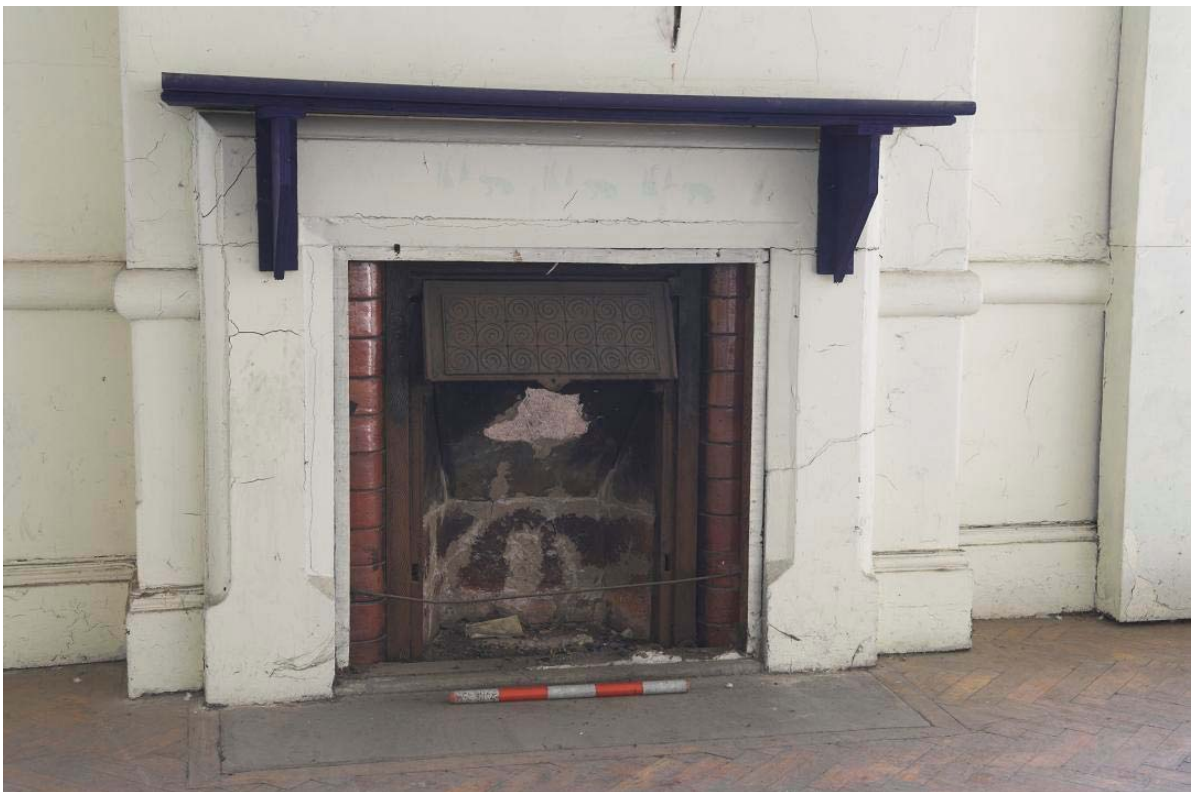
**Plate 57:** Fireplace in north-west wall of Room CH1F (Figure 15), Culross Hall

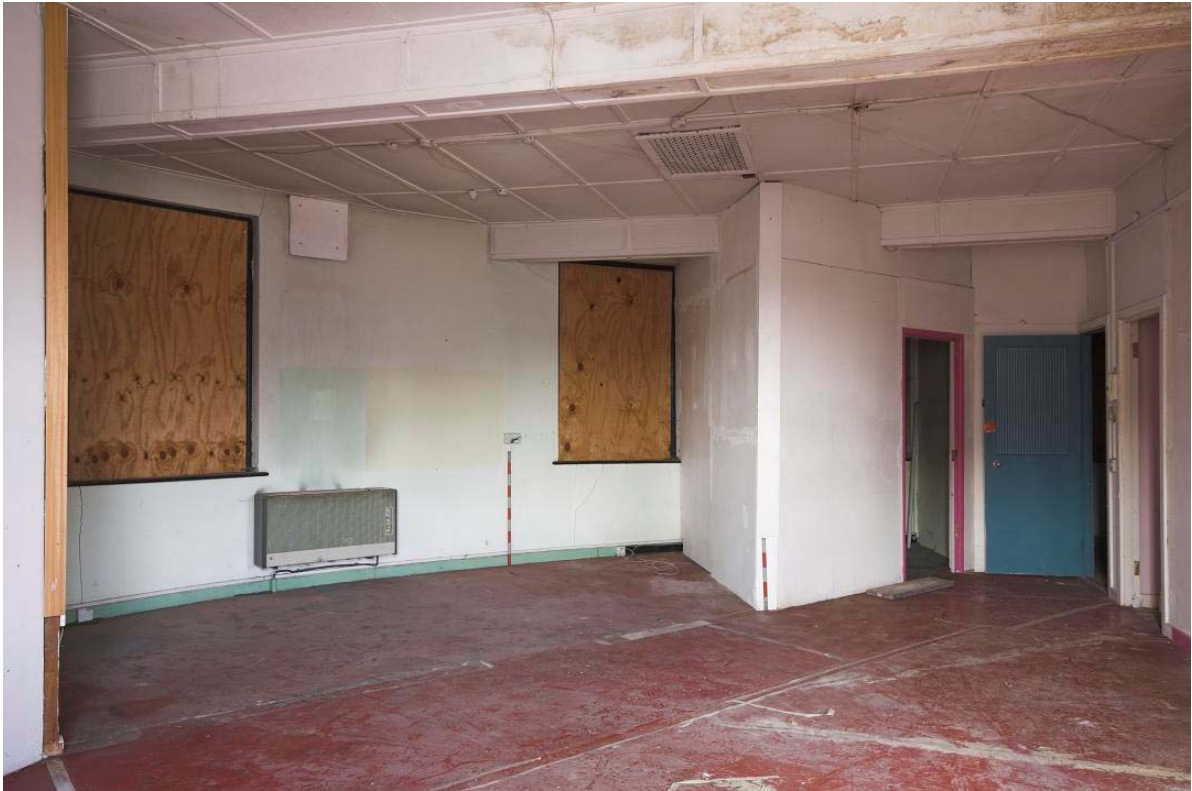
**Plate 72:** Covered RSJs in ground floor Meeting Room CB41D, No. 41 Battle Bridge Road, viewed from the north

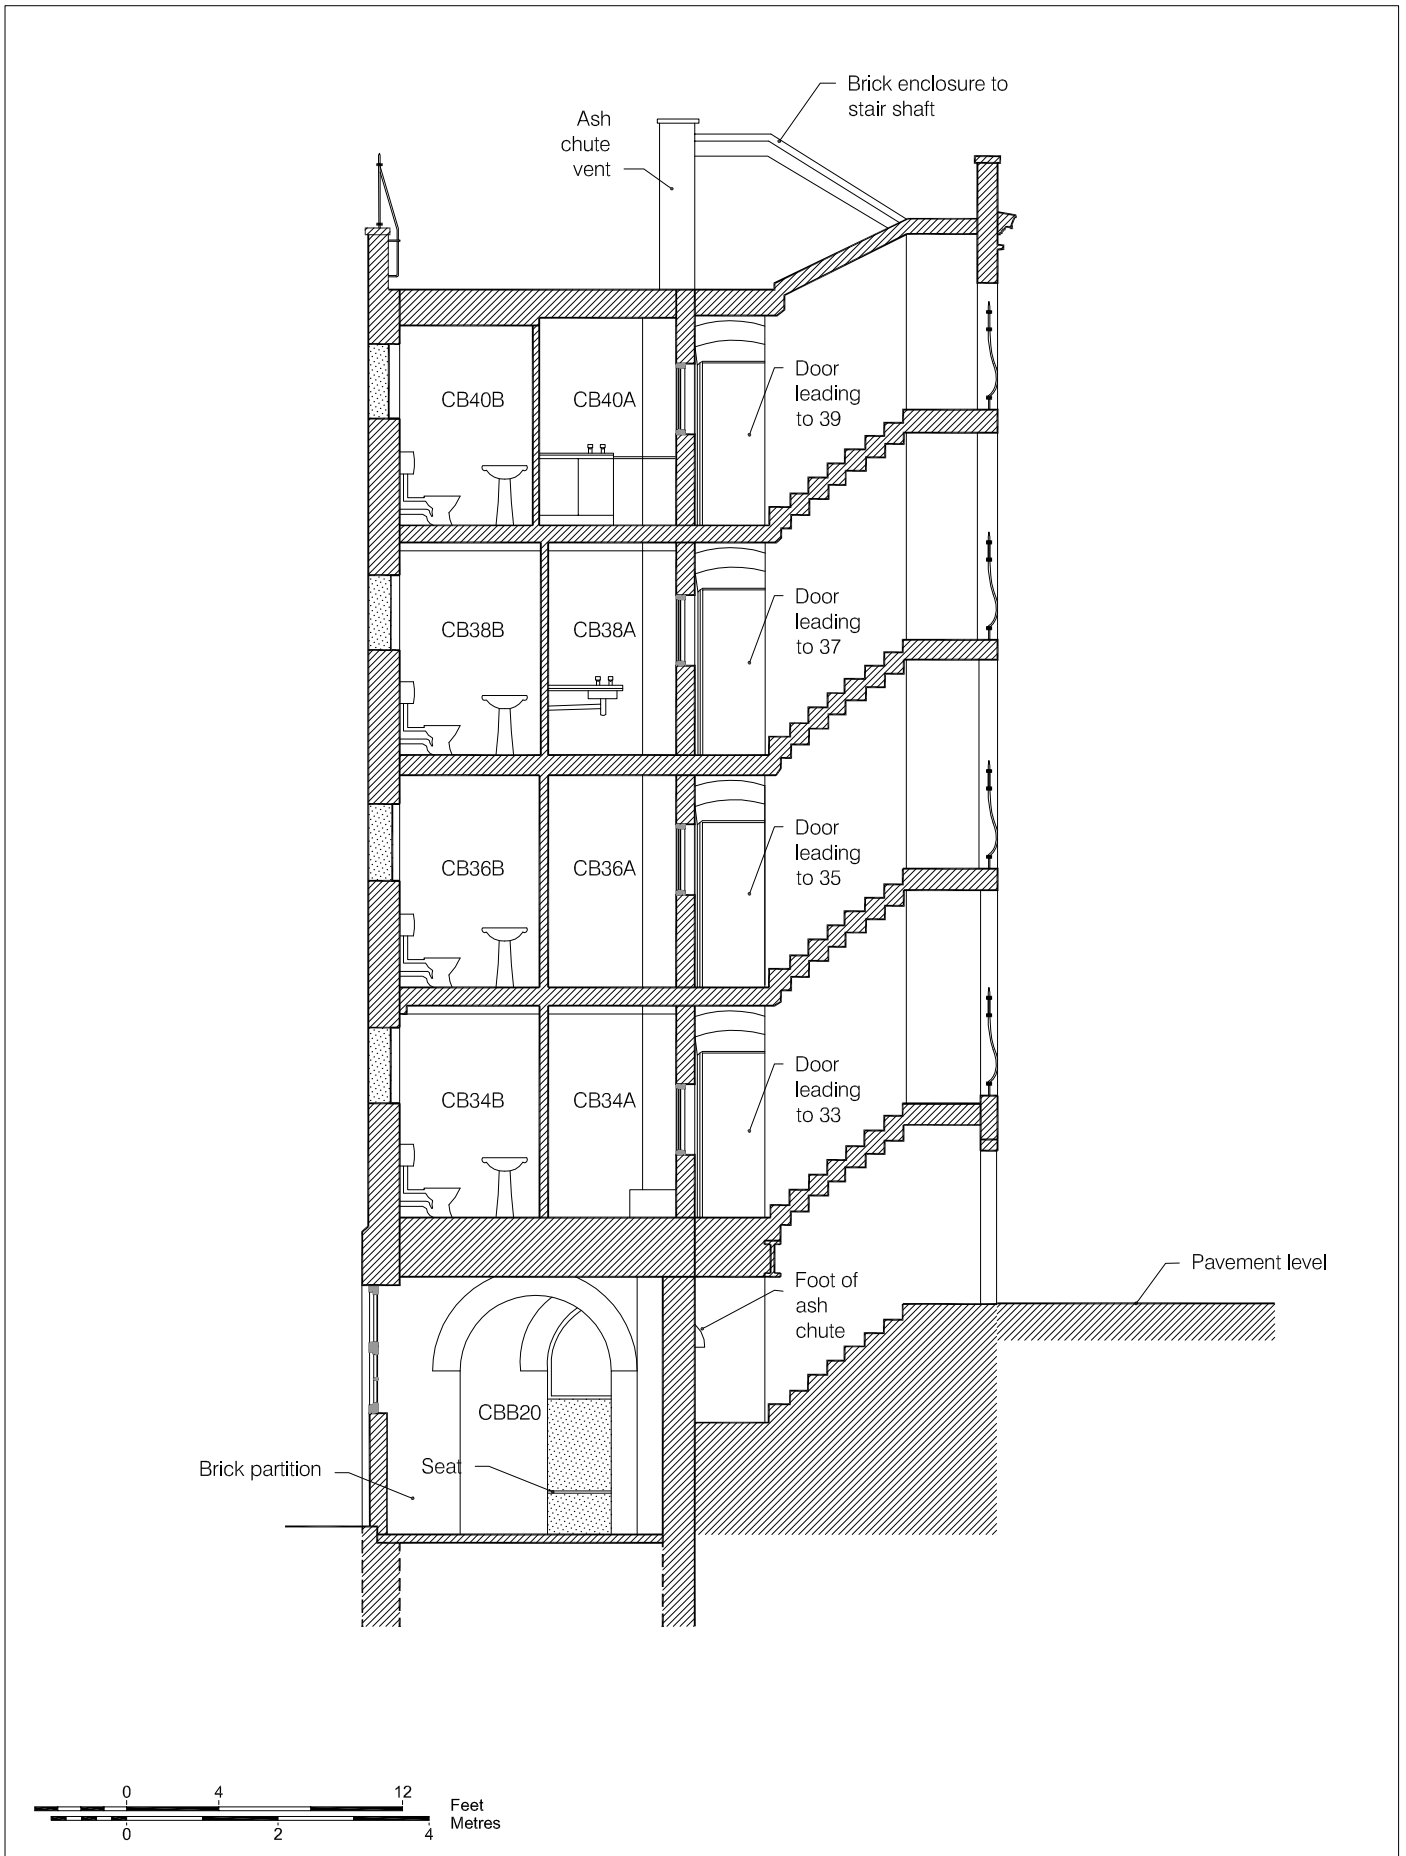
Figure 25  
 Cross-Sectional Elevation Through Smaller Flats  
 (Flats 34, 36, 38 and 40)  
 Culcross Building  
 King's Cross  
 1:100 at A4

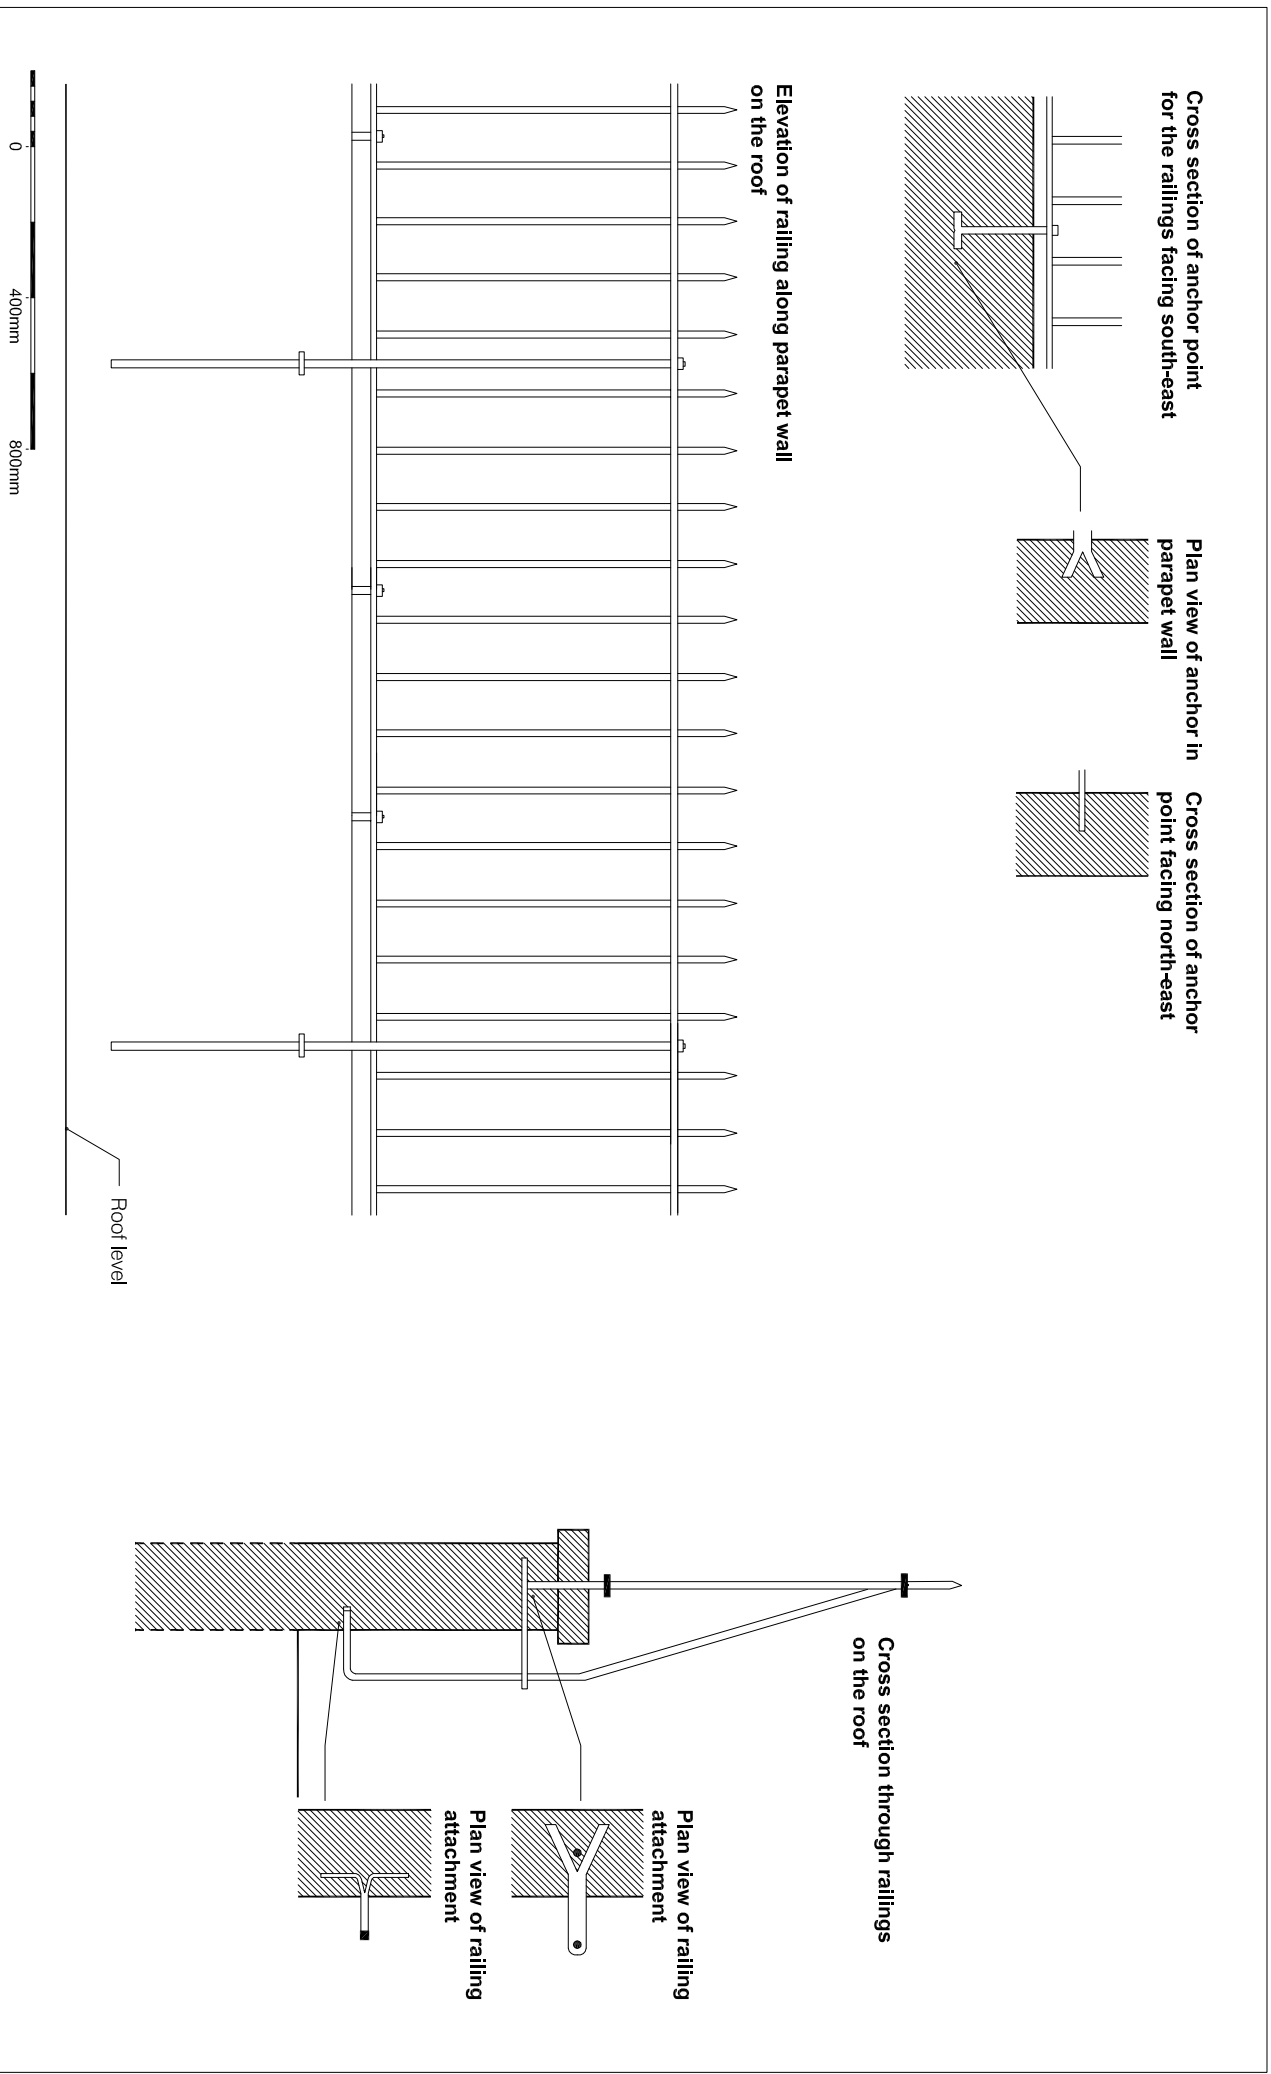
Figure 32

Detail of the Railings on the Parapet Wall of the Roof  
 Culross Building  
 King's Cross  
 1:20 at A4

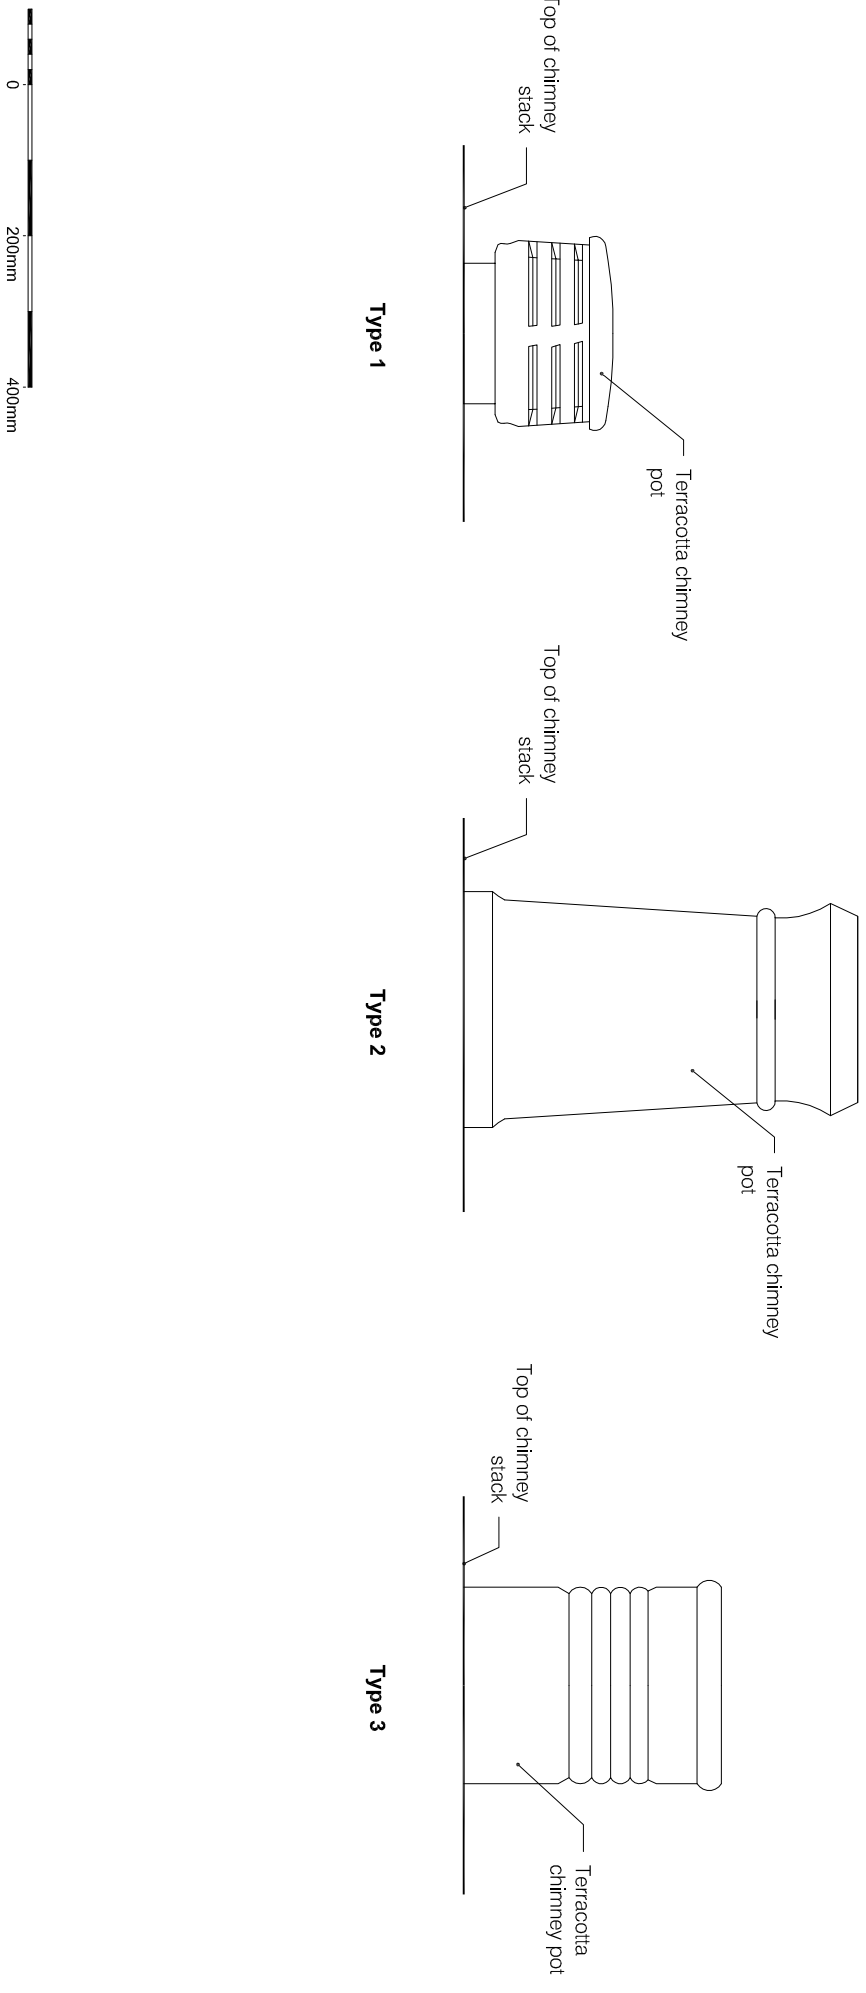
Figure 33  
 Types of Chimney Pots  
 Culross Building  
 King's Cross  
 1:10 at A4

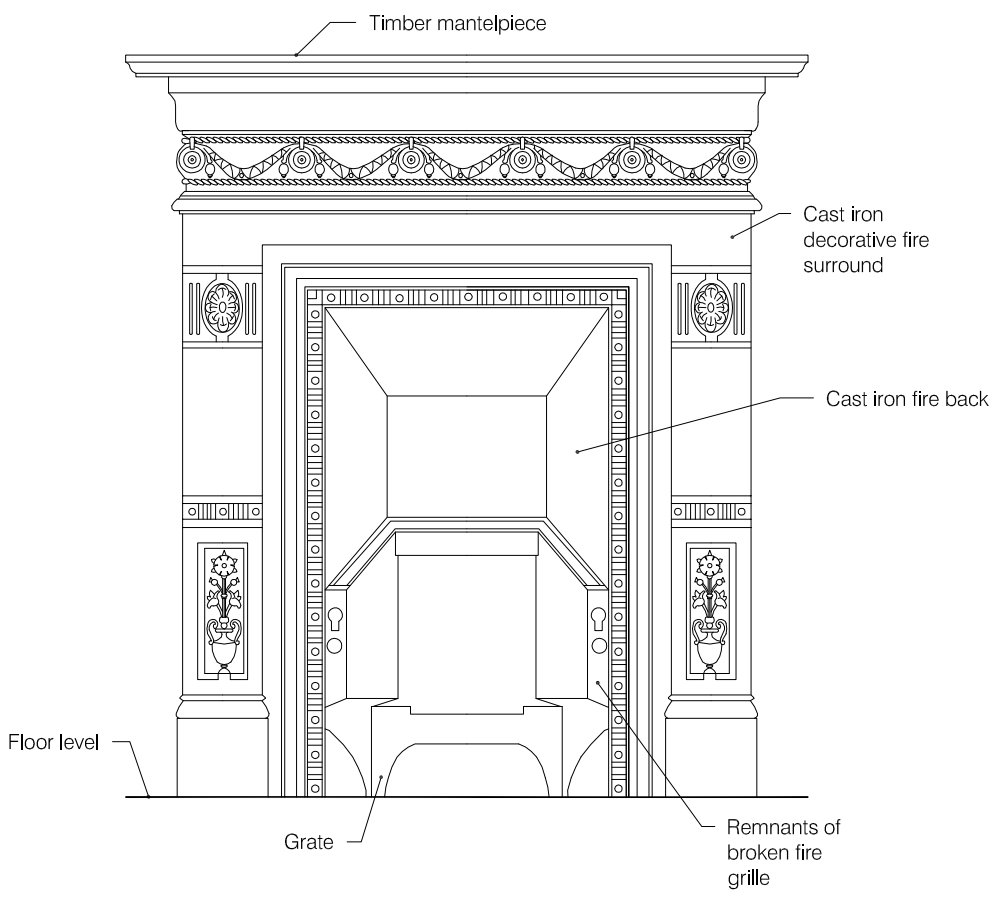
Figure 36  
 Fireplace in Bedroom CB16C  
 (See Figure 17 for Location)  
 Culross Building  
 King's Cross  
 1:10 at A4

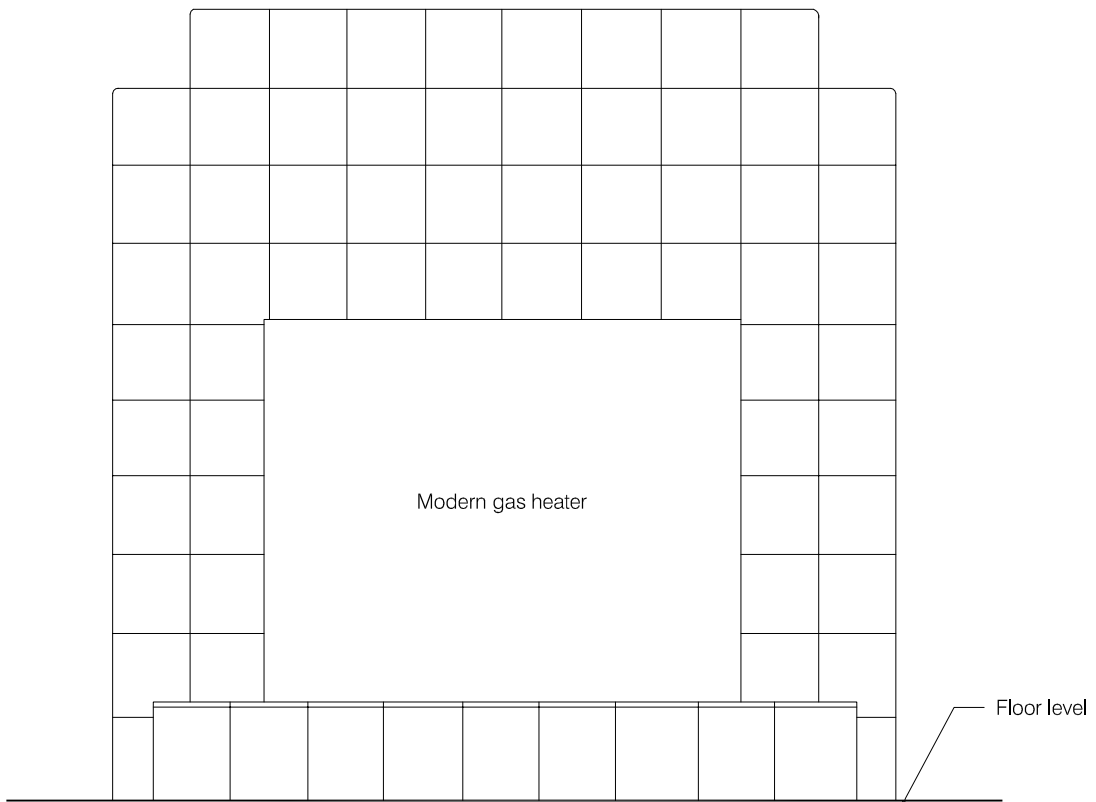
Figure 37  
Fireplace in Living Room CB4D  
(See Figure 15 for Location)  
Culross Building  
King's Cross  
1:10 at A4

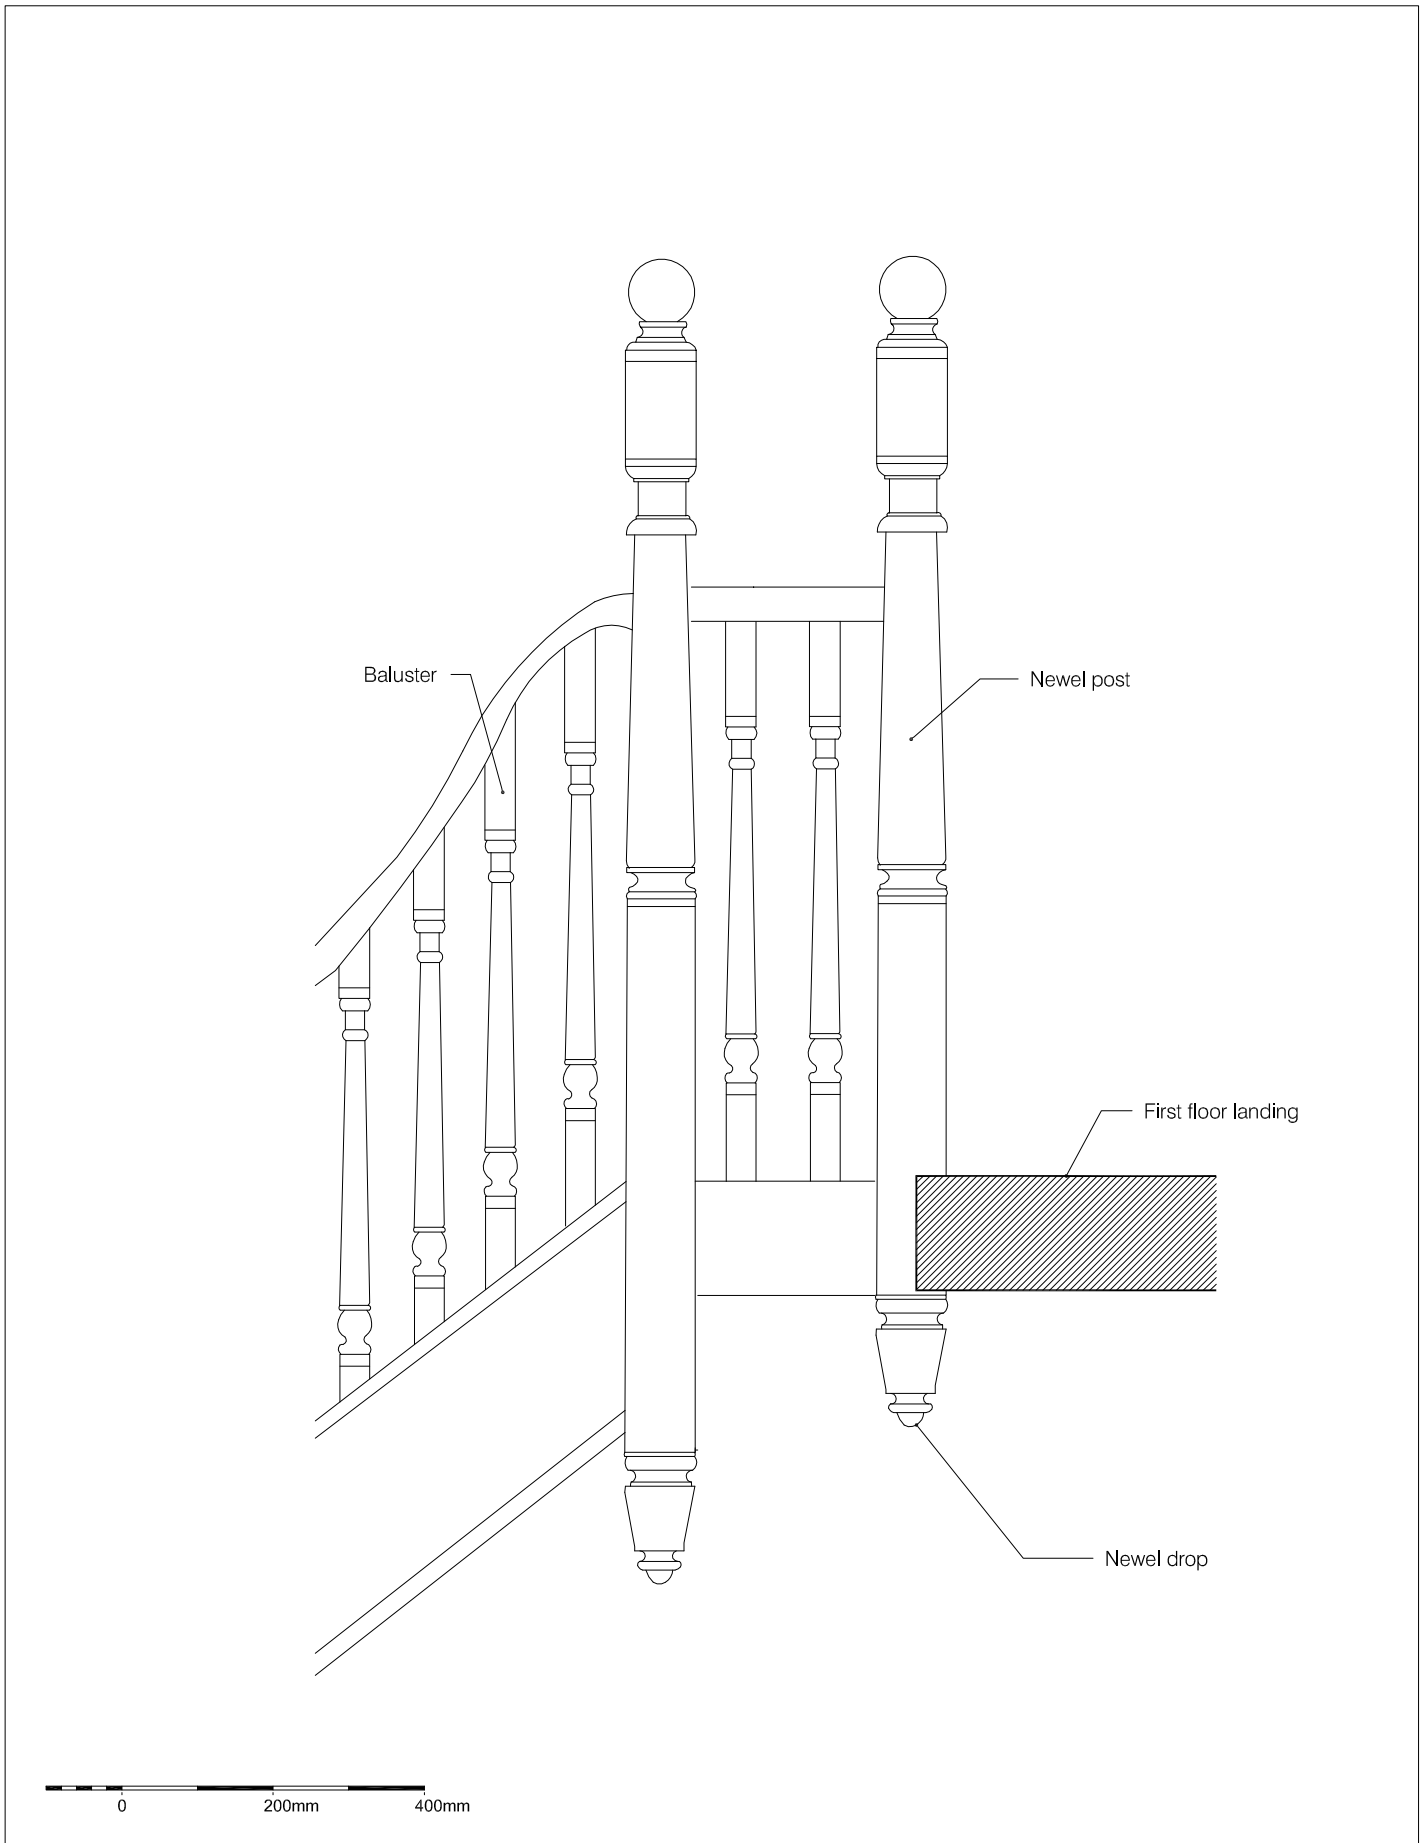
Figure 42  
Detail of Banister, Room CH1A  
(See Figure 14 for Location, See Also Plate 52)  
Culross Hall  
King's Cross  
1:10 at A4
