**HISTORIC BUILDING
RECORDING OF 11-13
PADDINGTON GREEN, CITY
OF WESTMINSTER, LONDON
W2 1LG**

SITE CODE: WEJ09

MAY 2010

Historic Building Recording

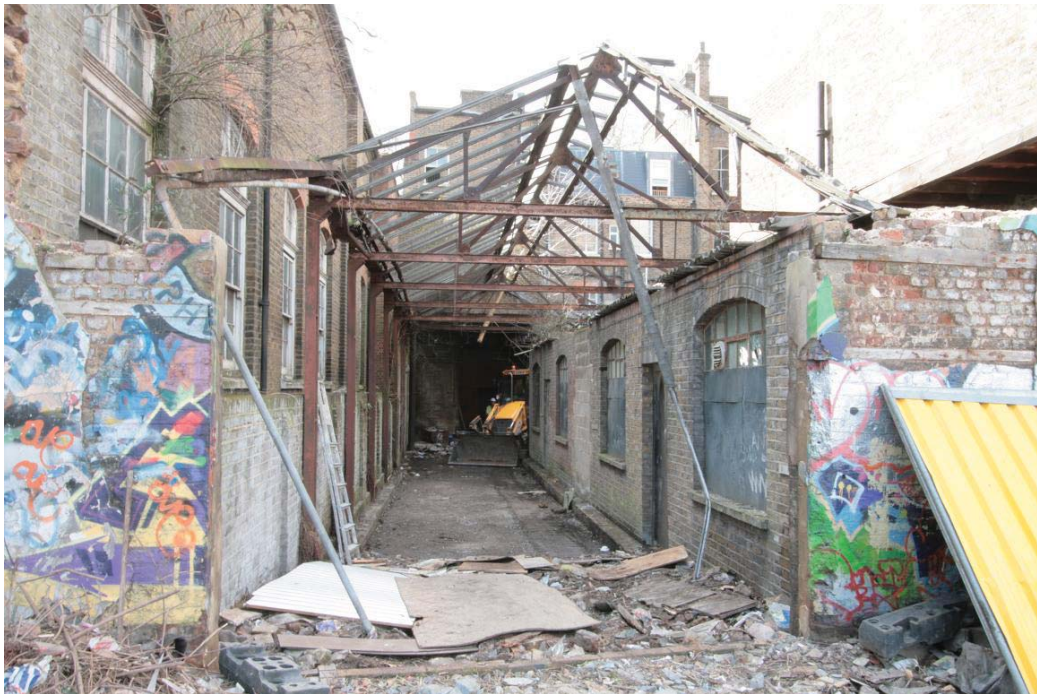
Plate 6. Derelict canopy over rear yard of 13 Paddington Green, theatre windows visible on left.

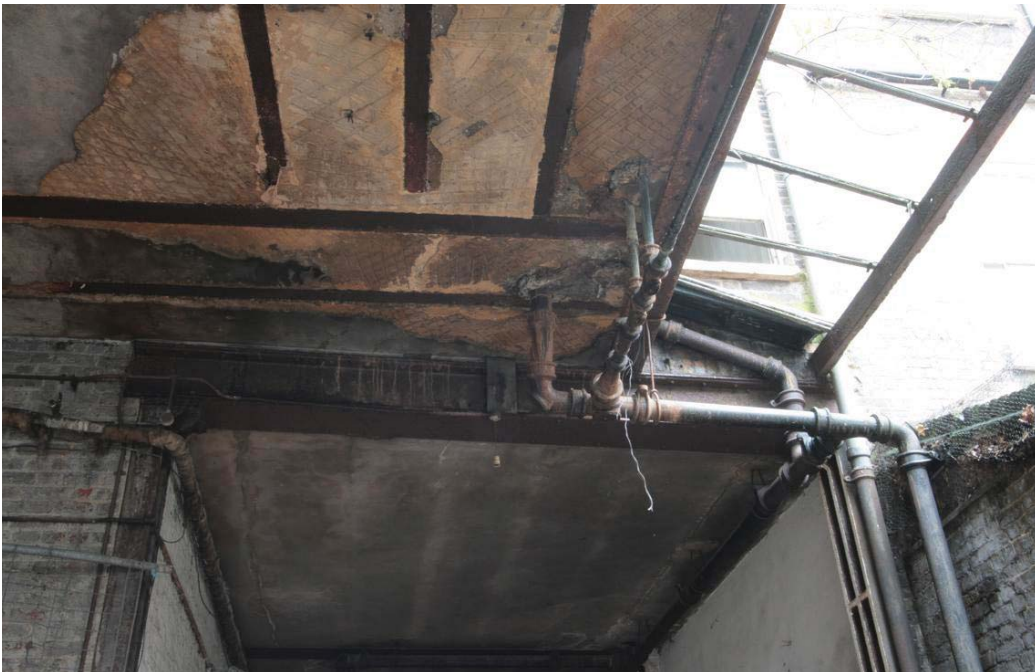
Plate 8. Detail view of underside of projecting first floor of 13 Paddington Green.

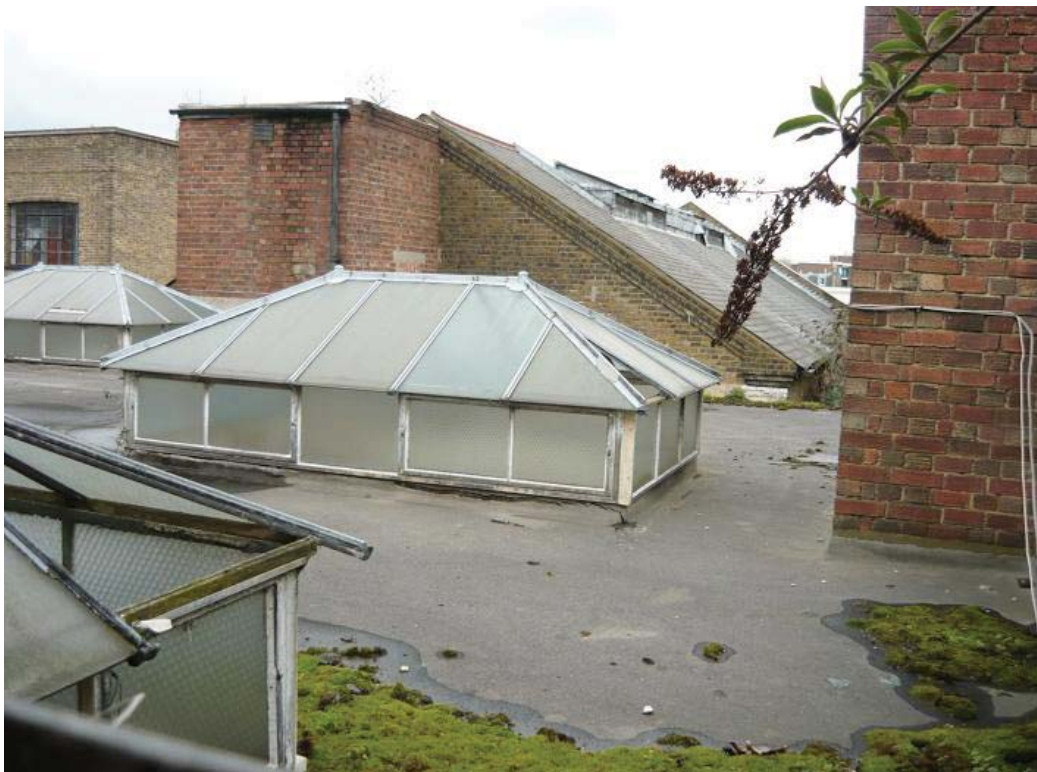
Plate 13. Skylight and flat roof over first floor of 11-12 Paddington Green, with gable end wall of theatre beyond showing added red brick lift shaft and scar from previous roof structure.

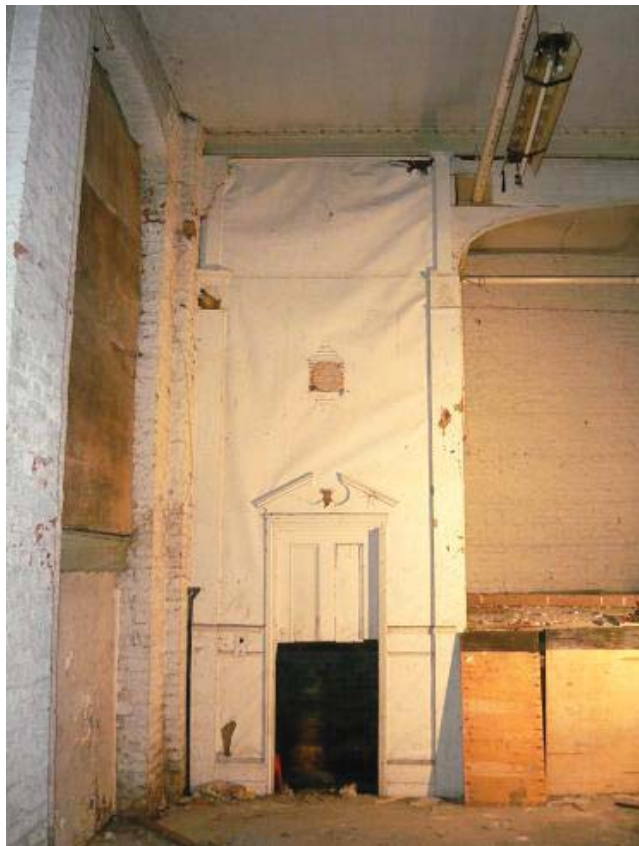
Plate 18. Detail of timber stage façade and door to under stage room, visible on the left is a shadow and scar where tongue and groove panelling once ran the length of the side wall.

- 6.2.36 The stage façade itself was a very decorative design. The panelled doors on either side of the stage had moulded architraves with ornate broken pediments set above. They were positioned centrally between a pair of two stage pilasters with plinth, dado and capital mouldings. The southern most of the four pilasters had the only surviving element of the foliate plasterwork embellishment to the capitals, which took the form of a three dimensional scrolled acanthus leaves (Plate 19). Above each of the doors was a circular hole cut into the façade. Although now nothing covered these apertures, paint scars showed that something once had and they may have been for actors or the stage hands to observe the auditorium while not being seen themselves.

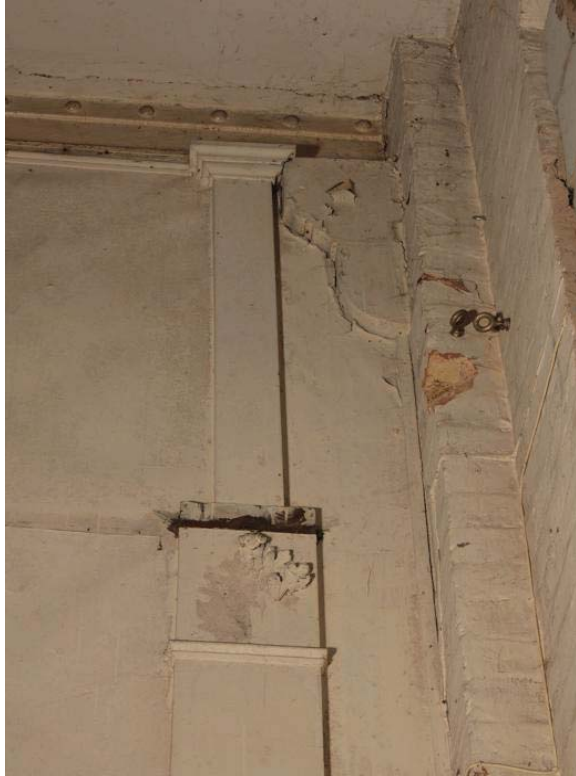
Plate 19. Detail of pilaster of stage façade showing classical mouldings and remnants of acanthus leaf embellishment to capital. Note the moulded corbel supporting a steel ceiling joist.

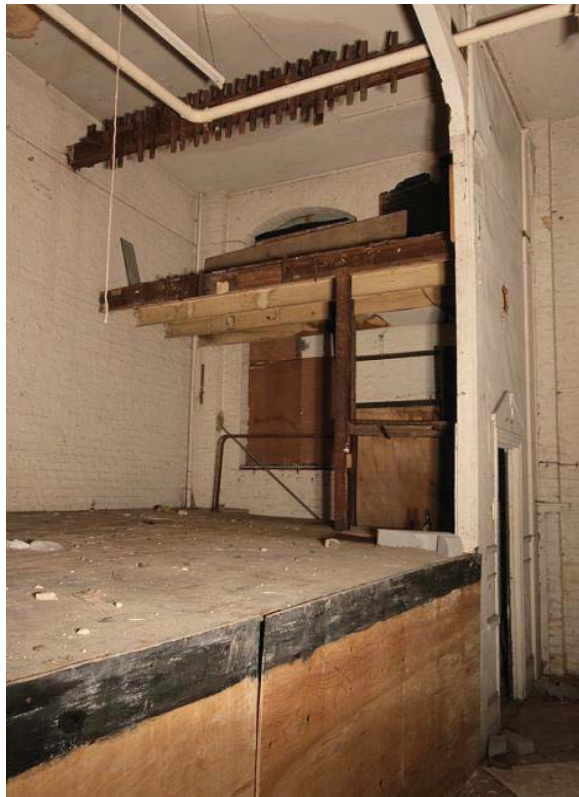
Plate 20. Stage and timber framing for stage scenery with intermediate floor level.

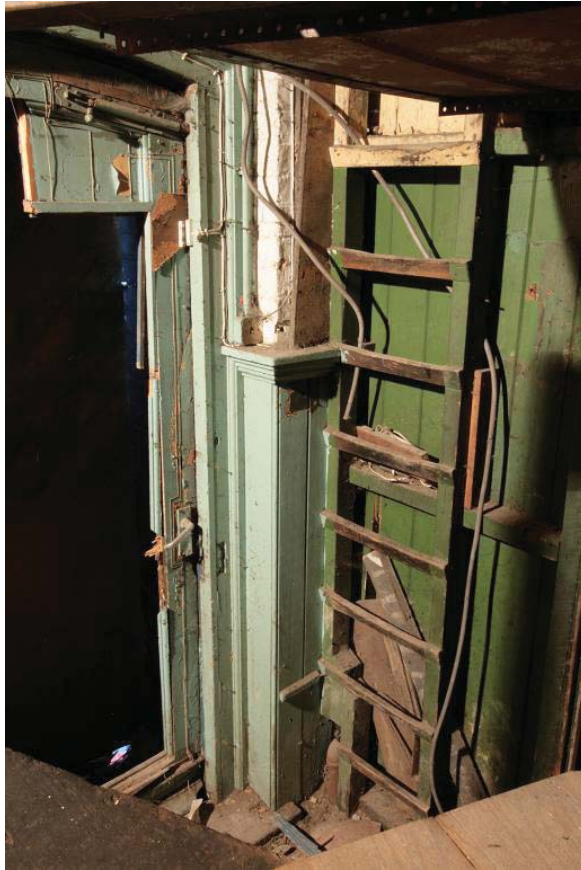
Plate 21. Ladder to intermediate floor level in wings, tongue and groove panelling and arched exit door to south elevation of theatre, view from the stage.

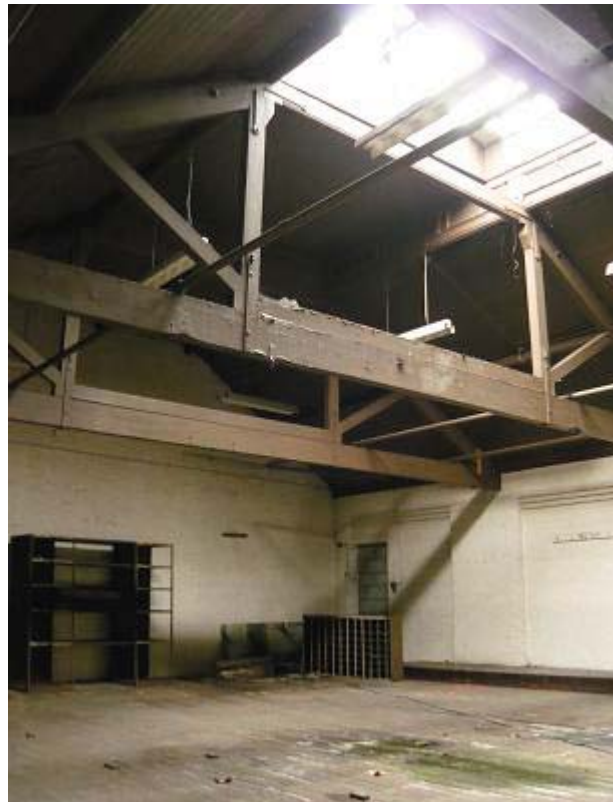
Plate 24. Detail of roof truss with skylight, first floor gymnasium.

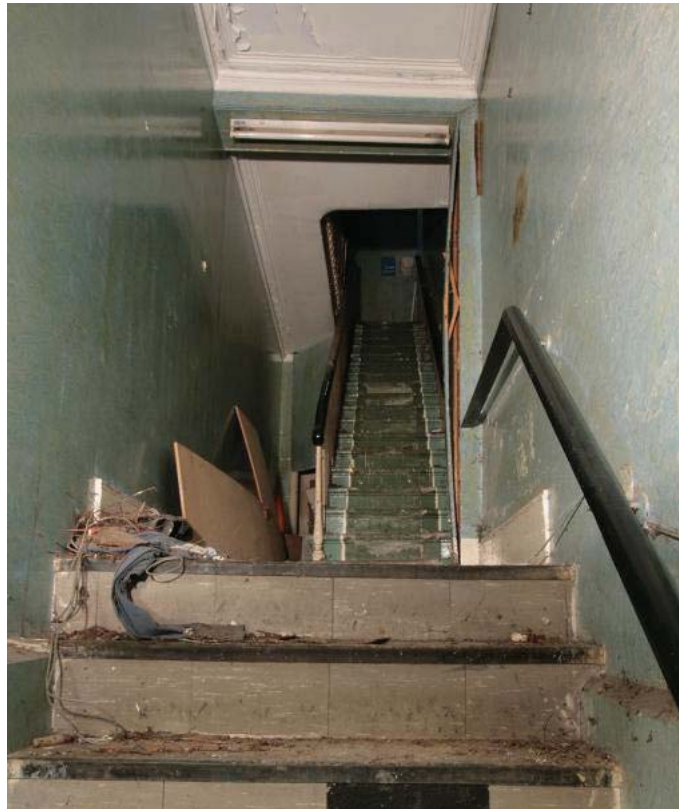
Plate 34. Entrance hall with corridor to basement to the left, stairs to first floor above and inserted stairs in the foreground..

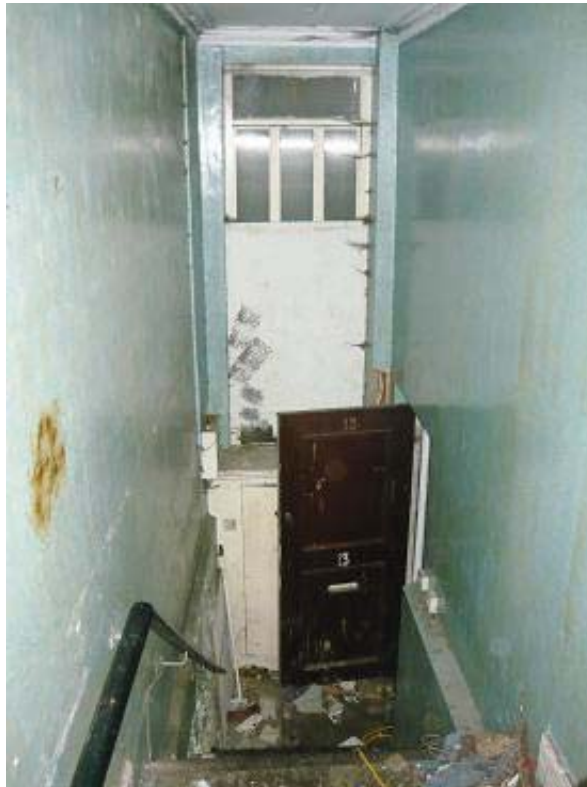
Plate 35. 13 Paddington Green entrance hall showing relocated front door and inserted steps up to ground floor level, the original floor level can be seen on the wall.

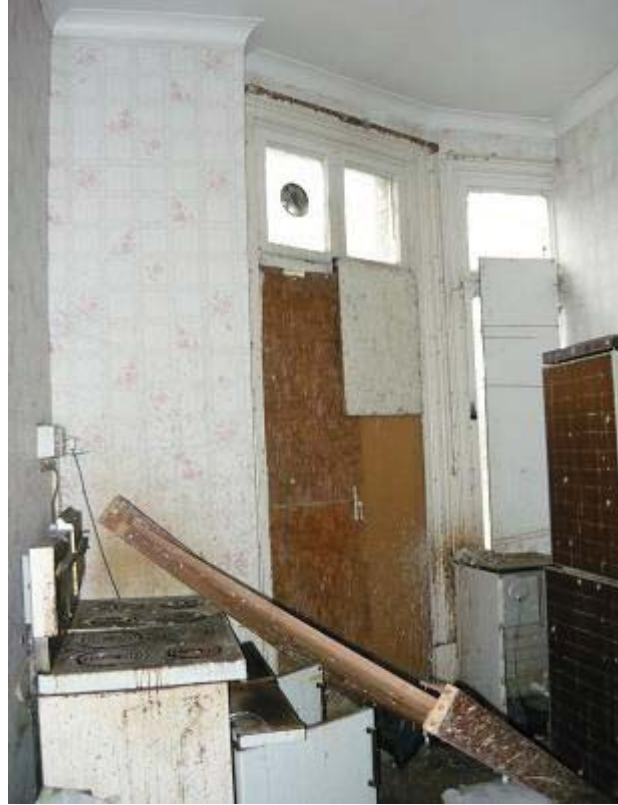
Plate 37. First floor room F2, full height original windows and partition wall on right.
