# FORMER SOUTH SHROPSHIRE DISTRICT COUNCIL OFFICES

Stone House, Lower Corve Street, Ludlow, Shropshire

## Historic Building Record, 2016

(Planning Ref: **16/02033/FUL**, Conditions 18/19)

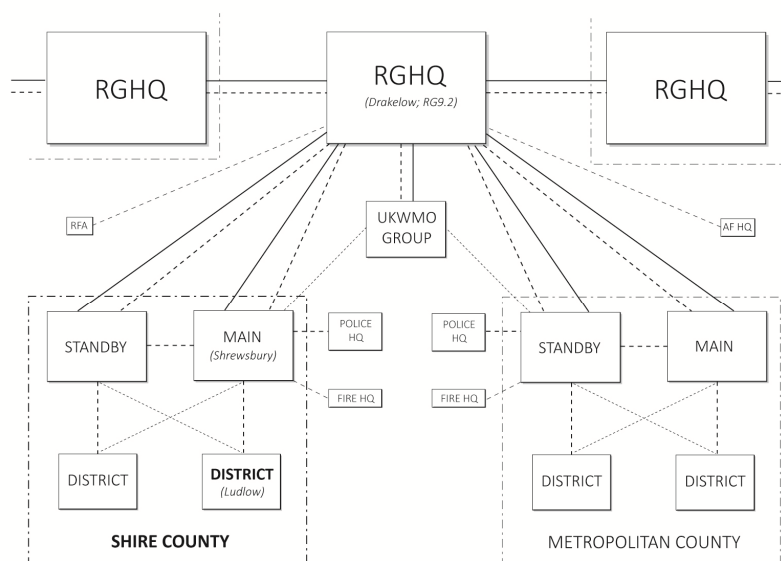
Diagram of emergency communications network as operational in the mid-1980s  
(after Cocroft and Thomas 2016, 211)

6.1.2 With the election of the Conservative government in 1979, a major overhaul of civil defence was put into effect with England and Wales being divided into ten 'home defence regions' (each sub-divided into two 'zones'), control within each region being held by the lead Regional Government Headquarters (RGHQ).<sup>43</sup> Below this operated a network of 'county main' centres (47 in total, usually located in the basements of county halls),<sup>44</sup> and secondary Borough and District emergency centres (see inset diagram below).<sup>45</sup> The system also incorporated the police and fire services and the United Kingdom Warning and Monitoring Organisation (UKWMO), the latter having been formed in the mid-1950s and having evolved from the WWII Royal Observatory Corps (ROC).<sup>46</sup>

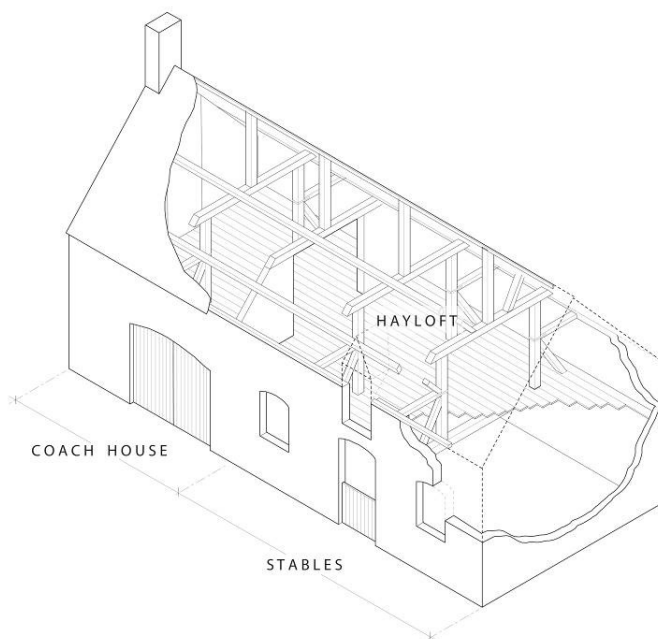
Stables / Coach House Block: isometric projection

- 7.2.7 Internally (Figure 18), the stables/coach house range is arranged on a five-bay plan, originally comprising a 3-bay stables to the west (Bays 1-3) and 2-bay coach house to the east (Bays 4/5), though this layout has been obscured somewhat, especially at ground floor level (Figure 18a), by subsequent remodelling associated with its conversion to office use.<sup>75</sup> The 3-bay stables would originally have been open at this level, 24ft (E/W) x 16ft (N/S), with stall partitions, feed racks etc. arranged against the south side of the building with a longitudinal access passage or gangway to the north (see Figure 19b),<sup>76</sup> though brick piers and partitions have been introduced beneath the original transverse, first floor beams at Bay 1/2 and Bay 2/3 resulting in a compartmentalised plan. The original stable door opens from the north at Bay 2 onto a small, square lobby area [G1], with an inserted, closed-well stair occupying the southern half of the bay.<sup>77</sup> A door off the west side of lobby [G1] opens onto a small office space [G2] which occupies the full extent of Bay 1 (Plate 48), while Bay 3 is no longer accessible from this end of the range, having been closed off by an inserted partition. Bay 3 is

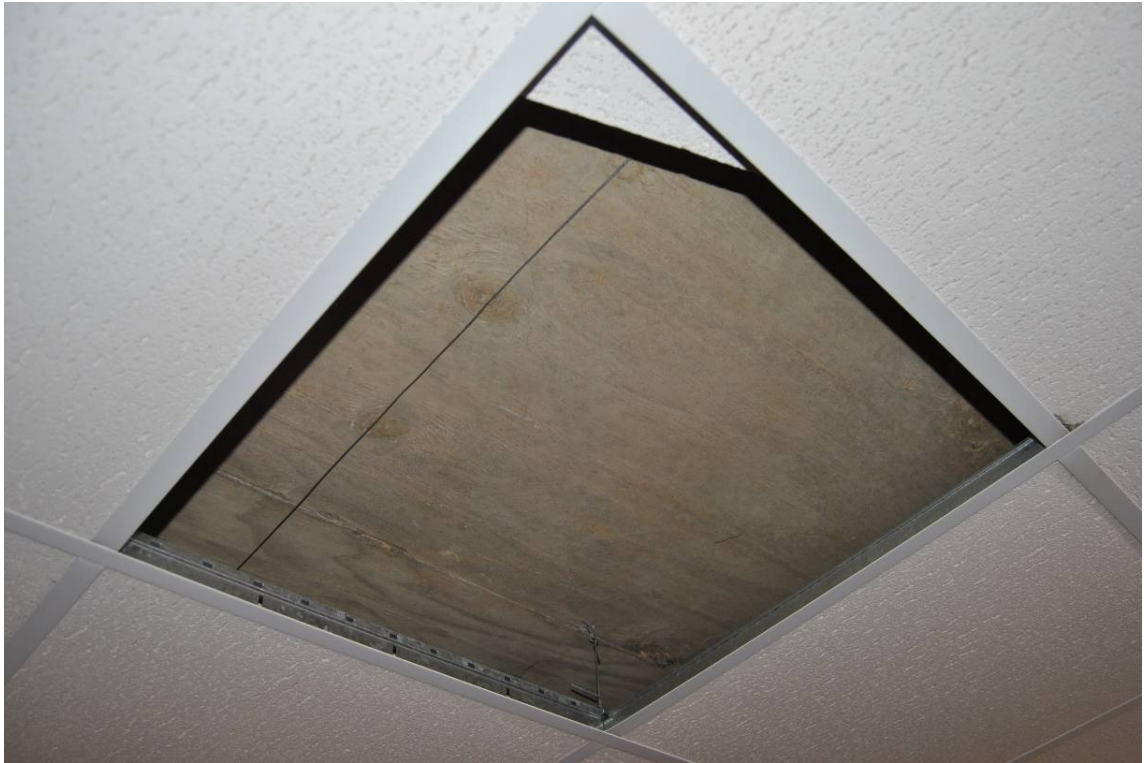
**Plate 6:** Suspended ceiling beneath concrete floor slab.

<sup>57</sup> Suspended ceiling formed of 600mm square, fissured-face pattern tiles.

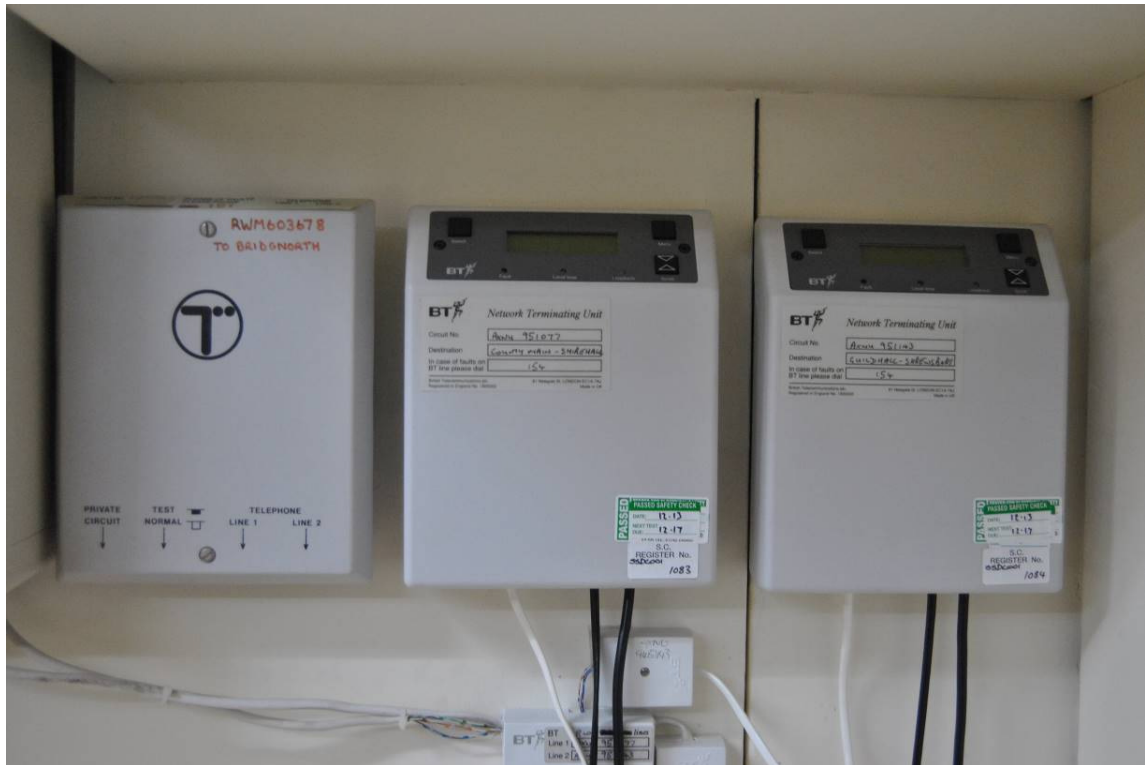
**Plate 19:** Late C20<sup>th</sup>-communications units (NTUs) to west wall of [B.02]; lines to 'Bridgorth' (left), 'County Main; Shirehall' (centre) and 'Guidhall; Shrewsbury' (right). **NB.** BT logos; that to the left hand unit current 1980-91, 'piper' logo to right hand units current 1991-2003.

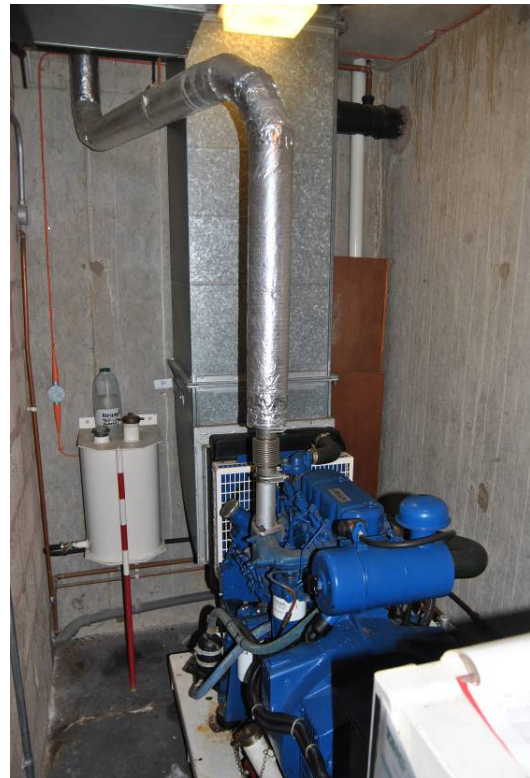
**Plate 21:** 'Plant Room' [B.08] looking north, **NB.** concrete exterior walls.

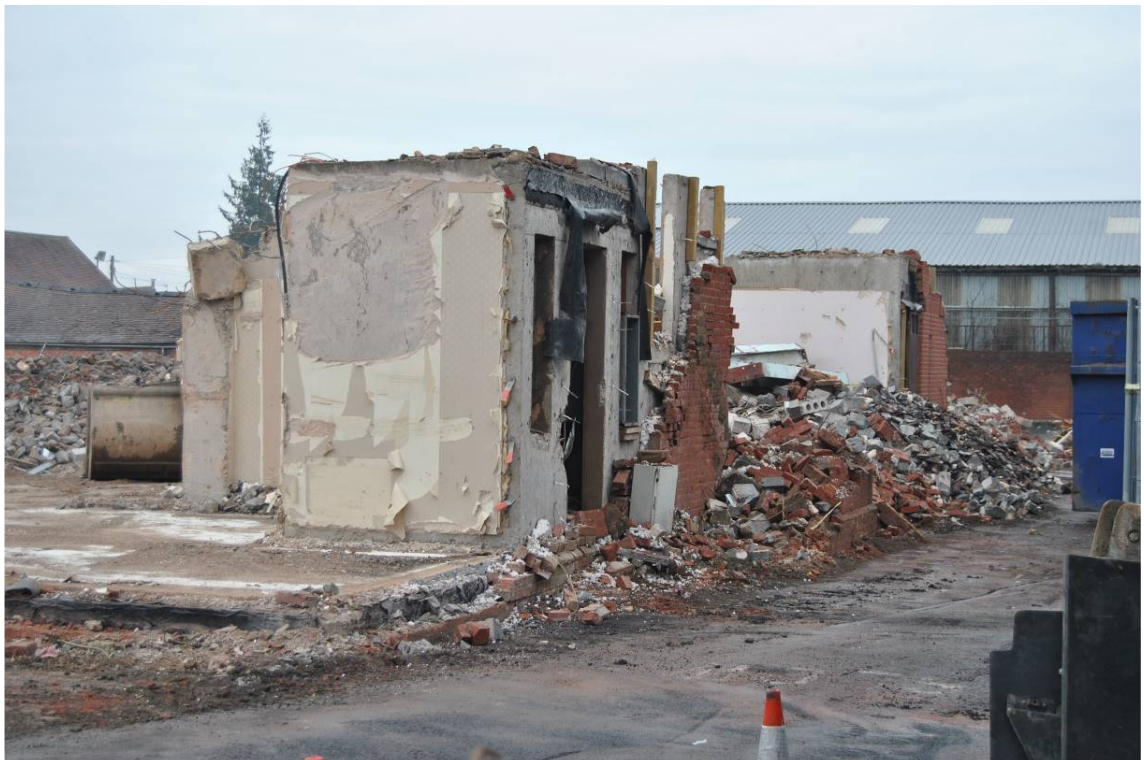
**Plate 27:** Reinforced concrete walling to heads of bunker stairwells (**A** left, **B** right), looking north-west (23.01.17).

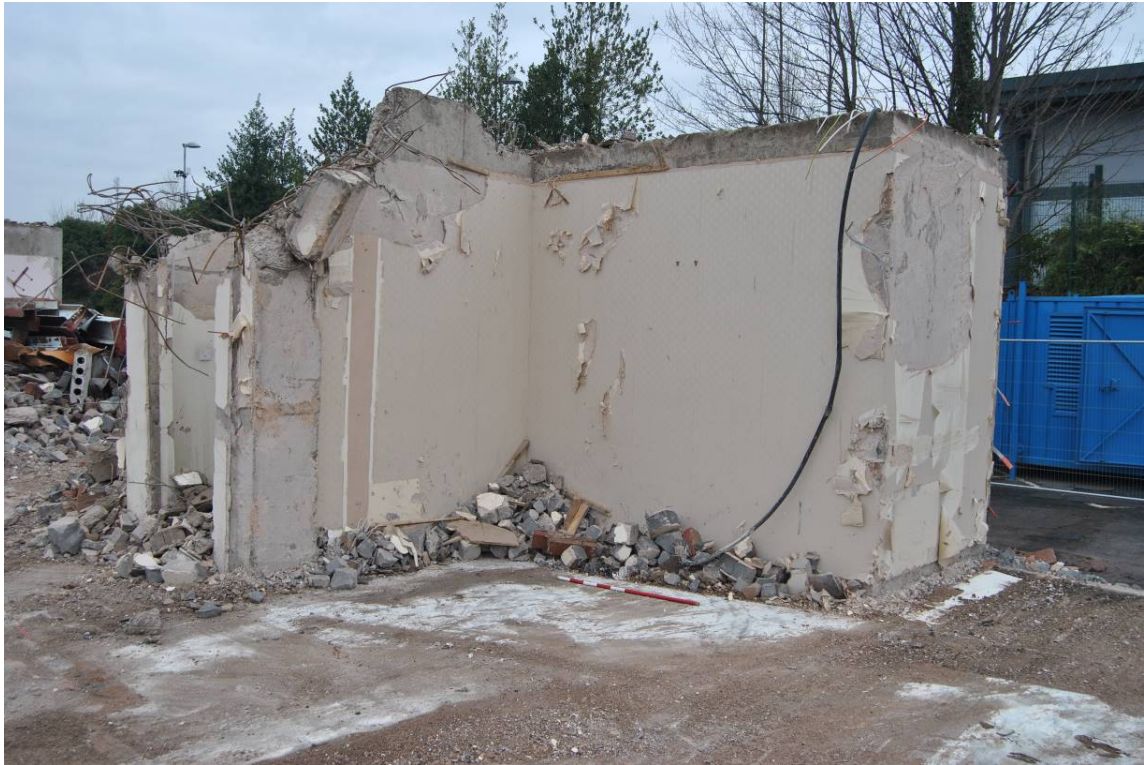
**Plate 28:** Reinforced concrete walling to head of southern stairwell **A**, looking north-east (23.01.17).

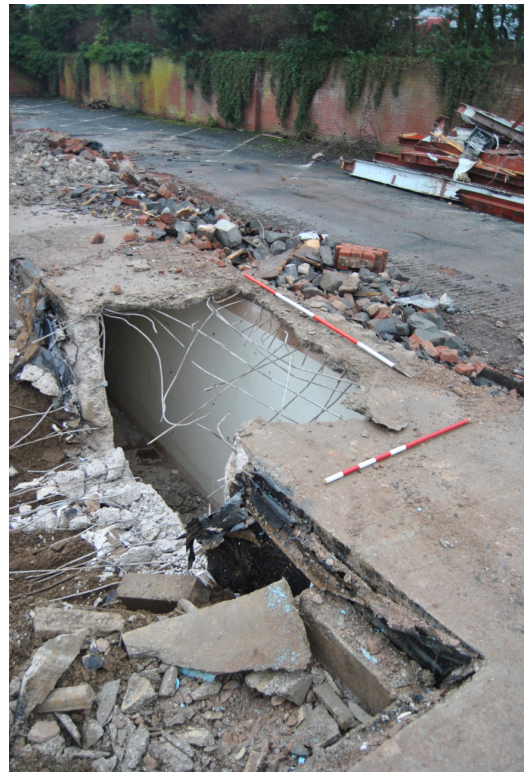
**Plate 31:** Details of wall / ceiling construction exposed during site clearance (31.01.17).

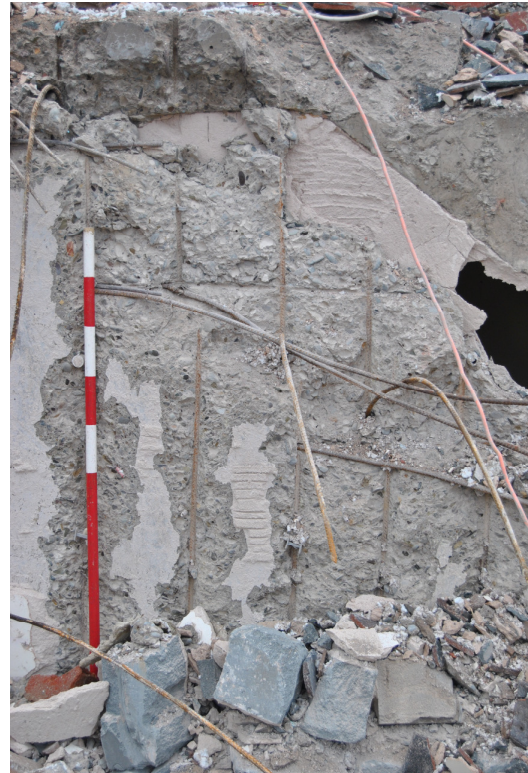
**Plate 33:** Detail of reinforcement bars.

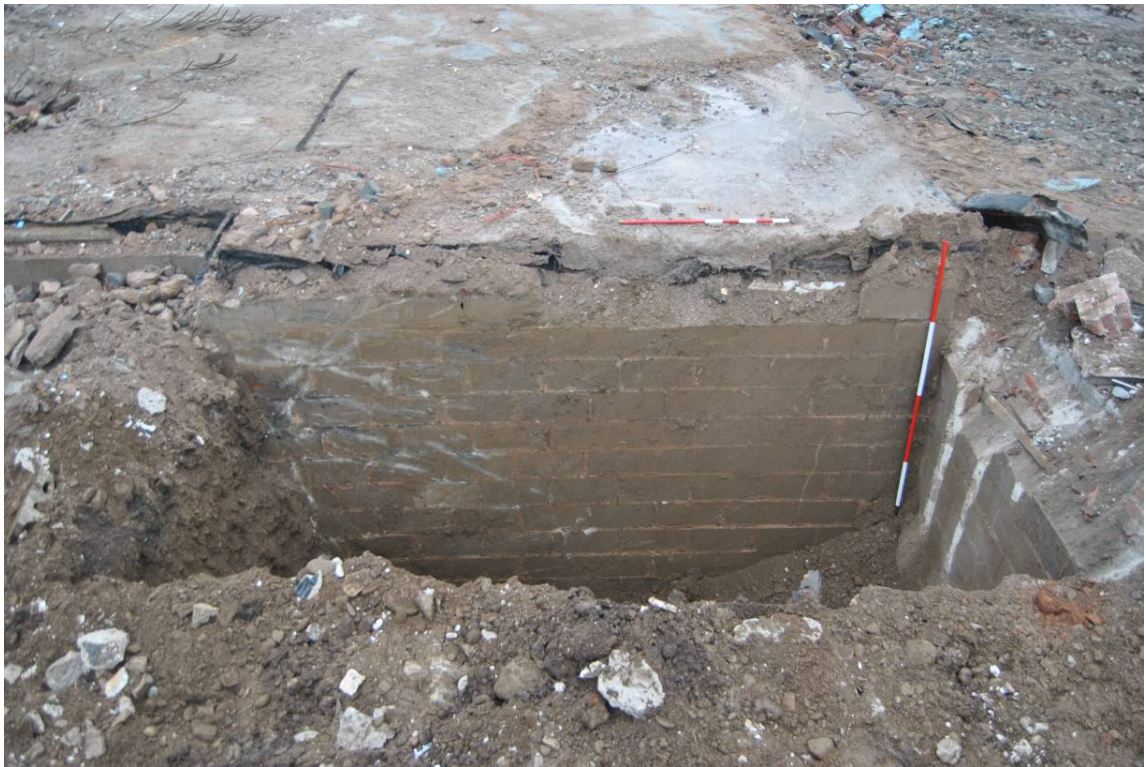
**Plate 34:** Outer breeze-block skin exposed in sondage excavated to north side of [B.07].

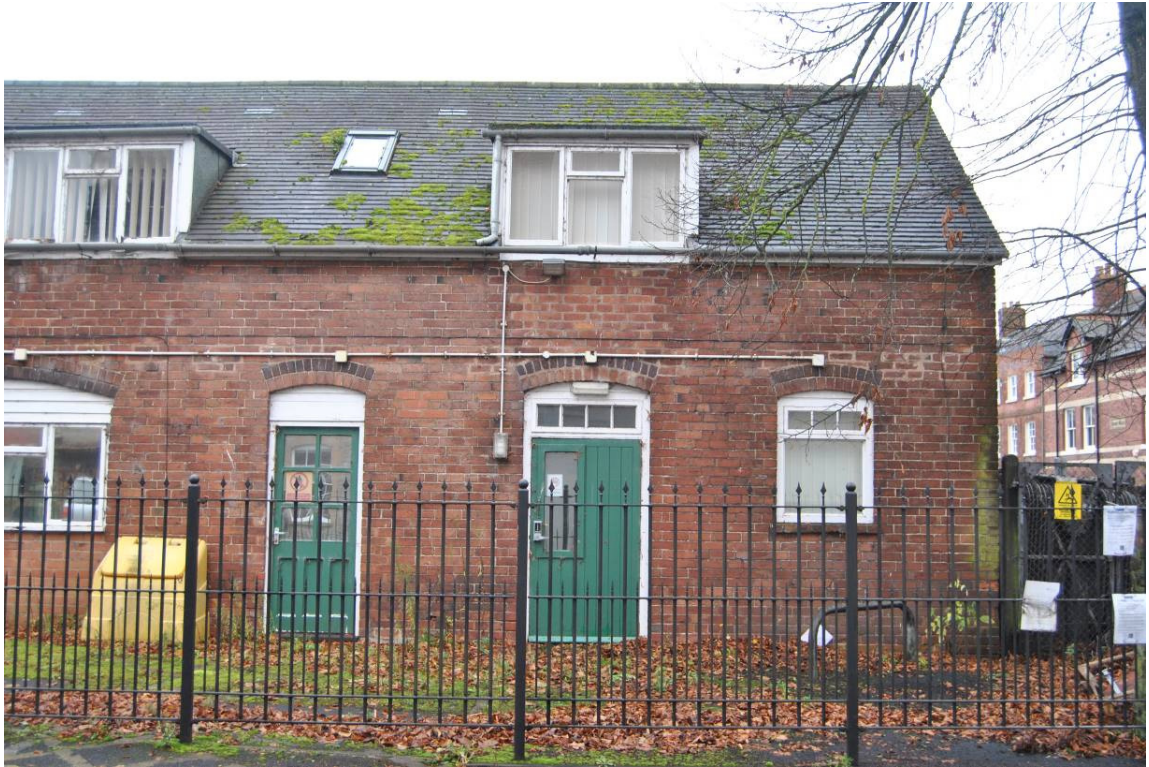
**Plate 38:** North elevation of stable block; **NB.** patching over central door denoting location of former pitching door.

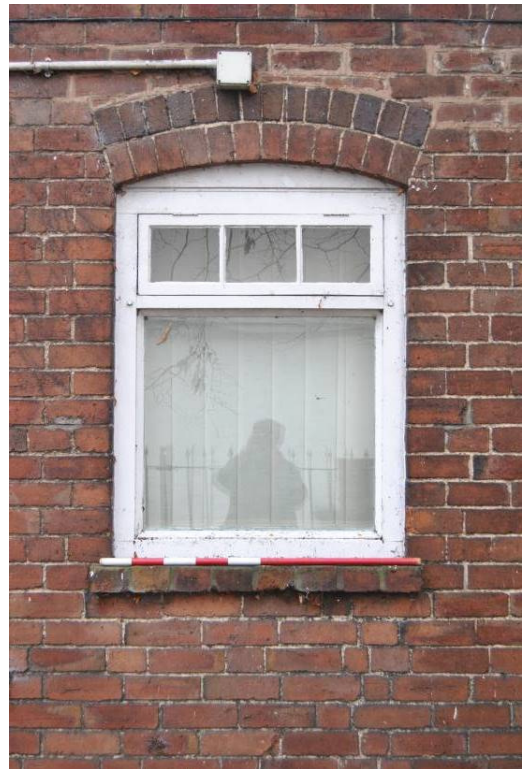
**Plate 40:** Window **w1** opening, with pegged frame.

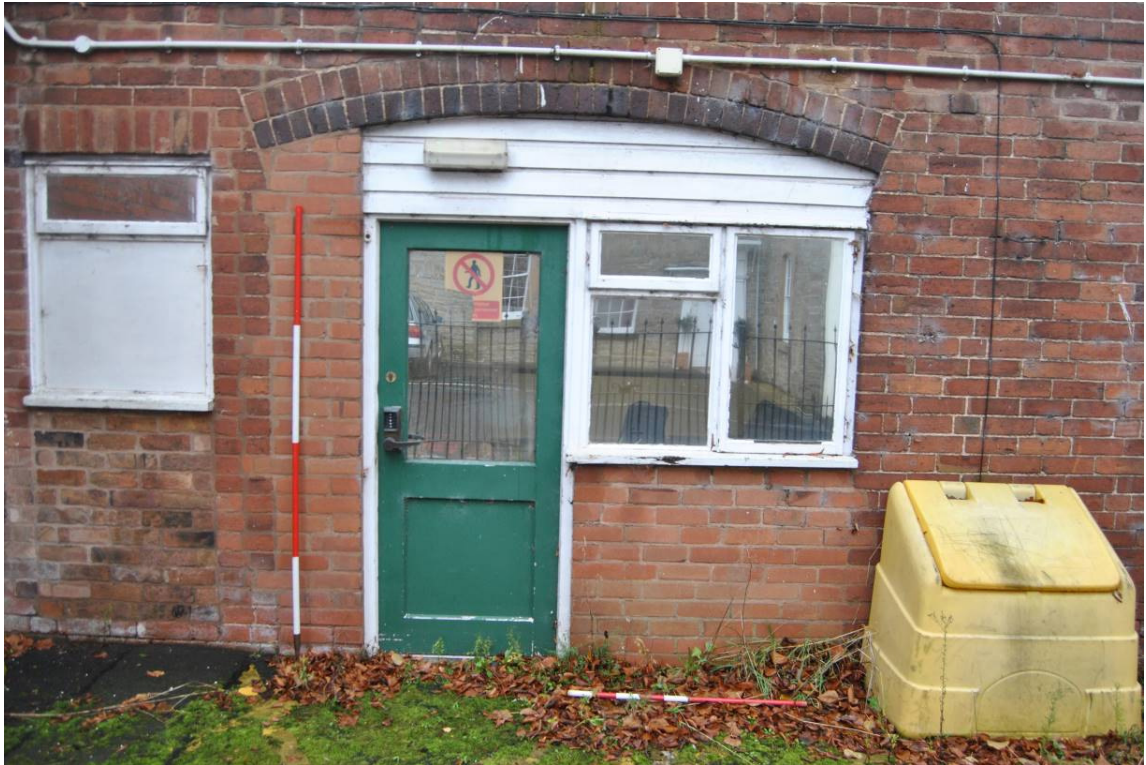
**Plate 41:** Modified coach house door **d3** and window **w2**.

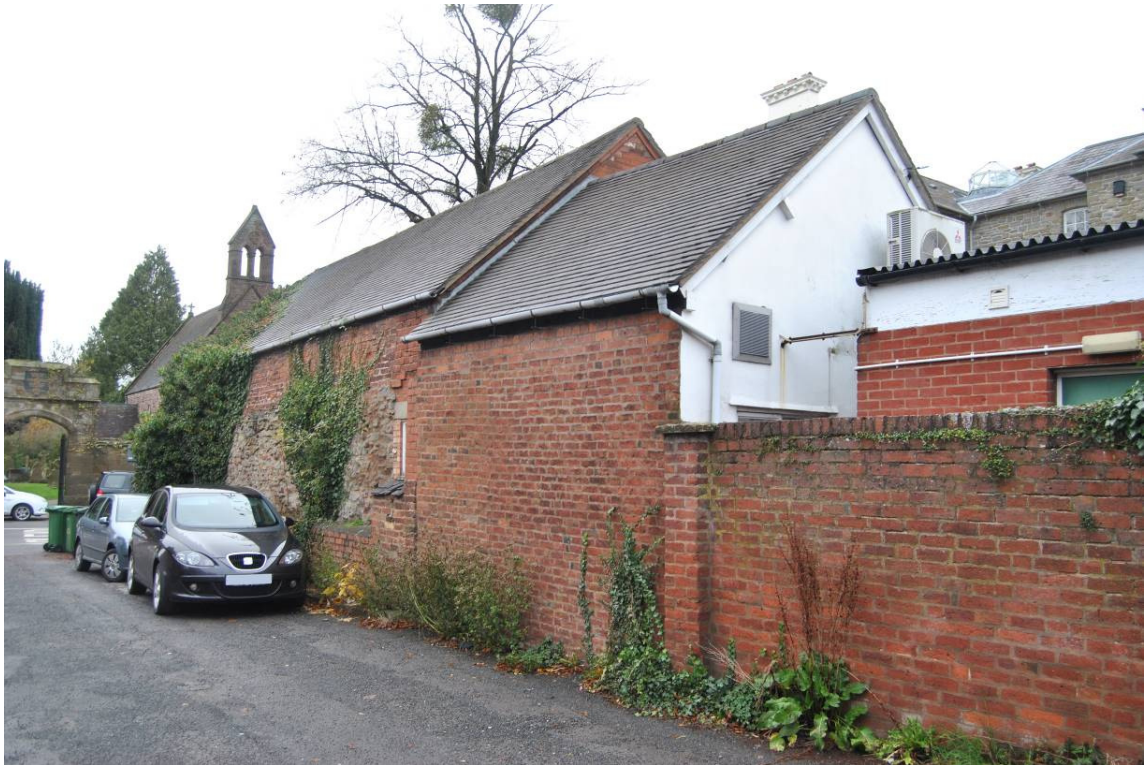
**Plate 45:** Stable block / coach house range, oblique view looking north-west **NB.** rendered gable end of early 'in-line' extension (right).

- 7.2.6 The **east elevation** (Figure 17b; Plate 45) comprises the gable end of the small ‘in-line’ continuation of the coach house range, shown on the 1862 map, fully rendered and with a single inserted window to the south. The block has been extended northwards (pre-1950) in orange brick beneath a hipped roof, initially to form a garage, accessed from the north. The apex of the brick built coach house gable is visible over.

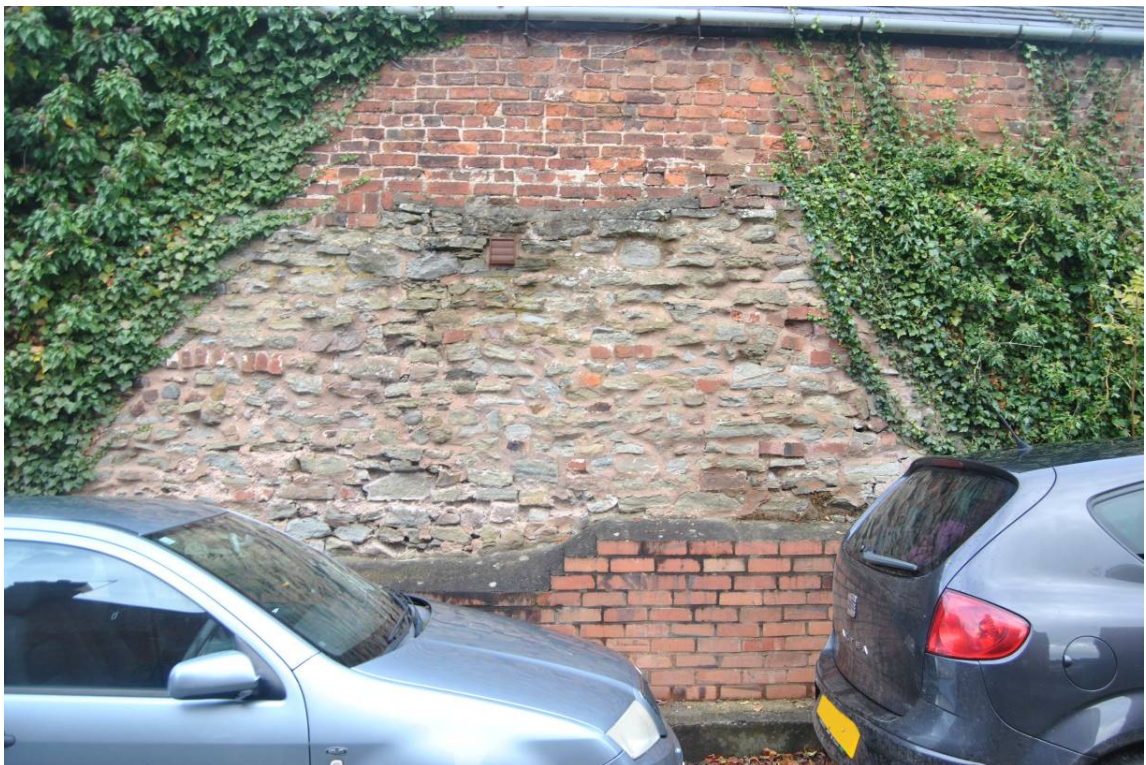
**Plate 46:** Varied construction of south wall of stable block (upper brickwork pre-dates construction of stables.)

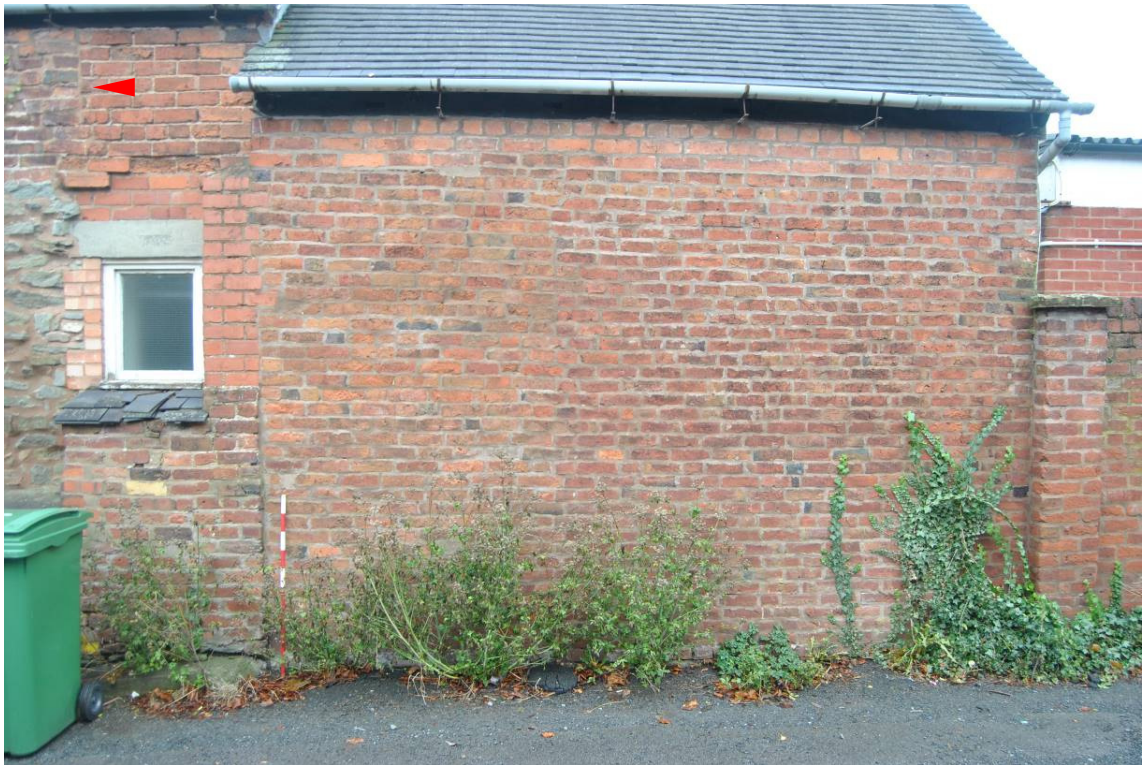
**Plate 47:** Early brickwork to south elevation of 'Stable Meeting Room' [G7], possibly part of a structure shown on the 1847 tithe map (Figure 4b). **NB.** SJ to left (marked with arrow) possibly indicates stable block built up against one of the early ranges depicted on historical mapping backing onto wall to north (see Figure 5).

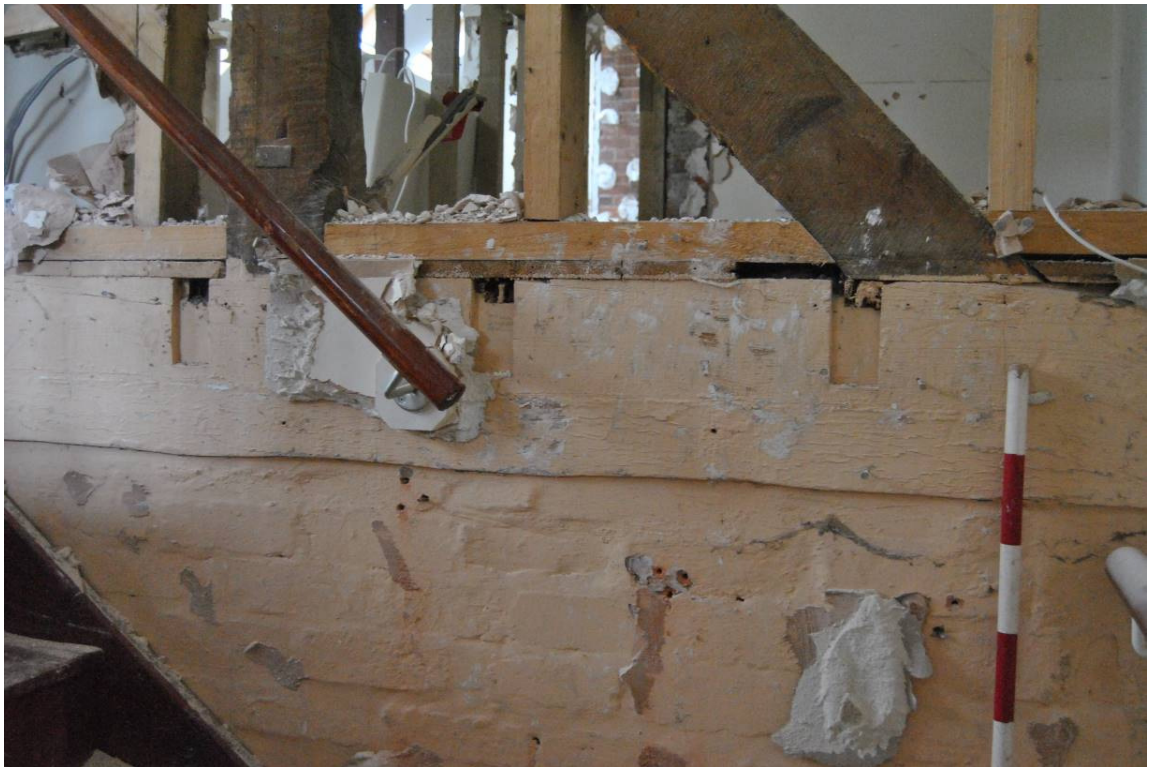
Plate 58: Original transverse 1F beam, visible in stair-well (east wall) after stripping.

<sup>78</sup> The associated, secondary floor structure is supported on north-south aligned common joists (8 x 3in. @ 17in. centres), and was noted to continue within room [G2] (though lacking the axial steel within the latter room). The details of the roof trusses recorded at first floor level (see below) indicate original transverse ceiling beams with common joist thus aligned east-west (see §.7.2.9; Plate 58).
