**Broadlees Bottom,
near Dover Castle,**

Walkover survey report

Project Code: BBD-DA-13

Report No: 2013/31

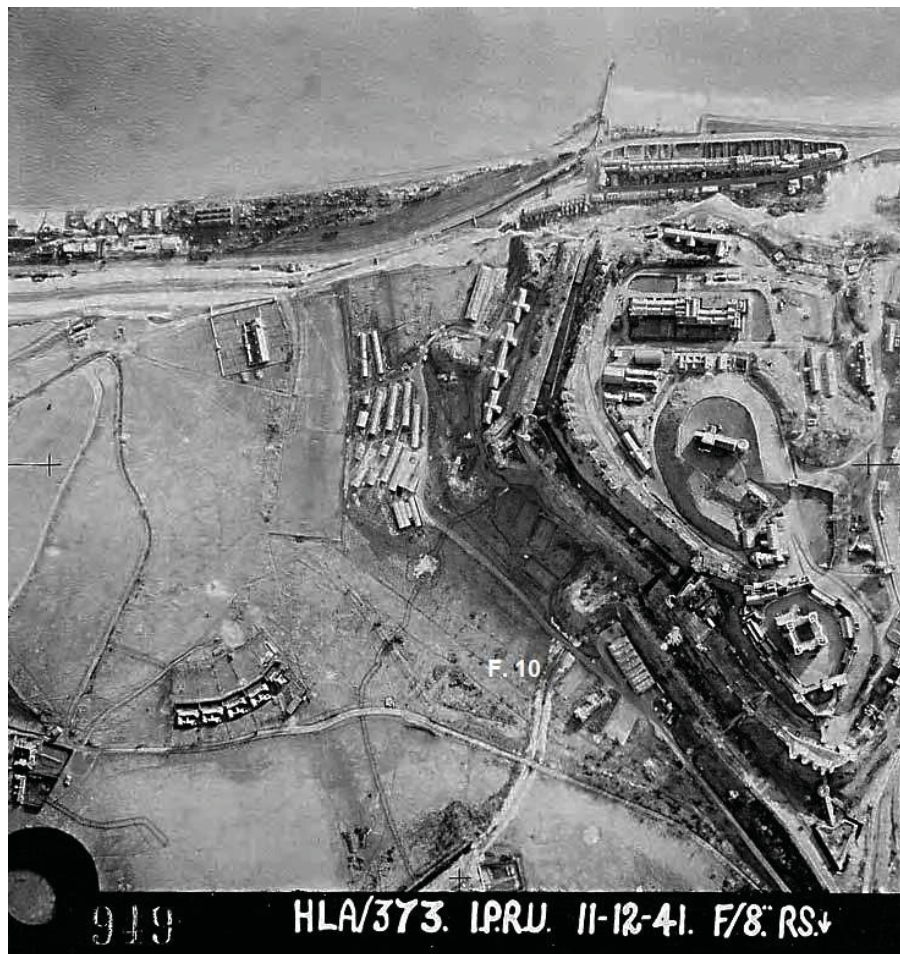
Plate VII, Aerial photograph dated 1941 showing line of anti-tank ditch (F. 10) running between Horseshoe Bastion and the East Wing Battery of Fort Burgoyne (image provided by Dover Museum)

A vertical aerial photograph taken in 1941 clearly shows this ditch as then being open (Plate VII), following a slightly sinuous course, running uphill from the Horseshoe Bastion of the Castle to connected with the ditch surrounding the East Wing Battery of Fort Burgoyne. A photograph taken in the 1950s (Plate VIII) reveals that by then the ditch across Northfall Meadow had been filled-in but a chalky scar still marks its line.

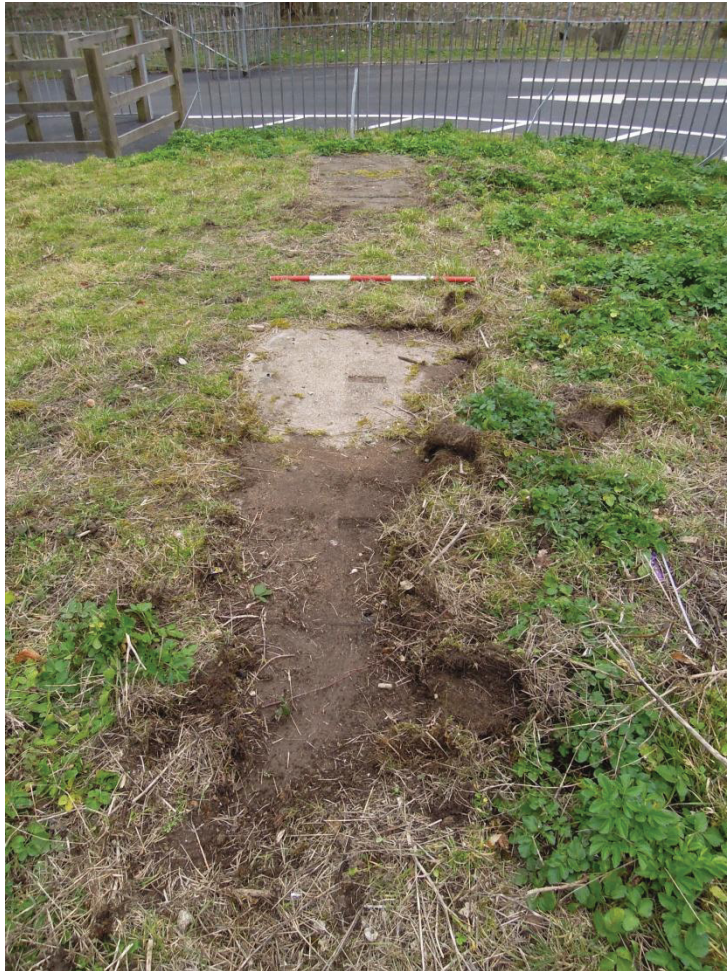
In the north-west point of the triangular study area, adjacent to Upper Road, are two modern concrete inspection chamber covers (Plate IX). These are both orientated roughly north-south and cast iron 'P O' plaques set into their tops (Plate X) indicate that they are connected with telecommunications equipment below. No attempt to open the chambers was made as they had every appearance of being in regular use. Some investigation in the potentially military origins of any telephone lines in this area (connection with the Second World War tunnels beneath Dover Castle?) could be of interest.

Plate IX, General view of concrete covers of two modern inspection chambers F.1, looking south (scale, 1m)

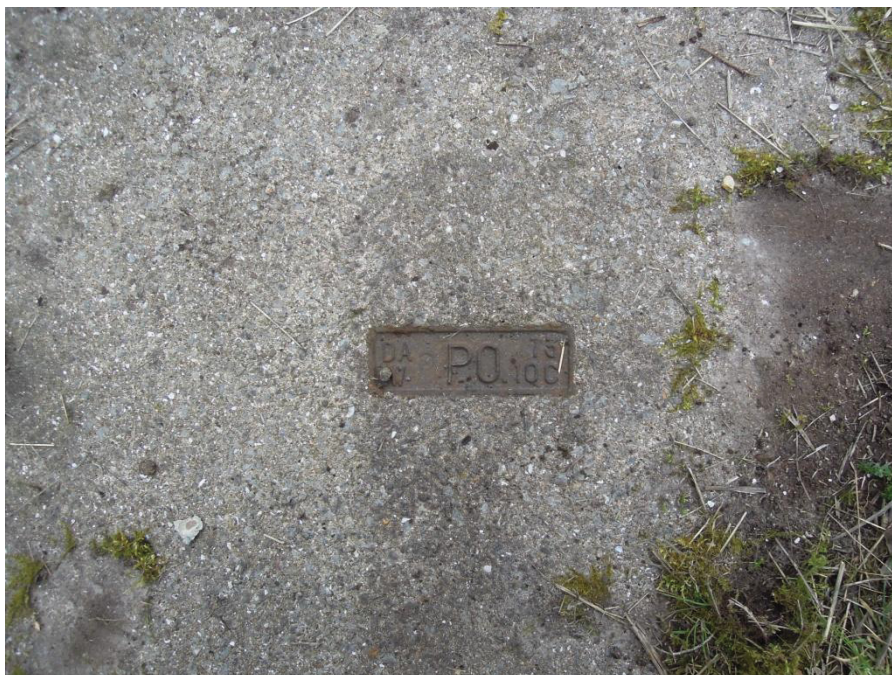
Plate X, Detail of concrete cover of inspection chamber F.1, showing iron 'P O' plaque

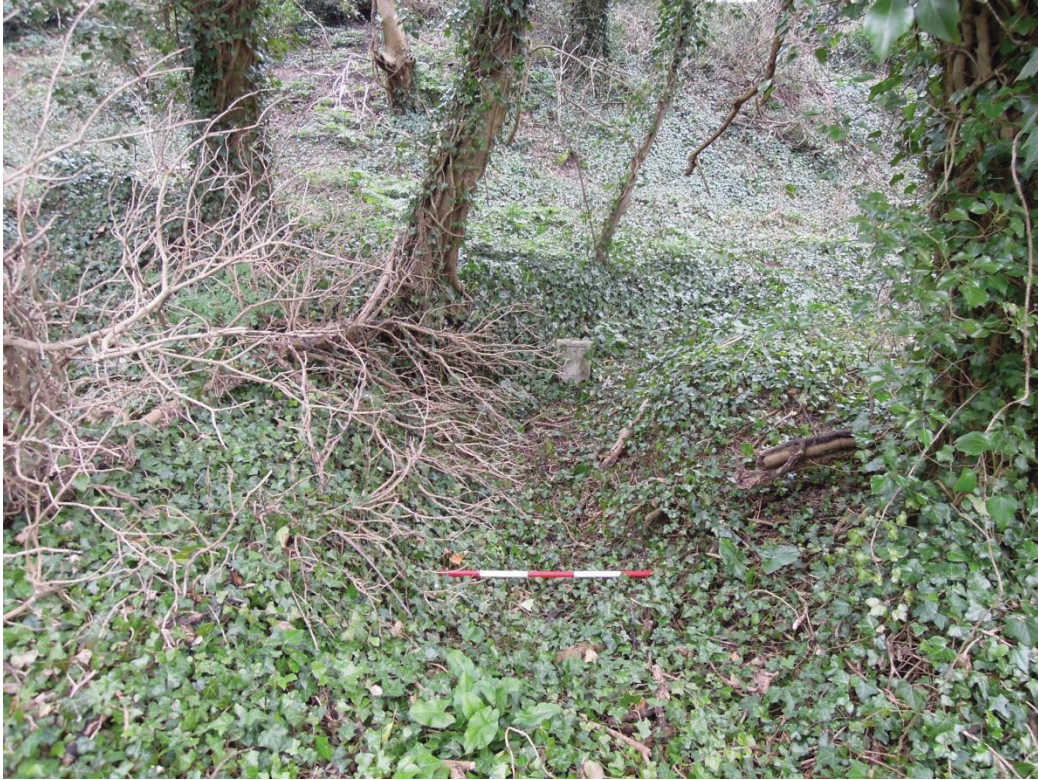
South-east of the F. 2, an irregular, overgrown trench with associated spoil heap was located 17.50m north-east of the military road. In detail, the trench was about 5m long (N–S), 2m wide and 1m deep. Set upright at its northern end was a concrete marker-post of a type used to indicate the presence of services (Plate XI). The overall impression gained was that this excavation represented an attempt to locate and mark the line of a buried service (perhaps the main drain leading down from Connaught Barracks, see notes on F. 11 below). No traces of any pipe or cable were visible in the base of the trench. The metal cover for a water-main stop-cock was noted amongst vegetation a short distance to the south of F. 3, opposite the Fitzwilliam Gate – blue spray paint on this suggested that it is still live.

Plate XI, General view of trench with concrete marker F. 3, looking north (scale, 1m)

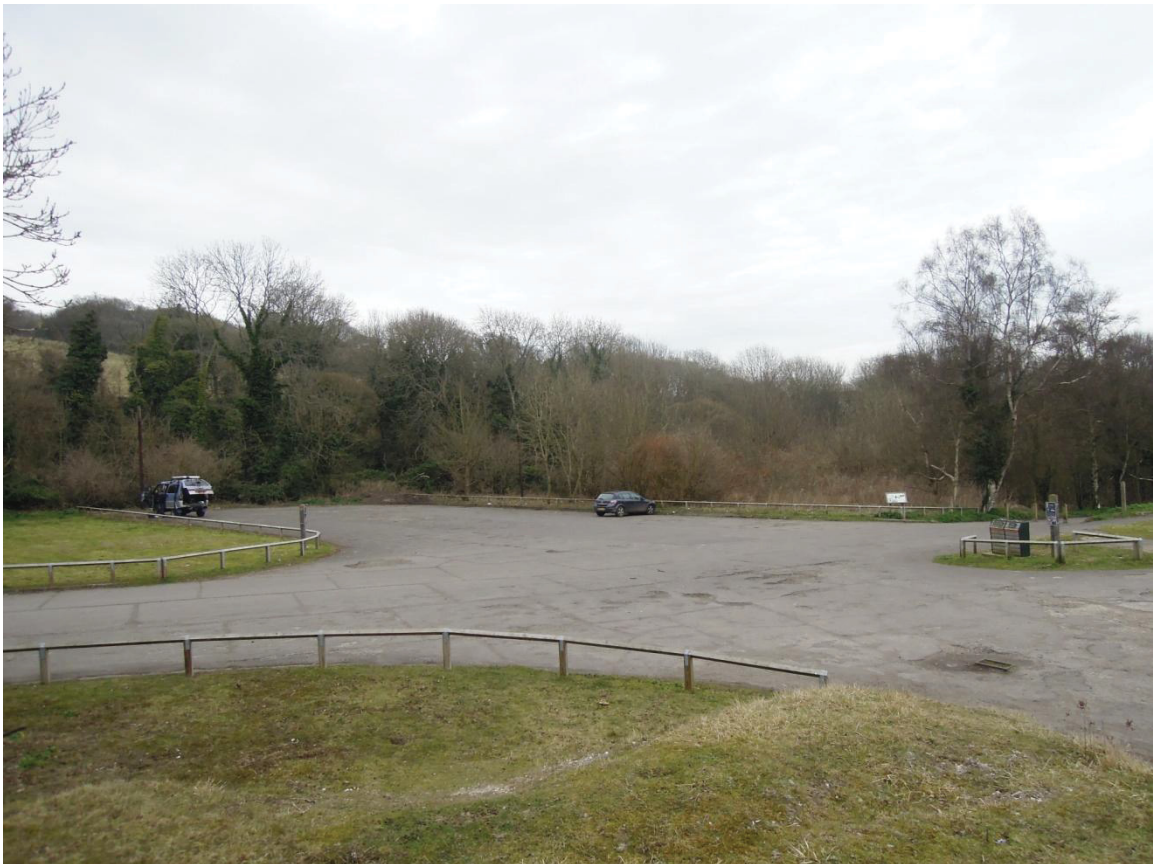
A large open area marked on the 1923 plan as ‘marshalling yard’ is still extant, opening off the northern side of the military road. It presently serves as a car park for visitors to the Blériot memorial (Plate XII). The yard measures about 23m (E–W) by 42m (N–S) and its surface stands at an elevation of about 74m above OD. As seen today, it consists of a rectangular area of laid tarmac (at least two phases), edged with concrete kerb stones along the north and east sides. A disused wooden telegraph pole stands near the north corner of the yard with another on the east side. Also at one point on the east side the outline of a square, brick-edged drain or man-hole is visible. More of these are shown on the 1997 survey.

Plate XII, General view of the former marshalling yard F.6, looking north-east

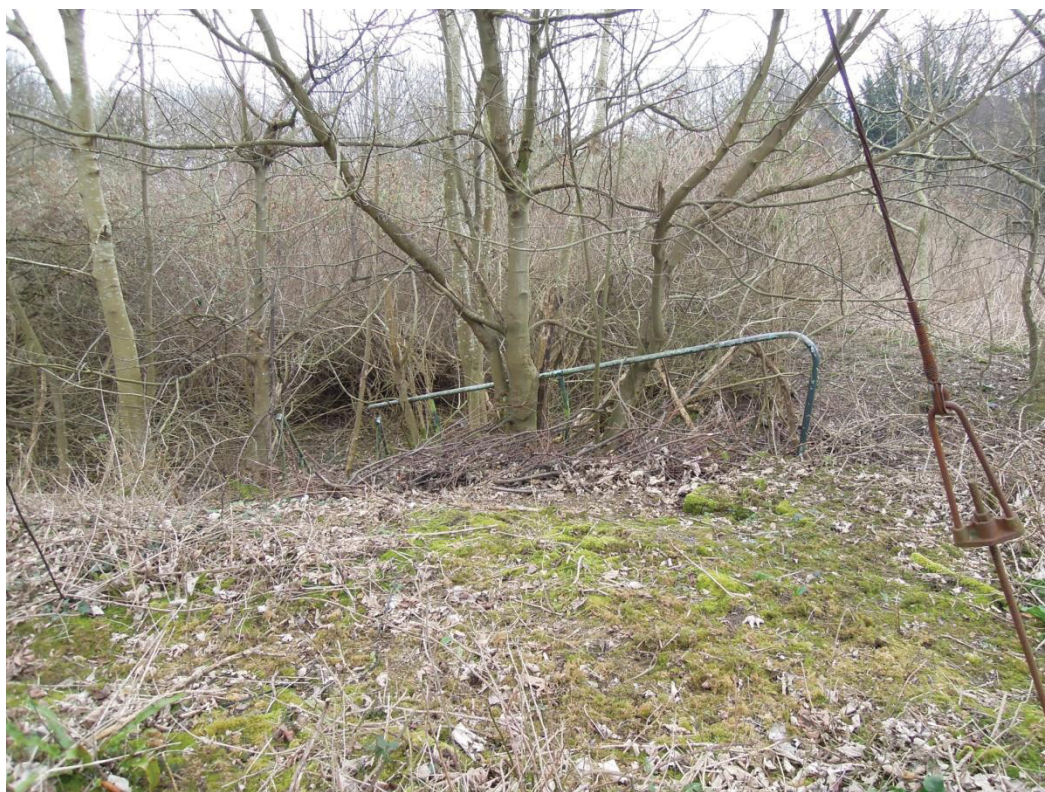
A series of brick and concrete steps run down from the marshalling yard to the site of the former Sergeants’ Mess which is set on a terrace around 3–4m below the level of the yard. An initial flight of ten steps, leading down north-eastwards, terminates just above the concrete retaining wall (F. 8, see below). Along the southern side, these steps are provided with a green-painted steel hand rail (Plate XIII). A shorter flight of four steps, laid out on a more easterly orientation, are set at a right-angle against the concrete retaining wall. Green-painted steel hand-rails are provided on both sides of these steps (Plate XIV).

Plate XIII, General view of steps and hand-rail F. 7 leading down from marshalling yard, looking south-east

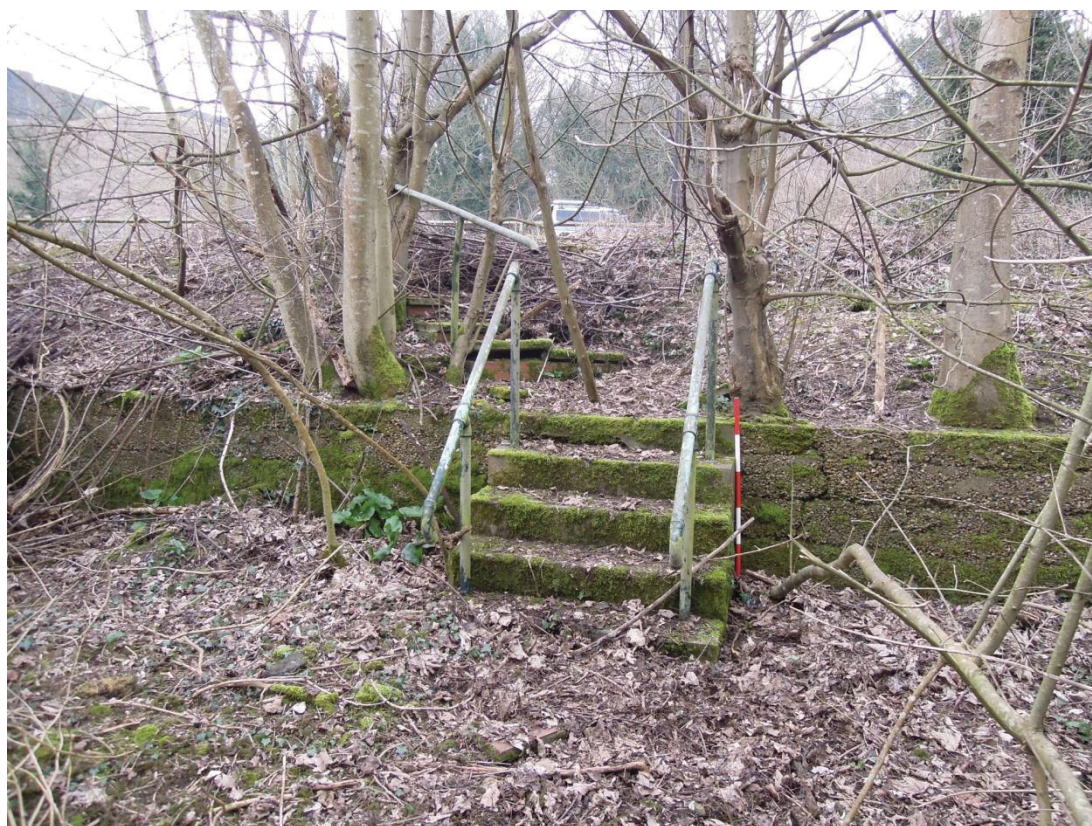
measured about 36m (NE–SW) by 15m (NW–SE) but no traces of the structure were noted in 2013 beyond a concrete wall, standing up to 1m high, retaining the terrace for the building along the western side (Plate XIV).

Plate XIV, Lower steps and concrete retaining wall relating to former building F. 8, looking north-west (scale, 1m)

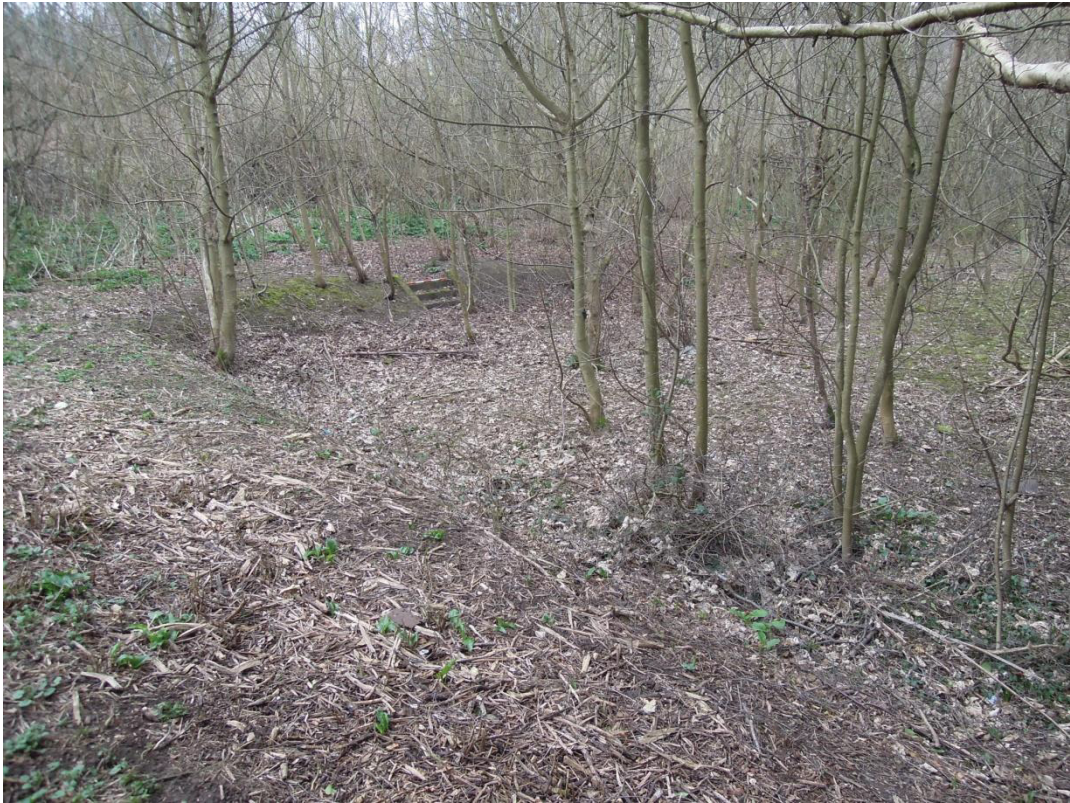
A short distance to the south-east of the site of the Sergeants' Mess and set square to it, is another level terraced area, with a bank up to 1m deep cut into the hill-slope along the north-western side. This terrace is now largely covered by trees (Plate XV). As traced on the ground, it measured about 35m (NE–SW) by at least 30m (NW–SE). Along the north-western side three short flights of concrete access steps survive, positioned one at either end (Plate XVI) and one in the middle. The middle flight is now largely destroyed by growing trees. The surface of the terrace lies at about 68m OD.

Plate XV, General view of west corner of lower terrace F. 9, with steps, looking north

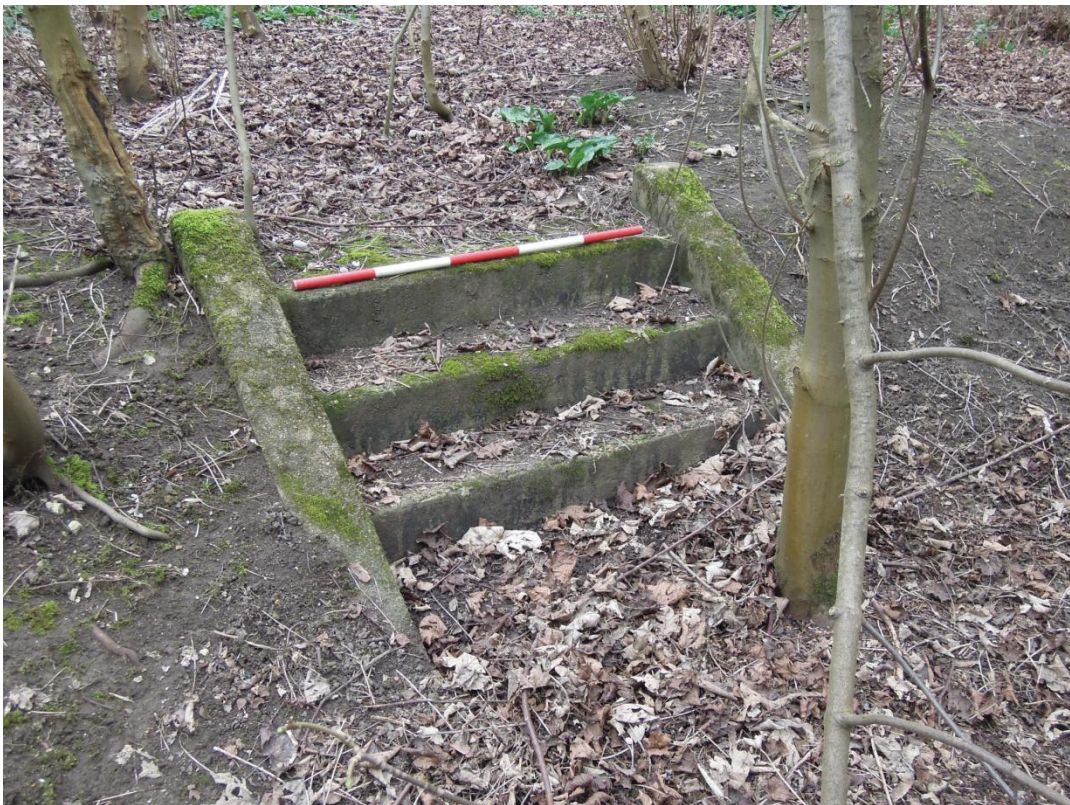
Plate XVI, South-western concrete steps associated with lower terrace F. 9, looking north-west (scale, 1m)

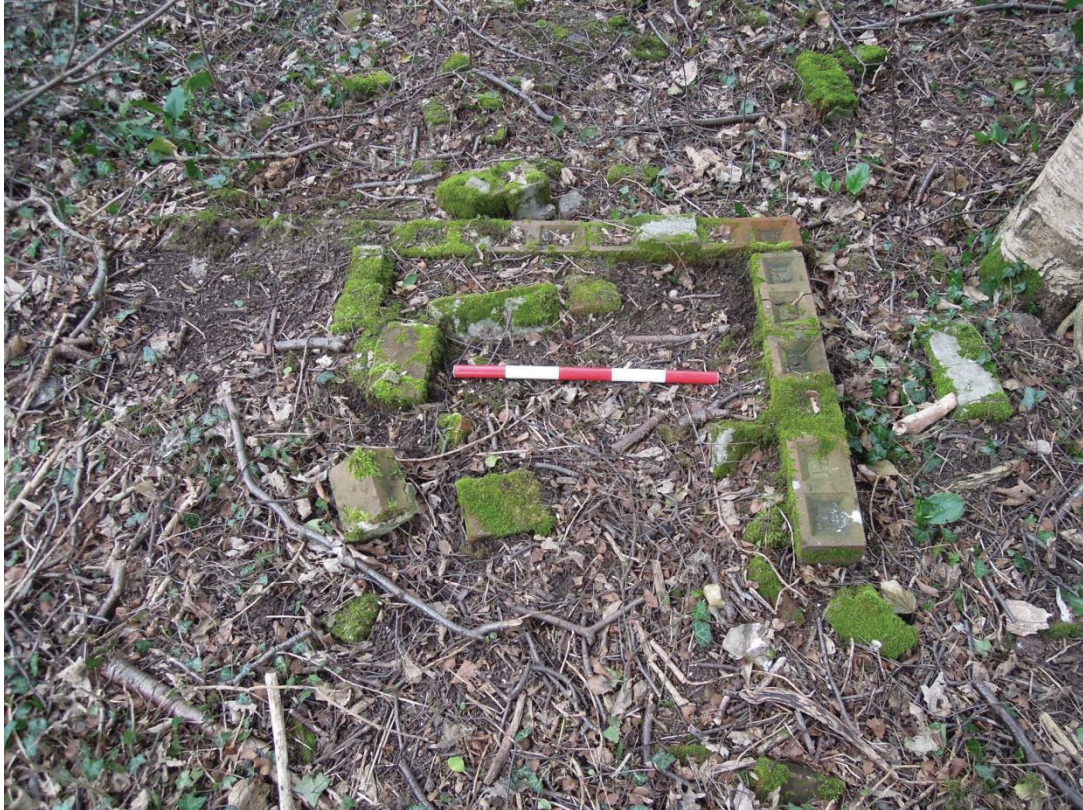
It initially seemed possible that this terrace marked the site of another building, but a photograph of Dover Castle taken in the 1950s clearly shows the feature then as open ground (Plate VIII). Ordnance Survey maps of the 1970s mark it as being a tennis court. In the light of this, the surface scatter of brick rubble noted across the terraced area in 2013 seems most likely to derive from the demolition of the adjacent Sergeants' Mess, with which the tennis court was probably originally associated. On the south-west side of the terrace, the outline of a small brick structure, perhaps a double man-hole, was noted in 2013 (Plate XVII).

Plate XVII, Brick base or man-hole on south-west side of lower terrace F. 9 (scale, 50 cm)

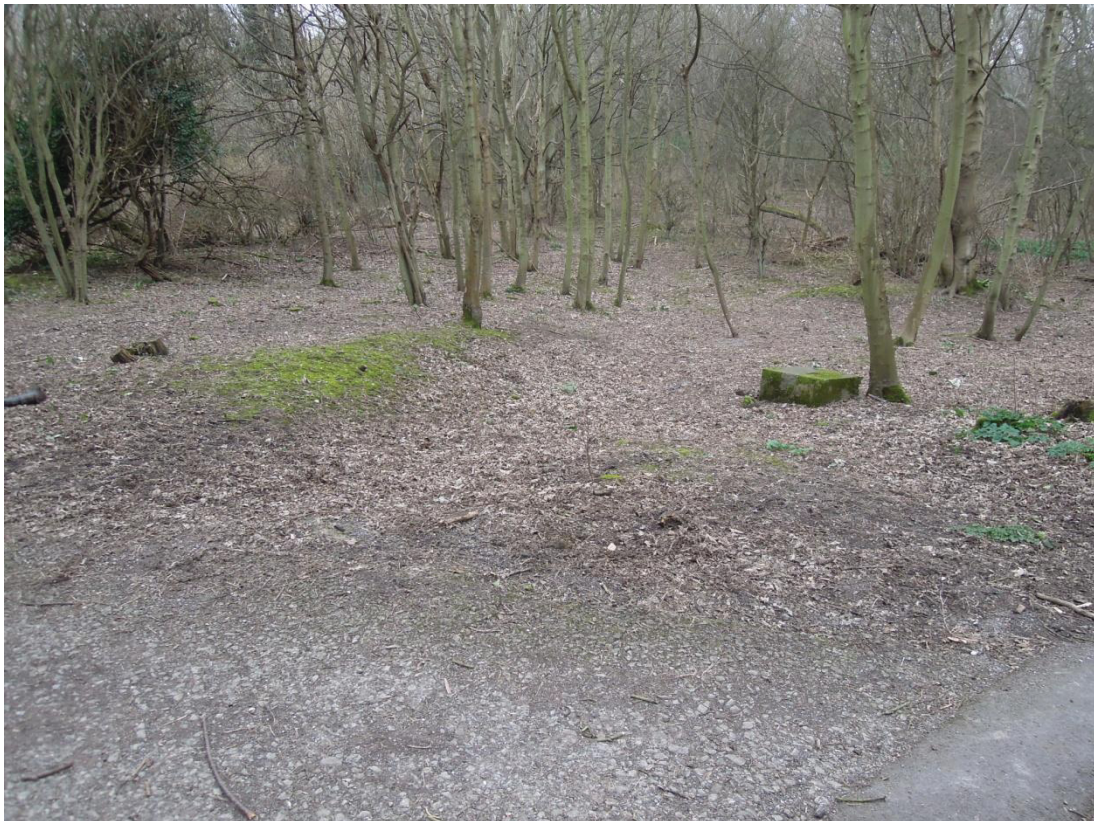
As seen on the ground, the line of this in-filled ditch was generally about 8m across the top and up to 1m deep (Plates XVIII & XIX). Immediately adjacent to Upper Road, however, the backfilling had been less complete and for a distance of about 20m here the ditch appeared to be little more than half full. Again, it was about 8m wide and some 2m deep. Traces of an associated bank survived on either side (Plate XXI).

Plate XVIII, Line of in-filled ditch F. 10, looking north (concrete block marks eastern edge)

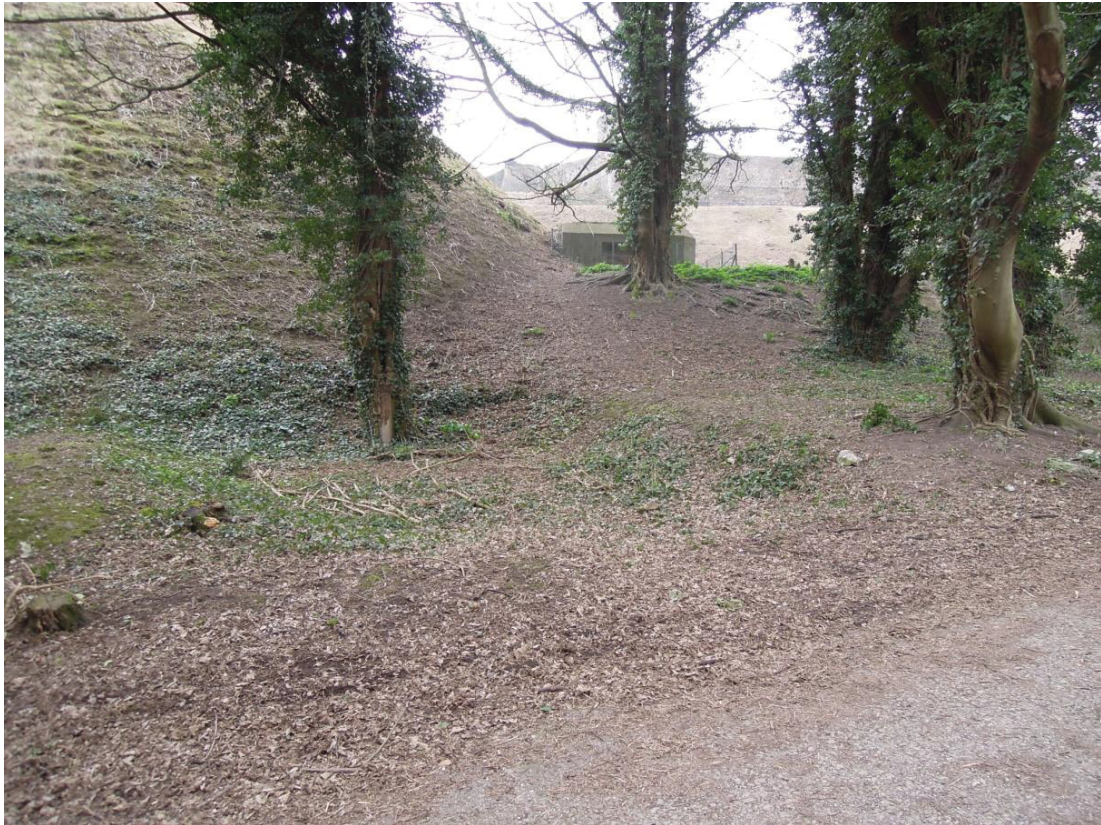
Plate XIX, Terminal of ditch F. 10 at foot of Horseshoe Bastion, looking south-west

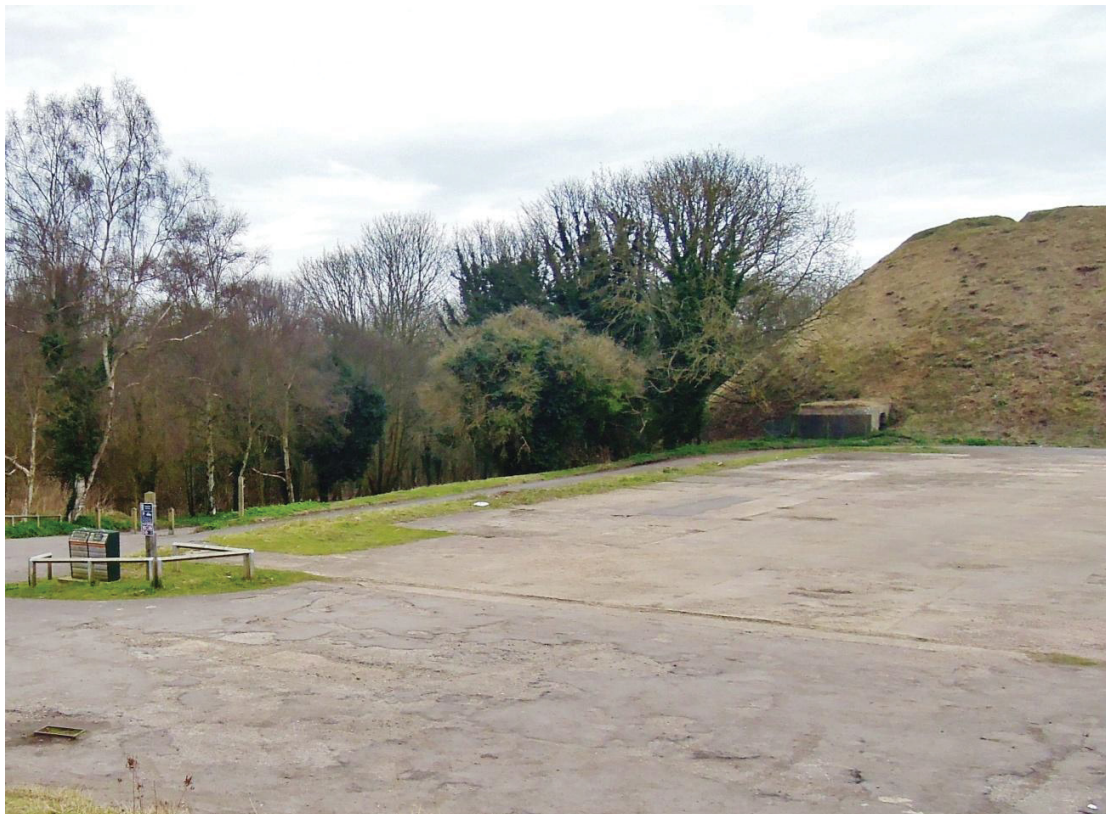
Plate XX, Anti-tank pillbox set into base of Horseshoe Bastion, looking south-east

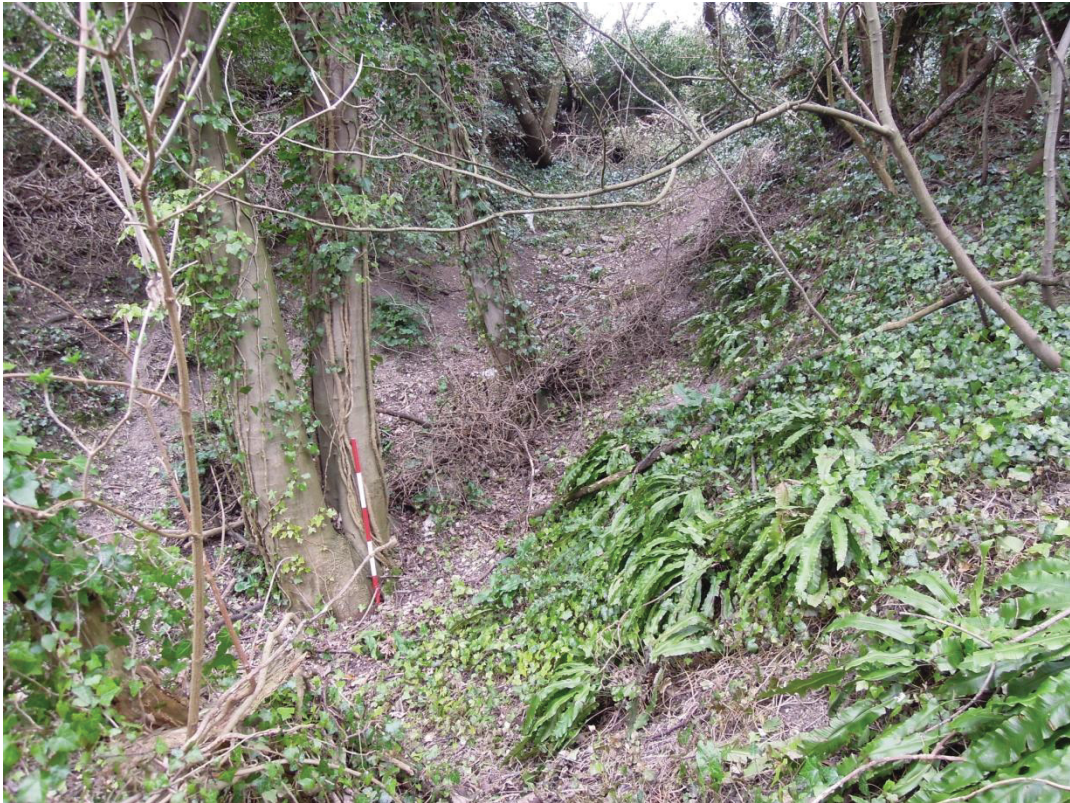
Plate XXI, Section of ditch F. 10, adjacent to Upper Road, looking north (scale, 1m)

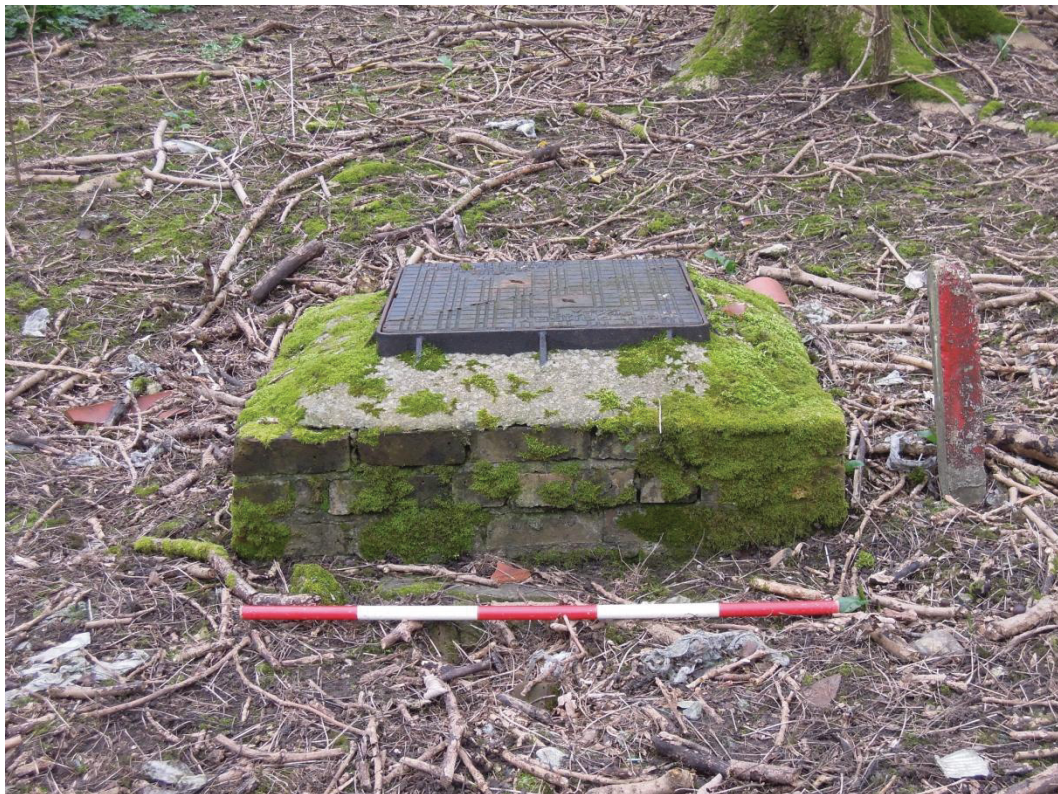
A single brick and concrete man-hole was located in the valley-bottom, towards the eastern side of the study area. This is approximately 1m square and stands 0.30m above present ground level at about 65m OD. It is surmounted by a modern square, cast iron cover and is still in use as a sewer (running water heard). A short (0.45m high) concrete marker post stands close-by on its northern side (Plate XXII).

Plate XXII, Brick and concrete man-hole F. 11, looking west (scale, 1m)

A map recording the drainage arrangements for the Broadlees Military Prison and Fort Burgoyne, dated 1949 (ref CLA DWG No. 542, accessed on Dover District Council website) shows the line of a main drain/sewer running west–east through Northfall Meadow. The present man-hole must be related to this. As indicated by the map, the drain then primarily served the military camp known as Fort Burgoyne Huts and married soldiers' quarters on Upper Road. The present man-hole would seem to be located at the point where this drain connected with a second one leading down from Fort

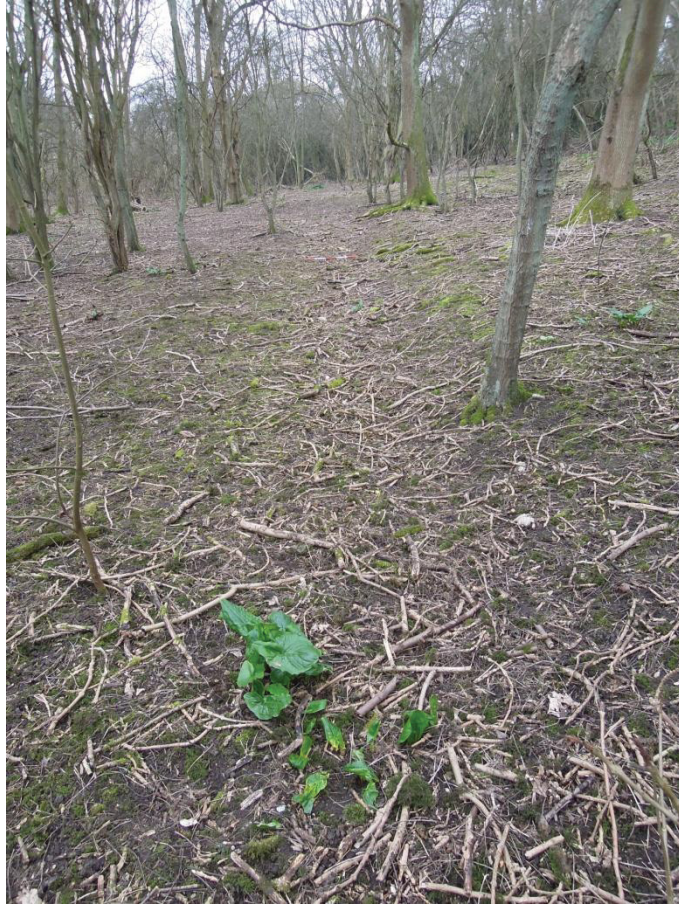
A shallow terrace about 2m wide and up to 0.50m deep, cut into the hill slope just above the valley bottom, appeared to represent the line of a former pathway (Plate XXIII). It lay about 26m north of the cambered roadway, F. 13 (see below). Seemingly cut through by the ditch, F. 10 it was otherwise traceable for around 180m, from the eastern boundary of the present study area, westwards at least as far as a point opposite the marshalling yard (F. 8). After this, it was completely obscured by vegetation. Eastwards beyond the study area, it continued on as a slightly more clearly defined track. There was no sign of any surface metalling and probing with a metal rod was somewhat inconclusive, although hard material was encountered at depths of between 0.10 and 0.15m in several places.

Plate XXIII, Line of lower terraced pathway F. 12, looking west (scale, 1m)

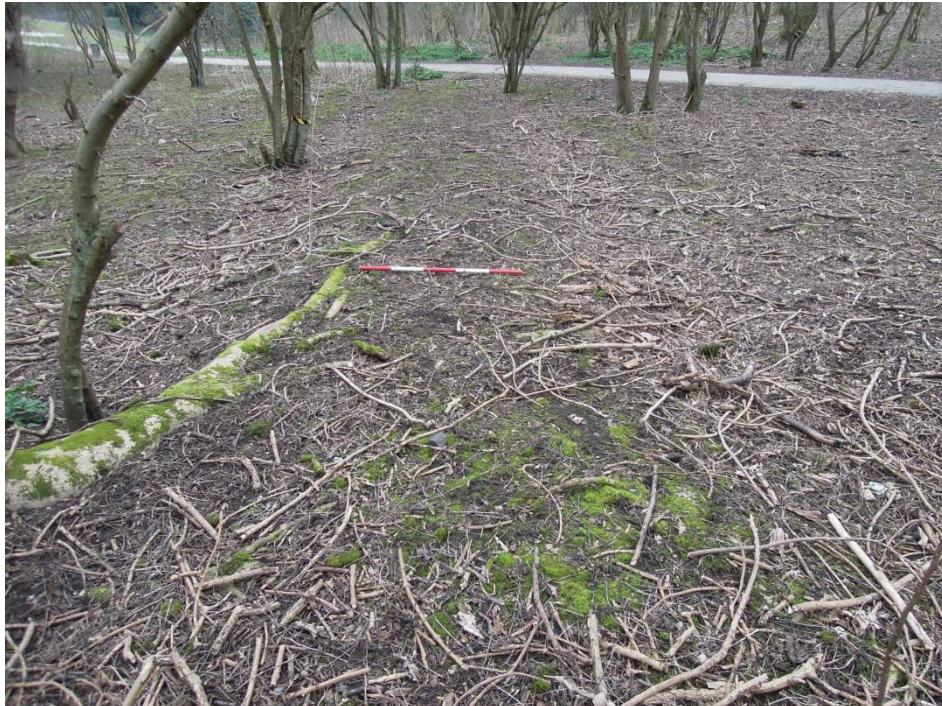
Running along the bottom of the valley, in the area between the footpath to Blériot's memorial and the in-filled ditch F. 10 were the earthwork remains of what appeared to be a cambered roadway with shallow side gutters (Plate XXIV). This was about 3m wide, aligned roughly east–west. The centre of this roadway lay about 8.50m south of man-hole, F. 11 and around 25m south of the lower terrace-way, F. 12, running roughly parallel with it.

At the western it seemed clear that the roadway had been cut through and destroyed by ditch F. 10. Eastwards beyond the footpath, it was traceable for another 100m or more. There was no sign of any surface metalling but probing with a metal rod suggested that a continuous hard layer, incorporating coal-fire ash and cinders, lay buried at a depth of between 0.10 and 0.15m under the modern soil and leaf mould.

Plate XXIV, Line of cambered roadway F. 13 looking south-east (scale, 1m)
