DEVELOPMENT AT CALVERT'S CARPETS YARD, THIRSK
SCHEDULED MONUMENT COUNTY NO. 711 TOWN BANKS & CASTLE

INTRODUCTION

THE WATCHING BRIEF

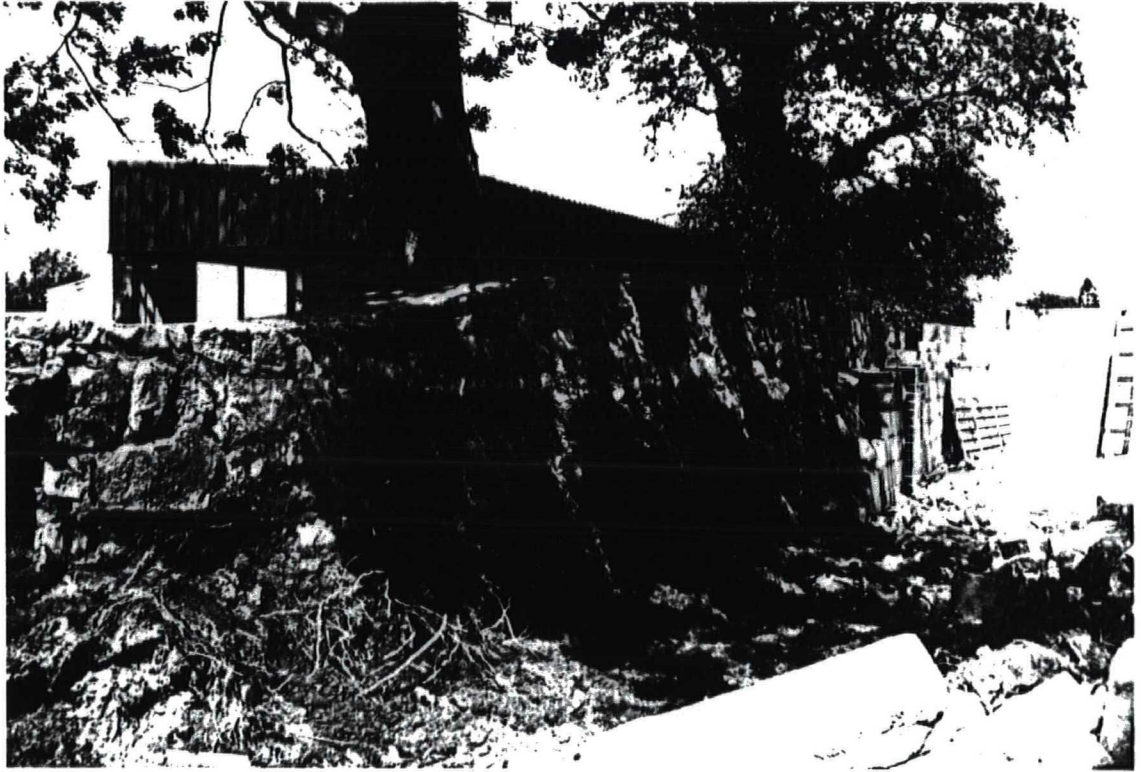
Pl. 5

The outside, western edge of the Town Bank remained in part as a boundary bank with a retaining wall between Calvert's Carpets Yard and Woodhead and Bray's Garage to the west (Pl. 5).

The western edge of the site, which forms the back of the new building, was also backed with a breeze block wall. This was topped for part of its length by a random stone wall c.1m high, running along the outside edge of the boundary bank which forms the remaining southern portion of the Town Bank (Pl. 5, 6, 7). The breeze block wall was partly demolished to create a straight line for the foundation trench of the new building. This revealed a section up to 1m above ground level and between 1m and 1.25m below it. The stone wall was left in situ above the bank.
