WHITBY ABBEY 1990 THE POND.

LANDSCAPE RESEARCH CENTRE  
(D. POWLESLAND)

During October 1990 small scale excavations undertaken both by machine and by hand and a borehole survey were undertaken to determine the condition and stability of the pond sediments and to gain some understanding of its construction and date range.

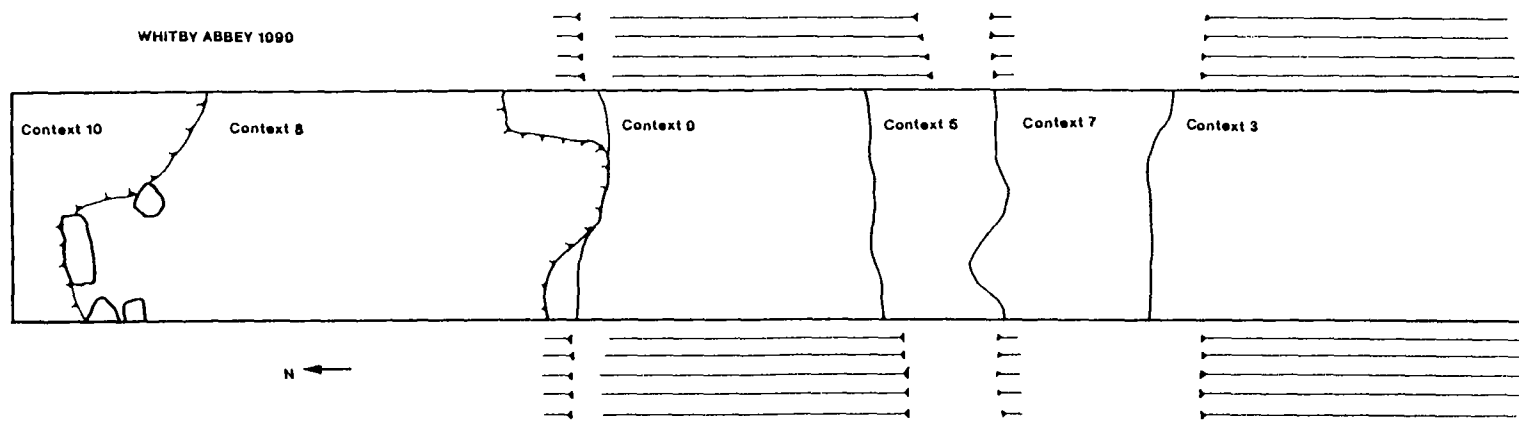
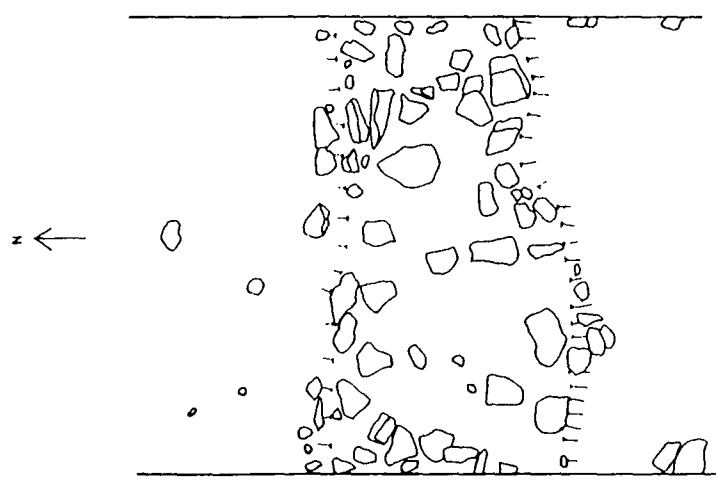
Context 5 Sandstone Concentration

Figure 5 plan of trench and Context 5.

On top of the bank a number of layers, (comprising contexts 3,4,5 and 6) would appear to be the progressive build up of material derived from clearing the pond. Context 5 was of particular interest, being visible before excavation as a slight rise running along the top of the bank. Once uncovered it could be seen to be a layer of hand sized fragments of limestone. This is most likely fragments of flag stones deposited during a recent pond clearance. The sediments also recovered and deposited at this time having been weathered a way to leave this heavier material behind. Although it must be admitted this layer was at first thought to be the vestiges of a low dry stone wall (figures 5 and 6). Material found in these layers comprised tile and pottery of both medieval and post medieval dates.

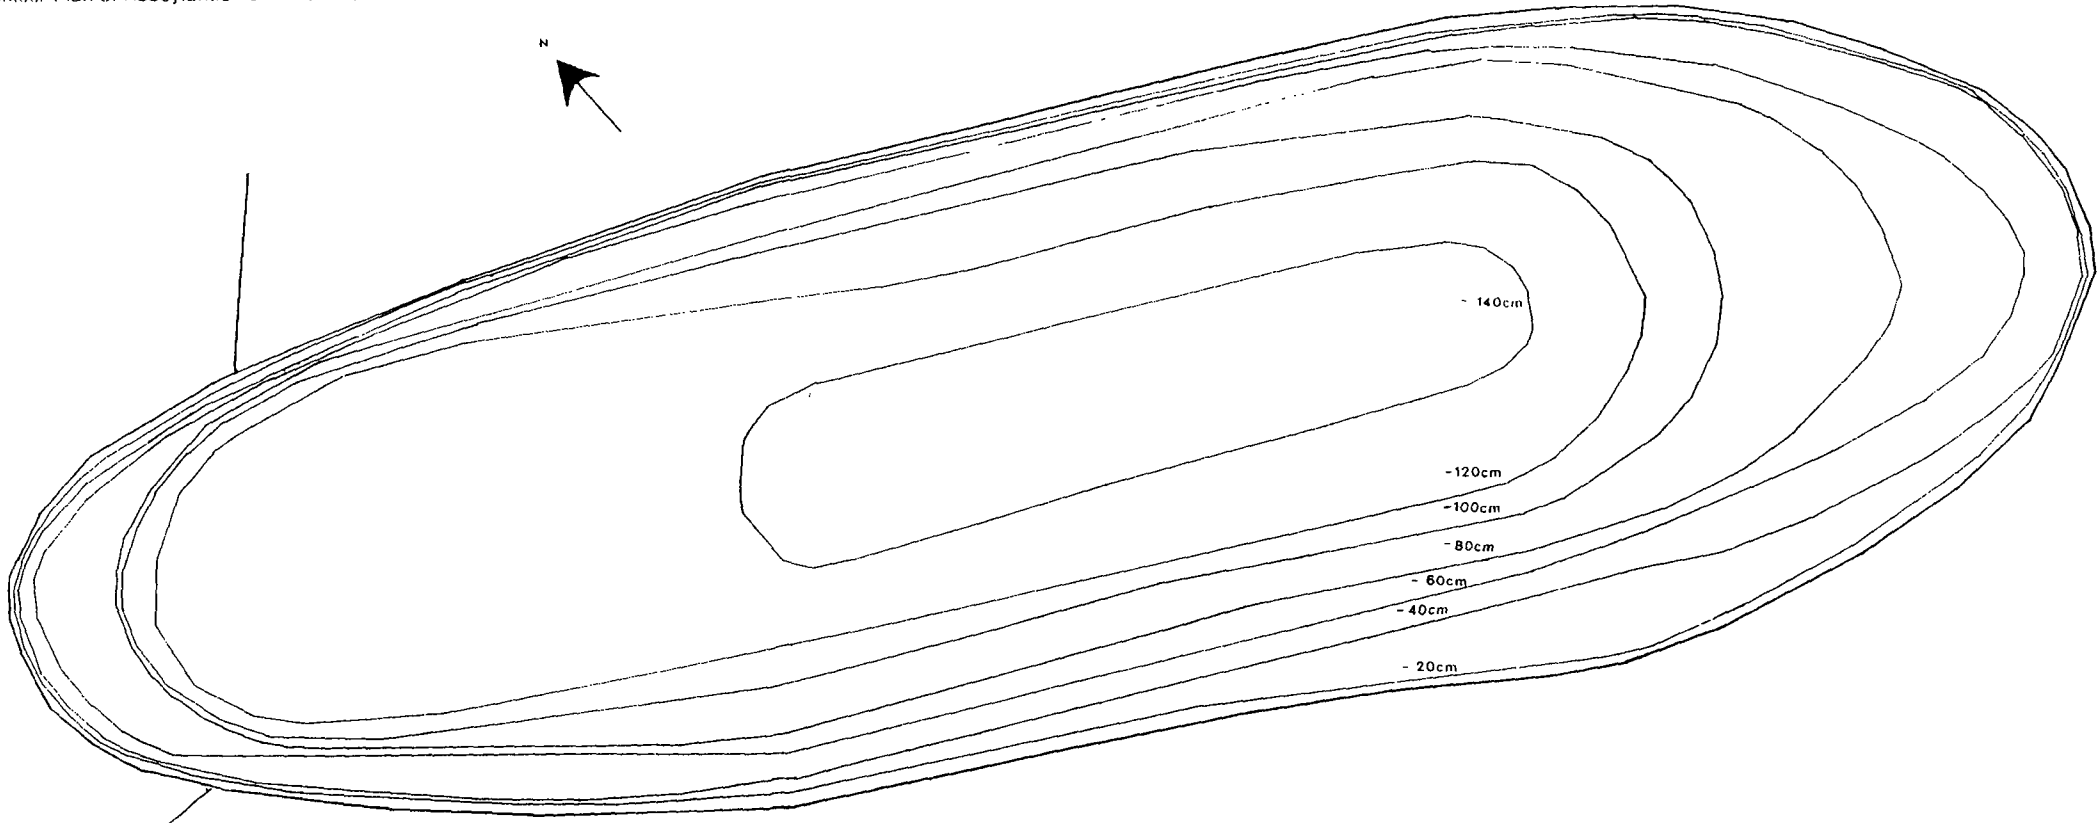
Figure 9 Contour Plan of Pond Base

Contour Plan of Abbeylands Farm Pond (Contours 20cm)

A longitudinal and three transverse lines were laid out and levelled on the pond surface. From these lines the depth was probed at metre intervals. A contour plan and profiles were prepared from these figures, ( Figures 9 to 13). Where encountered, the presence of a solid bottom was noted,

The pond has a broad U profile with a firmer lip running around the edge. To the north this forms the pavement displayed on the guardianship site, a platform some 20 meters long and the width of the pond extends to the south from this uncovered portion. A coherent pavement was not found at the southern end of the pond. The remainder of the pond had a clay base, this was partly exposed by the machine trench.

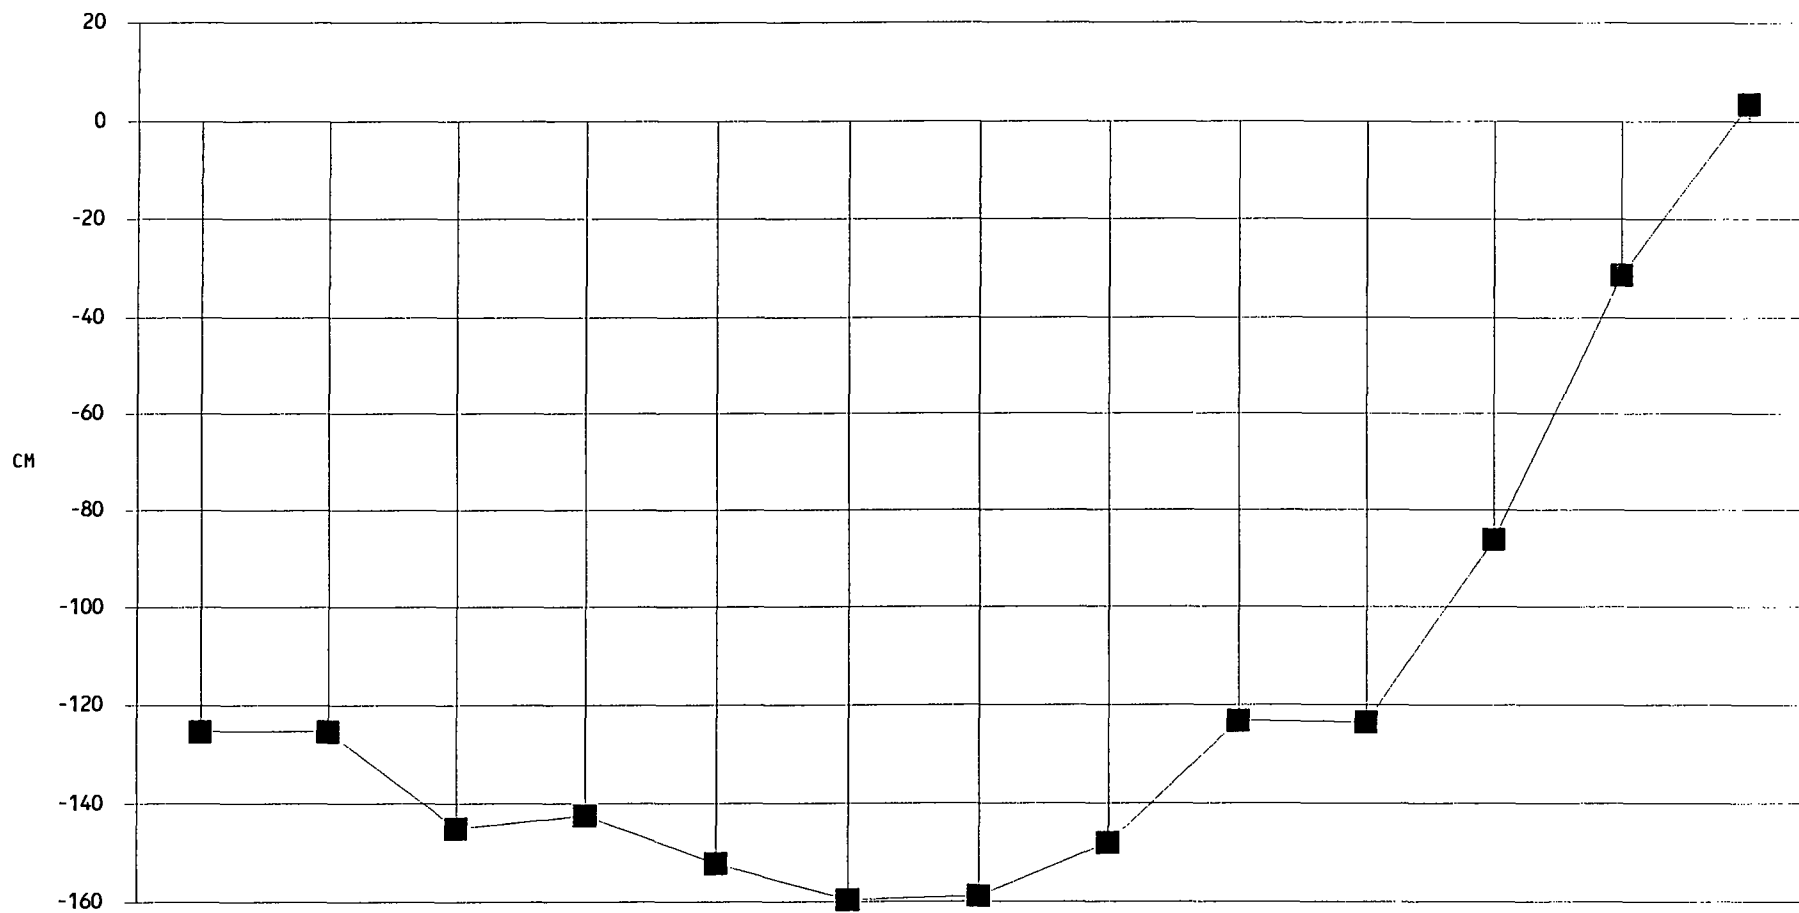
Figure 10; Profile Line 1.

1 bar equal to 1 meter.

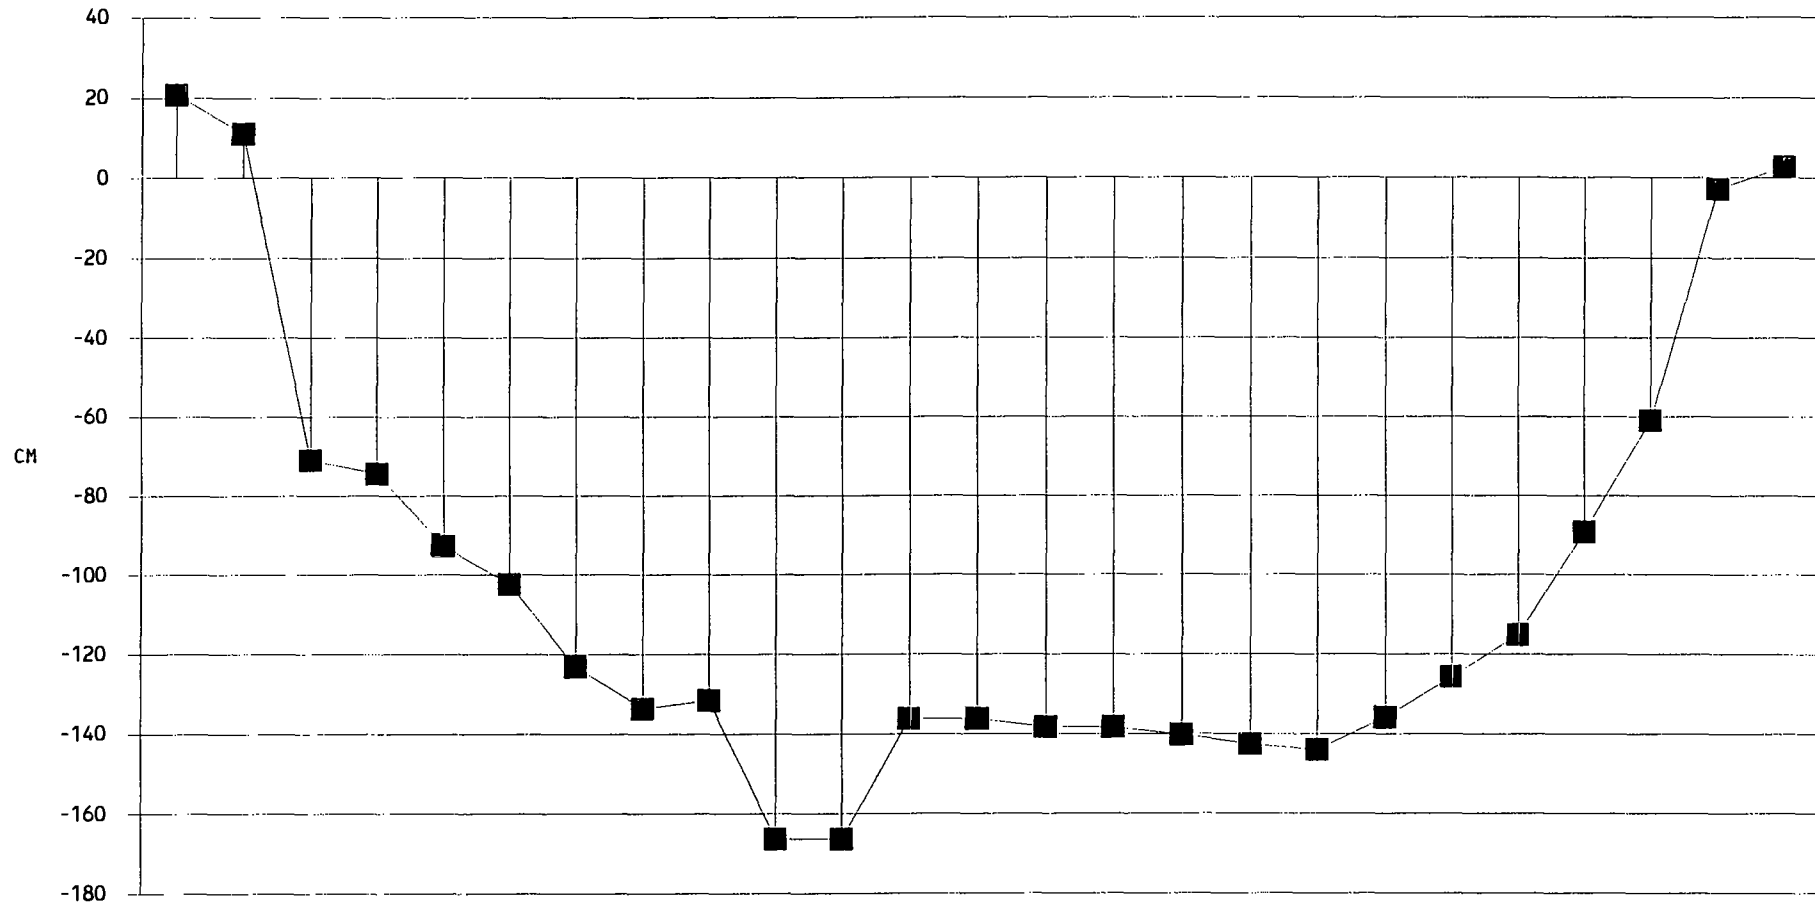
Figure 11; Profile Line 2.

1 bar equal to 1 meter

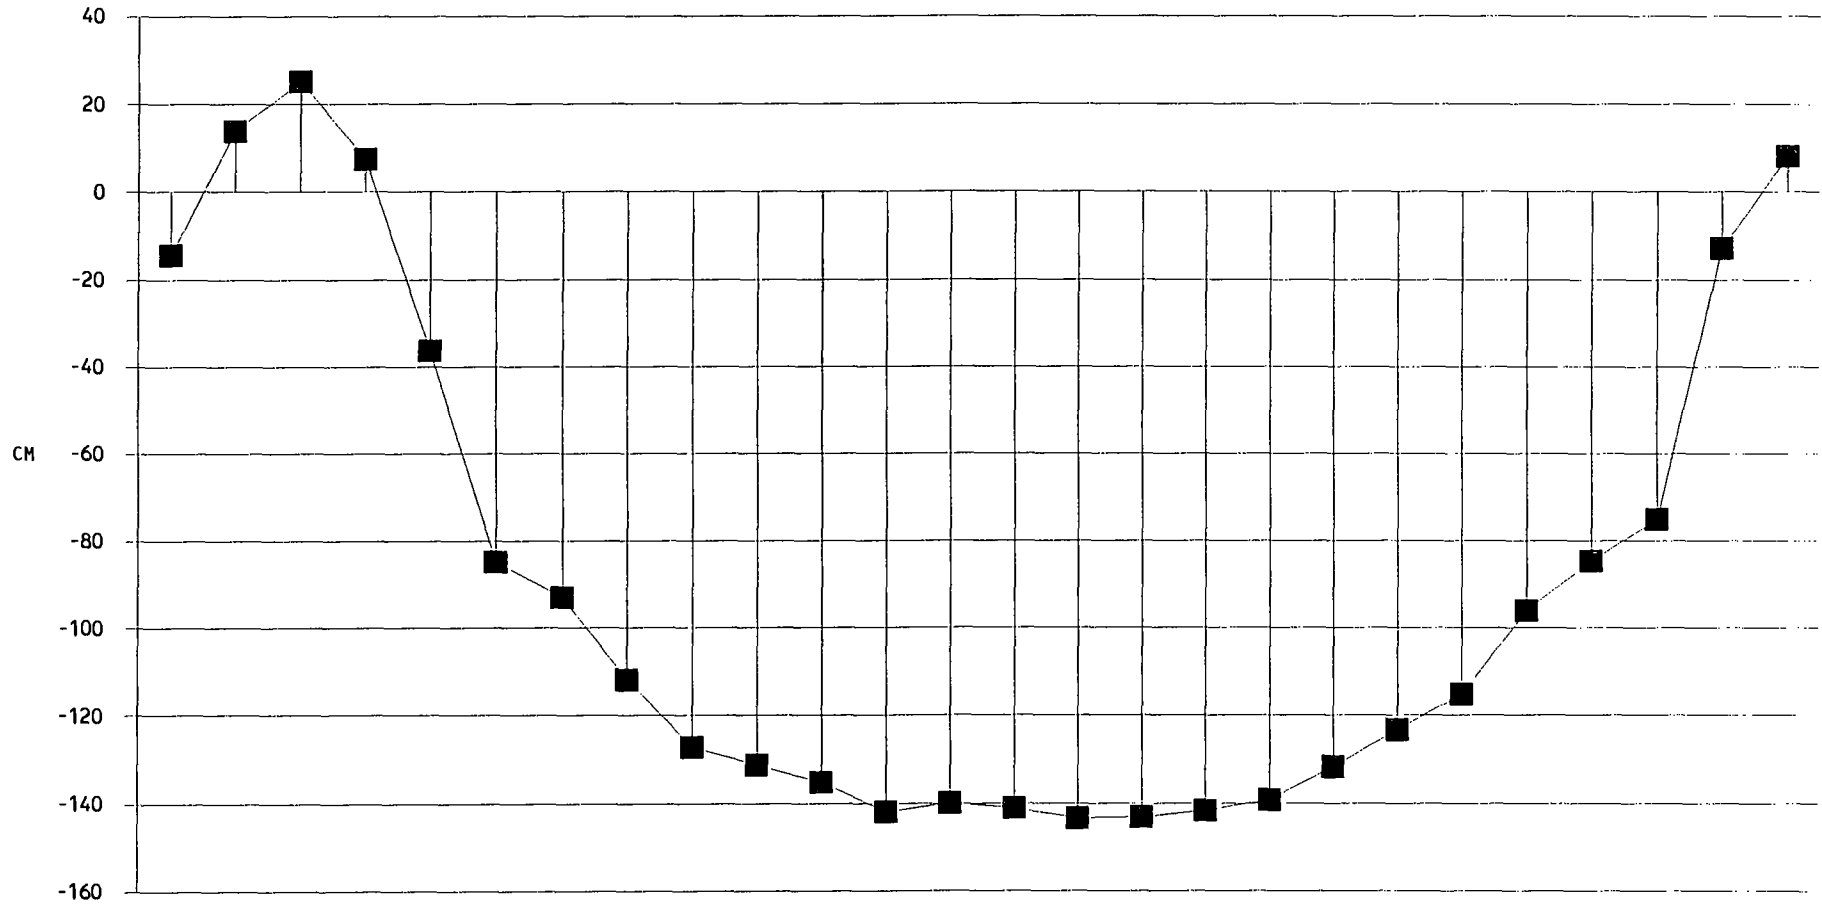
Figure 12; Profile Line 3.

1 bar equal to 1 meter.
