ART. XVII.—*Report of the Cumberland Excavation Committee for 1932.*

EXCAVATIONS ON HADRIAN'S WALL.

I. BIRDOSWALD.

By F. G. SIMPSON, M.A., Hon.F.S.A.Scot., and
I. A. RICHMOND, M.A., F.S.A.

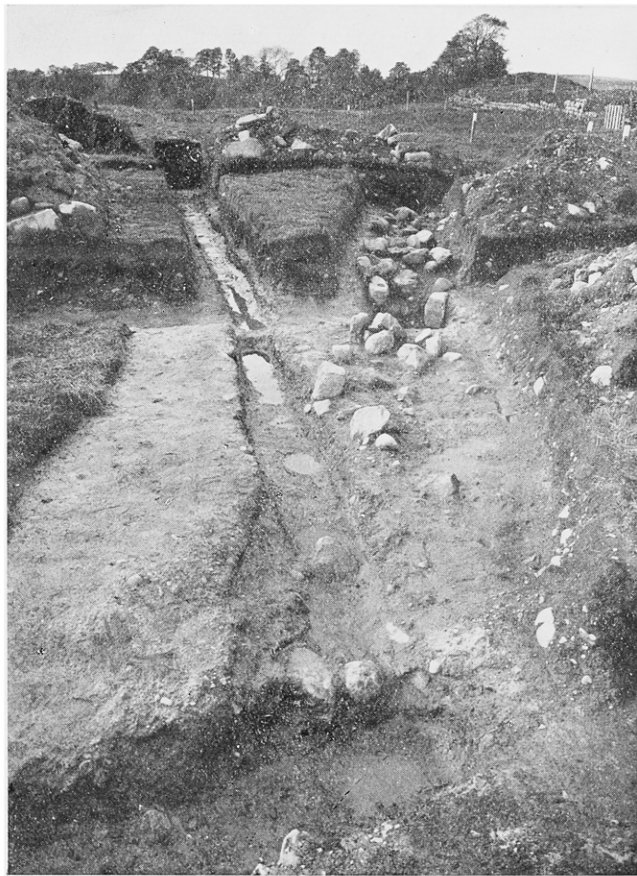
FIG. 1.—PALISADE-TRENCH OF POLYGONAL ENCLOSURE
(phase I) cut by irregular sleeper-trench of phase III.

Phase I. *The polygonal enclosure.* The long straight sectors of the double ditches of this enclosure were examined in detail. They yielded no relic of chronological value, but added to our stock of leather, giving us hemmed rectangles like pieces of tents, to be described, with analogies, later. Sixteen feet behind the centre line of the inner ditch and parallel to it, we recovered a broken stretch of palisade-trench, two feet wide and ten inches deep, filled with three rows of packing stones set on edge. Later levelling had removed the stakes it once held and reduced the trench to a mere heel; and even this heel had been delved away at the west end and levelled clean away at the east. Its age is fixed by its orientation with the ditches. Stratigraphically, it is cut by the outer multiple ditch of Period I, overlaid by sleeper-trenches of phase III (fig. 1) and designed with no possible relation to phase

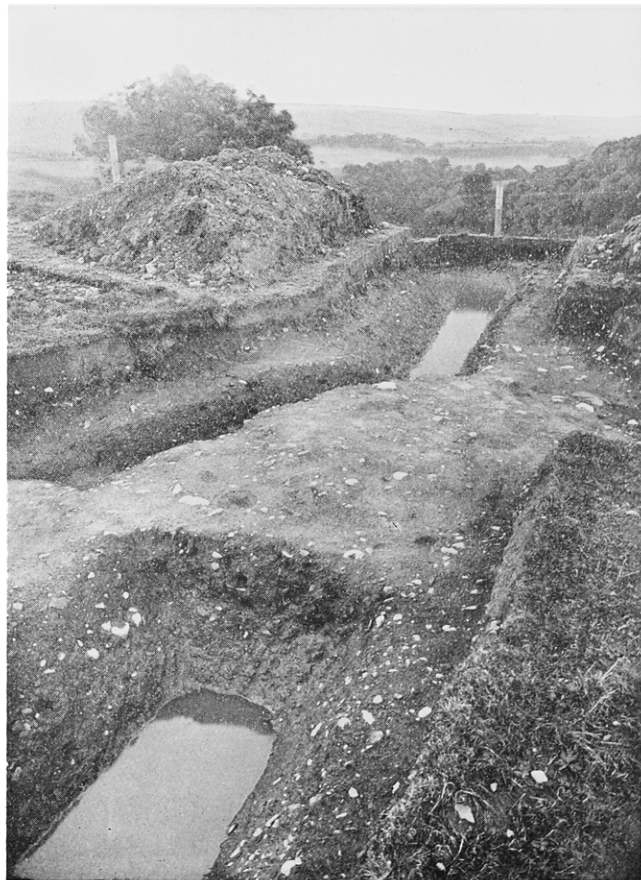
FIG. 2.—DITCH OF QUADRANGULAR ENCLOSURE (phase I)
with causeway cut by sleeper-trench of phase III.

A hint of what the yard itself contained was given at its western end, where trenching disclosed a quadrangular area, 62 by 112 feet, bounded by a shallow V-shaped ditch, showing traces of having been levelled down. The west side of the enclosure had vanished over the escarpment, but the north-west and south-west angles were left, with a causeway on the north side near the former (fig. 2). This enclosure lies on the highest part of the site, and looks as if it surrounded a special building in the yard, leaving the rest of the space free for stores or beacons. Its stratigraphical position is clear. It is cut through by the Vallum of phase II, and on its causeway intrudes a sleeper-trench of phase III (see fig. 2). Bad weather prevented an attempt to learn what it contained.

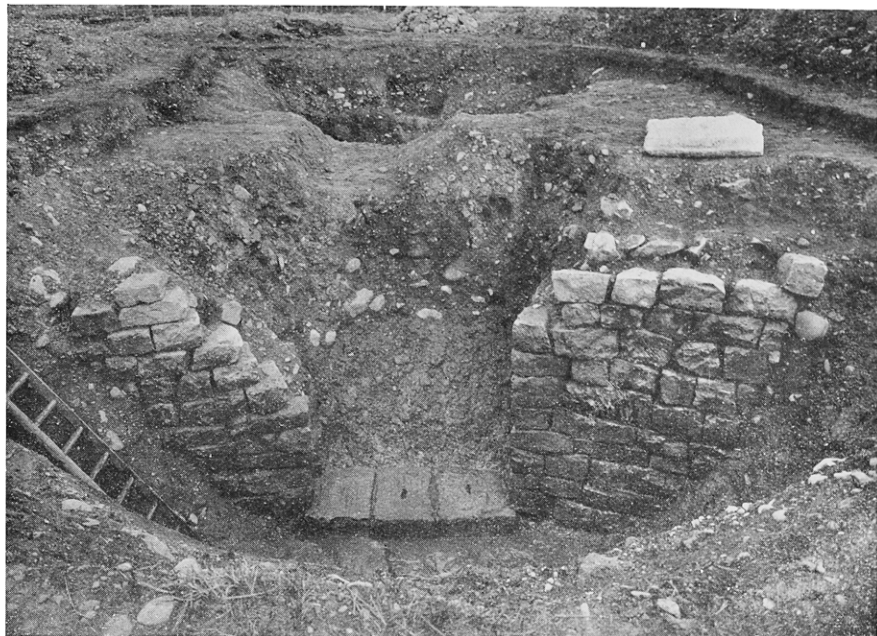
FIG. 5.—VALLUM-CAUSEWAY, BIRDOSWALD, west side.

The central panels of the causeway-walls had been robbed, but their discrepantly wide foundations remained (figs. 3-7). These were large squared blocks, three on the west and two on the east, originally swung into place by a crane with a lewis, and then trimmed in position, the trimming partly obliterating the lewis-holes. On the west side, a setting-out line was cut for the exact placing of the superincumbent masonry and was returned to mark the end of the wing-walls.

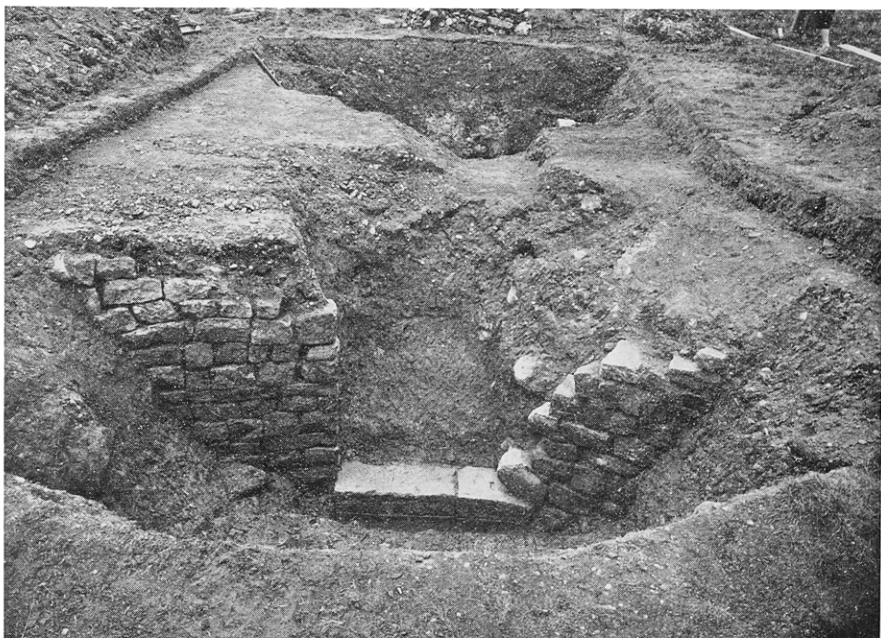
FIG. 6.—VALLUM-CAUSEWAY, BIRDOSWALD, east side.

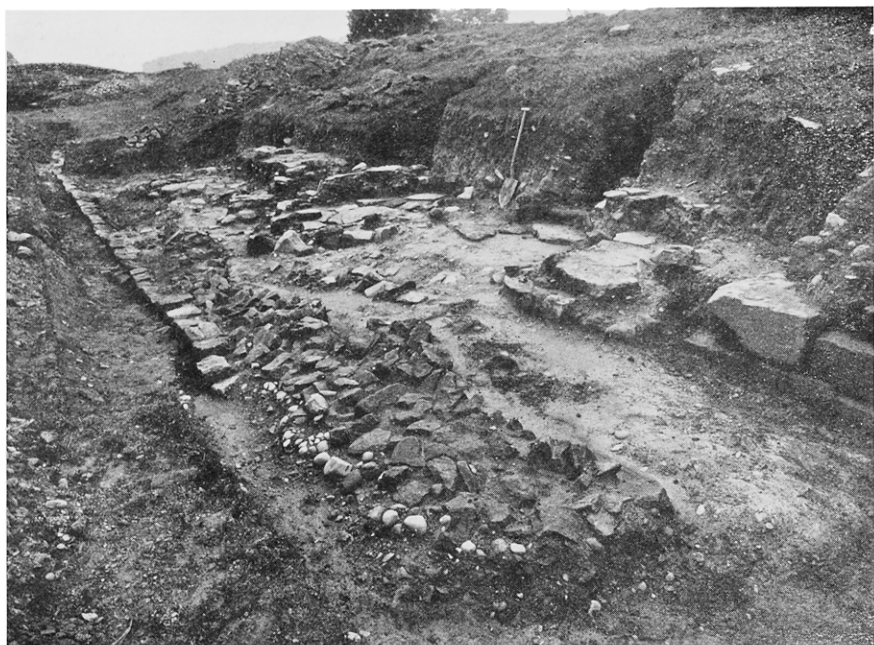
FIG. 8.—EARLY FOUNDATION (phase II)
cut away by oven-range behind S. rampart.

along the back of the Stone Fort's rampart; and the lowest layers of that rampart were packed in about the ovens in such a way as to show that the ovens were built with the rampart. When worn out, they were replaced by two successive series (see figs. 8, 10) of smaller ovens.

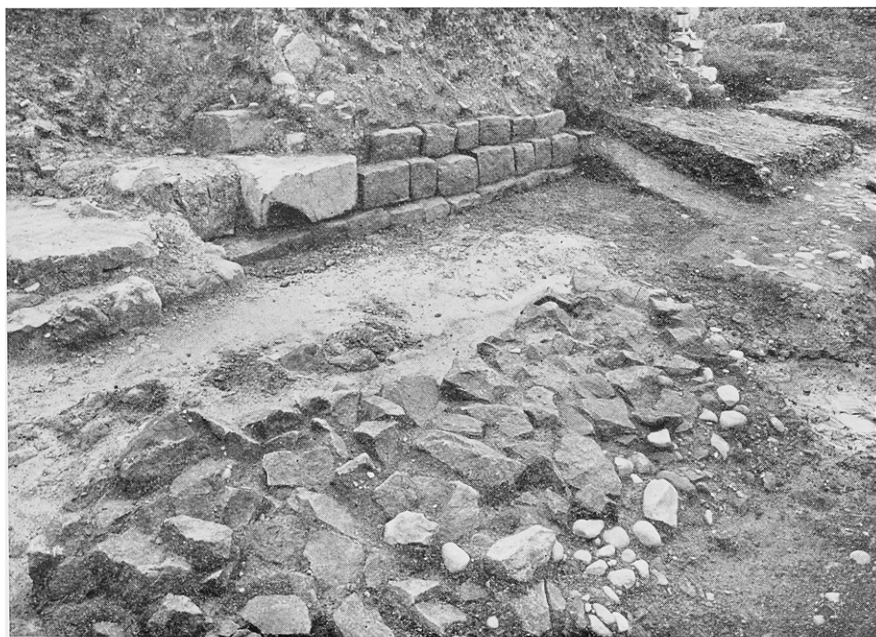
FIG. 9.—E. TOWER OF S. GATE ;
back wall with two levels of foot-path to guard-chamber doorway :
in foreground, early foundation cut off by cobbling of lower path.

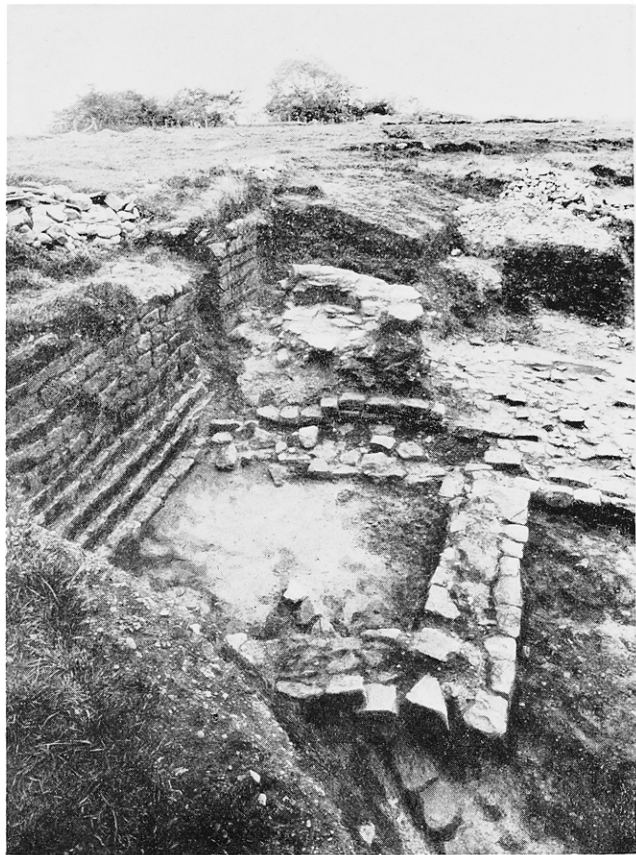
FIG. 11.—PENT-HOUSE AND OVEN, behind S E angle-tower.

already mentioned, which swept round northwards as if in continuation of the early foundation. This stone-work (fig. 11), when fully uncovered, proved to be a pitching of stones laid flat and largely re-used and worn, as different as possible from the genuine early pitching. Further, they were laid up

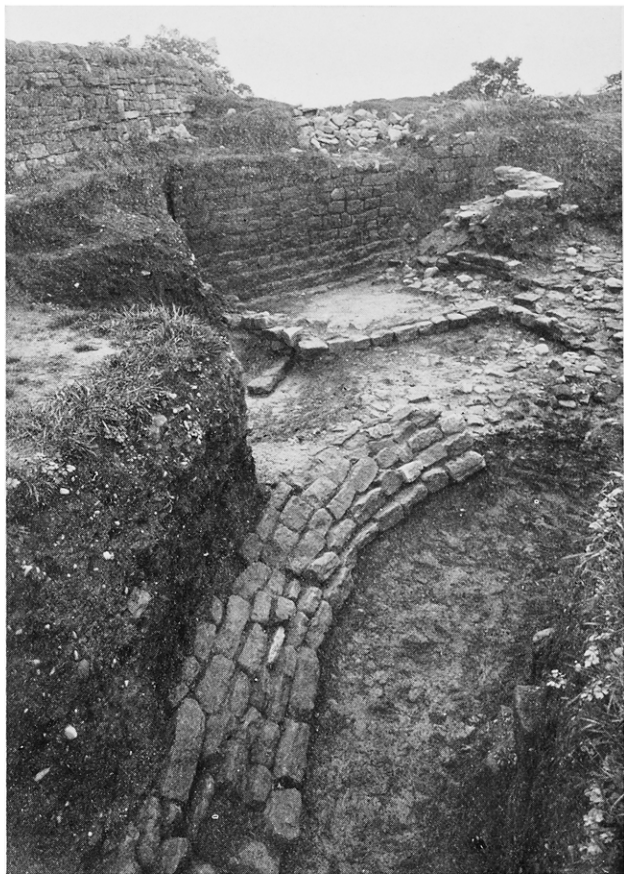
FIG 12.—S.E. ANGLE FROM NORTH,
showing revetted foot of rampart-backing.

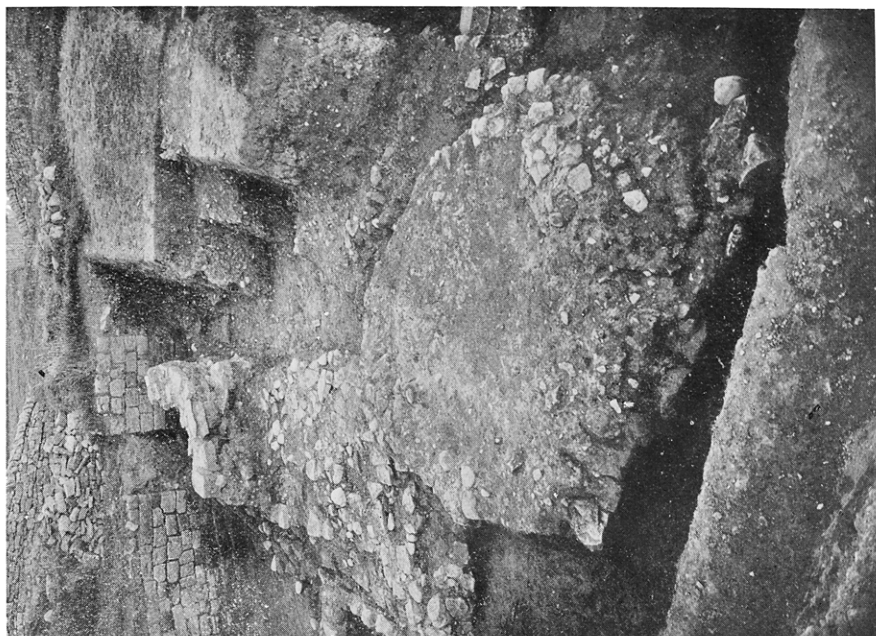
FIG. 14.—S.E. ANGLE, showing two ovens.

later than the Stone Fort, a conclusion consonant with the Antonine pottery associated with them. Again, the north-west angle of the pavement was sealed below a large oven-base (fig. 14), which itself covered Antonine sherds and yielded a fine gold ear-ring amongst its foundation. The room appeared to have no west wall, the structure resembling a west wall being the revetted edge of the path to the angle-tower door, flanked by a rough drain. Below the north-east angle of the building a line of kerb-stones was found (fig. 11) manifestly early but disconnected from all intelligible associations: they fit neither the Stone Fort nor what is known of the Vallum Fort, and remain inexplicable.

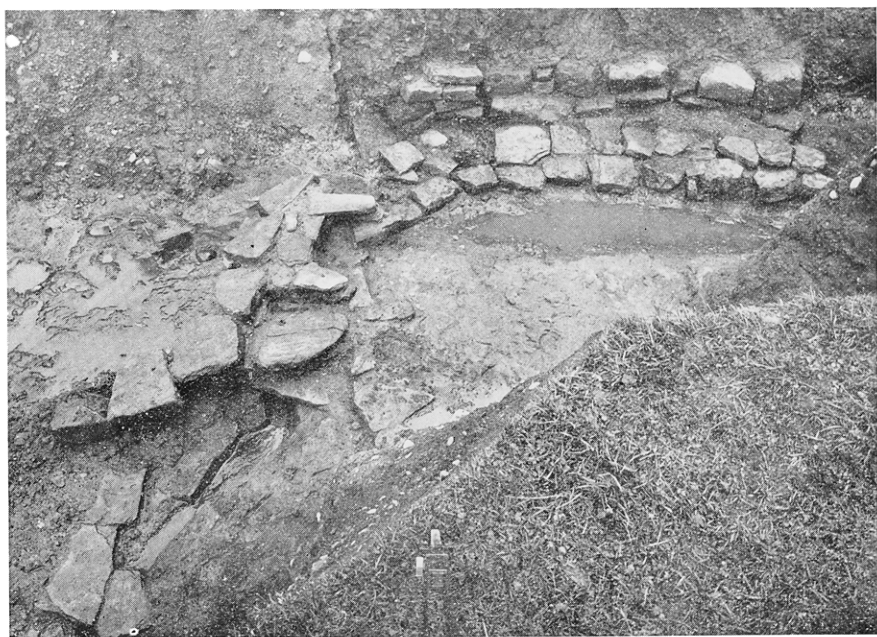
FIG. 15.—FIREPLACE AND DRAIN AT S.E. ANGLE.

Further west, the fireplace was examined. This (fig. 15) proved to be very heavily fired, rather like a forge. Below it ran a curved drain, which can be planned (see fig. 15) but not interpreted; and this in turn was bounded on the south by a slightly curved wall. No associated object shed light upon the date or purpose of the structure: but it lay in the track of the early foundation, which had here been removed. It must thus be associated with the Stone Fort.

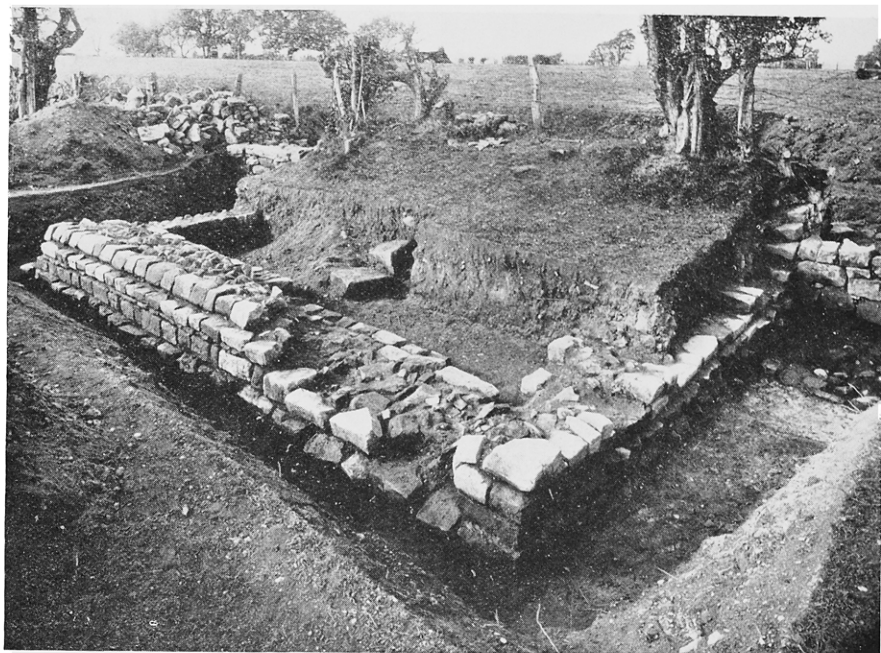
FIG. 18.—HARE HILL TURRET, 53a, from the south-east.

The turret (figs. 17-19) was of normal size and conformed in structure, narrow berm-width (6 feet) and independence of the Stone Wall, to the standard of turrets 51a, 51b and 52a. Its walls were built upon a foundation of stones packed with clay in trenches about a foot deep. A flag footing course covered the foundation. Above the

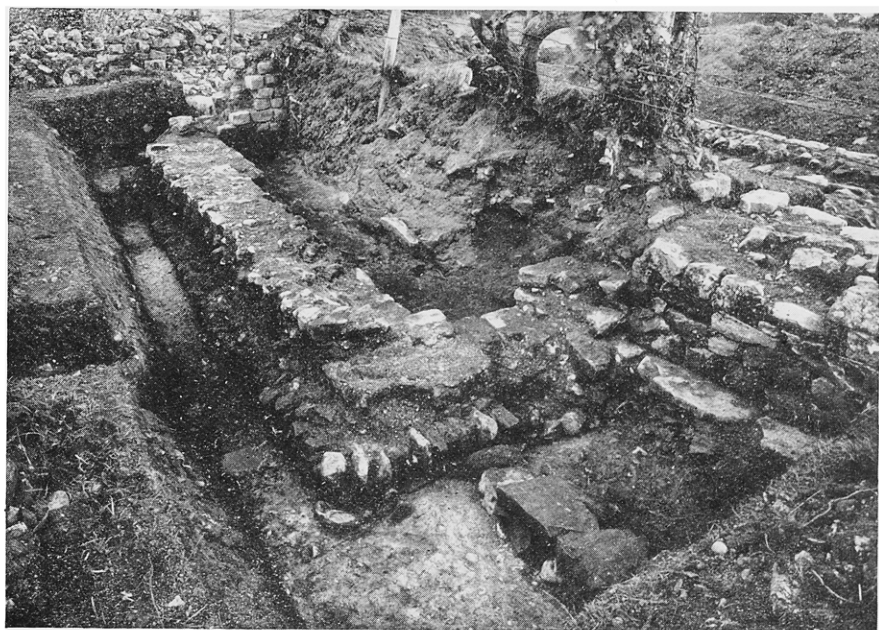
FIG. 19.—HARE HILL TURRET, 53a, from the north-west.

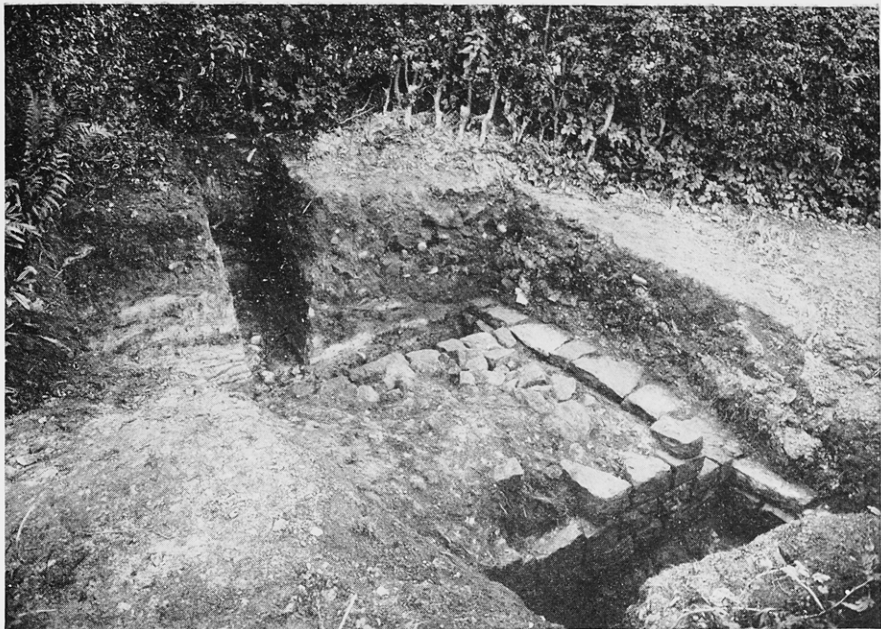
FIG. 21.--BANKS BURN MILECASTLE, 53:
east junction and remains of Turf Wall, from the south-east.

Banks Burn Milecastle, 53 (figs. 20-22). Previous observers believed this milecastle to have been situated nearer Hare Hill than Banks Burn (Maclauchlan, *Memoir*, p. 58), and in consequence it was named Hare Hill in Mr. R. G. Collingwood's "*System of numerical references to Hadrian's Wall*" (these *Transactions*, N.S. xxx, p. 108). It was found, a few yards east of the supposed position, at Banks Burn farmhouse, which proved to be wholly within its walls. Banks Burn, 53, as the milecastle will now be named, is 1678 yards west of the assumed position of Bankshead, 52, and 393 yards east of Hare Hill Turret, 53a.

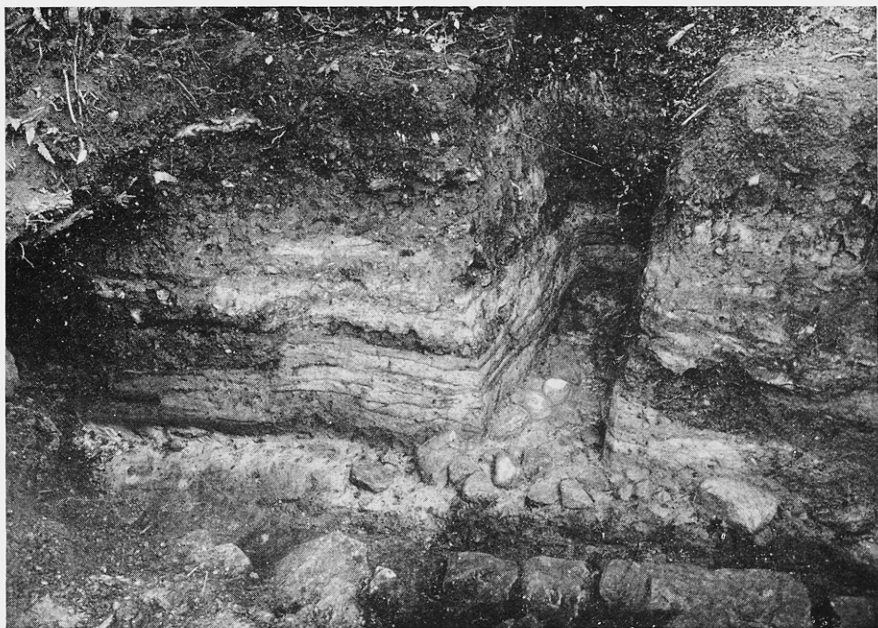
FIG. 22.—BANKS BURN MILECASTLE, 53:
section of Turf Wall, showing layer of cobbles.

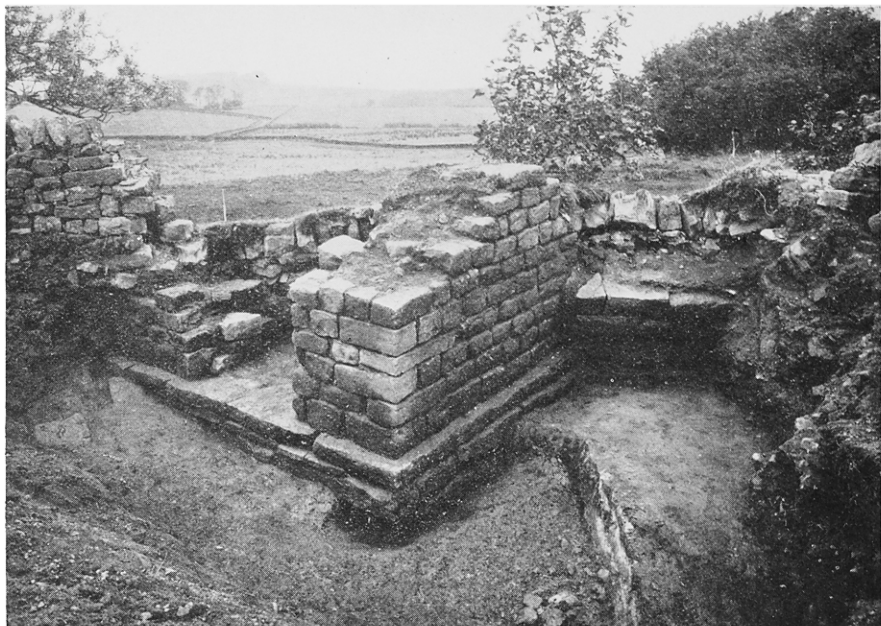
FIG. 23.—PIKE HILL SIGNAL-TOWER, from the south-east :
remains of Turf Wall in foreground.

The Signal-Tower (figs. 23-27). Continuing the work of 1931 (*ibid.*, N.S. xxxii, p. 145), further trenching near the tower on the south and south-west showed that the sloping ground had been quite open in Roman times and that there was no ditch around the tower. A quarried hollow in the rock found last year about 20 feet west of the tower therefore represents minor quarrying only.

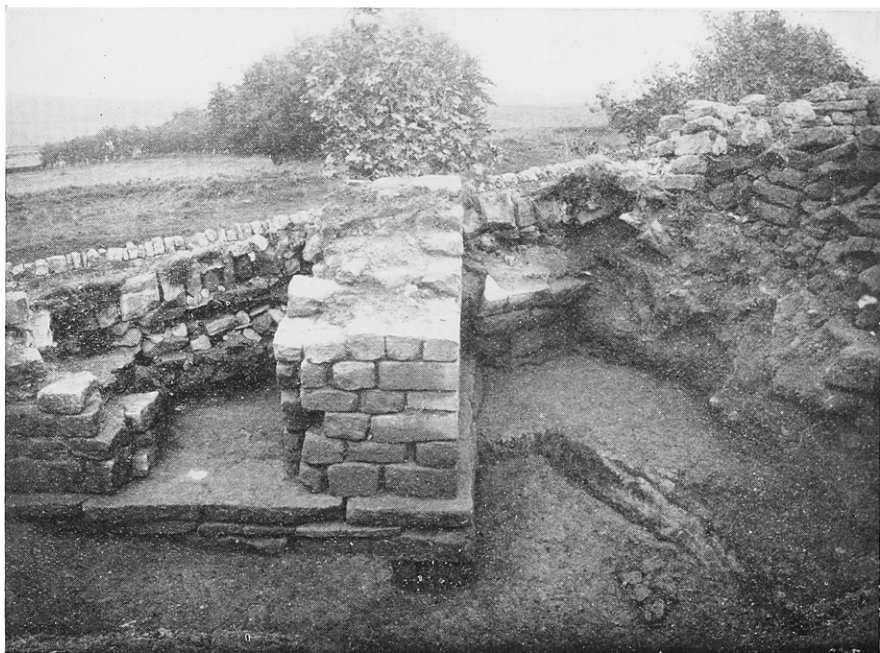
FIG 24.—PIKE HILL SIGNAL-TOWER, from the south.

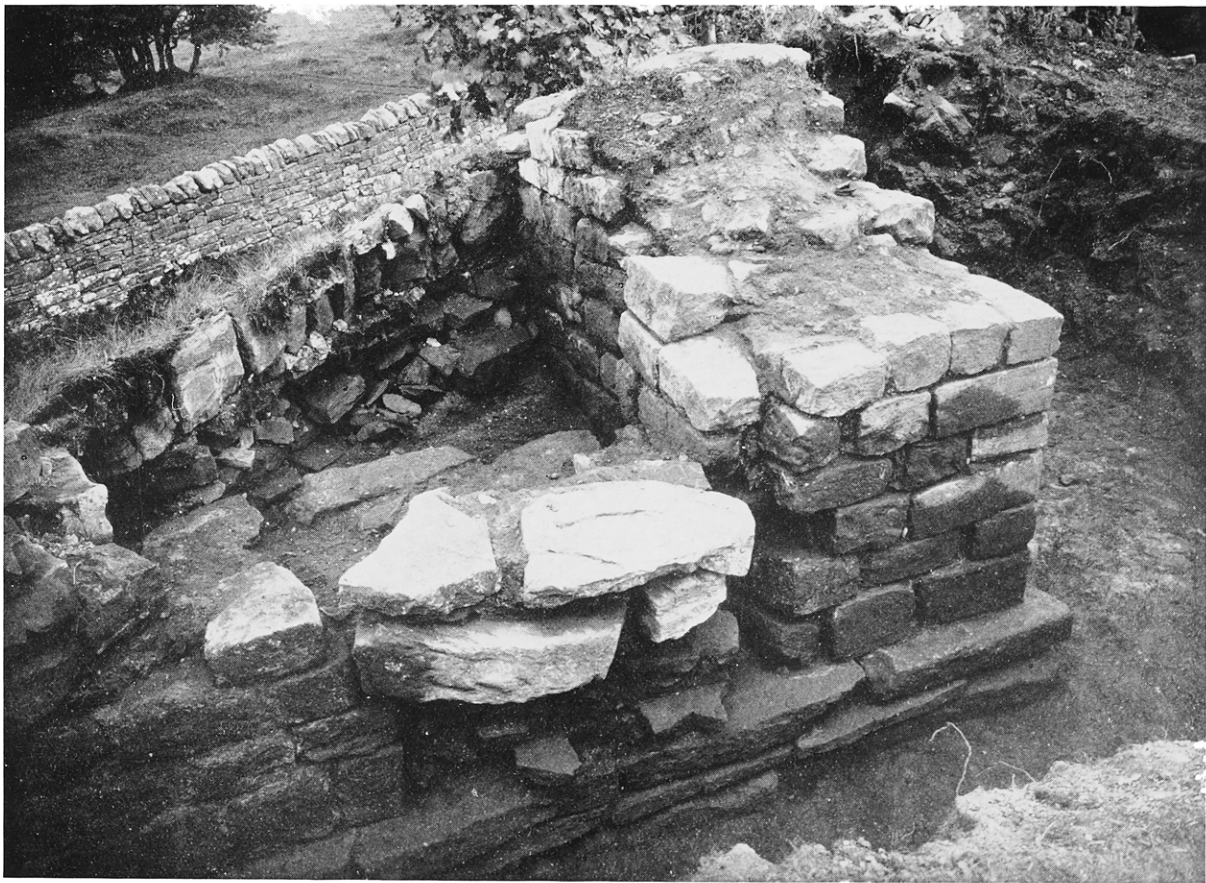
FIG. 25.—PIKE HILL SIGNAL-TOWER: showing rough walling in doorway
tcwaas_002_1933_vol33_0020

In construction the tower was unlike the Turf Wall turrets. The foundation was unique among the types known along the Wall. The tower stood on a platform of mortared rubble, faced with walling about 2 feet wide and 1 foot 4 inches deep constructed of three courses of large flags (one was over 4 feet long), bedded in clay. The walls were set back 3 inches from the edge of the platform: they were 3 feet thick and of excellent masonry. The doorway was 2 feet 8 inches wide. At the outer corners there were vertical rebates about $5\frac{1}{2}$ inches square, showing that the masonry had been built up to a wooden door-frame (*cf. Northumberland County History*, XIII, p. 504). There were similar though rougher rebates at the inner corners of the doorway.

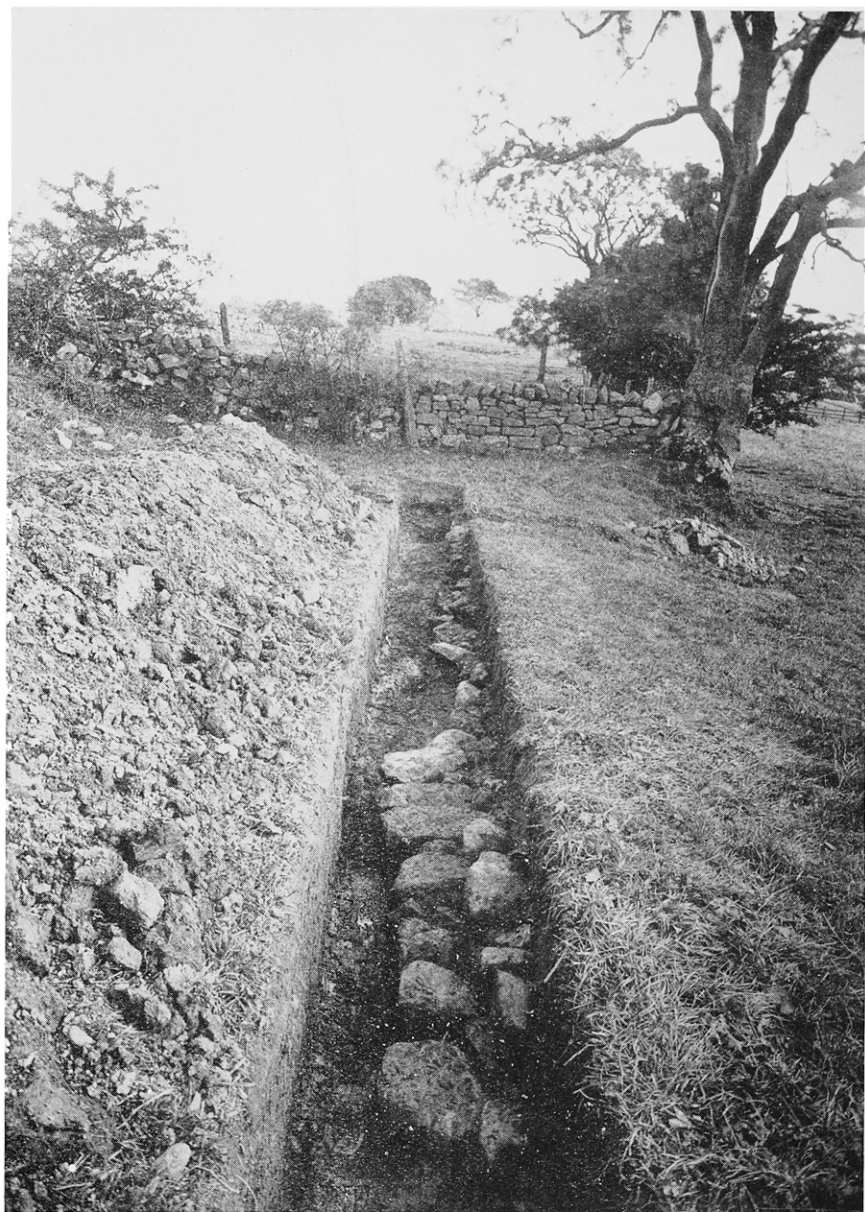
FIG. 28.—NORTH KERB OF MILITARY WAY: Bankshead in the distance.
