ART. IV.—Hadrian's Wall, turret 51A (Piper Sike). By Dorothy Charlesworth, F.S.A.

TURRET 51A

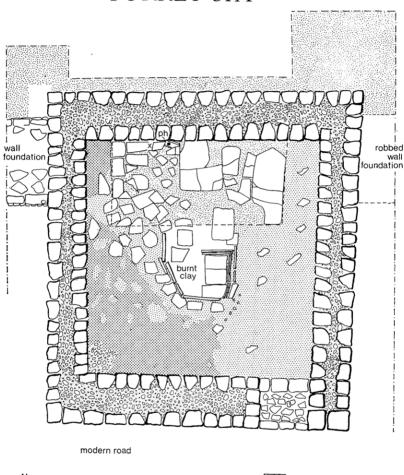
51A is the normal type of turret, measuring externally 6m north-south and 5.80 east-west, associated with the Turf Wall, a free-standing building with its north and south walls thicker than its east and west, .95m compared with .75m, to take a plinth to keep the turret face in step with the batter of the faces of the Turf Wall. The north wall of the turret stands 5 courses, but the south wall has been more heavily robbed and much of it is only 3 courses high. There is no plinth course in situ as there is on turret 52A (Banks East) above the seventh course. The door is on the east side, with all its fittings robbed. The walls are of rather small stones, generally without the tapering "tail" of the facing stones of the turrets and curtain wall east of the Irthing, which bonds them firmly with the core. The core is of small rubble and mortar. There is a single layer of rubble foundation on the natural clay. On the west side of the turret some remains of the Turf Wall can be seen (Plate I) up to the level of the top of the first course, and there was a considerable scatter of

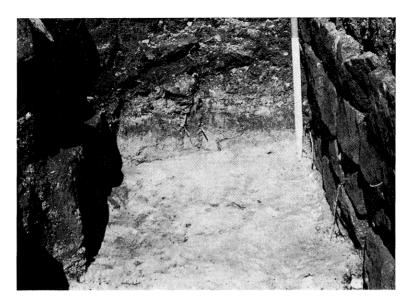
PLATE I.—Turret west wall and remains of Turf Wall.

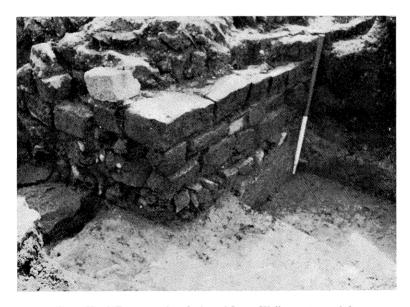
PLATE II.—NE. corner, foundation of Stone Wall on extreme left.

turf on the berm north of the turret and trampled inside it. This scatter dates from the replacement of the Turf Wall in stone, known to have taken place in Hadrian's reign, in this sector.2 But before this the north-east corner had been repaired (Plate II) and on its east side, where it would be hidden by the turf-work, rubble had been put into the face up to the second course. The building of the Stone Wall, slightly further back, exposed this. A wide crack in the east wall, right down to foundation level (Plate III) and the use of a long, narrow stone in place of a proper quoin on the northwest corner (Plate IV), both indicate the lack of skill of the masons. The facing stones of the curtain wall with their well-fitting joints and larger size (seen on the right of Plate IV) point the contrast with the walling of the turret and strengthen the possibility that it was lack of skilled masons that caused the curtain wall west of the Irthing to be built in turf instead of stone. In this sector there is no lack of suitable building stone, limestone, which was also required for making mortar. There is a quarry, with Roman inscriptions³ on its face, about $\frac{1}{4}$ mile from 51A.

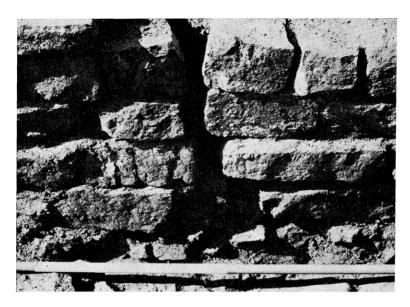
PLATE III.—Turret east wall, settlement crack.

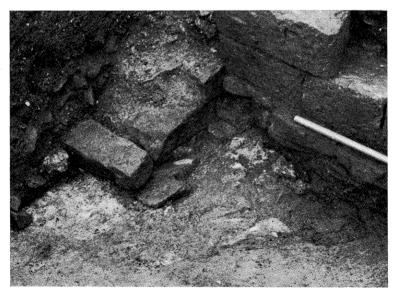
PLATE IV.—NW. corner, N. face of Wall on right.

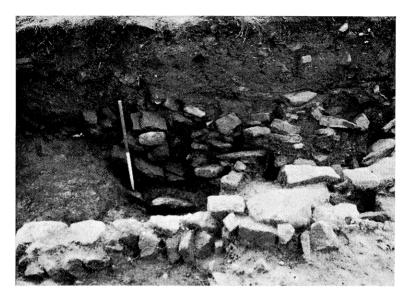
PLATE V.—E. face of central baulk, ranging pole at S. end of hearth.

It was intended to dig the turret in two parts with a central baulk as a check on the levels, but when the main level of occupation was reached the baulk had greatly increased in width by the necessity of leaving projecting pieces of rubble and flagstones (Plate V) and it had to be removed before the lower levels and the sunk hearth could be cleared. It served, however, to illustrate the thick layer of debris which separated the two main layers of occupation.

the baulk near the north wall. It stopped short of the platform and did not extend up into the upper floor level. Two large flags on its north side may be fallen from the rampart walk. No other post-hole was located near it. In approximately the centre of the east face of the baulk, over the cooking-pit, was a gap in the debris (Plate V) which suggests that a post or piece of fallen beam may have lain there.

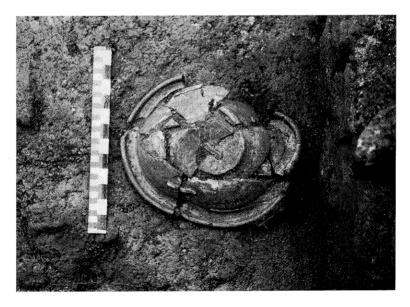
PLATE VI.—Mortarium on upper occupation layer.

The pottery is all 2nd century in date and a sample, the more complete pieces, is illustrated. The mortarium (Plate VI) in buff ware has, unfortunately, vanished. Only one coin, found in the disturbed soil of the gateway, cannot in view of its position and the total absence of any other 3rd-century finds be taken as evidence for occupation in the 3rd century. On the other hand there is no evidence that this turret was obliterated, as was 50A.

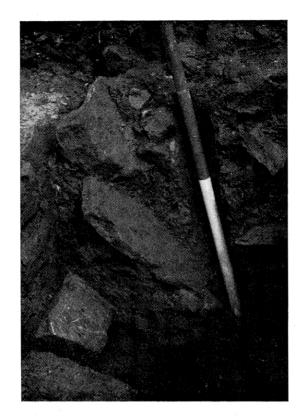
PLATE VII.—Post-hole in debris near north wall.

One curious feature in the debris layer was a sloping post-hole (Plate VII), very sharply defined, exactly the size for a 2 x 3-in. post. It was in the west face of

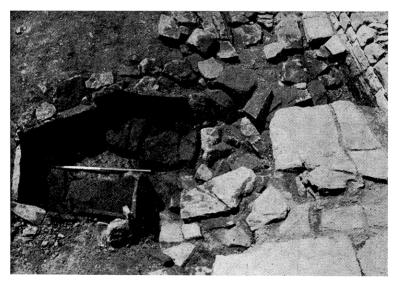
PLATE VIII.—Sunk hearth and remains of platform against north wall.

Below the debris was evidence of intense occupation. In its earliest phase, probably contemporary with the building of the turret and adjacent part of the Turf Wall, was a well-constructed hearth (Plate VIII), sunk in the floor below the level of the lowest course.⁴ This

looked rather large for a mere domestic hearth and the burning on it was intense, a new hearth-stone having been inserted after some time, but there was nothing to suggest any industrial use, as has been found occasionally in turrets. The whole floor, mainly clay, sagged towards this hearth. On it had accumulated burnt material, bones and sherds, scattered about even in the doorway. It was evident that flags had been laid, or clay spread, or a patch of mortar added to this floor wherever it became too dirty, and that no complete new floor had been inserted. In its upper levels the rubble had pressed down into it and so a quantity of clay and sherds was in the lower debris rather than on the floor itself. It was an irregular build-up of occupation material, suggesting a period of concentrated, and undisciplined, use. At the north end of the turret a platform of large flags was put in (Plate VIII). It is not an original feature. The south end of it partly collapsed into the less consolidated material of the sunk hearth and under it, against the north wall, was a cooking-hearth, with a pot base in it. The platform was only some .20m above the general floor level, but it was conspicuously free from rubbish and must have formed the living area where meals could be taken. The same feature is found in the next turret, 51B and again in 52B, but in the north-west corner. It has nothing to do with a ladder-platform. The probable site for such a feature is in the south-west corner, also noticeably clean, where a pile of rubble and mortar was found (Plate IX). This could be the ladder-platform for access to the first floor. Even if there is no question now of these platforms being required in stone wall turrets because a movable ladder could not reach the full height of the room, in such conditions as most turrets exhibit at ground level, a dry and level platform for a fixed ladder would obviously be desirable. The very confined space

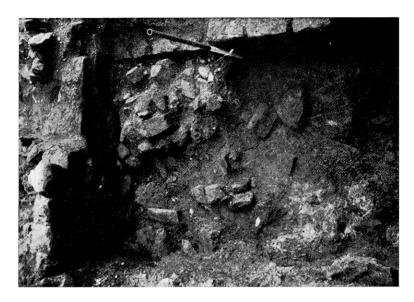
PLATE IX.—SW. corner of the turret, pile of mortar and rubble.
