Excavations on and close to the defences

Hereford City Excavations Volume 2

Excavations on and close
to the defences

by R Shoesmith

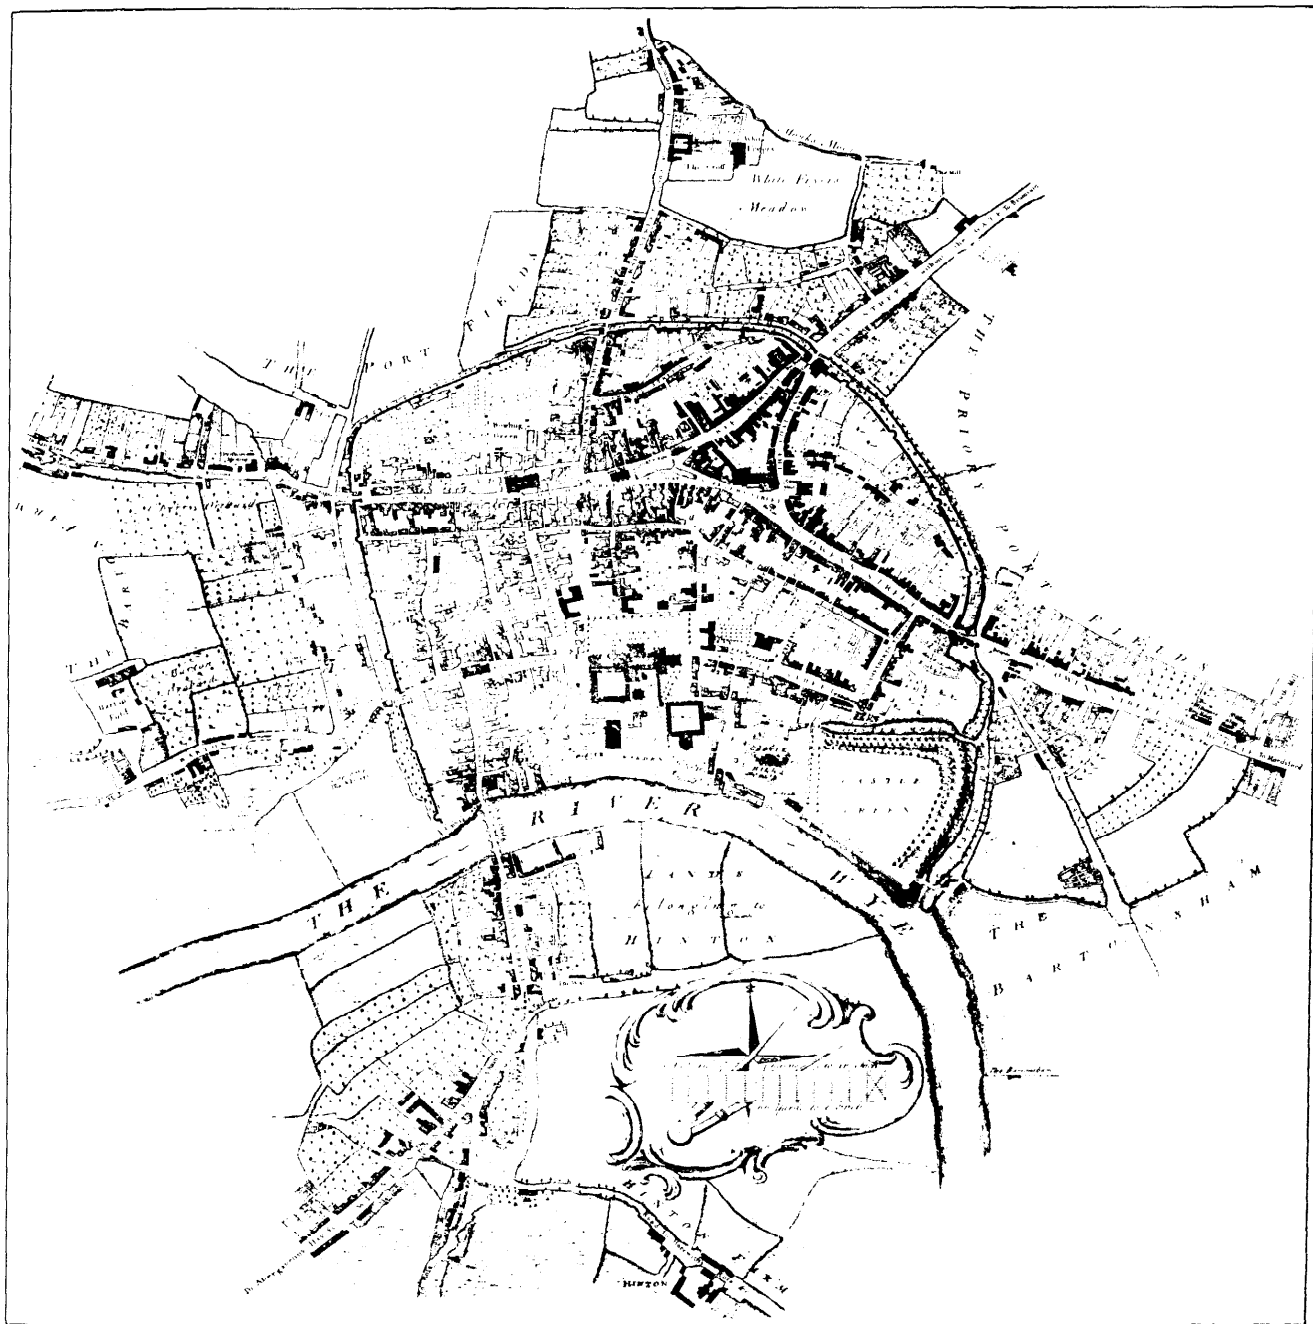
Fig K The central park of Taylor's map of Hereford 1757

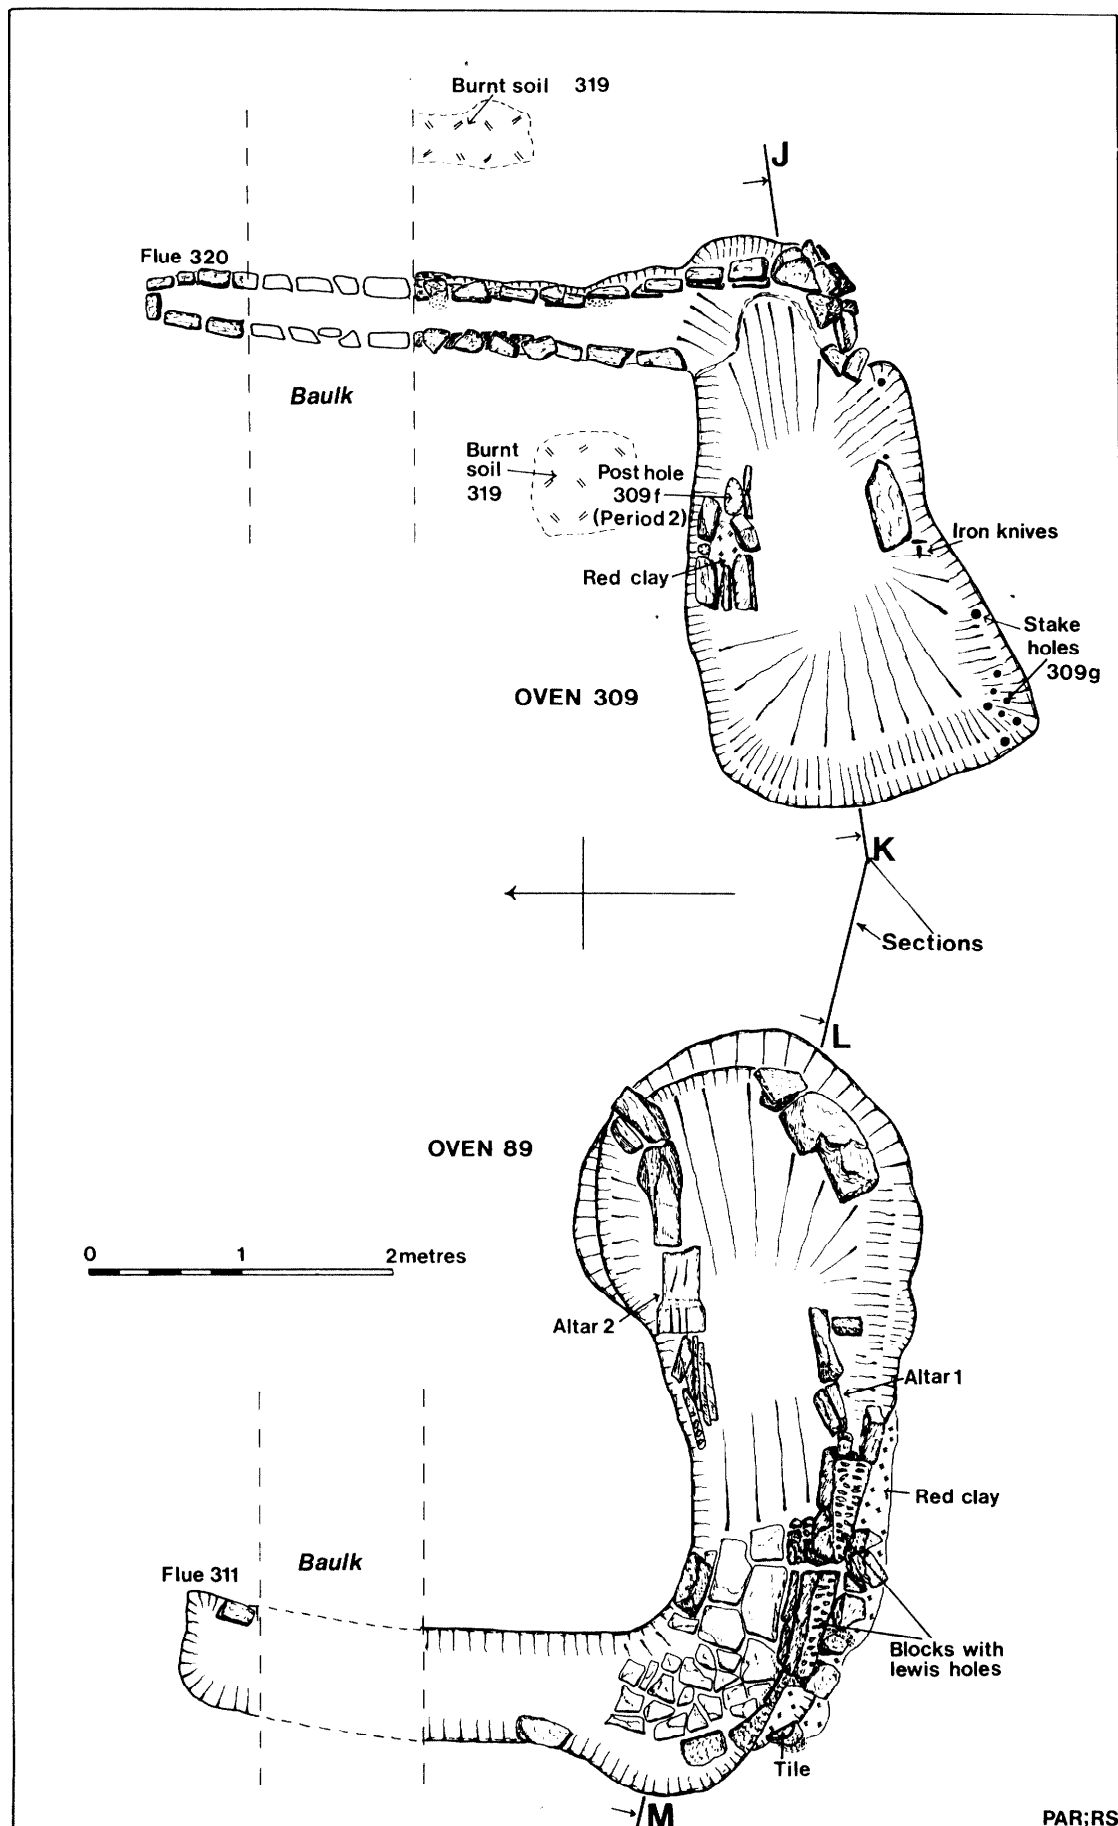
Fig 16 Victoria Street. Period 1. Plan of the grain drying ovens

The two ovens (89 and 309) were of similar shape and size but with the stoke holes facing opposite ways (Fig 16). They had maximum depths of 0.8m and fills of ash, burnt grain and many large pieces of fired daub. The daub, which had many impressions of wattle, was

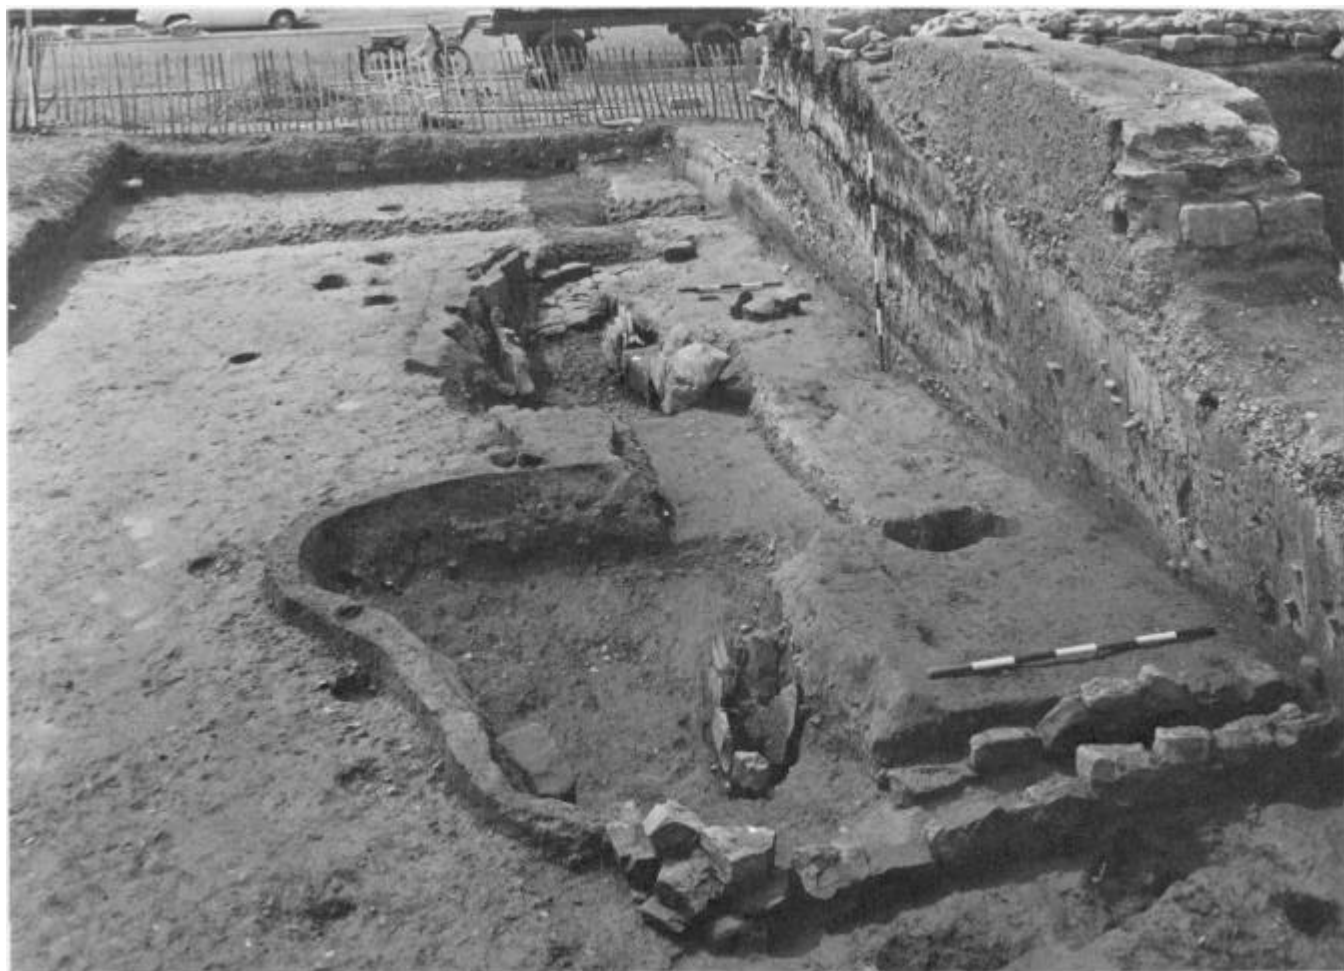
Fig 18 Victoria Street. The site from the east. Oven 309 is in the foreground and the retained baulk can be seen on the right

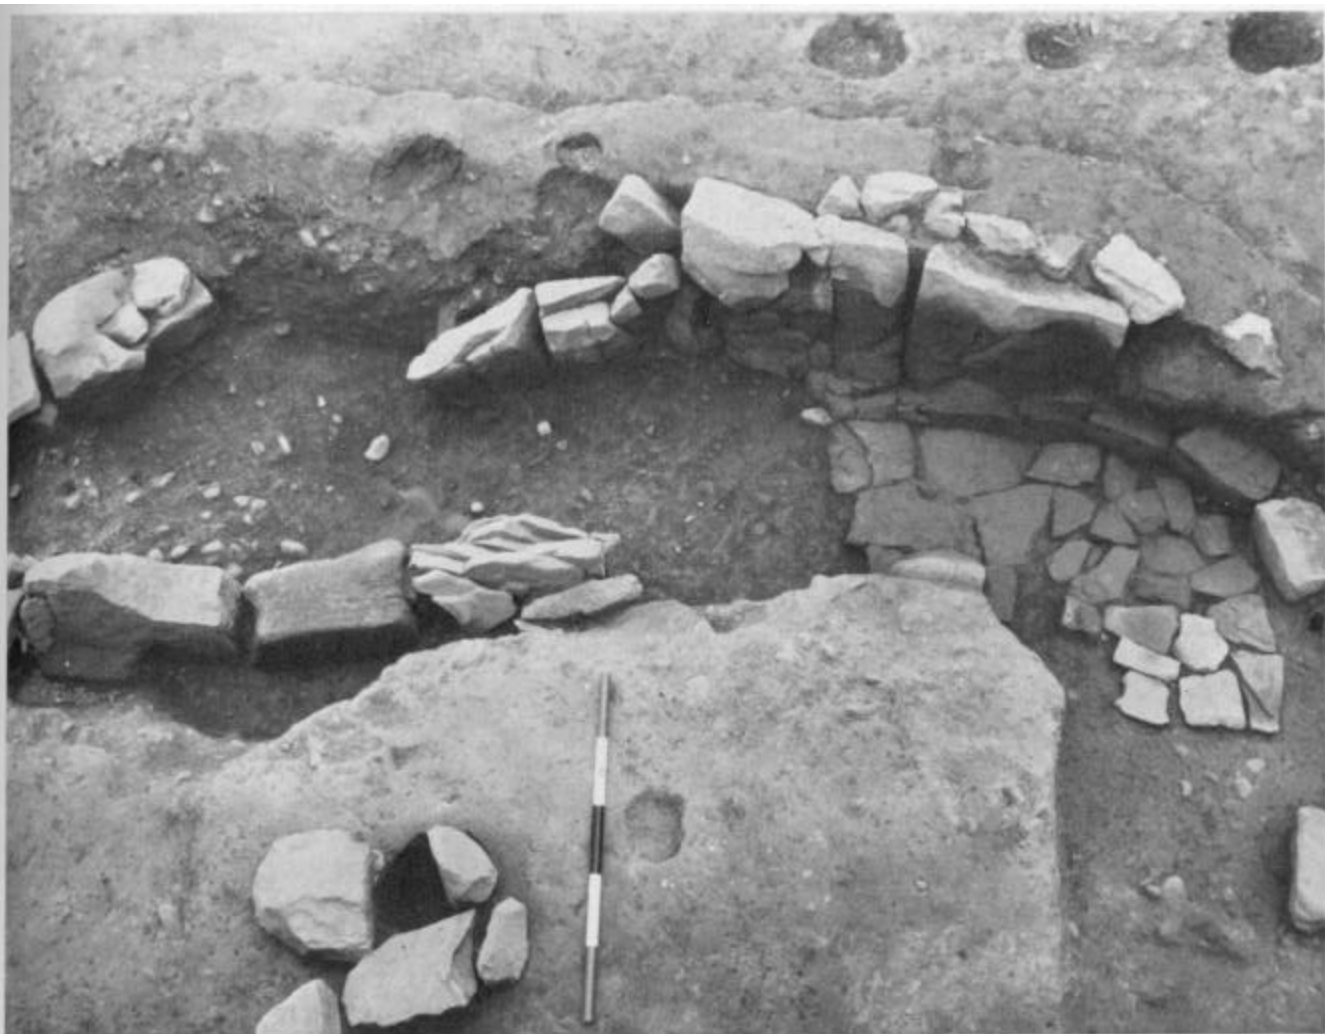
Fig 19 Victoria Street. Period 1. Detail of oven 89 showing the reused Roman masonry. In the foreground is posthole 306 of the period 2 building

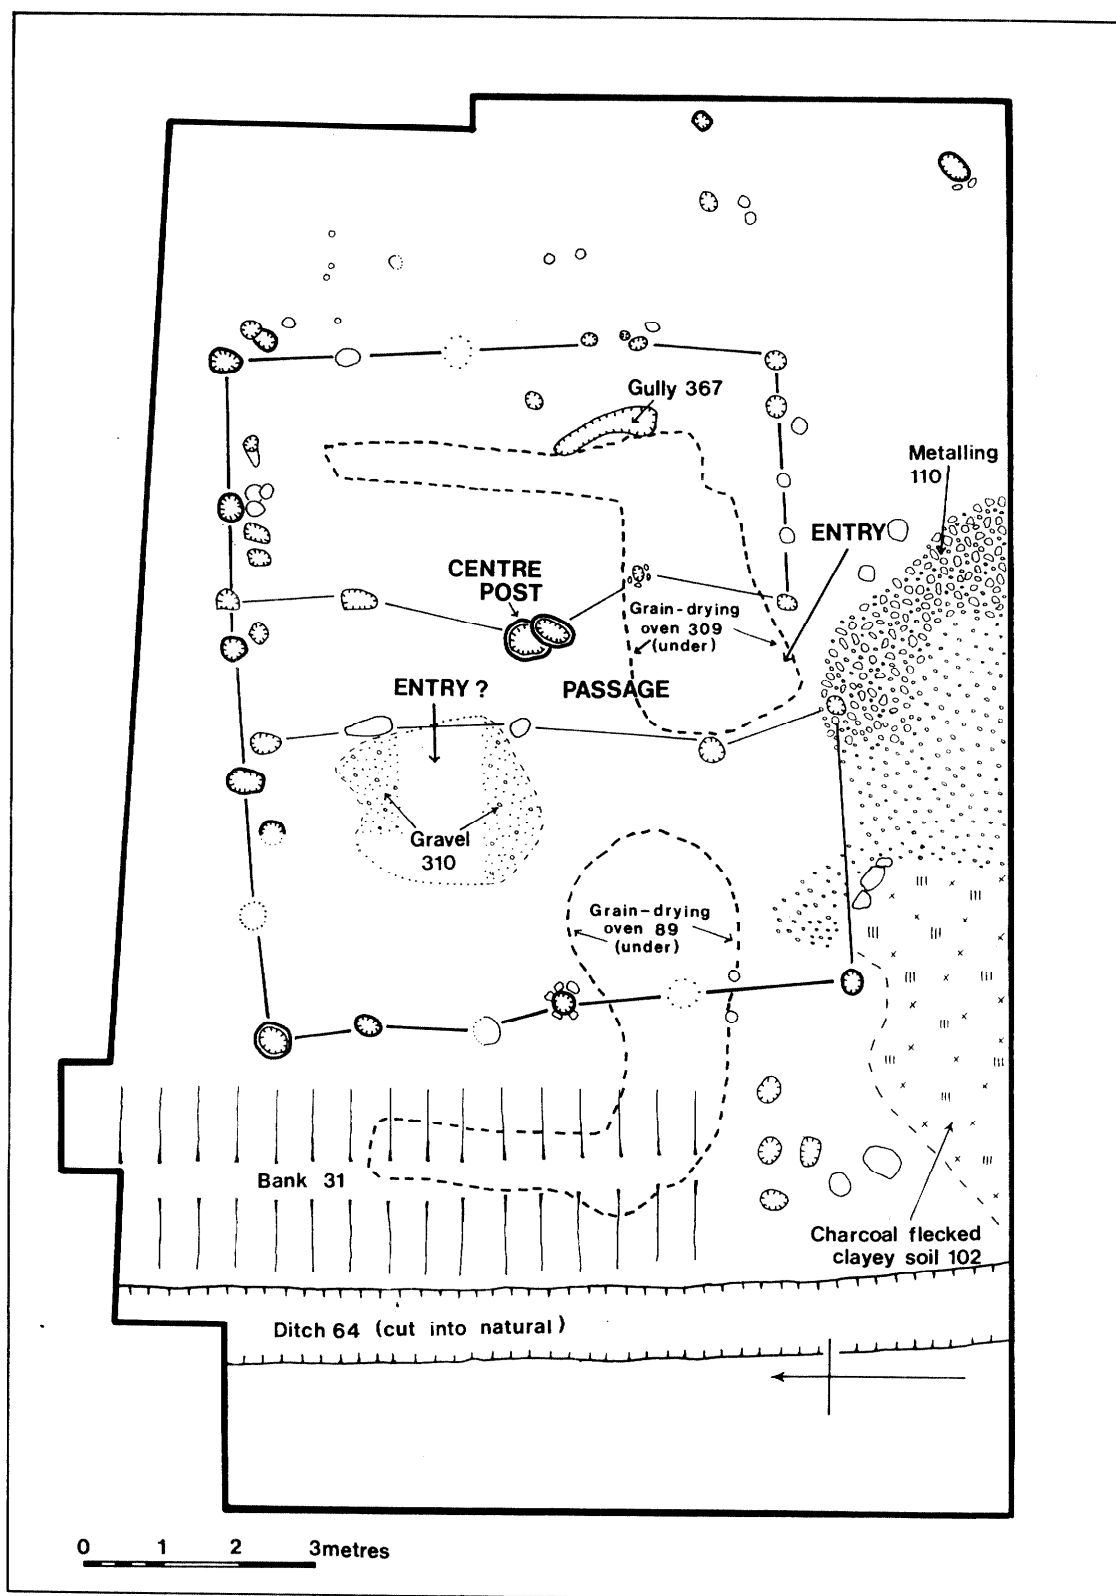
Fig 21 Victoria Street. Period 2. The relationship of the postholes of period 2 and the bank and ditch of period 3 with the grain drying ovens of period 1

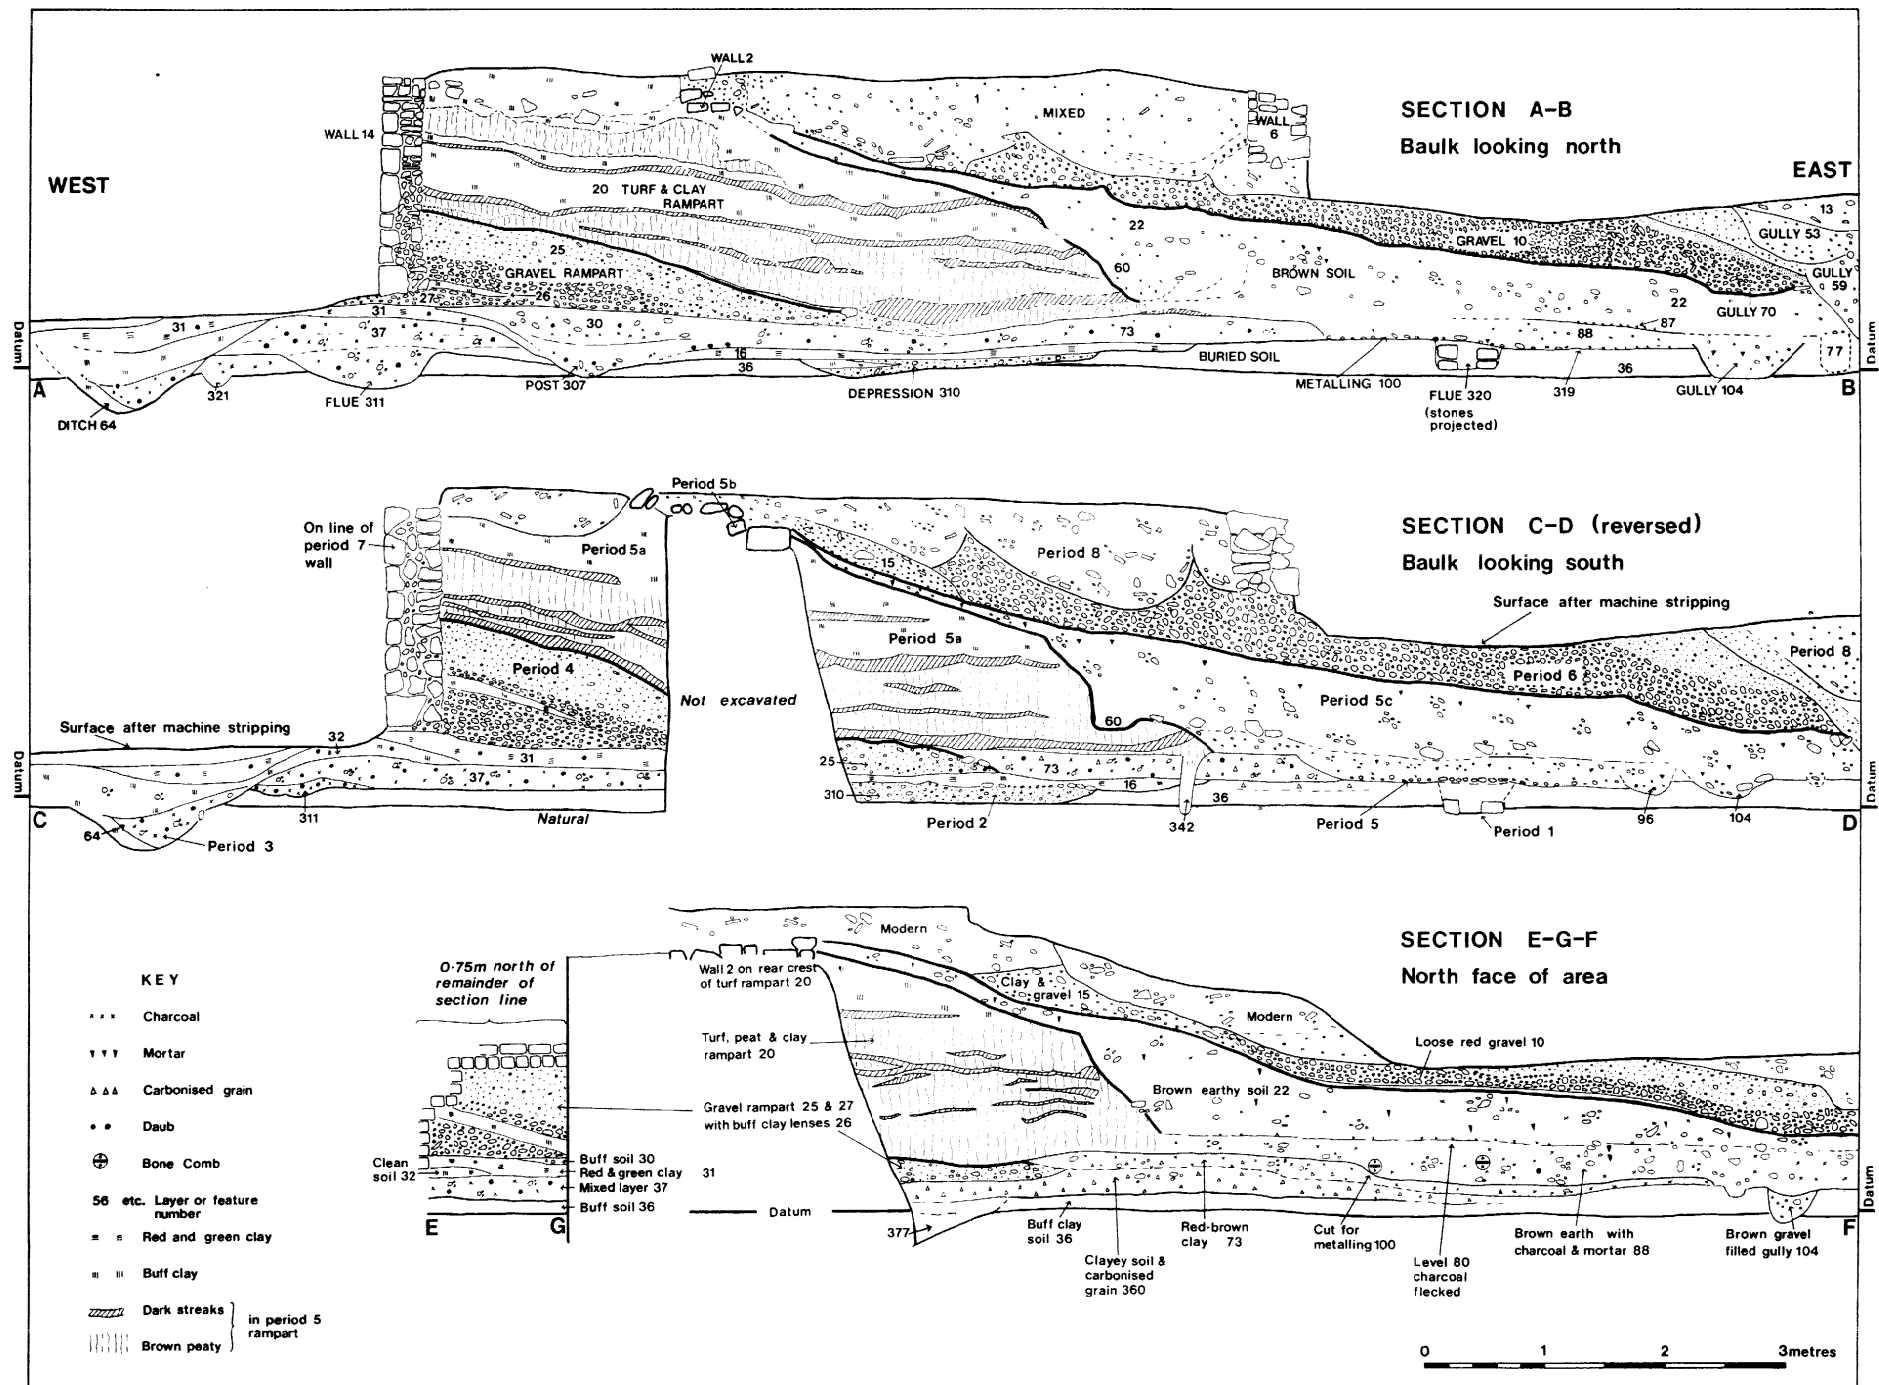
Fig 22 Victoria Street. The main sections A-B, C-D and E-G-F across the defences (see microfiche fig 20:M1.C3 for positions of sections)

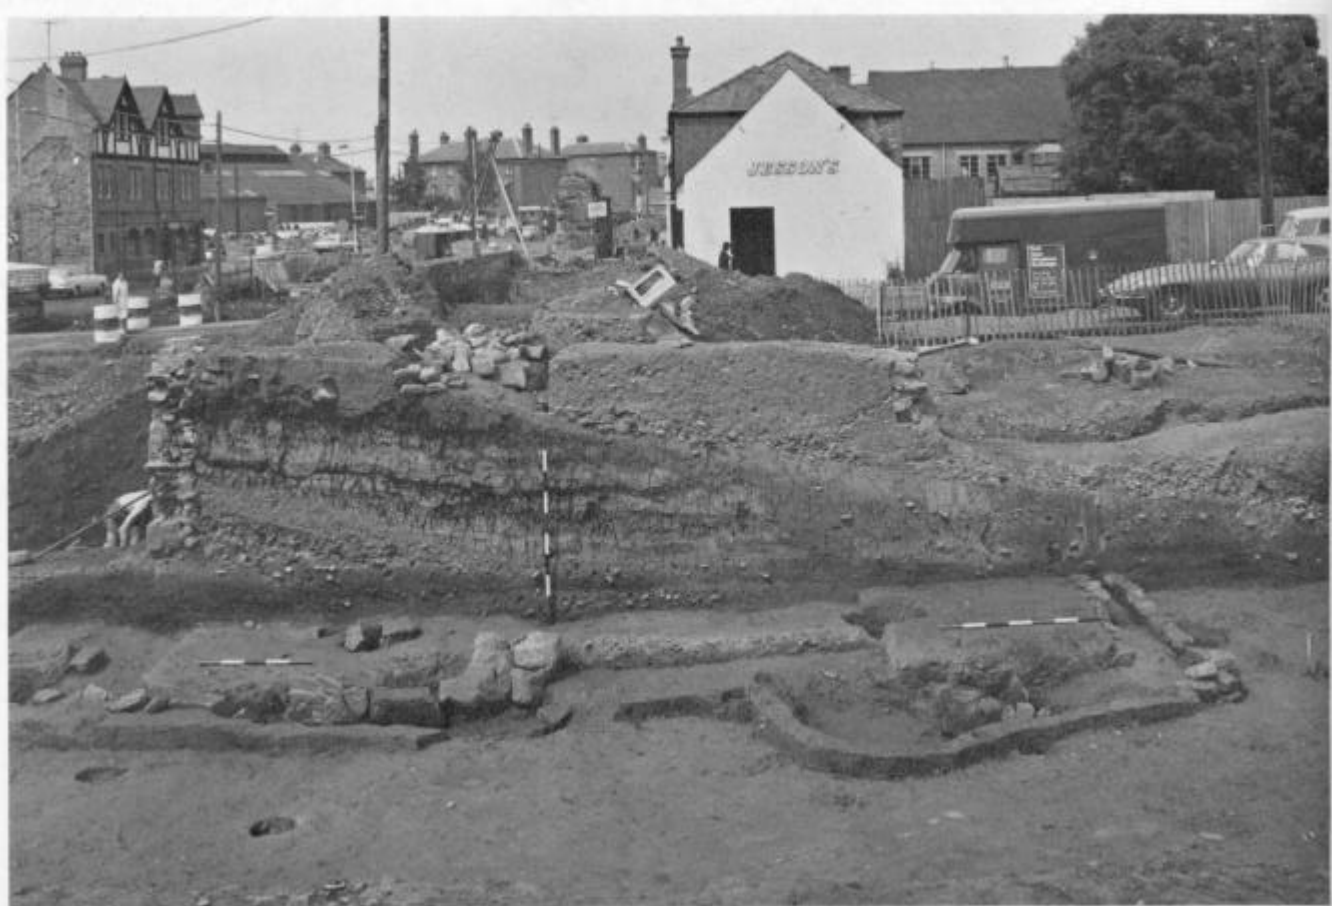
Fig 23 Victoria Street. The site from the south showing the retained baulk and section A-B. Wall 2 is above and to the left of the central ranging rod. The period 1 grain drying ovens are in the foreground

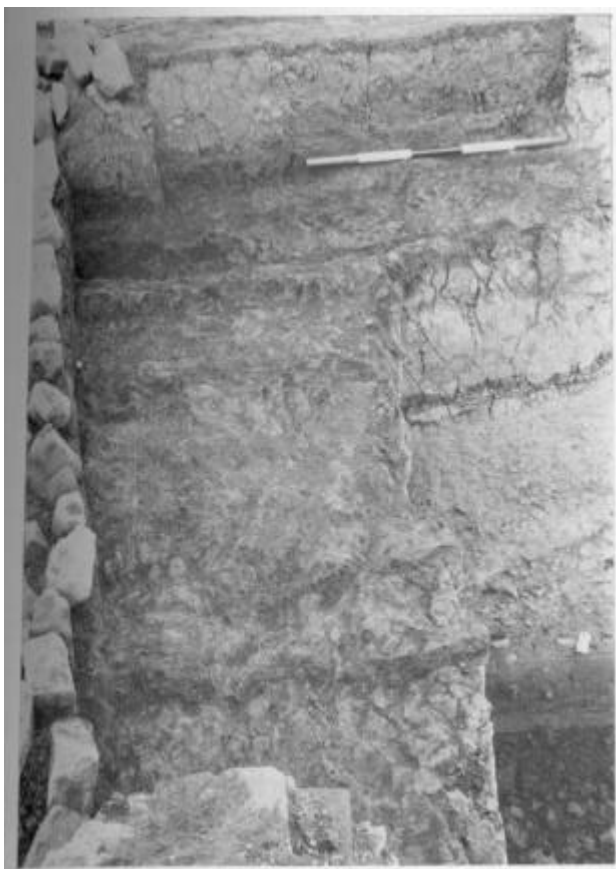
Fig 25 Victoria Street. Period 5. Detail of the stage 2 timber strengthening of the rampart to the west of wall 2 line

The turf and clay rampart (Figs 22, 23, and 25)

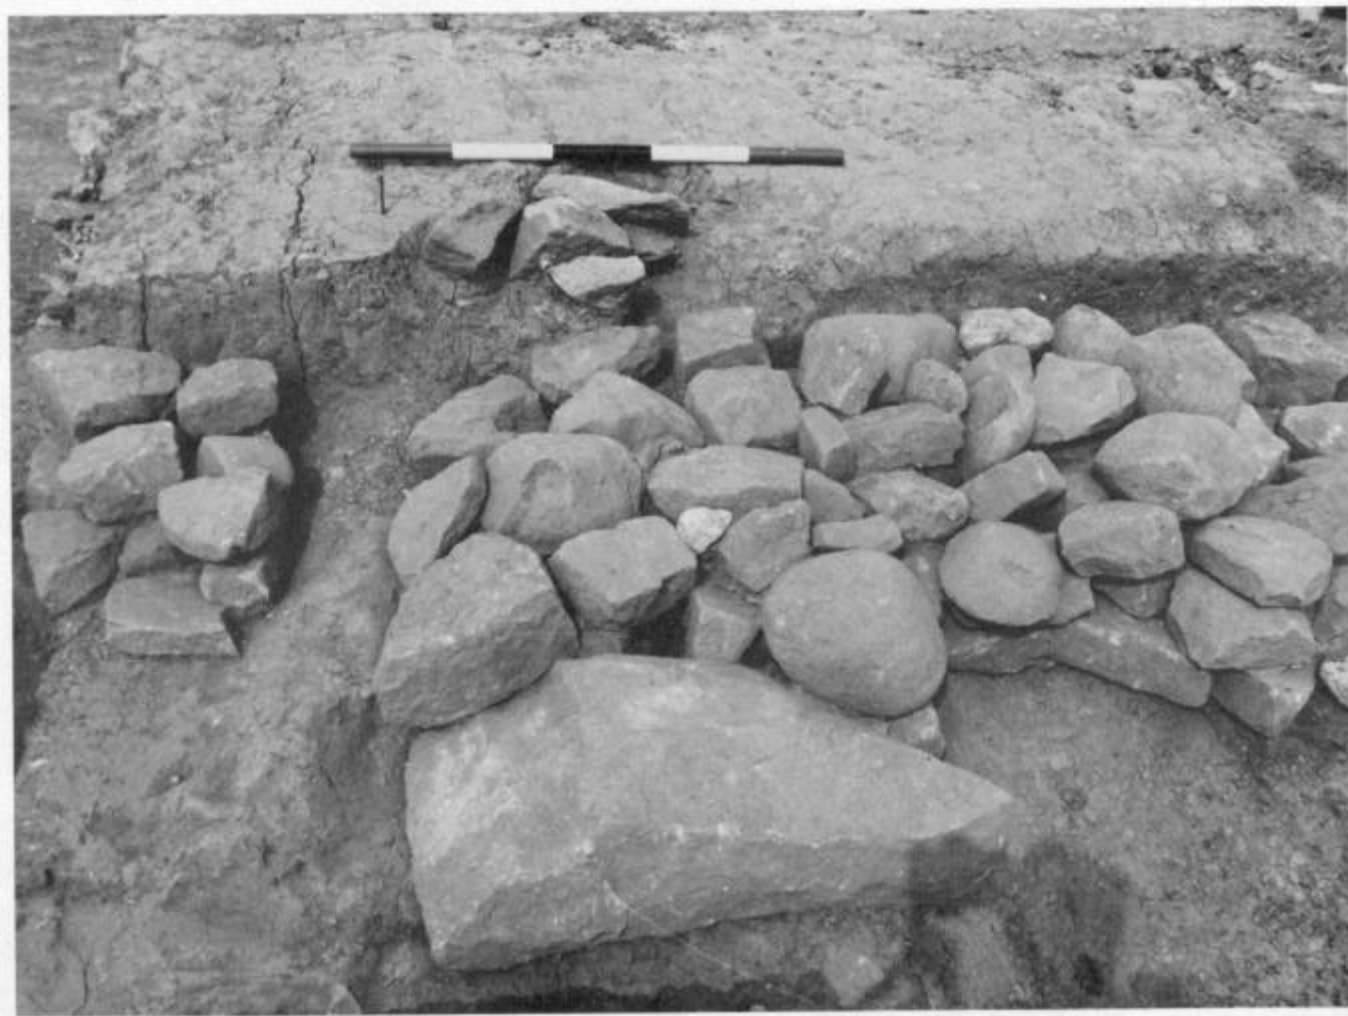
Fig 29 Victoria Street. Period 5b. The stage 3 wall, 2, from the east showing the possible position for a joist for a timber platform

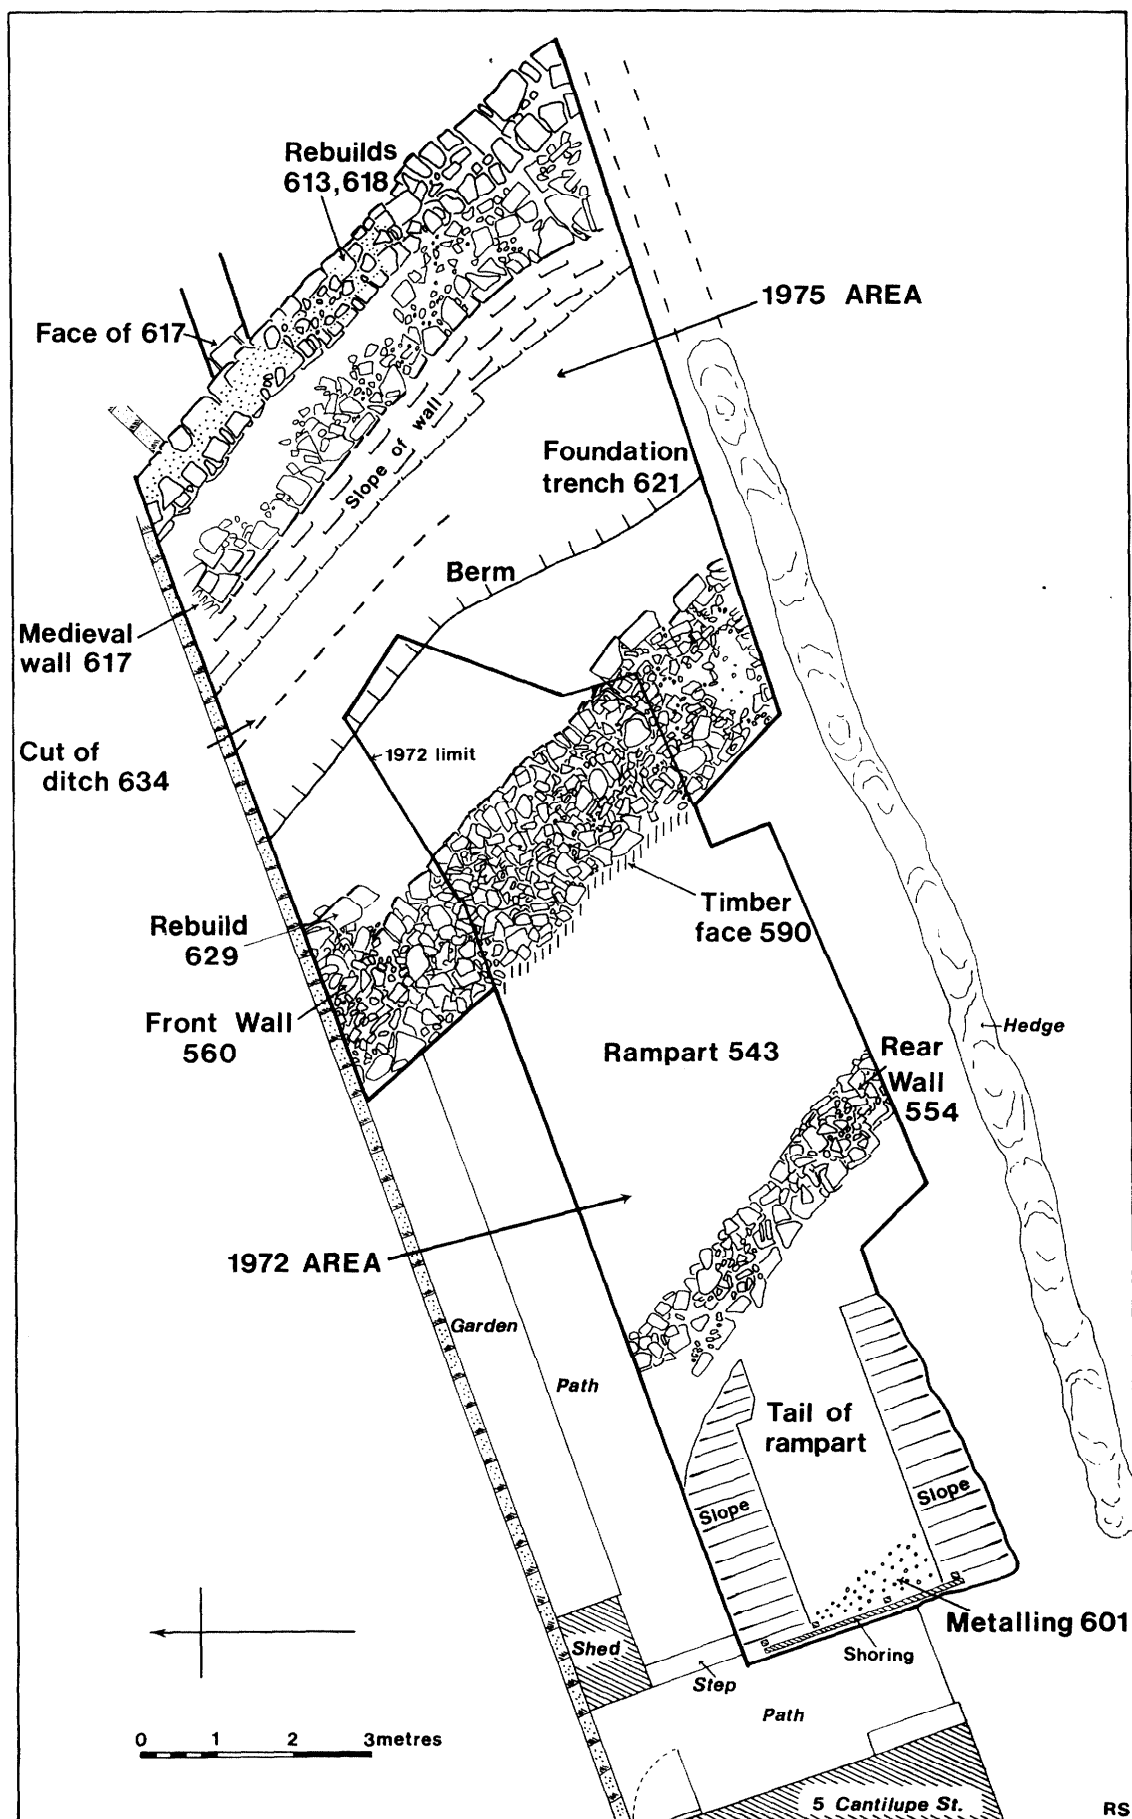
Fig 35 Cantilupe Street. Plan of T5 showing areas excavated in 1972 and 1975 and the position of the principal features

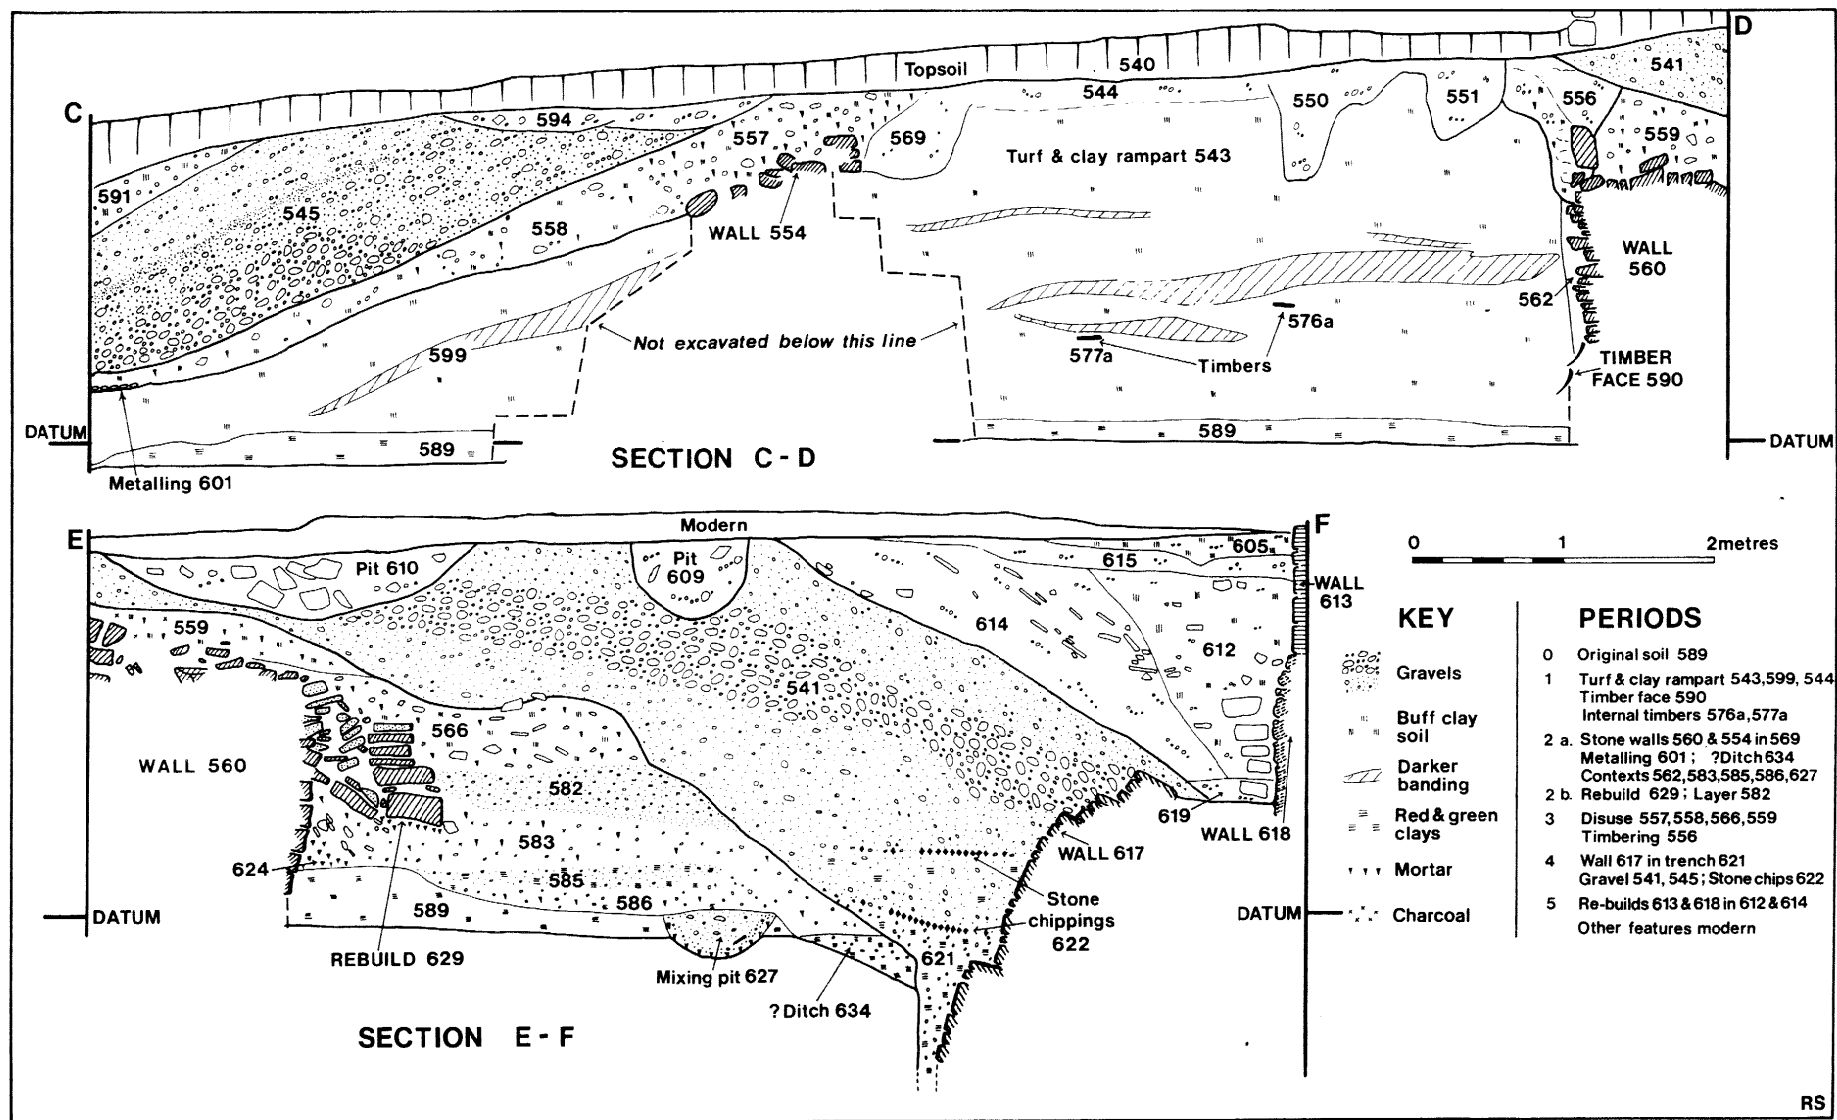
Fig 37 Cantilupe Street. Sections C-D and E-F. See Fig 36 for positions

Part of a metalled surface, 601, consisting of small river washed pebbles, was found on the lower tail of the rampart (Fig 37). On the berm in front of wall 560,

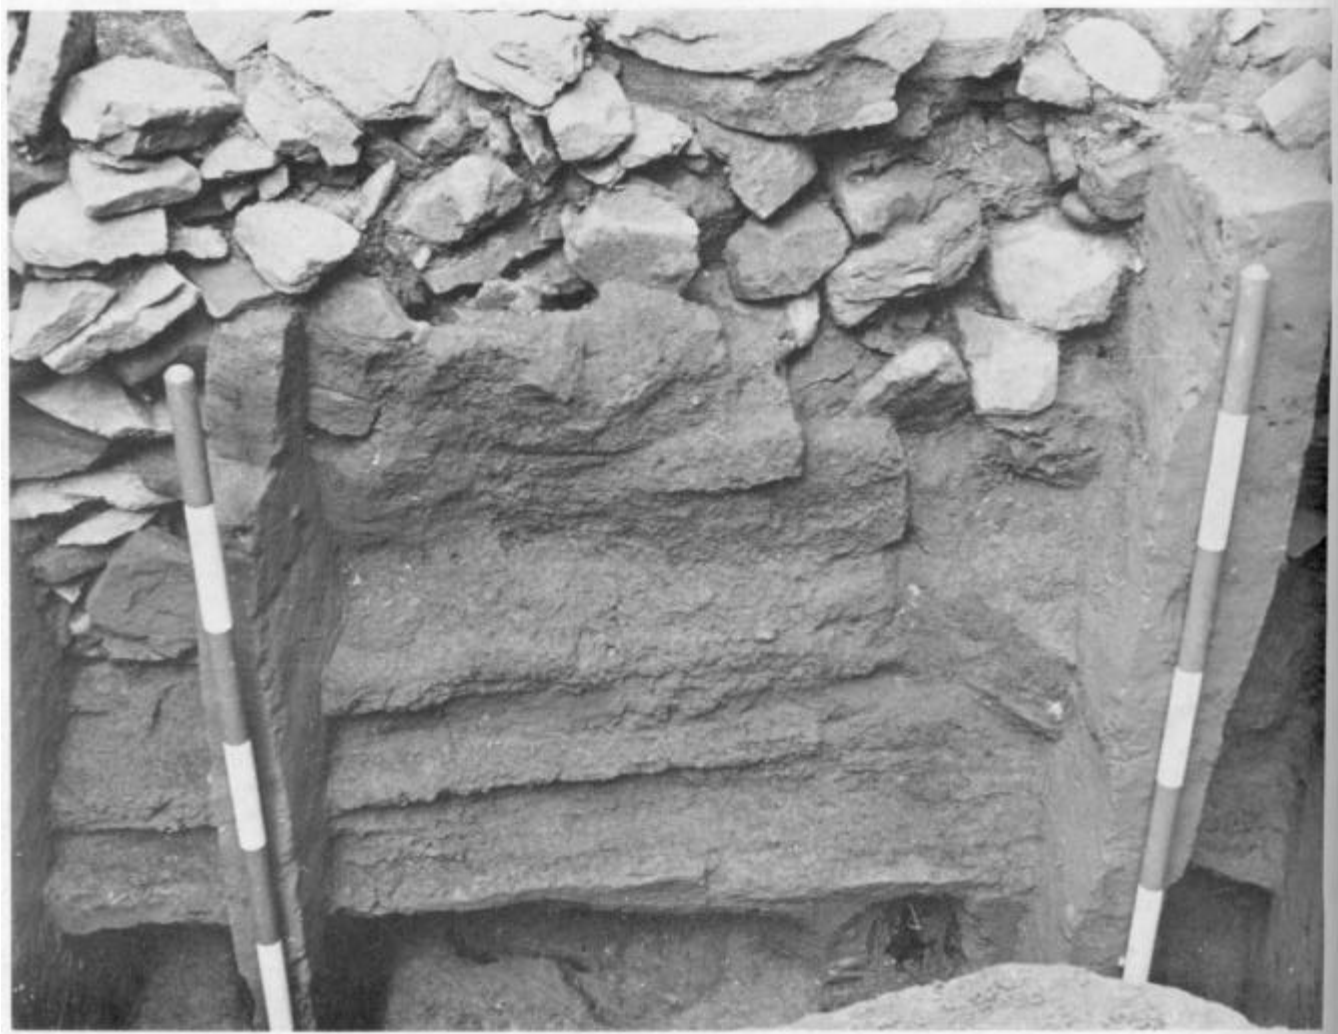
Fig 41 Cantilupe Street. Period 1. The remains of the stage 2 timber face 590 after removal of part of the rampart

The rampart was faced in timber and sufficient traces survived to postulate the design and method of construction (Fig 41). It is suggested that, before piling up the turves of the rampart, posts between 0.13 and 0.25m in diameter were set in line along the proposed face about 1m apart. Turves were then laid, and, as the platform thus created grew in height, logs of about 0.25m scantling, which had been split in half, were placed horizontally between the growing rampart and the vertical timbers, with the split side towards the rampart. Each split log was placed on top of the previous one and the eventual external aspect must have been very impressive, comprising a solid timber face without any use of nails or fastenings. It is presumed that the timber face was carried above

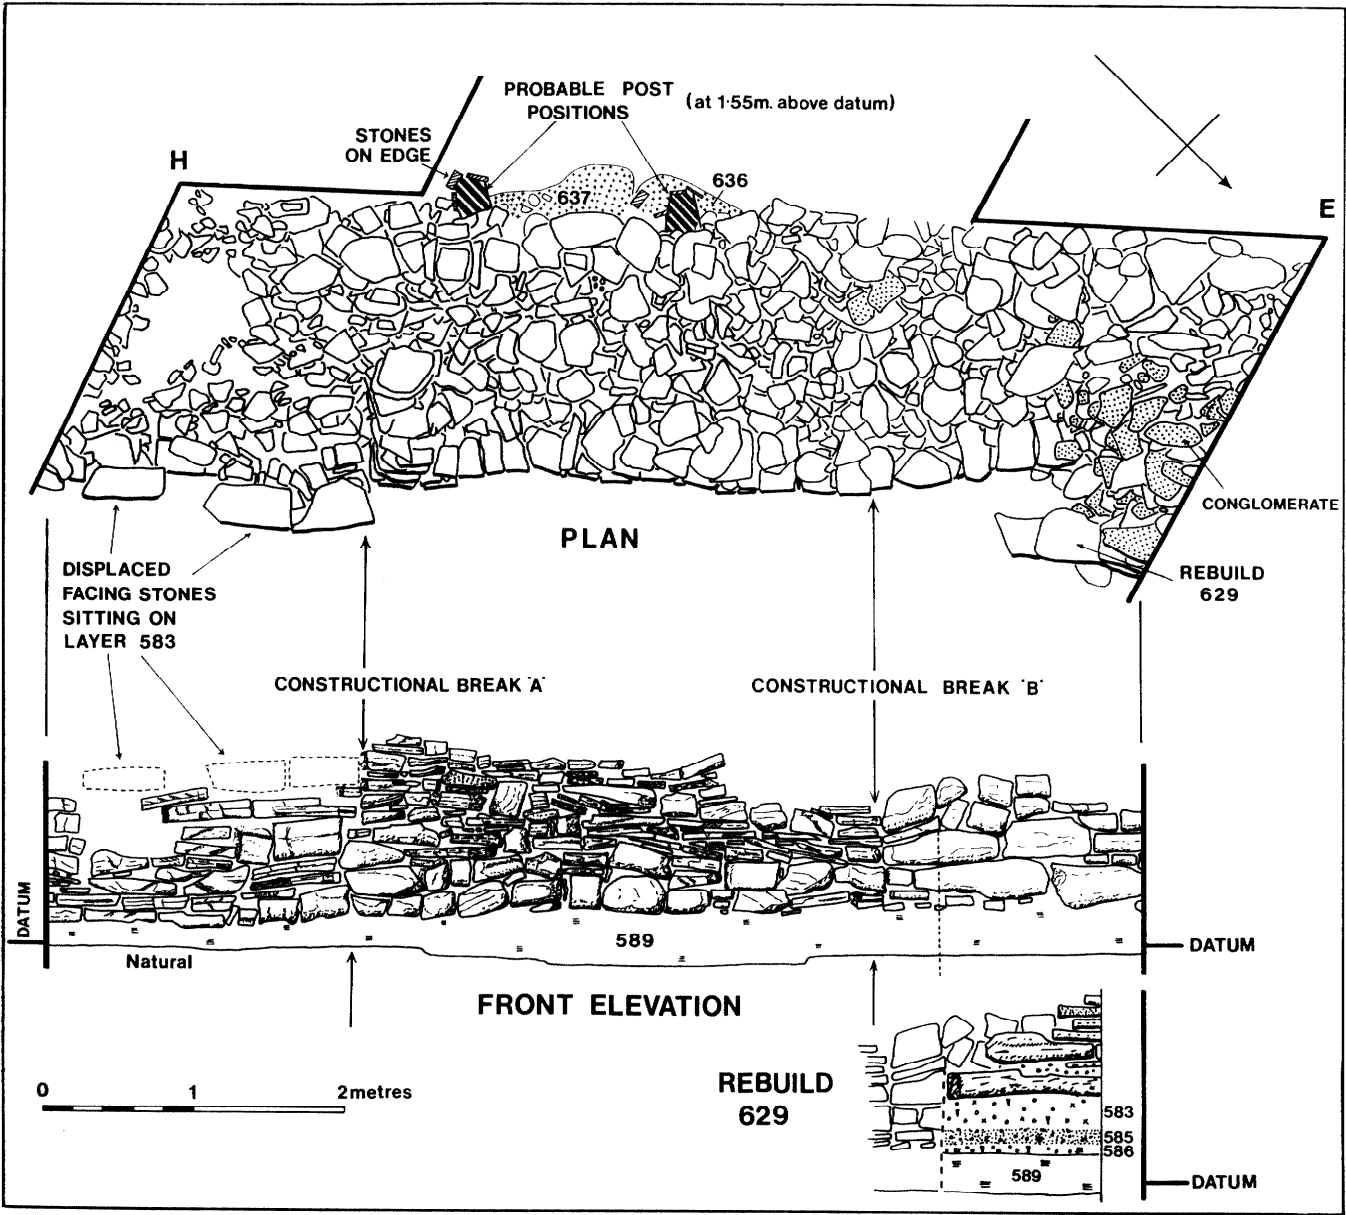
Fig 42 Cantilupe Street. Period 2a. Plan and elevation of the stage 3 wall, 560, and associated features including the rebuild 629 of period 2b
