Excavations on and close to the defences

Hereford City Excavations Volume 2

Excavations on and close
to the defences

by R Shoesmith

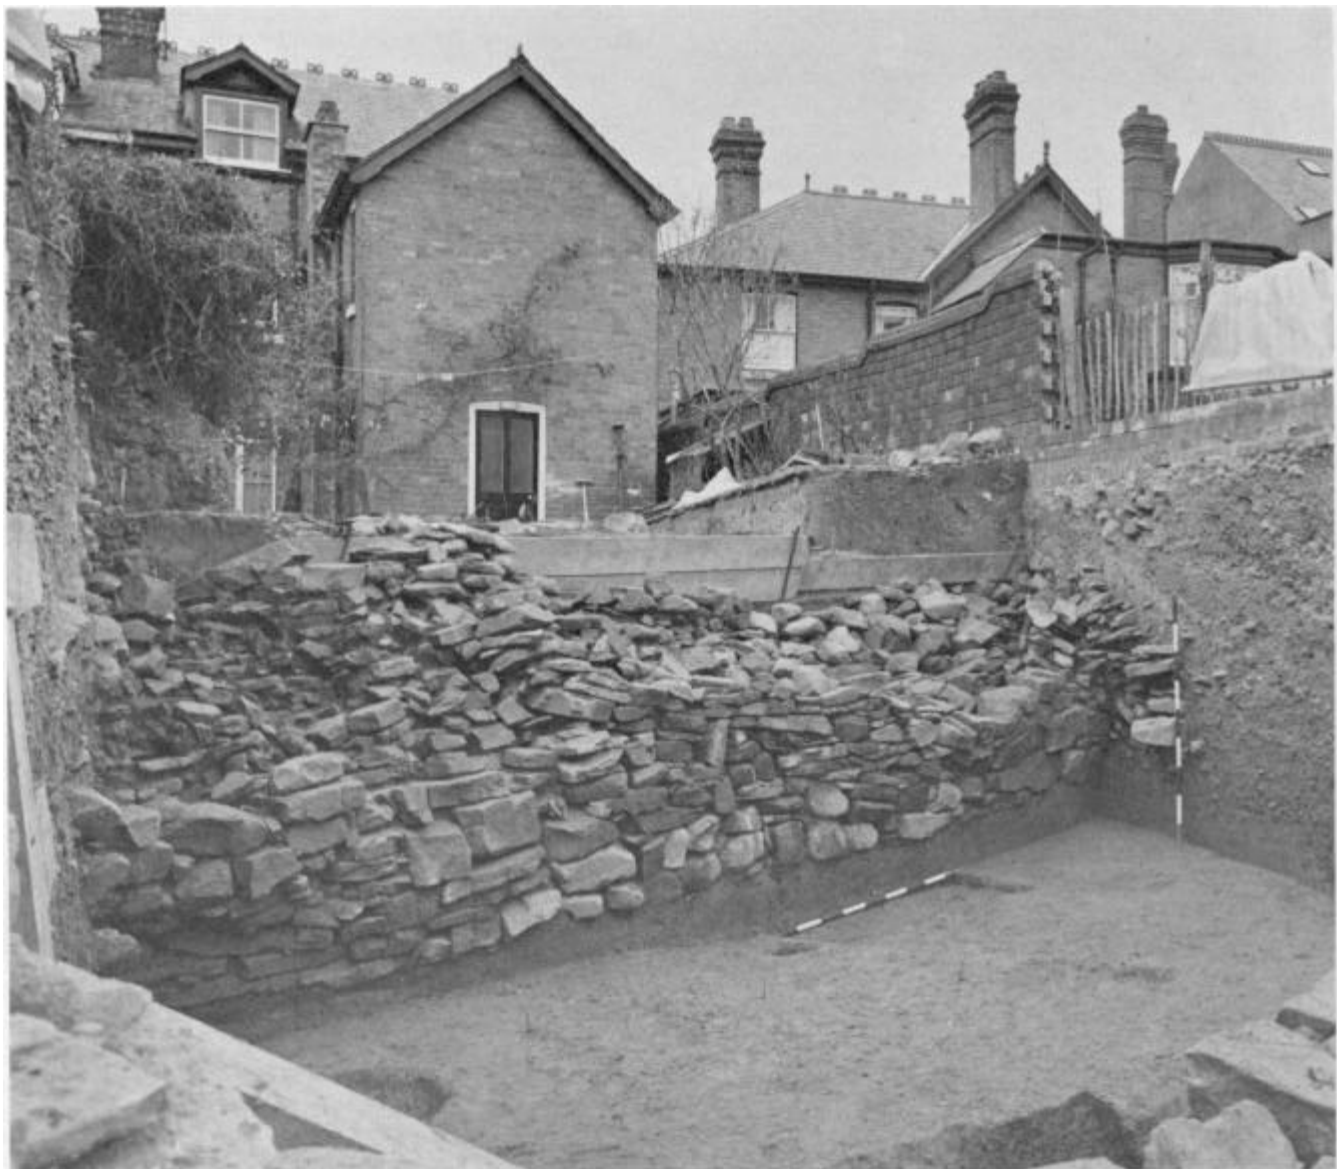
Fig 43 Cantilupe Street. Period 2a. The stage 3 wall, 560, with the houses in Cantilupe Street in the background

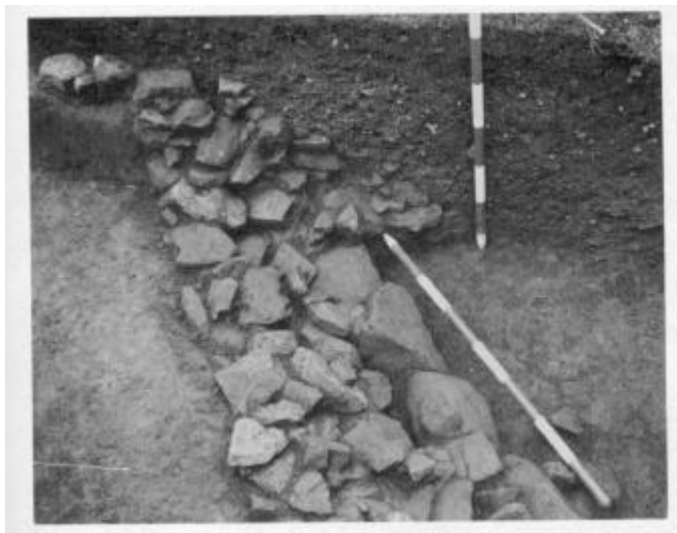
Fig 45 Cantilupe Street. Period 2a. The stage 3 wall, 554, during excavation

A second wall was built on a step cut into the rear crest of the rampart about 4.7m behind the rear of the front wall. It was about 0.7m wide and a maximum of 0.5m high (Fig 45) and may have acted as a rear revetment for the flat platform or as a foundation for a plank floor. There was little attempt at coursing and only a few traces of mortar.

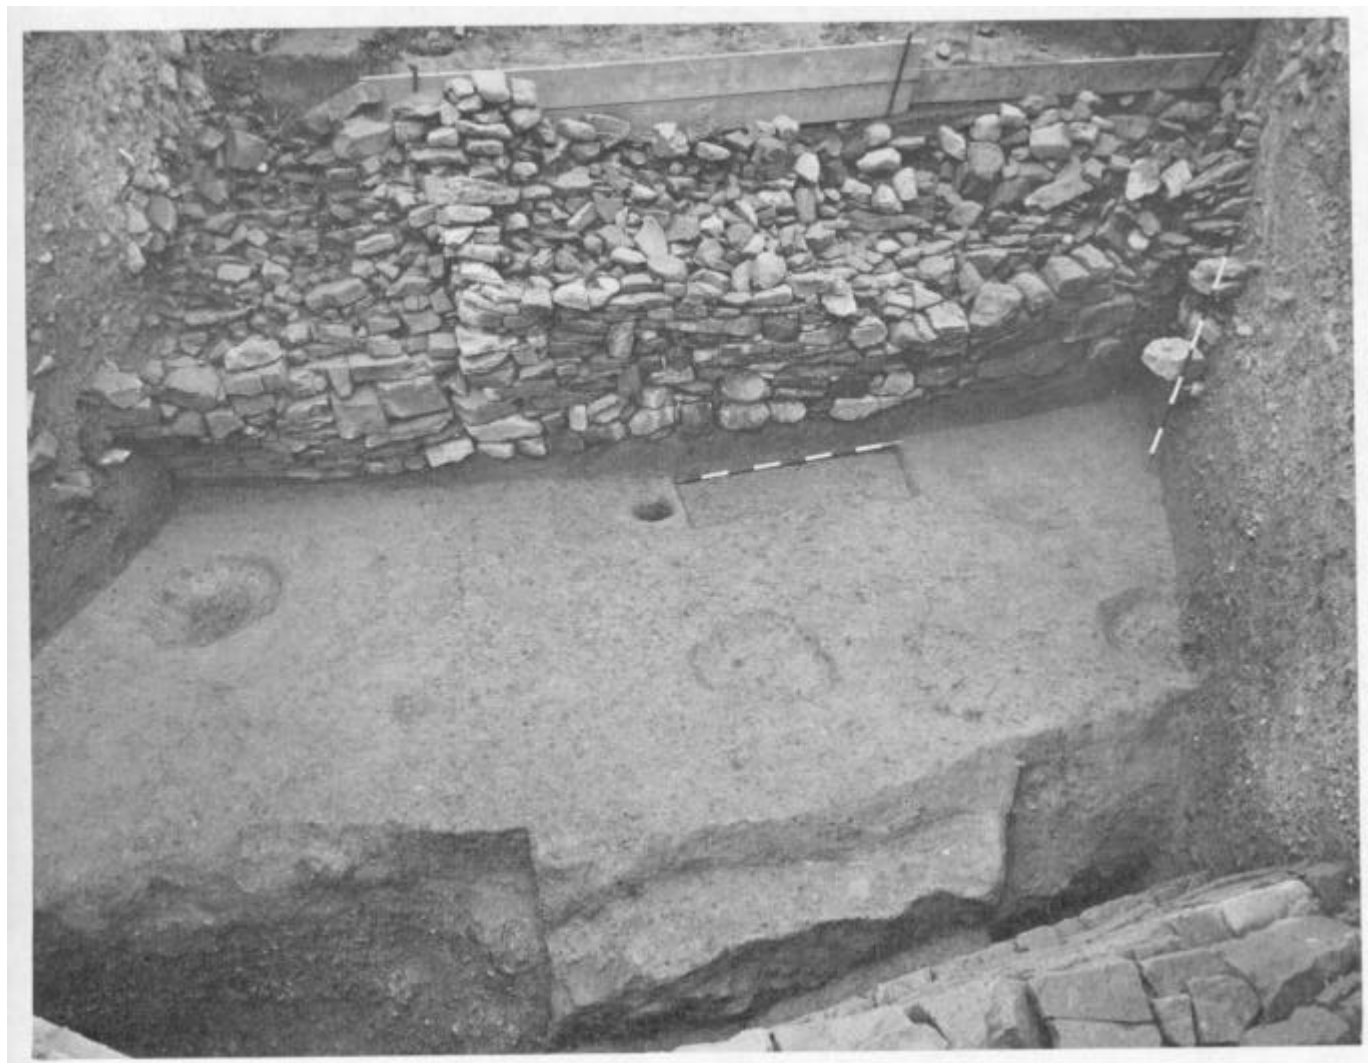
Fig 48 Cantilupe Street. The stage 3 wall, 560, and the period 2a mortar mixing pits from above. The two construction breaks on wall 560 are apparent, as is the lip of the ditch which was mainly cut away as a foundation trench for the period 4 medieval wall

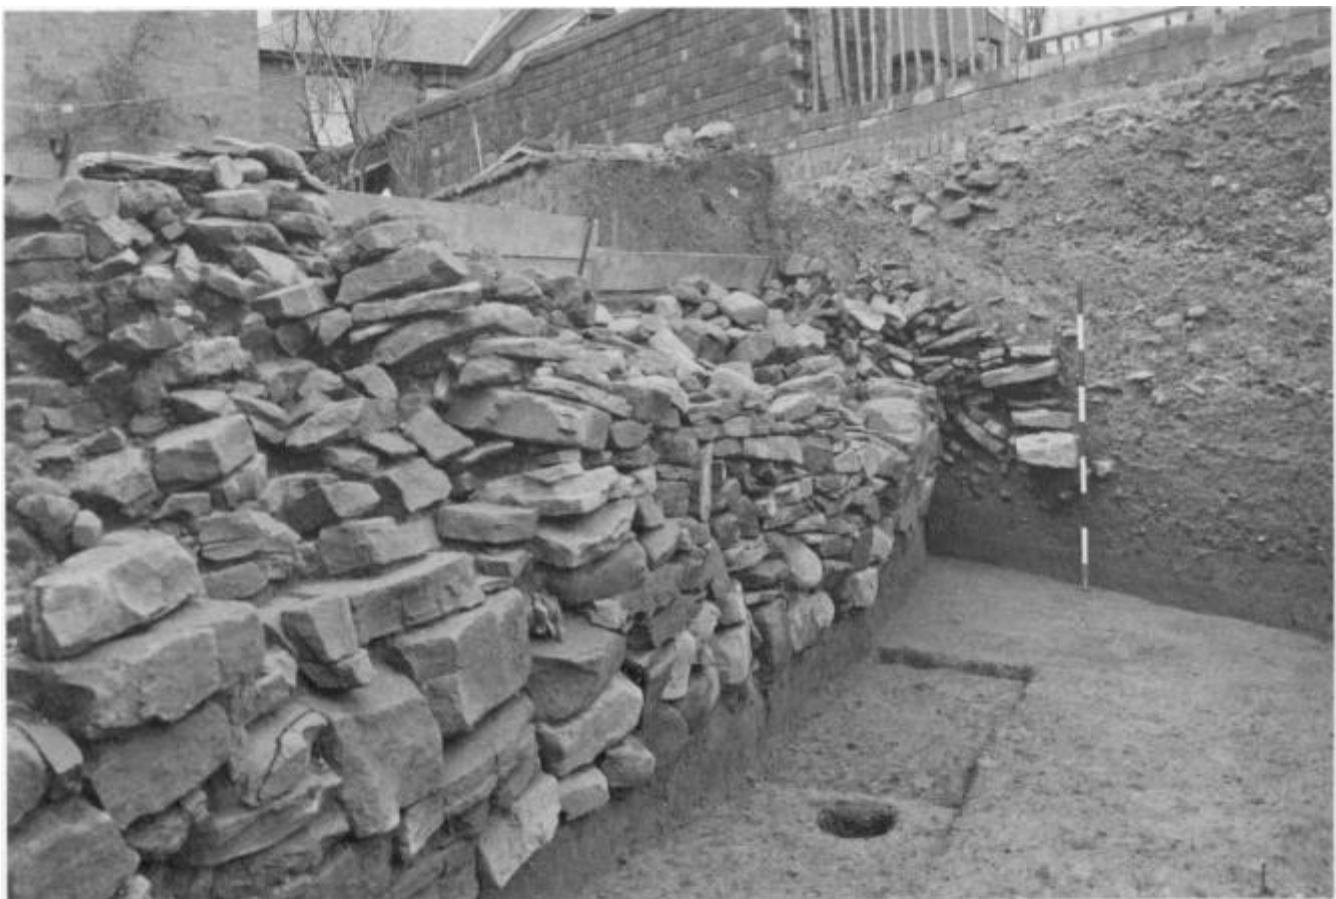
Fig 49 Cantilupe Street. The stage 3 wall, 560, and the associated section from the south showing the period 2b rebuild 629 in section

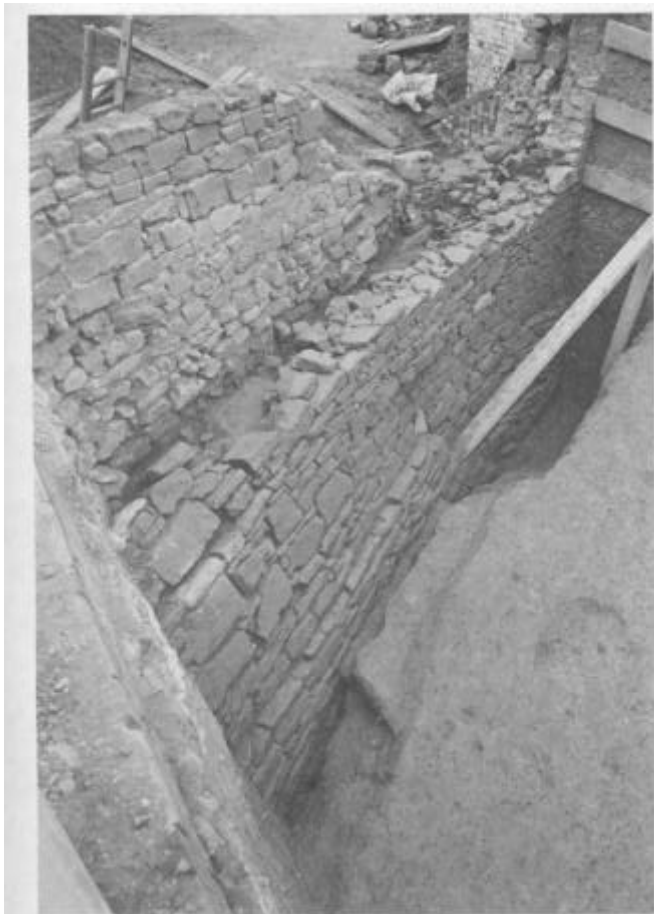
Fig 54 Cantilupe Street. The internal faces of the stage 6 walls 613, 617 and 618 after the removal of the period 4 gravel infilling

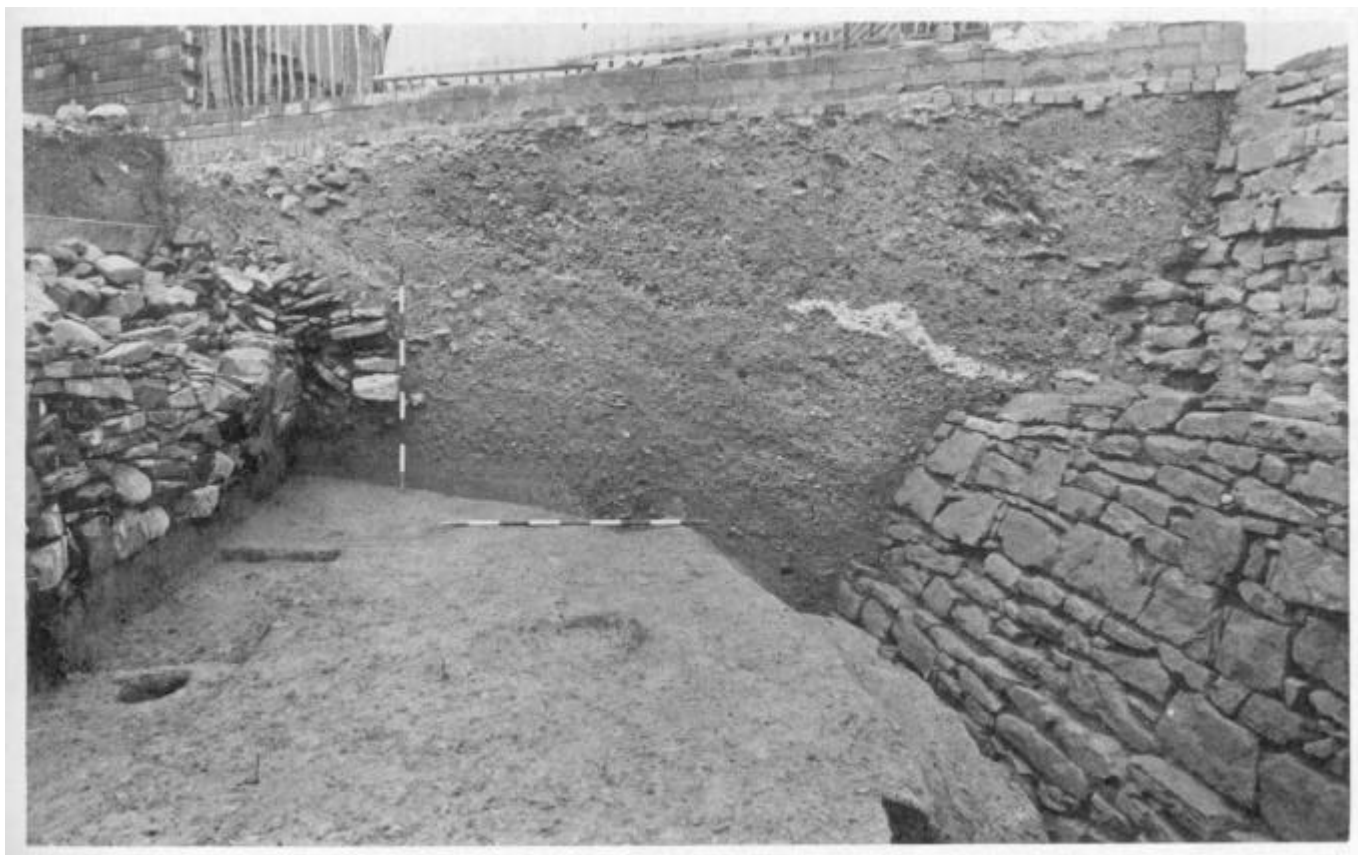
Fig 55 Cantilupe Street. The collapse of the stage 6 wall, 617, and the gravel infill between the Saxon and medieval defences

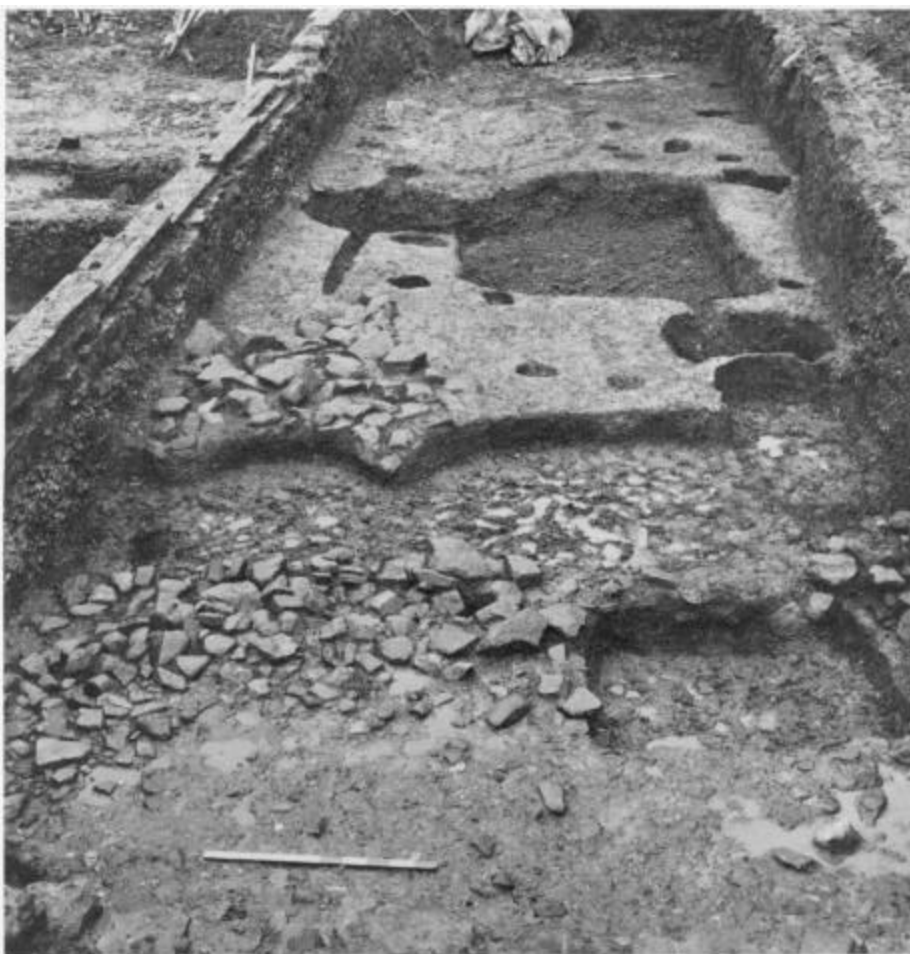
Fig 60 Berrington Street. Period 1. Site 1 from the west showing the remains of building A

Buildings A-D were all in the western part of the area with their long axes east-west (Figs 60 and 64). They fronted on to a metalled trackway about 4m wide which ran north-south up the western extremity of the excavated area (Fig 67). To the west of the trackway, in an extension to site 1, a group of postholes, 79, were found under circumstances which left their stratified position in some doubt. It is suggested that this group of postholes, the eastern curve at the southern end of the north-south trackway, and the more easterly position of building A as compared with buildings B, C, and D to the north, are all related. If it is accepted that this relationship is due to a later realignment of the line of King Street and St Nicholas Street (M2.C4) then it can be postulated that this posthole group could represent a watch tower on the northern side of the western gate, associated with stage 1 of the defensive sequence.

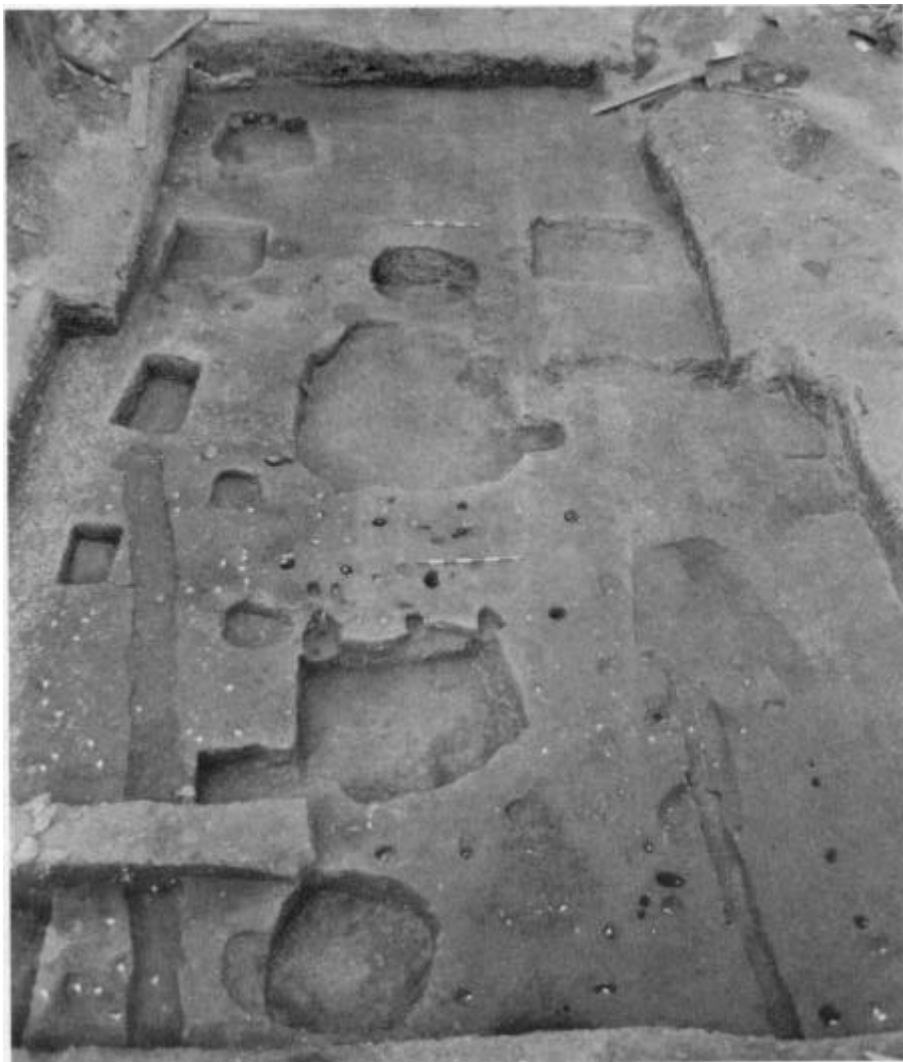
Fig 64 Berrington Street. Period 1. Site 2 from the south showing the remains of building B

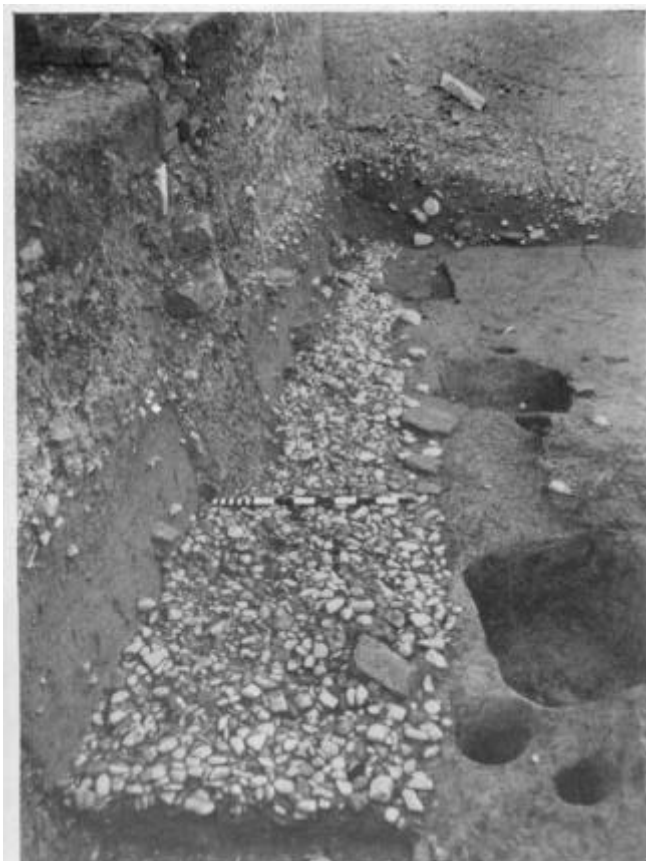
Fig 67 Berrington Street, Period 1. Western part of site 3 from the south showing metalling 527

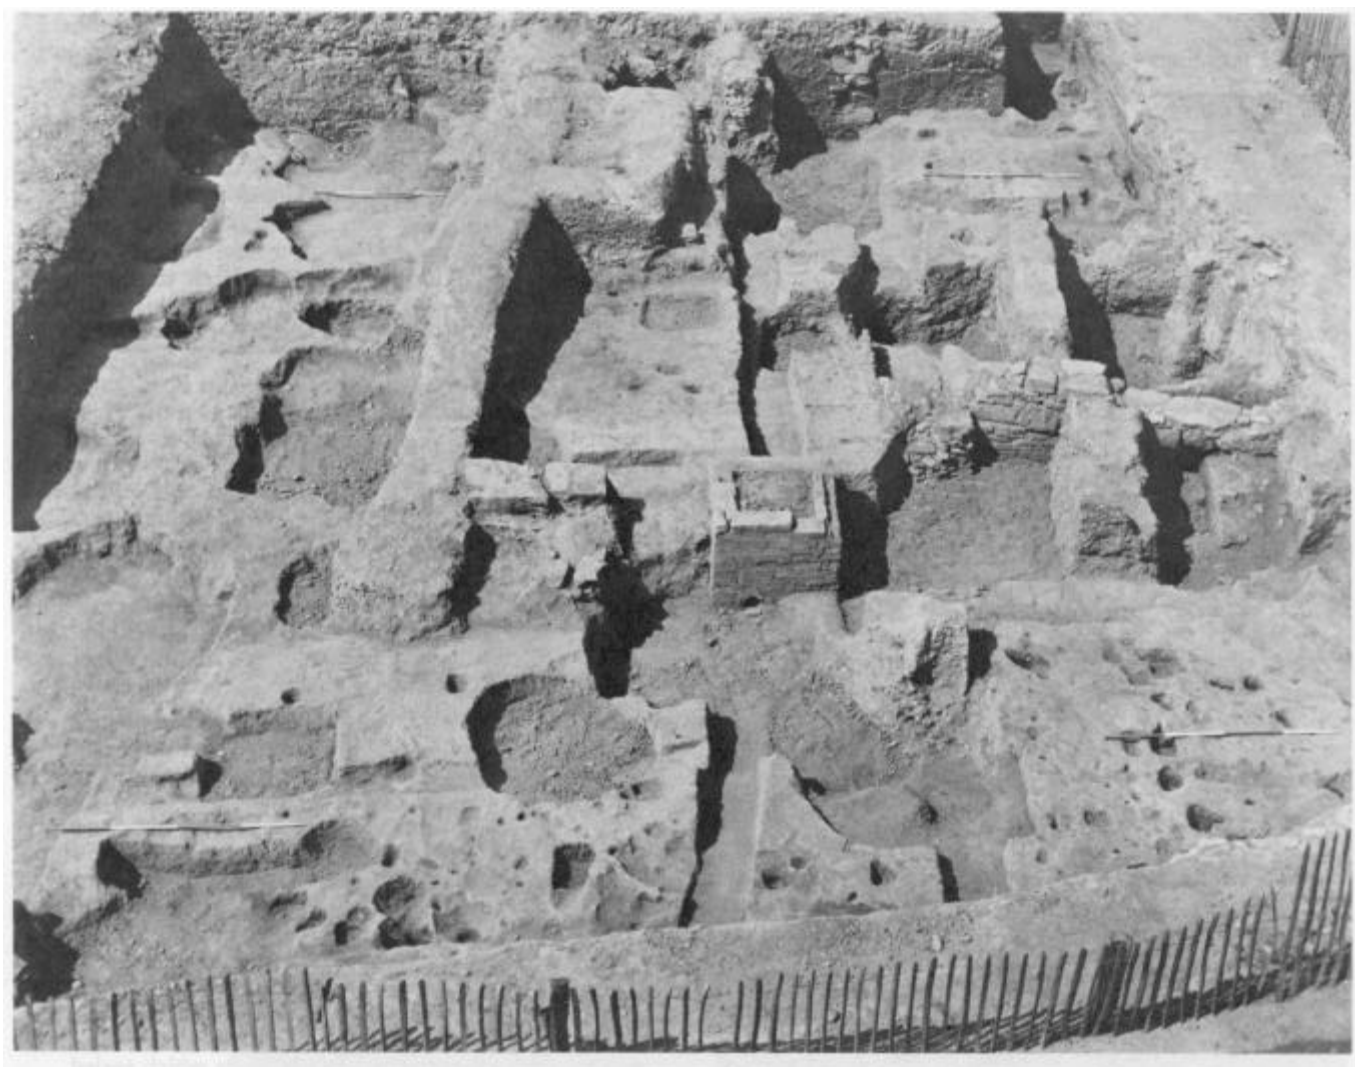
Fig 70 Berrington Street. Site 4 from the south. The small areas of the period 1 levels can be seen

The remains of the buildings in the east of the area on site 4 were in a very fragmentary state but included traces of floor levels and hearths (Fig 70). The buildings apparently fronted on to the line of Berrington Street and were also orientated with their long axes east-west.

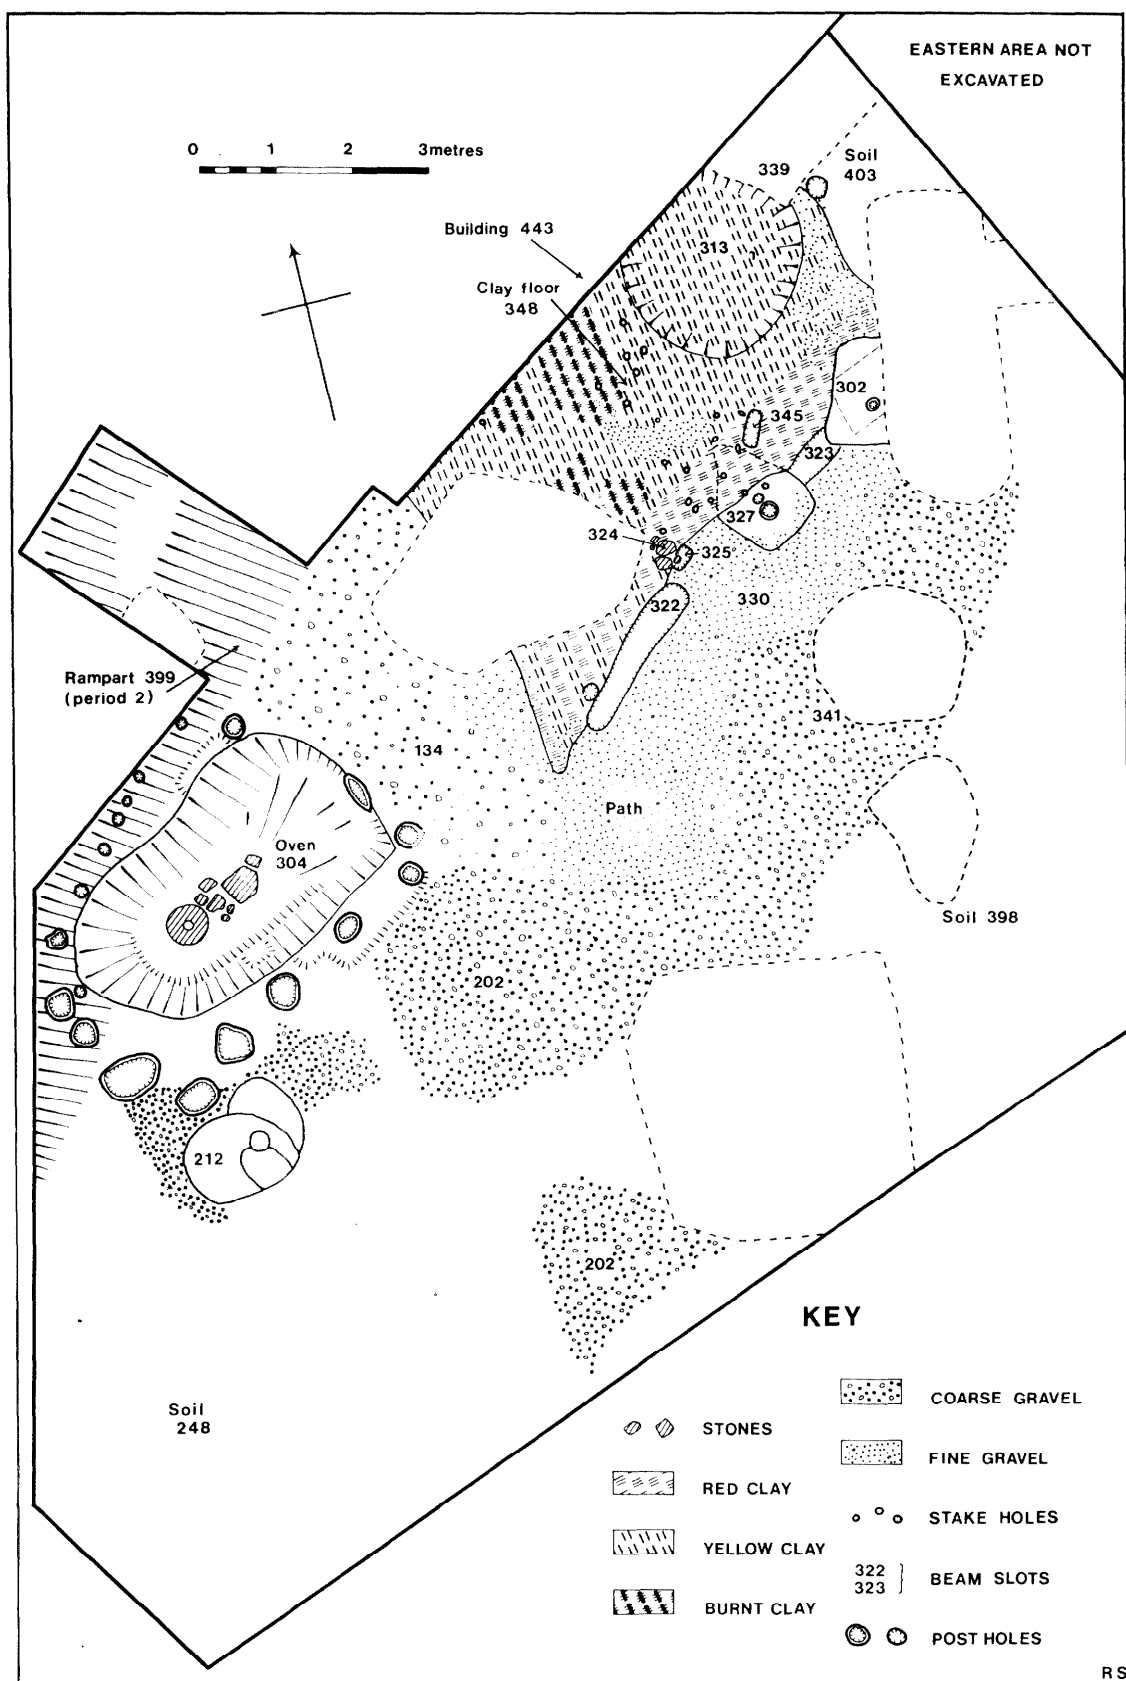
Fig 87 Bewell House. Period 4. Plan of features including oven 304 and building 443

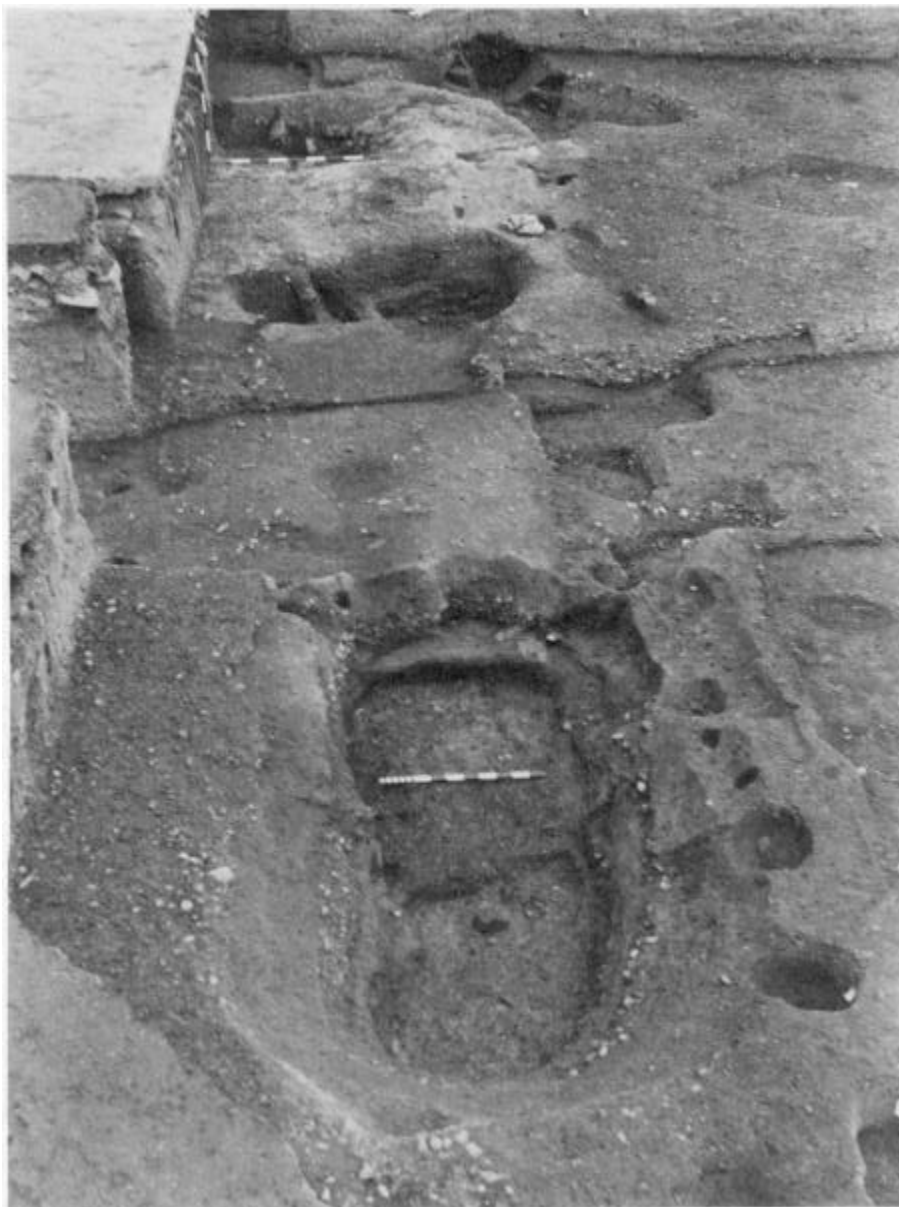
Fig 88 Bewell House. Period 4 features from the west. Oven 304 is in the foreground with building 443 behind

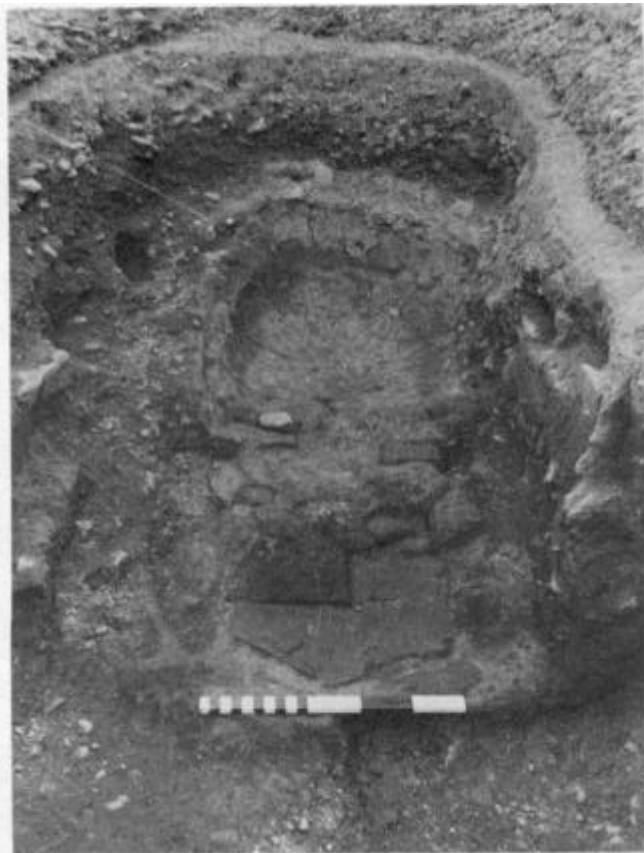
Fig 94 Bewell House. Period 4. Oven 304 from the east

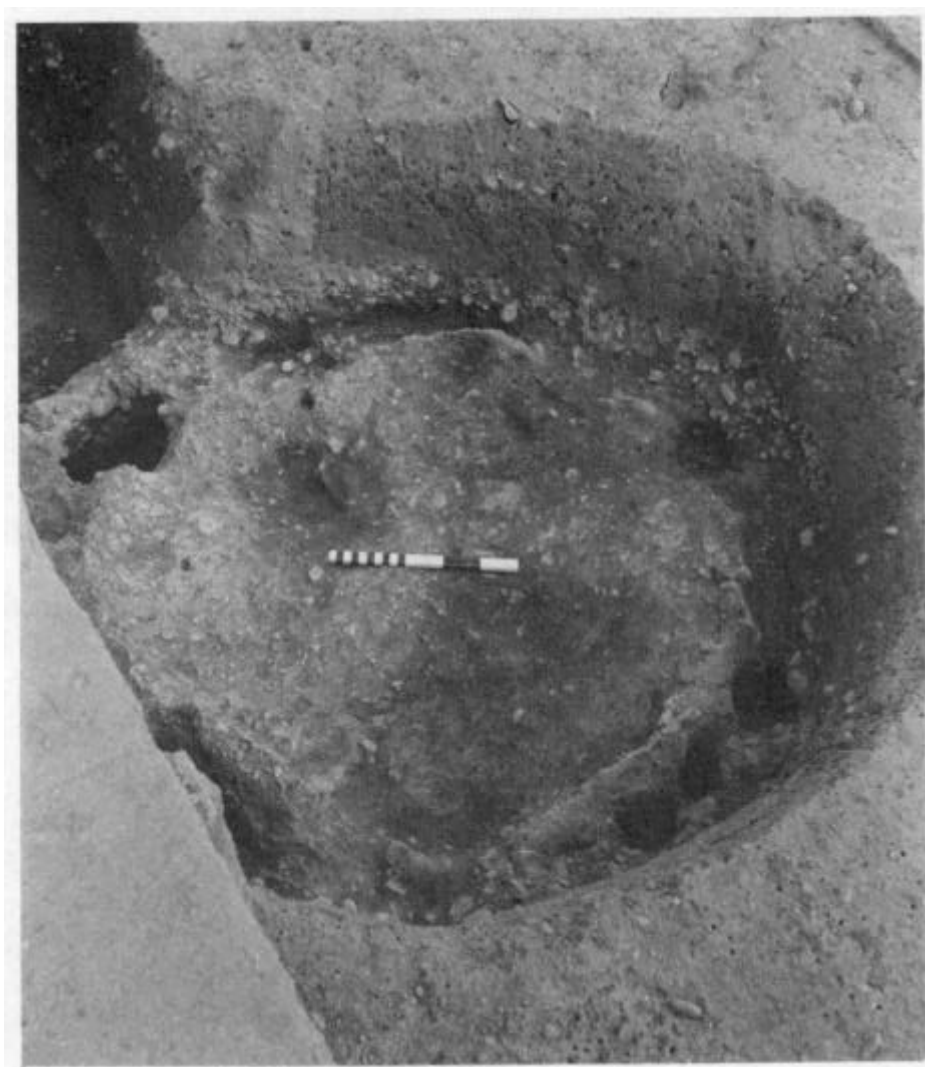
Fig 97 Bewell House. Periods 3 and 4. Detail of pit 313/384

places. There were signs of a flimsy partition which separated the building into two rooms. Much of the n&h-eastern room was above the cesspit 384 of period 3. The upper part of the pit was apparently re-used during period 4 as a shallow clay-lined hole, 313, between 0.7 and 0.9m deep, considerably greater than would have occurred by any subsidence in the earlier pit. The base and the sides of the upper pit, within the postulated period 3 timber lining, were covered in clay similar to that of the floor of the building (Fig 97). The clay floor, the pit and the surrounding post and beam positions, were all covered in a thick layer of charcoal, and the remaining part of the pit was filled with a wet gravelly soil.

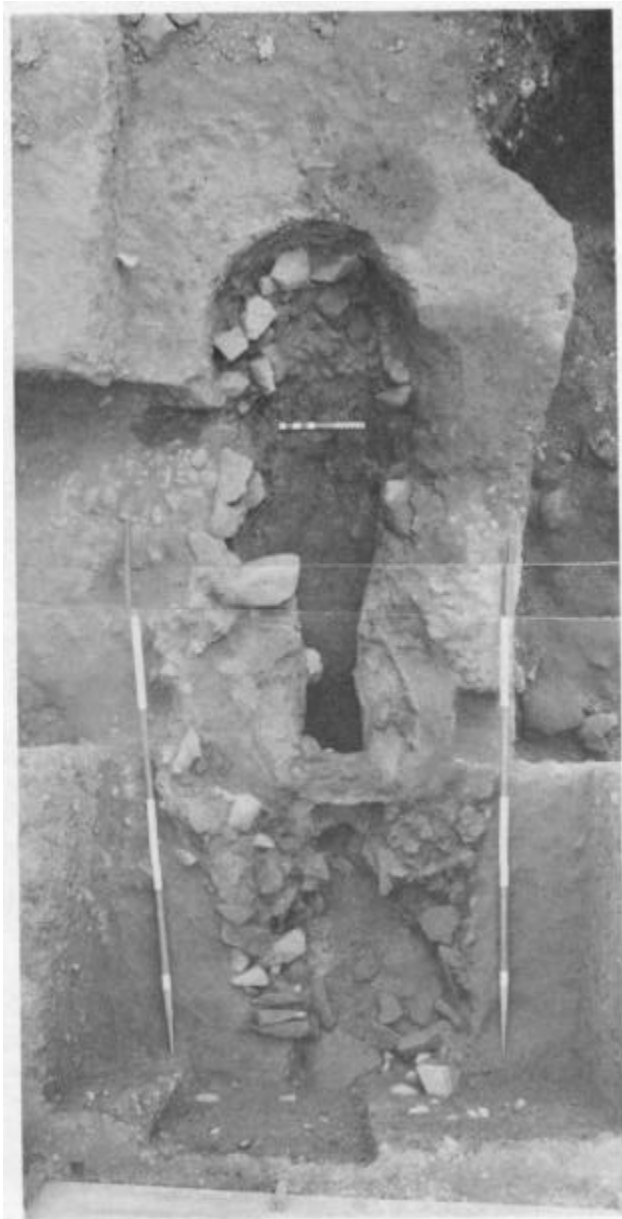
Fig 108 Brewery site. Period 2b. Furnace 169 from above with east at the top (composite photograph)

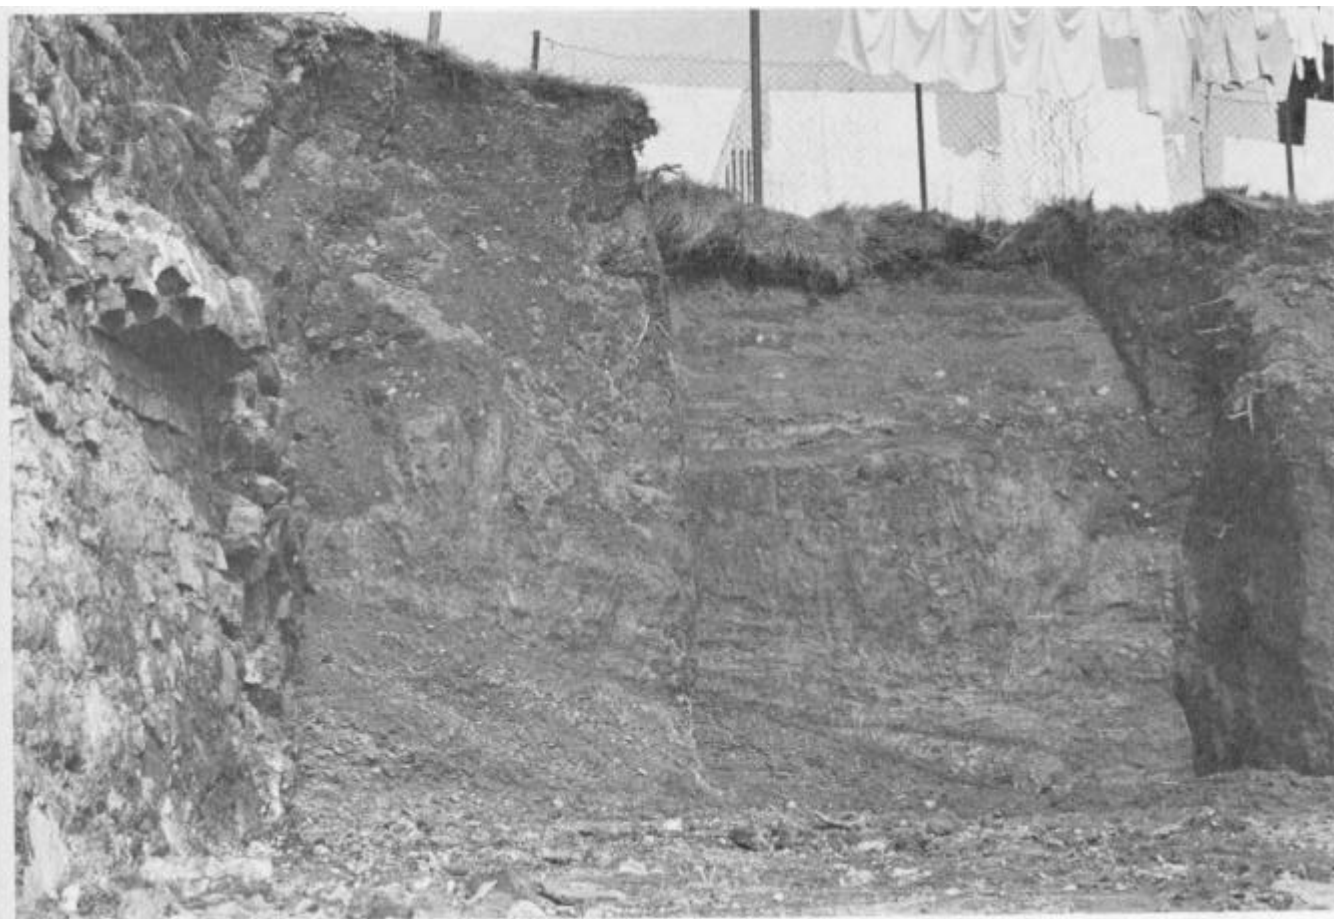
Fig 123 Friars' Gate. The western part of the section

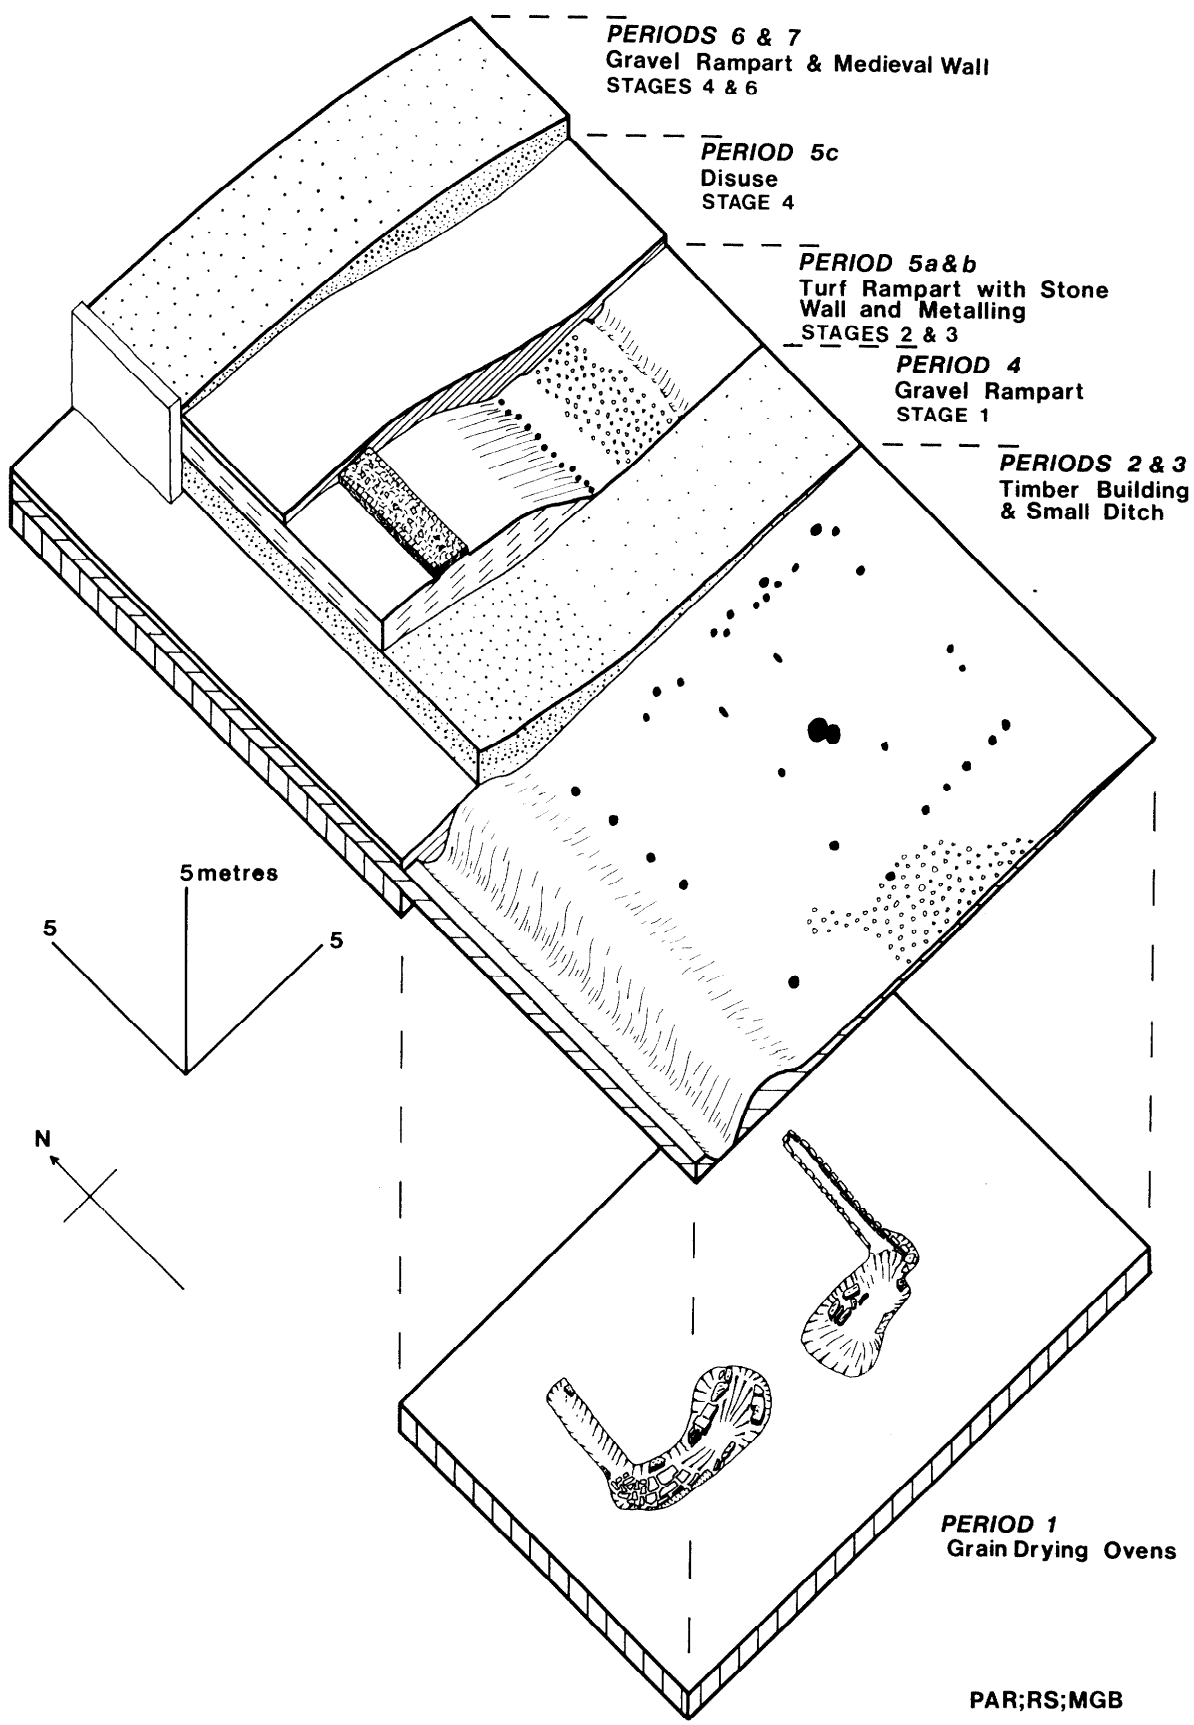
Fig 129 Victoria Street. Isometric projection of the occupation and defensive periods

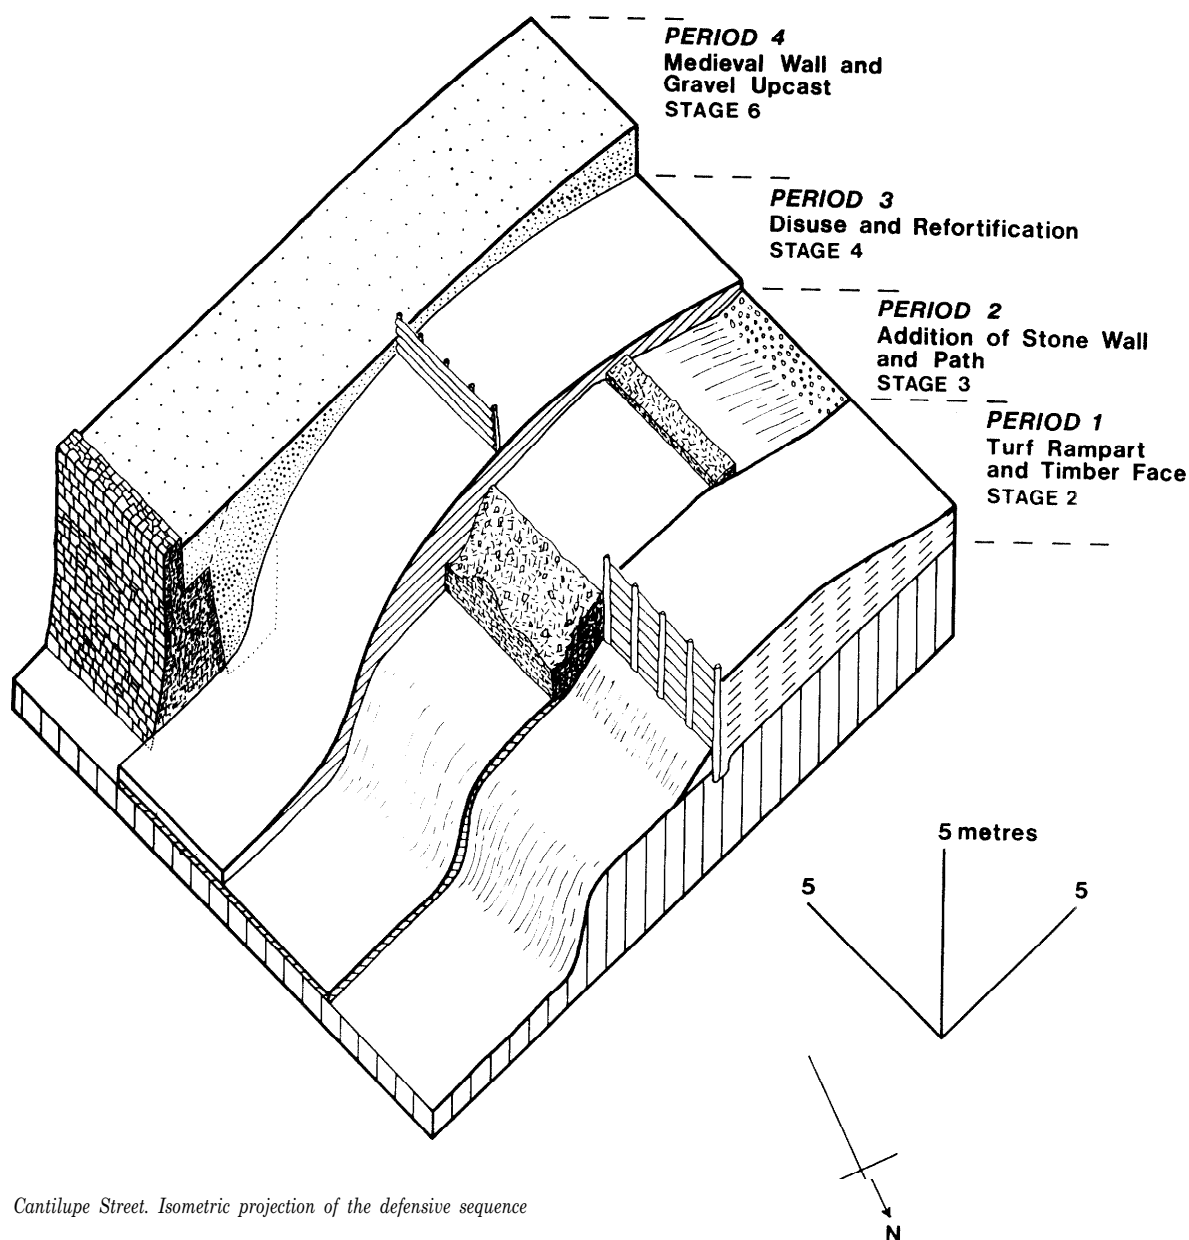
Fig 130 Cantilupe Street. Isometric projection of the defensive sequence

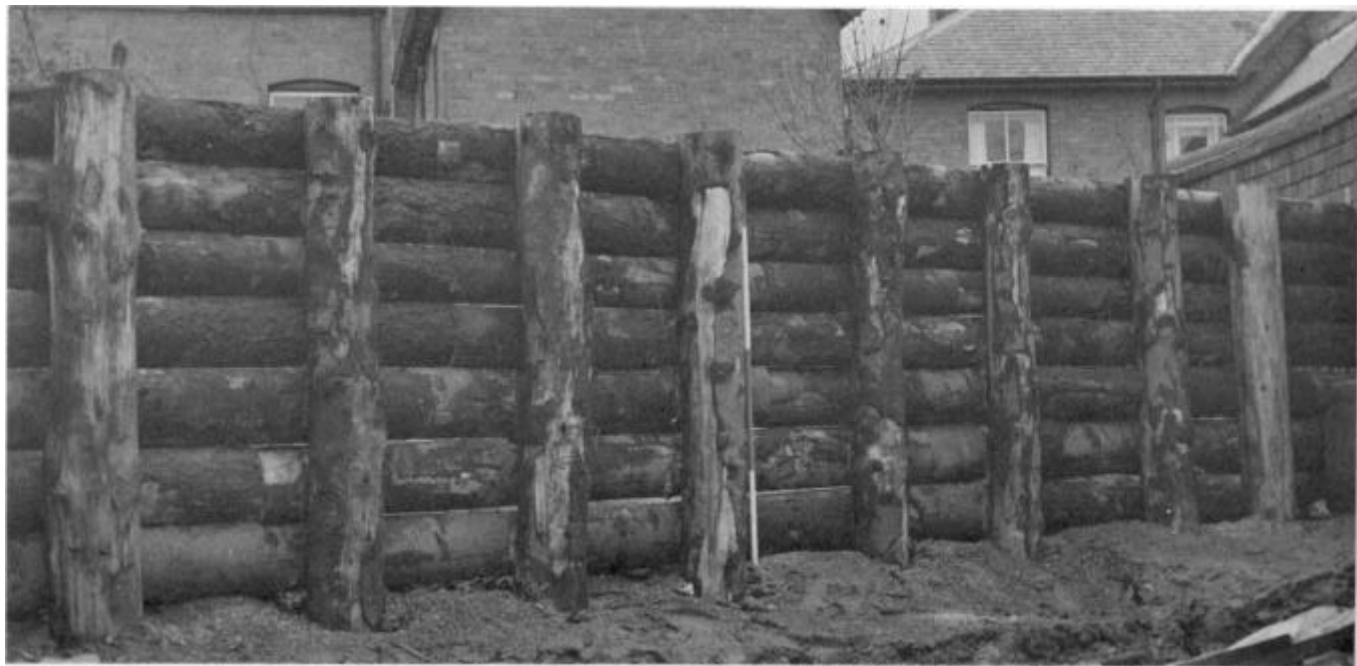
Fig 132 Cantilupe Street. The reconstructed stage 2 defences which now act as a garden fence separating the remaining part of the garden of 5 Cantilupe Street from the area open to public view

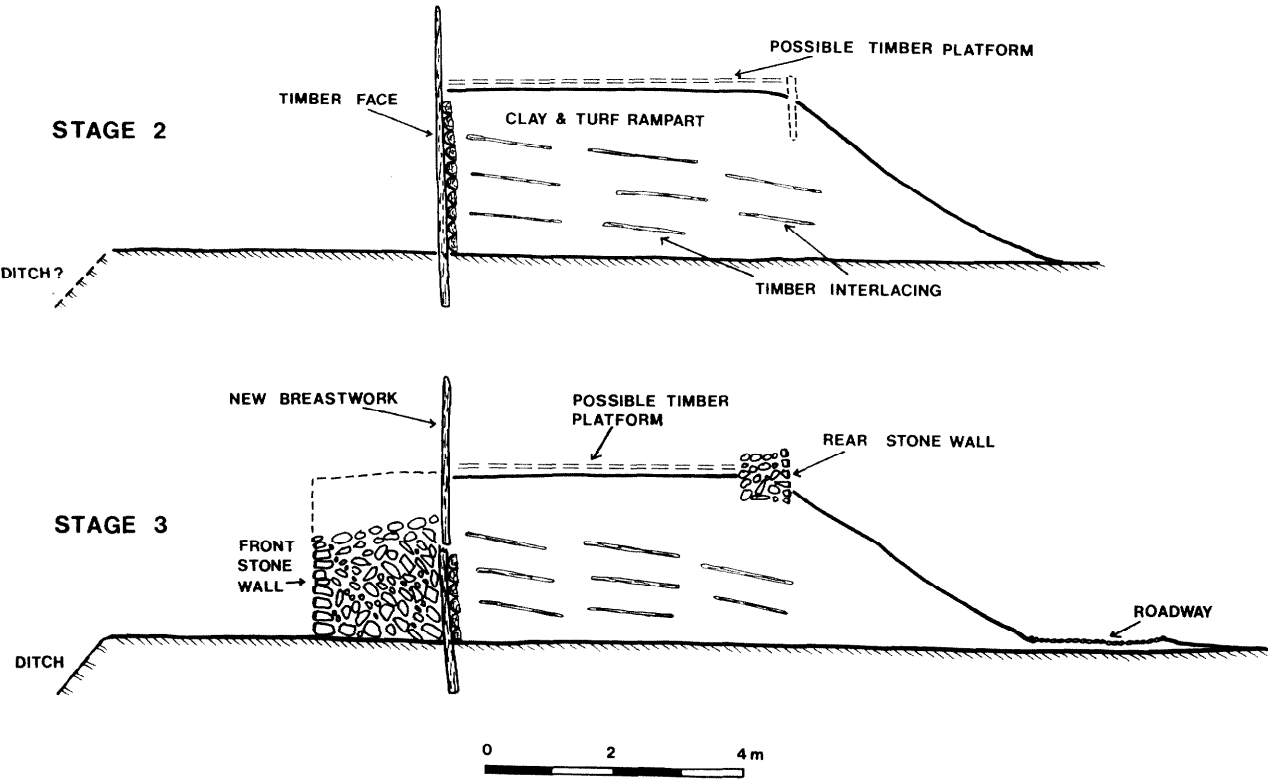
Fig 133 Idealized cross-sections of the defences of stages 2 and 3
