Excavations on and close to the defences

Hereford City Excavations Volume 2

Excavations on and close
to the defences

by R Shoesmith

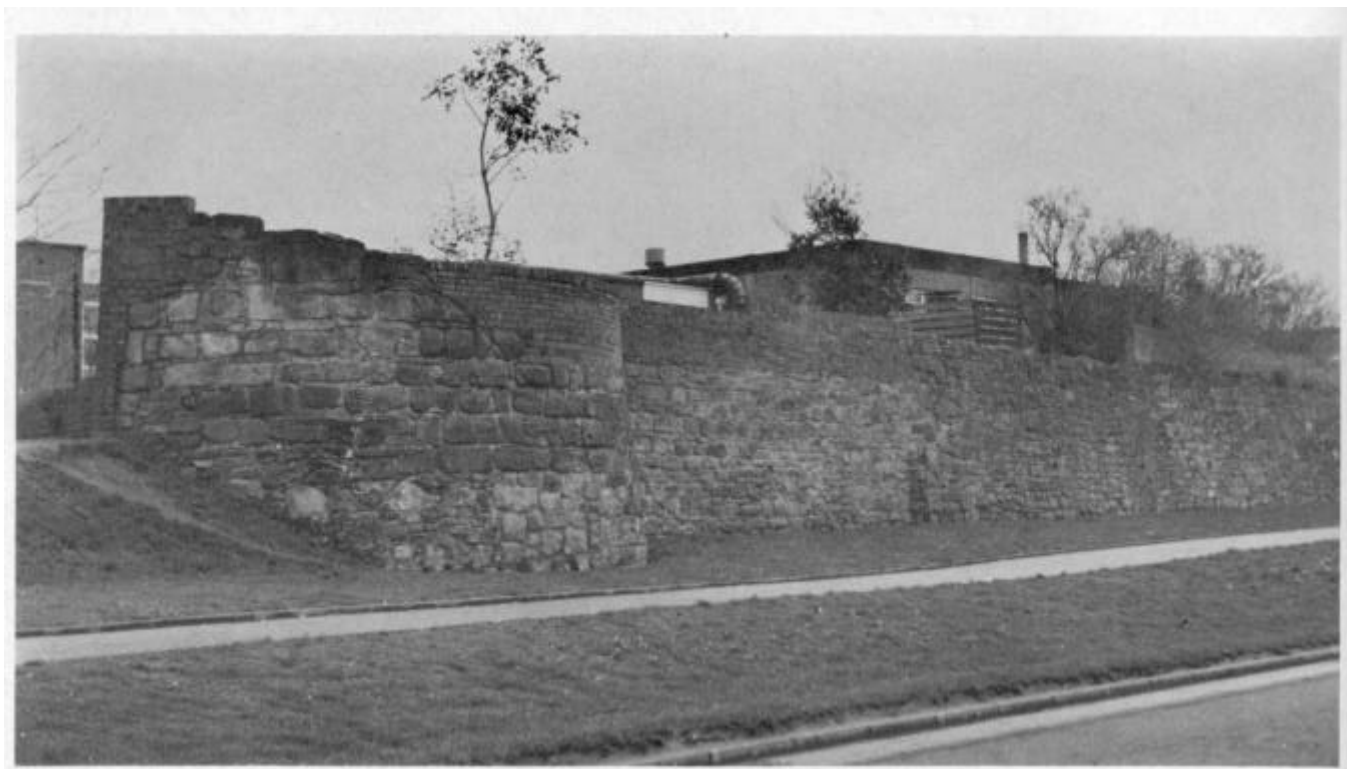
Fig 140 The stage 6 medieval wall and bastion 4 in Victoria Street

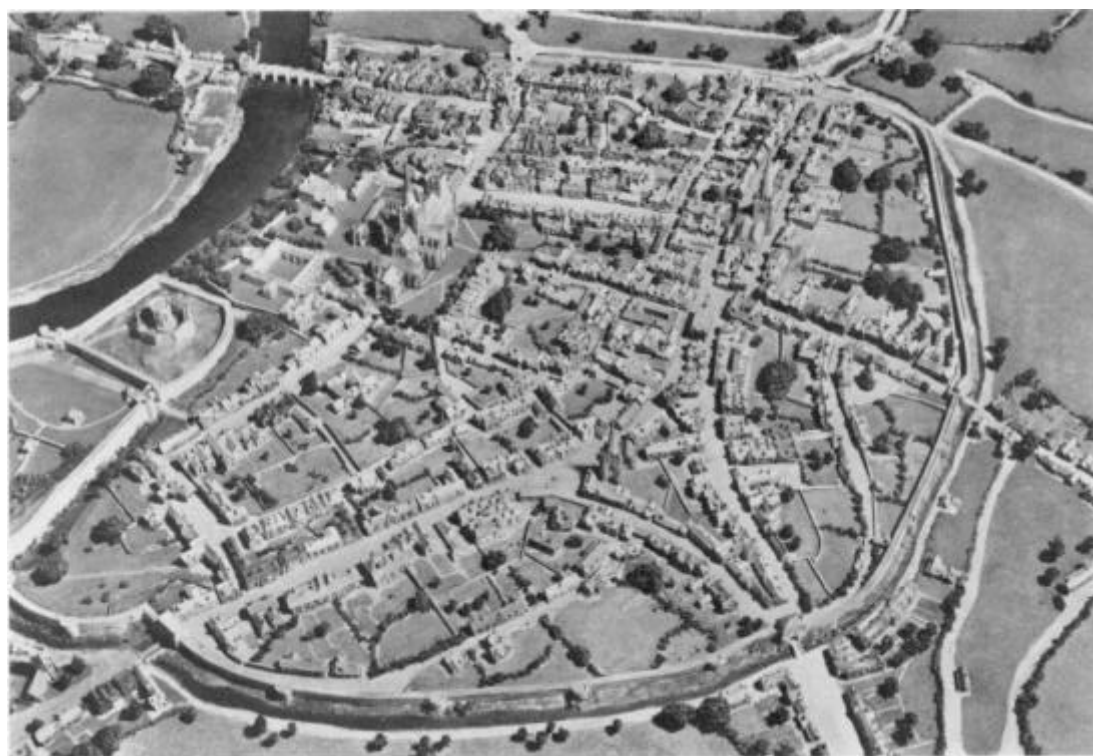
Fig 144 A model of the city of Hereford as it was in the late medieval period. St Owen's Gate is in the foreground to the left and Bye Street Gate to the right

There was to be little change in the plan of the city after the end of the 13th century until the industrial revolution, and the model of the city as it was at the beginning of the 17th century (Fig 144) probably equally represents the city in the late medieval period.
