Survey and excavation at Dunstaffnage Castle, Argyll

Recent investigations at Dunstaffnage, partially funded by Historic Scotland, have provided additional information regarding the castle's constructional history. Excavations have identified features associated with its initial construction in the 13th century and subsequent refurbishment episodes over the following centuries. Additionally, two medieval lime kilns have been located outside of the castle walls associated with these developments. In the 18th century extensive landscaping took place in the immediate environs of the castle as part of the 'improvement' and redevelopment of the site.

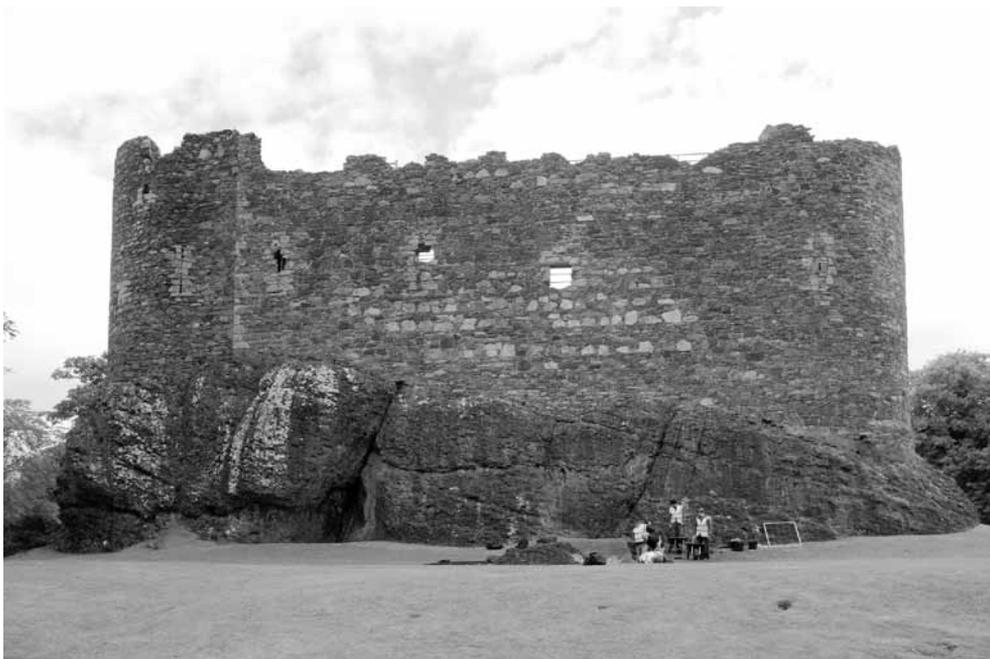
ILLUS 2 Photograph of the south-west elevation of Dunstaffnage Castle and the excavation of Trench 4

In its initial phase, Dunstaffnage seems to have been a relatively simple polygonal-enclosure castle. There has been considerable discussion on the date of similar castles in Western Scotland and Ulster (Oram & Stell 2005), with one strand of the debate focusing on an early 13th-century date. A number of lancet windows and arrow-slits are visible within the surviving curtain wall and are also indicative of an early construction date (illus 2).

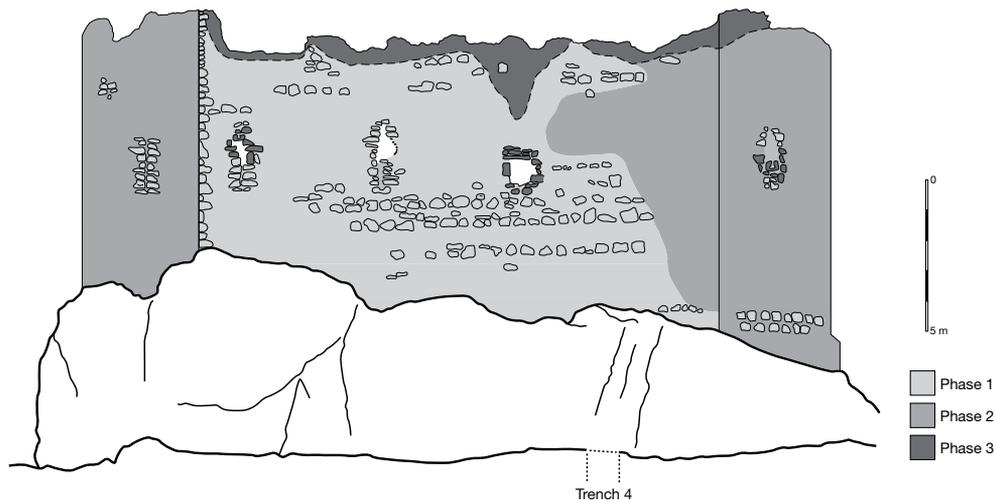
ILLUS 3 Interpretative south-west elevation showing the general architectural sequencing of the castle's structural development. The earliest surviving phase consisted of the central part of the wall characterised by the lancet windows and large facing stones. Corner towers were later added while larger windows and gun loops were added in the late medieval period. In the 18th century additional refurbishment of the parapet took place

by artefactual evidence including the recovery of two Edward I silver pennies, dating to the first two decades of the 14th century, from the one of the subsequent basal infilling deposits that had begun to build up in the tower at end of the 1200s and continued to develop over the following century. A number of decorative mounts of a 14th-century date were also recovered from the same deposit while a ring brooch of a comparative date engraved with a chevron design was found in a similar lower deposit. Architectural details on the south-west wall would also suggest that the castle has been subject to a number of major rebuilds and refurbishment episodes and that both the west tower and the east corner post-date the initial construction phase (illus 3).

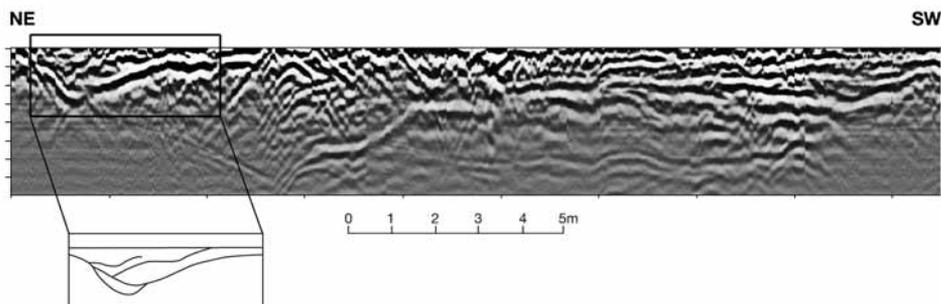
ILLUS 4 22.5m long GPR Line 11 running from the castle, across a break of slope and through the interior of the 18th-century building range lying to the south-west. An apparent V- or U-shaped ditch feature was imaged close to the base of the bedrock below the castle to the extreme left of the image. The stratigraphy associated with this feature is interpreted in the underlying box

During the course of the 2007 survey undertaken by the authors, a possible V-shaped ditch was identified at various points around the castle (Breen 2008). A number of GPR transects indicated that this was of varying depth and width but averaged 8m wide and *c* 1.5m deep (illus 4). In 2008 an 8m × 1m trench was positioned against the south-west base of the castle to further investigate this feature (illus 5). The key findings from the trench were a number of horizons associated

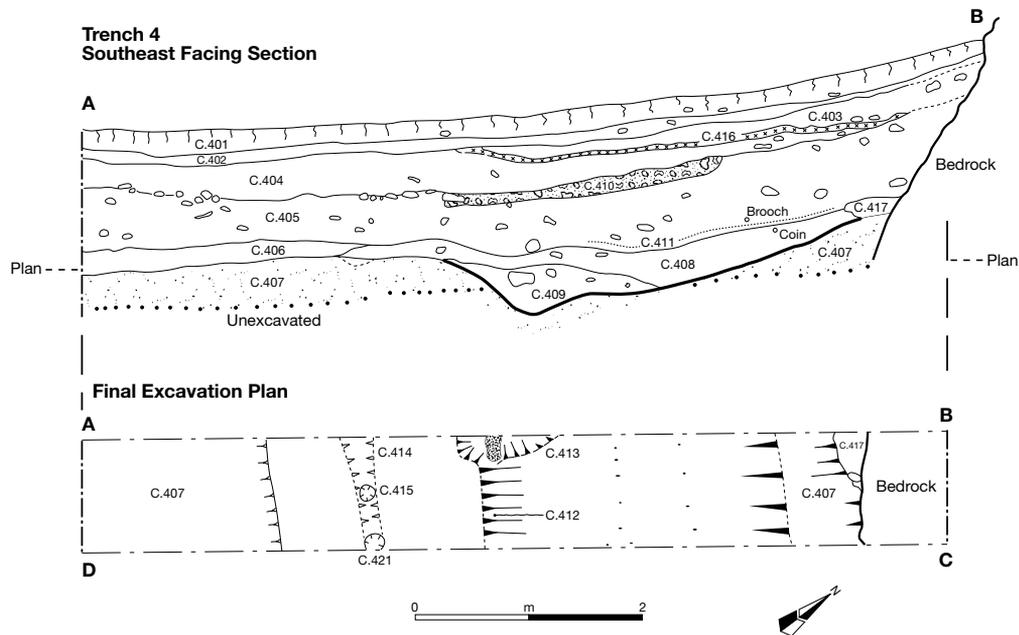
ILLUS 6 Final excavation plan and section of Trench 4

with the construction and refurbishment of the castle. While a large defensive ditch was not identified a smaller ditch (context 412) was found at the base of the trench (illus 6). This had been cut into the subsoil (C407) through two original ground surfaces (C417 and C406), consisting in each case of a thin deposit of brown soil. Additionally, C406 contained a number of stones that were possibly deliberately set in the deposit and may have constituted a metallised surface. The limited nature of the excavation trench size, however, meant that no definitive statement could be made on this interpretation. The shallow ditch (C412) was over 4m wide and up to 0.7m in depth and contained a shallow trench (C414) with two stake holes at its base as well as a pit (C413) located at the southern edge of the ditch. The shallow morphology of this feature would indicate that it did not serve a defensive function but was probably

a structural feature associated with the initial construction of the castle. The two stake holes would appear to have been associated with a fence that would have stood at the southern edge of the trench. Following initial construction it is clear that the ditch gradually filled with domestic debris from the castle including animal bone. Additionally, a late 13th-century coin was also found in the upper levels of one of the fills (C408). This has been identified as an Edward I (1272–1307) silver penny, probably from the Berwick-upon-Tweed mint. While these are common finds, the coin is a useful dating indicator that the ditch continued to fill to at least the end of the 13th century. The recovery of this coin also corresponds well with the two recovered by Lewis (1996) in the basal layers of the north tower. The coin in Trench 4 became important stratigraphically as a deposit of clay and a thin layer of a putty-like deposit (C411) was found

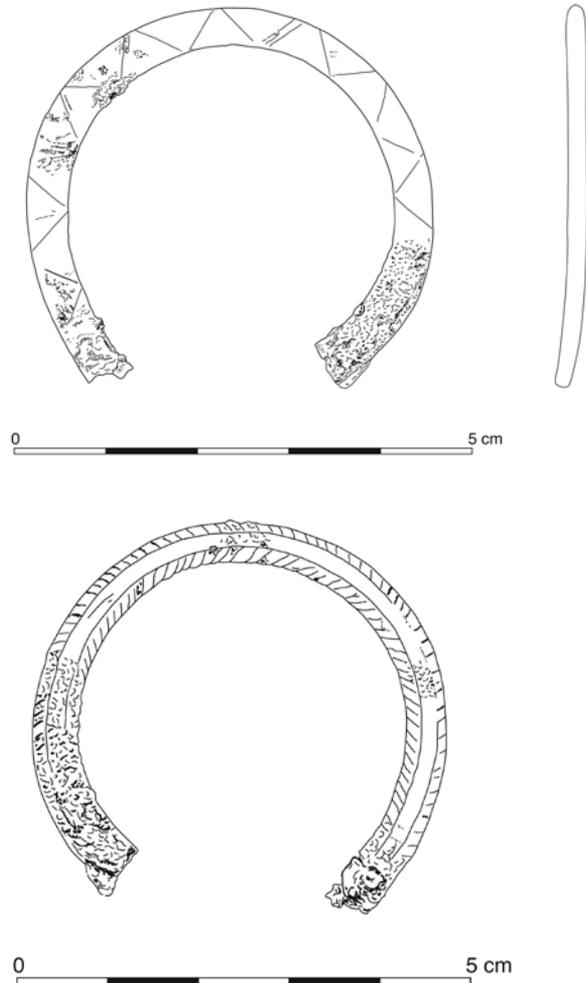
ILLUS 7 Drawing of the 14th-century brooch recovered from Trench 4 (Rosemary McConkey)

The dating of this episode is relative, provided by the underlying coin and the location of a copper alloy ring brooch found

immediately above this 'putty' deposit in C405 (illus 7). The brooch has a chevron design of plain line triangles and a decoration of closely notched edges on the reverse. A brooch of very similar type with a 'chevron design of alternate plain and line triangles' and five groups of notches on the reverse was found in one of the lower deposits in the north tower and dated provisionally to the 14th century by David Caldwell (Lewis 1996:

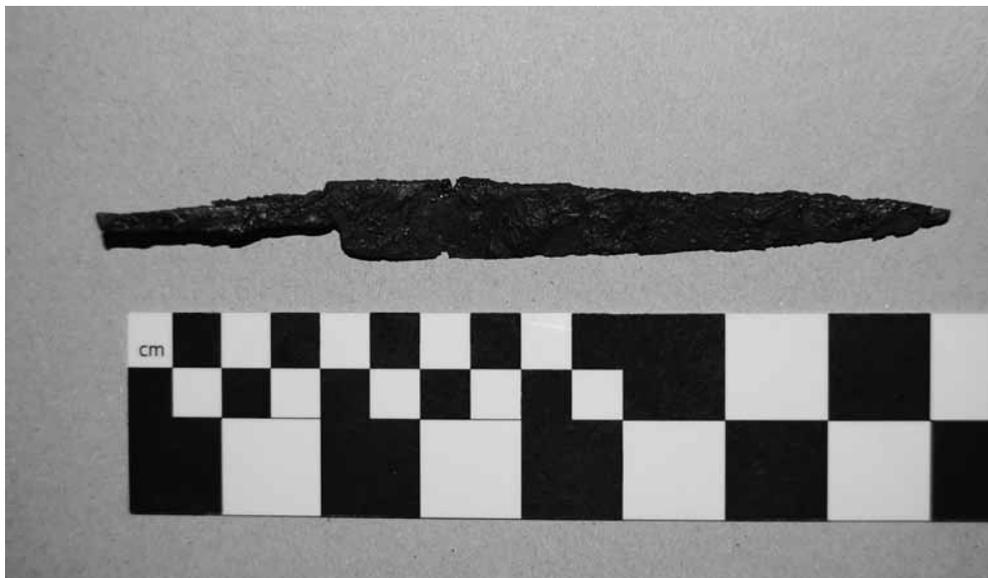
ILLUS 8 A post-conservation photograph of the medieval knife recovered from Trench 4 (Wes Forsythe)

The succeeding layers within the excavation area consisted largely of domestic dump material that built up against the base of the castle walls throughout the later medieval period. The primary deposit (C405) had a maximum depth of 0.7m and had a noticeable concentration of animal bone at its northern end closest to the castle wall. Interestingly, aside from cattle the deposit also had a quantity of deer bone reflective of the diet and hunting practices of the castle occupants (E Murray pers comm). A medieval single edged whittle tang iron knife was found in one of the fills (C404) with a blade length of 118mm (illus 8). This is not dissimilar to a number of the knives recovered from the Dunadd

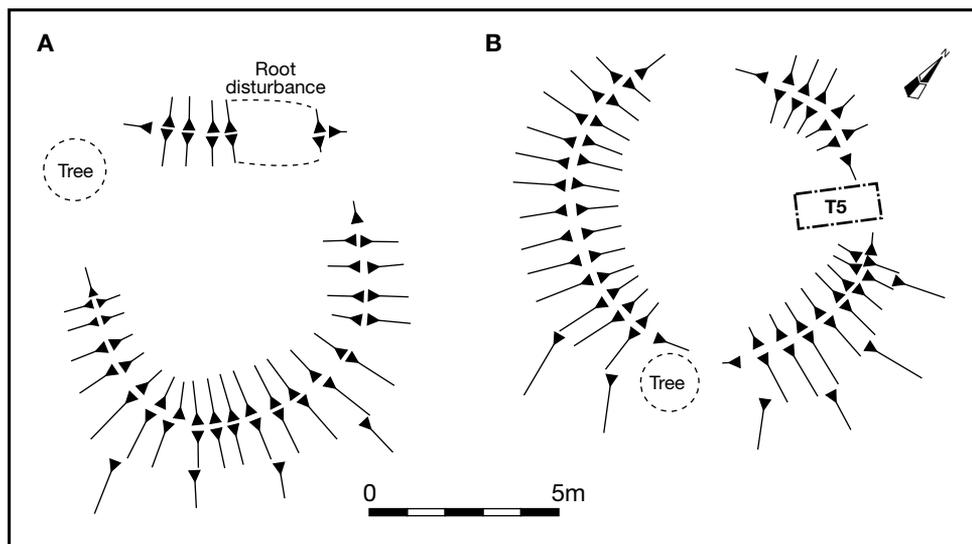
ILLUS 9 Plan of the kiln structures A and B with the location of Trench 5 shown

and covered with vegetation. In order to ascertain their morphology and function a 2m × 1m trench (Trench 5) was excavated across feature B (illus 9). The test trench was positioned along the southern edge of the structure through an apparent opening in the wall. Removal of the upper soil deposit (C501) exposed an underlying build up of sediment and stone (C502). This in turn overlay intact stone coursing at the base of a wall with an associated gap probably representing a flue. The underlying context (C504) represented a 0.22m–0.24m deposit of lime with some disturbed charcoal flecking. The trench was not bottomed out due to the depth of the deposits and the loose nature of the overburden and sections. While no finds or dating evidence were recovered it is apparent on structural and comparative grounds that this feature was a lime kiln. The opening in the wall would originally have functioned as one of three possible flues present in the original structure. The positioning and structural similarities between both structures A and B

strongly suggest that both were kilns and their identification adds an important dimension to the castle's adjacent landscape.
