**The Stable,  
Stone Farm,  
Blaxhall, Suffolk  
BLX 019**

**Historic Building Record**

# **The Stable, Stone Farm, Station Road, Blaxhall, Suffolk**

## **Historic Building Record**

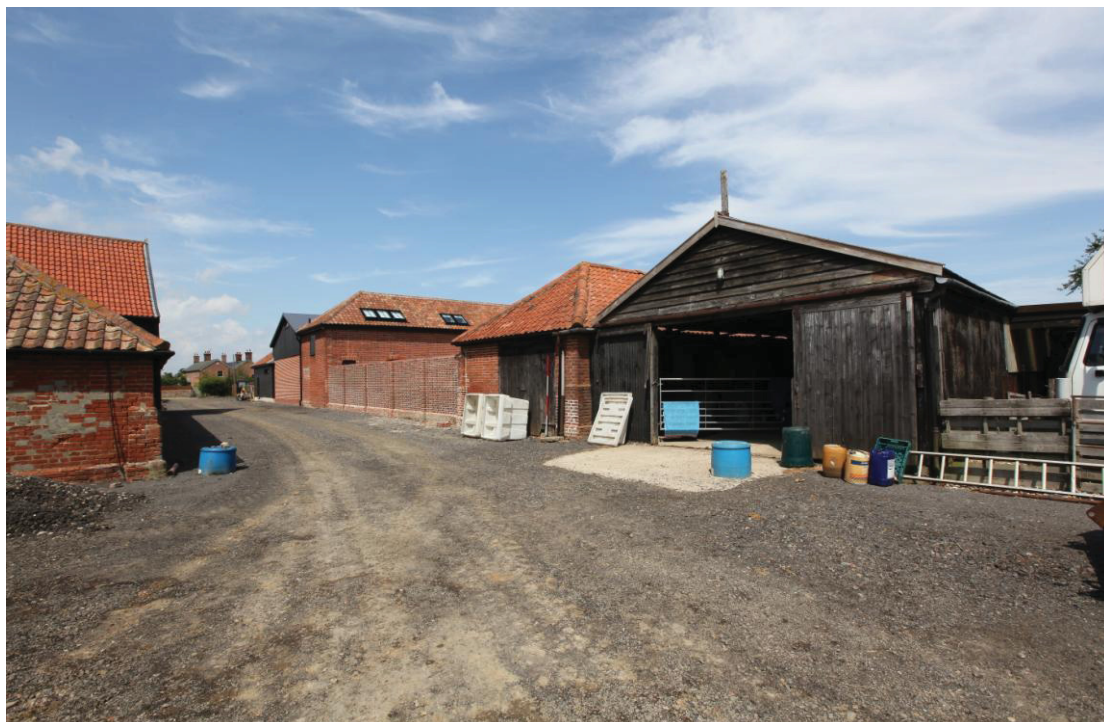
**Illus. 1. General view of site from south-west showing western gable of red-brick and pantiled single-storied stable (1) in centre with adjoining 20<sup>th</sup> century covered yard to right and converted barn to left.**

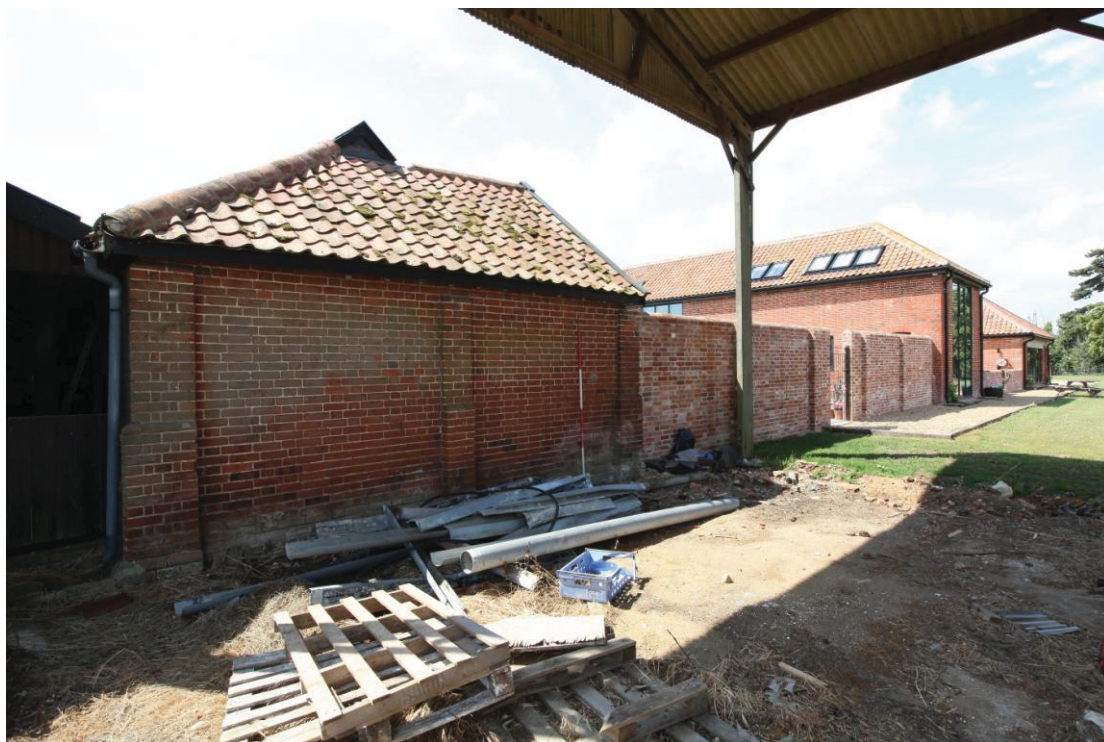
**Illus. 2. General view of site from the south-east showing the eastern gable of the stable (1) to the left and the converted probable stable range and other farm buildings to the right.**

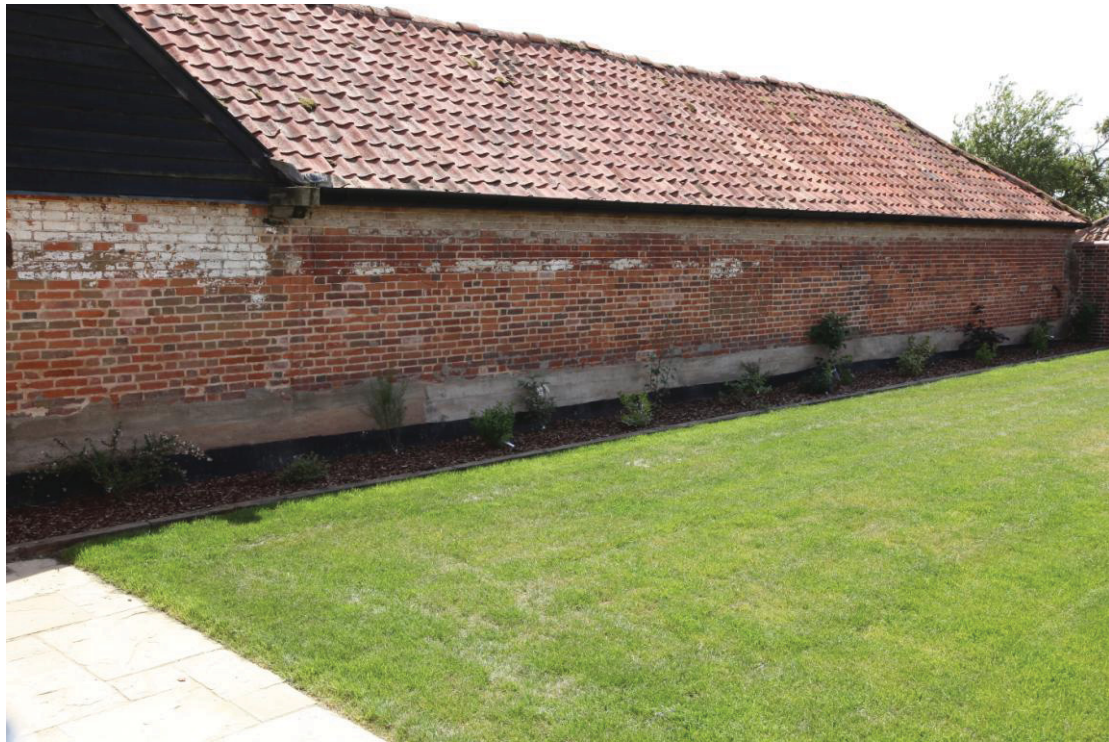
**Illus. 3. The northern external elevation of the stable (1) showing the outline of a blocked central window or hatch. The roof and scar of a demolished wing that formerly projected from the eastern end of the structure is visible to the left.**

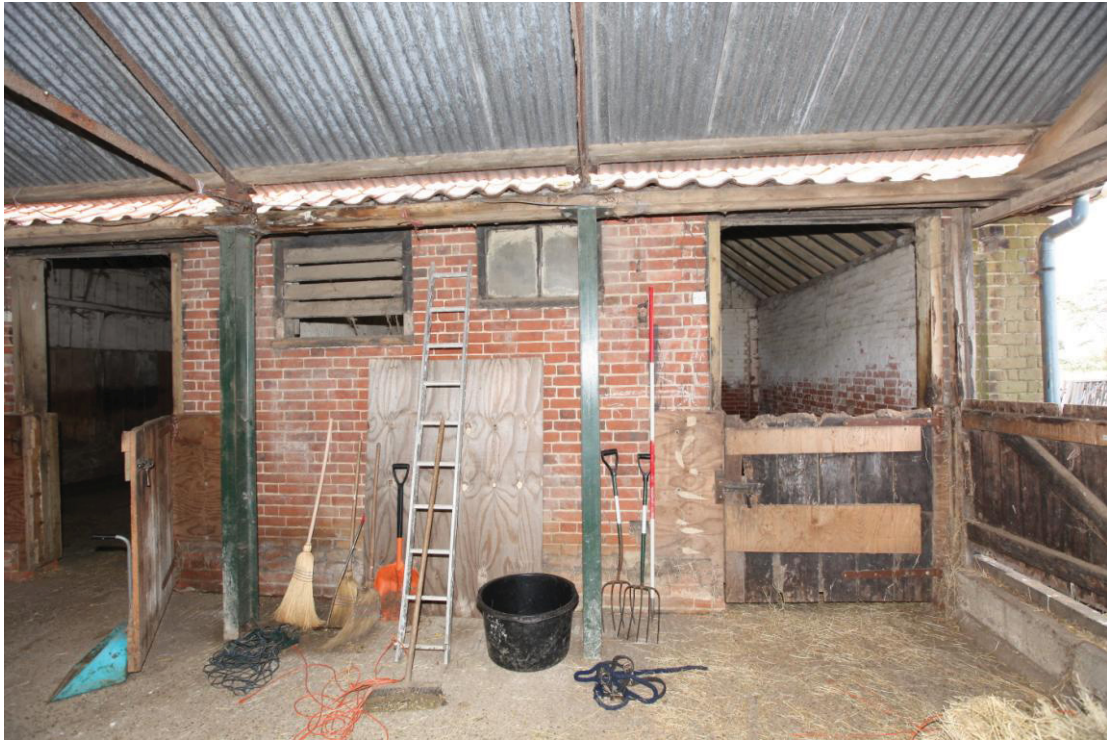
**Illus. 5. The eastern end of the southern exterior of the stable (1) showing the original louver, glazed window and entrance to the eastern loose box (1e) to the right with the door to the neighbouring identical box (1d) to the left.**

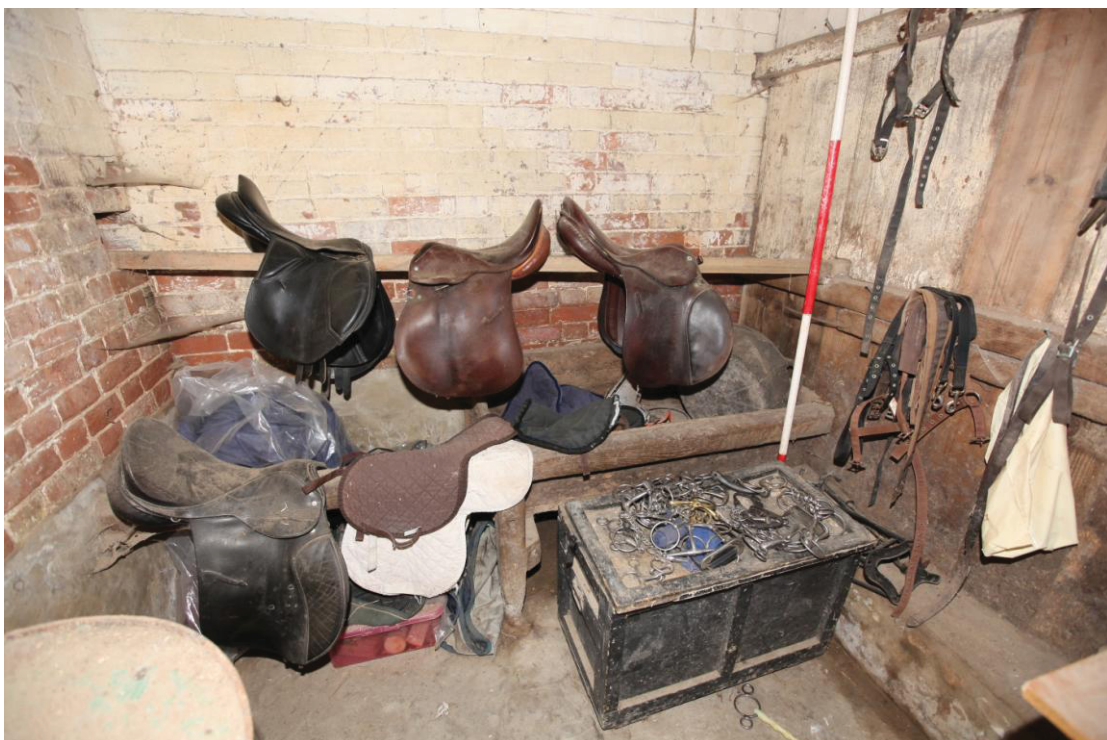
Although used most recently as stabling for horses the loose boxes were almost certainly designed as bullock sheds, as indicated by the low height of the extant manger and the presence of three small yards on the Ordnance Surveys. Horses were not normally stalled in this way during the 19<sup>th</sup> century.

**Illus. 6. Detail of the low boarded manger attached to the northern internal wall of the narrow stall (1b) adjoining the western vehicle or feed shed (1a). At just 0.65 m (25 ins) in height this manger was clearly designed for cattle rather than horses.**

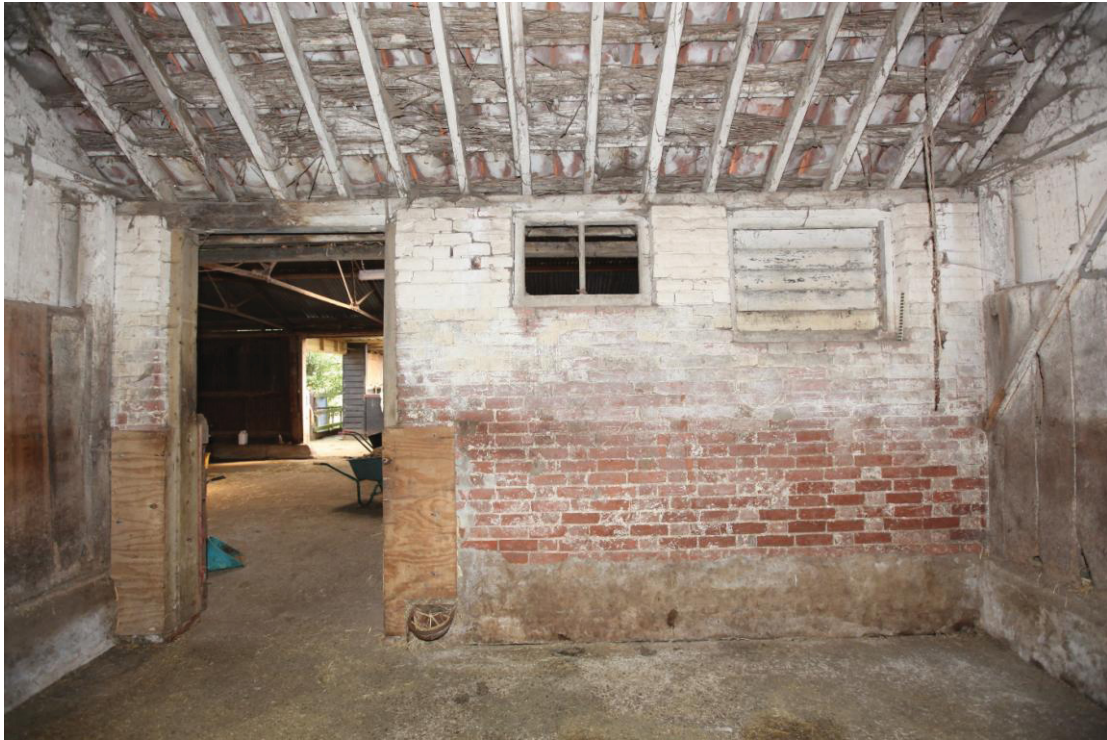
**Illus. 7. Southern interior of penultimate eastern loose box (1d) showing its original door, window and louver.**

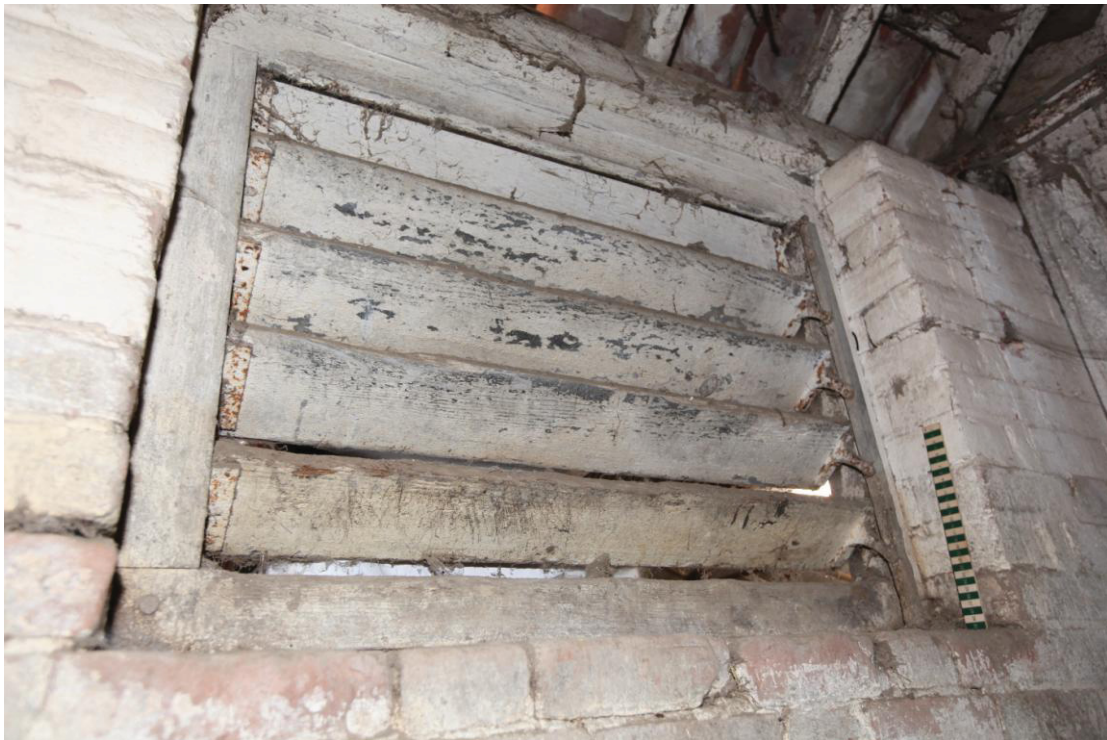
**Illus. 8. Detail of the original louver in the southern interior of the penultimate eastern box (1d). The slats are shown in the open position with the vertical control bar to the right lowered. Raising the bar closes the slats.**

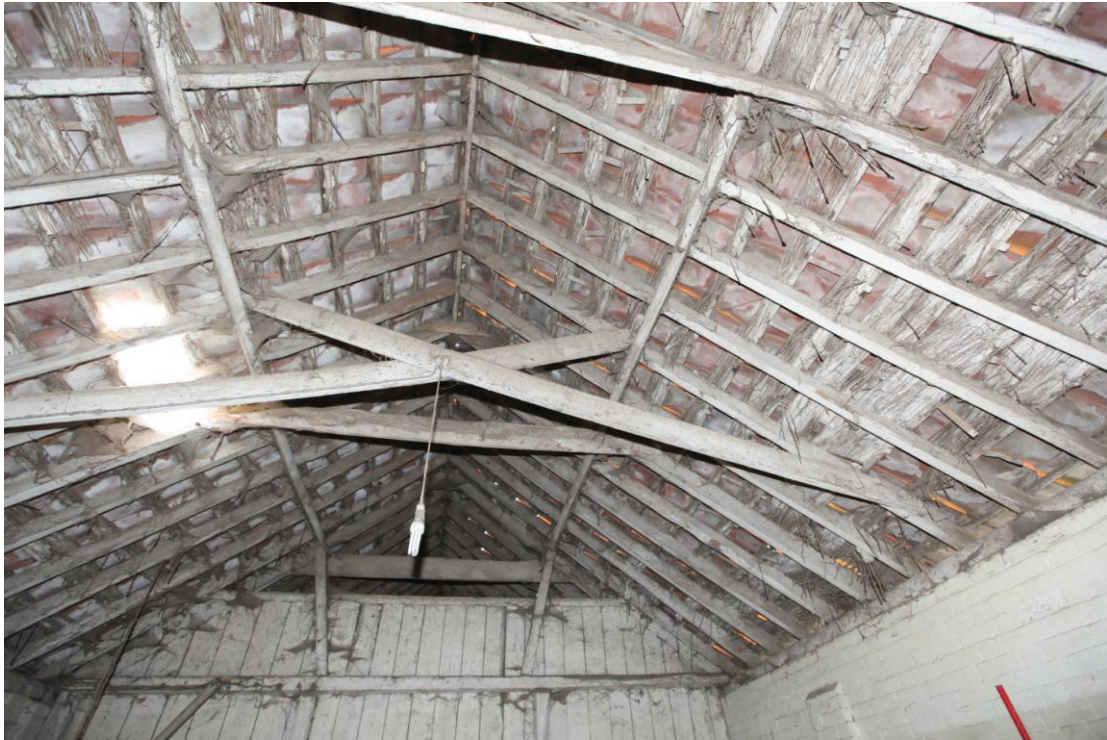
The stable is a single-storied red-brick structure on an east-west axis that rises to 2.6 m at its eaves (8.5 ft) and extends to 22.25 m in length by 5.8 m in width overall (73 ft by 19 ft). The bricks are laid in Monk bond (with two stretchers between every header) and the clasped-purlin hipped roof of machine-sawn softwood is covered in its original pantiles with the remains of reed fleaking beneath.

**Illus. 9.** The original roof structure seen from the penultimate eastern box (1d) showing nailed scissor braces and collars with the remains of reed fleaking beneath the pantiles.

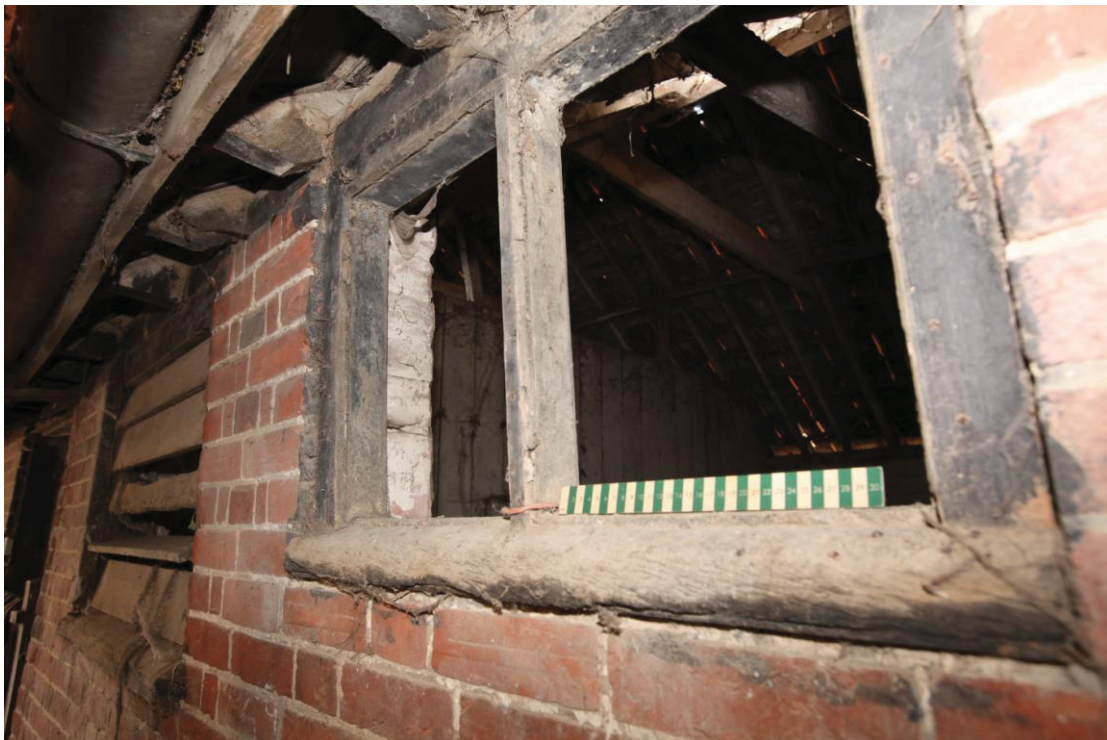
**Illus. 10.** Detail of the original window to the central loose box (1c) in its southern exterior, showing grey pigment and a rebate for glass (or possibly a lattice).
