**An Archaeological Standing Building Survey
of Astley's Paints, The Former
Calcott Brothers Factory,
Far Gosford Street, Coventry
(SP 755 604)**

**University of Leicester
Archaeological Services**

ULAS Report Number 2006-050

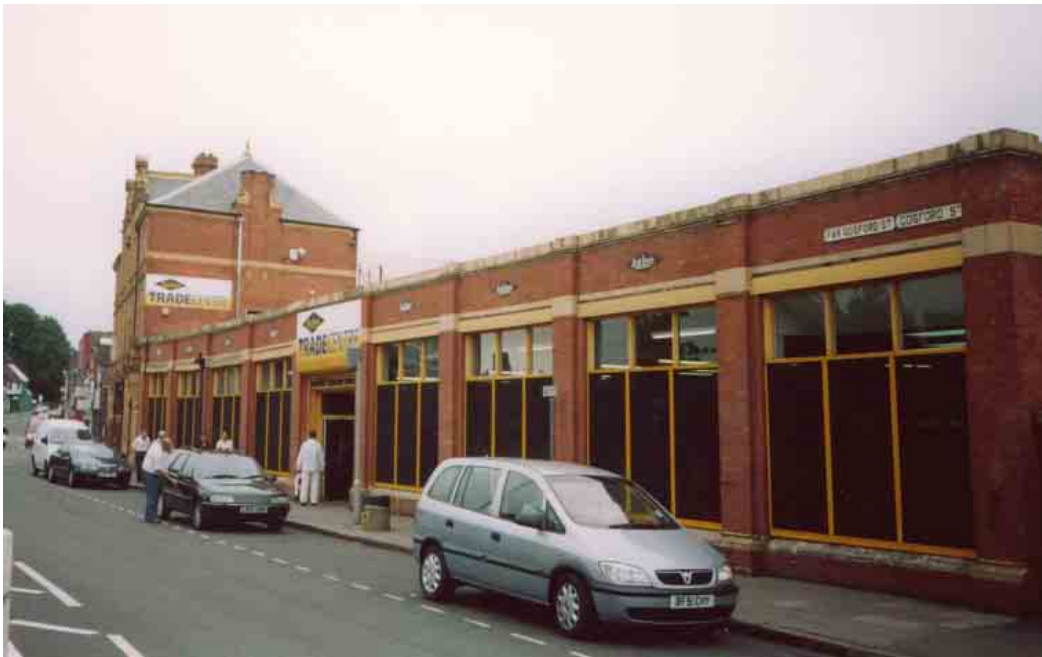
3.2.1 Building **1** consisted of three distinct elements; **1a** is a single storey showroom-type building to the right of the original Calcott Bros building (Plate 9). This addition was added by Singer in 1927 and is the final addition of historic interest to the site; the building itself consists of red brick-built structure with a flat roof; there are eight floor to ceiling windows and a central pedestrian entrance. The sills are of yellow terracotta, mimicking the decoration of the original building, next door; there is also a yellow terracotta lintel dressing running the full width of the building immediately above the windows. There is also a plinth, approximately 500mm in height at ground level, again with yellow terracotta dressing. Finally there is yellow terracotta coping atop the front wall, being out of sight the back wall has a simple brick coping.

3.2.2 Internally building **1a** is sparse having been originally constructed as a showroom and lately used as a shop floor, there is little of architectural merit, it appears that the most effort was placed upon blending the exterior with the original building, next door. The roof construction is of 500mm by 500mm re-enforced concrete beams supporting the flat roof. There is a substantial sliding door on the rear wall, probably providing vehicular access to the next building (Building **1c**), although any original ramp has since been removed. There is pedestrian access via a double wood and glazed door towards the back of the left wall into the Calcott Bros building (Building **1b**).

Plate 9: Building **1a** - single storey 1927 Singer Showroom building

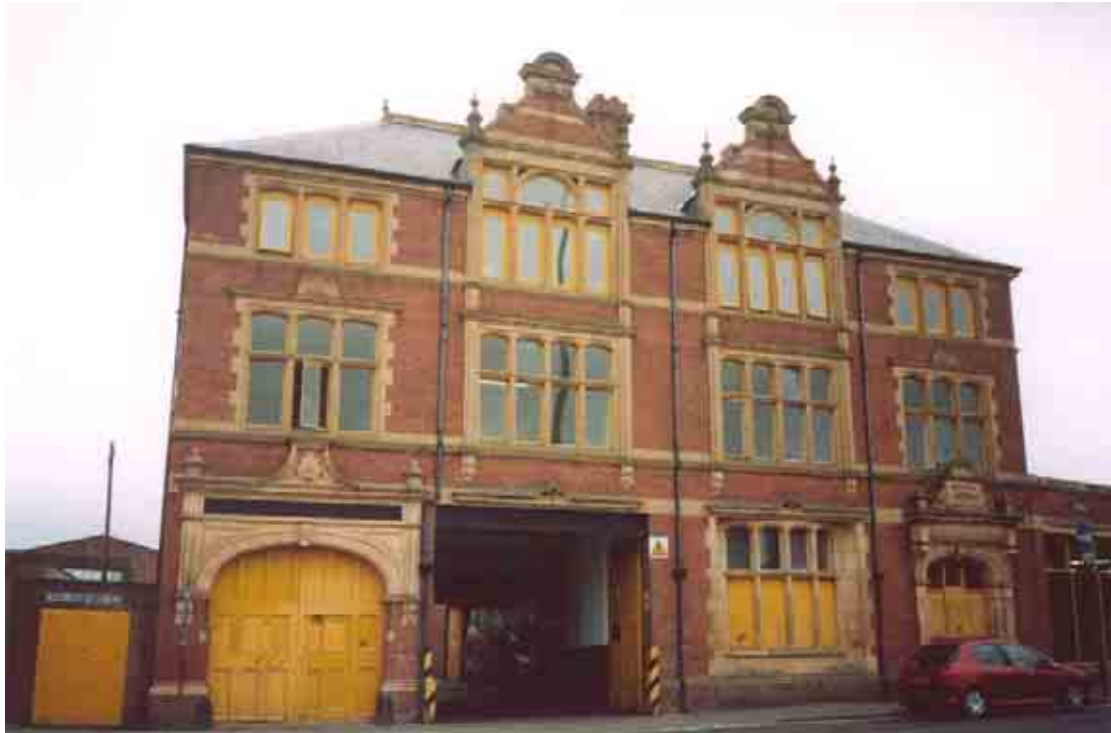
Plate 10: Building **1b** (and **2f** – left hand side) – Calcott Brothers Office Buildings of 1896 Far Gosford Street frontage

3.2.3 Building **1b** (and **2f**) is without a doubt the most visually striking of Astley's buildings and was originally built as company offices in 1896 (Plate 10). The building itself is of three storied brick construction with hipped slate roof and large gables, the epitome of a Victorian factory. The Far Gosford Street frontage is highly

decorated with yellow terracotta tracery and doors, the original entrance was the grandly decorated doorway on the right of the building (now bricked up), above which is an inscribed date stone, again of yellow terracotta (Plate 11). Original vehicular access is via a double door on the left of the building, again with decoration, but not as elegant, this access has been replaced by larger access to the right created by the removal of the original bay window and whatever rooms were originally behind it (there are plans to restore this window). The exact date of the removal of the bay window could not be ascertained, but is later than 1921 (original window visible on Plate 12) and is indicated as a passageway on the 1948 1:1250 Ordnance Survey map (Figure 4). Presumably the passageway was inserted at a similar time to the construction of the showroom in 1927 when Singer bought the factory.

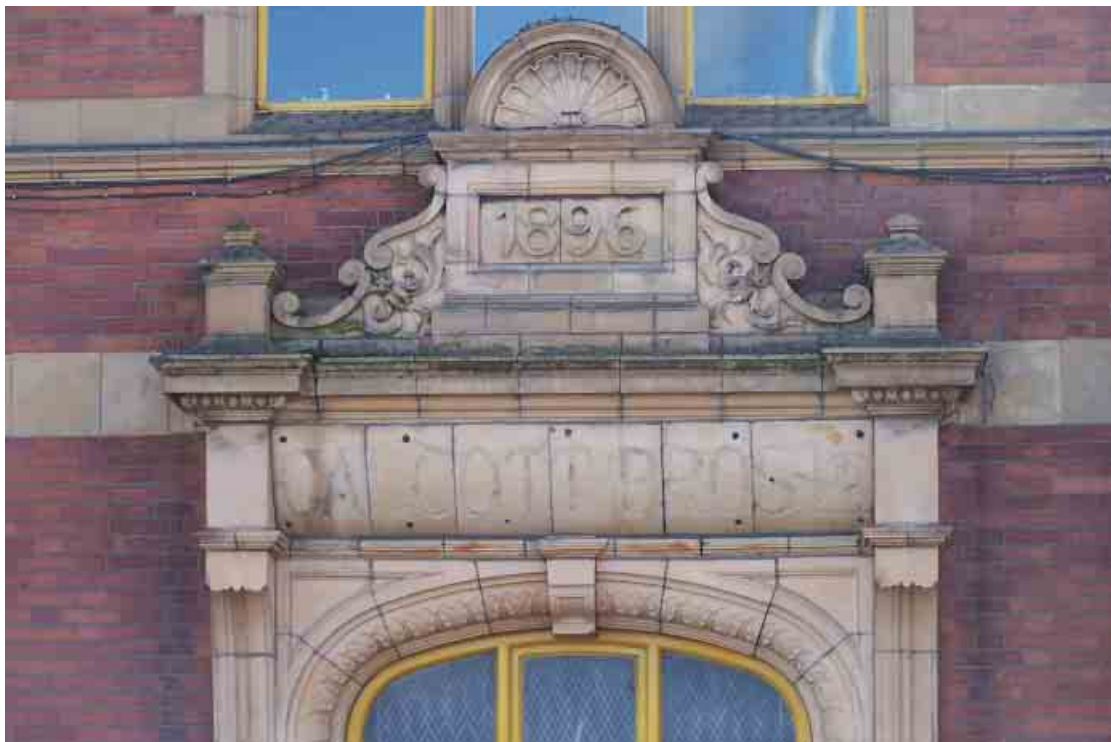
Plate 11: Date stone and 'Calcott Bros Ltd' (defaced) on detail above doorway on Far Gosford Street Frontage

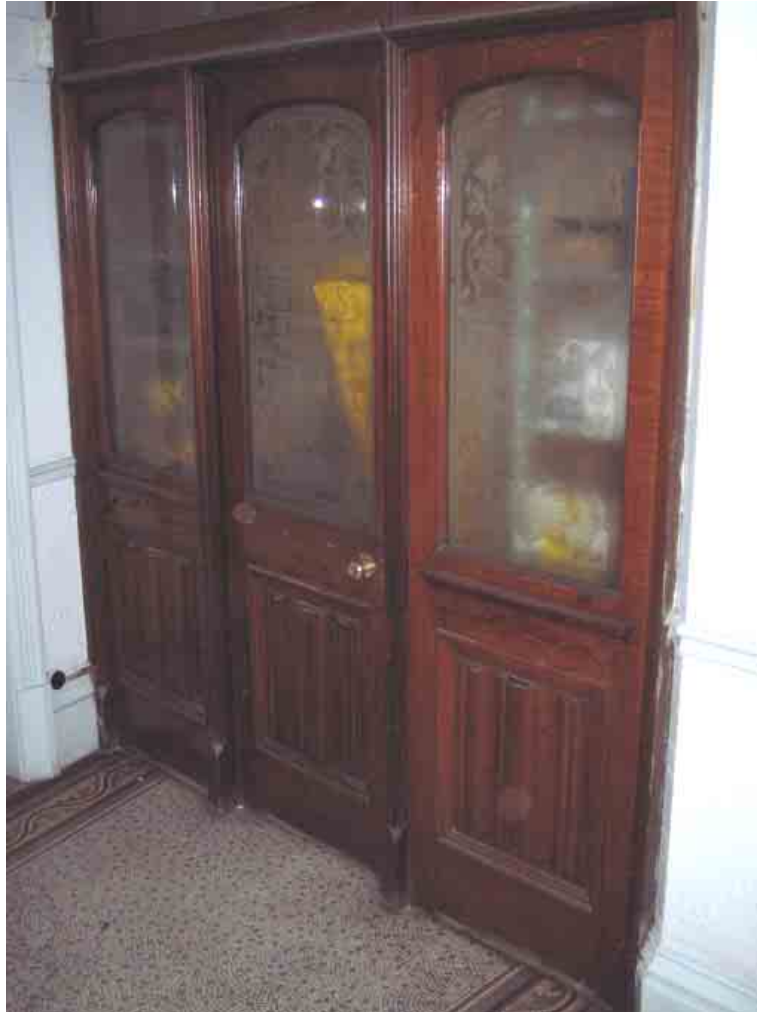
Plate 13: Screen.

3.2.6 Although there have been some later alterations, the interior of *1b* still reflects the original grandeur of the building. Access from *1a* is via carved double half glazed doors, leading to a hallway with decorative mosaic floor, deep moulded skirting board, dado and picture rails. There is an ornate oak staircase leading to the first floor on the rear wall and two doors on the front wall leading to office space and another on the rear wall. One of which is a half glazed oak moulded door within a tripartite screen (Plate 13), the glass is decoratively etched and labelled Offices. Beyond this door is the original entranceway, now used for storage; again with mosaic floors and plaster cornices the original doorway from Far Gosford Street has since been blocked, there is an open door frame on the left hand wall, again with timber moulding.

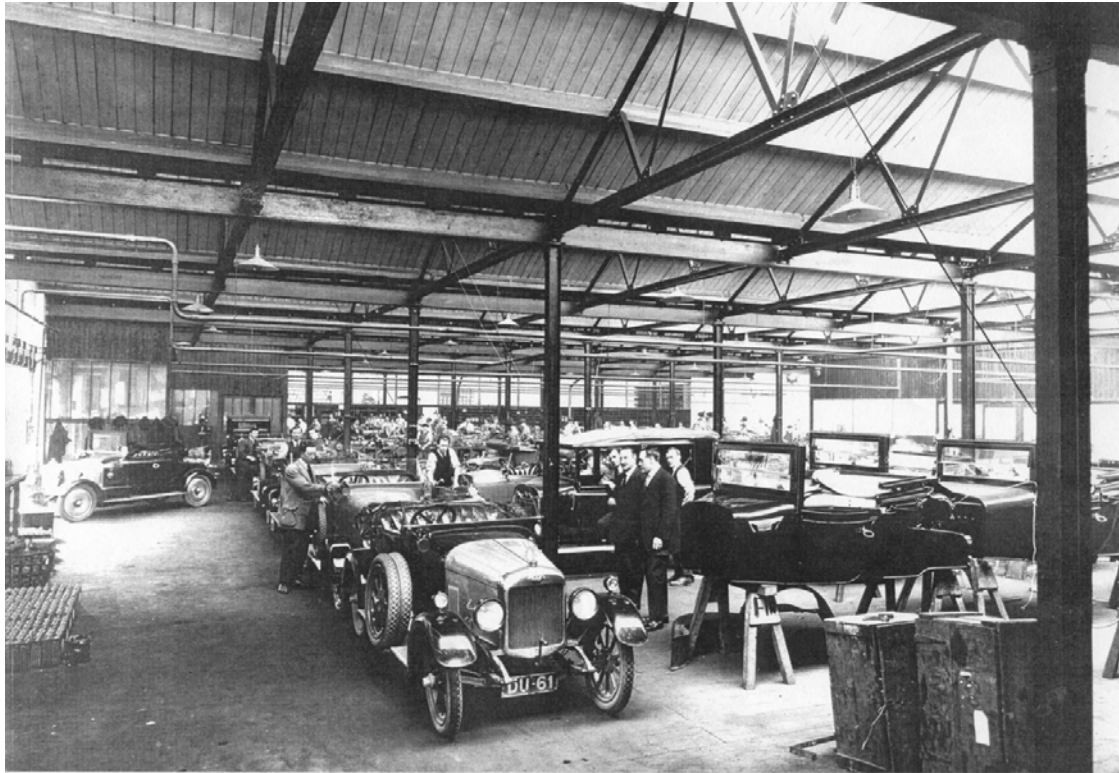
3.2.14 The building immediately to the rear of offices and showroom is the factory building (**1c**) and is the first of the buildings scheduled for demolition. The building consists of single storey brick and slate construction with north light roof of eight bays; the bays themselves are 6 metres wide by 7 metres tall with concrete floors. The brickwork consisted of machine made 9 inch by 3 inch red bricks laid mainly in a Dutch Bond; the bricks of the rearmost bay are 8^{1/2} inch by 2^{3/4} inch and also a different colour. A study of the original architects plans indicates that this bay is contemporary and it appears, simply that, different bricks were used. The roof has been sealed with "lick & dick" bitumen; however, the slate below will almost certainly be Welsh.

Plate 14: 1921 View of Calcott Works, Building 1c. (Coventry Transport Museum)

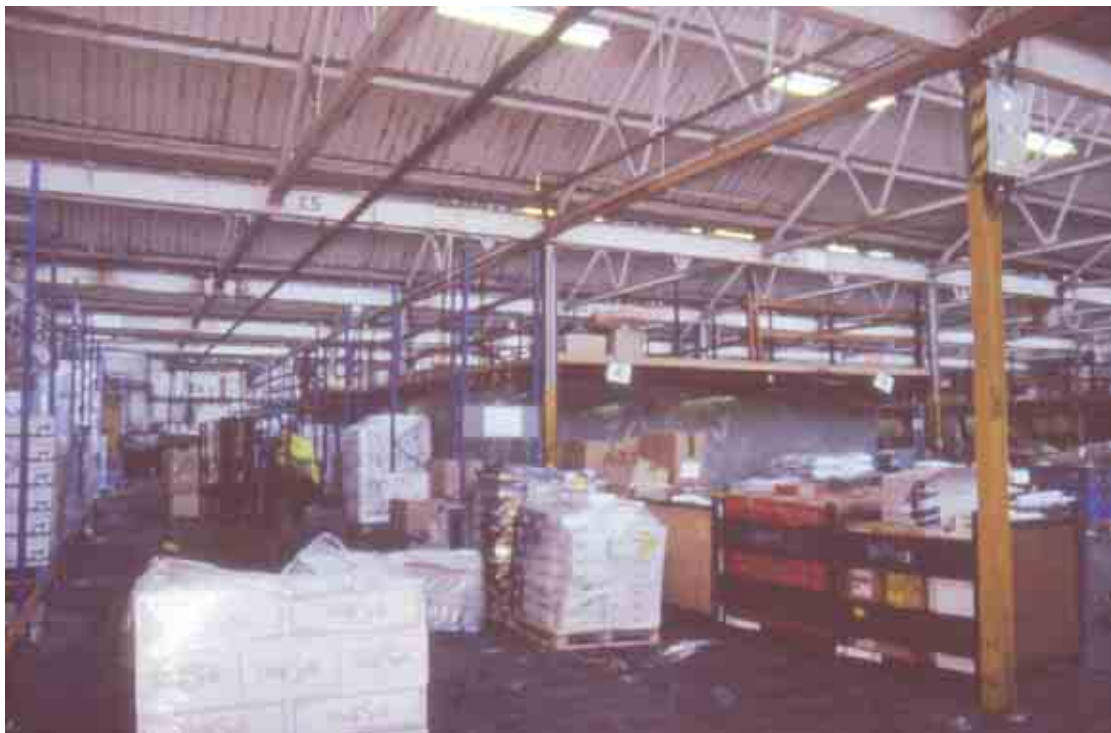
Plate 15: 1921 View & 2005 View, Building 1c.

3.2.15 Internally the building is structurally unaltered, although a substantial timber mezzanine floor has been added to the front and right of the building and a series of prefabricated offices have been built in the front left corner of the building. The original timber floors seen in the 1921 photographic tour (Coventry Transport Museum; Plate 14) have been replaced with concrete (Plate 15). There are two

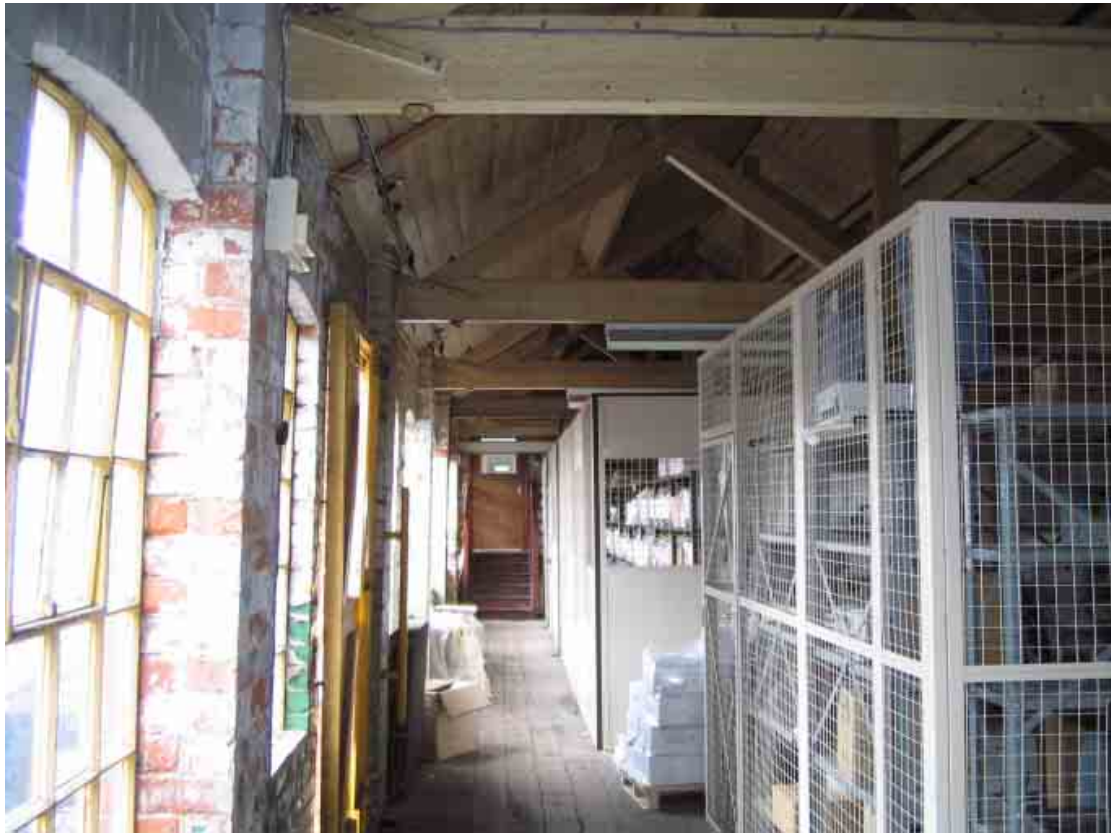
3.3.4 The first floor is similarly devoid of any identifiable architectural features; the roof is of king post with raking brace design.

3.3.5 There is evidence of timber replacement along the rear of the building and a number of steel RSJ beams have been inserted as strengtheners immediately below the original timber tie beam. Unlike the ground floor there appears to be no modern sub-divisions and the layout is likely to be original; there appears to be an internal chimneybreast on the rear wall, modern steel racking and asbestos prevented a closer

Plate 16: Building **2a**, First Floor.

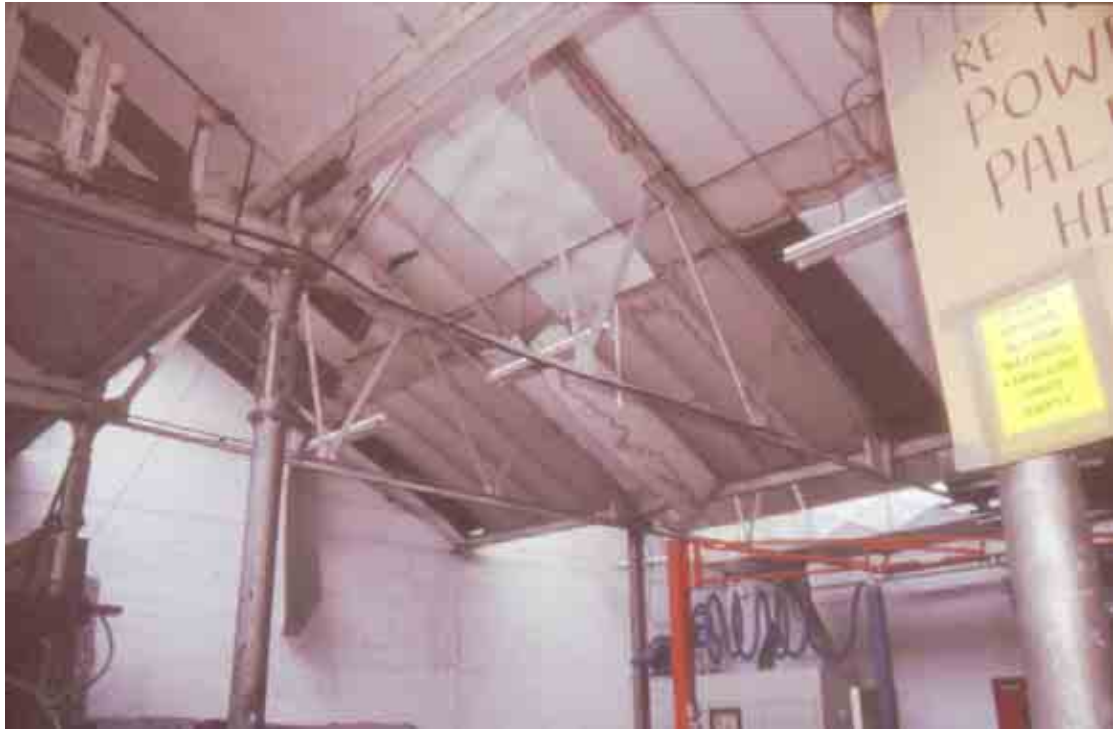
Plate 17: Replaced Roof Trusses (Building 3).

3.4.2 Internally, as with building 1c the interior has remained largely unaltered, with the exception of a range of laboratories and offices being built along the left hand wall in concrete blockwork, the bays themselves are 6 metres wide and 6.5 metres high at the apex of the roof. A modern partition in concrete blockwork within bay 8 creates a separate room; there is a second brick partition between bays 11 and 12, probably the original exterior wall, fronting onto Gulson Road. As with building 1c, it is the roof construction, which is the most diagnostic, the bulk of the roof is of timber beam construction atop cylindrical cast iron columns with square upper sections to carry line shaft bearings, however there are some later repairs, most notably the timber roof on the left of bays 10 and 11 has been replaced with a steel frame (Plate 17). Anecdotal evidence suggests this was caused by bomb damage during 1941 (Richard Astley *pers. com*).

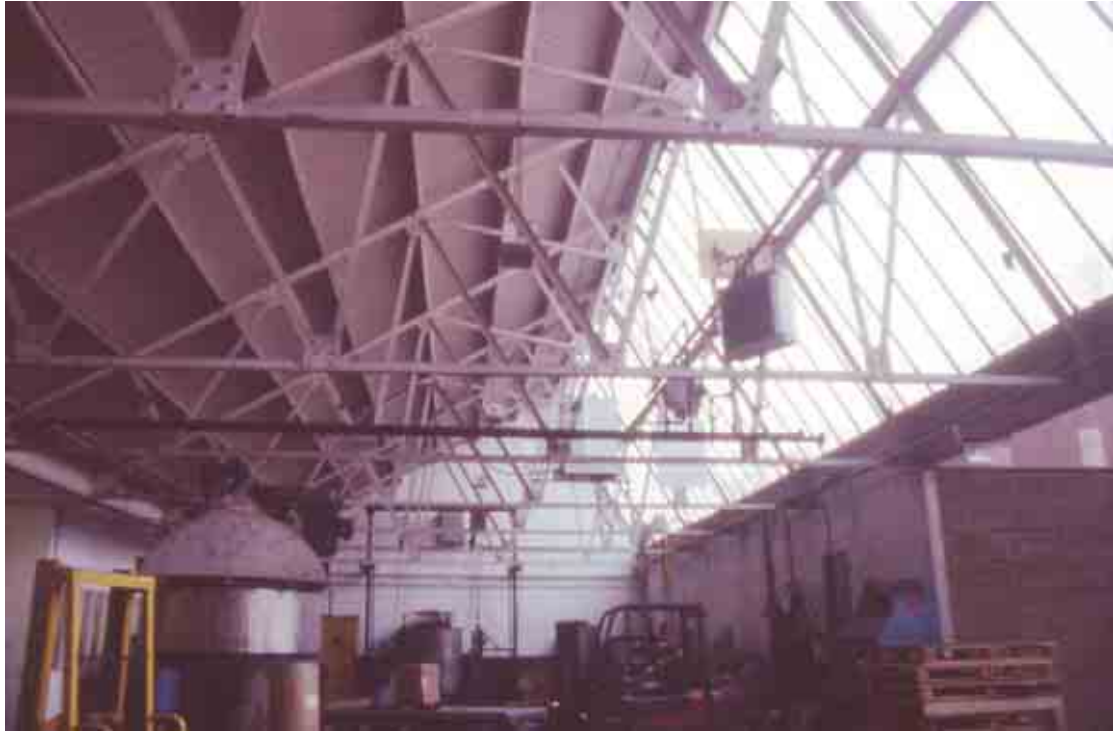
Plate 18: Gulson Road Bays.

3.4.5 The final part of this building are the three bays on the Gulson Road frontage, these are a later addition and were built during the later 1920s replacing some earlier detached sheds and a chimney (possibly the site the original engine house). The bays are much larger than the earlier buildings (Figure 10), measuring 10 metres wide and 8 metres high at the apex of the roof. The roof is of a steel frame north light construction with an enclosed attic space within the bay fronting onto Gulson Road, built on 12 inch (300mm) RSJ pillars. Once again the interior appears largely unaltered. Structurally the building is of 9"by 3" machine made red brick with blue coping stones atop; the roof is of concrete roof tiles, possibly original. There are two double doors on the far right and left of the building with ramped access opening onto Gulson Road as well as a hoarding advertising Astley's as a producer of "*Industrial Paint, Canvas Products & Rope*".

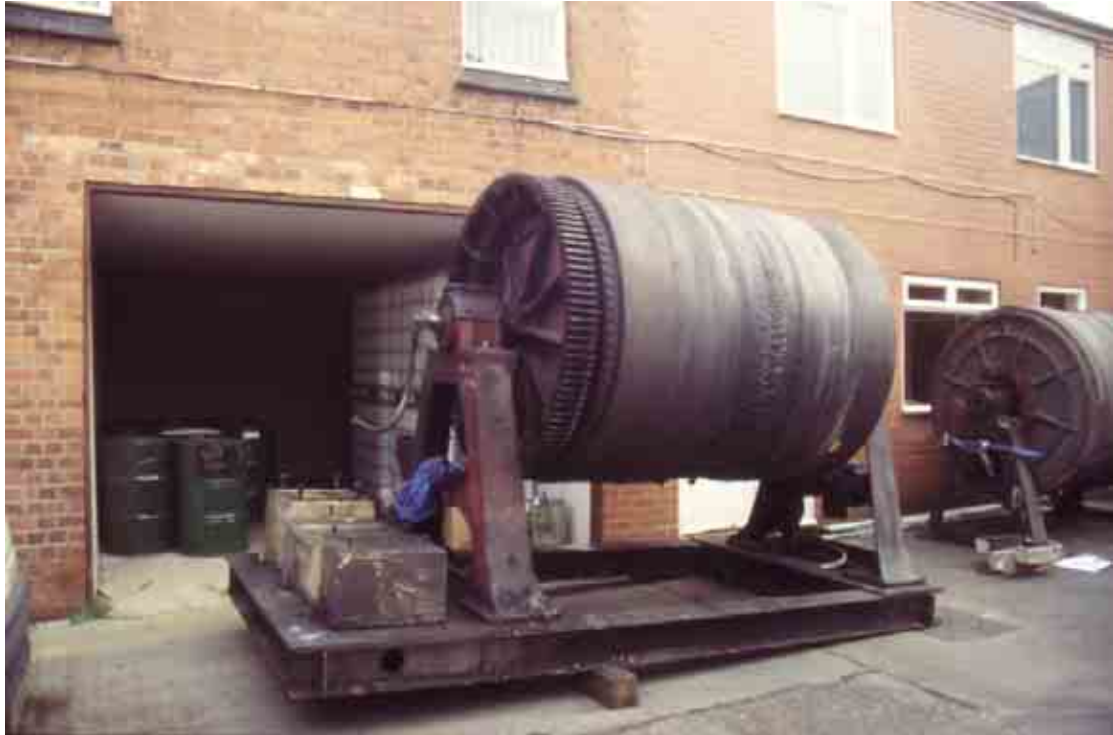
3.4.6 Astley's has most recently used this part of the site for paint manufacture. Some of the equipment was still *in-situ* while other equipment, including the ball mills had already been removed and sold on to other paint manufactures. The mills themselves had been manufactured by Steele & Cowlshaw Ltd of Stoke-on-Trent; the company no longer produces mills although it continues trading under the name APV Baker of Peterborough.

Plate 19: Ball Mills.

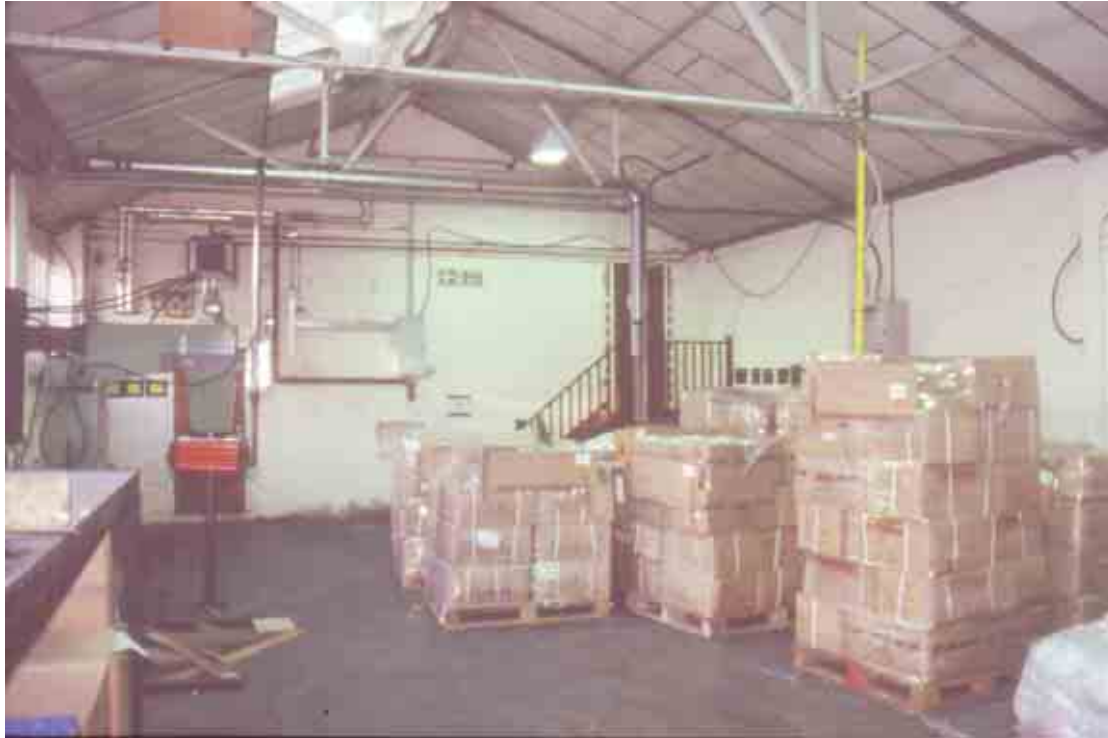
3.5.1 The final significant building of interest within the proposed development area is building **4**, an annexe to the left of building **3**. There is vehicle access from building **3** via a covered steel ramp, which crosses the line of Shut Lane as well as a large sliding vehicle door on the front opening onto a yard, which faces Vecqueray Street. The building itself is a single storey red brick and corrugated asbestos sheet construction with a steel framed pitched roof, with north facing sky lights sat atop 450mm by 450mm brick built columns.

3.5.2 The front of the building consists of 5 half-length steel framed windows, the brickwork below these windows does not match the brickwork within the remainder of the building, suggesting that this side may originally have been open. The rear wall has an interior skin of concrete blockwork and the exterior was not visible due to a neighbouring building abutting it.

Plate 20: Building 4.

3.5.3 The building appears to be post Second World War in date and was part of Henry Burbidge's wood turning works until Astley's acquired this part of the site in 1998 and it became part of the paint factory.
