**WEST POWDER MAGAZINE NORTH BLAST WALL  
TILBURY FORT  
ESSEX**

**ARCHAEOLOGICAL MONITORING  
AND RECORDING**

**Essex County Council**  
Field Archaeology Unit

**May 2008**

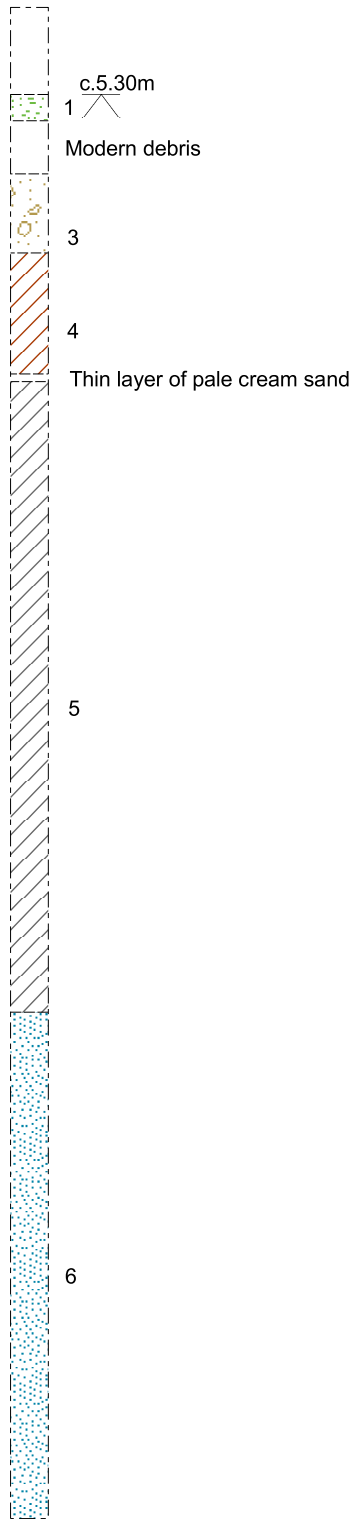
### Borehole 1

Three main layers were identified by boreholes 1, 2, and 3 (figs 1 and 2). Rich organic alluvial silts (6) were consistently found at the base of each bore-hole at c.2.90m OD. These silts represent the original marshland soils that included preserved plant matter and carbonised remains. Unsurprisingly, no finds were recovered to date the soils. Overlying the alluvial silts were layers (4) and (5) that denote successive levellings of the site, including the massive earthen bank to the rear of the northern curtain wall. Both likely dated to the early phases of the fort's construction and comprised clean mixed re-deposited natural clays, silts, and sands with few inclusions other than occasional rounded gravels and grits.

Above the clean re-deposited alluvium in boreholes 1 and 3 was re-worked, re-deposited alluvium (3). The composition of the layer was similar to the clean clay silts below but contained abundant flecks and fragments of chalk, tile, and brick. It was probably up-cast from later excavation into the earth banks during construction of the blast wall that surrounds the western powder magazine.

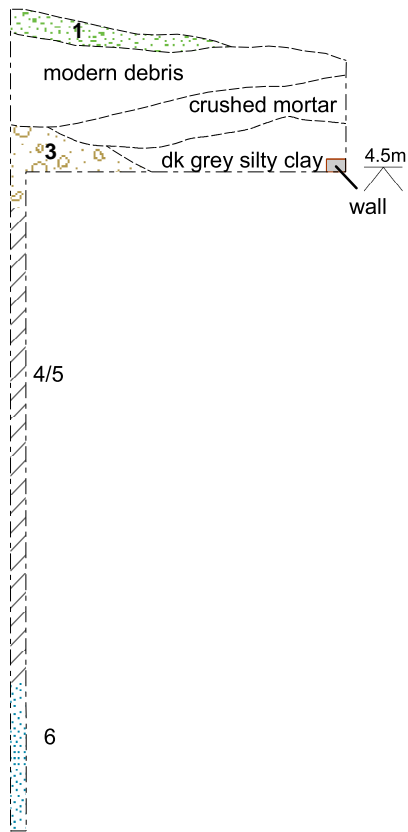
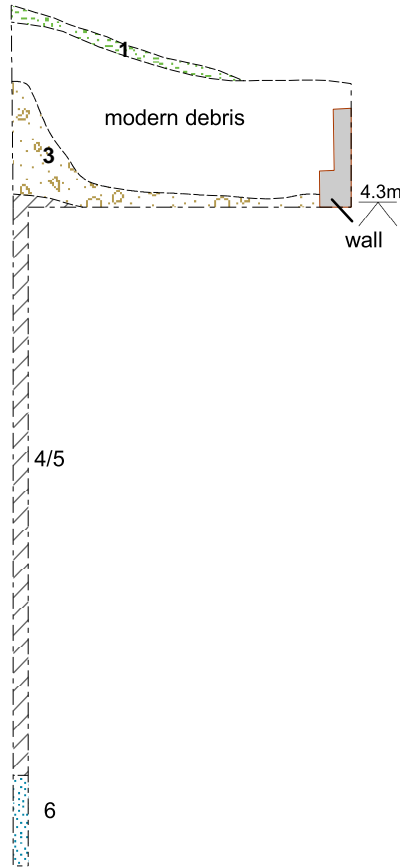
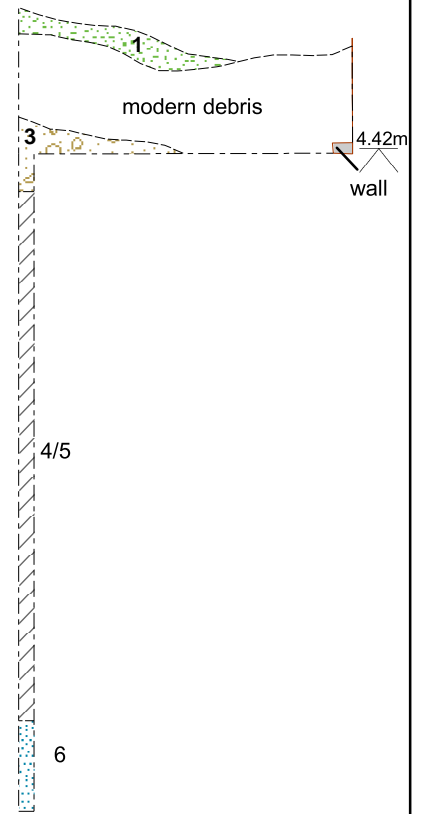
Fig.3. Access pits and auger holes 1, 8 and 15.

The access pits were excavated to a depth of c.0.60m (figs. 1 and 3). They only encountered one soil horizon of modern debris that butted up against the blast wall and overlay the re-worked clay (3) first seen in the previous borehole survey (see section 5.1).

Hand augering undertaken in access pits 1, 8 and 15 (fig. 3) enabled a deeper investigation of the underlying soils whilst also ensuring that the anchors would not cause any damage to buried archaeological remains.

The hand augering encountered the alluvial clays at their expected depth between 2.78 and 2.93m OD. Overlying these marshland deposits was the clean mixture of clays, silts and sands (4/5) that have been built up into the earthen banks behind the curtain wall. The re-worked clay, which contained small fragments and flecks of brick, tile, chalk together with gravels and grit, overlay the clean build-up layer. None of the localised deposits previously identified were present this close to the wall and no earlier foundations or buried walls were encountered.

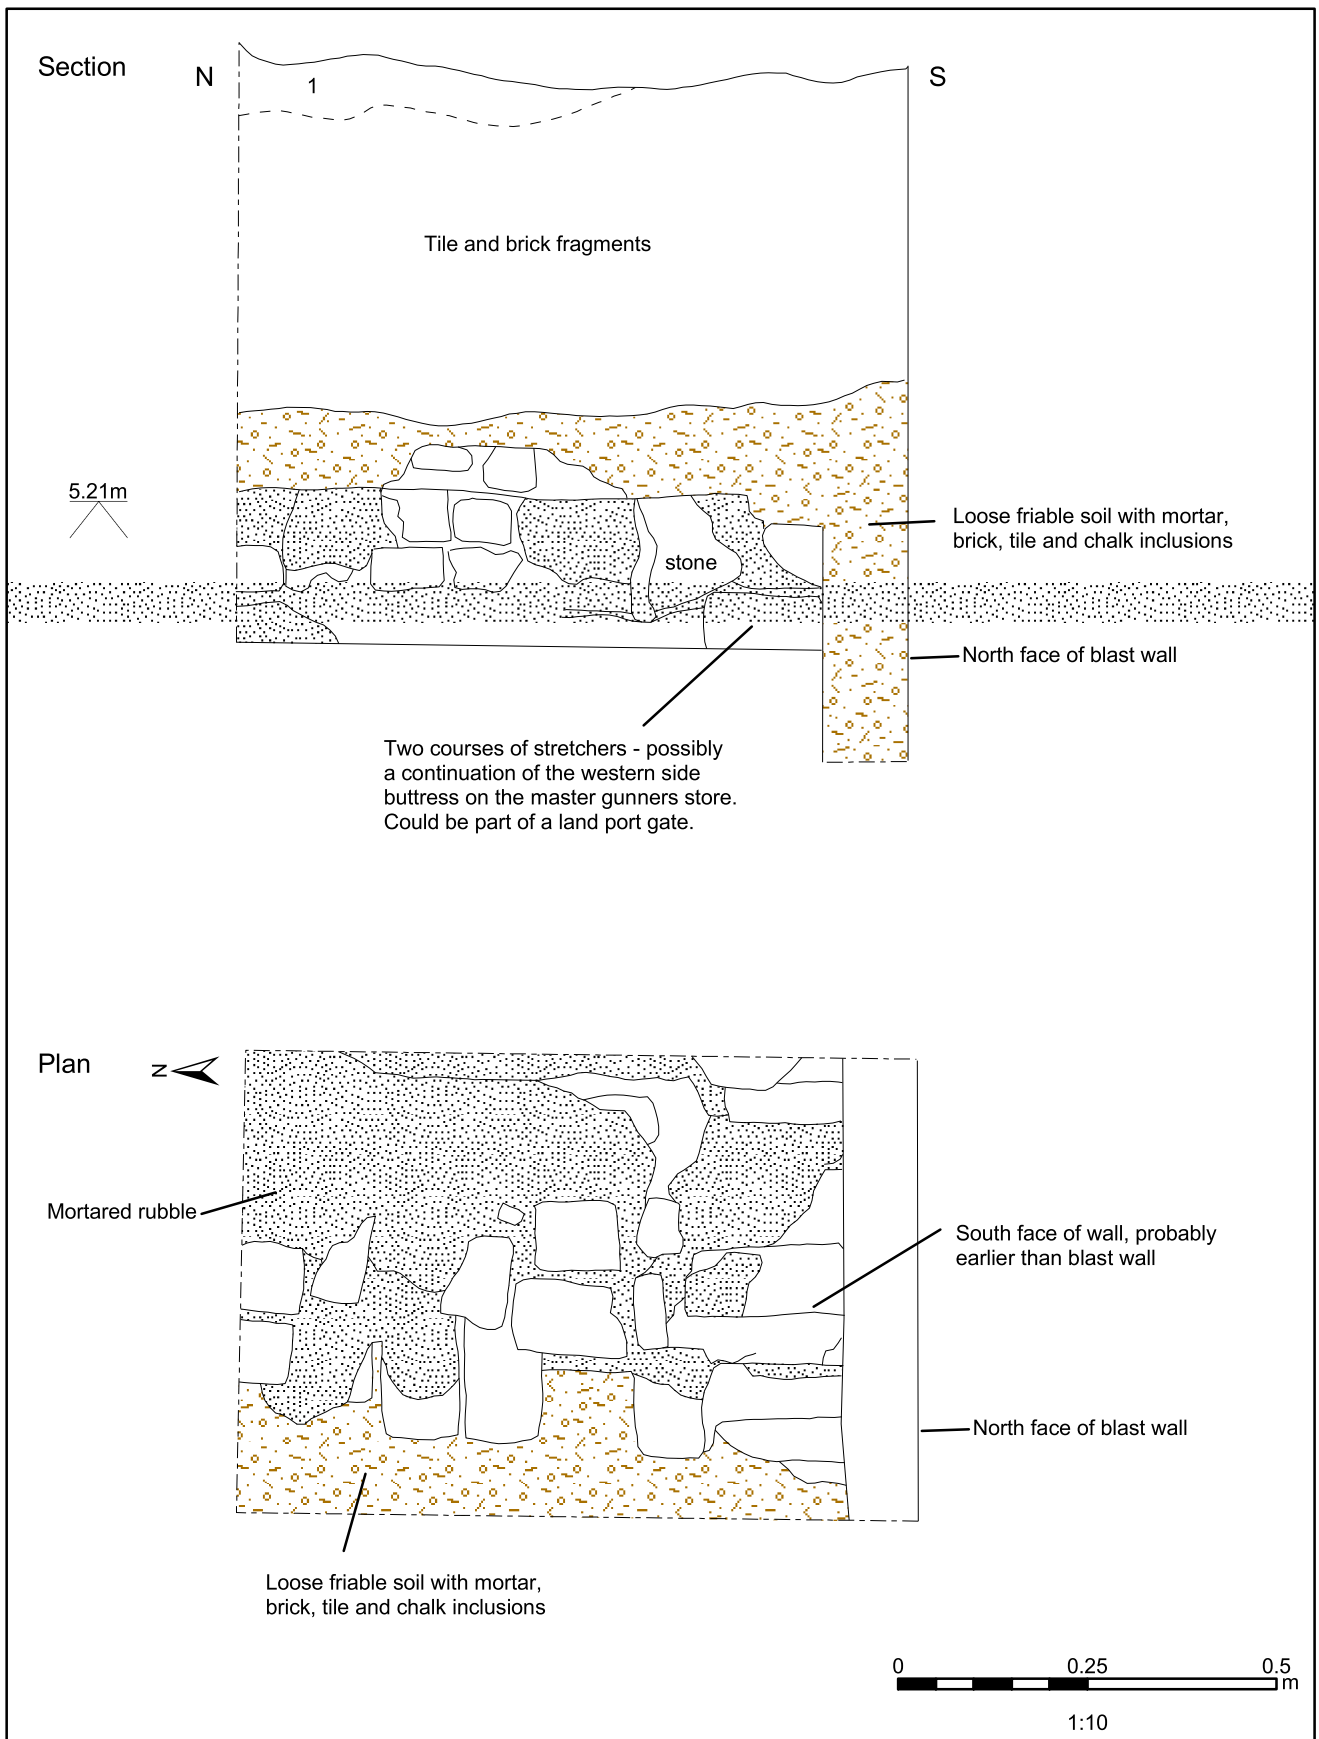
Fig.4. Access pit 16

Structural remains, other than the base of the blast wall, were identified in access pit 16. A substantial but incomplete brick-built structure that consisted of a well laid and finished southern face with a core of roughly mortared brick and stone (fig. 4) marked the continuation of a buttress against the western façade of the Master Gunner's Store. A gap of c.0.10m existed between the buttress and the blast wall. Unfortunately, because of the limited size of the access pit only a small part of the buttress was observed. Archaeological evidence together with the impractical distance between the two structures, suggests that the buttress pre-dated the blast wall.

In access pit 16, the continuation of a buttress to the Master Gunner's store was identified. It was in poor condition and may have been partially dismantled at some point or was simply unfinished. Its construction pre-dated the northern blast wall.
