**WEST POWDER MAGAZINE NORTH BLAST WALL  
TILBURY FORT  
ESSEX**

**ARCHAEOLOGICAL MONITORING  
AND RECORDING**

**Essex County Council**  
Field Archaeology Unit

May 2008

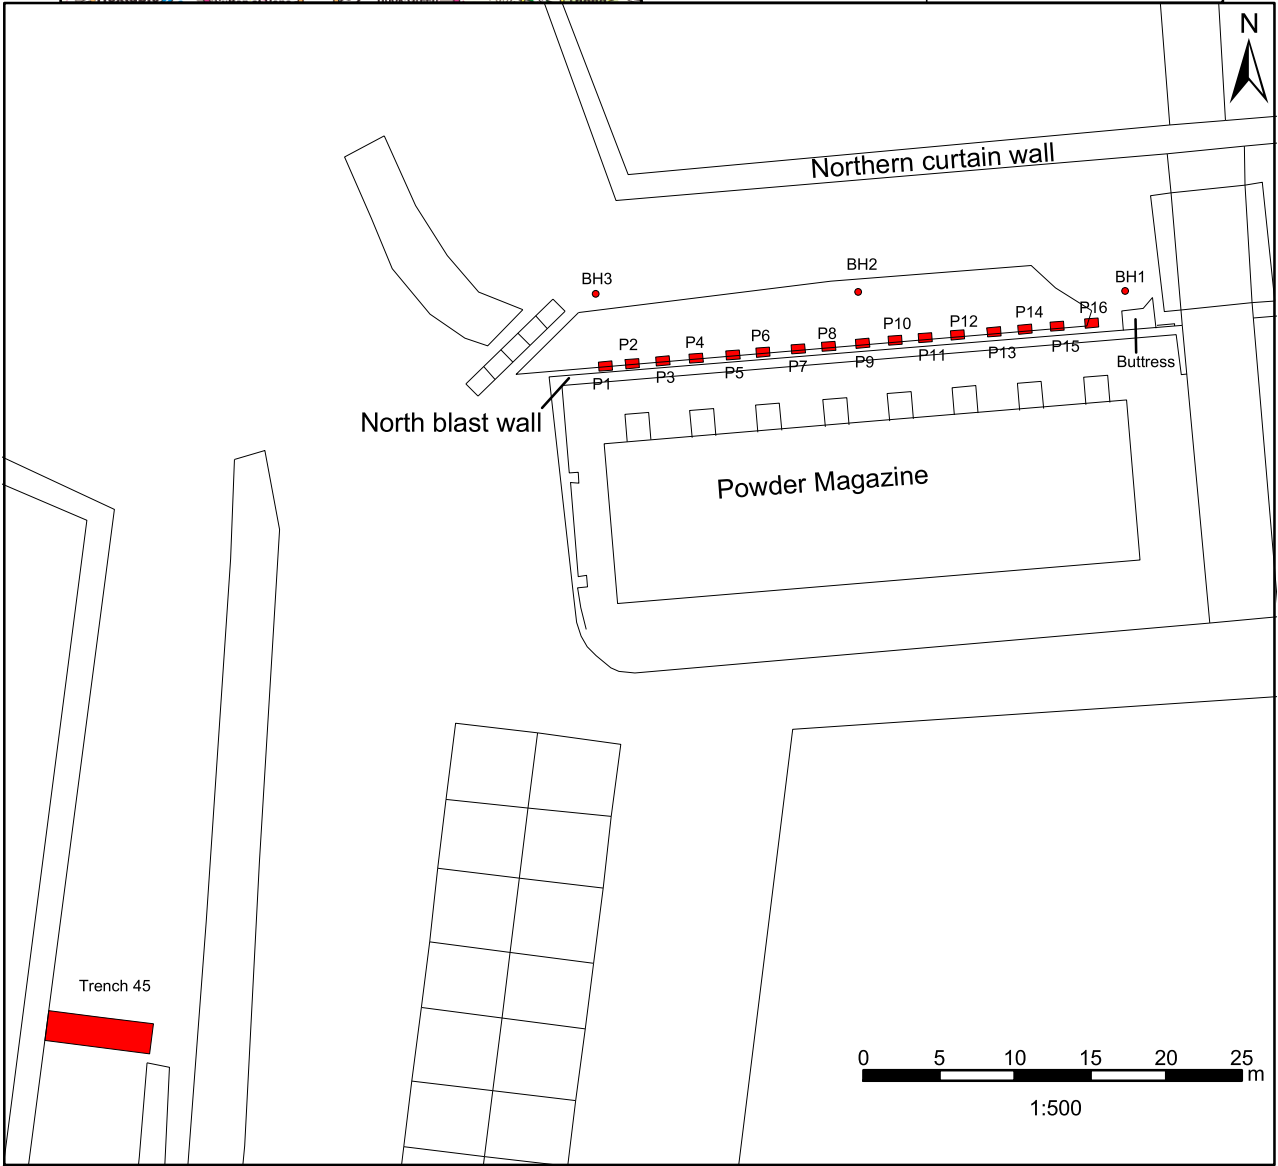
Fig.1. Location of Boreholes (BH) and Access-pits (P)

The archaeological investigation comprised two stages. The first involved the monitoring and recording of samples from three 4m-deep boreholes sunk on the upper slopes of the earth embankment adjacent and to the south of the north blast wall (figs. 1 and 2). The second part of the archaeological works comprised the excavation of sixteen access pits that were situated against the north blast wall, measuring 0.9x0.3m and 0.6m deep. These would eventually act as access pits for the ground anchors and were positioned in line with, and between the buttresses of the western powder magazine's southern façade (fig. 1). Unfortunately, the previous machine-dug boreholes were unable to get close enough to the blast wall to ensure that the ground anchors would not disturb buried wall lines or other archaeological remains in close proximity. Consequently, hand augering was undertaken to a depth of 1.5m in three of the access pits 1, 8, and 15 (fig. 3).

A layer of mixed organic soil and rubble sealed layer (3) in two of the three boreholes. This layer of modern debris was also found within all sixteen subsequent access pits dug at the base of the blast wall (fig. 1). Topsoil and turf capped the described soil sequence in each of the boreholes.

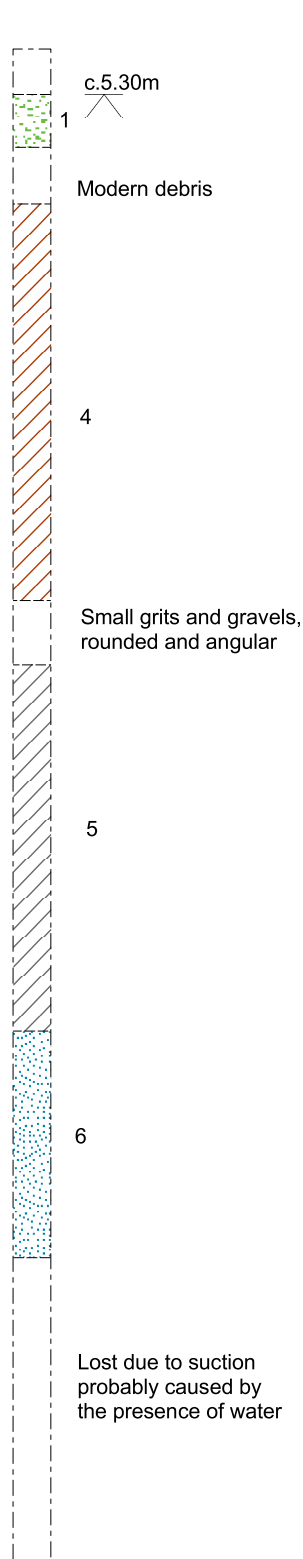
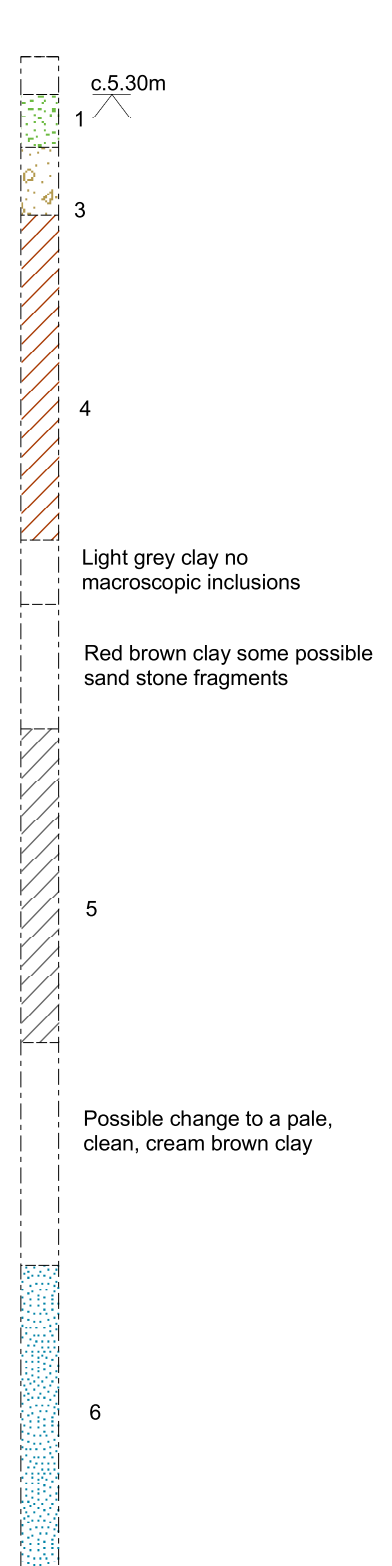
Fig.2. Boreholes 1-3

Three main layers were identified by boreholes 1, 2, and 3 (figs 1 and 2). Rich organic alluvial silts (6) were consistently found at the base of each bore-hole at c.2.90m OD. These silts represent the original marshland soils that included preserved plant matter and carbonised remains. Unsurprisingly, no finds were recovered to date the soils. Overlying the alluvial silts were layers (4) and (5) that denote successive levellings of the site, including the massive earthen bank to the rear of the northern curtain wall. Both likely dated to the early phases of the fort's construction and comprised clean mixed re-deposited natural clays, silts, and sands with few inclusions other than occasional rounded gravels and grits.

Periodically, the boreholes discovered pockets or lenses of other material sandwiched between the three main layers. These localised deposits were not assigned a numerical identification but are described in figure 2. These represent localised variations of material dumped during the construction process. Again, no finds were recovered to date these deposits.

Above the clean re-deposited alluvium in boreholes 1 and 3 was re-worked, re-deposited alluvium (3). The composition of the layer was similar to the clean clay silts below but contained abundant flecks and fragments of chalk, tile, and brick. It was probably up-cast from later excavation into the earth banks during construction of the blast wall that surrounds the western powder magazine.

The borehole survey identified the lower sequence of soils on site that began with alluvial marshland silts and the water table at c.2.8m OD. The fort seems to have been built directly on top of this original land surface, which, alongside any potential earlier archaeological features, deposits, or layers, remain well preserved below. Certainly the recovery of a prehistoric flint scraper suggests that during the fort's construction earlier remains may have been encountered. Above the marshland was evidence for a succession of deposits that formed a level platform for the fort and the earthen bank behind the northern curtain wall. Two of the more substantial layers (4) and (5), both undated, suggest at least two main episodes of construction. Overlying these deposits was evidence for the re-deposition of layer (4) into a re-worked layer (3). This may have been created from the upcast produced upon excavation for the footings of the northern blast wall in the middle of the 18th century. Above (3) was a relatively thin spread of modern debris (unnumbered) that was capped by the turf line.

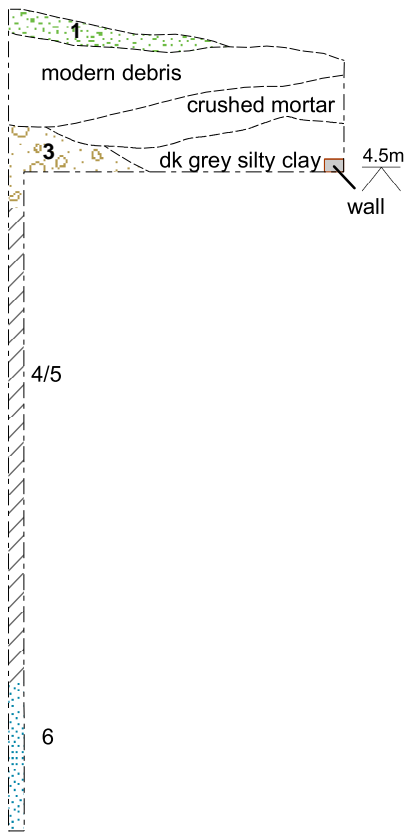
Fig.3. Access pits and auger holes 1, 8 and 15.

The access pits were excavated to a depth of c.0.60m (figs. 1 and 3). They only encountered one soil horizon of modern debris that butted up against the blast wall and overlay the re-worked clay (3) first seen in the previous borehole survey (see section 5.1).

Hand augering undertaken in access pits 1, 8 and 15 (fig. 3) enabled a deeper investigation of the underlying soils whilst also ensuring that the anchors would not cause any damage to buried archaeological remains.

The hand augering encountered the alluvial clays at their expected depth between 2.78 and 2.93m OD. Overlying these marshland deposits was the clean mixture of clays, silts and sands (4/5) that have been built up into the earthen banks behind the curtain wall. The re-worked clay, which contained small fragments and flecks of brick, tile, chalk together with gravels and grit, overlay the clean build-up layer. None of the localised deposits previously identified were present this close to the wall and no earlier foundations or buried walls were encountered.

The hand augering undertaken at the base of access pits 1, 8, and 15 achieved a depth of c.2.6m OD, and encountered a similar sequence of soil build-up found during the previous bore-hole survey. The 0.6m-deep access pits only encountered the upper limit of the soil sequence and identified a single layer of dark organic silt that overlay layer (3) that contained a significant quantity of modern debris. This could relate to the spread of material from the more recent demolition of buildings on other parts of the site in WWII (see section 2.2).
