**CANFIELD MOAT, HIGH CROSS LANE  
LITTLE CANFIELD  
ESSEX**

**ARCHAEOLOGICAL MONITORING**

**Essex County Council  
Field Archaeology Unit**

**February 2010**

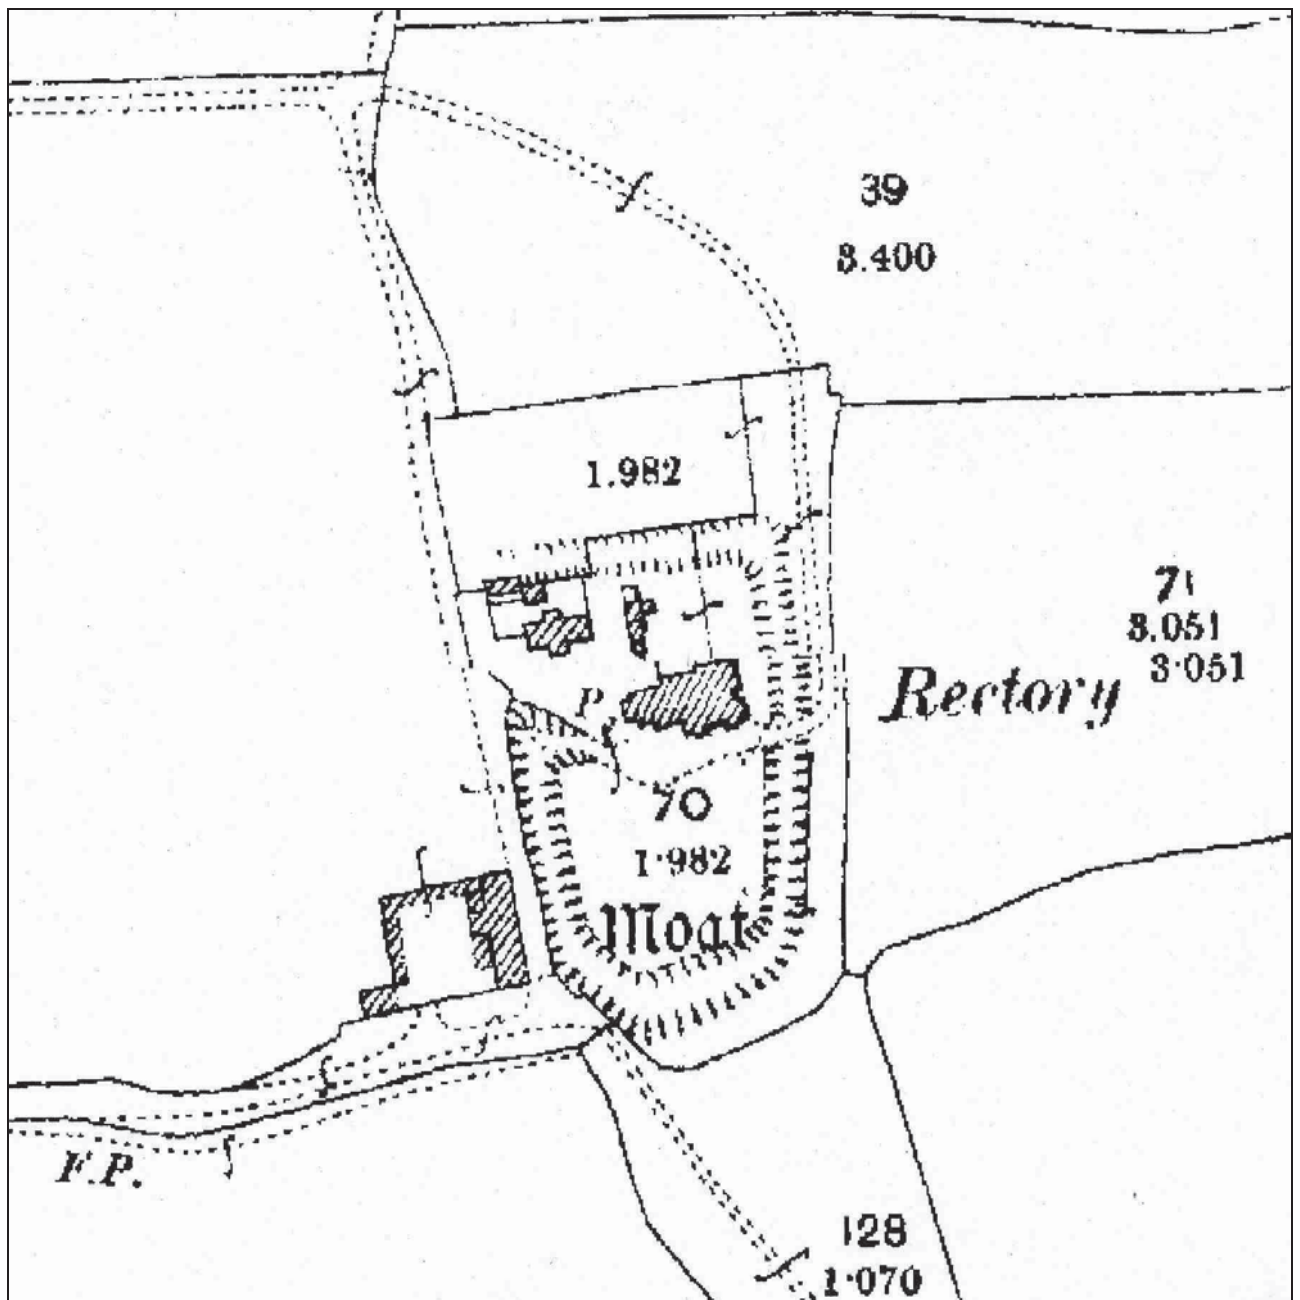
Fig. 2 Ordnance Survey map from c.1897

The 1777 Chapman and Andre map shows an earlier building, a parsonage, located inside a rectangular moat with an entrance midway on the western side. This may have been, or contained parts of, the earlier medieval house. Later 19th century maps suggest a double moat; with the remains of a central arm mostly in-filled, perhaps when the present house was built. In particular, the c.1897 OS map suggests the northern part had been at least partly in-filled by this stage, with buildings encroaching upon its edge (fig. 2).

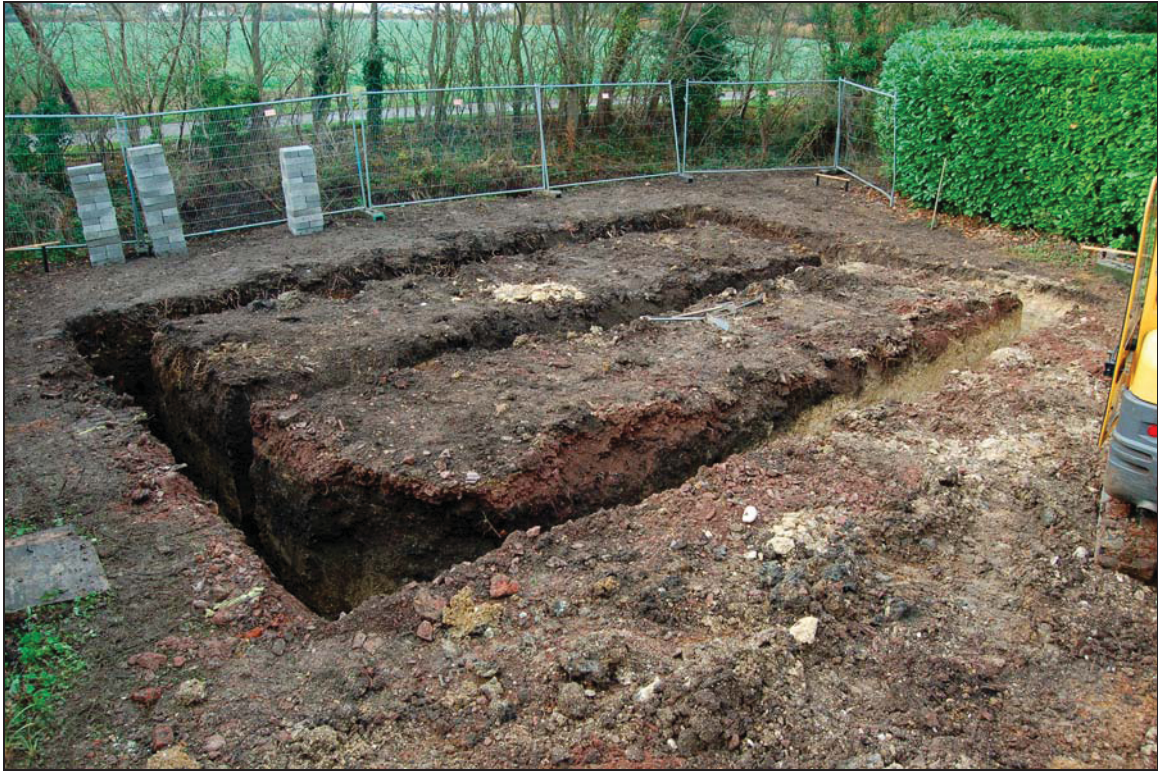
The northern edge of the moat (context 7) was recorded on the line of the earthwork seen in the garden to the east, but slightly to the south of the line plotted on the current OS map (fig. 1). The moat extends at least 5m to the south, with the opposing edge beneath the existing outbuilding (fig. 1). The moat was filled with a series of four substantial silty clay backfill deposits containing ceramics dating to the late 19th or early 20th century (contexts 2-5). The bottom fill, context 5, was especially water-logged and contained decayed vegetable matter and part of a square-toed leather boot, as well as pottery of the same date, indicating backfilling as a single event. The flat base of the feature was recorded at a depth of 2m, cut into the natural chalk (plate 1).

A 'spur' extends to the north (context 8), to the same depth beyond the limit of excavation. It may represent a short irregularity in the north-west corner that with limited excavation cannot be clearly understood, and there is no map evidence for it. This was also cut through the natural chalk (plate 1) and backfilled with the same deposits as the moat, plus a fifth deposit

Plate 1 View to north-east of backfilled moat deposits in new garage area with the moat and northern spur cutting natural chalk on the right side of the photograph

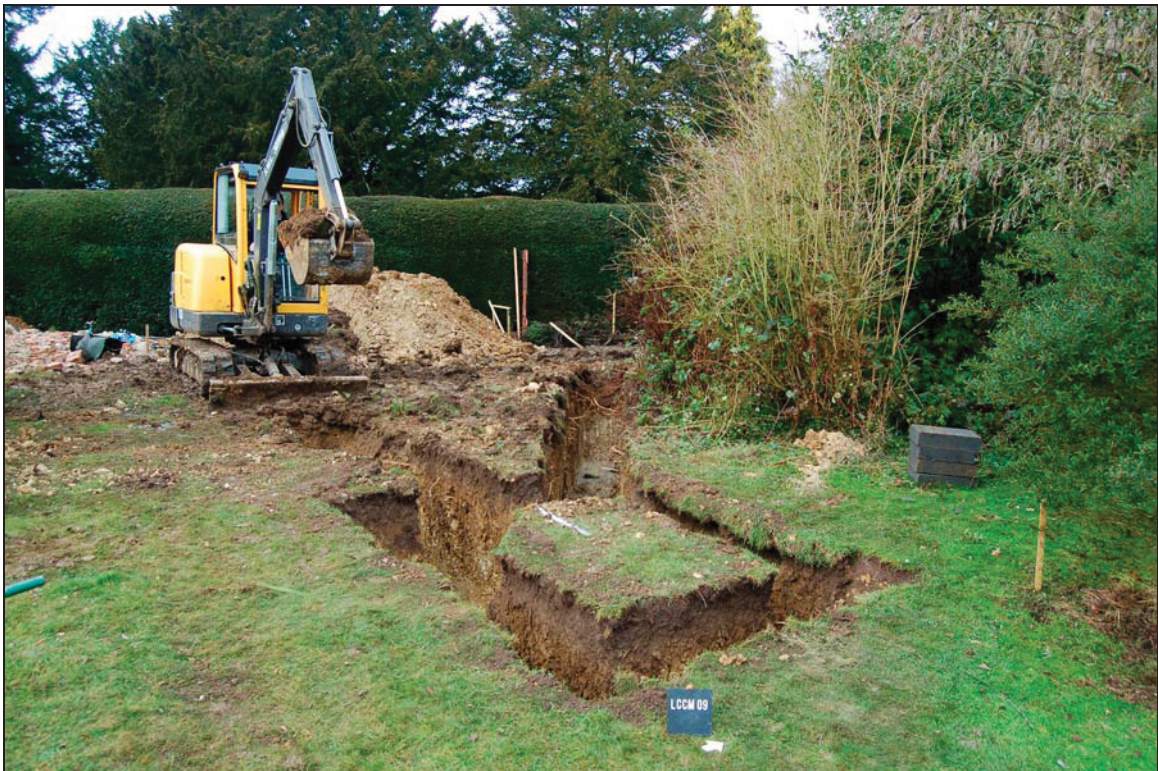
The location of the new pool house was repositioned from the north side to the north-east side of the swimming pool, which appears to be on the eastern arm of the moat (fig. 1). Excavations were carried out to a depth of 1.2m and found undisturbed deposits of clay subsoil beneath the topsoil/turf layer and natural chalky boulder clay 0.5m below ground level (plate 2). There was no evidence of the moat, which is likely to be a short distance to the west, on the line of the swimming pool.

Plate 2 Excavation for pool house on undisturbed ground to the east of the moat
