14 PRIORS HILL Pirton, Hertfordshire

(HN325)

Archaeological Monitoring Report

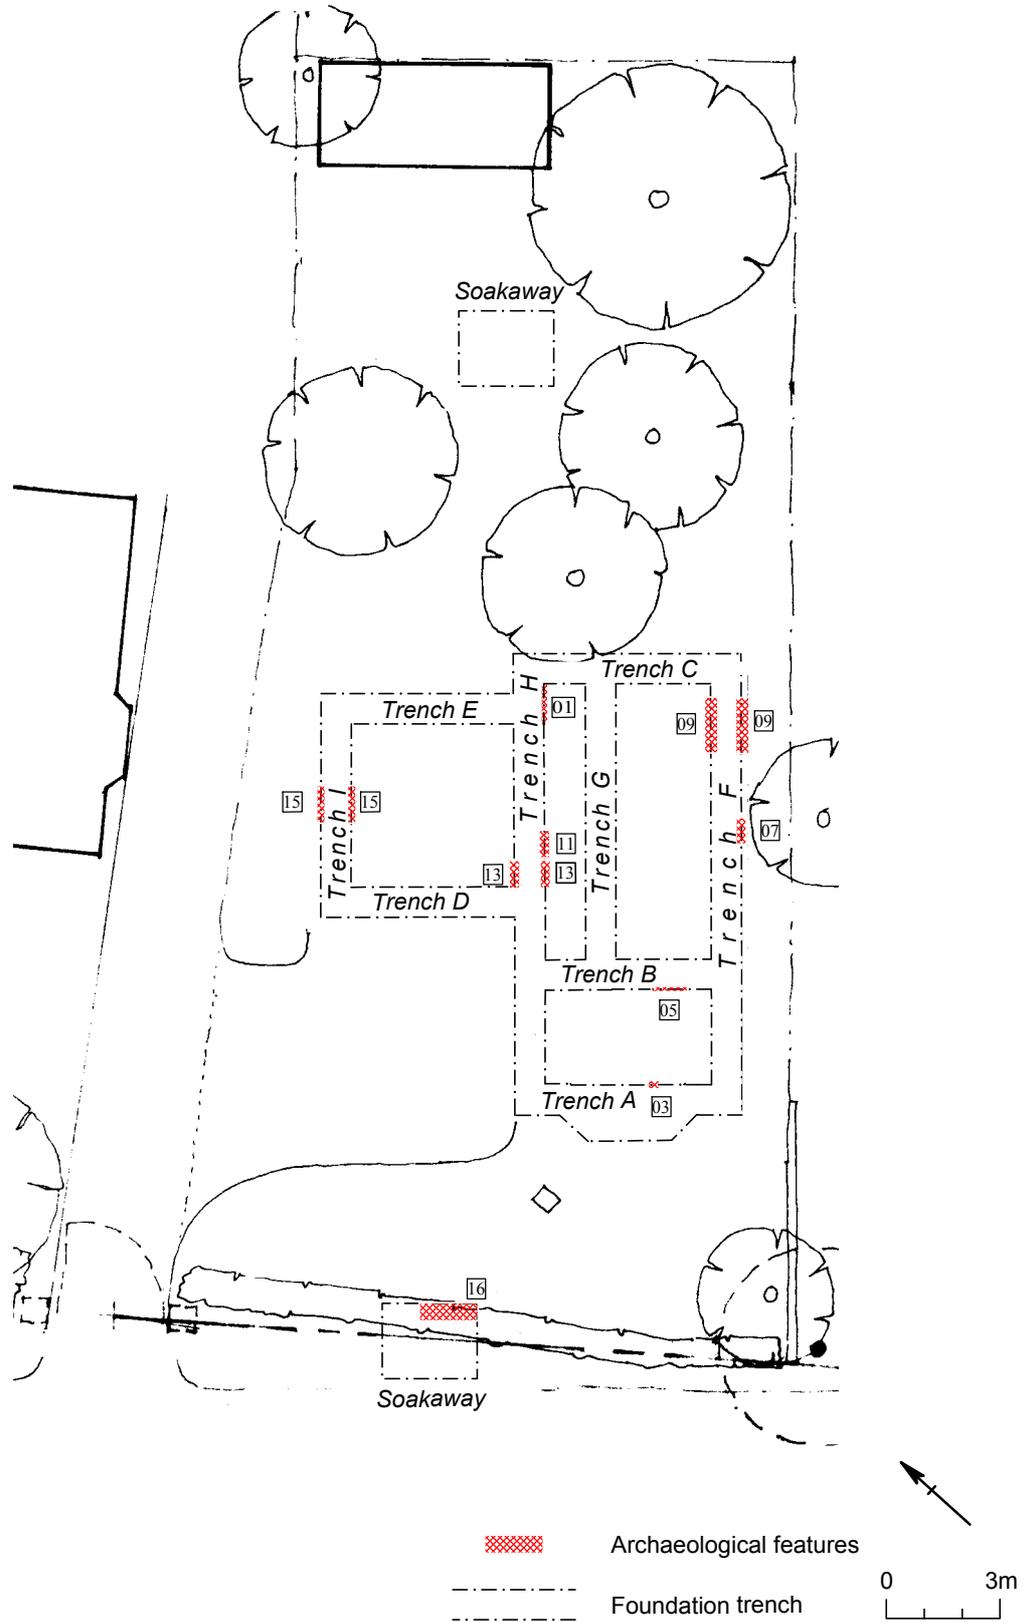
Figure 2

Site layout
(Plan courtesy of AT4 Architects Ltd.)

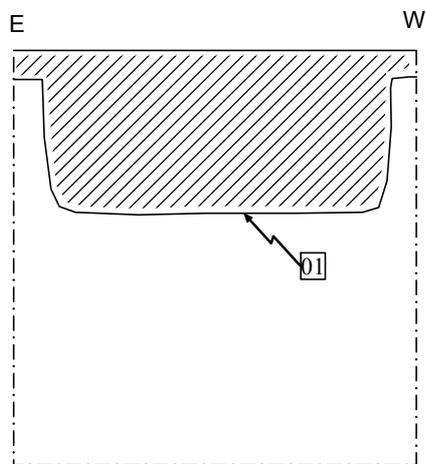
Context	Type	Description and interpretation	Max Th (m.)
01	Cut	U-shaped feature measuring 0.85m wide in north facing section of trench C.	
02	Fill	Fill of [01]. Sandy clay fill with sub angular stones and occasional chalk fragments. No finds.	0.43
03	Cut	Flat based feature measuring 0.30m wide in west facing section of trench A. No finds.	
04	Fill	Fill of [03]. Very dark greyish brown (2.5Y 3/2) clay fill. An iron object was found at the base of the feature.	0.80
05	Cut	U-shaped feature measuring 0.95m wide was observed in the east facing section of Trench B.	
06	Fill	Fill of [05]. Dark yellowish brown (10YR 4/6) sand fill. No finds.	0.50
07	Cut	U-shaped feature measuring 0.70m wide in the south facing section of Trench F.	
08	Fill	Fill of [07]. Light olive brown (2.5Y 5/4) clay. No finds.	0.70
09	Cut	U-shaped feature measuring 1.50m wide was observed in both section of trench F.	
10	Fill	Fill of [09]. Light olive brown (2.5Y 5/3) silty sand. No finds.	1.00

3.4 Despite the proximity of the site to Roman, Anglo-Saxon and medieval remains, the lack of finds makes it impossible to date the identified features. However, it seems likely that they are modern in date as several appeared very regular in section, with flat bases and straight sides, including features [01], [11] and [16] (Figure 3).

North facing section of feature [01]

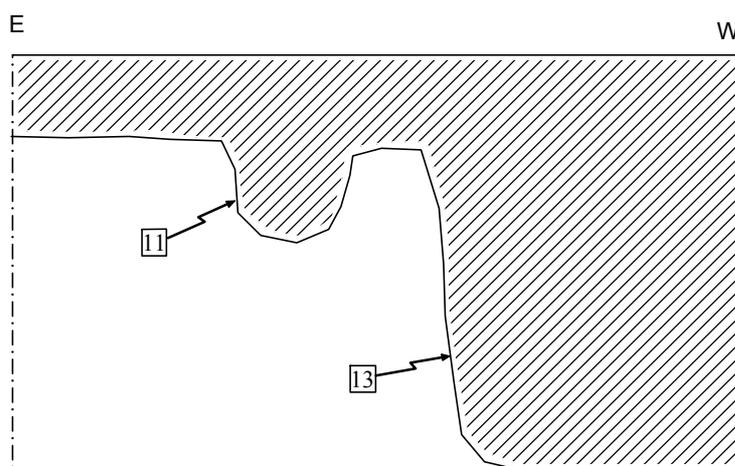
11	Cut	U-shaped feature measuring 0.75m wide was in the north facing section of Trench H with adjoining Feature [13].	
12	Fill	Fill of [11]. Light olive brown (2.5Y 5/3) silty sand. No finds.	0.50
13	Cut	Flat based feature observed in both sections of Trench H with adjoining Feature [11]	
14	Fill	Fill of [13]. Light olive brown (2.5Y 5/3) silty sand fill. No finds.	1.10+
15	Layer	Charcoal layer measuring 1.0m wide by 0.82m long in both sections of Trench I. An almost U-shaped cut was noted in the north facing section but was very indistinct in the south facing. No finds.	0.06

3.2 Five of the features, cuts [01], [03], [05], [07] and [11] were only identified in one section, indicating that these may have been pits. Two of the other features, cuts [09] and [13] possibly represent gullies and ditches. Layer [15] was also observed in both trench sections. The high concentration of charcoal in this layer is indicative of burning, but the lack of any further information relating to the feature makes a more accurate interpretation impossible.

North facing section of features [11] & [13]

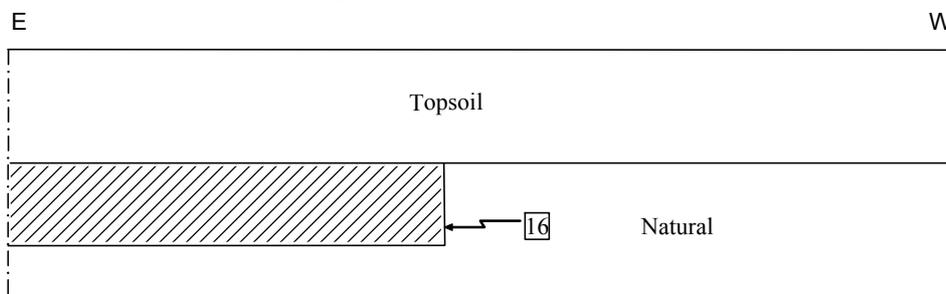
2.4 Two soakaways, measuring approximately 2.0m by 2.0m by 0.65m deep, were excavated at the front and rear of the plot (Figure 2). The stratigraphy in both consisted of a 0.30m deep layer of brown (10YR 4/3) silty clay topsoil over a 0.35m deep layer of grey (2.5Y 6/1) clay natural. No archaeology was observed in the rear soakaway, but a linear feature [16] was observed in the one to the front of the development.

Context	Type	Description and interpretation	Max Th (m)
16	Cut	Linear feature measuring 1.15m+ wide by 2.0m+ long with straight sides and a flat base	
17	Fill	Dark greyish brown (10YR 4/2), silty clay containing occasional flint inclusions and root activity. No finds.	0.22

North facing section of the front soakaway
