**14 PRIORS HILL
Pirton, Hertfordshire**

(HN325)

Archaeological Monitoring Report

Land at
14 PRIORS HILL
Pirton, Herts.

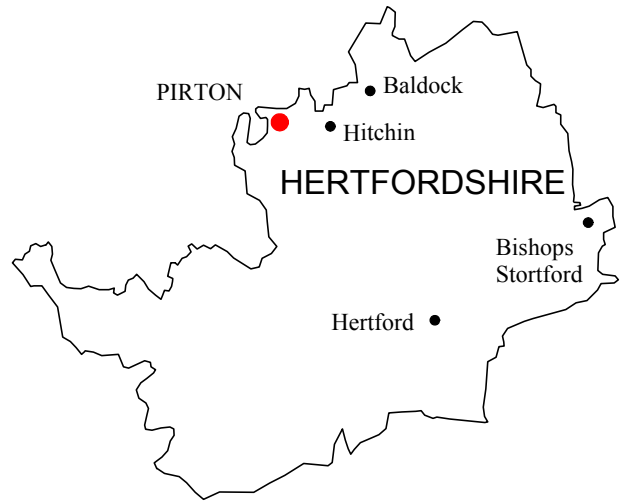
Site Location

1.2 The site is located on the southern limits of Pirton, centred on NGR TL 1445 3155 (Figure 1). The development involved the construction of a new dwelling, garage, and associated landscaping (Fig.2).

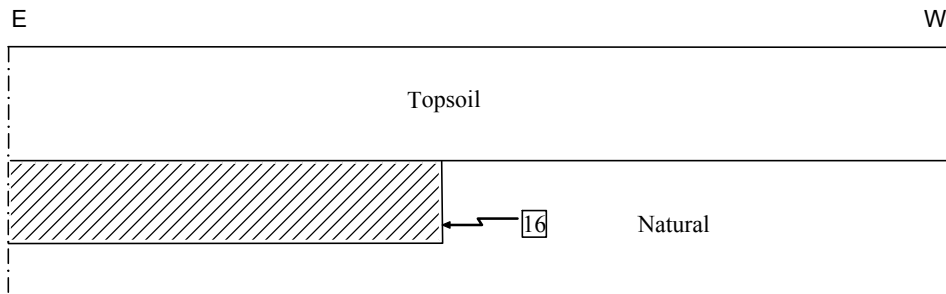
2.4 Two soakaways, measuring approximately 2.0m by 2.0m by 0.65m deep, were excavated at the front and rear of the plot (Figure 2). The stratigraphy in both consisted of a 0.30m deep layer of brown (10YR 4/3) silty clay topsoil over a 0.35m deep layer of grey (2.5Y 6/1) clay natural. No archaeology was observed in the rear soakaway, but a linear feature [16] was observed in the one to the front of the development.

Context	Type	Description and interpretation	Max Th (m)
16	Cut	Linear feature measuring 1.15m+ wide by 2.0m+ long with straight sides and a flat base	
17	Fill	Dark greyish brown (10YR 4/2), silty clay containing occasional flint inclusions and root activity. No finds.	0.22

North facing section of the front soakaway

3.4 Despite the proximity of the site to Roman, Anglo-Saxon and medieval remains, the lack of finds makes it impossible to date the identified features. However, it seems likely that they are modern in date as several appeared very regular in section, with flat bases and straight sides, including features [01], [11] and [16] (Figure 3).
