Excavations at the mouth of Deptford Creek, Greenwich Reach

David Divers
Chris Jarrett

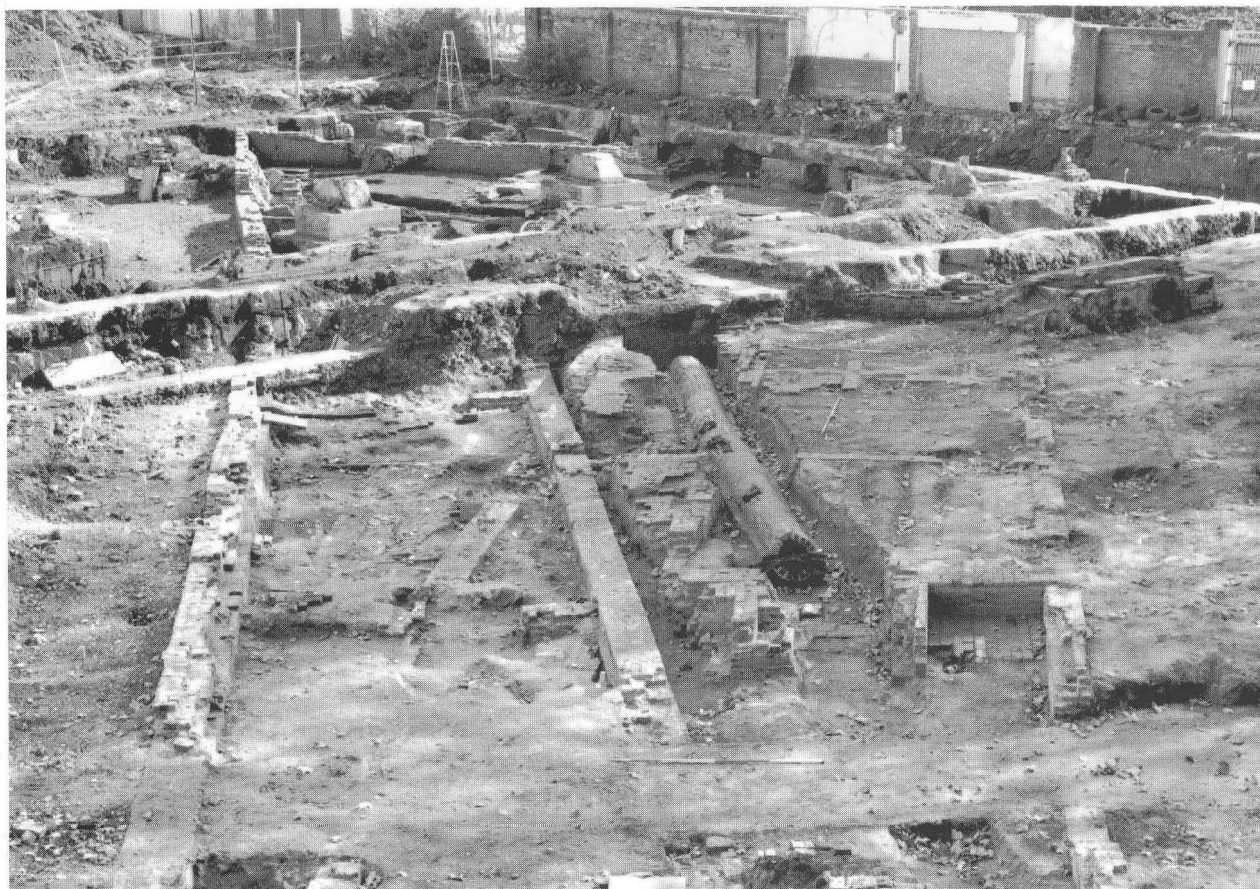
Fig. 5: general view of the Area A almshouse excavation (PCA)

the only structural element of the earlier phase of building to remain in use. A general view of these almshouses overlying the earlier 17th century remains are shown in Fig. 5.

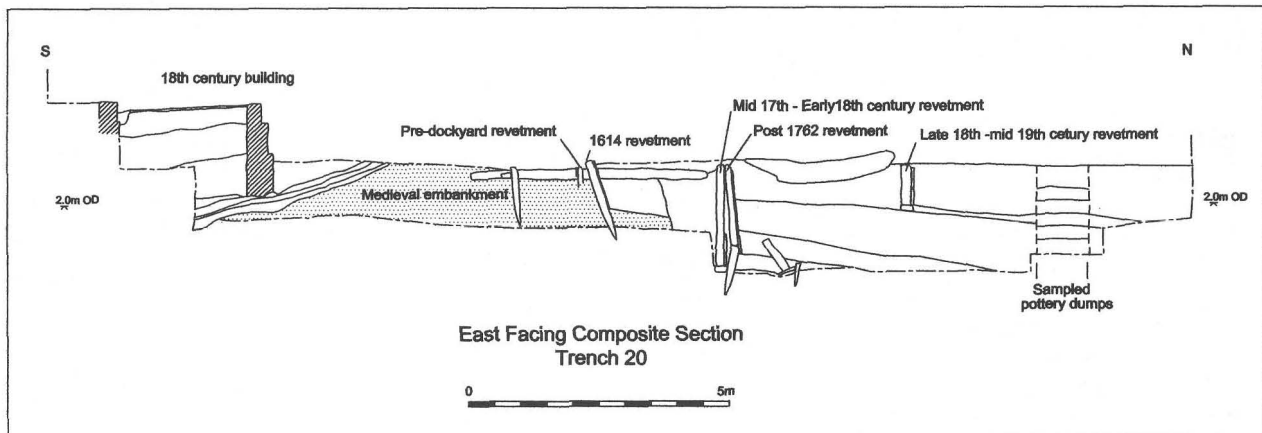
Fig. 6: east-facing section showing possible embankment and revetments

shipbuilding (Fig. 6, 7 and 8). The high levels of silty clay to the south-east of Area D, and the profile of these deposits shown in Fig. 6, may be evidence of the medieval embankment. This received commission of repair by the early 14th century suggesting that it was well established by that time¹⁰. No structural elements to this feature were found although a shallow revetment along its upper northern edge may be a repair or consolidation of the postulated embankment (Fig. 7a).

A new river wall, built between the mid 17th and early 18th century, was substantially deeper than its predecessor, with no attempt to reclaim a significant amount of land (Fig. 6 and 7c). These revetments were built in a similar fashion with horizontal planks nailed to the front of posts set into a baseplate; both front and back bracing was recorded.

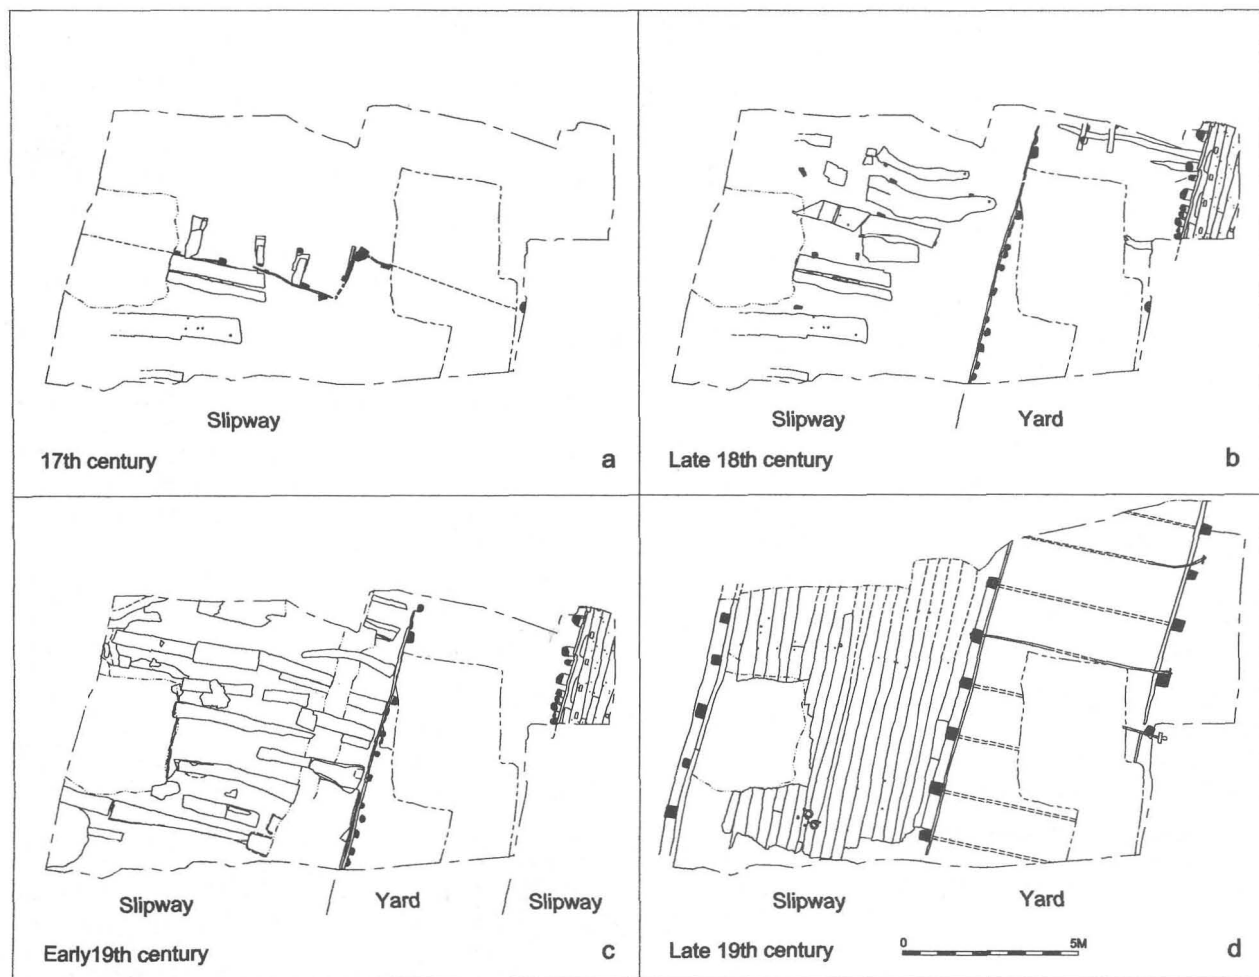
Fig. 8: detail plans showing development of Slipway 1

Before this late-18th-century development, Slipway 1 had consisted of large horizontal timbers creating a load-bearing surface adjacent to the river, its full extent remaining unknown (Fig. 8a). The northernmost timber was fixed to the revetment via mortises into which tenons on top of revetment posts fitted. The late 18th century saw this slipway extended towards the north, with the construction of a north-south revetment holding back made ground and defining the eastern edge of the slipway. Mixed deposits and timbers were then dumped on the foreshore and large horizontal timbers staked down, creating a sloping area of hard-standing (Fig. 8b).

This slipway was later strengthened, probably in the early 19th century, with the addition of several large long north-south timbers secured to the slipway's surface, followed by a layer of substantial east-west timbers within a chalk packing (Figs. 7e and 8c). This may reflect the technological developments which permitted the construction of larger ships after c. 1800.

timber revetment 2.5m high, back-braced with iron tie-rods, was added to its eastern side with a concrete wall built to the west (Fig. 8d). This last manifestation of the slipway was probably built at the same time as Ferranti's power station (1887), possibly for the delivery of coal rather than the construction of ships.

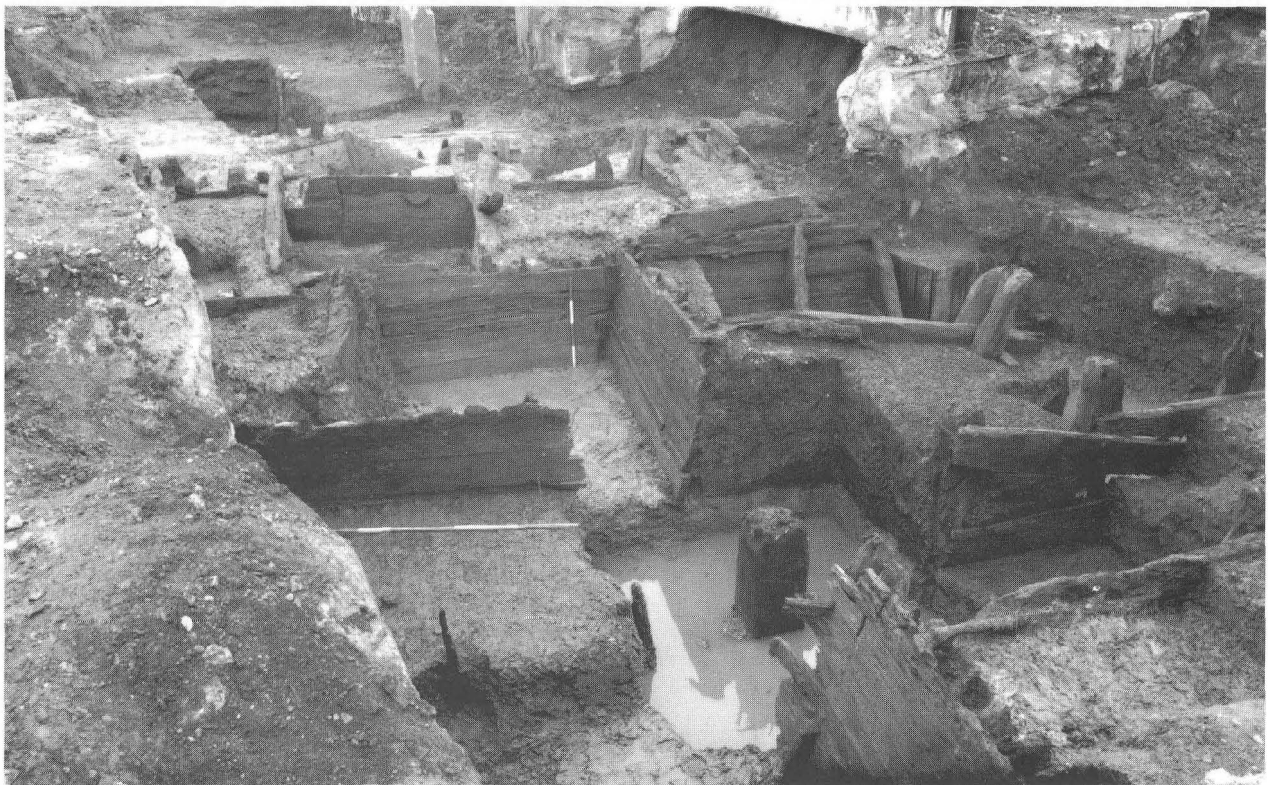
Fig. 9: general view of the Area D dockyard excavation (PCA)

The excavation exposed two distinct areas of the dockyard. The eastern half was an open yard area with deep wharves for loading and unloading (Fig. 9) and a brick-walled building associated with the third phase of dockyard construction to the south. The building was marked 'crane house & saw pits' on a 1789 map of the dockyard although no evidence of either activity was found. The lower

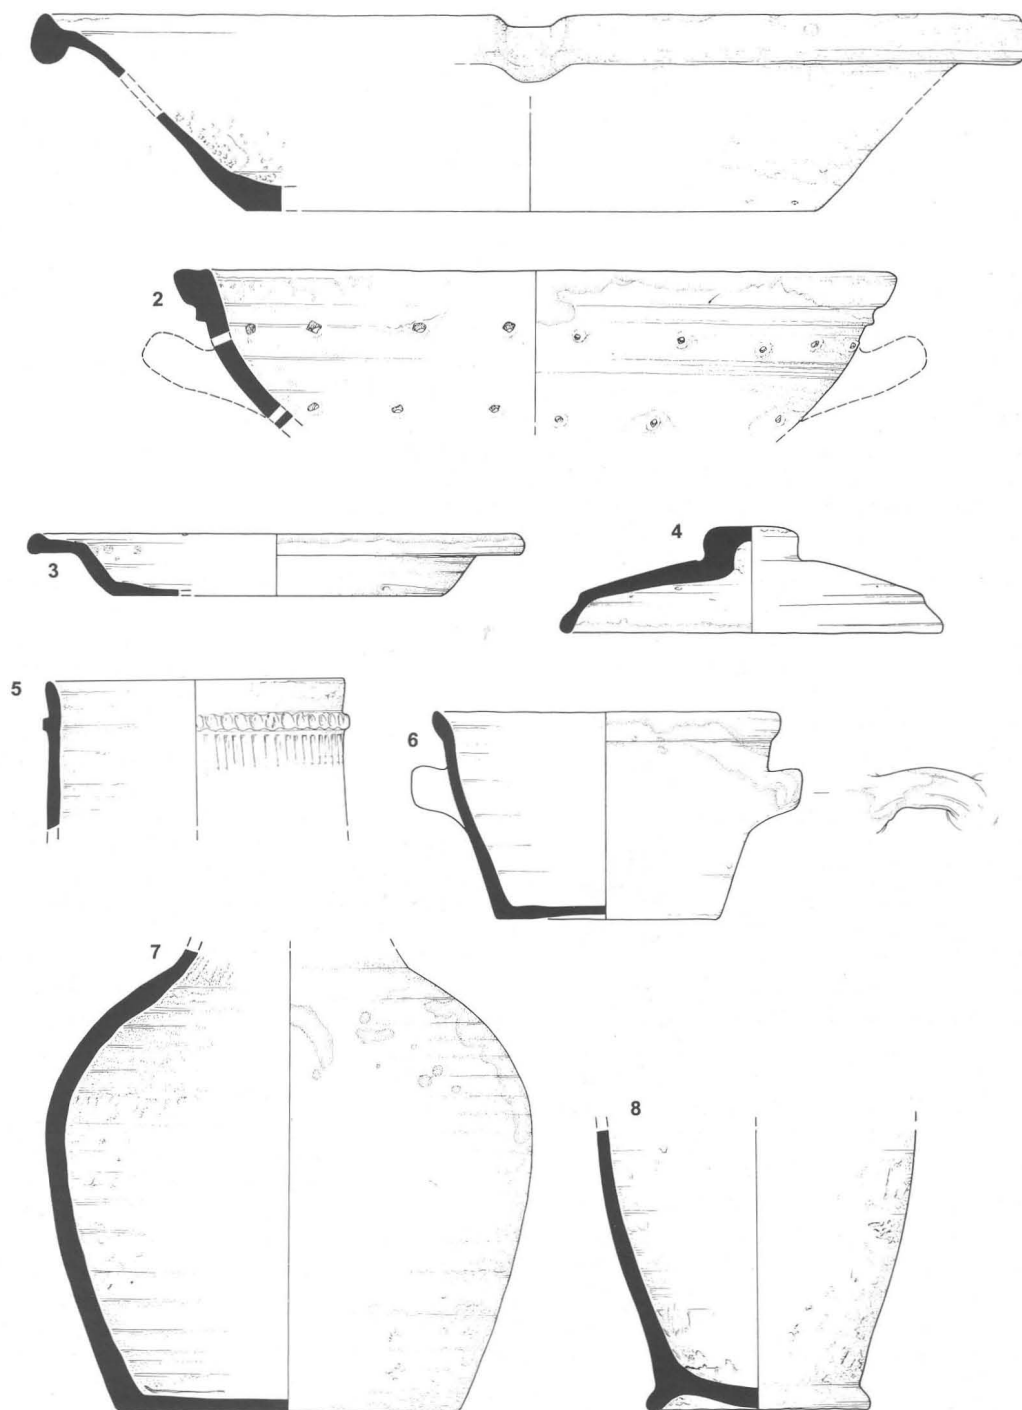
Fig. 10: post-medieval redware kiln waste; 1 pancheon, 2 colander, 3 dish, 4 collared lid, 5 cylindrical jar, 6 small handled bowl, 7 distillation flask, 8 syrup-collecting jar (scale 1:4).

A second group of dumps associated with the partial backfilling, and subsequent total backfilling of a possible dock during the late 18th and 19th century consisted of pottery waste (Fig. 10) presumably from one of Deptford's potters, one of whom occupied the northeast corner of the site during the 18th and possibly 17th century. Evaluation failed to locate the pottery buildings, the remains of which were probably truncated during construction of the power station.

Approximately 2% of each dump of wasters was 'randomly' sampled, and analysis showed that three pottery-types were present; glazed and unglazed coarse post-medieval redware (PMR), a post-medieval black-glazed type ware and a white earthenware. The latter was solely present as crucibles, for which Deptford was famous during the 17th century¹². The vessels present in PMR consisted largely of flower pots and industrial wares; sugar cone moulds, syrup-collecting jars, distillation flasks and a waisted jar or bottle. Domestic shapes were
