**LAND AT ESSEX HALL, 313 BILLET ROAD, LONDON E17**  
**LONDON BOROUGH OF WALTHAM FOREST**  
**PHASE 1 DEVELOPMENT (SURE START)**  
**AN ARCHAEOLOGICAL EVALUATION**

SITE CODE: ESX05

COMPASS ARCHAEOLOGY LIMITED

April 2005

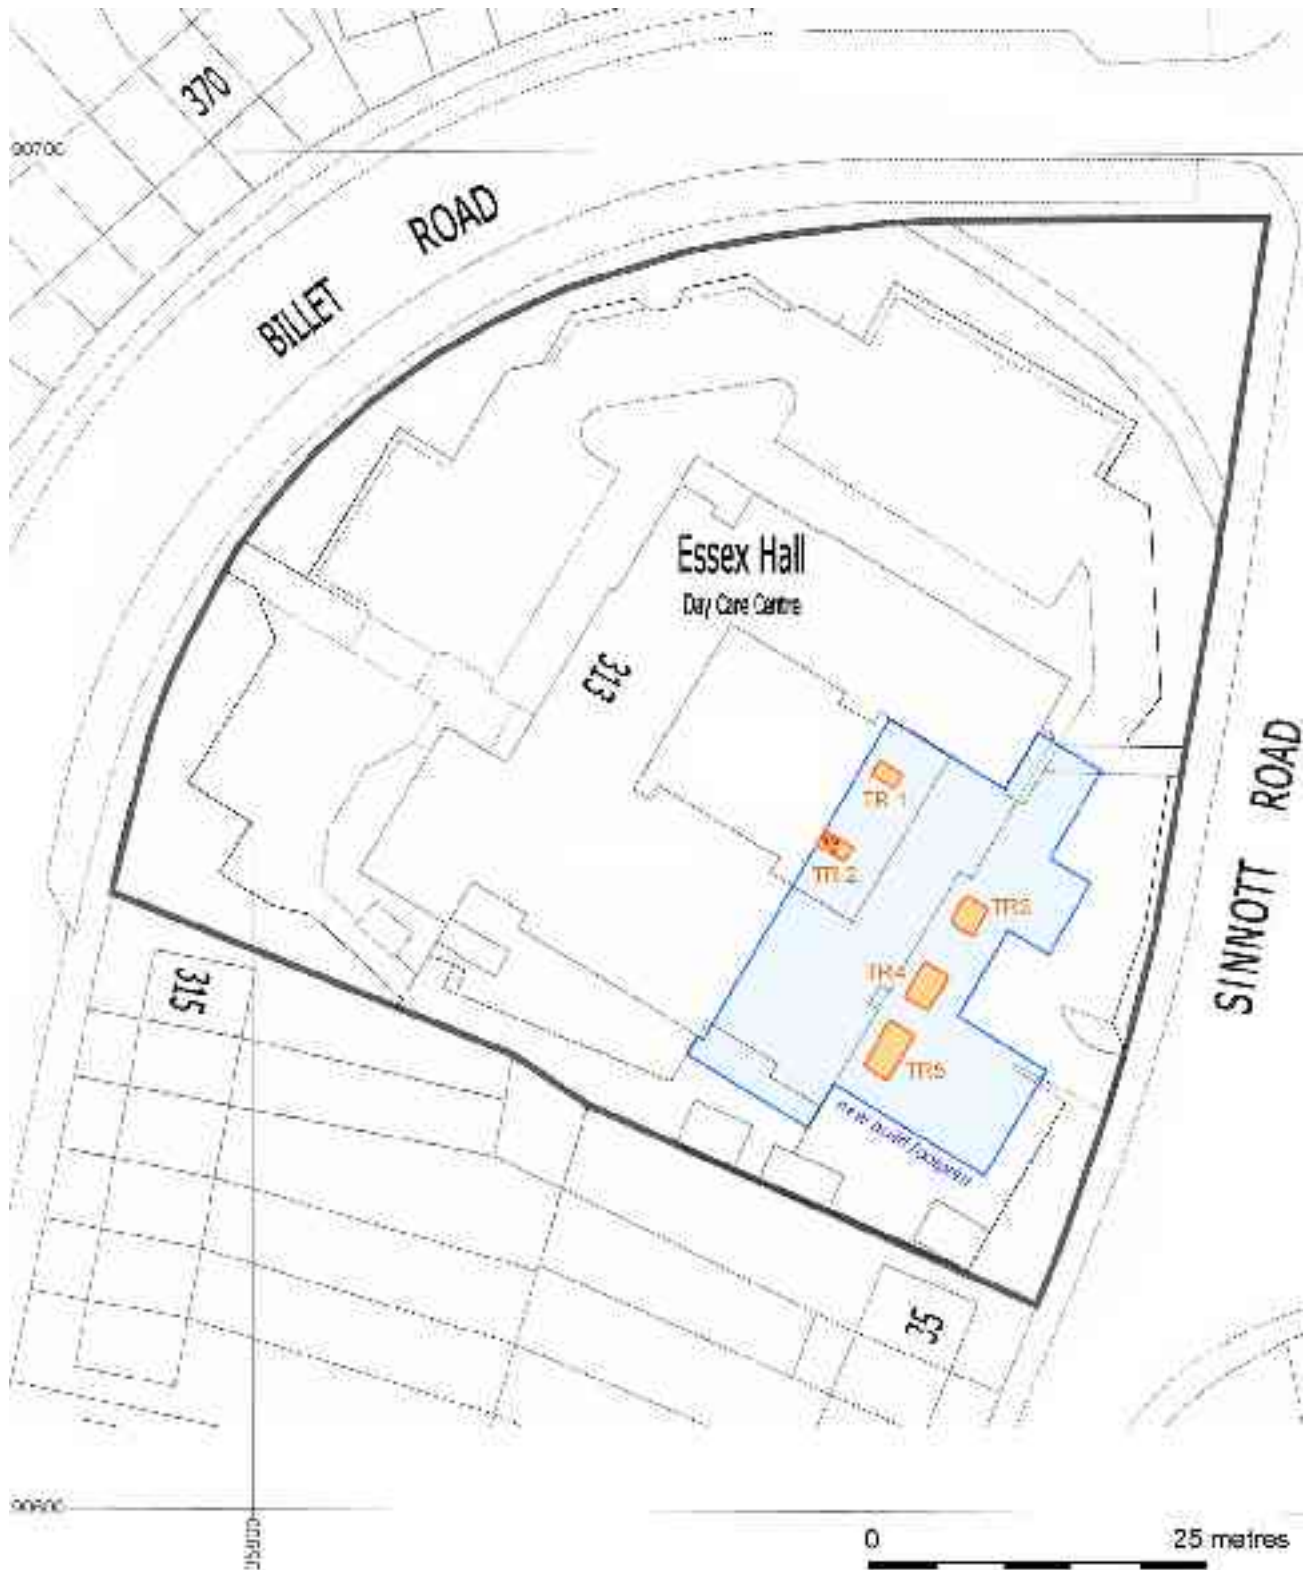
Fig 1 Site outline and location of the evaluation trenches (1 to 5) in relation to the proposed redevelopment footprint

5.2 The evaluation comprised a total of five trial trenches, all located within the area of proposed development as shown on Figure 1:

- Two hand-dug trenches in the existing central courtyard, on an approximate east-west alignment just over 5m apart. Both trenches were set out to measurements of 2.0m by 1.2m in plan, although Trench 2 was extended to 2.45m in response to the findings that were made during the evaluation.
- Three machine-dug trenches in the car park on the eastern side of the present building, each set out to a width of 2m and respectively 2m, 3m and 4m in length.

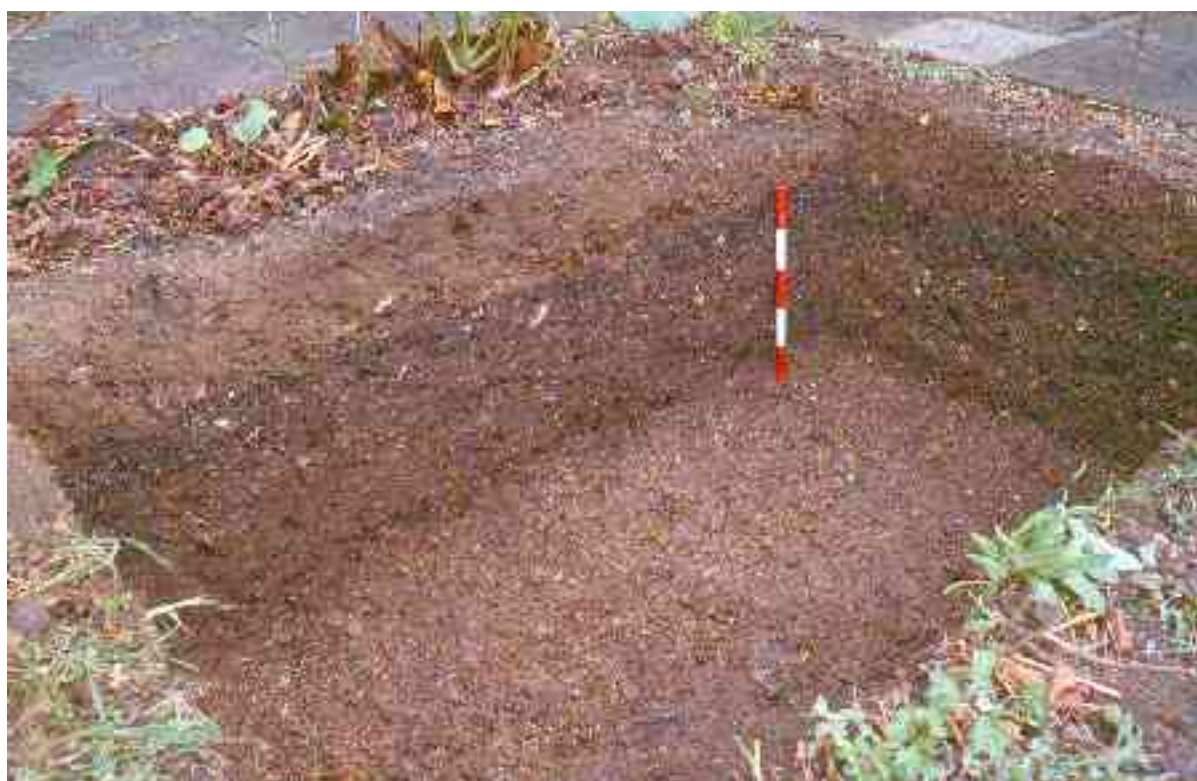
Fig 4 View of Trench 1, looking northeast (*50cm scale*)

The natural gravel was overlaid by a simple buried soil profile slightly less than 500mm thick, comprising subsoil [4], intermediate layer [3] and topsoil [2]. A few finds were produced by the lower two layers, including three pottery sherds dating broadly to the later 16<sup>th</sup> to 19<sup>th</sup> centuries (Appendix I). Significantly more finds were recovered from context [2], with included pottery of mainly 19<sup>th</sup> century date. There was also some earlier, potentially 17<sup>th</sup> or 18<sup>th</sup> century, material. It is assumed that these finds were deposited over a considerable period of time and reworked within a cultivated soil. There were also a number of small fragments of ceramic building material (roof tile and occasional brick), plus three short (<34mm) lengths of clay pipe stem, but nothing particularly diagnostic.

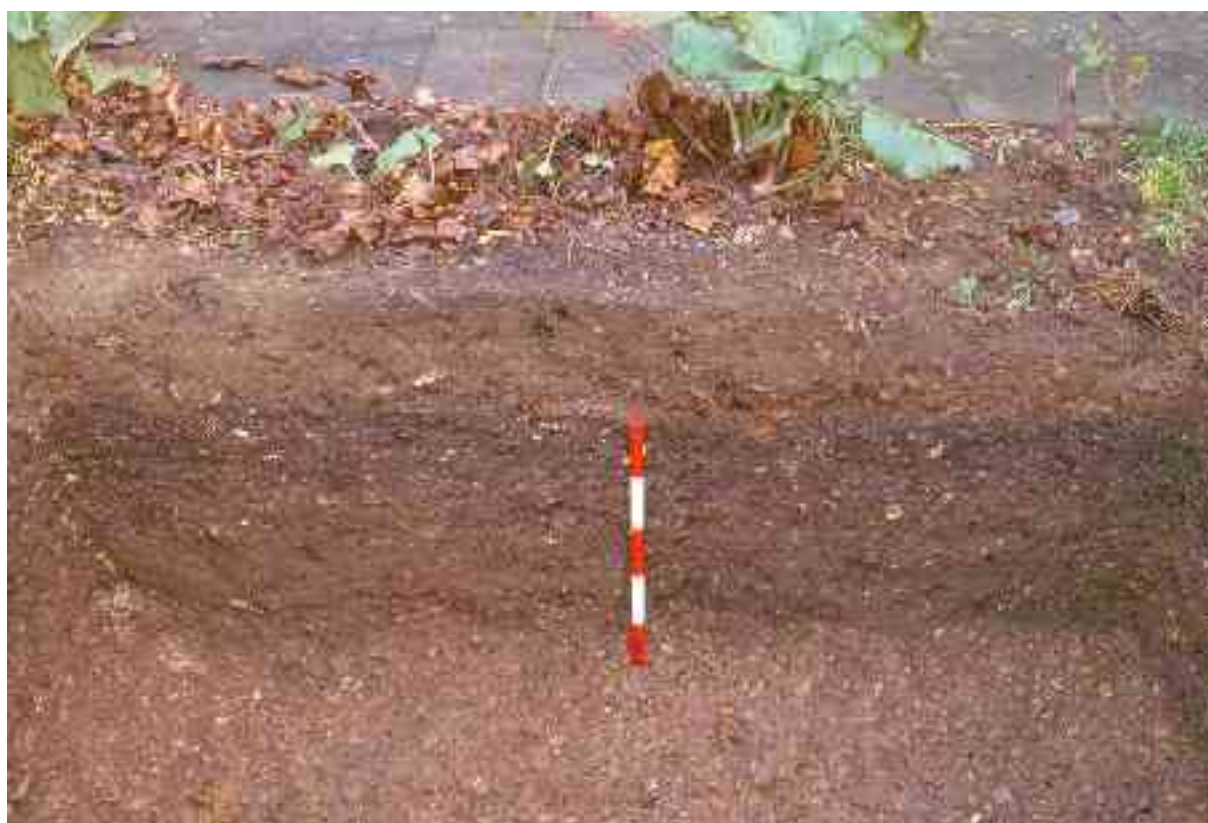
Fig 6 View of deposits shown in Figure 5

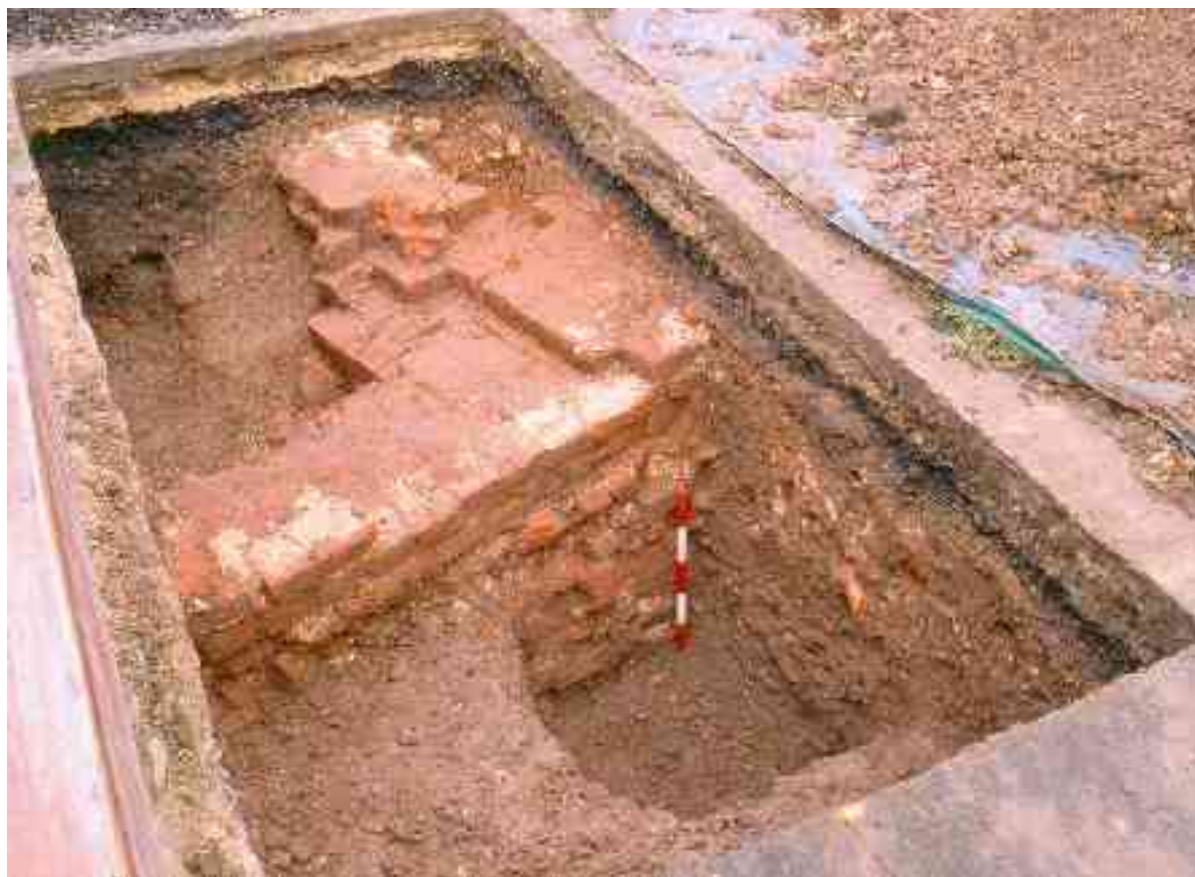
Fig 8 View of Trench 2, looking northwest (*50cm scale*)

The cut [12] contained a substantial brick wall base [8], built on the same alignments as the historic house (see Fig 2). The main section of the wall ran north-south, though to the north it either turned a corner or formed a junction to the west. A small (*c* 0.3m<sup>2</sup>) exploratory hole just outside the main trial trench failed to resolve this, although hand-auger boreholes undertaken during previous soil investigation just to the northwest do suggest that the wall continued (see concluding para. 3.2.2). Indeed, it is suggested that there may be a lower floor level or cellar in this area.

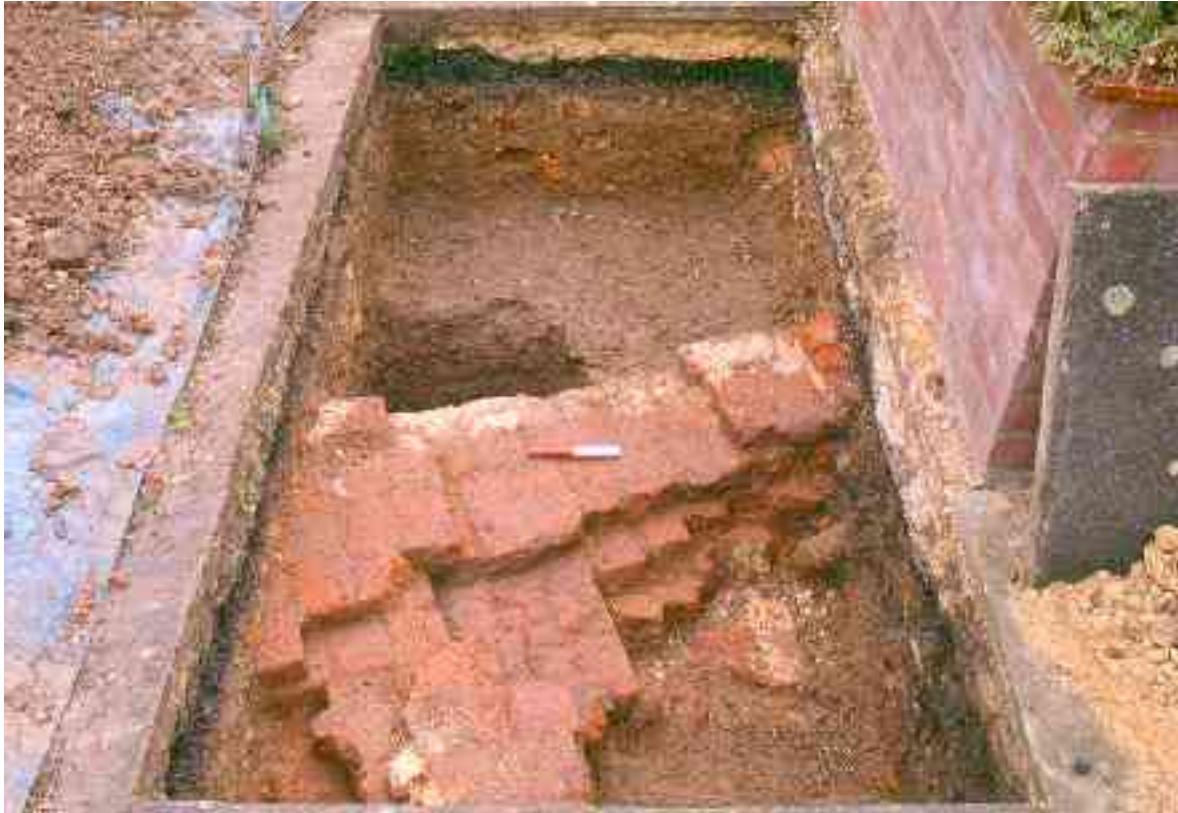
Fig 9 Further view of Trench 2, looking east (*20cm scale*)

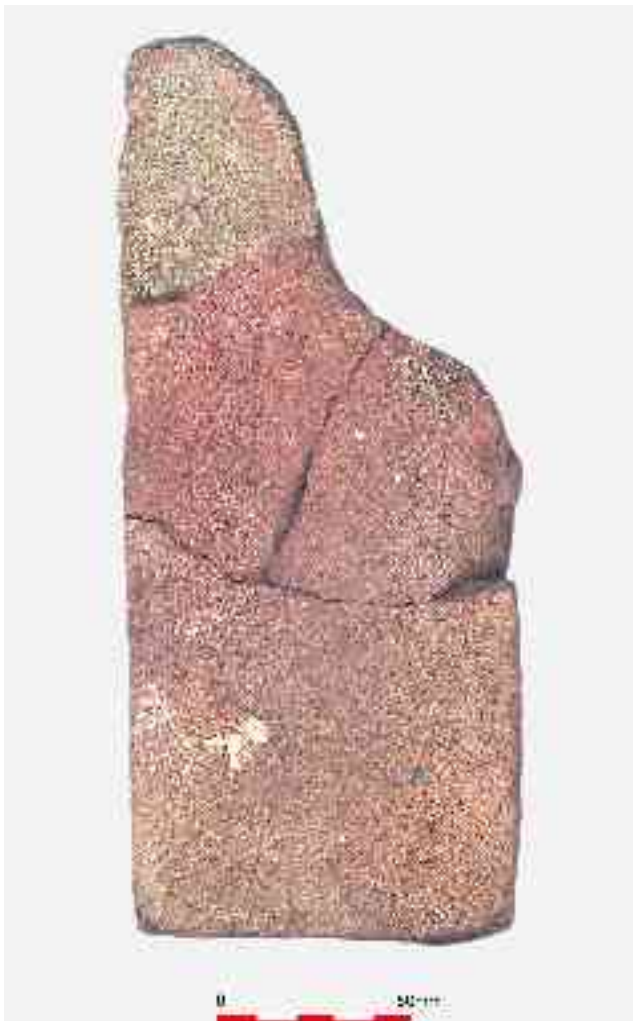
Fig 10 Reconstruction of a moulded brick removed from the lower part of the wall foundation [8]

Two of the brick samples from the foundation level were also moulded, and were evidently manufactured to form a decorative surround to a door, window or similar opening (Fig 10). As such the sample may well represent an original feature of the Elizabethan house, these particular bricks having been broken and discarded during construction.

The other two bricks are rather more interesting, as they have been made in an especially shaped mould prior to firing (Fig 10). Each brick has part of one corner replaced by a cutaway area. Such bricks are fairly common in the 16<sup>th</sup> and 17<sup>th</sup> centuries but shaping was more frequently done after the bricks were fired and had been mortared into position.

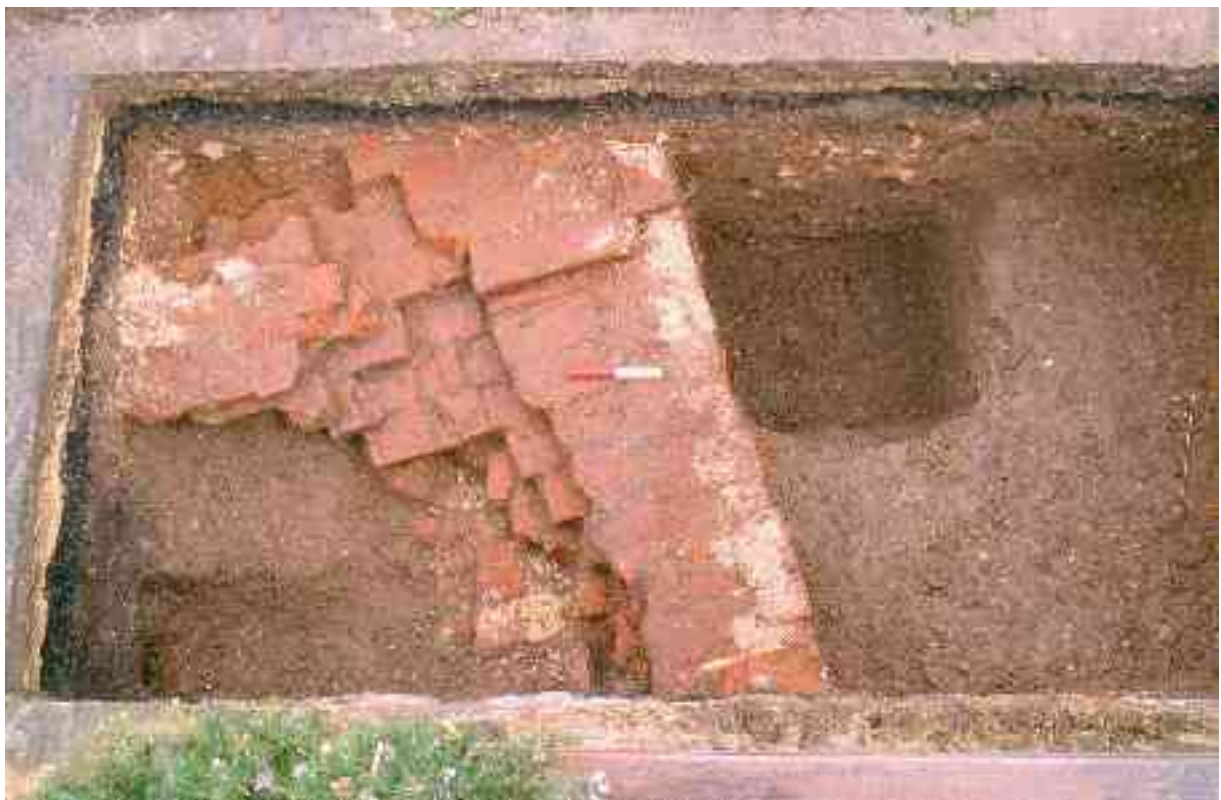
Fig 12 View of Trench 2 from above looking north, and including deposits shown in Figure 11 (*20 cm scale*)

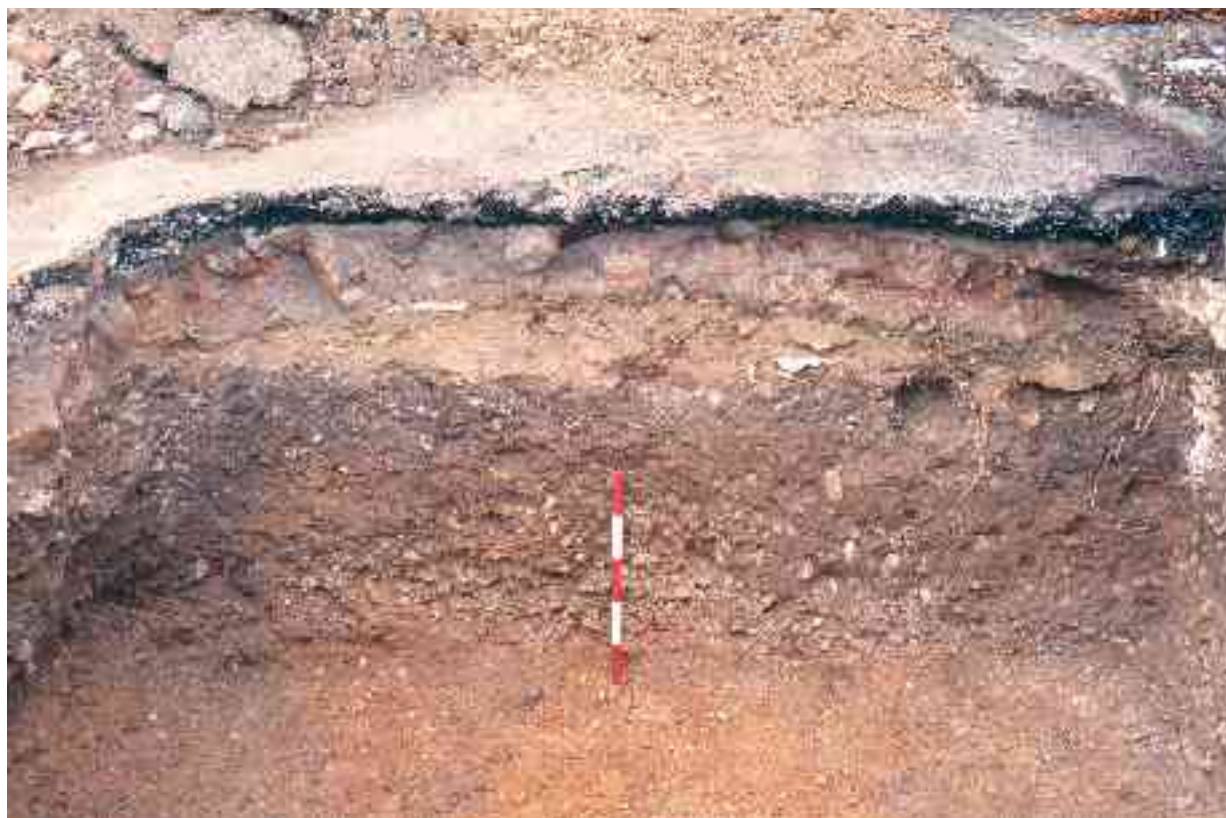
Fig 15 View of deposits shown in Figure 14 (*50cm scale*)

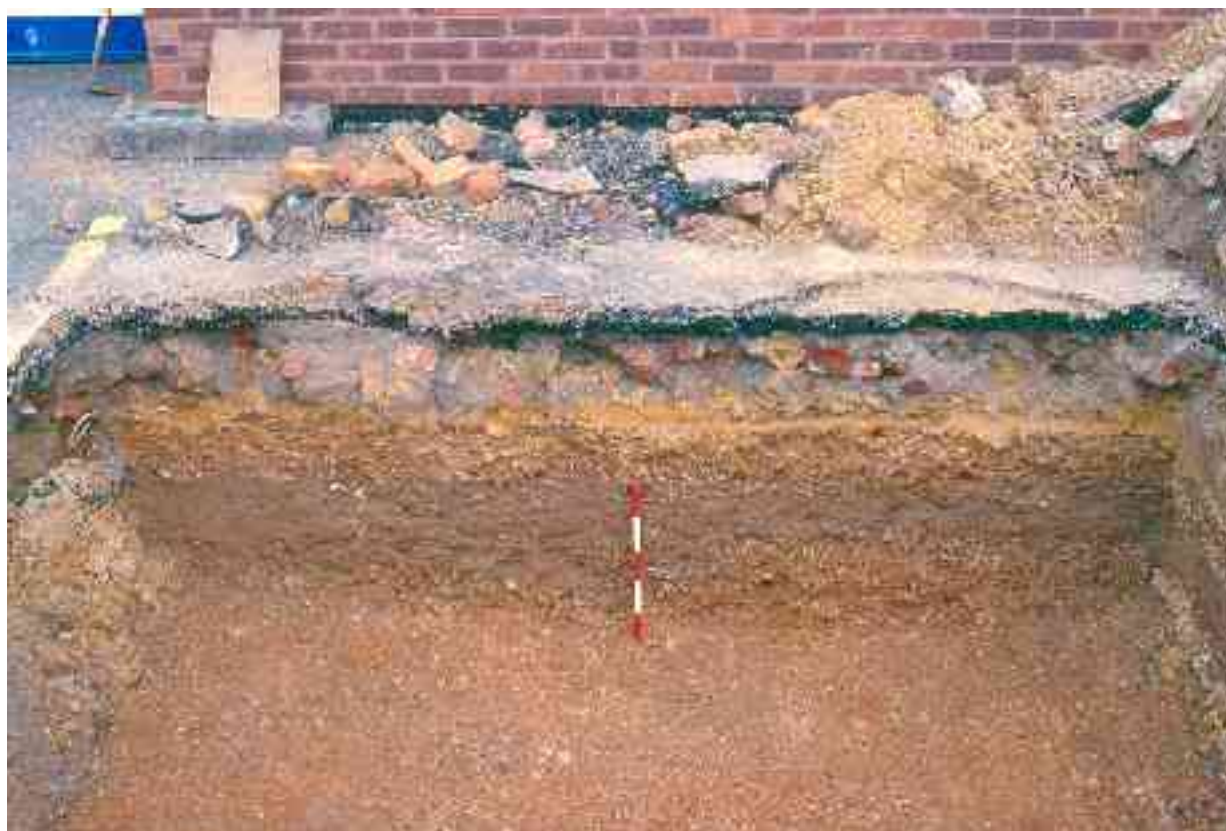
Fig 17 View of deposits shown in Figure 16 (*50cm scale*)

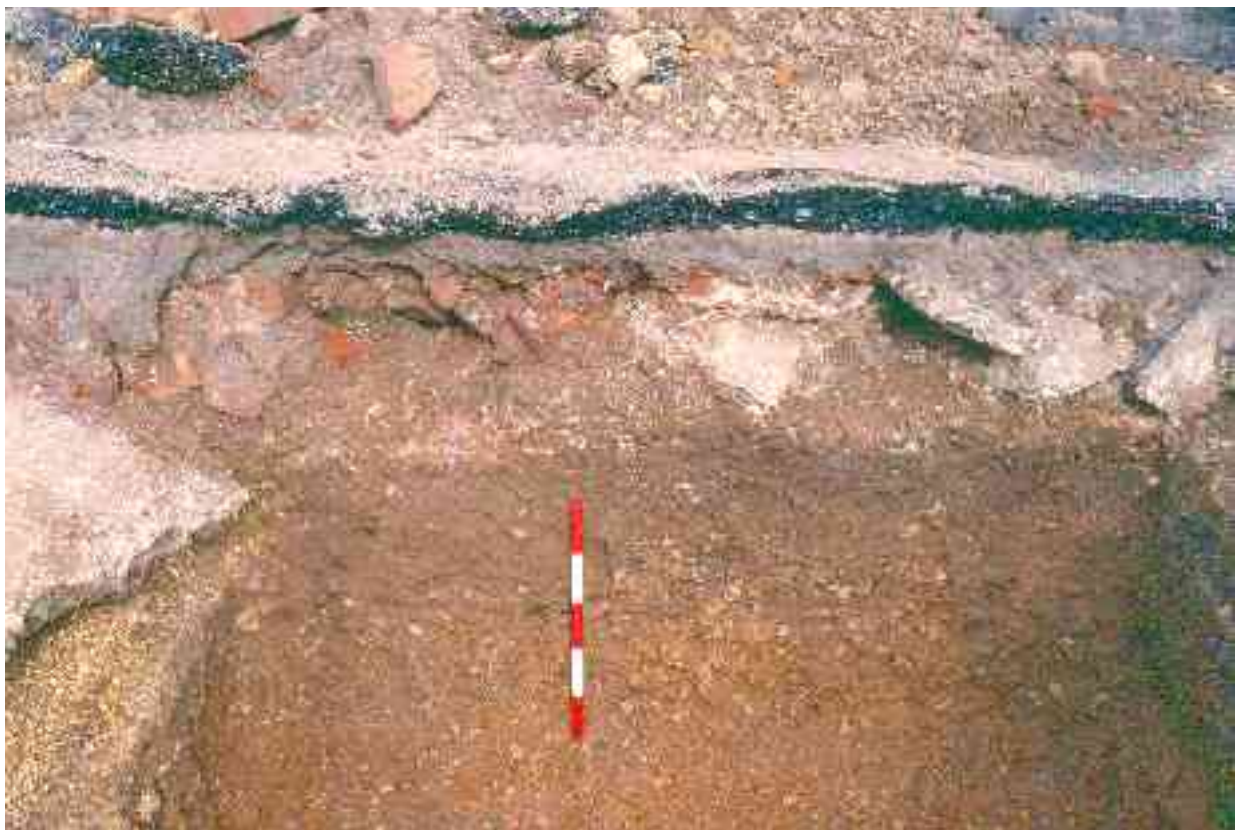
Fig 19 View of deposits shown in Figure 18 (*50cm scale*)
