**HISTORIC BUILDING APPRAISAL OF
195 HIGH STREET, EXETER**

Prepared for the Greggs PLC

Exeter Archaeology

Report No. 10.62

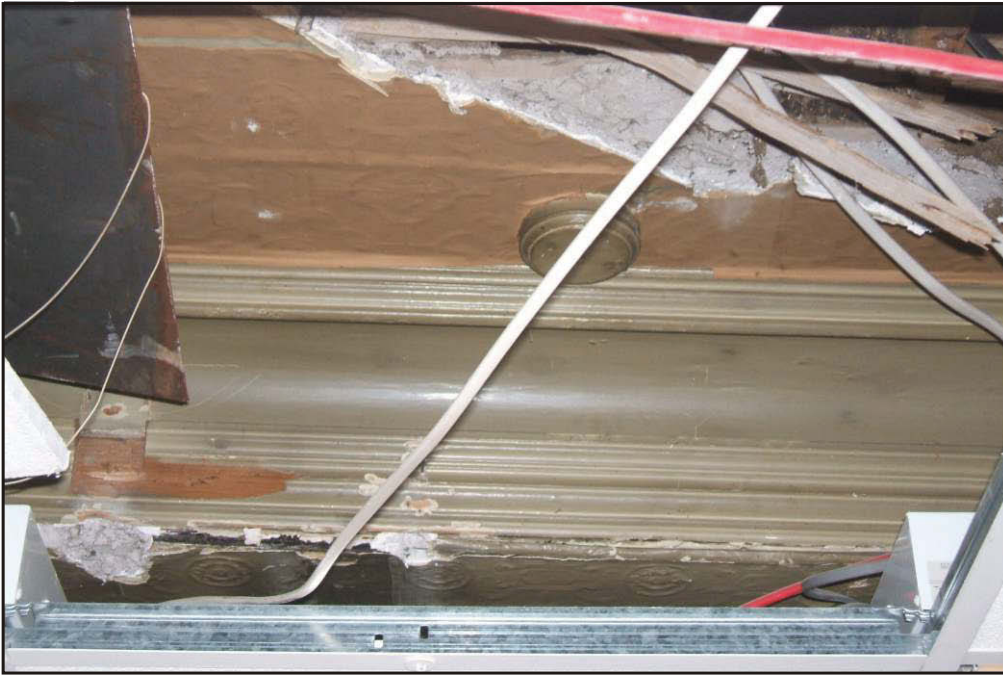
is a lath and plaster ceiling. In both rooms are the remains of a wooden cornice (Pl. 1), of unknown antiquity, but possibly fairly late (?19th/early 20th-century).

Plate 1 Ground-floor front room showing cornice above modern suspended ceiling, looking northwest.

Raising of the ground-floor suspended ceiling	Present modern suspended ceiling removed and new suspended ceiling inserted	None, but its removal will expose historic ceiling timbers and finishes
Raising of the basement suspended ceiling	Present modern suspended ceiling removed and new suspended ceiling inserted	Surviving historic floor joists above appear to be at different levels, and raising of the present ceiling level may affect these timbers at the front of the building
Removal of ground-floor partitions	Removal of ground-floor partitions	Generally no impact, but one partition, at least of 19th- or early 20th-century date, survive within the rear store
Removal of basement partitions	Removal of basement partitions	None – all partitions are modern
Removal of ground- and first-floor shop fittings and lining to exterior walls	Removal of modern shop fittings and lining to external walls and replacement with new linings	None, but removal will expose earlier panelling and potentially earlier fabric of the building

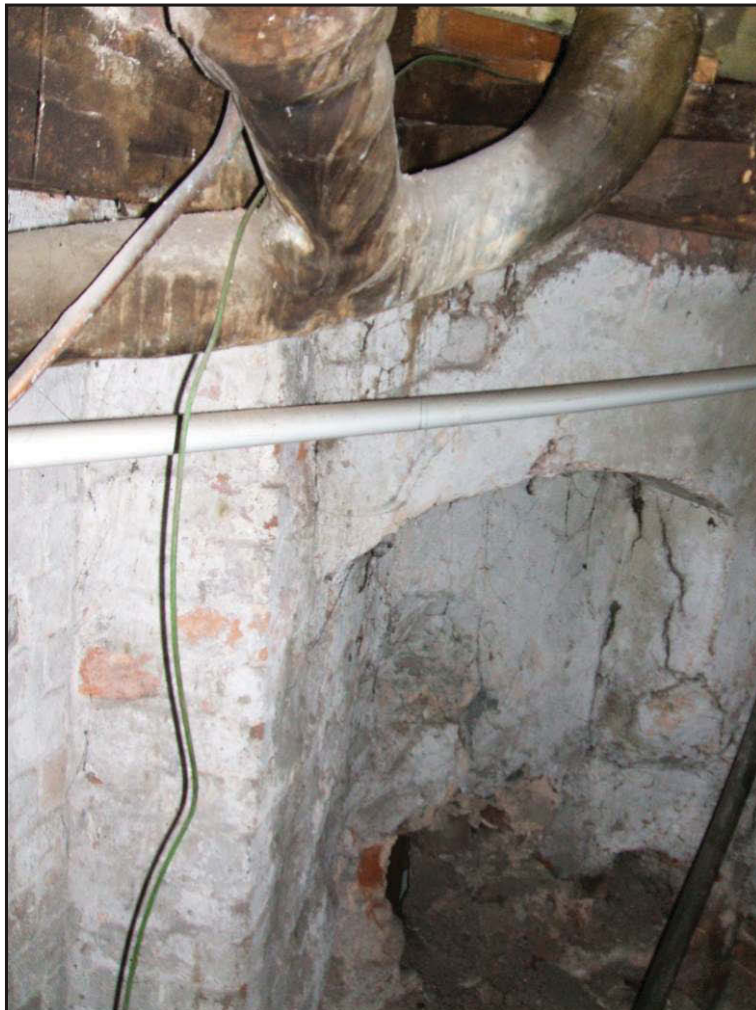
The upper floors are accessed by a very fine late 17th-century staircase. The lower section between the ground and first floors was replaced in the 19th century. At its base three steps lead up to a half-landing, where there is access to a store under the first-floor toilets (Pl. 2). Within this store are a number of features. In the south-west wall is a blocked opening (with timber framing and brick nogging) that may predate the position of the stairs in this location. In the north-east elevation is an arched opening, one side of which is angled towards the back of the building. This masonry also incorporates a blocked opening. To the west there is evidence of a break in masonry, but the structural sequence could not be established.

Plate 2 Ground-floor store behind the stairs showing arch and 'splayed' masonry, looking east.

Installation of the new stairs to the basement should allow the investigation of part of the party wall with 196 High Street, and the nature of below-ground deposits visible within the ground-floor rear store behind the stairs.

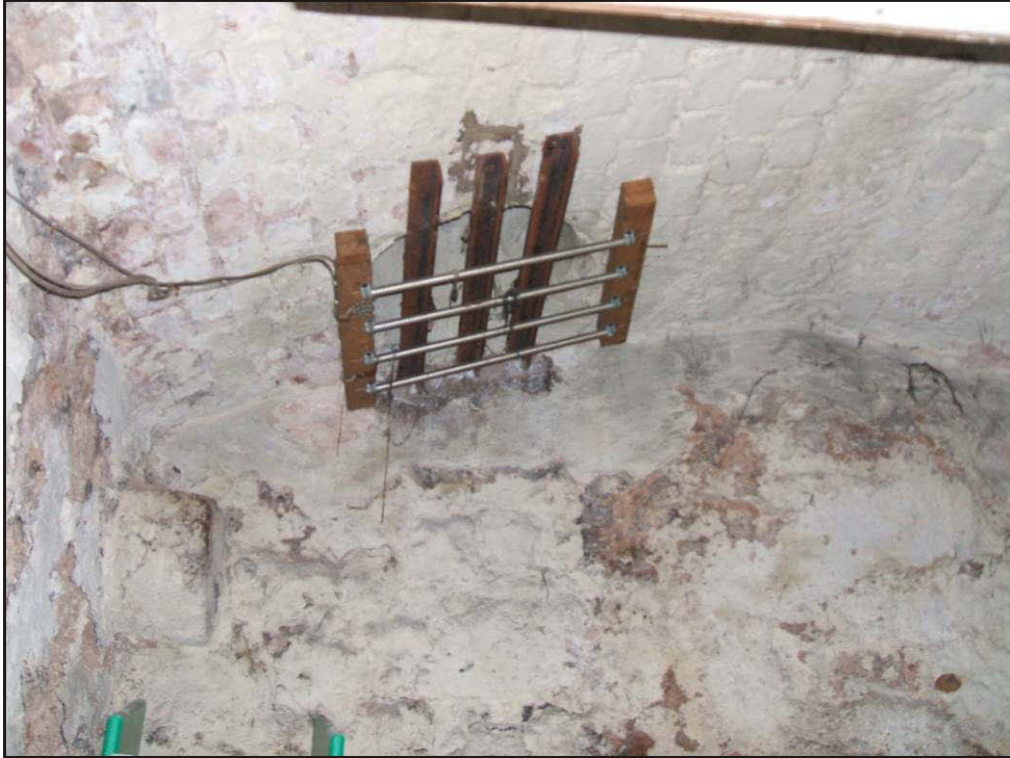
At the rear is a small store, constructed of stone with a brick vaulted ceiling (Pl. 3). This vaulting has been partially removed, and services have been taken through the side walls of the store.

Plate 3 Basement brick vault in rear store, looking northwest.

Alteration	Required works	Impact on historic fabric
New dumb waiter	Insertion of a dumb waiter from the basement to the ground floor, located within the rear store	Limited, or no, impact on basement ceiling, since at this location the vaulted ceiling has been removed
New drainage in Basement	Reusing of existing drainage	Possible impact on below-ground deposits or wall fabric, but full existing drainage runs in the basement obscured and was not investigated
New stairs to the basement (1)	Removal of lowest three treads of lower staircase	Removal of part of the 19th-century replacement staircase
New stairs to the basement (2)	Insertion of new stairs through a disused store.	Note shape of the store is not as regular as depicted on the architect's plans. Removal of some masonry associated with the party wall with 196 High Street, below-ground deposits (of unknown date), and drains will probably be required

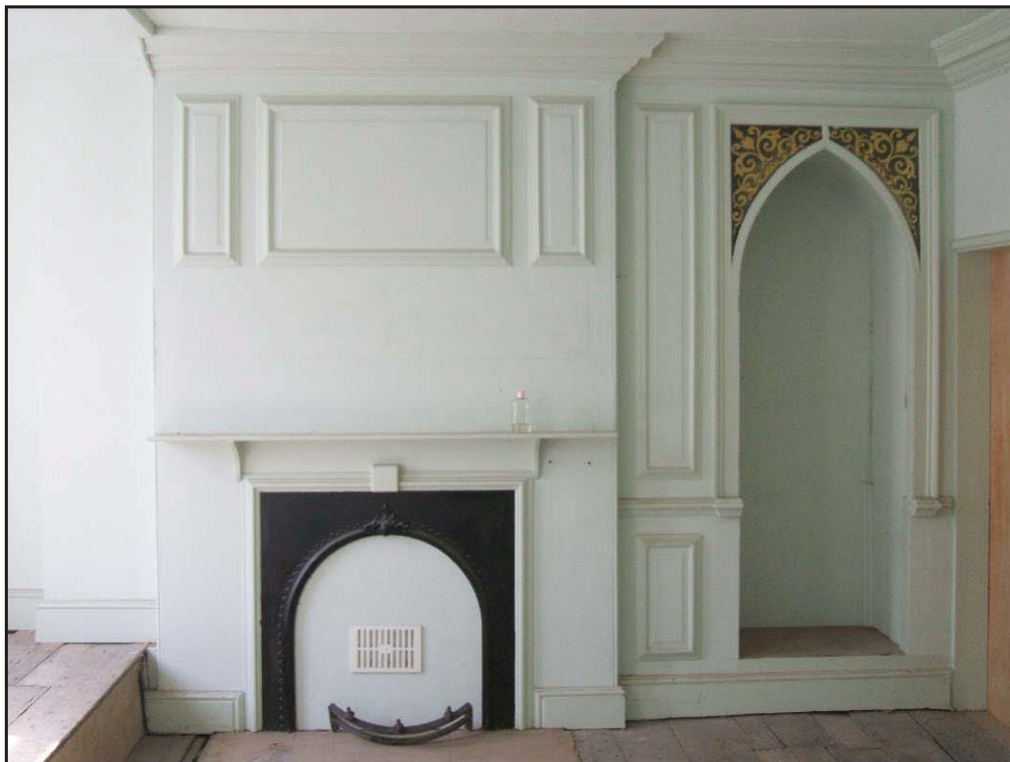
On the first floor the fireplace in the front room has been boarded up, but part of the 19th-century grate lies within the room (Pl. 4). The condition of this fireplace is not known but the removal of the grate may indicate this is poorer than in 1998.

Plate 4 First-floor front room showing fireplace, panelling and recess, looking southwest.

Installation of a new air duct	Installation of a new dir duct from the ground floor to the first floor, utilising existing fireplaces, and exiting through a rear window	Potential damage to 19th-century grates in fireplaces, but these are currently blocked and are not visible. Rear window is a modern replacement
