Land Adjacent to the Old Fire
Station, Hales Street, Coventry:

An Archaeological Evaluation,
2006

Project No. 1469

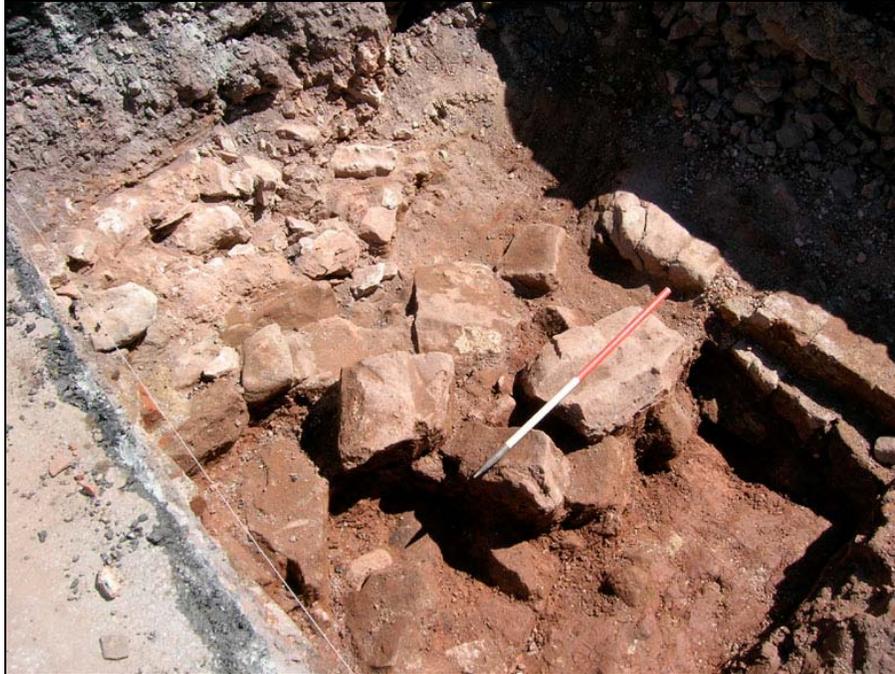
Plate 4 Core of the town wall

The rubble core of what appeared to be the town boundary wall were uncovered at a depth of 78.55m AOD. The footings followed a northwest-southeast orientation and comprised pieces of sandstone, which were loosely bonded with a lime mortar (1004, Fig. 13). Immediately to the west of the core of the wall was a tumble of stone identified as being the original facing for the wall (Plate 4). This comprised un-bonded dressed sandstone blocks varying in size between 0.3mX0.2m and 0.3X0.6m. The full width of the wall could not be ascertained due to the presence of live services immediately to the north of the trench. No datable artefacts were recovered from this feature.

Following the Restoration and despite the orders of King Charles II in 1642 to raze the walls of Coventry to the ground, some sections of wall survive on the ground today. The general construction of the wall (1004), with the sandstone being loosely bonded with lime mortar, concurs with the remains of the medieval town wall which are still standing. The location of the wall (1004) at the northern end of the trench suggests that its associated defensive ditch, which would have been on the outer side of the town circuit, may still survive to the north of the trench. However, due to the presence of live services here it was not possible to excavate this area. The alignment of the wall did, however, line up well with the scarring visible on the Swanswell Gate on the opposite side of Hales Street.

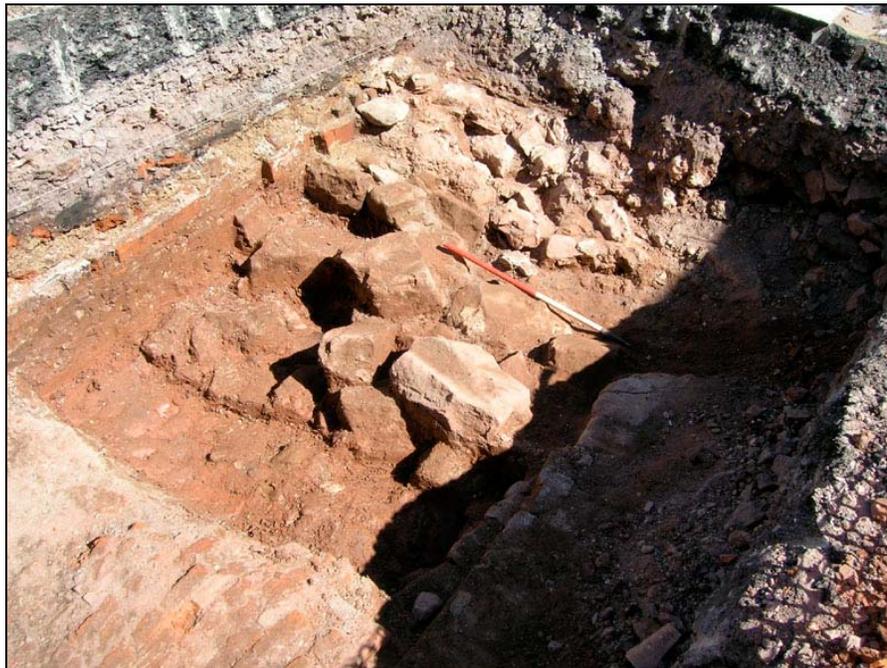
Plate 5 Levelling layers associated with the early-mid 19th century building

The wall was sealed by a compact red-brown clay-rich levelling layer (1008, Fig. 13 and Plate 5), measuring 0.5m in depth and containing fragments of sandstone, brick and charcoal. Artefacts recovered from this layer included pottery dating from the medieval period to the mid-19th century (see Rátkai below), as well as animal bone, snail shells and tile. This layer probably represents a levelling layer for the later floor surface visible in the section on Plate 5.

The range of pottery collected from the early levelling layer (1008) is interesting in that there was nothing later than the mid-19th century, which suggests that the surface was associated with the building that is depicted on the Coventry Board of Health Map of 1851, which therefore predates the Fire Station.

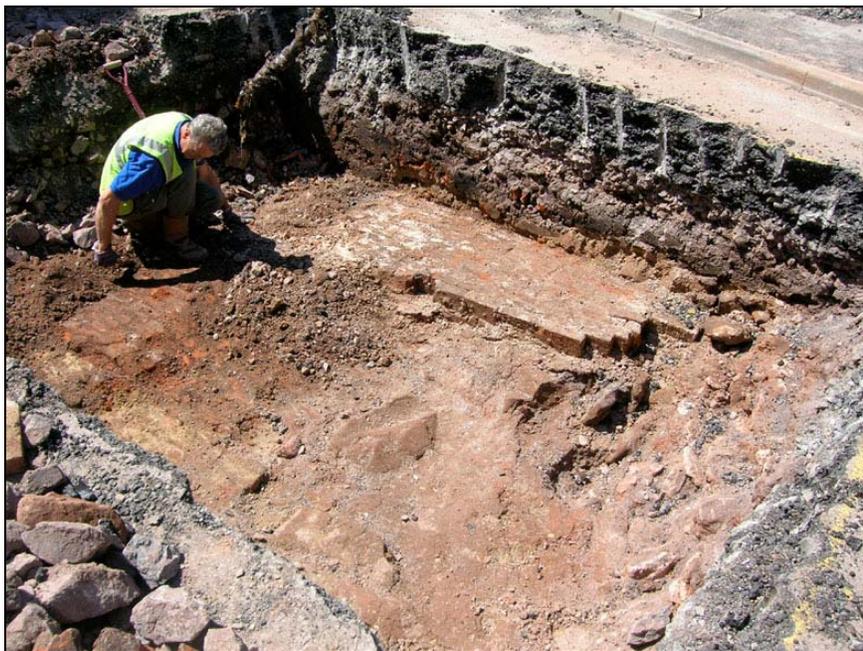
Plate 6 Floor surfaces associated with the early-mid 19th century building

The line of the medieval wall was cut by a later wall (1009) on a north-south alignment. The footings for the wall was made up of two courses of sandstone, which were probably reused stone robbed from the medieval wall. This formed the foundation for a brick wall (1005), which survived up to two courses high. It was constructed from bricks measuring 0.23mX0.12m. To the west of the wall were the remains of a brick floor or yard surface (1007 and 1003, Plate 5). Both areas of floor (1003 and 1007) overlay levelling layer 1008 and were in turn sealed by a very mixed layer of demolition material (1006) measuring 0.22m in depth. These archaeological layers had all been sealed by a dark brown levelling layer (1002), which measured 0.24m in depth, and had been cut towards the eastern edge of the trench by a modern service trench. A compact layer of scalplings (1001), measuring 0.22m in depth served as the support for the modern tarmac surface (1000), which measured 0.3m in depth (Fig. 13).

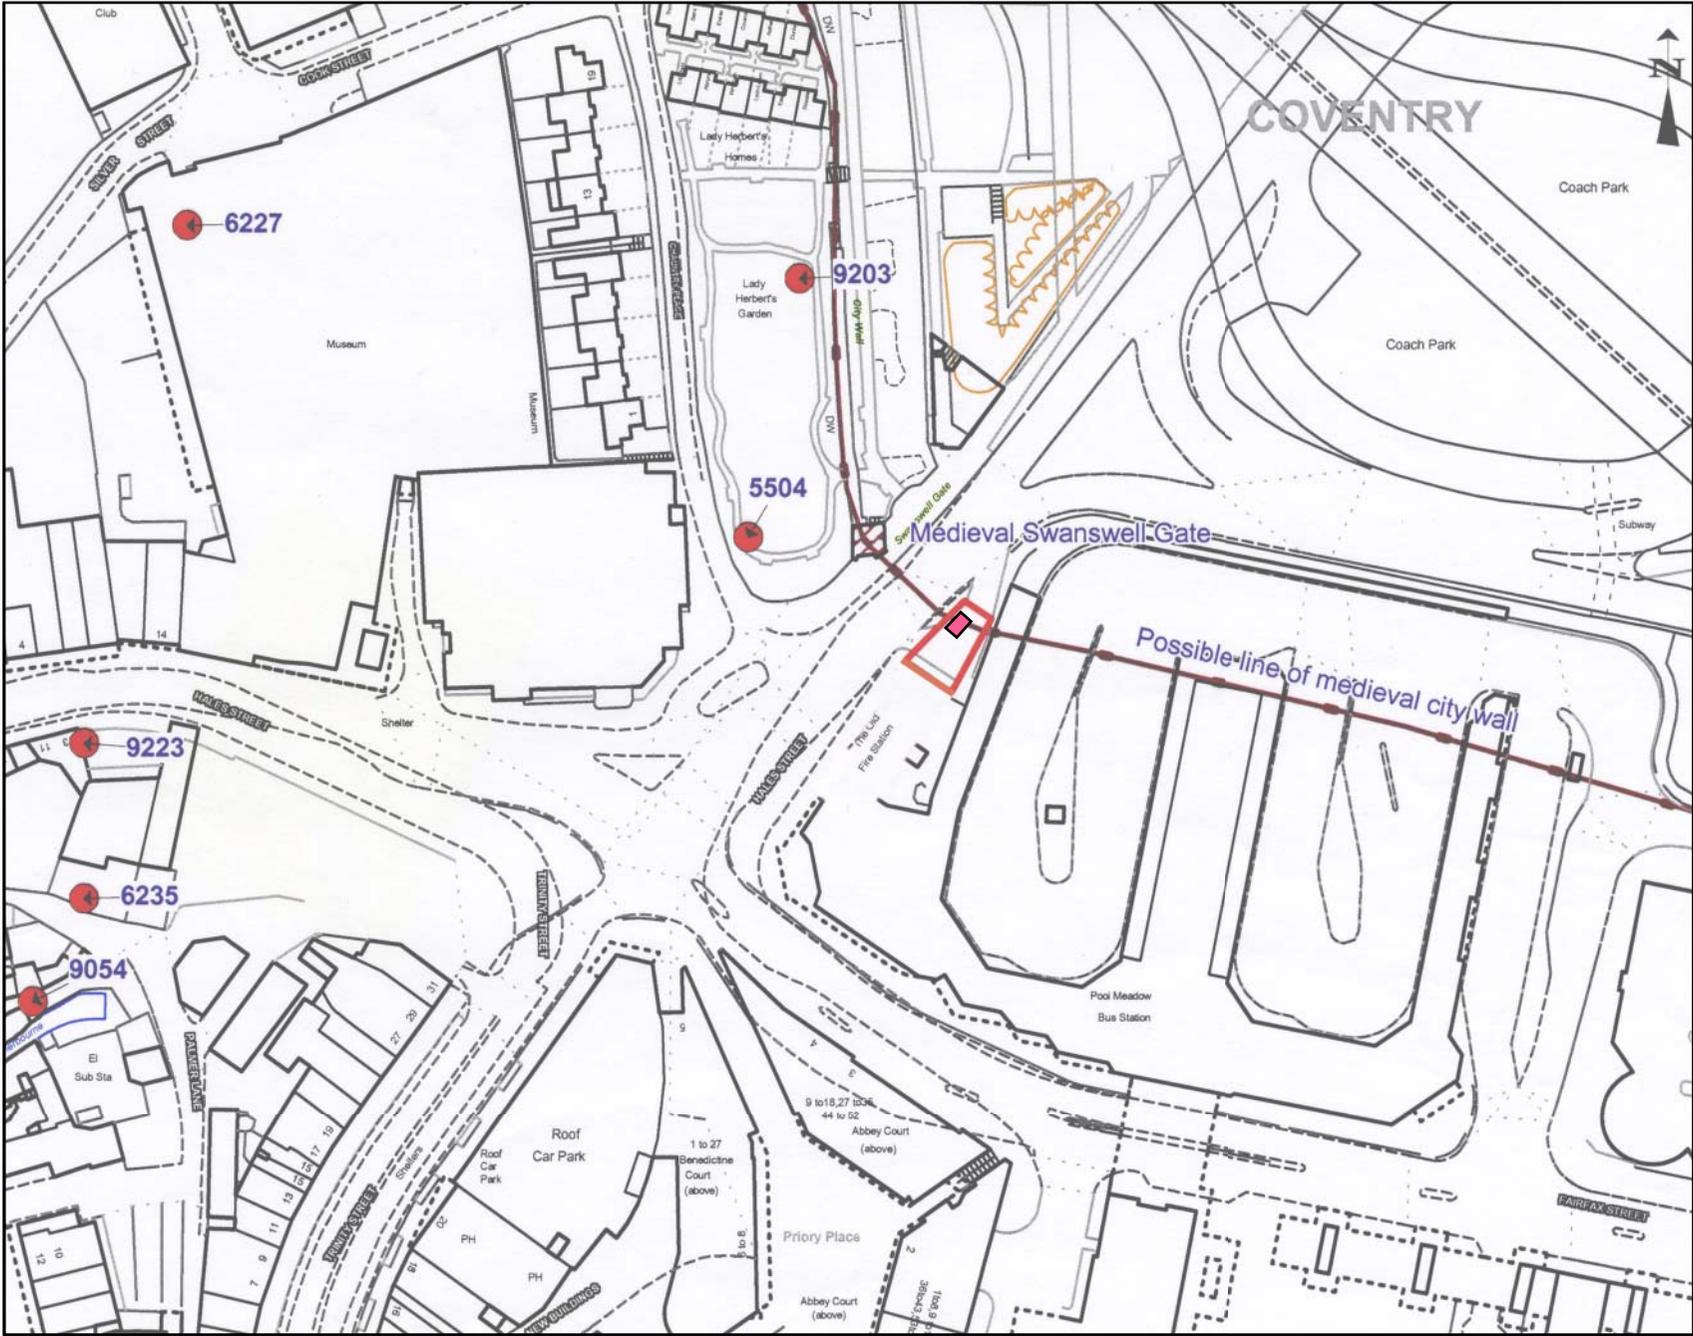
Fig.2

Excavations in the immediate vicinity of the site were undertaken as part of Coventry's Millennium Project (The Phoenix Initiative) these are reported upon elsewhere (Rylatt and Mason 2003). Other sites of interest held on the City's Historic Environment Record (Fig. 2) include the site of St Agnes' well (SMR 6227) which is reputedly said to have had healing properties, Palmer Lane Bridge (SMR 9223) believed to have 15th century origins, and the site of the Priory Mill (SMR 9054). Significant artefactual finds in the locale also include a fragment from a Saxon Cross shaft (SMR 6235).

A single trench was excavated, measuring 4m by 2.8m (Fig. 2), this was smaller than originally planned, but all changes to the brief were made in consultation with the City Planning Archaeologist. The ditch was orientated north-south in order to intersect the line of the town wall and ditch as indicated by the wall scar on Swanswell Gate tower to the north-west. All topsoil and modern overburden were removed using a JCB mechanical excavator with a toothless ditching bucket, under direct archaeological supervision, down to the top of the uppermost archaeological horizon or the subsoil. Subsequent cleaning and excavation was by hand.

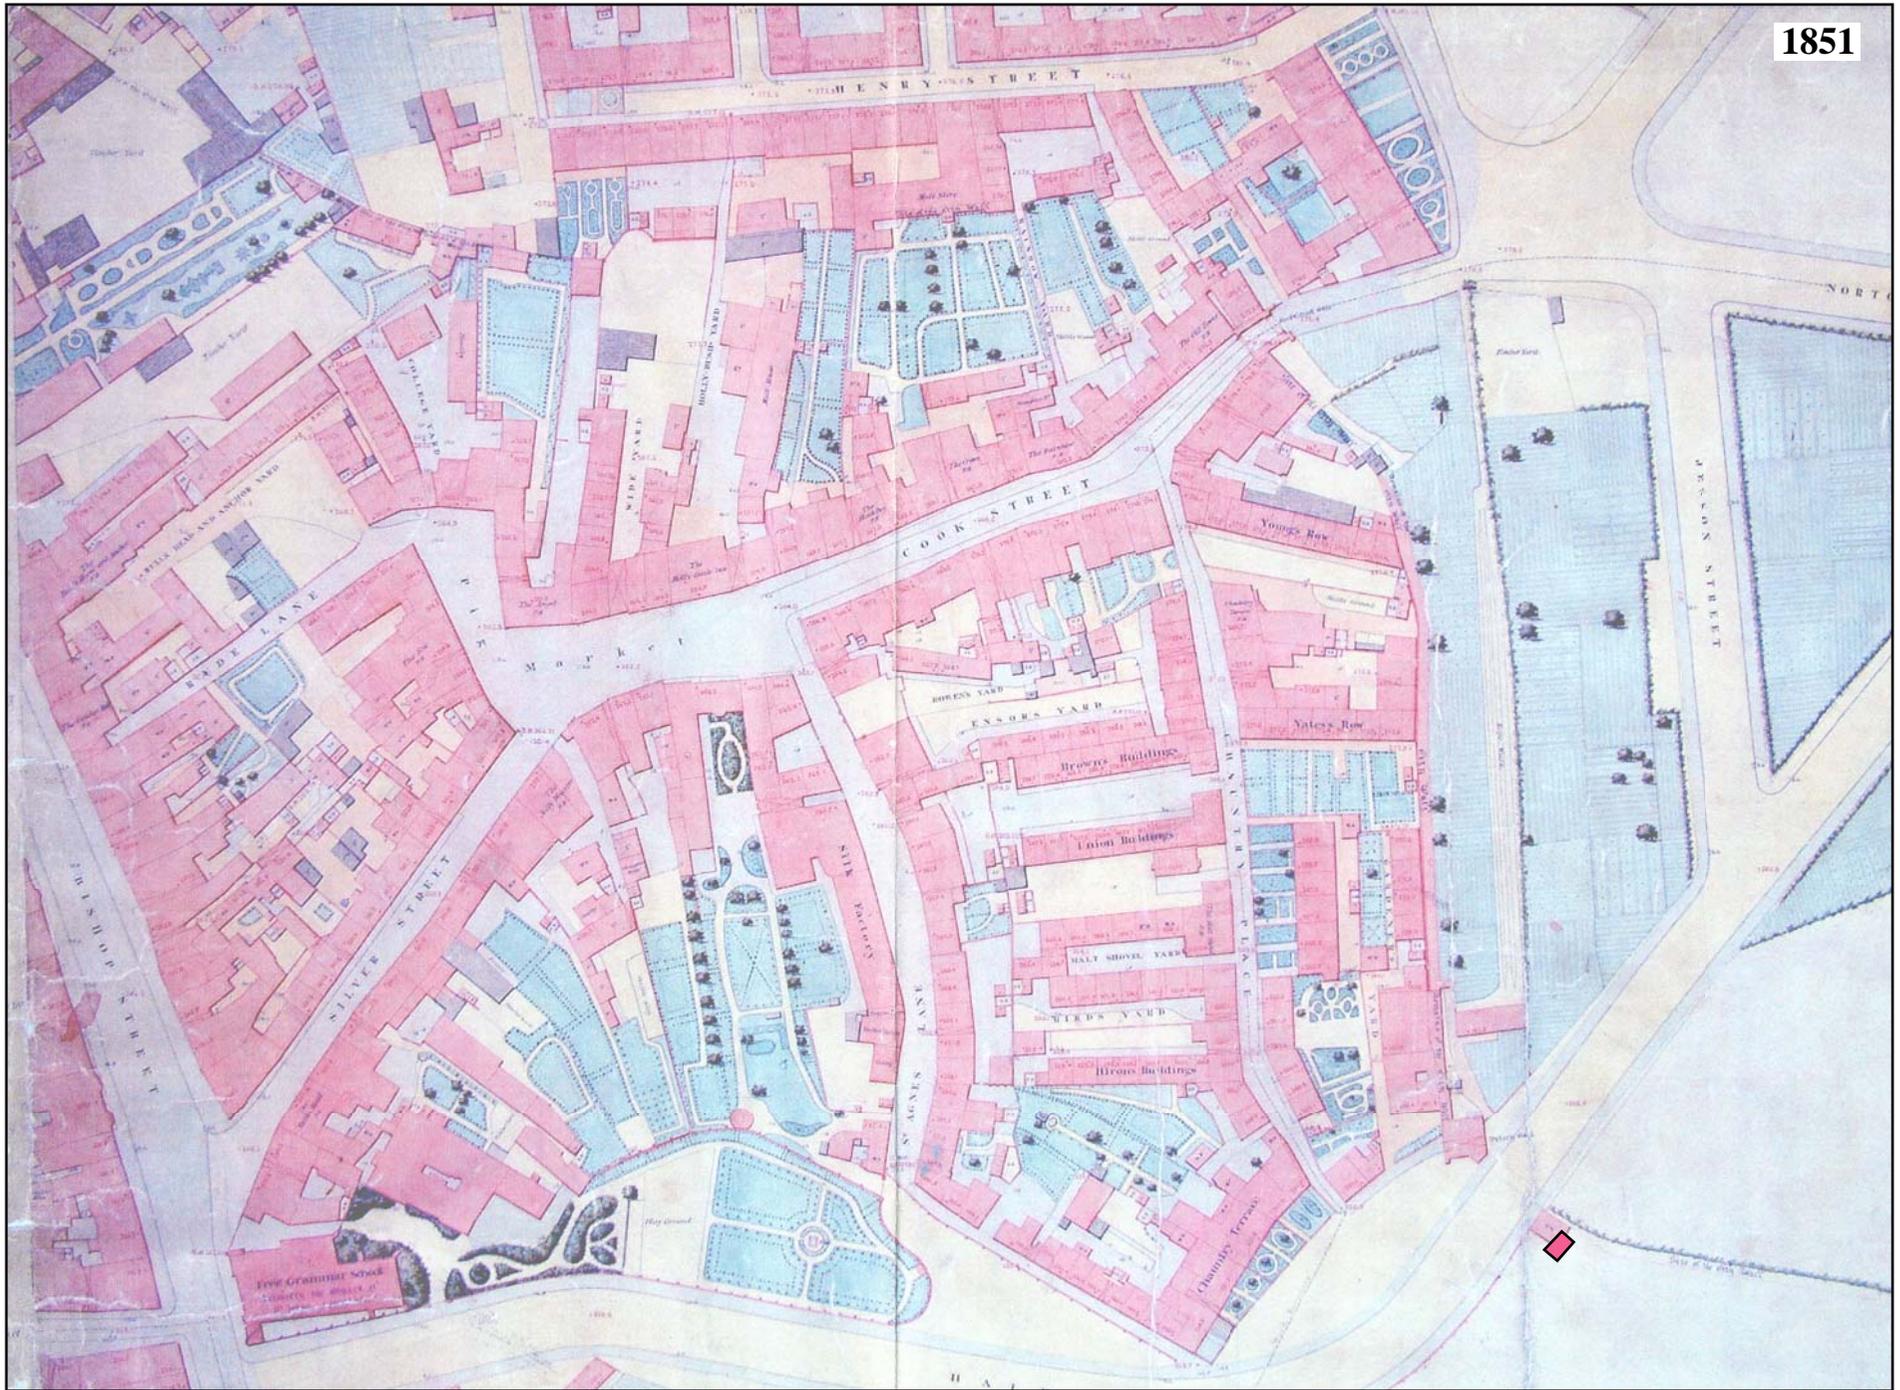
Fig.5

Hales Street itself was laid out in 1848-50; it bypassed the gate which presented the opportunity of blocking the archway and incorporating the monument in a private residence (Demidowicz 2003, 51). Land in the area was subsequently sold for housing, however, stipulations were made by the Trustees of the Thomas White's Charity that any proposed development must have 'uniform elevations and must each cost not less than £300' (VCH 1969, 150). The Coventry Board of Health Map (dated 1851) depicts the area of the site as being undeveloped. However, the Swanswell Gatehouse is shown, with a corresponding building on the opposite side of the road, and the original line of the town boundary ditch is annotated (Fig. 5).

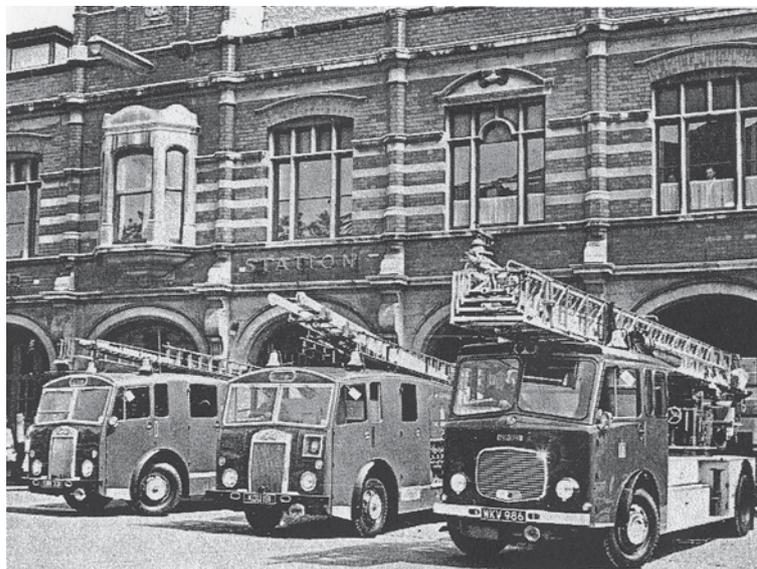
Plate 3

The Fire Station building was extended in 1934, increasing the number of appliance bays from three to six, and adding to the quarters available over them (Anon 1961, 13). It was built to replicate the earlier building exactly (Plate 3). By 1936 Chantry Terrace, on the opposite side of the road to the study area, had been replaced by the Hippodrome Theatre (Fig. 9), and the Fire Station itself is shown as a continuous building along the frontage, following its earlier extension to the north. In the post-war period the site of the original Hippodrome was landscaped with gardens and a pond (1950 Ordnance Survey Map, Fig. 10), possibly due to bomb damage during the Coventry Blitz. By 1959 the Hippodrome Theatre had become the Coventry Theatre, and Trinity School was being used as warehousing (Fig. 11). The area of the study area was therefore not affected by the post-war rebuilding of the City.
