Land to the Rear of
Draper's Hall,
Coventry

Archaeological
Evaluation
2008

Project No. 1767

**LAND TO THE REAR OF DRAPER'S HALL, COVENTRY
ARCHAEOLOGICAL EVALUATION 2008**

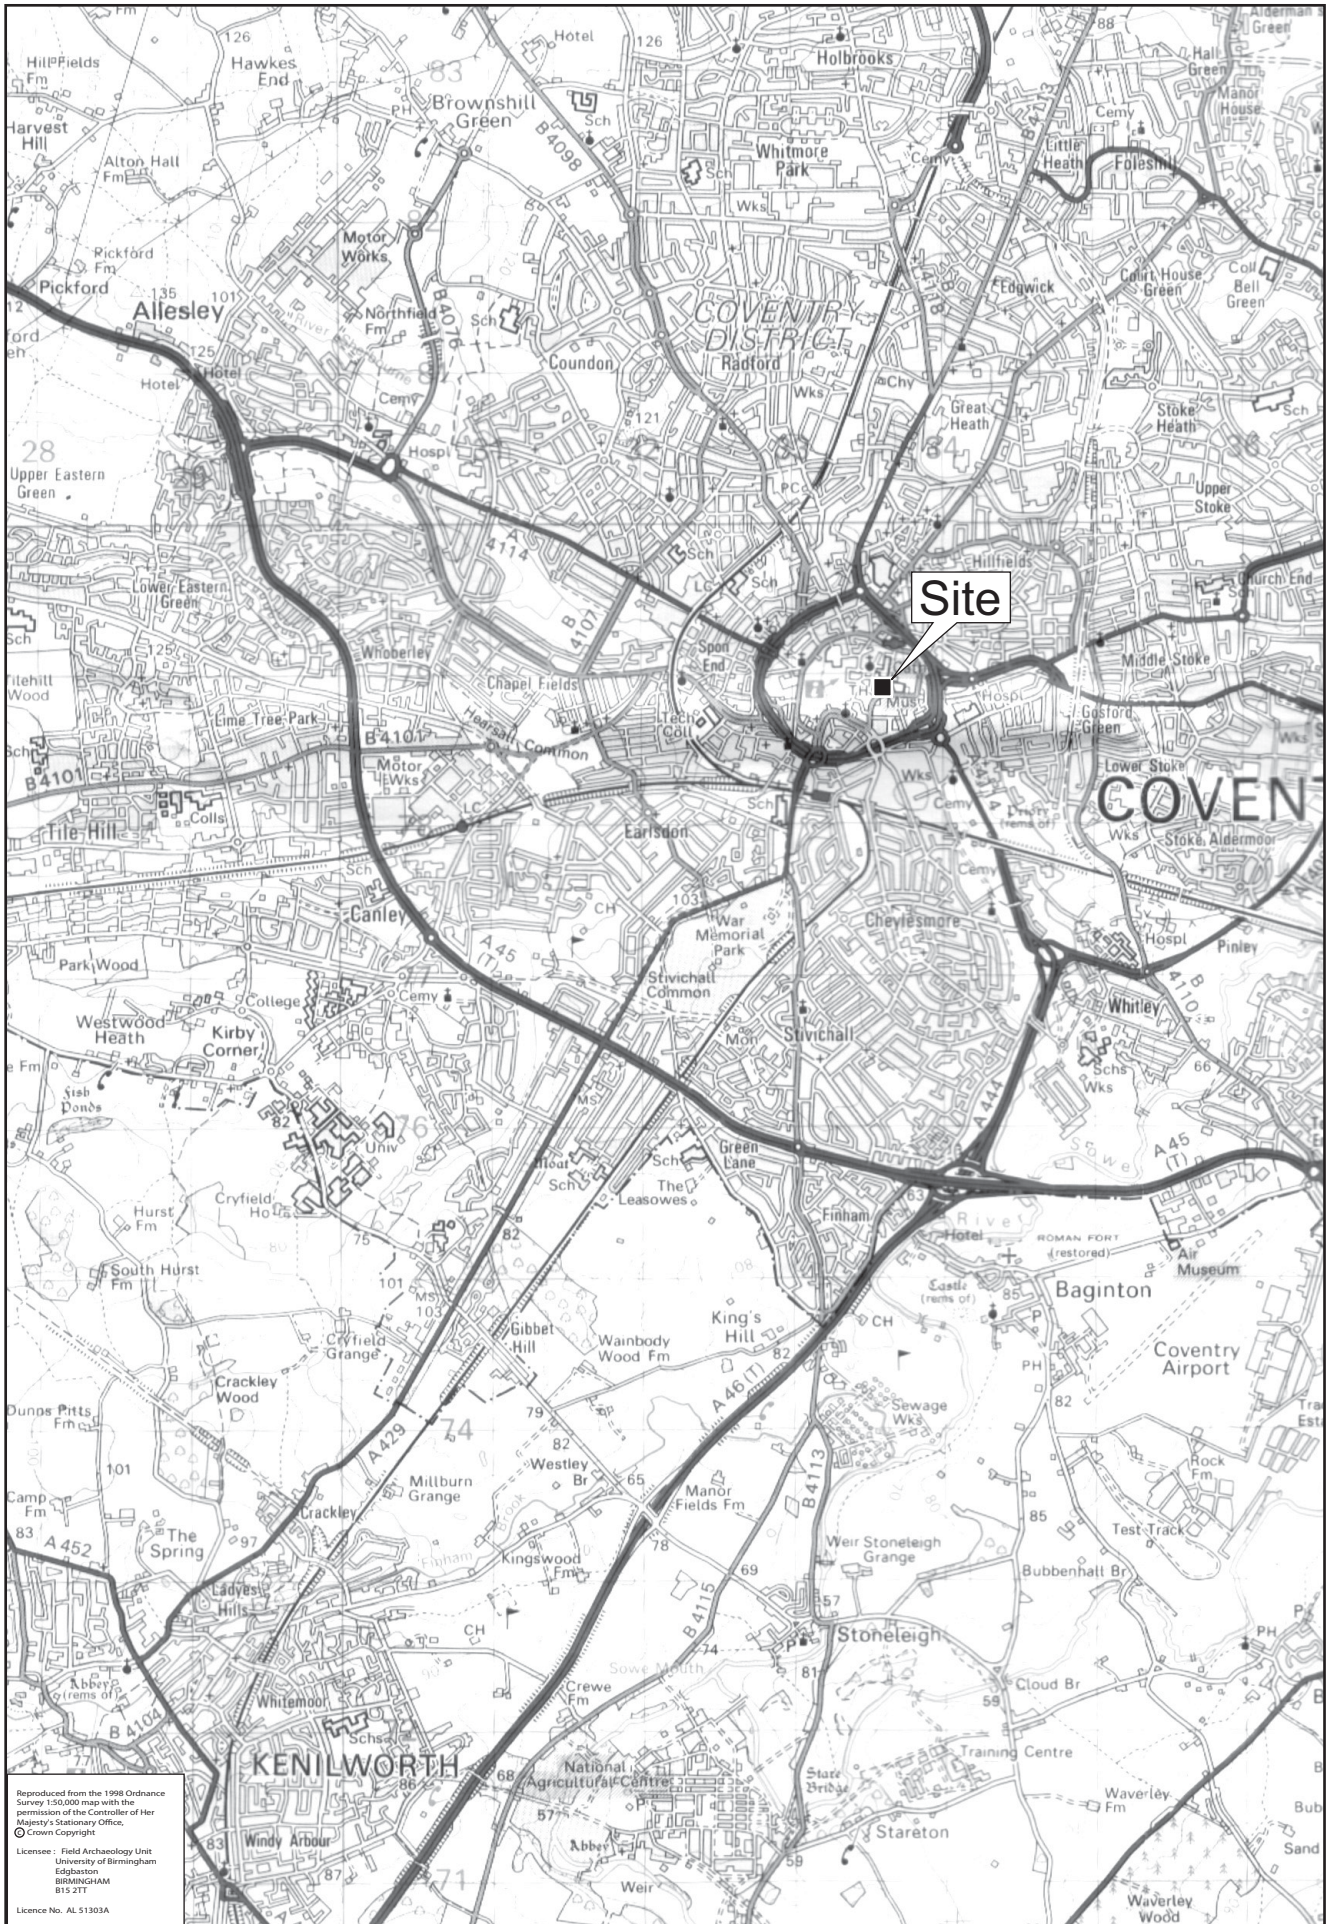
Fig.2

Figure 2: Site location plan

The site is located near to Coventry City centre, and is centred on NGR: SP 3362 7892 (Fig. 2). The site is currently a landscaped public garden and is bounded to the east by Bayley Lane, by Brown's restaurant to the south, by St. Mary's Street to the west and Draper's Hall to the north (Fig.3).

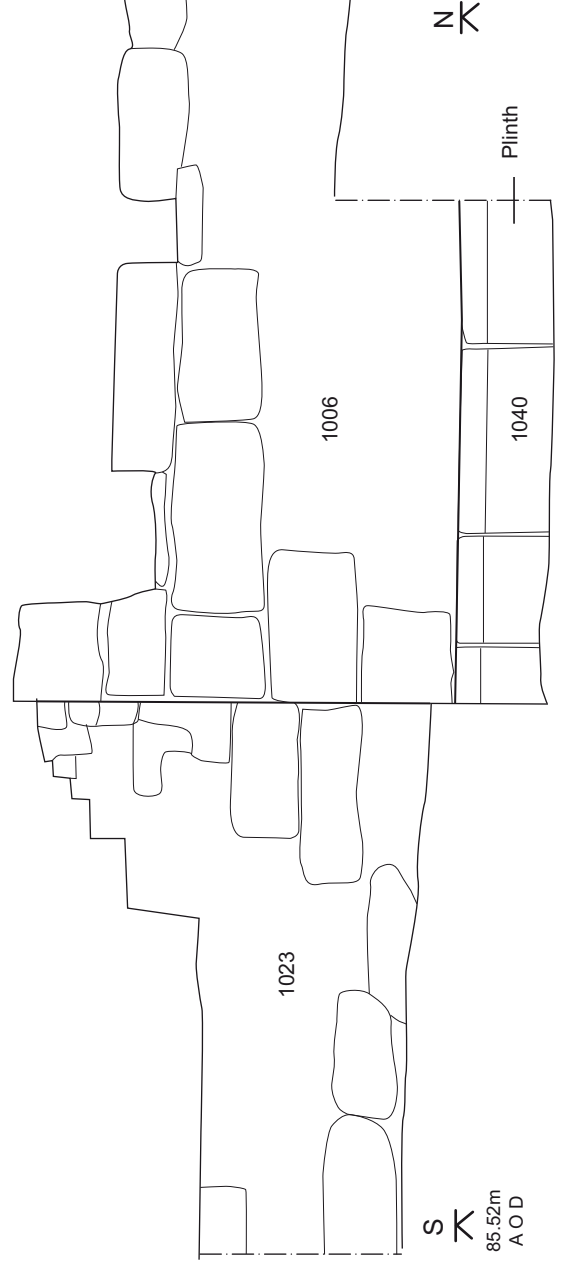
Fig.6

Figure 6: Wall elevations

The stones comprising wall **1041** (Fig. 6, Plate 7) were abutted by a layer of mid grey-brown silty clay sand **1036**. In order to determine the earliest stratigraphic sequence in the southern most area of the site, an auger was used. It was apparent that layer **1036** and possibly sandstone wall **1041** were overlying a dark grey organic deposit (**1043**). The deposit appeared to be between 0.70-0.90m in depth and was overlying reddish clay **1044** which may represent lining of a water filled feature, perhaps a ditch or moat. The possible base of the organic deposit was detected at a depth of approximately 4.05m below the level of the topsoil. The aforementioned layer (**1036**) overlay the waterlogged deposit (**1043**) and was between 0.20 and 0.38m in depth. Layer **1036** was overlain by a very thin layer of yellow sand **1035** which an east-west aligned brick floor surface (**1031**) had been set onto. The surface was two bricks wide with two other rows of bricks slumping sharply to the south that suggests disturbed underlying ground conditions. The hand made red bricks measured 10 x 4.25 x 2.50 inches in size and may indicate post-medieval cellaring activity. The floor surface was sealed by a levelling layer (**1015**), which was comprised mainly of mortar and contained a large number of clay pipe bowls and stems probably dating to the late 18th century and fragments of an onion bottle dating to the late 17th century.

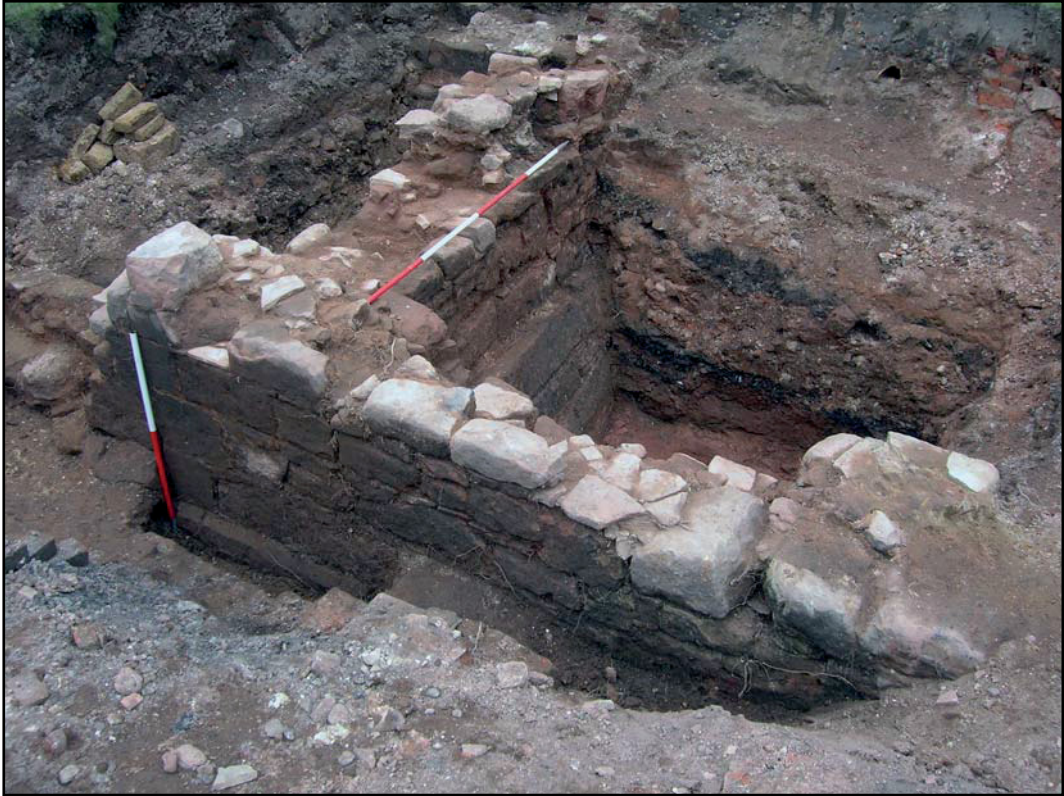
Plate 3

Another layer of sandstone building rubble (**1014**) overlay layer **1025** and produced brown glazed pottery and a large amount of tile. It measured 0.55m in depth and represented the latest in the sequence of building rubble layers which had accumulated up against the medieval sandstone walls **1040** and **1006** (Plate 3).

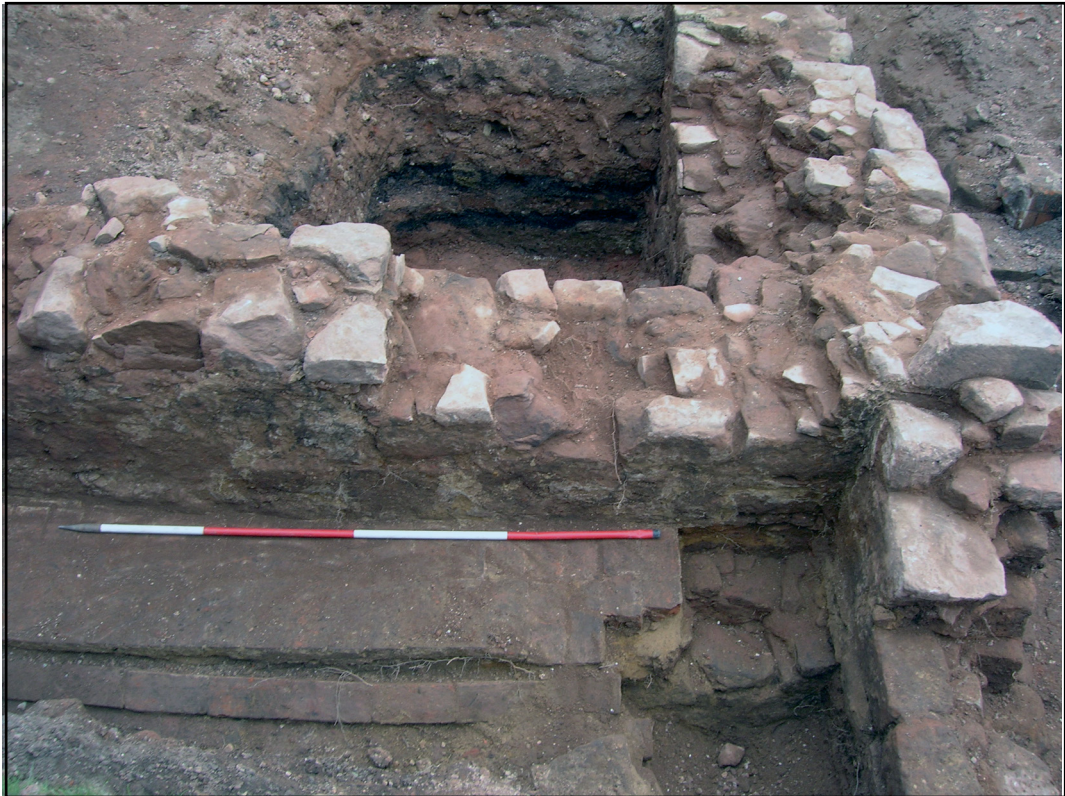
Plate 7

The length of the southern wall which was exposed measured 4.50m, the wall had probably survived to the west beyond the edge of the excavation. It was comprised of large sandstone blocks, the most substantial measuring 1.10-1.40m in length by 0.26m high. The length of the exposed eastern wall was approximately 3.20m and probably survived further to the north outside the limit of the evaluation trench. The sandstone blocks forming the eastern side of the structure measured between 0.30-0.50m in length by 0.26m and the stones of the east facing side were noticeably well faced (Plate 7).

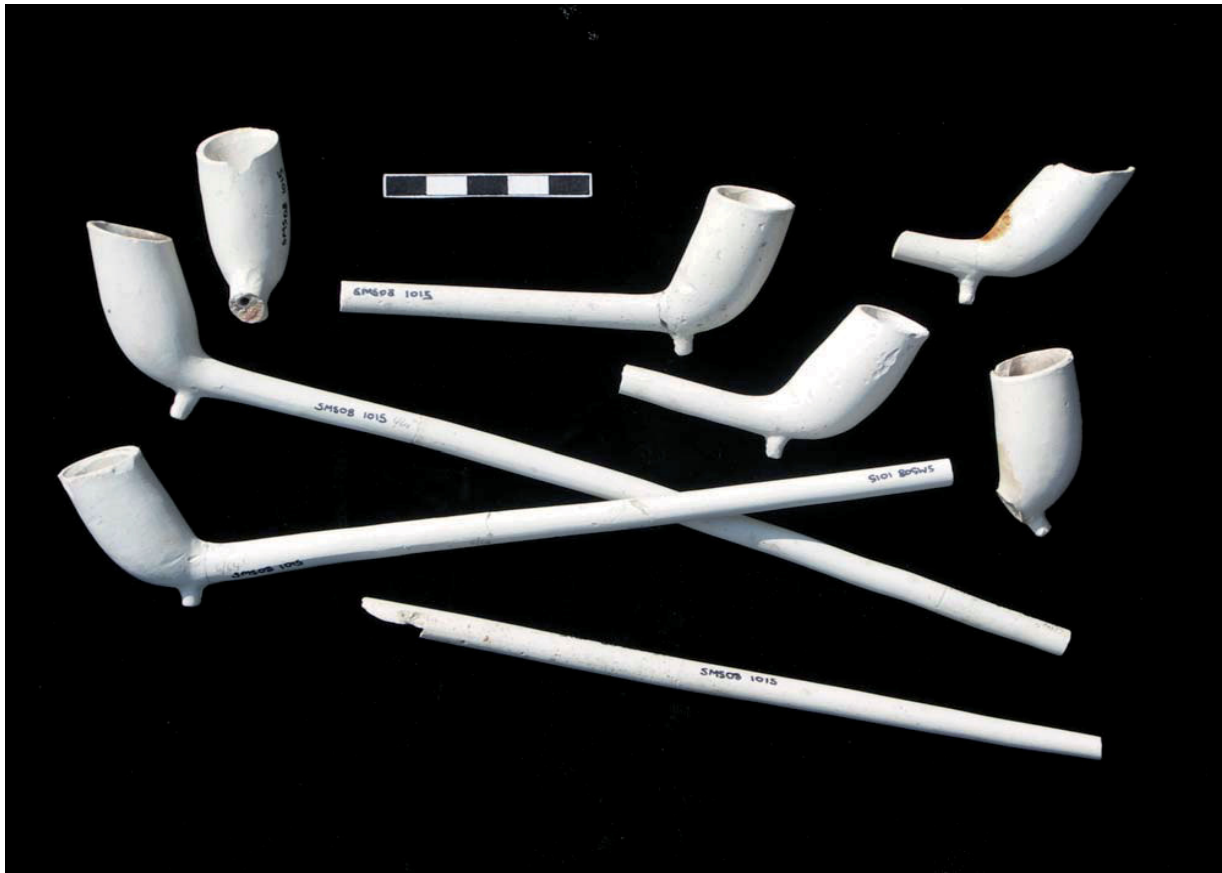
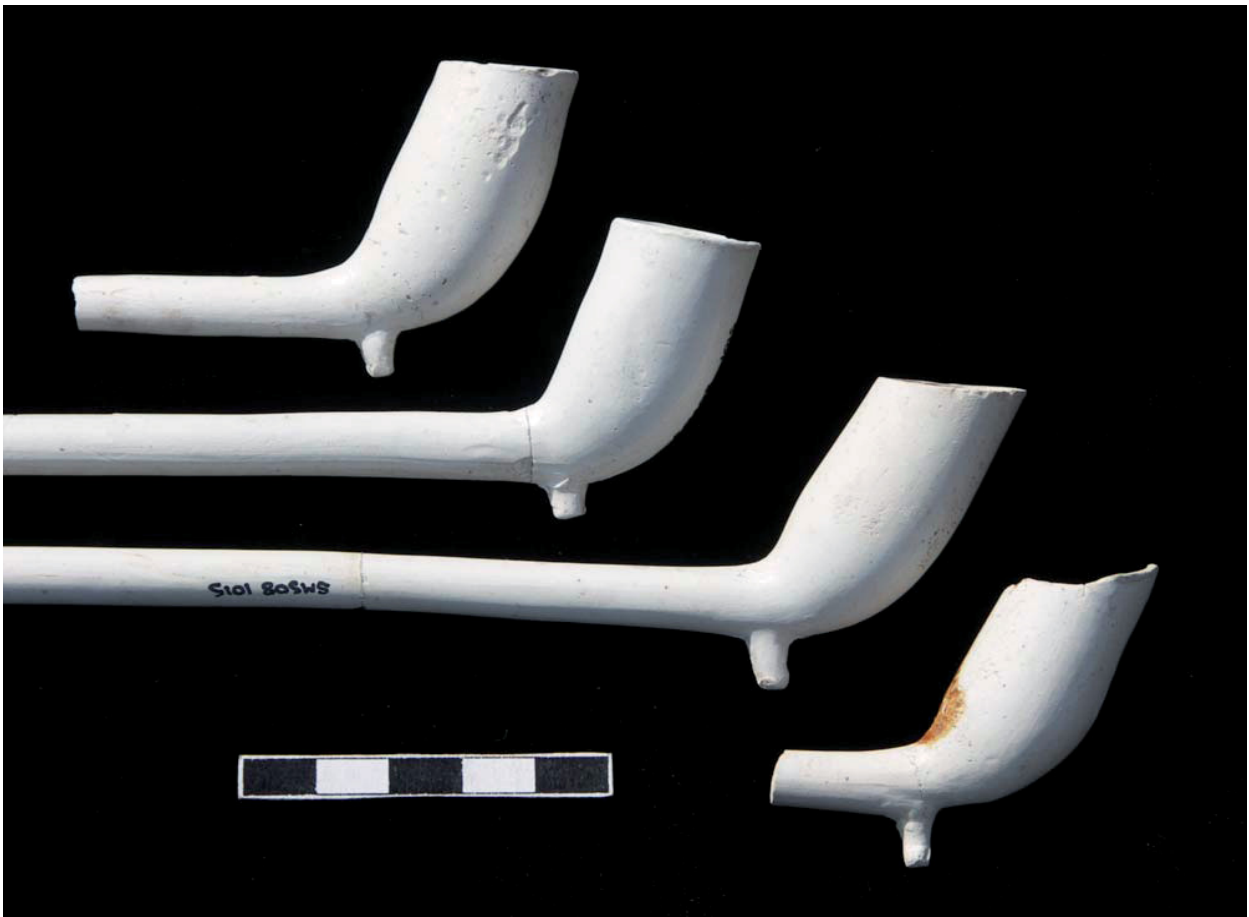
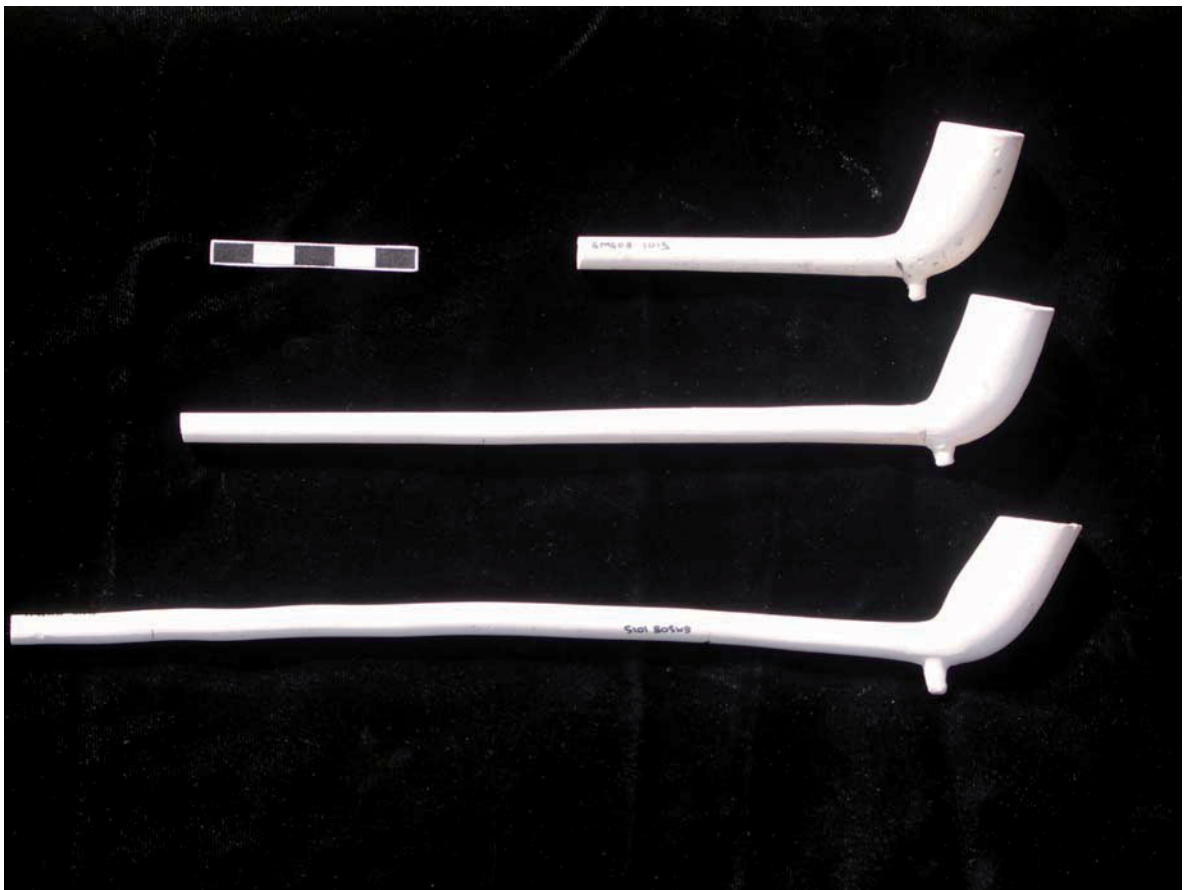
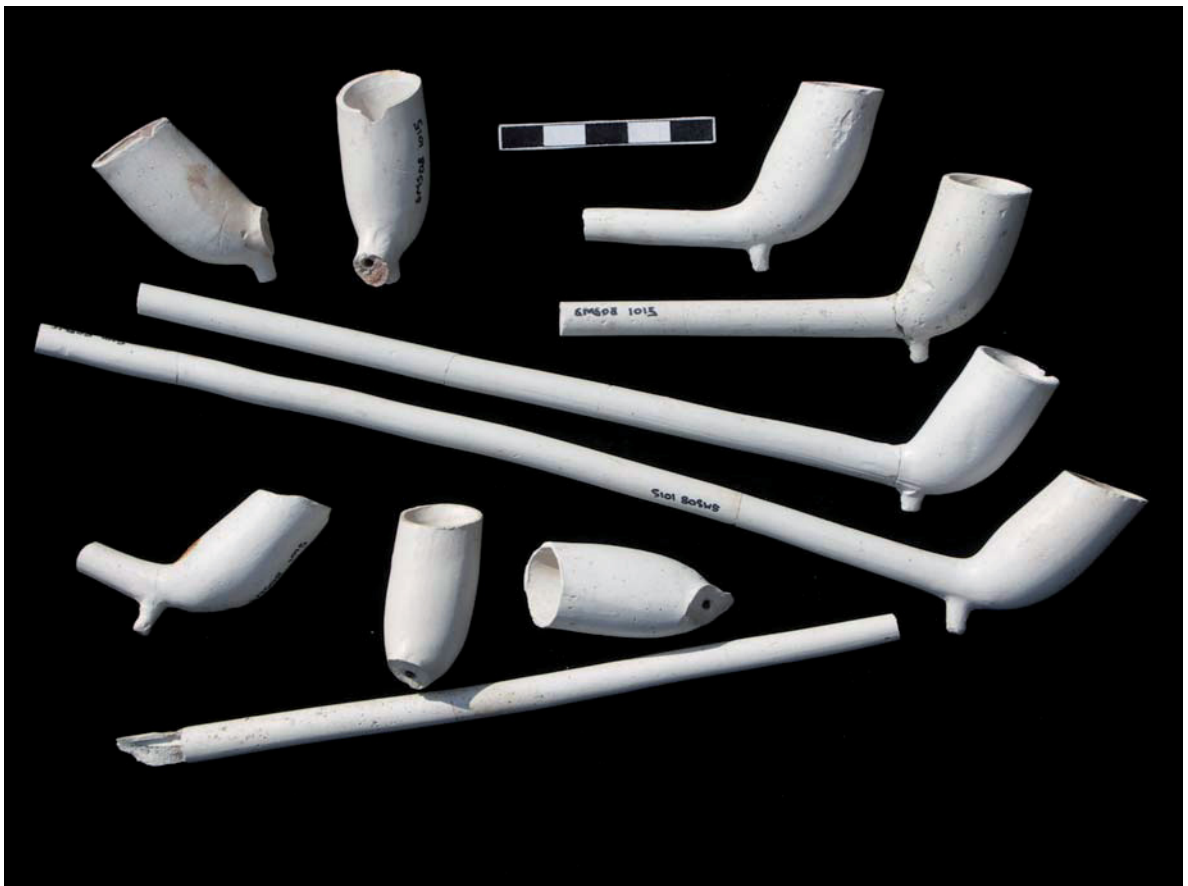
Plates 8 to 11: The clay pipe group from context 1015

Context 1015 (Fig. 1 and Plates 8 to 11)

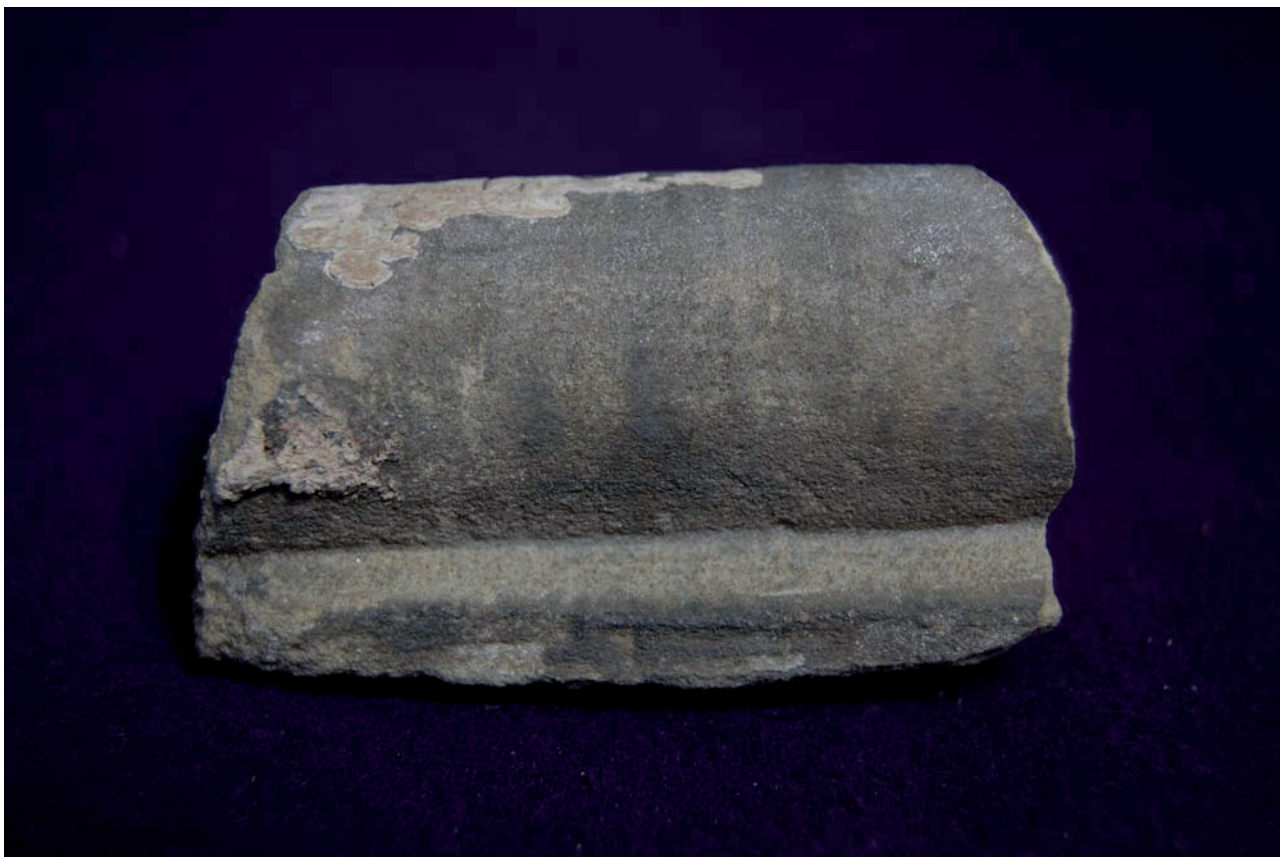
Plate 13

Plate 13: Stone molding from 1022

A burnt section of window moulding or tracery in a fine, light-coloured micaceous sandstone, possibly of 15th-century date, was found in **1022**.
