**ST PAUL'S CHURCHYARD, BEDFORD,
BEDFORDSHIRE**

**A PROGRAMME OF ARCHAEOLOGICAL
OBSERVATION, INVESTIGATION, RECORDING,
ANALYSIS AND PUBLICATION**

Document: 2006/13
Project: SP1025

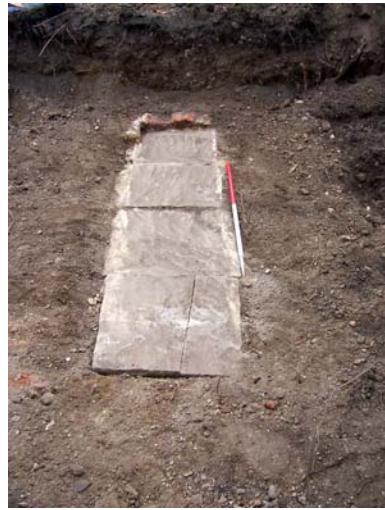
Grave [315]

During groundworks, four E to W aligned brick lined tombs were revealed ([315], [321], [325] and [328]). They ranged in size from 2.35m to 1.45m long and 0.75m to 0.45m wide and were c.0.50m below the existing ground surface. Each truncated subsoil layer (329), but was sealed by the modern topsoil (300). The style of brickwork in these tombs suggests a mid 19th to early 20th century date. The tombs were backfilled with inert material (fine gravel) and preserved *in situ* beneath the new driveway.

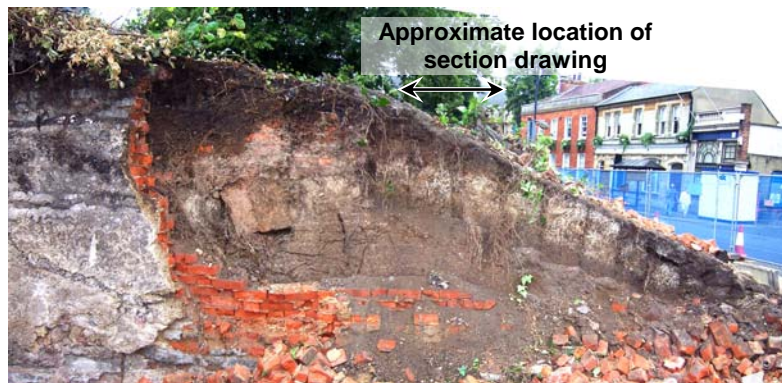
Mound cross section

The removal of the churchyard mound (c.72m²) revealed four layers of dumped deposits, in ascending order these were (302) (303) (304) and (305). Deposits (303) and (304) contained substantial amounts of disarticulated human bone.

The quantity of human bone recovered from the mound is consistent with it having been derived from within the churchyard. Burials were probably disturbed during the construction of the north aisle of St Paul's Church (19th century). During this work disarticulated human bone would have become mixed with the topsoil and subsoil which made up the spoil heap/mound.

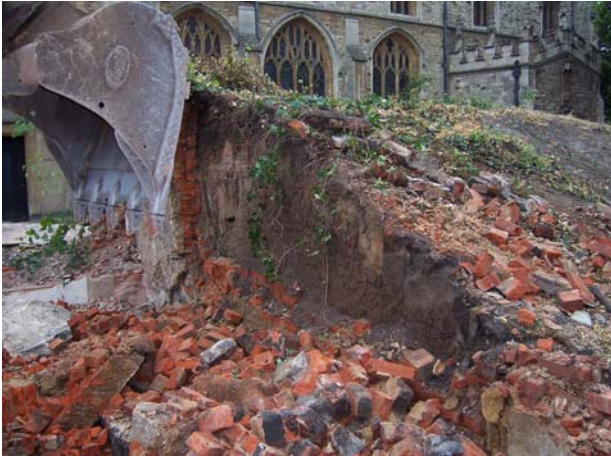
The limestone slab encountered during the earlier evaluation of the mound (Albion Archaeology 2004a) was not revealed at the level to which the mound was lowered (Plates 1 and 2).

Plate 1: Area 2, during the removal of the earth mound and associated late 19th century wall

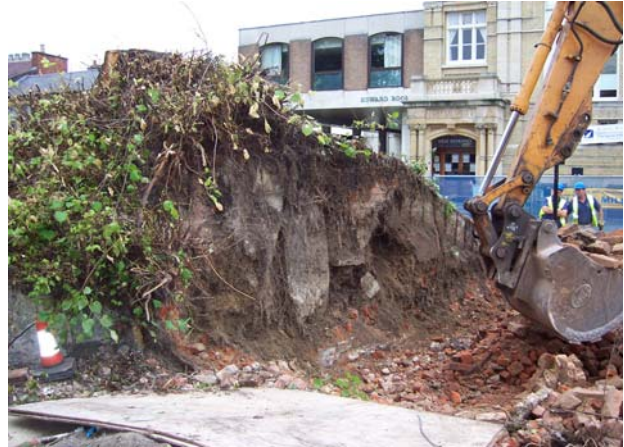
Plate 2: Area 2, during the removal of the earth mound

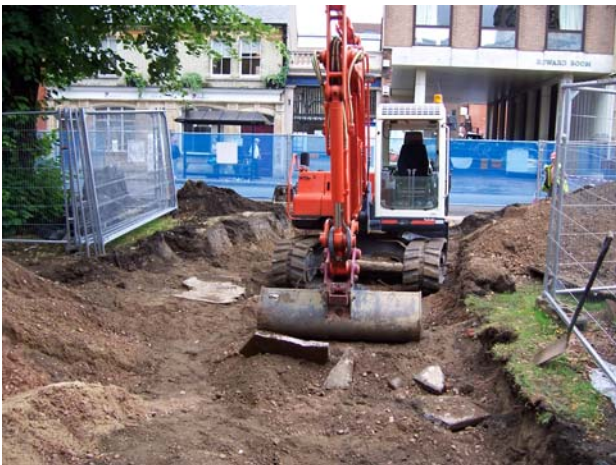
The new driveway covered an area of c.130m². It affected land immediately north and west of the north door of the church (Figures 1 and 2, Plates 3 and 4).

Plate 3: Area 3, removal of overburden prior to the construction of new driveway

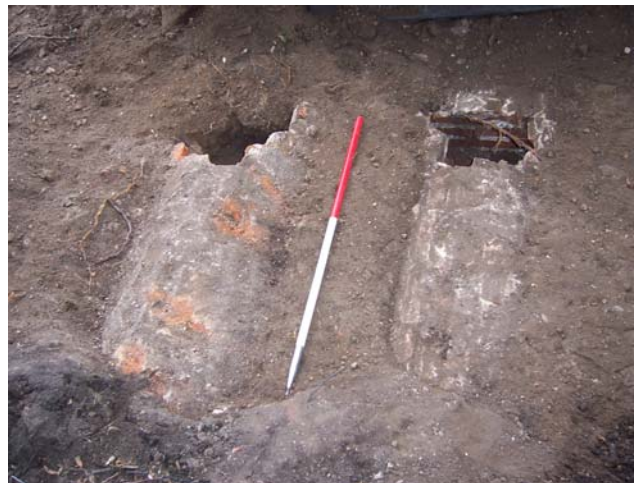
Plate 4: Area 3, brick-lined graves [321] and [325]

Four 19th/early 20th century brick-lined tombs were revealed within the footprint of the new driveway (Area 3). Careful infilling with inert material ensured these tombs were protected, and the inhumations within them were preserved *in situ*, while allowing the development works to continue.

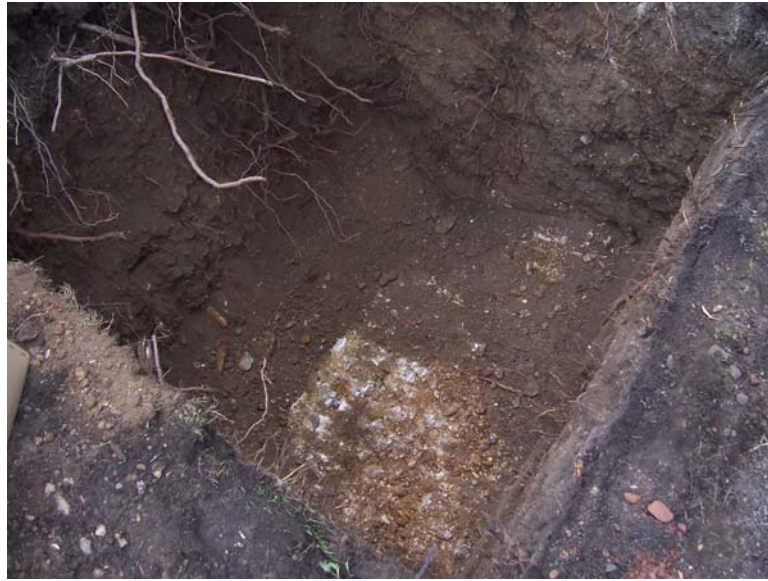
A soak away c.2m² in diameter and 1.5m deep was excavated adjacent to the north churchyard wall (Figures 1 and 2, Plate 5). The vertical section revealed by these works demonstrated the presence of a dark brown topsoil (331) 0.30m deep. This overlay a 0.60m deep subsoil (332) which contained abundant disarticulated human remains. These layers sealed the undisturbed river gravel terrace (330) which lay 0.90m below the current ground surface.

Plate 5: Area 4, excavations for gate pier foundation

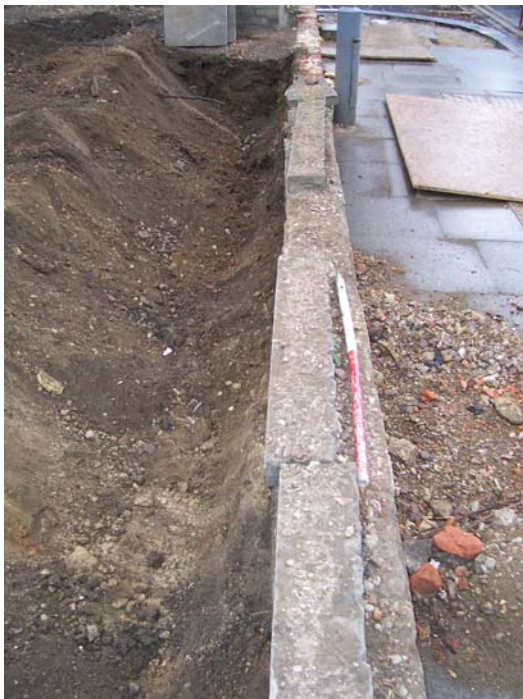
Repairs to the perimeter wall of the churchyard required the reduction of the ground surface adjacent to the northern, north-western and north-eastern parts of the wall. A trench c.42m long, 0.40m wide and 0.50m deep (Figure 1, Plates 6 and 7) was excavated.

The footings for this part of the churchyard wall (309), its foundation trench [311] and backfill (310) were revealed in the course of the work. No other archaeological remains were observed.

Plate 6: Area 5, excavation within the churchyard, against the north churchyard wall.

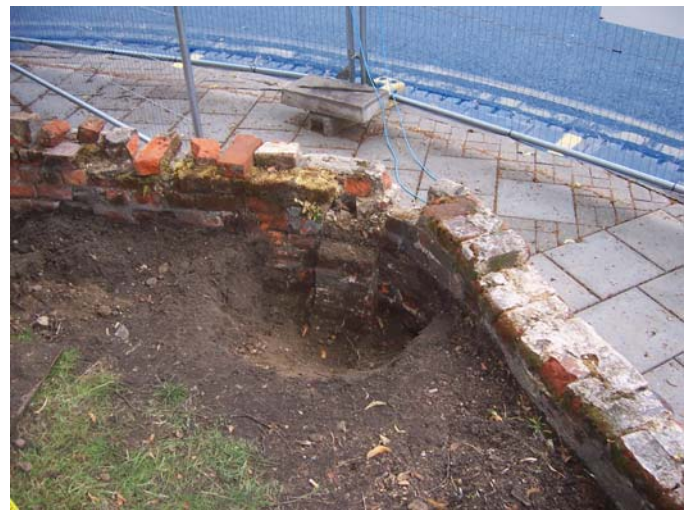
Plate 7: Area 5, excavation of pier against the north churchyard wall
