ST KATHERINE'S CHURCH, ICKLEFORD, HERTFORDSHIRE

Precautionary Archaeological Attendance, Observation, Recording and Reporting

Report No: 2007/62

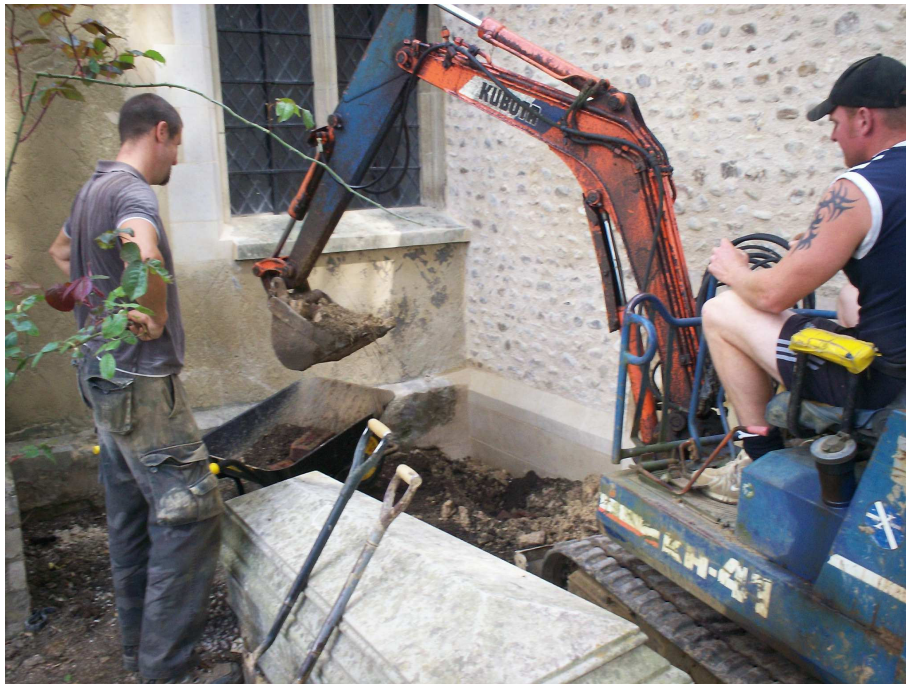
Plate 1: Excavation of trench adjacent to the porch

No archaeological features or deposits were found, either in section or plan, within the excavated pipe trench. Material removed from the trench around the porch (Plate 1) comprised friable grey sand silt which contained fragments of brick, tile and mortar.

Exposed wall footings revealed within the trench comprised of at least five courses of bricks beneath the aisle and chapel walls. There was no obvious significant foundation or consolidation beneath the walls of the porch.

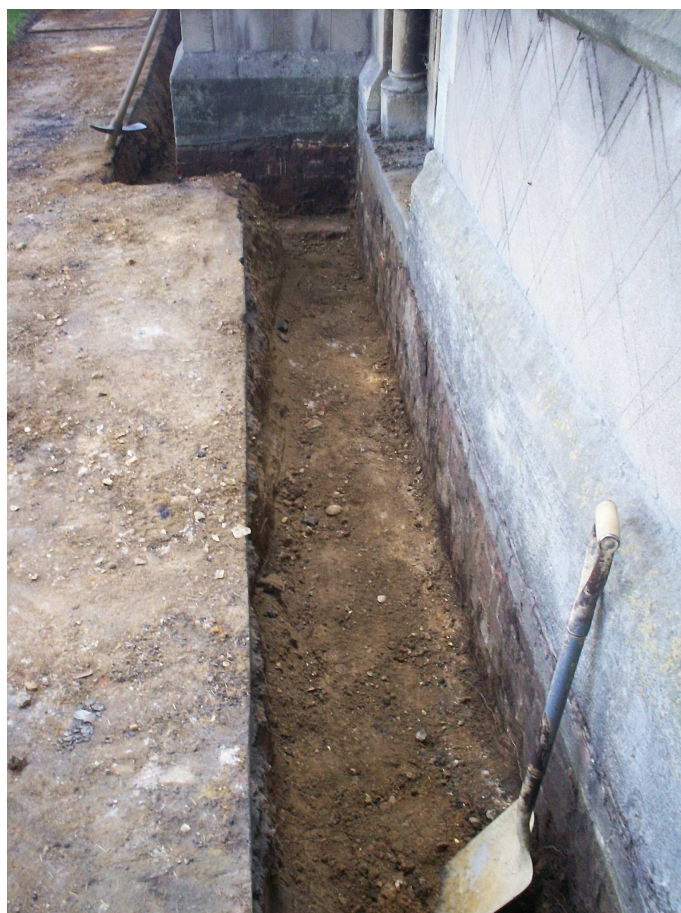
Plate 2: Excavated trench adjacent to chapel

To the east of the porch, excavated material comprised orange brown silt sand which contained pieces of worked limestone, tile, brick and large flint nodules. The worked stone, brick and tile were 19th century in date and were recovered in front of the door leading to the chapel (Plate 2). It is believed that this material originally formed part of the make-up of a paved entranceway which may have been demolished and dumped during the renovation works carried out in 1859.
