An archaeological evaluation at
IKEA
Corporation Street, Coventry
July 2006

September 2006

Report 06/114

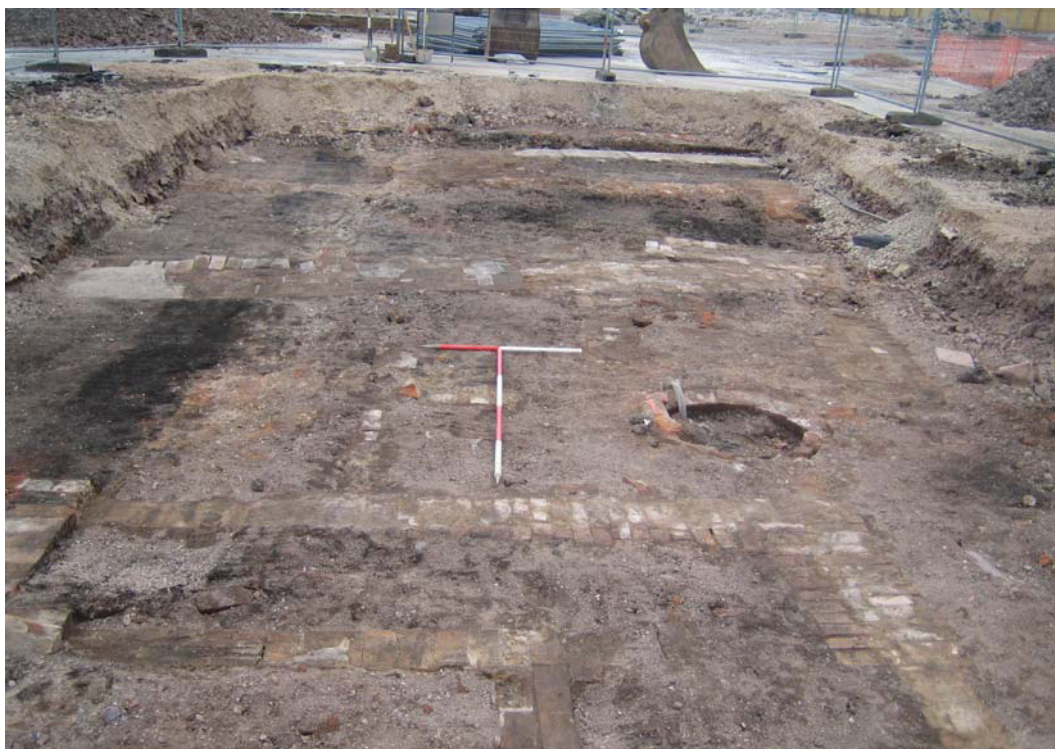
Plate 1: Trench 1 looking south, cellar and corridor in foreground

The northern end of the trench was occupied by part of a cellar comprising the inner wall (106), the upper door stop (112) and part of an encircling corridor wall (105) (Plate 1). Due to the unstable nature of the cellar and corridor fills the outer wall was left in situ to form the northern baulk when the rest of the trench was deepened.

A brick-lined well (114) was present between the cellar and wall (Plate 1). Measuring 1m in diameter, it had been surmounted by a contemporary brick cone to prevent rubbish falling in. Upon reduction it was seen to extend 1.15m down from the excavated surface to the natural substrate and an unknown depth beneath that. A lead pipe for water extraction extended down the side of the well.

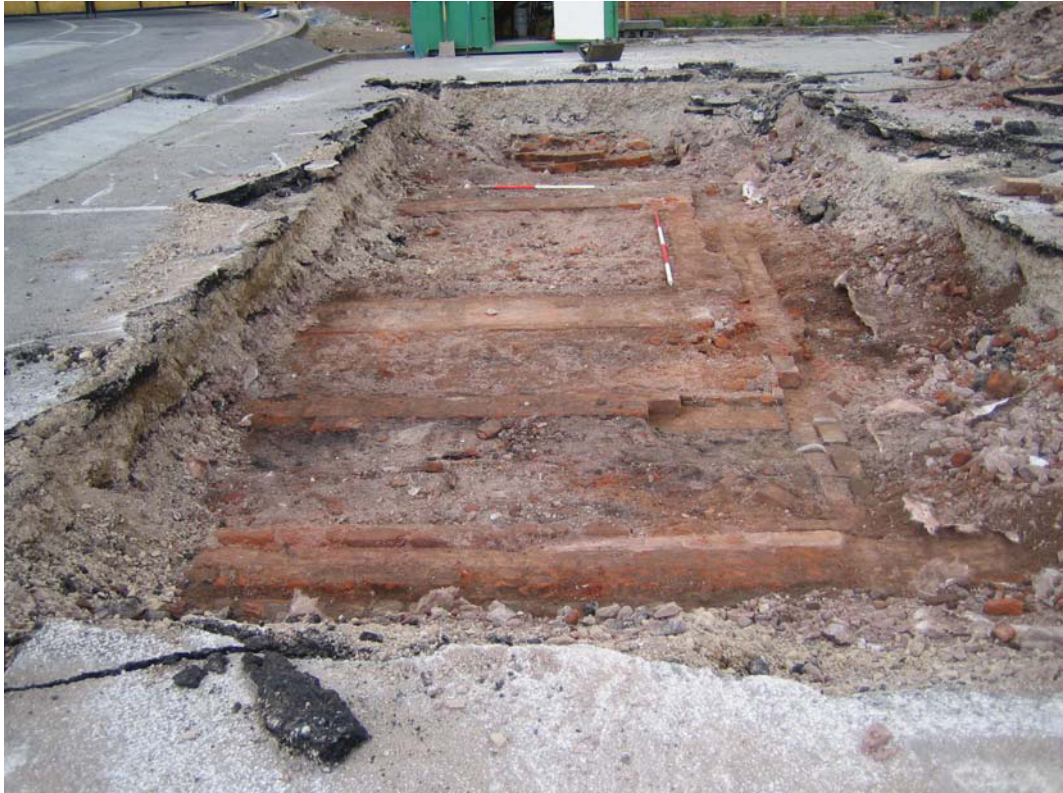
Plate 2: Trench 3 looking west

Cutting into this deposit was an array of brick and concrete foundations. Wall (306) was 700mm below the modern ground surface and make-up (301-304 on Fig 5). There were large open rubble-strewn areas between some of the relatively insubstantial brick walls such as (306) and (313), (Fig 5, Section 1), which were of 2 bricks thickness equalling standard domestic 9-inch walls) (Plate 2). There were patches of surviving brick floor of which none

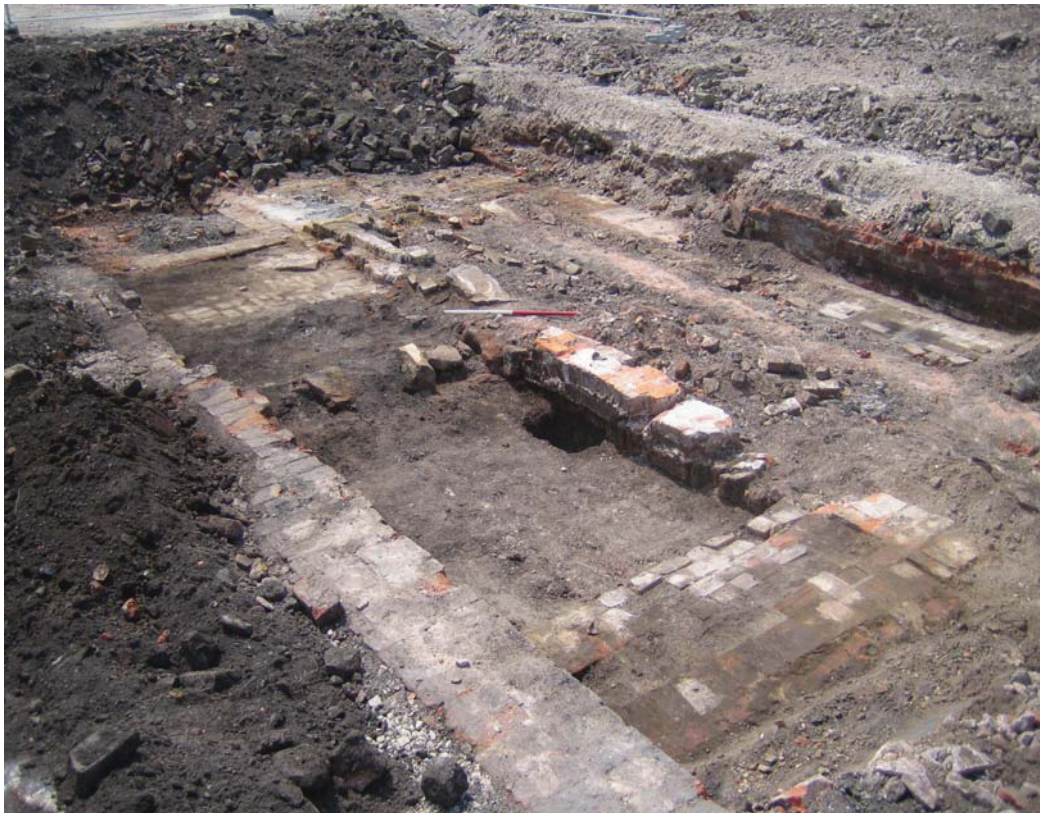
Plate 3: Trench 4 looking south-west, the tank (410) is at far left.

This trench was intended to measure *c*15m x 6m at the surface but sub-surface constraints and live services were encountered which involved extending the machine-dug area to the west considerably in order to select a sensible area for scrutiny. Once this area was chosen it was seen to contain numerous brick foundations, some of which were built on sandstone footings. The foundations here were more substantial than in most other trenches and relatively tightly-packed. They included a square, brick-built tank (410) with an inner cement lining, flanked by a major north to south-aligned wall (406) and other lesser cross-walls with brick floors (409), (414) between (Plate 3).

The judgement on site was that these remains constituted the remnants of the Silk Dye Works mapped in 1851 (Fig 7) and it was decided not to proceed to any greater depth but to leave these preserved under the new scheme. Subsequent map analysis has shown this to be the correct identification.

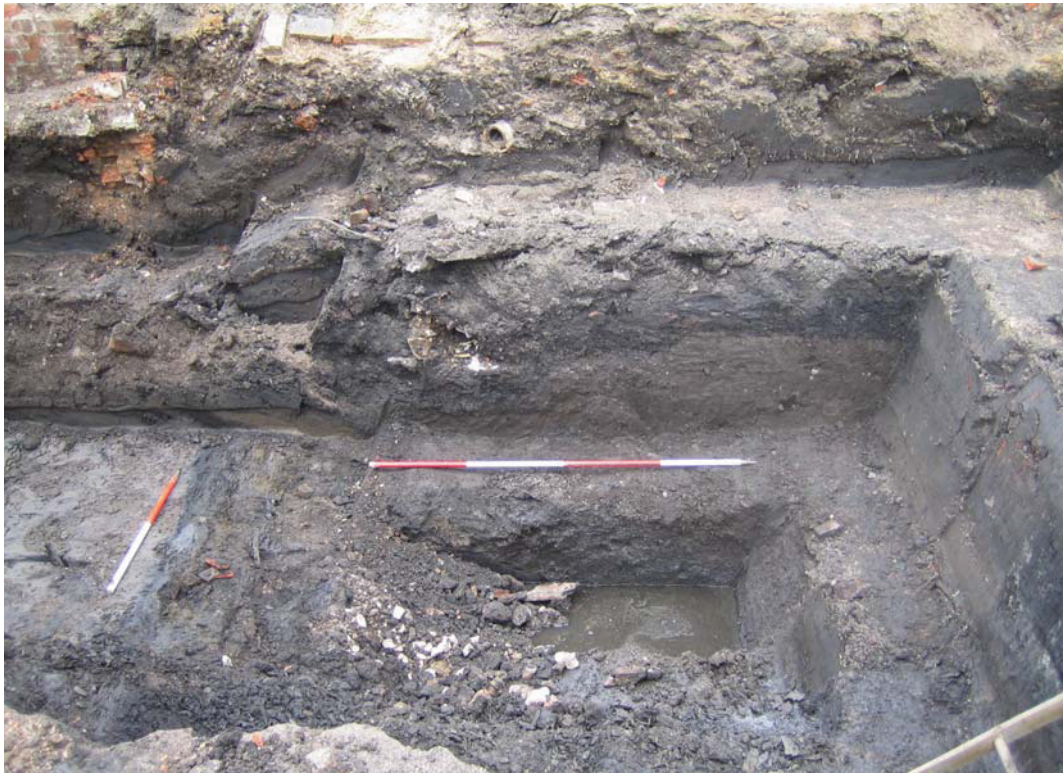
Plate 4: Trench 5, looking north-tanning pit [525]

Into this alluvium had been cut three large rectilinear pits [518], [520], [525] which contained small quantities of domestic waste in a waterlogged matrix and seen to comprise silt and birch-bark, a constituent raw material of tanning industries. One of the pits [520] is at least 5m long and another [525] where sampled, was 500mm deep (Fig 4 and 5, Section 2, Plate 4). Water flowed steadily in at this level. Fragments of leather, including mainly shoes were retrieved from waterlogged levels in pit fill (524), part of the domestic waste with which they were filled (Fig 6). On site they were provisionally dated to the late medieval period (Paul Thompson [HAGM], pers comm). This would make them residual amongst the 17th-century pottery. These will need to be conserved, a process which will take up to a year, and thus form no part of this report, the pits already being properly dated by pottery. They will be deposited with the site archive.

In Trench 5 the tanning pits [518], [520] and [525] are securely dated in the 17th centuries (pottery from their fills 517, 519 and 524). In each case the sherds are large and unabraded (the two Midland Black examples are intact half-tygs) suggesting primary refuse dumping.

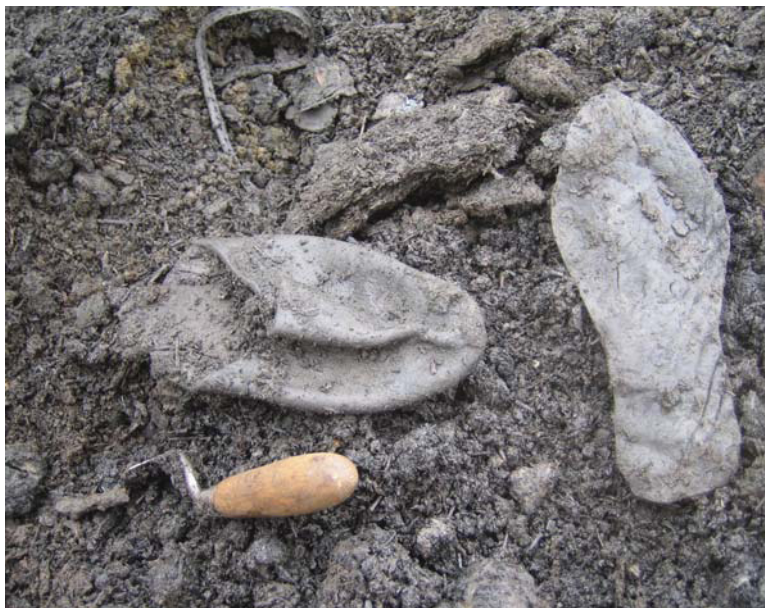
Plate 5: Trench 5 (detail), leather shoe parts from (524)

A group of leather fragments was recovered from the fill of one of the 17th-century tanning pits in Trench 5 (Context 524). The following is a catalogue of the entire assemblage, the datable styles of which indicate that all all constitute residual medieval material. All of the items have been cleaned and washed prior to all being drawn for archive (to provide a record before any possible shrinkage during freeze-drying), although mere scraps/offcuts and the poorly preserved fragments have not been included for illustration in the present report. All the items have now been sent for conservation at Museum of London Archaeology Services Conservation Laboratories prior to their deposition with the site archive. The items below have been compared for parallels with the published Coventry material of Thomas (1980 [Shelton Collection]; 1986 [Cox Street excavations 1976-8]; 1996 [Broadgate excavations 1974]).

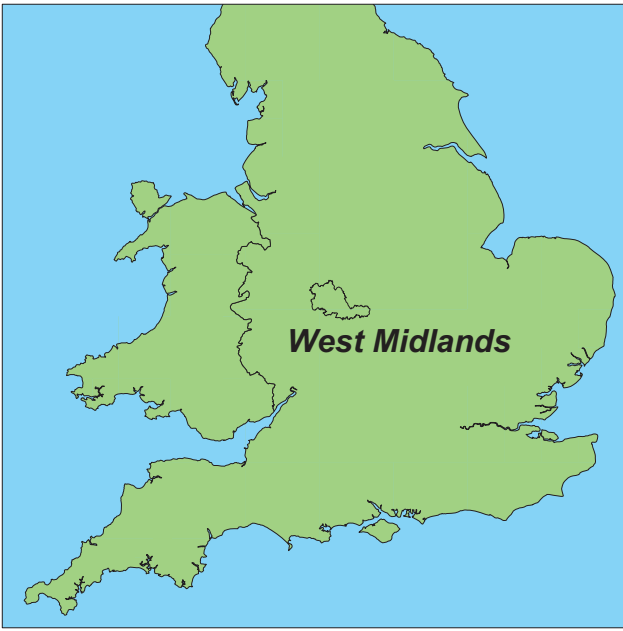
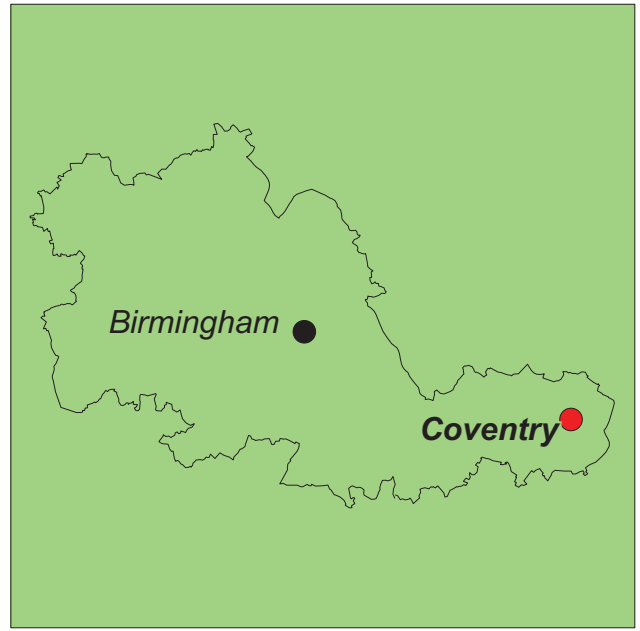
Site location Fig 1

Scale 1:10,000

Planning permission has been granted for the re-development of the former Co-op site for a new IKEA store in Corporation Street, Coventry (NGR: SP 329 788, Fig 1). The development occupies a 2ha plot bounded by Corporation Street to the east, Croft Road to the south and Spon Street to the north. On the west side lie the premises of Coventry Skydome multiplex cinema (Fig 2).

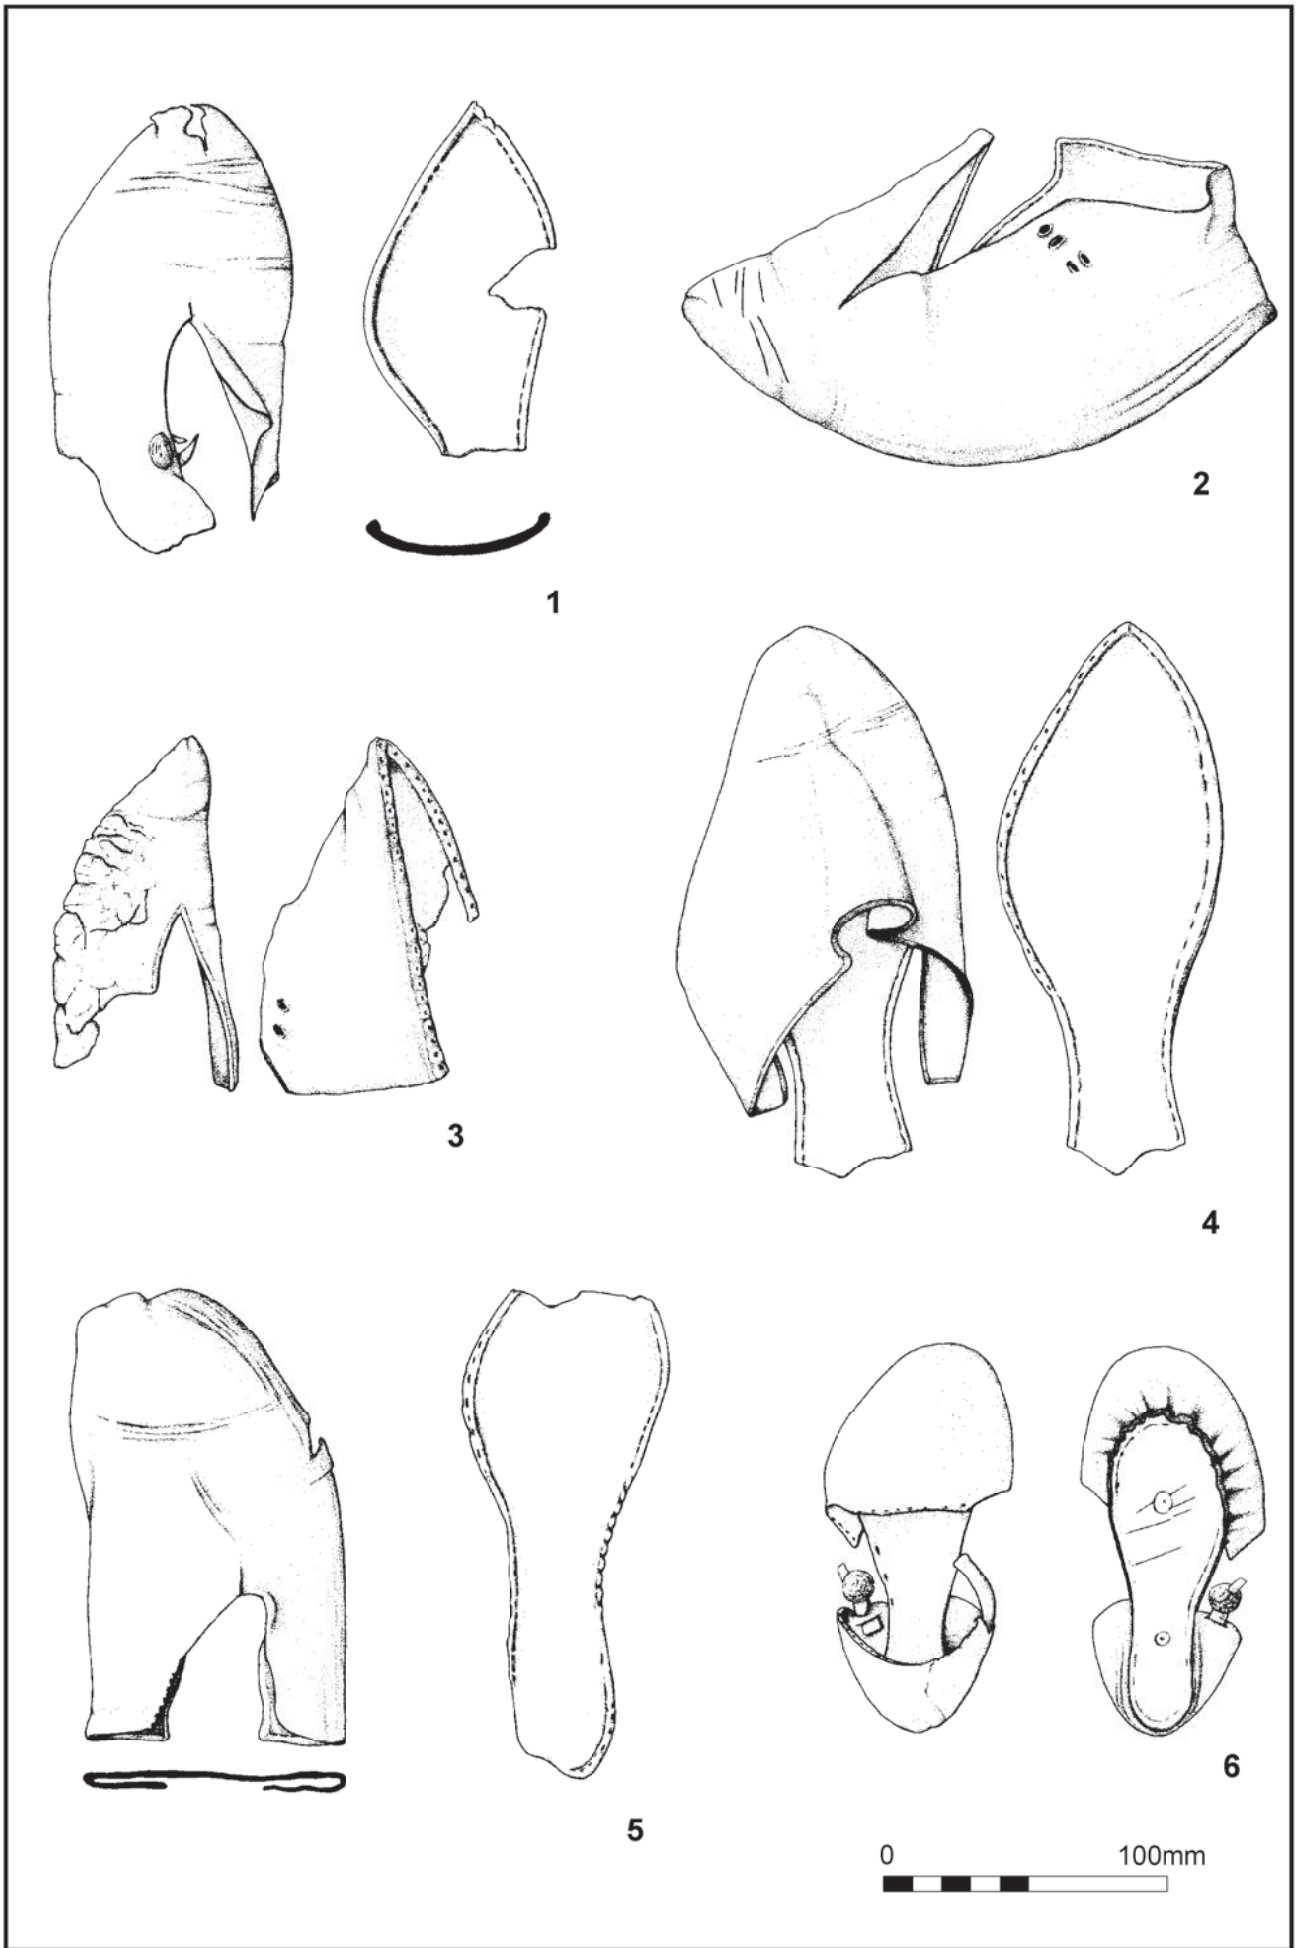
Leather shoes Fig 6

1. SF1. Left ankle boot upper of economy turnshoe construction, together with separated pointed-toe sole, probably of the same shoe, heavily worn through at the ball of the foot. A small iron buckle survives on the upper but is heavily corroded (Thomas type 1b). The strap is missing. A group of six leather offcuts and featureless strips have been similarly numbered as part of the assemblage SF1 but they are unlikely to derive from the same shoe (no edges match). The closest parallels are from Shelton Colln (Broadgate) – HAGM Acc no 78/51/52 and from the Belgrade site – HAGM Acc No 57/113/6 (Thomas 1980, Figs 2 & 4). Pre-1600 in date.

2. SF2. Left ankle boot upper of economy turnshoe construction, similar to SF1 but laced instead of buckled and a full ankle-height piece of leather. The closest parallel is that from the Shelton Collection (Broadgate) HAGM Acc no 78/51/60. A separate unused turnshoe sole (not illustrated; without any evidence of stitching) was found close by of a shape closely paralleled by a similar (but used) sole from the 1974 Broadgate excavations (Thomas 1996, Fig 56, no 12). There its parent context was dated to the mid-12th to mid-13th centuries (Rylatt and Stokes 1996). The shape has a distinctive cut off toe with a wide instep. Fragments of a third shoe were also recovered but they are very poorly preserved (not illustrated).

3. SF3. Fragmentary left upper from a vamp with pointed toe, formerly laced. Most closely resembles Thomas' type 4 (Thomas 1980). The nearest parallel of the toe-shape and cut of the opening is perhaps that from the Shelton Collection (West Orchard Chapel), HAGM Acc No 49/180/5 (Thomas 1980 fig 17). Medieval in date.

4. SF4. Sole, vamp and heel fragment from a shoe to which the closest parallel is perhaps that from the Shelton Collection (Newsome's Garage site, Corporation Street) HAGM Acc no 49/210/15 (Thomas 1980 fig 13). With this example it shares the distinctive pleat in the leather. Possibly 16th-century.

5. SF5. Incomplete sole and upper from a turnshoe with a relatively rounded toe, (although the sole is missing its toe). The upper was possibly laced but the edge where the lace-holes ought to be is frayed, serrations marking the possible former holes. Possibly of 16th-century date, the piece has only generic late medieval parallels (such as

6. SF6. Almost complete child's shoe, fastening with an iron buckle. Only two child's shoes are currently published from Coventry, from the Shelton Collection (New Art Gallery Site) HAGM Acc No 56/64/1 (Thomas 1980, fig 12). This example is not dissimilar, although not as complete as that from the Shelton Collection. Its rounded toe is redolent of a 16th-century date although the level of concession made to the growth of children's feet is unknown, making the development of fashionable shapes perhaps less reliable.

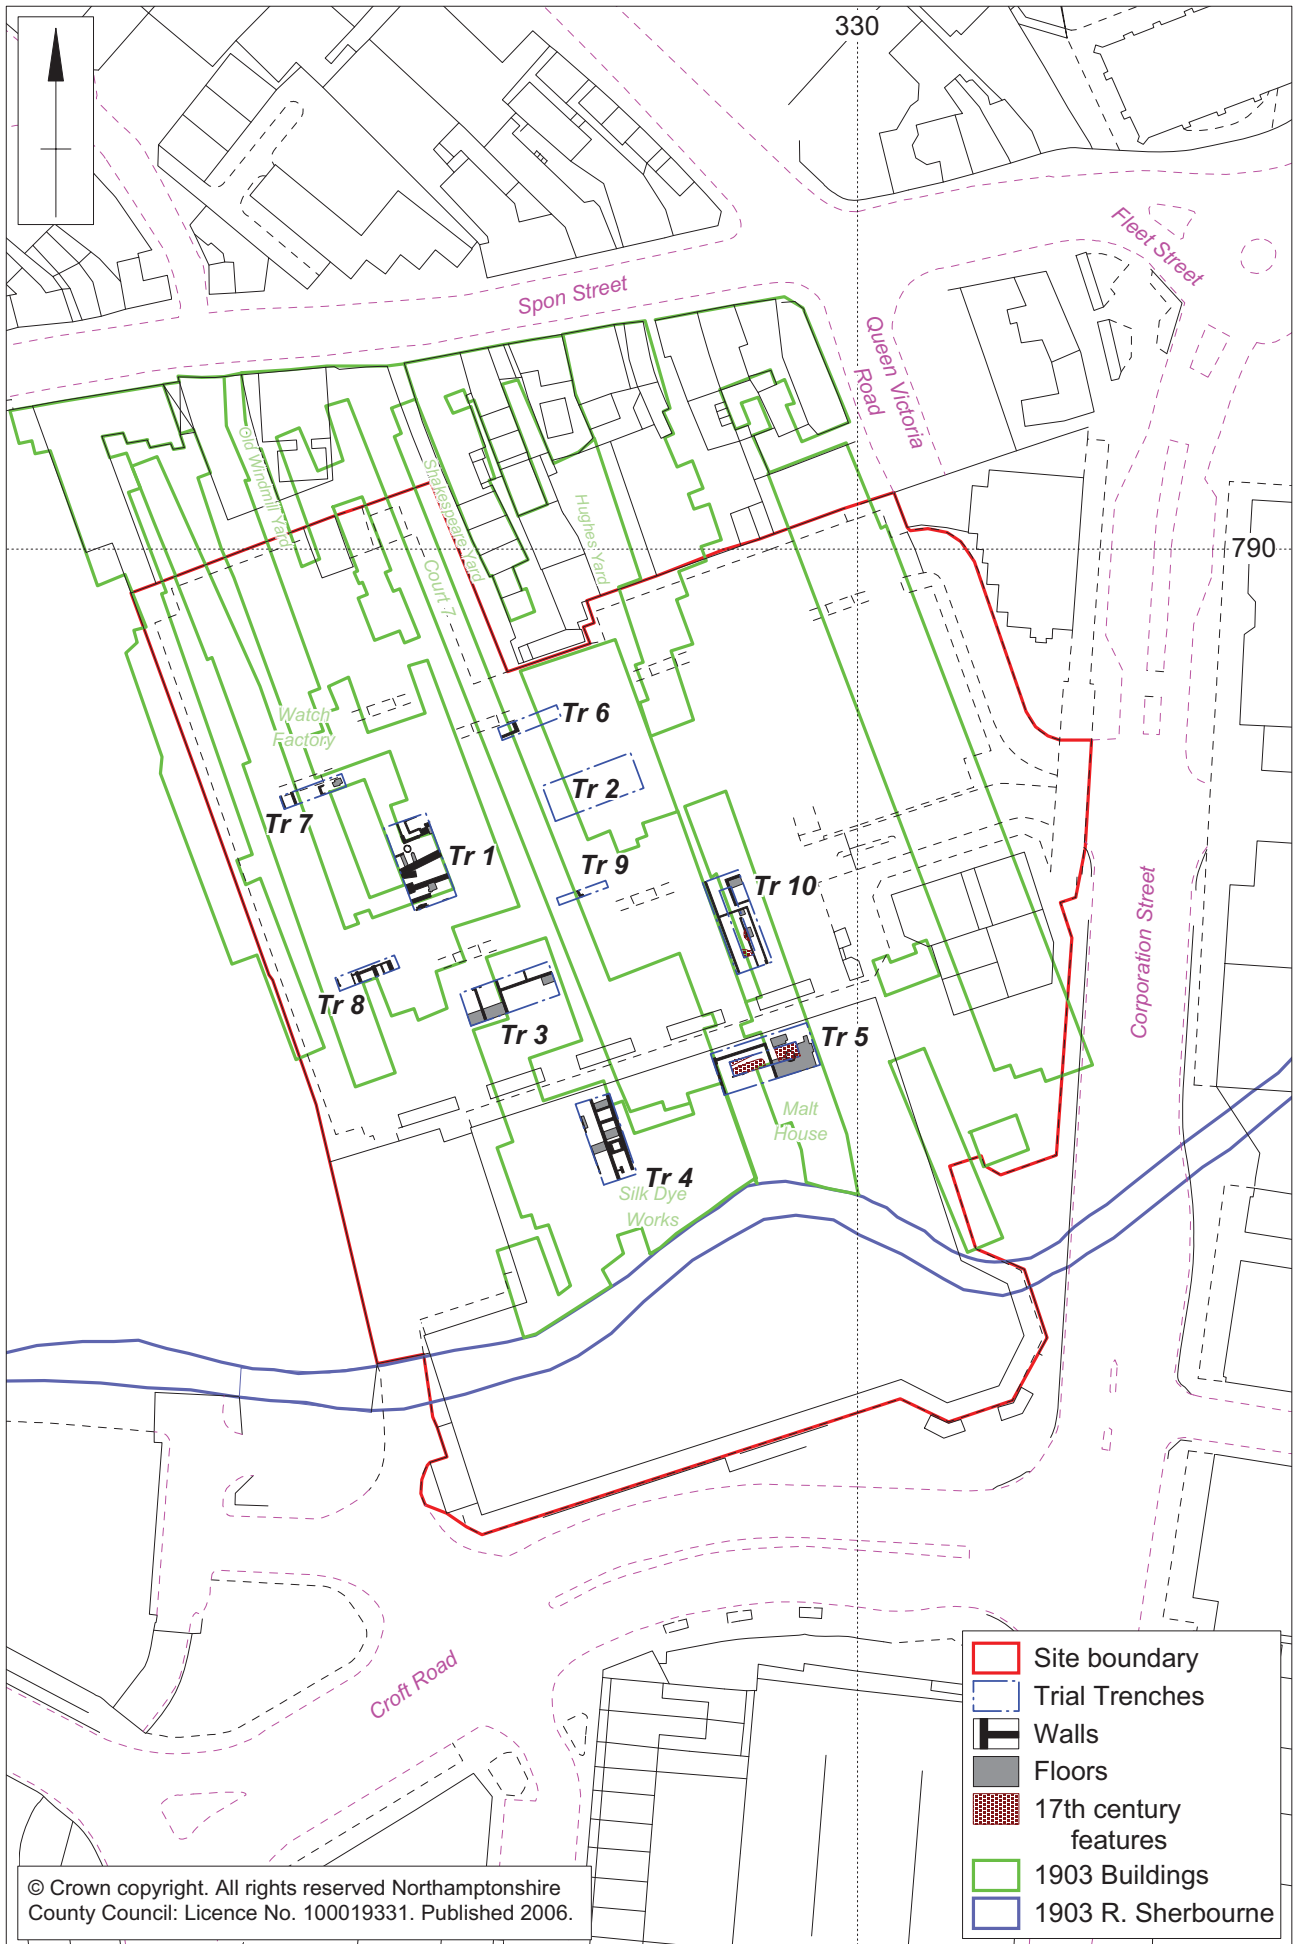
Ordnance Survey Map 1903 overlay Fig 8

Most trenches contained 19th- or 20th-century brick foundations, lying directly beneath the modern car park the dating confirmed by pottery from Trench 1. Map analysis shows that remains located in the following trenches can be associated with mapped buildings from 1851 and later (Figs 7 and 8 map overlays):
