# TREVEAN CHAPEL ROSUDGEON PENZANCE CORNWALL

## Historic Building Record

Report No.: 130925  
Date: 04.10.2013  
Author: D. Laing-Trengove

*South West Archaeology Ltd. was instructed by Sarah de Larrinaga and Steve Lavis to undertake a historic building record of a former Wesleyan Chapel on Trevean Lane, Rosudgeon, Penzance, Cornwall. A structure is marked in the position of the chapel on the available 19<sup>th</sup> century mapping and the building retains 19<sup>th</sup> century period detailing to the interior and to the exterior openings.*

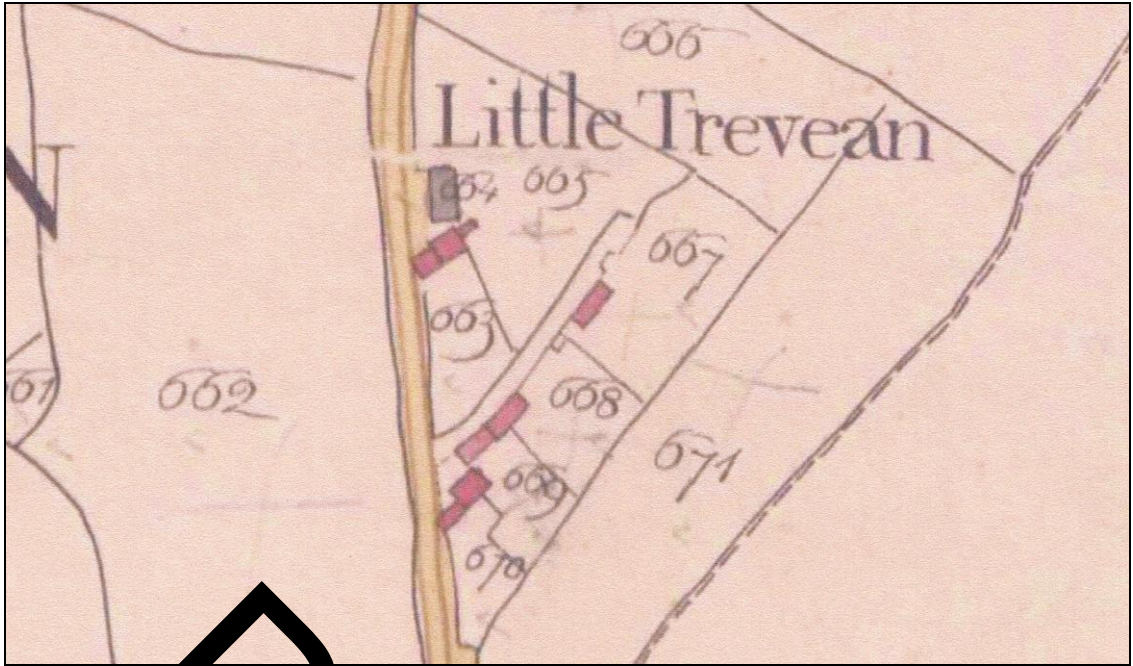
The Perranuthnoe tithe map of *circa*.1841 (Figure 2) shows a small settlement of Little Trevean divided into a number of plots and with a building in the exact position of the extant chapel at that time. The chapel is numbered 664 and is listed in the Apportionment as *Meeting House and Plot*, owned by a *Richard Mildrum* and leased to the *Wesleyan Methodists Trustees of*. The building is coloured grey, rather than pink, indicating that it was not a domestic building, unlike the others within the settlement. Interestingly the settlement to the south at this date consists of a number of cottages rather than the single farm it is today. The plot immediately to the south of the chapel (numbered 663) contains two cottages.

Figure 2: Detail from the 1841 Perranuthnoe tithe map, the Chapel is coloured grey. (CRO)

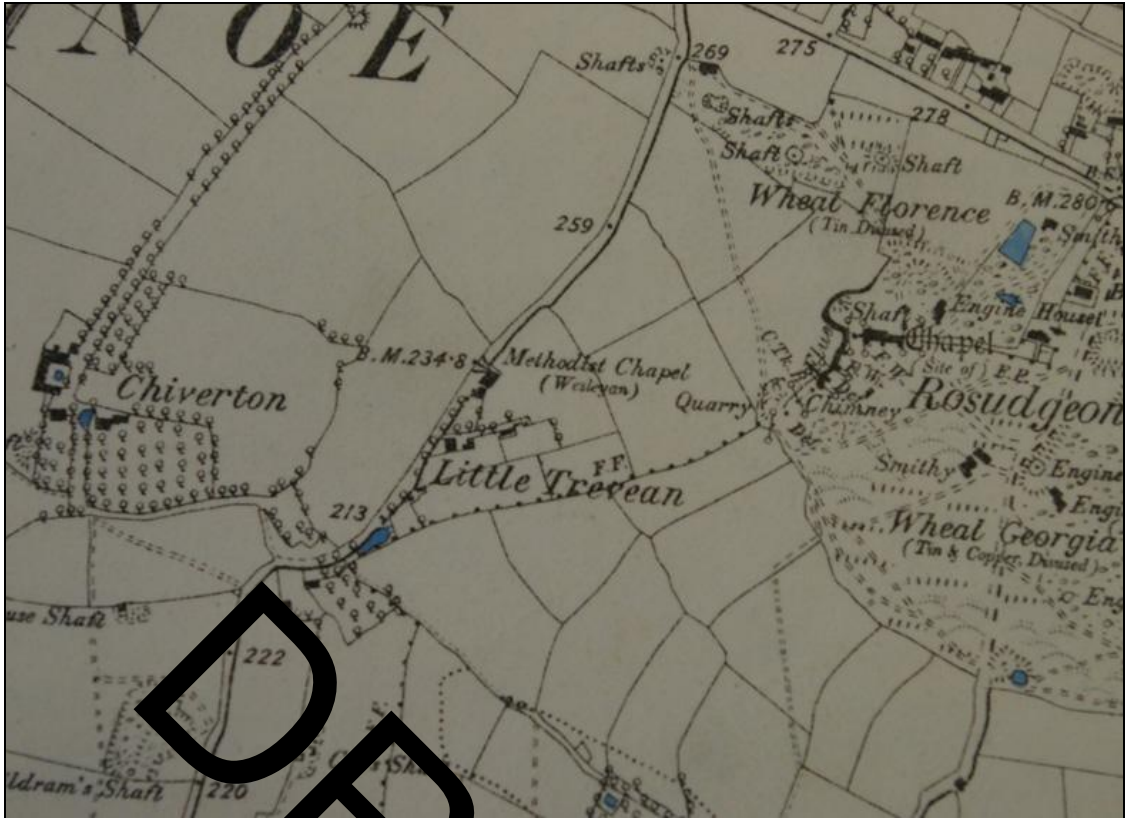
Figure 3: Extract from the 1888 Ordnance Survey First Edition 6 inch map. (CRO)

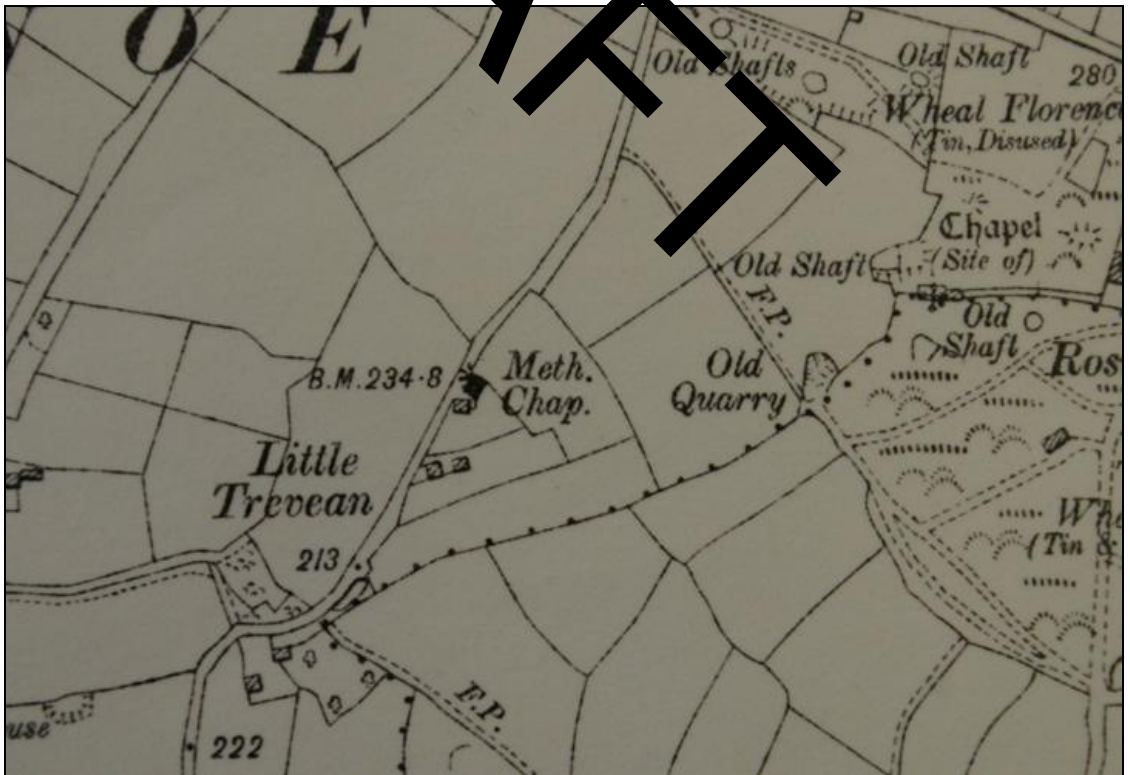
This Second Edition map shows no discernible change to the building, marked here simply as *Meth Chap*, although unlike its depiction on the previous map it now appears to abut the boundary to the north. This boundary now continues round to the east of the building and adjoins a previously existing boundary associated with the cottages to the south-east. The cottages adjacent to the chapel and two of the domestic buildings to the south remain, but the building/s further to the south-east have now gone. The mines on Rosudgeon Common have clearly gone out of use by this date and are now marked as *old* and *disused*.

Figure 4: Extract from the Ordnance Survey Second Edition map of c.1906. (CRO)

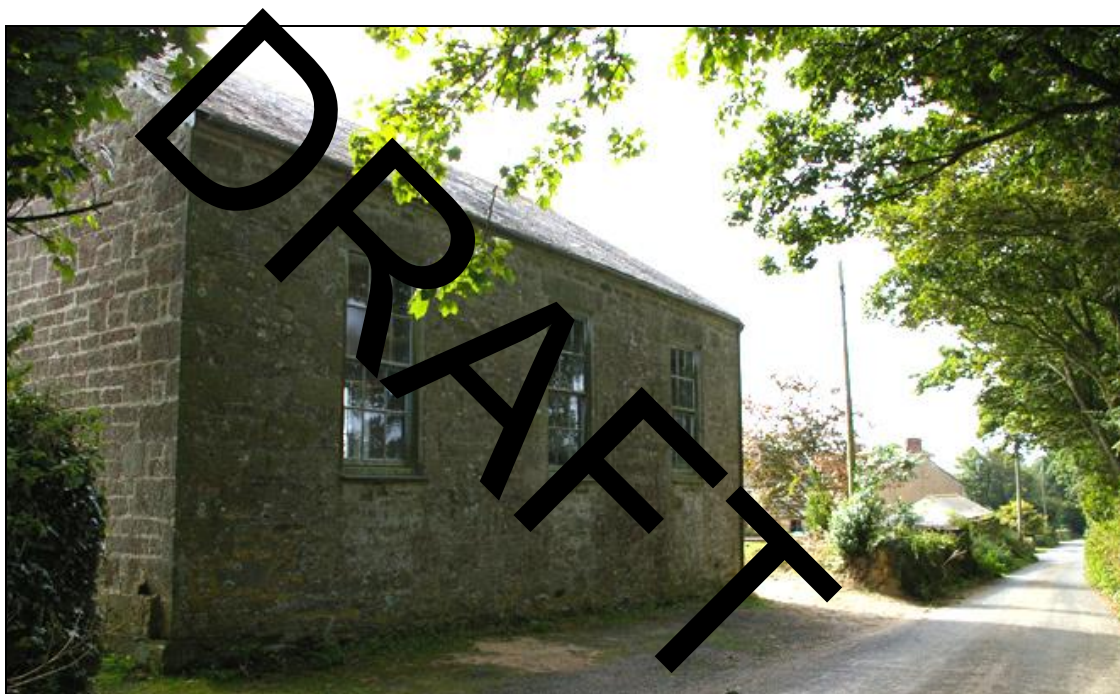
Figure 5: The exterior west elevation of the chapel; viewed from the north.

The exterior west elevation (see Figure 5), against the road, contains three symmetrically positioned hornless sash windows original to the build, with matching cut slate sills and

original glass panes; 2x3 to each sash of each window. The wall also contains three decorative air vents/bricks toward the base and has a cast iron down pipe and hopper at the southern end. The window openings all have large, dressed granite lintels and quoins which are blockier than the rest of the irregular rubble stonework of the elevation; there are also dressed quoins to each corner. The rubble stonework of the majority of the wall has been 'tidied up' by the application of indented or incised straight lines within the pale gray, sandy mortar flush pointing, giving the impression of ashlar stonework. The original guttering to the roof has been replaced with modern plastic guttering set onto a beaded plank fascia board. The windows have been painted with aluminium paint. There are remnants of large nails protruding from the south end of the wall, probably marking the former position of a notice board or sign.

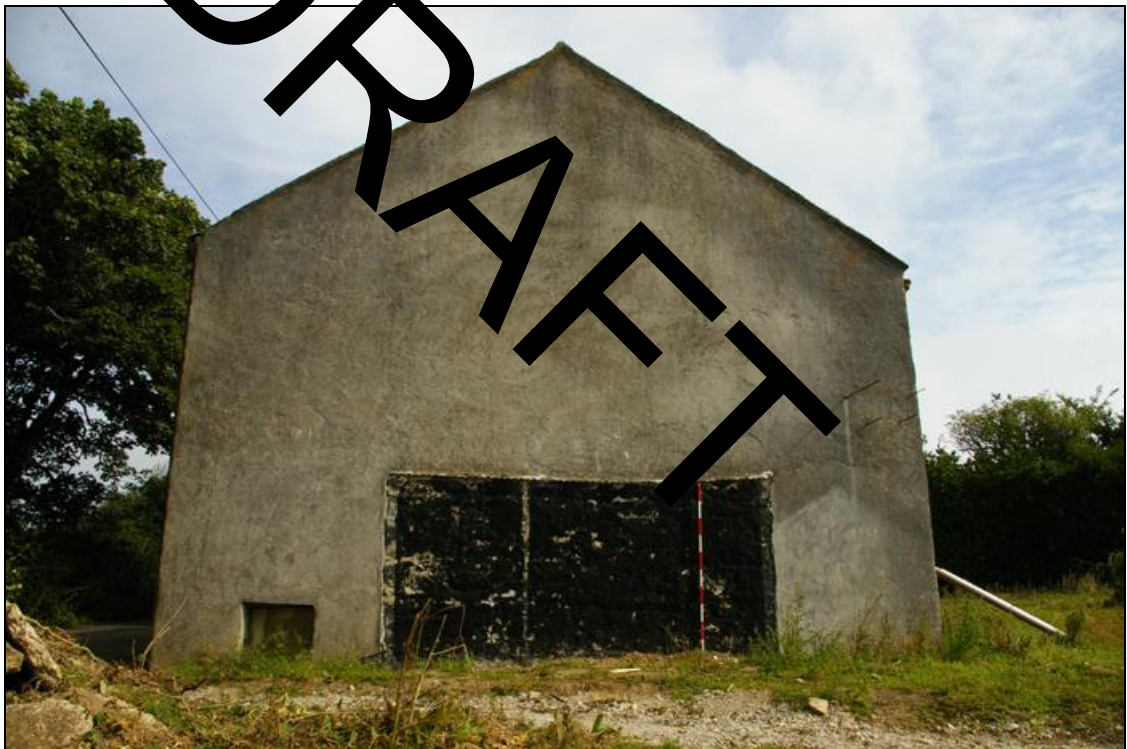
The south elevation has been rendered in grey cement within the last 40 or so years (Steve Lavis *pers. comm.*) around the position of a former lean-to, formerly set within the centre of the elevation at ground floor level (Figure 6). Toward the south-west corner of the elevation, at the base of the wall is a small opening with a plank door accessing a small cellar space – probably a former fuel store? There are some metal rods of unknown function protruding from the wall at roughly first floor height to the east. The wall surface at ground floor level, which previously formed the north wall of the lean-to, is unrendered, although painted. The unrendered stonework does not have the straight lines in the mortar of the north (and west) walls, and is clearly constructed of granite rubble.

Figure 6: The exterior south elevation of the chapel; viewed from the south-west.

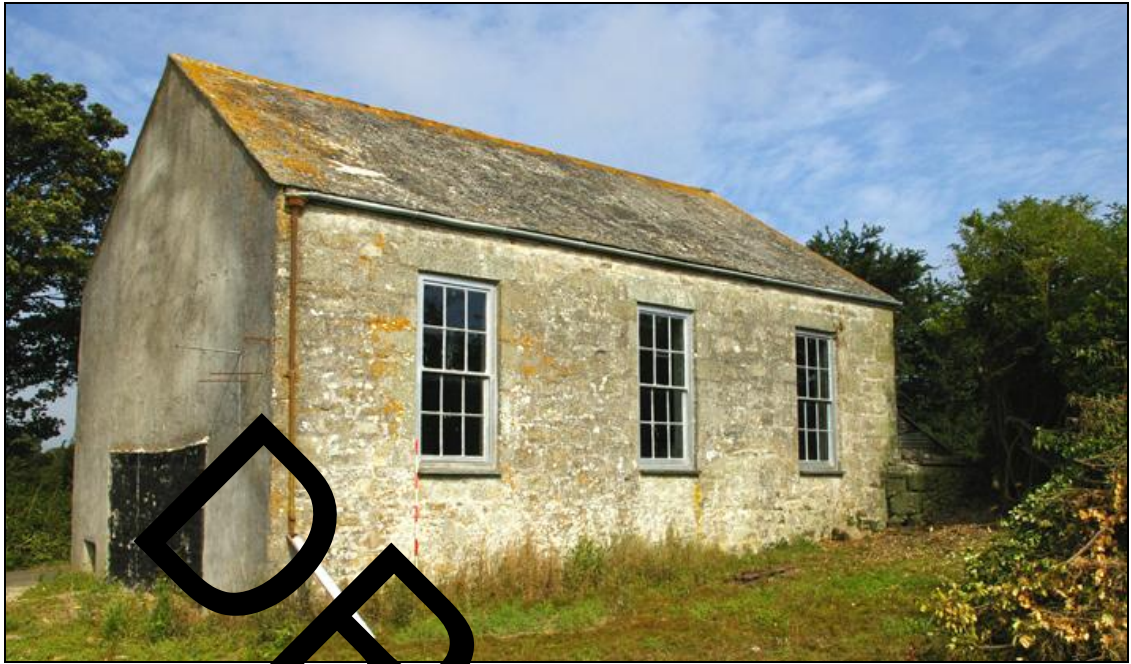
The wall to the east is as to the west with ashlar granite blocks to the corners and openings; although the pointing is not set with incised lines but has been left roughly flush with the stone (Figure 7). As to the west, the wall has three window openings with tall sash windows and plastic guttering with an earlier cast iron downpipe. At the north end of the elevation the ashlar quoins are abutted to the east by a rubble granite wall topped with pebbles set in a sandy, pale grey mortar.

Figure 7: The exterior south and east elevations of the chapel; viewed from the south-east.

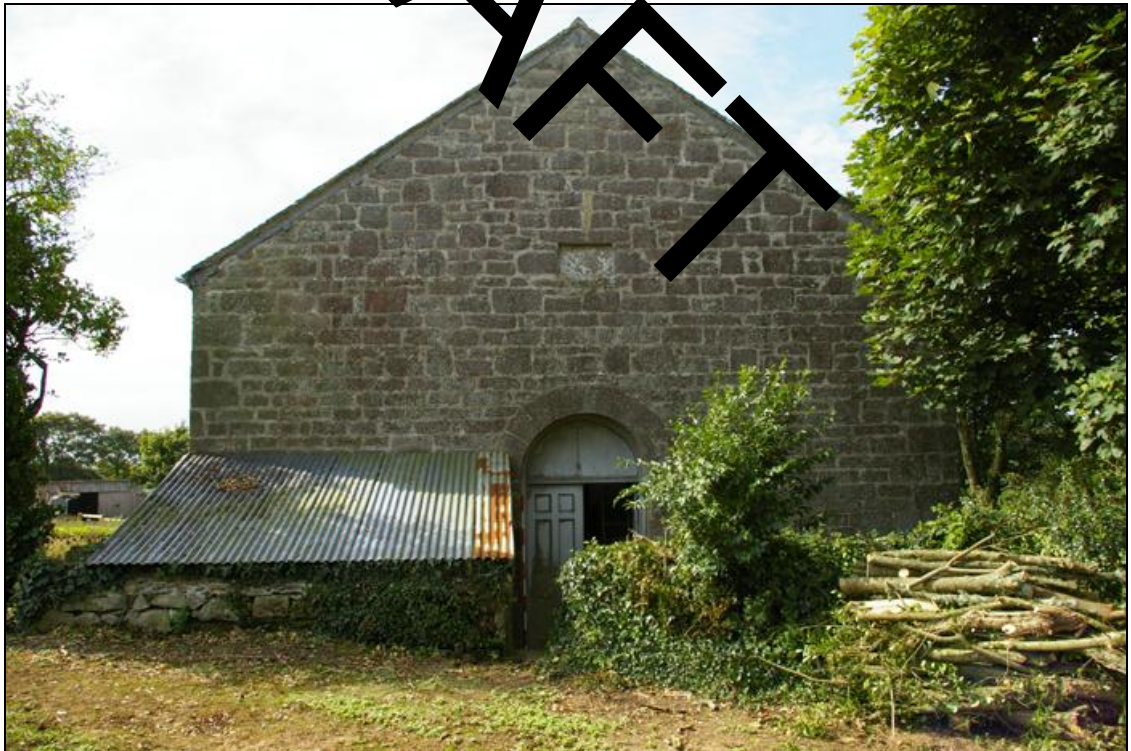
Figure 8: The exterior north elevation of the chapel; viewed from the north-east.

The north wall is constructed of coursed dressed ashlar granite, pointed as to the west, giving a neat presentation face to the main entrance elevation (Figure 8). Unlike those to south, west and east, it has an ashlar granite block plinth projecting from the base. There are also a small

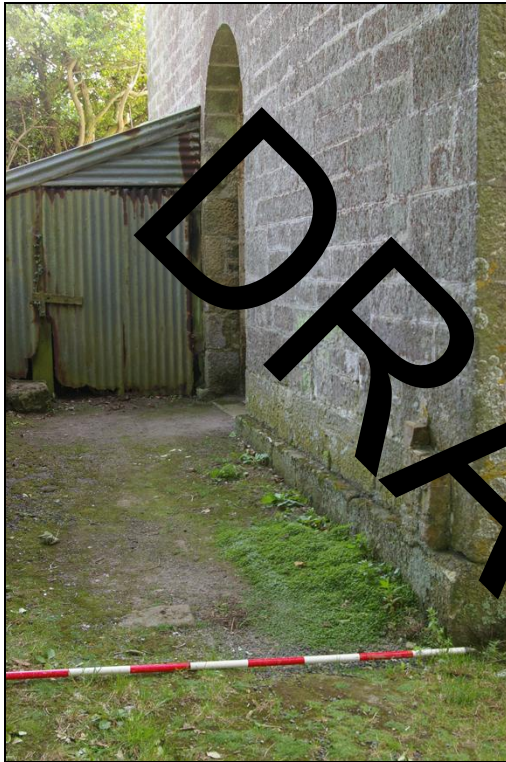
number of bricks cemented to the wall toward the western end which appear to be associated with a former gate in this position, marked by a stone containing a bolt hole set within the ground to the north of the building (Figure 9). The entrance to the building is positioned centrally with a large, arched opening, with large block quoins to the sides and a neat arch of granite voussoirs above (Figure 10). Above the arched door opening is an empty rectangular recess and above that, set into the wall, are two airbricks (as before within the western elevation) set on end. Along the edge of the gable, to the soffit, instead of barge boarding reused slates have been set (see Figure 8). The door opening contains moulded panelled double doors with a brass finger latch and key plate, the door frame is beaded with formerly a glass four light fanlight above, now boarded. To the base of the opening in the stone of the threshold is an incised drip channel, with a central bolt hole, that leads water out to the west.

Figure 9: The north elevation of the chapel, with secondary bricks to the western end and stone setting in the ground for a bolt, both associated with a former gate, and the sheet metal lean-to against the eastern end, viewed from the west.

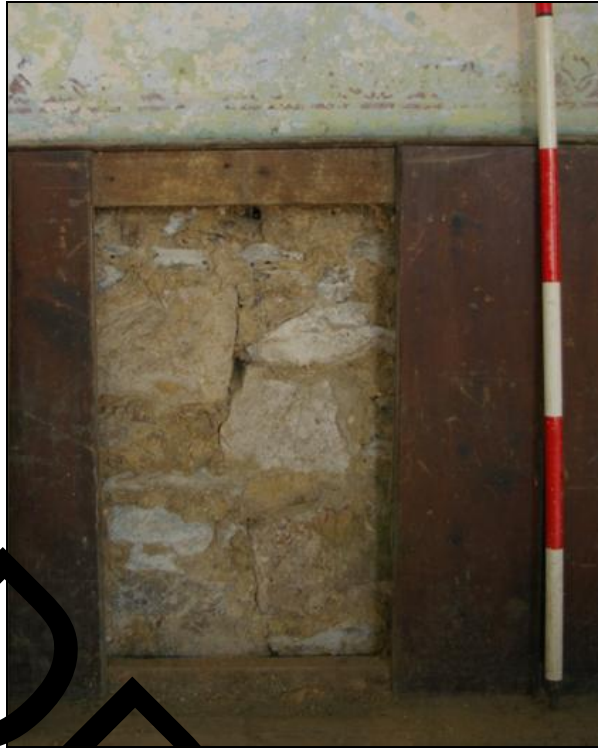
The interior of the chapel comprises a single open space with a timber plank floor and high plaster ceiling, which appears to be all of a single phase, with the exception of a panelled pine cupboard or small cloakroom set within the north-east corner of the room. The walls are panelled with stained pine boards to dado height to north, west and east, with the panelling fixed immediately against the unplastered walls, which are plastered above and painted green with a decorative painted frieze just above the top rail of the panelling (Figure 12).

Figure 12: The interior face and fabric of the east wall, exposed where panels have been removed; viewed from the west.

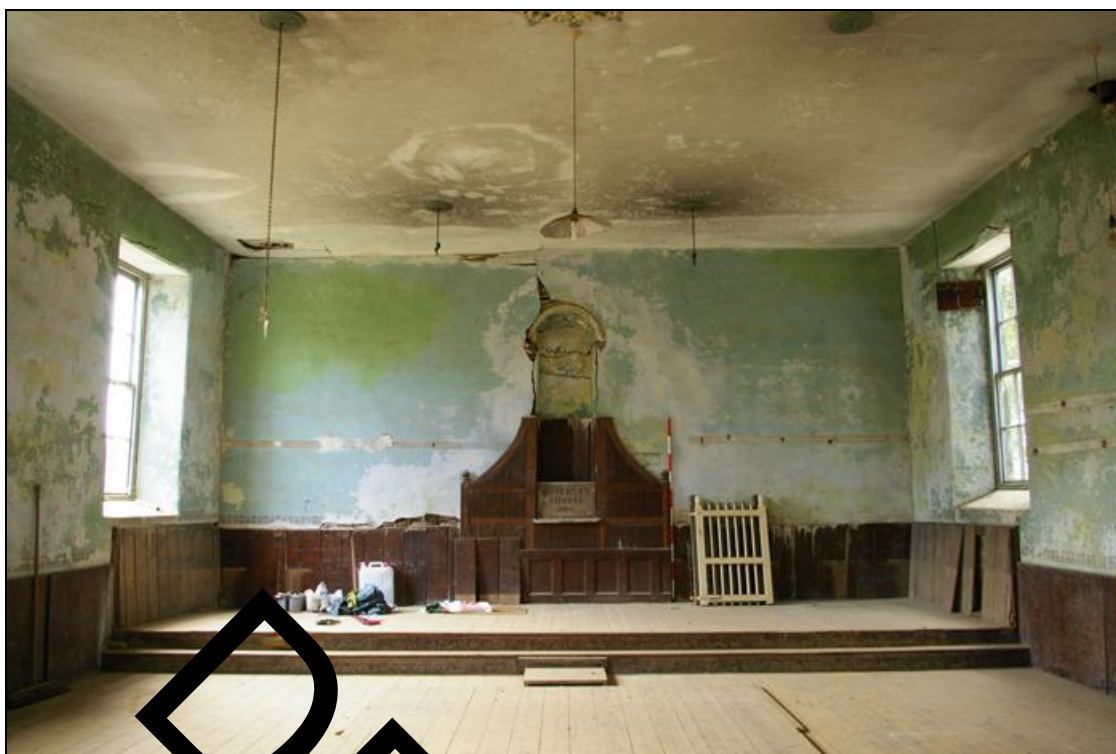
To either side of the alcove are scars of a similar size to those to the west but these are single rather than the double rows seen to the west and north-west (Figure 13). The panelling to the east and west of the central timberwork retains the scars of former benches or pews (as does the floor, see below) formerly facing inward to the centre of this raised area (see Figure 13).

Figure 13: The interior south wall of the chapel; viewed from the north.

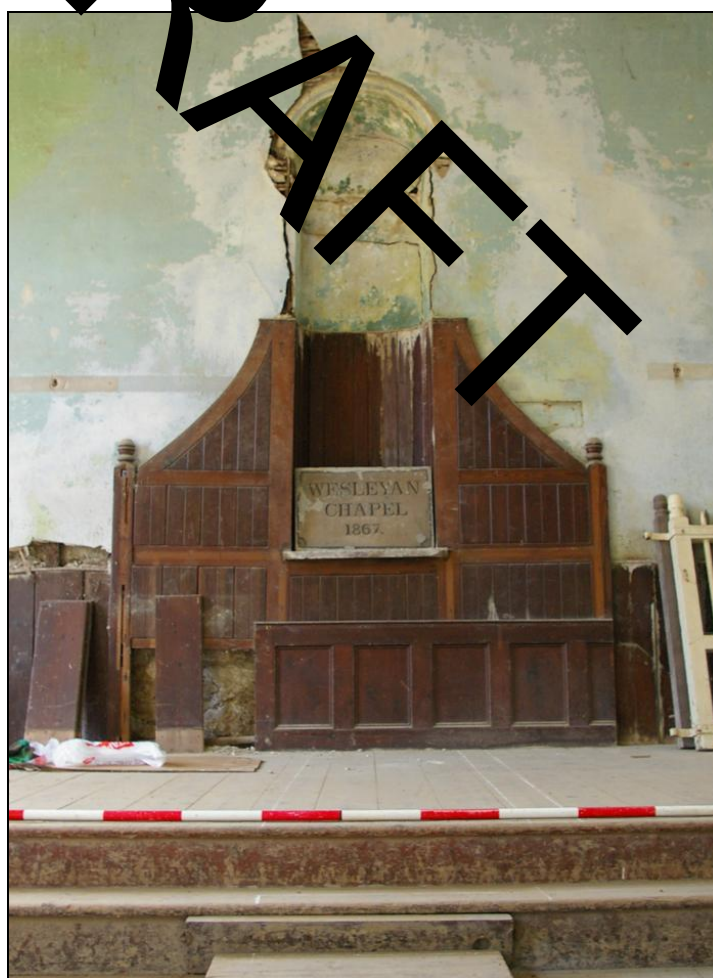
The south wall is as to the west but with a central timber plank screen fitted to the wall and incorporating a curving alcove that extends into the timberwork above, topped with a moulded plaster arch (Figures 13 & 14). The wall here is covered with a layer of plaster that is applied to laths affixed to timber studwork which is fixed to the lower timber panelling, rather than applied straight onto the wall surface as to north, east and west.

Within the lower timber section of the alcove a rectangular slab declares this to be a Wesleyan Chapel dating from 1867. This plaque may have come from the recess in the exterior north wall, although the date appears slightly later than the building, which has a number of features apparently dating to the late 18<sup>th</sup>/early 19<sup>th</sup> century, such as the hornless sash windows and fan light above the door. It may have come from elsewhere (according to the previous owner) or alternatively may commemorate a refurbishment of the building carried out later in the 19<sup>th</sup> century.

Figure 14: Detail of screen and alcove on the south wall.

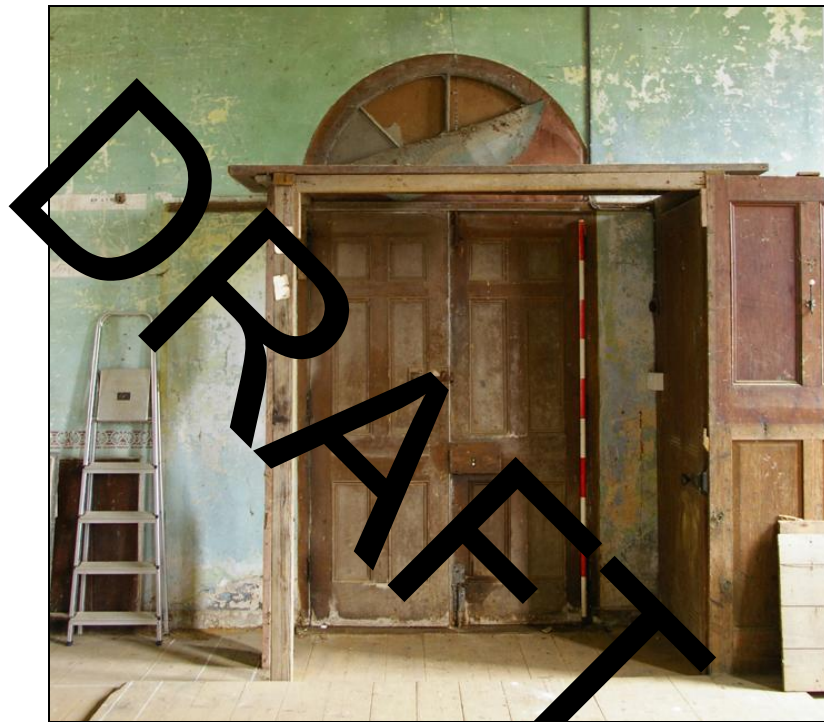
To the north the wall is as described and with the same scars of former fittings as on the west wall to the west of the door. There are also signs of a former partition to the east and west of the central opening, which are truncated to the east by the later cupboard/ cloakroom; to the west of the door the panelling stops at the position of the former partition. There are the remnants of a timber structure to either side of the doorway that may relate to an earlier lobby area in this position, prior to the insertion of the panelled cupboard to the east (Figure 15 and see Figure 11). The extant partition timberwork of the cloakroom may have been reused from the earlier arrangement as the length of the panelling is comparable to the area formerly enclosed around the door opening. This partition wall has simple moulded panels to the interior but only moulded upper panels to the exterior. The staining also only covers the upper, suggesting something else was positioned against the south side. The interior of the cloakroom is fitted with a row of hooks on a timber board to the north.

Figure 15: The interior north wall of the chapel with the central door opening; viewed from the south-west.

The central timber door is panelled and moulded as to the exterior and fitted with a reused timber stock lock and bolts to top and bottom of the east door with a latch to the west. The fan light above retains some decorative glass within the western of four lights within the arch.

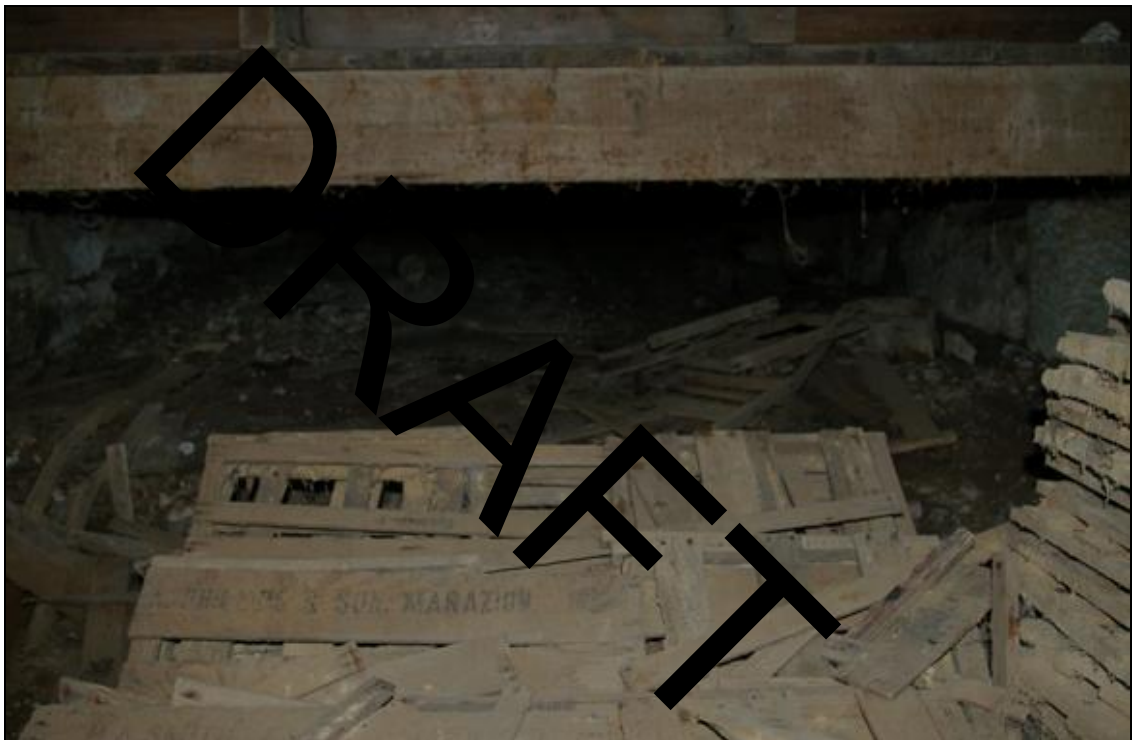
The floor is comprised of 7 inch pine boards with a large central area raised up by one boards thickness, with chamfered edging cut to east and west by the position of the former pews but with no marks or scars elsewhere (see Figure 11). There are two steps up at the south end of the room to the final 7.6" (2.30m). The lip of the top step is cut to east and west in the position of former pews positioned facing inward (those to the north within the body of the chapel would have faced towards the south end). The first step up has two sections of the riser that can be removed- for ventilation? To the south-west is a small hatch in the floor down to a small cellar or fuel store, also accessed from the exterior. The cellar appeared to only occupy the

south-west corner of the building and at the time of the survey contained a large number of flower boxes marked H A SMITH & SON MARAZION (Figure 16). The floor of the chapel was seen to be supported on dwarf masonry walls

Figure 16: The interior of the former cellar/fuel store under the south-west corner of the raised platform; viewed from the south.

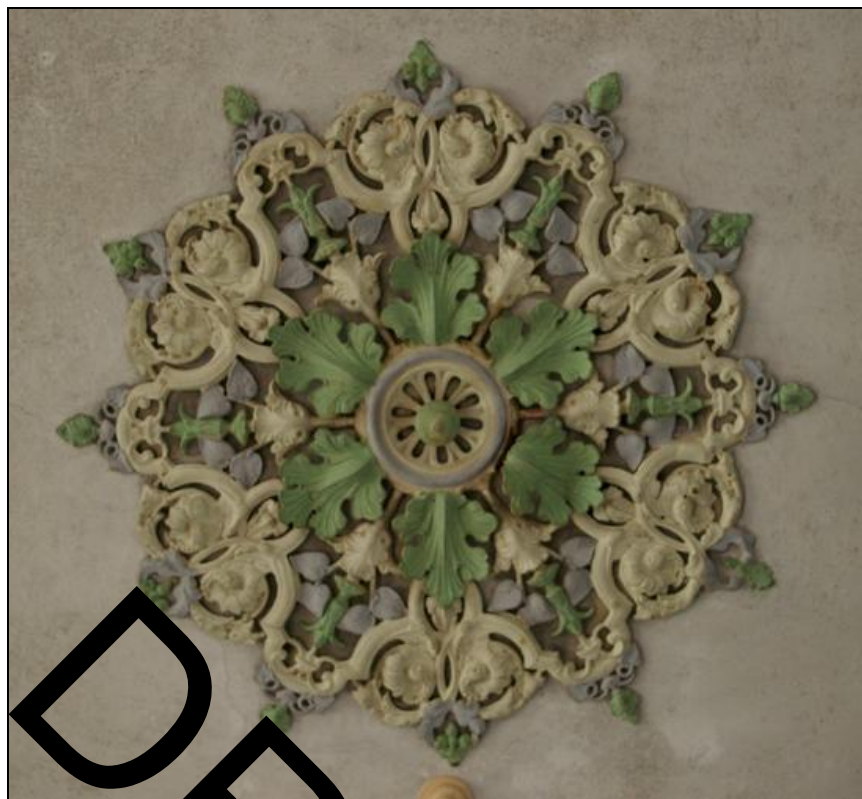
The ceiling is plastered, with a central decorative ceiling rose, probably also with the practical use as a vent, and six symmetrically placed flanking fittings for former gas light fittings, with chains falling from the centre. There are also two 20<sup>th</sup> century light fittings to centre west and a hatch to the roof space to the north above the door opening. The ceiling also, unusually, has a large amount of graffiti comprising mainly of names and dates. This apparently dates from the last half of the 20<sup>th</sup> century when this building was used as a store for flowers prior to their distribution. They were often piled so high that they could be climbed to the ceiling (Steve & Mr Smith (former owner) *pers. com.*). These boxes were presumably as those piled in the cellar. The earliest dates observed were from the 1940s.

Figure 17: The central ceiling rose and vent.

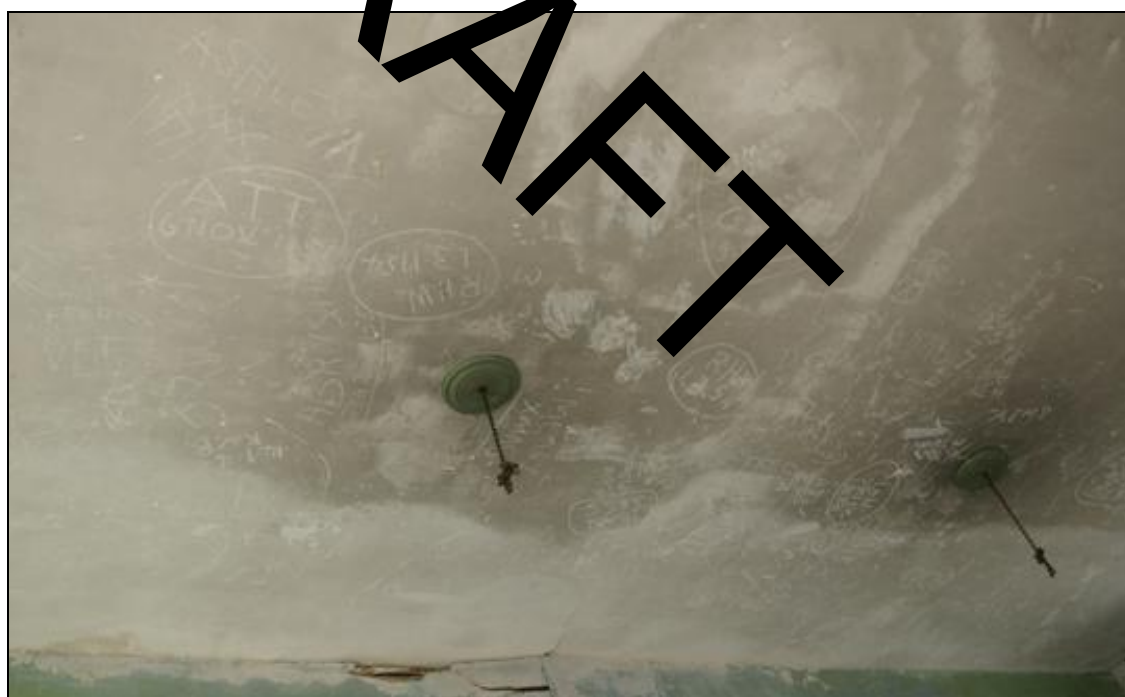
Figure 18: The ceiling above the raised alter platform, showing mid-late 20<sup>th</sup> century graffiti.

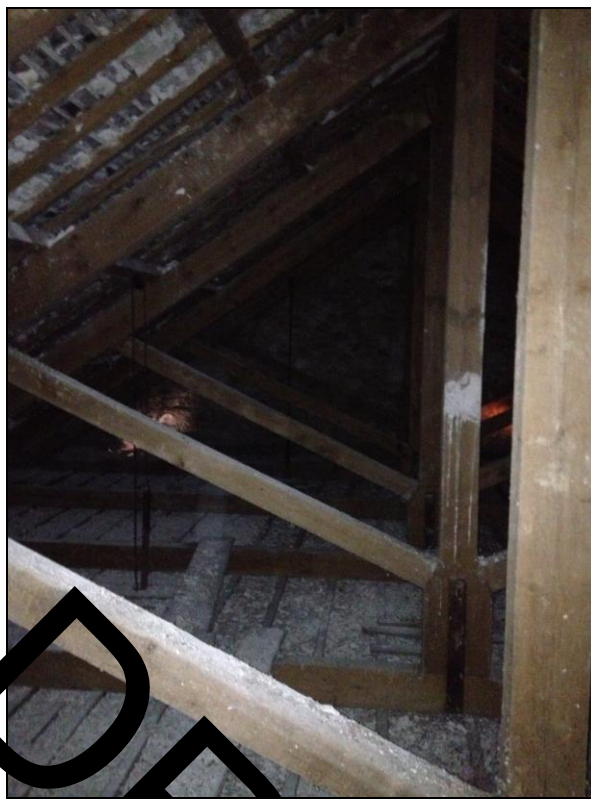
The roof structure is comprised of 19th century kingpost trusses, the kingposts fixed at the base by metal brackets to the tiebeams (Figures 17 & 18).

Figure 19: The kingpost roof trusses on the east pitch of the chapel, viewed from the north.

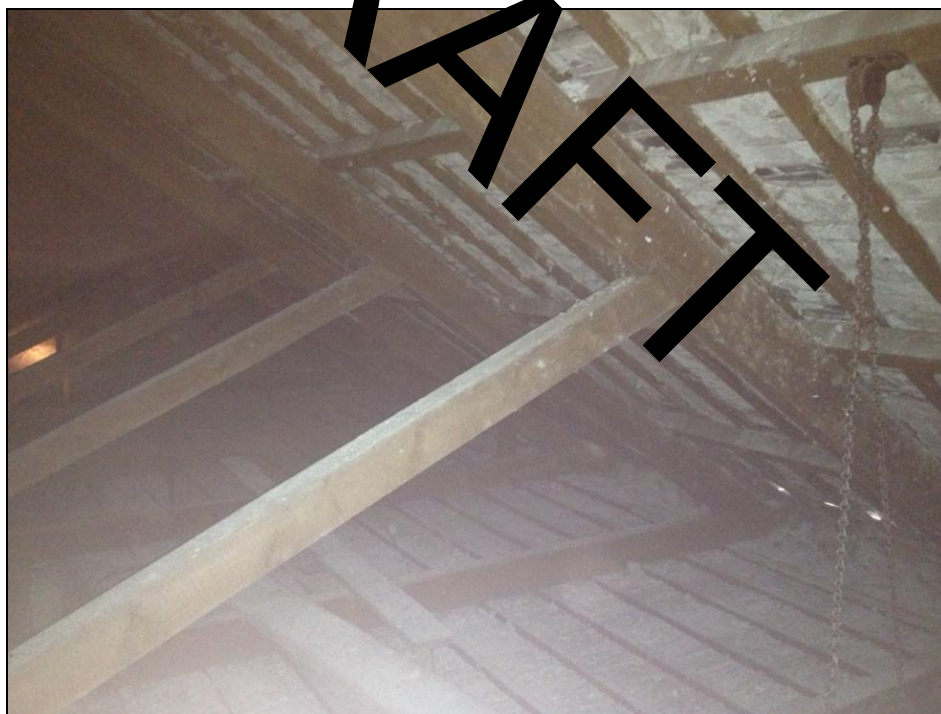
Figure 20: The truss blades, purlins and struts on the west pitch of the roof, viewed from the north.
