Historic Building Record

For The Fleece, 8-10 Northgate,

Hartlepool

TA06/07

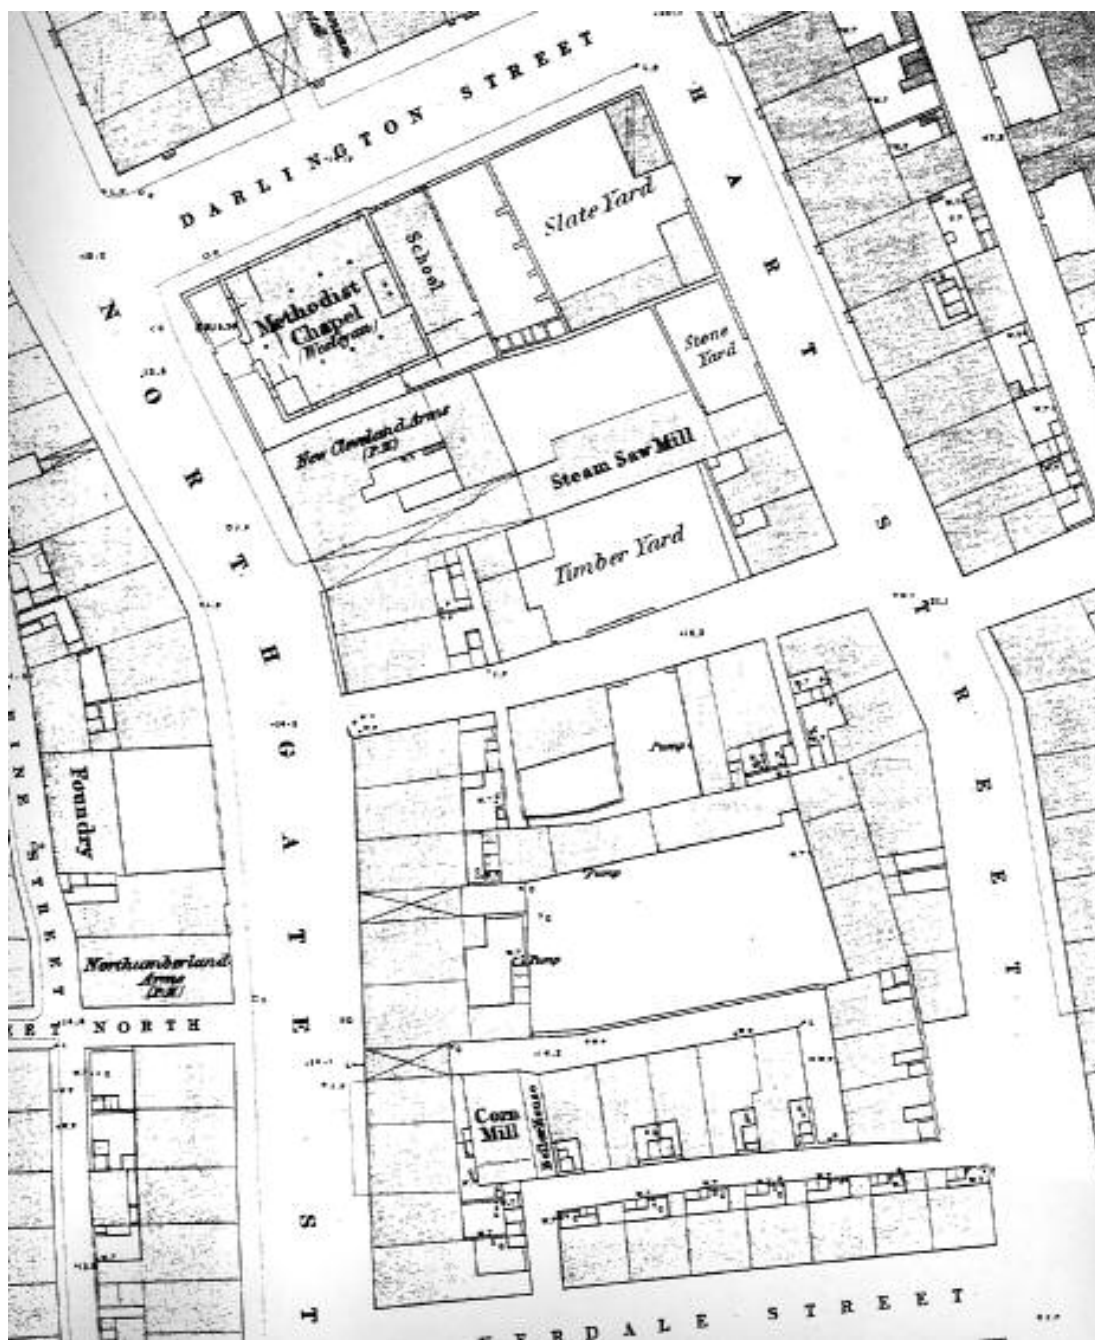
Figure 1.

The building is shown on the 1857 Ordnance Survey map (Figure 1.) as the New Cleveland Inn. J.T.W. Bell shows an unnamed building, with a similar floor plan, on the 1841 plan of the Port and Town of Hartlepool (Figure 2).

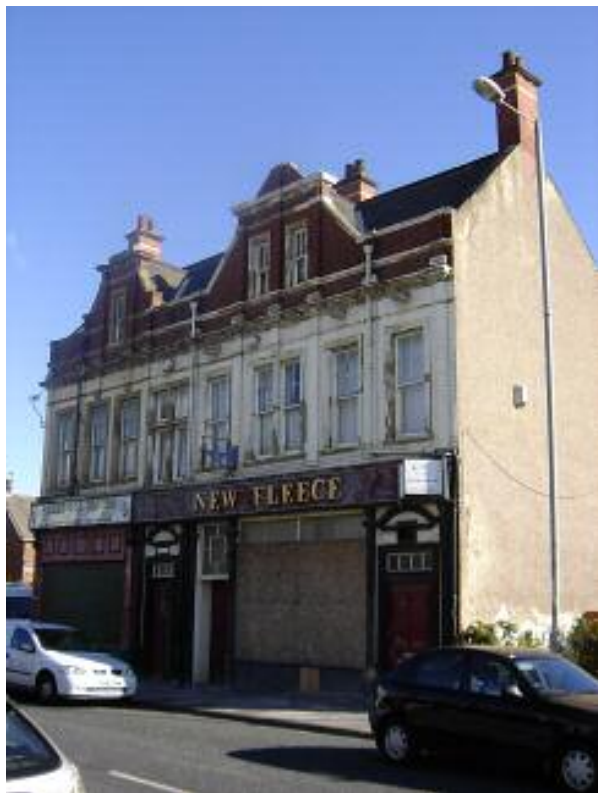
Figure 3.

The principal elevation of the public house is south facing with its large front window dominating this aspect of the building. There are three front doors all with panelled windows above them, two of which are matching with arches above the doors and columns on either side. (Figure 3.) The columns are in a Greco-Roman style, (Figure 4.) which was extremely popular in the Victorian period. Above the front façades there is a row of ten sash windows and above them in the attic there is a double sash window above The New Fleece and a single one above number 10/The Shop.

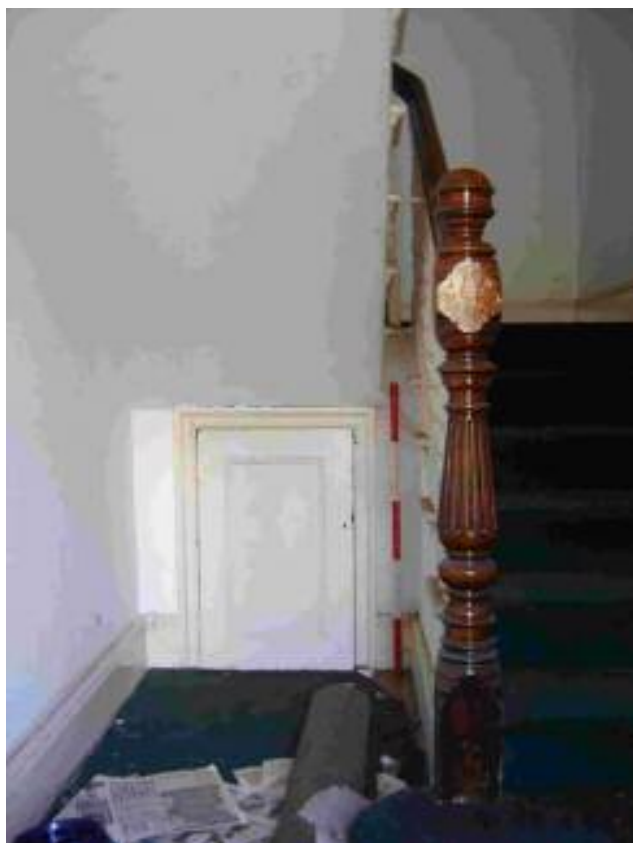
Figure 5.

Each of the doors was double and had six panels. In the entrance to number eight there is a very small vestibule, about 8 inches deep with a second panelled window above. In the entranceway to number eight the original 8-inch skirting board still remains, as does the cupboard under the stairs and banister and rails. (Figure 5.) As there is no longer a dividing wall between number eight and number ten, there is a doorway just before the stairway of number ten that leads into the entrance hall of number eight. Here there still remains the original plaster moulded ceiling. (Figure 6.)

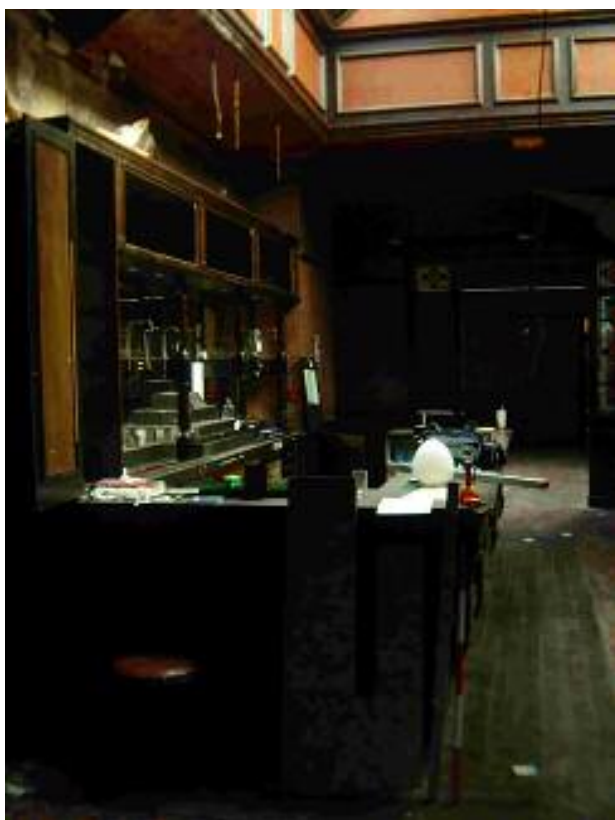
Figure 7.

When entering the bar there is a small area to the south where box seating has been arranged around the front window. To the north is the main bar area, known as the long bar by locals (Figure 7.). Above this there is a leaded glass roof with a floral decoration. (Figure 8.) This decoration is carried on throughout the bar area as the doors, seating alcoves and the dividing doors into the lounge area have stained glass windows of a similar, if not more elaborate design incorporated into them. (Figure 9.). The entire bar is thought to have been refit in the past 20 years.

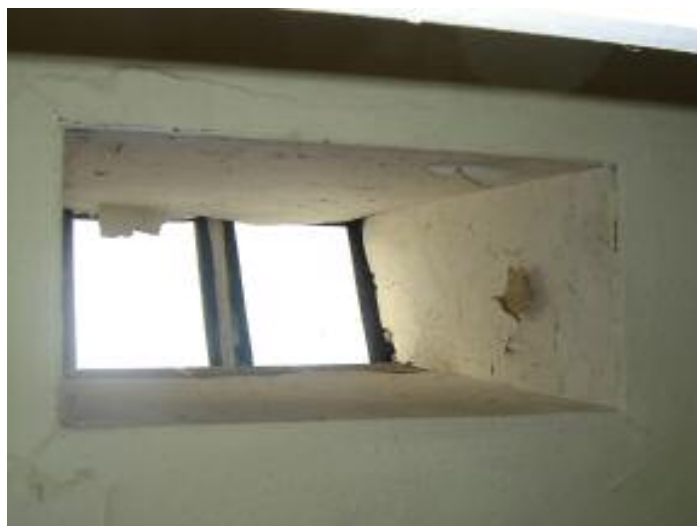
Figure 10.

Original features of the toilets include a central skylight in the men's (Figure 10.) and the original ceiling mouldings in the ladies (Figure 11).

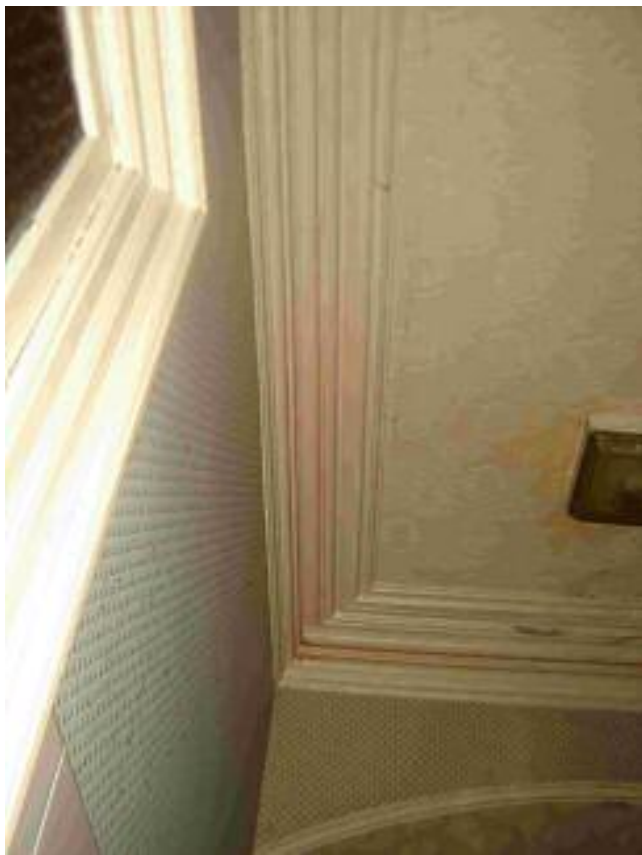
Figure 12.

From this room there is a small corridor that leads to the stairs to the cellar. The cellar consists of four distinct rooms, three of which are in a line, progressing to the south and the pavement. In the first room there still remains the hatch from the beer casks to be unloaded into the cellar. (Figure 12.) The walls are typically made of rough limestone and some brick. (Figure 13.) On the west wall of the cellar there are the remains of the pipes for the beer pumps (Figure 14.) and on the east wall there is a sink and drain. (Figure 15) To the east of the central room/area there is a small basement room for under number ten, however only accessible from The Fleece's cellar. At the very front of the property there is a smaller room and this is where the fuse boxes are kept. (Figure 16.)

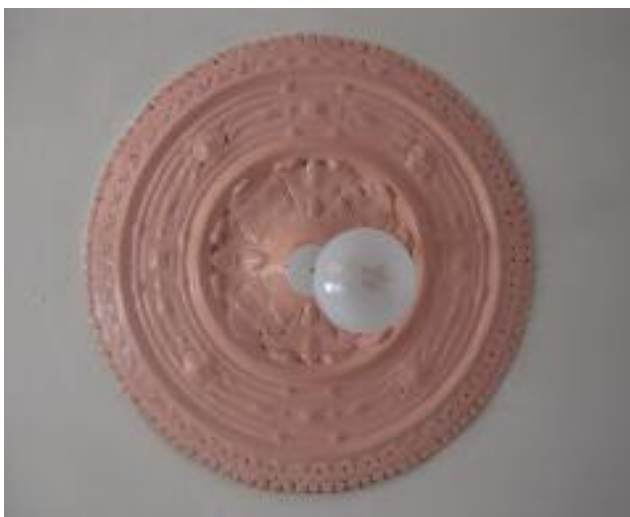
Figure 17.

The second storey formed the living areas above both of the businesses. The main living room is the first room accessed by the stairs and is on the west hand side of the house. It has three sash windows and 9-inch skirting boards. This was presumably the main 'receiving room' for guests. The small central room to the front of the building had been completely refurbished and no original features remain. The room to the far east of the building has a single and a double set of sash windows, the original ceiling rose (Figure 17.) and the original built in cupboard. This cupboard has the original carpentry on the doorframe, however the door itself is not original. (Figure 18.)

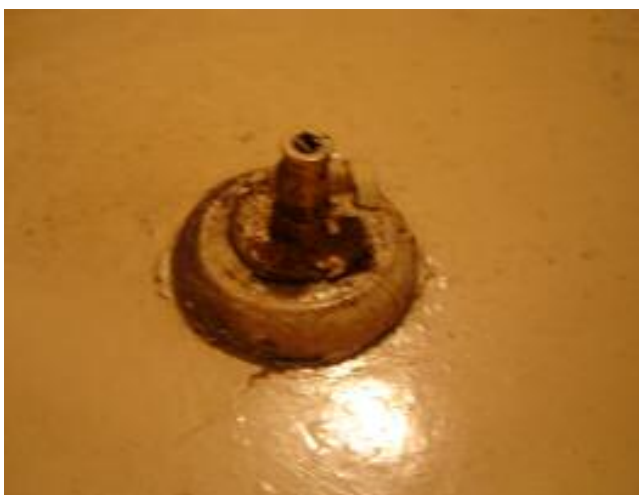
Figure 19.

On this floor but towards the back of the building are the kitchen, bathroom and the staircase to allow entry in to the back yard. On the stairs down to the yard there is a singular remaining gas light fitting (Figure 19.) and the evidence of where another just by the door had been removed.

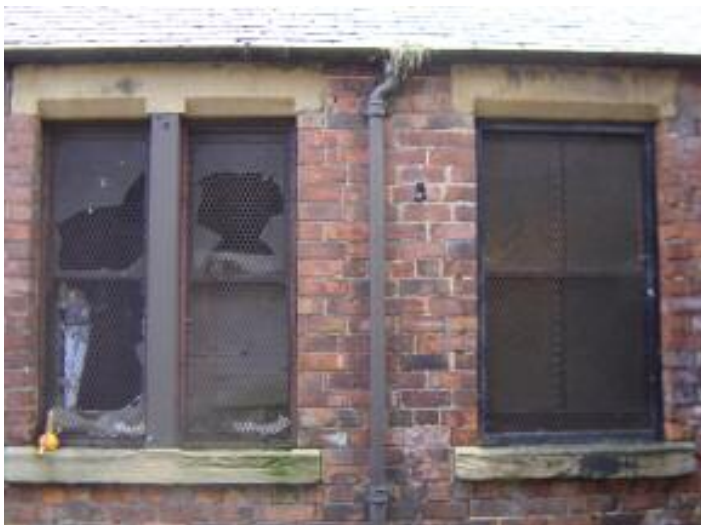
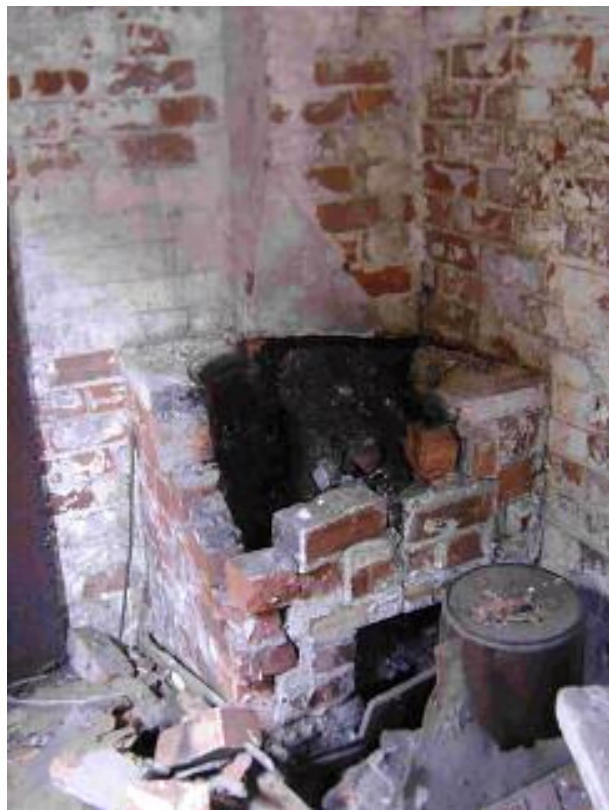
Figure 20.

At the bottom of the stairs there is a toilet and outside there is a washhouse with a boiler attached to the back of The Fleece, (Figures 20 & 21.) but accessible only through the yard. Built against the limestone boundary wall and the back of the down stairs toilet there are three further small out houses. The first is approximately 2m wide and 3m long, the second is approximately 1.5m square with surviving shelving and is a mirror of the final out house, however this out house has lost all of the shelves. (Figure 22)

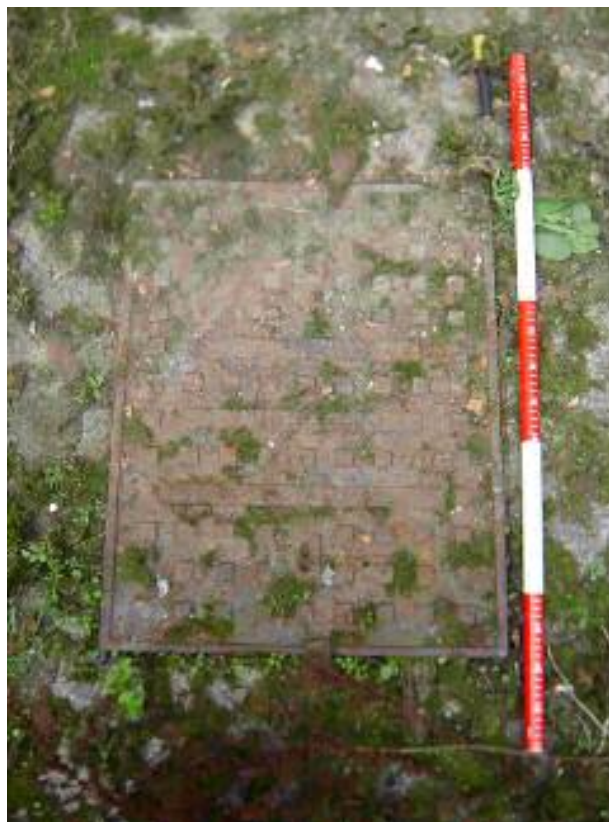
Figure 23.

In this yard there is a drain cover, just by the entrance to both the shop and the stairway into the main house. (Figure 23.). This drain cover reads, 'Joseph Howe, Contractor, West Hartlepool'. Hartlepool (the headland) and West Hartlepool were separate political entities until the end of the 1960s.
