SURVEY OF FOUR WORLD WAR II AIR RAID SHELTERS, HARPENDEN, HERTFORDSHIRE

on behalf of Harpenden Town Council

MAY 2007

ASC: 896/HAS/1

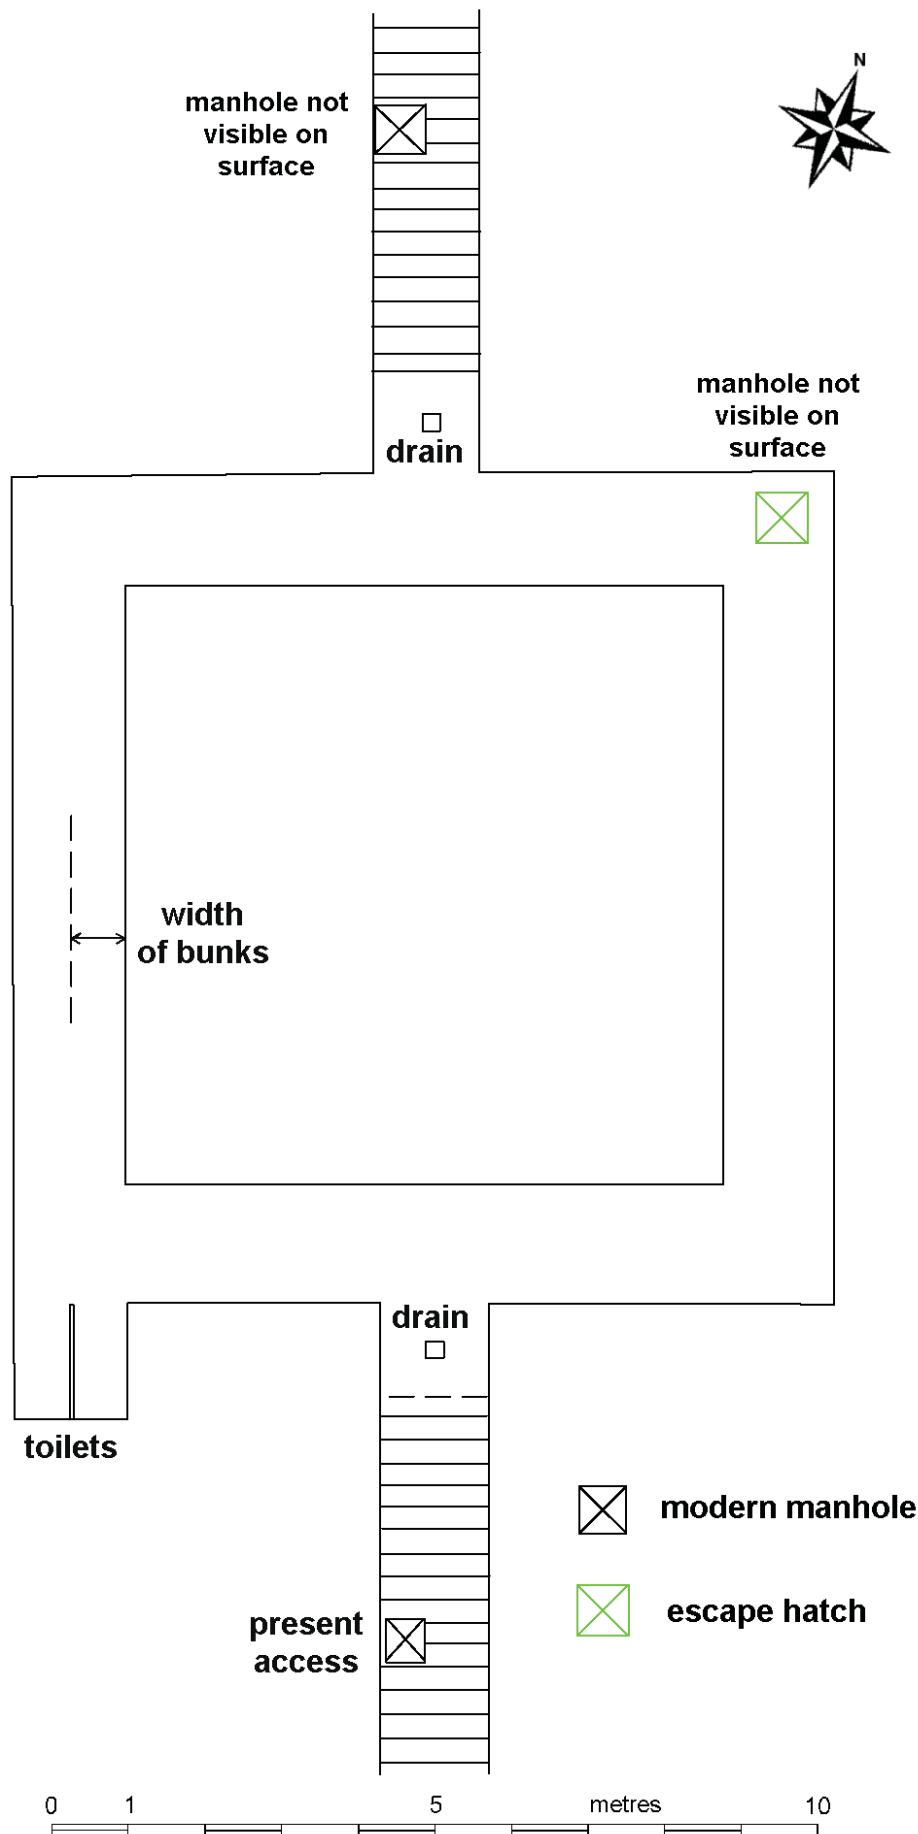
Figure 10: Queens Road shelter (scale 1:100)

Layout: In the Queens Road shelter the passages, totalling 36m in length, form a square with entrances to the north and south. The toilets are located at the south corner, c.4m from the south entrance. There is a single escape hatch in the north corner. From the surviving wall fixings, the aforementioned bunks appear to have been located against the inner walls on the north-east and south-west sides, with a passage around the outside.

Capacity: Seated c.120, allowing for benches on both sides of the passage. Bunks would have significantly reduced the shelter's capacity to c.76, comprised of 60 seats and 16 bunks.

Condition: Generally sound and dry. Access is presently by the manhole over the south entrance. The manholes over the north entrance and escape hatch are not visible on the surface.

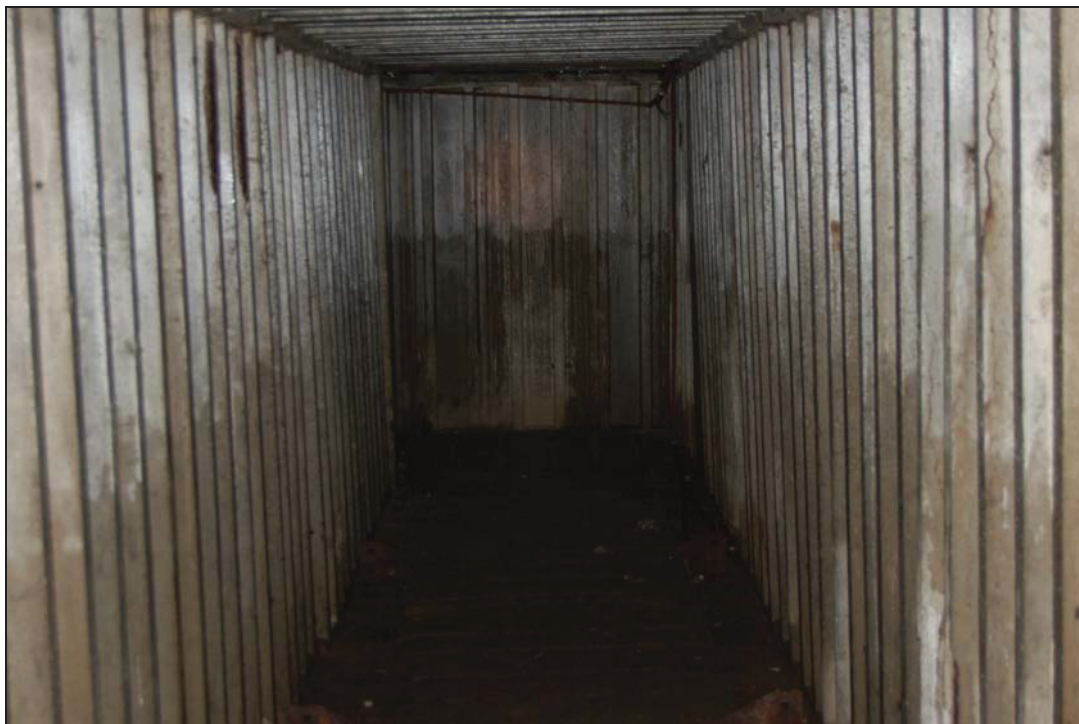
Plate 1: Bowers Parade, interior

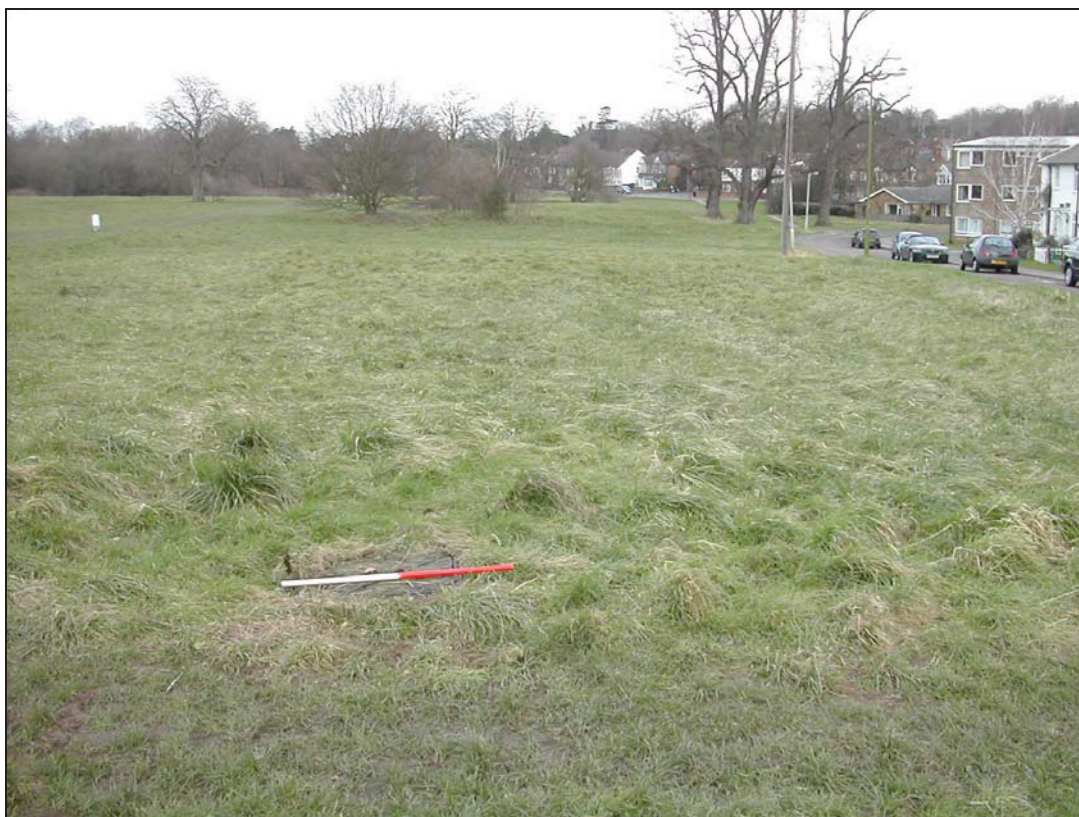
Plate 2: Queens Road, exterior (entrance in foreground)
