**HISTORIC BUILDING RECORDING :
DUKE OF YORK PH
19 WATFORD ROAD
CROXLEY GREEN
HERTFORDSHIRE**

on behalf of Simpson McHugh

July 2007

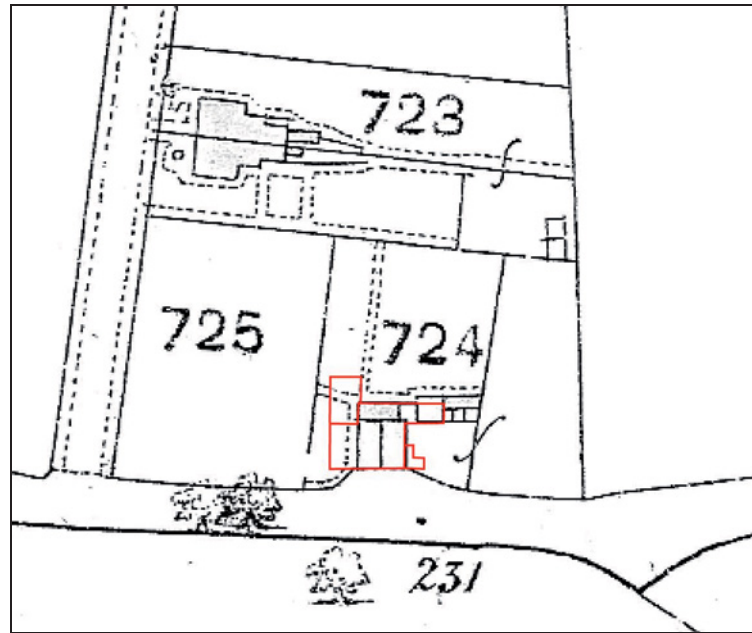
Figure 3: Extract from the 1878 Ordnance Survey Map (*not to scale*)

The earliest known cartographic evidence for the building is the 1st edition 1878 Ordnance Survey Map (Fig. 3). There are additional structures to the rear of the main building, which extend eastwards to form an open courtyard. There appears to be little change in the 1898 Ordnance Survey Map (Fig. 4), but by 1914 the extension to the west of the building has been added (Fig. 5).

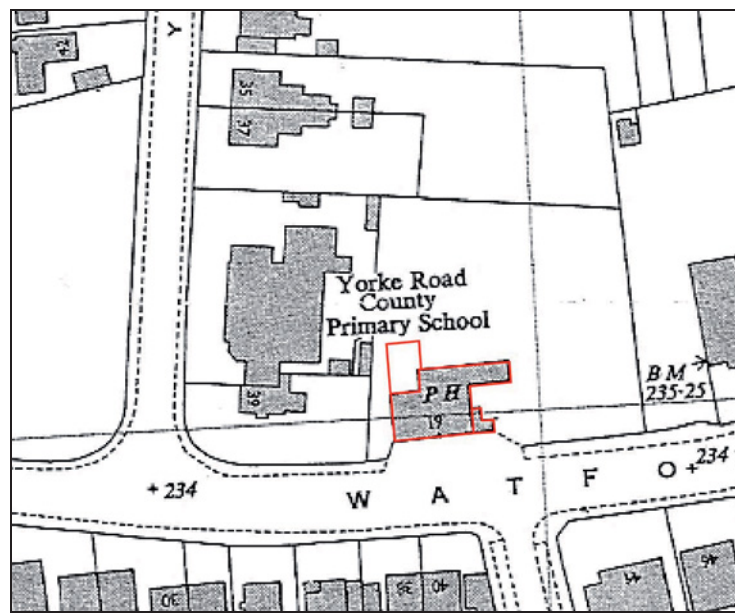
Figure 6: Extract from the 1961 Ordnance Survey Map (*not to scale*)

Most of the changes occurred between 1914 and 1961, when the original outbuilding to the rear were demolished and the present extension added to the northeastern corner of the building (Fig. 6). The extension to the southeastern corner of the building also occurred within this time frame. The extension to the northwest was added some time between 1961 and the present (Fig. 2).

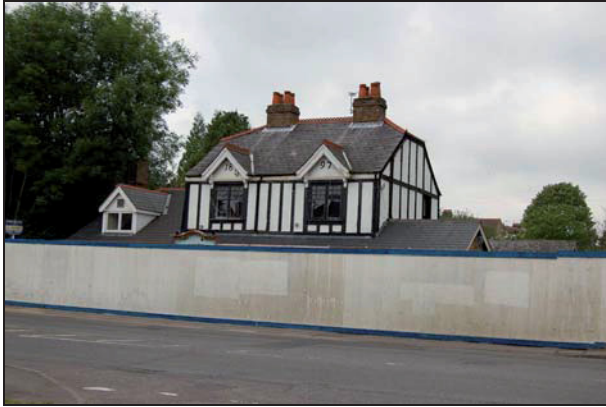
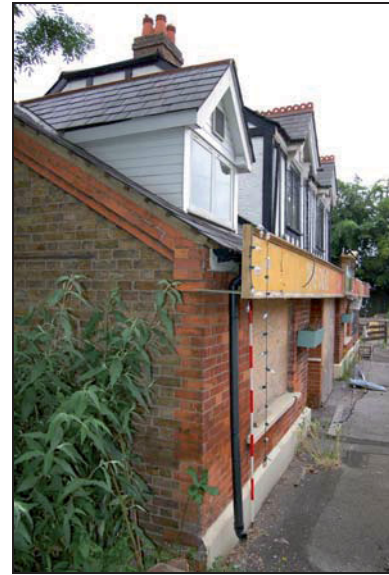
This is the front elevation of the building. The ground floor of the 19th century core of the building is brick built and the first floor is rendered with decorative timber studs. The brickwork is in a Flemish Bond and there are queen closers to all the openings. There is a 0.45m high plinth painted yellow at the base of the elevation. There are later brick extensions to either side of the 19th century core, and a brick entrance has also been added to the original front door.

The main entrance has a single fixed window on either side with a large pane of glass below 9 smaller panes. There is a bullseye in alternate smaller panes of glass. There are two larger windows with 9 lights at either end of the ground floor. A pub sign is located in front of the ground floor guttering and runs the entire width of the extensions. Behind this is a form of pentice roof.

The extensions are of red brick set in a Flemish Bond in cement mortar, with queen closers marking the window and door openings. The first floor of the Victorian build is rendered, painted white and decorated with black timber studs. There are two dormer windows under gable roofs with the date 1897 divided between the two. The windows are timber casements, similar to those on either side of the front door. The roofs are slated with decorative ridge tiles in red on the main, half-hipped roof as well as those over the dormer windows. There are two sets of 4 chimney pots on brick stacks.

The extension to the west of the Victorian structure has a modern 2-light dormer window with an air vent in the gable above.

Plate 1: South elevation

Plate 2: South elevation

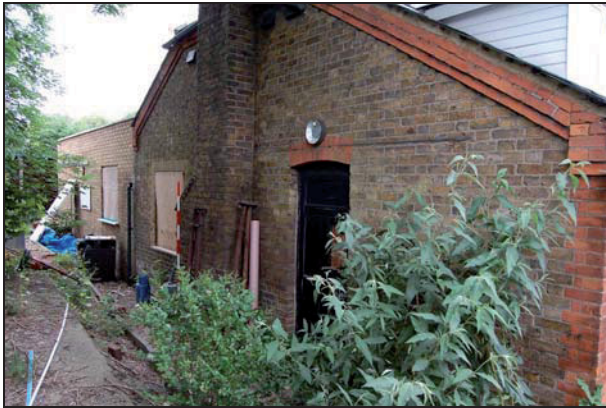
Plate 3: West elevation

The southern end of the west elevation is the earliest (early 20th century) extension to the building. It has an external, brick built chimneystack, with a single door to the south and a window to the north. The door has a cambered red brick relieving arch and the window has a yellow brick surround with a soldier course providing the lintel above, and is clearly a later insertion. The brickwork, which is predominantly yellow, is set in a Flemish Bond with decorative courses in red brick below the eaves and at the southern end of the wall. The roof is half-hipped with a slate covering.

The northern end of the elevation consists of a modern, flat-roofed extension built in a Stretcher Bond. There is a window (now boarded up) at the southern end of the with a plastic sill and no relieving arch.

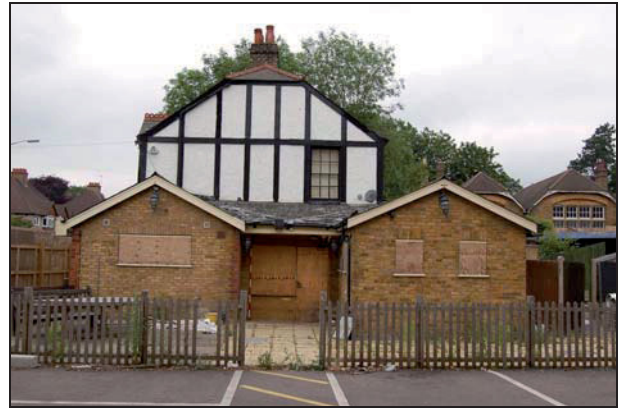
Plate 4: East elevation

The ground floor of the east elevation also consists of later extensions, but the rendered and timbered first floor of the Victorian structure is still visible above. It has a single 9 over 9 light window towards the northern end of the elevation.

The ground floor extensions consist of a gabled single storey structure to either side of a side door into the pub also built within a new extension. The southern extension has a long window with a soldier course above, and two smaller windows with soldier courses light the extension to the north of the door, as does a window in its southern elevation. The extensions differ in that the southern one has red brickwork at the corners incorporating queen closers, whereas the northern extensions remains undecorated. Both extensions are in a Stretcher Bond, but the colour of the bricks as well as that of the mortar is slightly different.

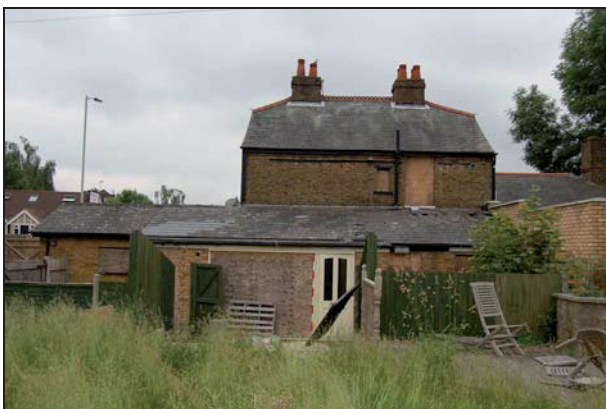
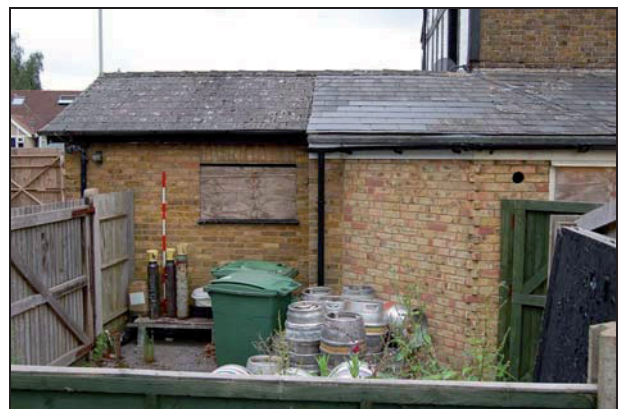
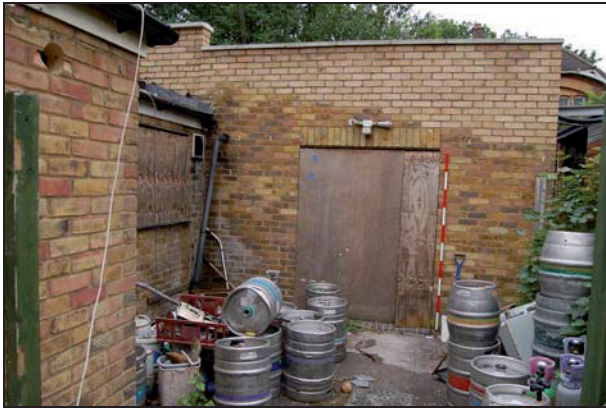
Only the first floor of the Victorian building is not obscured by later extensions. It has a large 4-light window to the east of a small, 6- light window.

The ground floor consists of a number of extensions that incorporate a half glazed rear door to the pub, another, now boarded door into the private area to the rear of the kitchen, a window under a soldier course in the eastern extension, and a further window in the extension to the west of the door.

Plate 5: North elevation

Plate 6: North elevation, east end

Plate 7: North elevation, west end

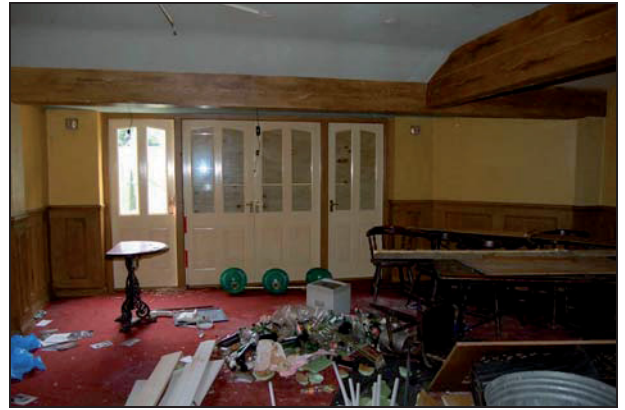
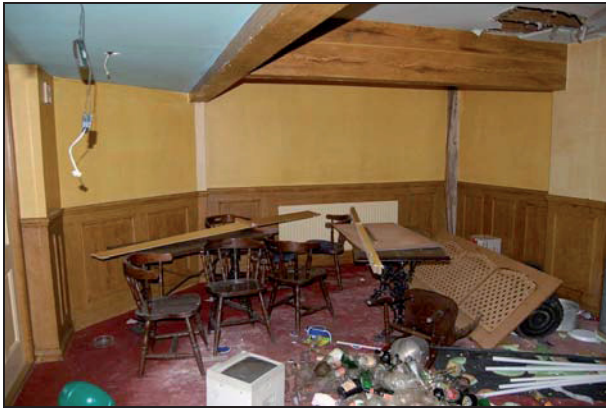
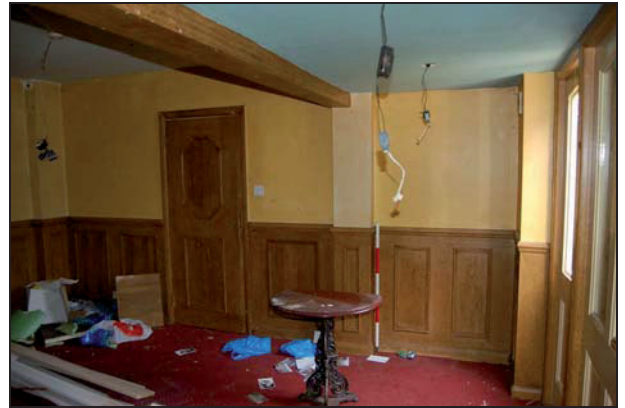
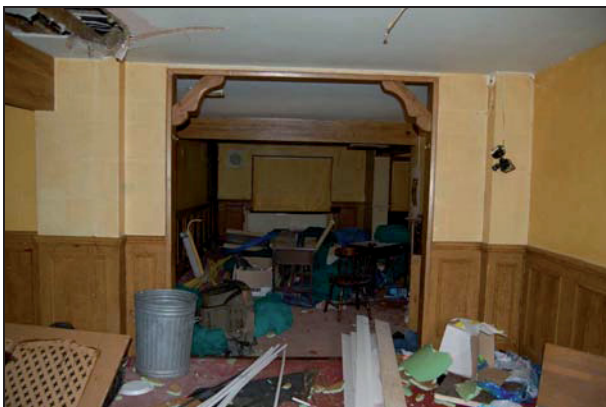
Description: This has four half glazed doors in the north wall opening into the garden, a single panelled door leading into the internal lobby (G6) and is linked to G2 (Bar Area 2) by an opening in the north wall. The walls are half panelled with wallpaper above, some of which is demarcated to give an ashlar stone effect. The ceiling is painted and has large axial beams providing a decorative effect. The floor is carpeted.

Plate 8: Room G1: north wall

Plate 9: Room G1: east wall

Plate 10: Room G1: west wall

Plate 11: Room G1: opening to Room G2

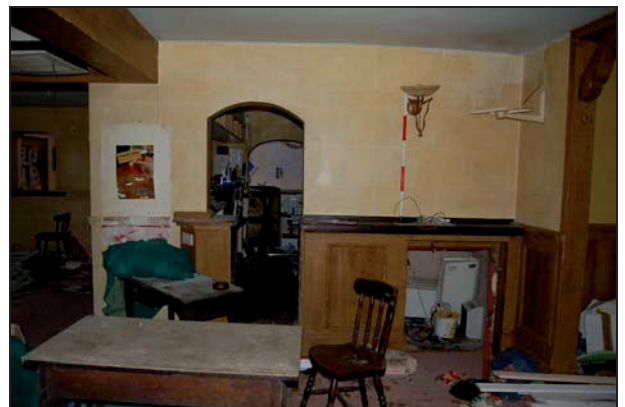
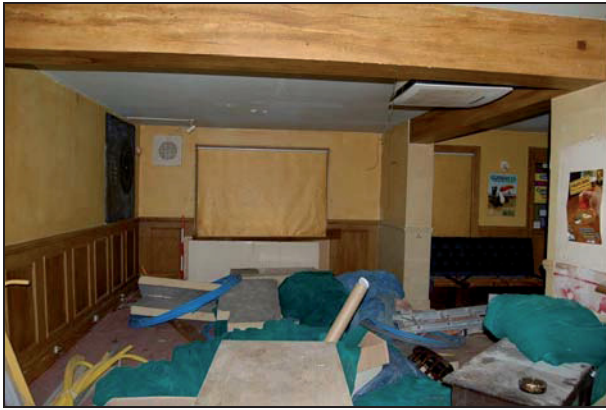
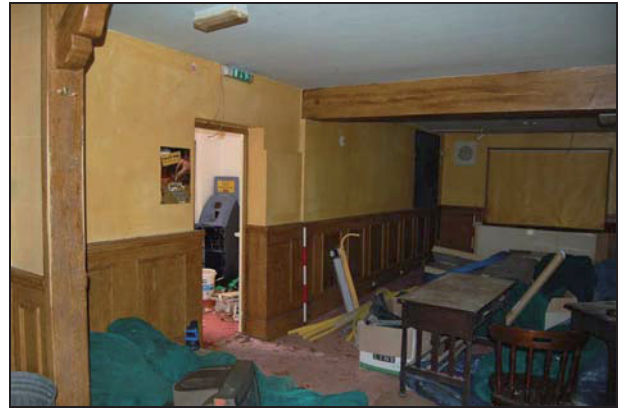
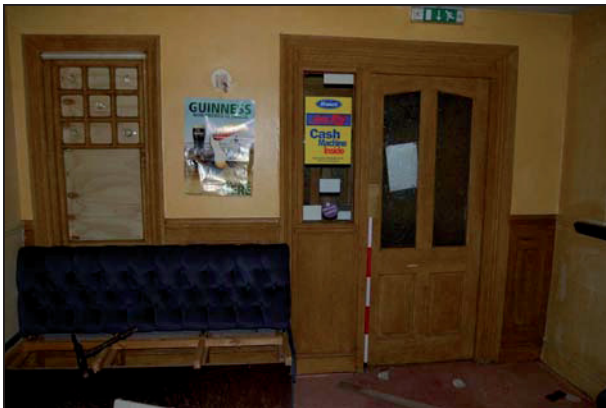
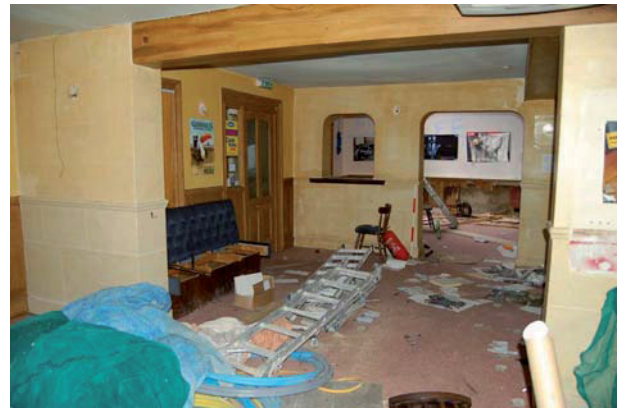
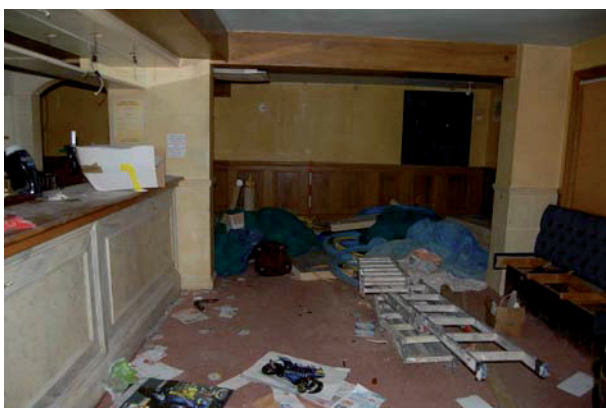
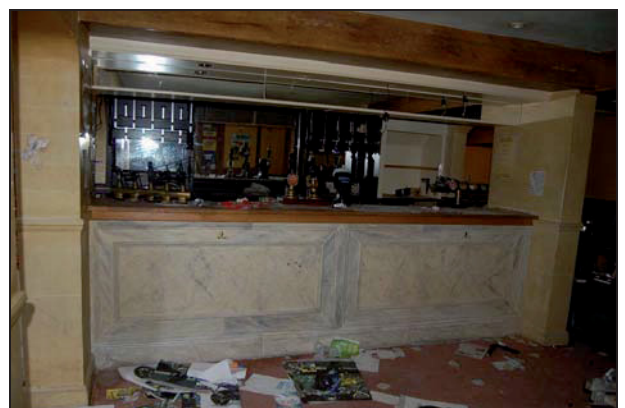
Description: This is an L-shaped room that has the front door in the south wall and the bar immediately opposite it. The décor is the same as in Bar Area 1 (G1) with the addition of a blackboard in the southeast corner and a shelf opposite the door in the east wall leading to the external lobby (G7). Both doors are half glazed and the front door has a window to the east of it. The windows in the south wall are as described in Section 4.2 above.

Plate 12: Room G2: west wall

Plate 13: Room G2: south wall

Plate 14: Room G2: east wall

Plate 15: Room G2: south entrance

Plate 16: Room G2 looking west

Plate 17: Room G2 looking east

Plate 18: Room G2: bar

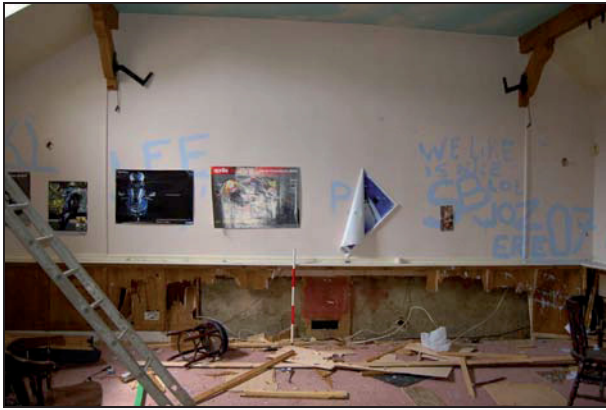
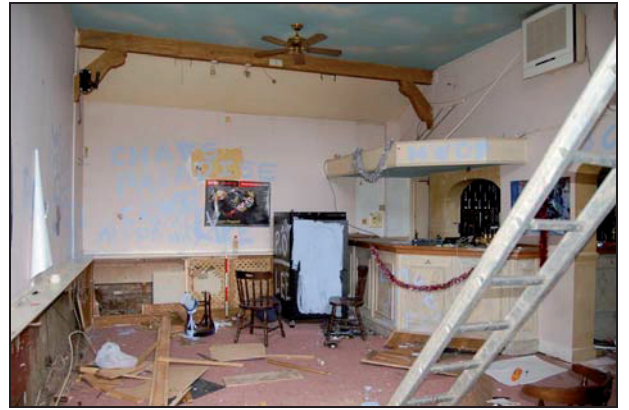
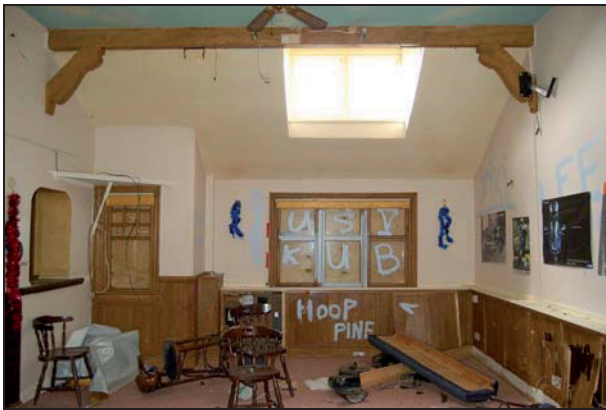
Description: This appears to have been a pool room, with a dormer window and two other windows in the south wall. The windows that were formerly in the west and north walls have been bricked up, as has the fireplace in the west wall. The panelling is shorter here than in Bar Areas 1 & 2, and it has a narrow shelf running above it. The ceiling is painted blue with clouds and there are two axial beams with decorative braces.

The bar doglegs around the northeast corner of the room, which is accessed by an opening in the wall between it and Bar Area 2 (G2).

Plate 19: Room G3: west wall

Plate 20: Room G3: north wall

Plate 21: Room G3: south wall

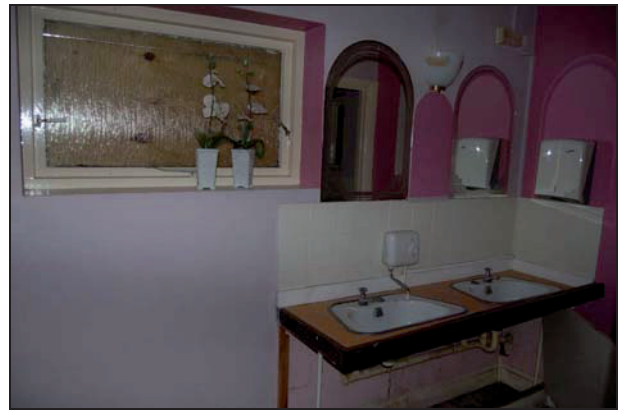
Plate 22: Room G8: north wall

Description: This modern extension houses the Ladies WC, which has a door with a single glazed opening in the west wall, a single light window in the north wall and another in the east wall. There are two cubicles along the south wall and two handbasins with mirrors above along the north wall. The walls and ceiling are painted and the floor is covered with vinyl tiles.

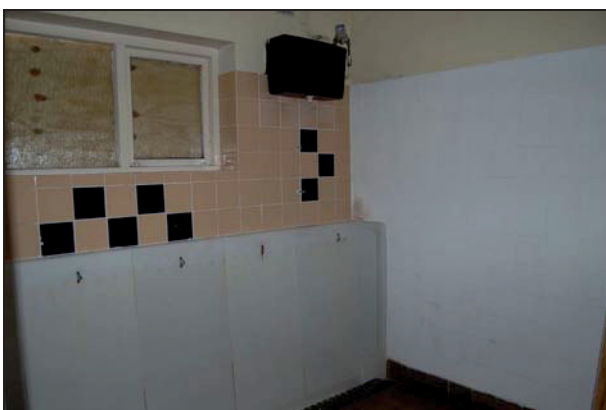
Plate 23: Room G9: east wall

Description: This houses the Gents WC, which is accessed by a door in the north wall. There is a large 3-light casement window in the east wall, a cubicle in the northeast corner of the room, urinals below the window, and a handbasin against the west wall. The walls and ceiling are painted and the floor has quarry tiles. There is also a hatch to the roof space.

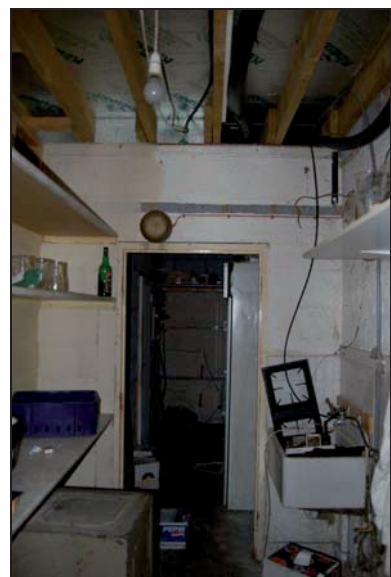
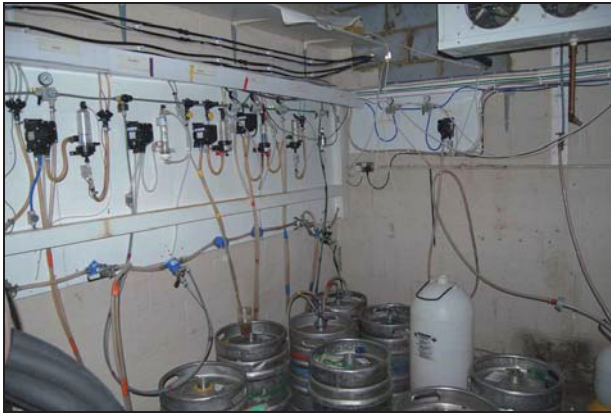
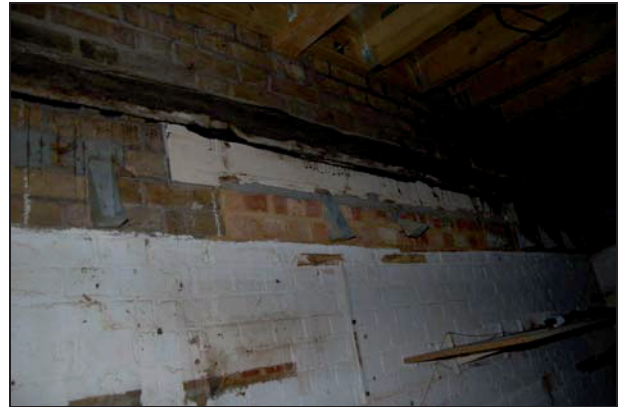
Description: This is the most recent extension to the building and has been subdivided to form an office, cellar and other service areas. It is breeze block and painted brick with a concrete floor. There are double service doors in the east wall and a 2-light window in the west wall. A window in the north wall of Room G3 has been bricked up, but the wooden lintel is still *in situ*.

Plate 24: Room G10: looking north

Plate 25: Room G10: cellar area

Plate 26: Room G10: lintel over bricked up window to G3

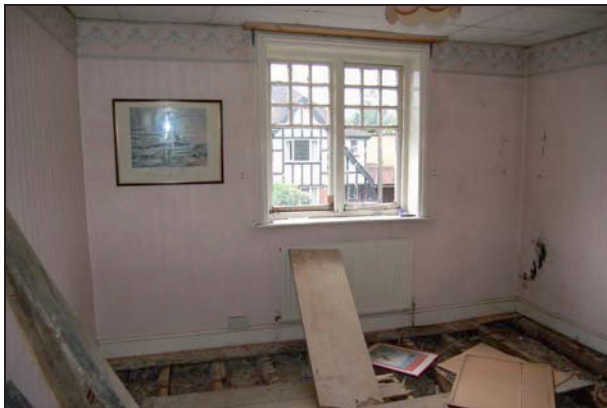
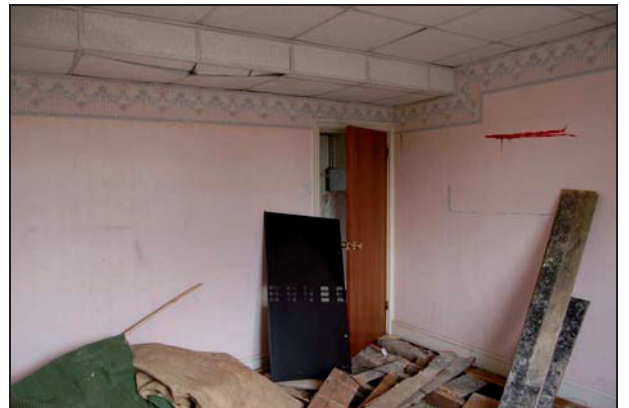
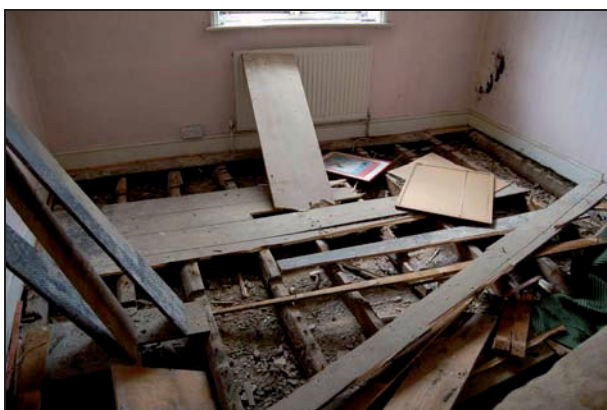
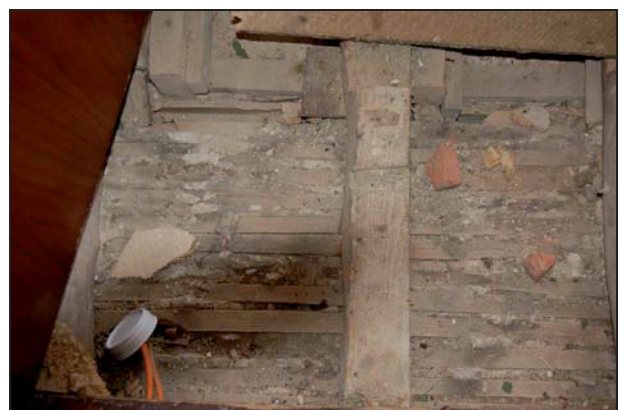
Description: The bedroom is accessed by a modern door in the north wall. There is a timber window in the south wall with 9 small panes over a single large pane in both sides of the casement. The walls are papered with a moulded skirting board and the ceiling is a modern suspended ceiling with polystyrene tiles. The floor boards, joists and the lath and plaster ceiling have been revealed by vandals. The boards run east to west, and all the timbers are machine sawn.

Plate 27: Room F1: south wall

Plate 28: Room F1: northeast corner

Plate 29: Room F1: floor

Plate 30: Room F1: lath & plaster ceiling below floor

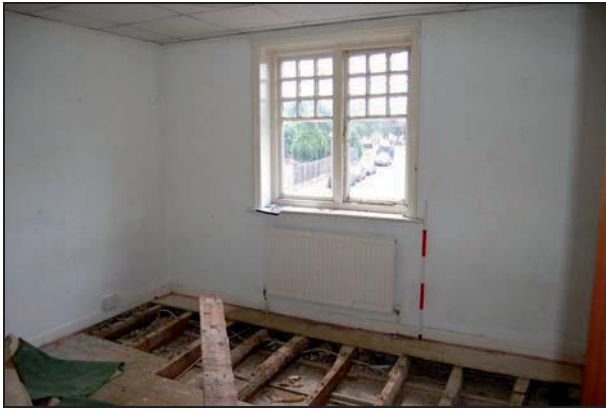
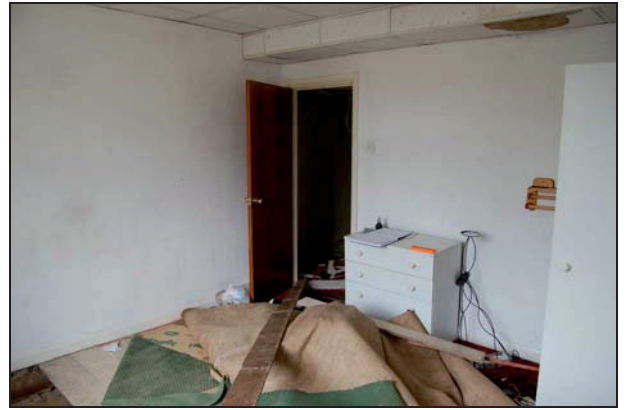
Description: The window, door, ceiling and floor are the same as Room F1, and the walls are also papered.

Plate 31: Room F2: south wall

Plate 32: Room F2: northwest corner

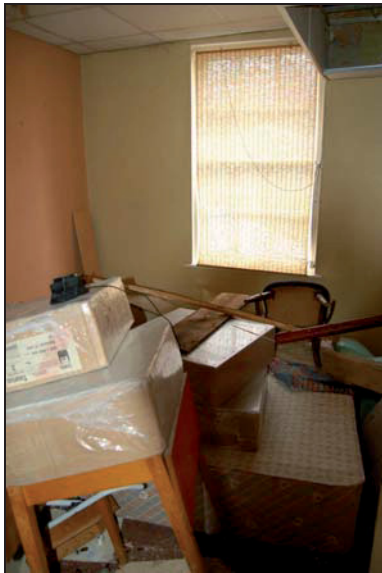
Plate 33: Room F3: east wall

Description: The room is accessed by a modern door in the southwest corner. The window in the east wall is a 12-light sash. The walls are papered, the floor carpeted and the ceiling is the same as in Room F1.

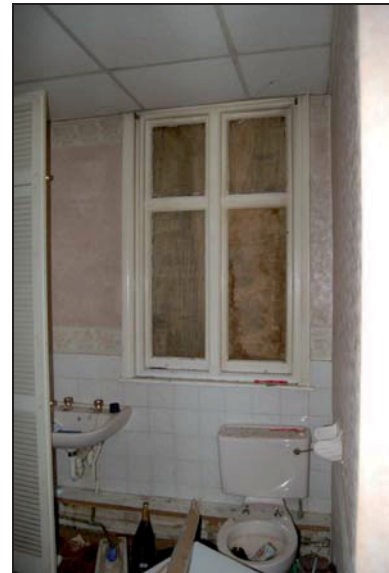
Plate 34: Room F4: north wall

Description: This is a bathroom with a corner bath in the southwest corner of the room, an airing cupboard in the northwest corner and a basin and WC against the north wall. There is a 4-light window in the north wall. The walls are papered and part tiled over the bath, basin and WC. The floor is carpeted over floorboards and the ceiling is the same as in the other rooms on the first floor. The room is accessed by a door in the east wall.

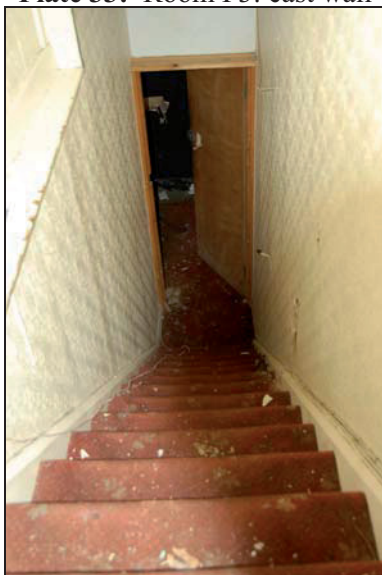
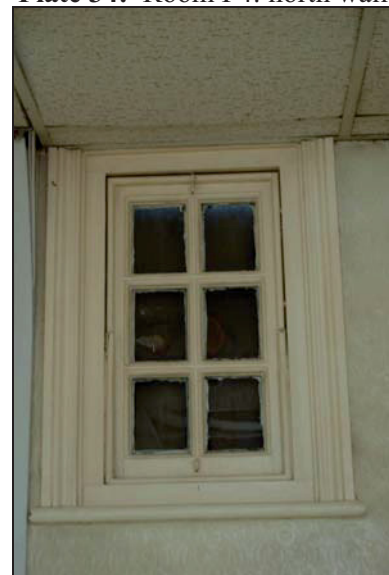
Description: The landing has a shelf running along the western side of the staircase, which is the base of the east wall of Room F4. There is a 6-light window above the staircase, which is enclosed and has 13 treads. The floor and ceiling are the same as in Room F1.

Plate 35: Staircase

Plate 36: Window over staircase

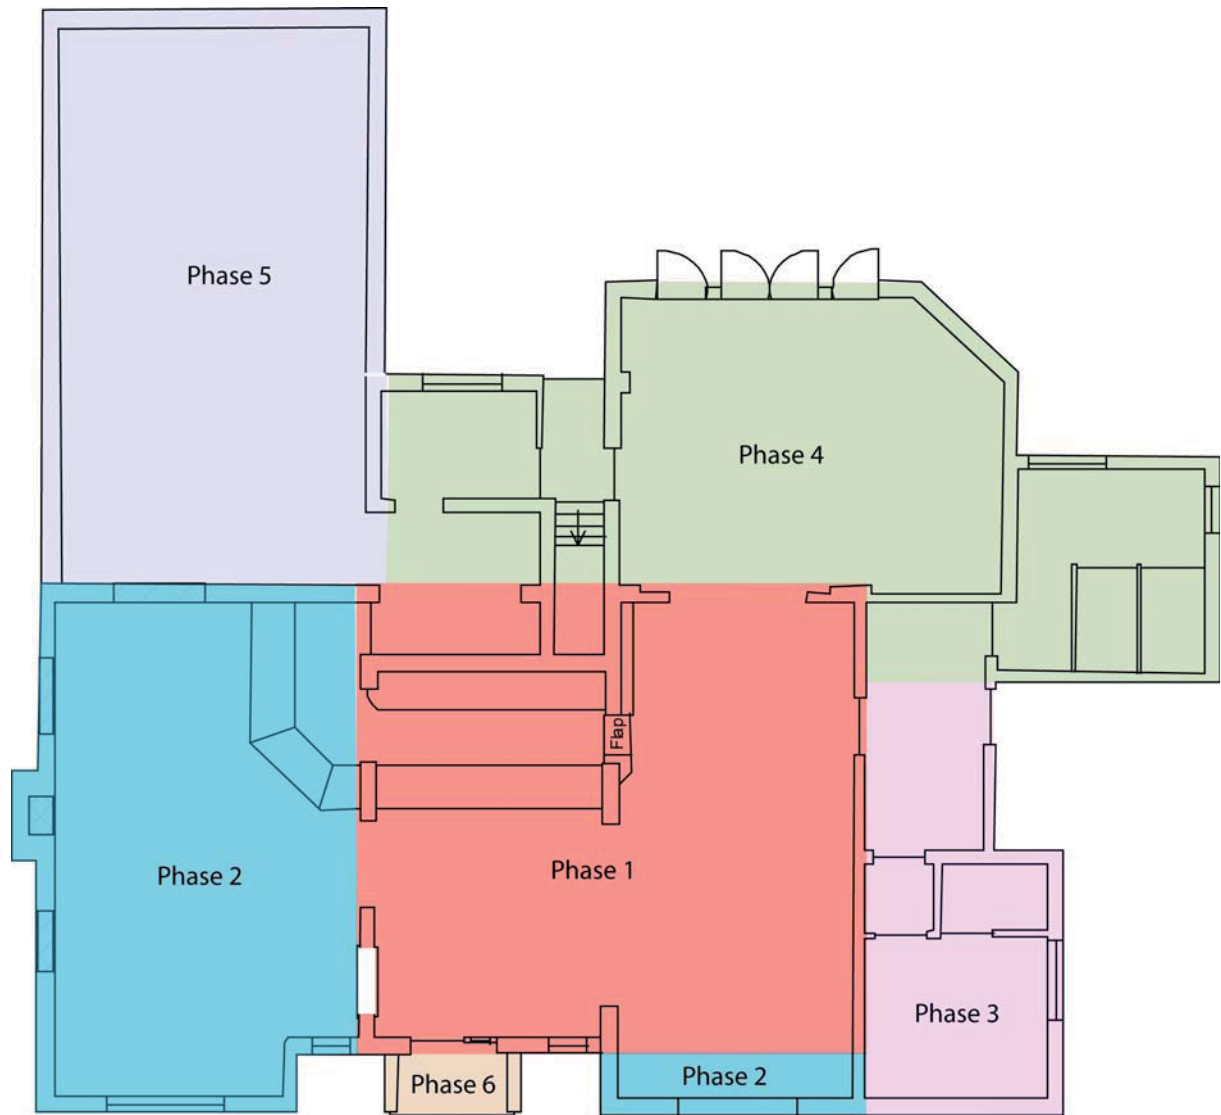
Figure 13: Phase plan (*not to scale*)

- 5.2** The building appears to have been initially constructed as a pub (Phase 1) and had a series of outbuildings to the rear that were replaced between 1914 and 1961. An extension was added to the west in the early 20th century, when the frontage was rebuilt and the smaller windows to either side of the front door installed (Phase 2). The extension in the southeast corner comprises Phase 3. The northern end of Bar Area 1 (Phase 4) appears to be a more recent amendment to the earlier extensions to the rear of the building and the northern part of the western extension, containing the service and cellar areas, is clearly of late 20th century date (Phase 5). The small brick extension to the front door is also of late 20th century date and has been assigned to Phase 6. Phases 4-6 are not closely dated and may be interchangeable. There is also a degree of survival of an earlier building within Phase 4 in that the staircase and kitchen extend into this. There is no architectural evidence for this other than the plan analysis.
