Anglo-Saxon Houses at Chalton, Hampshire

By P. V. ADDYMAN and D. LEIGH

Department of Archaeology, University of Southampton

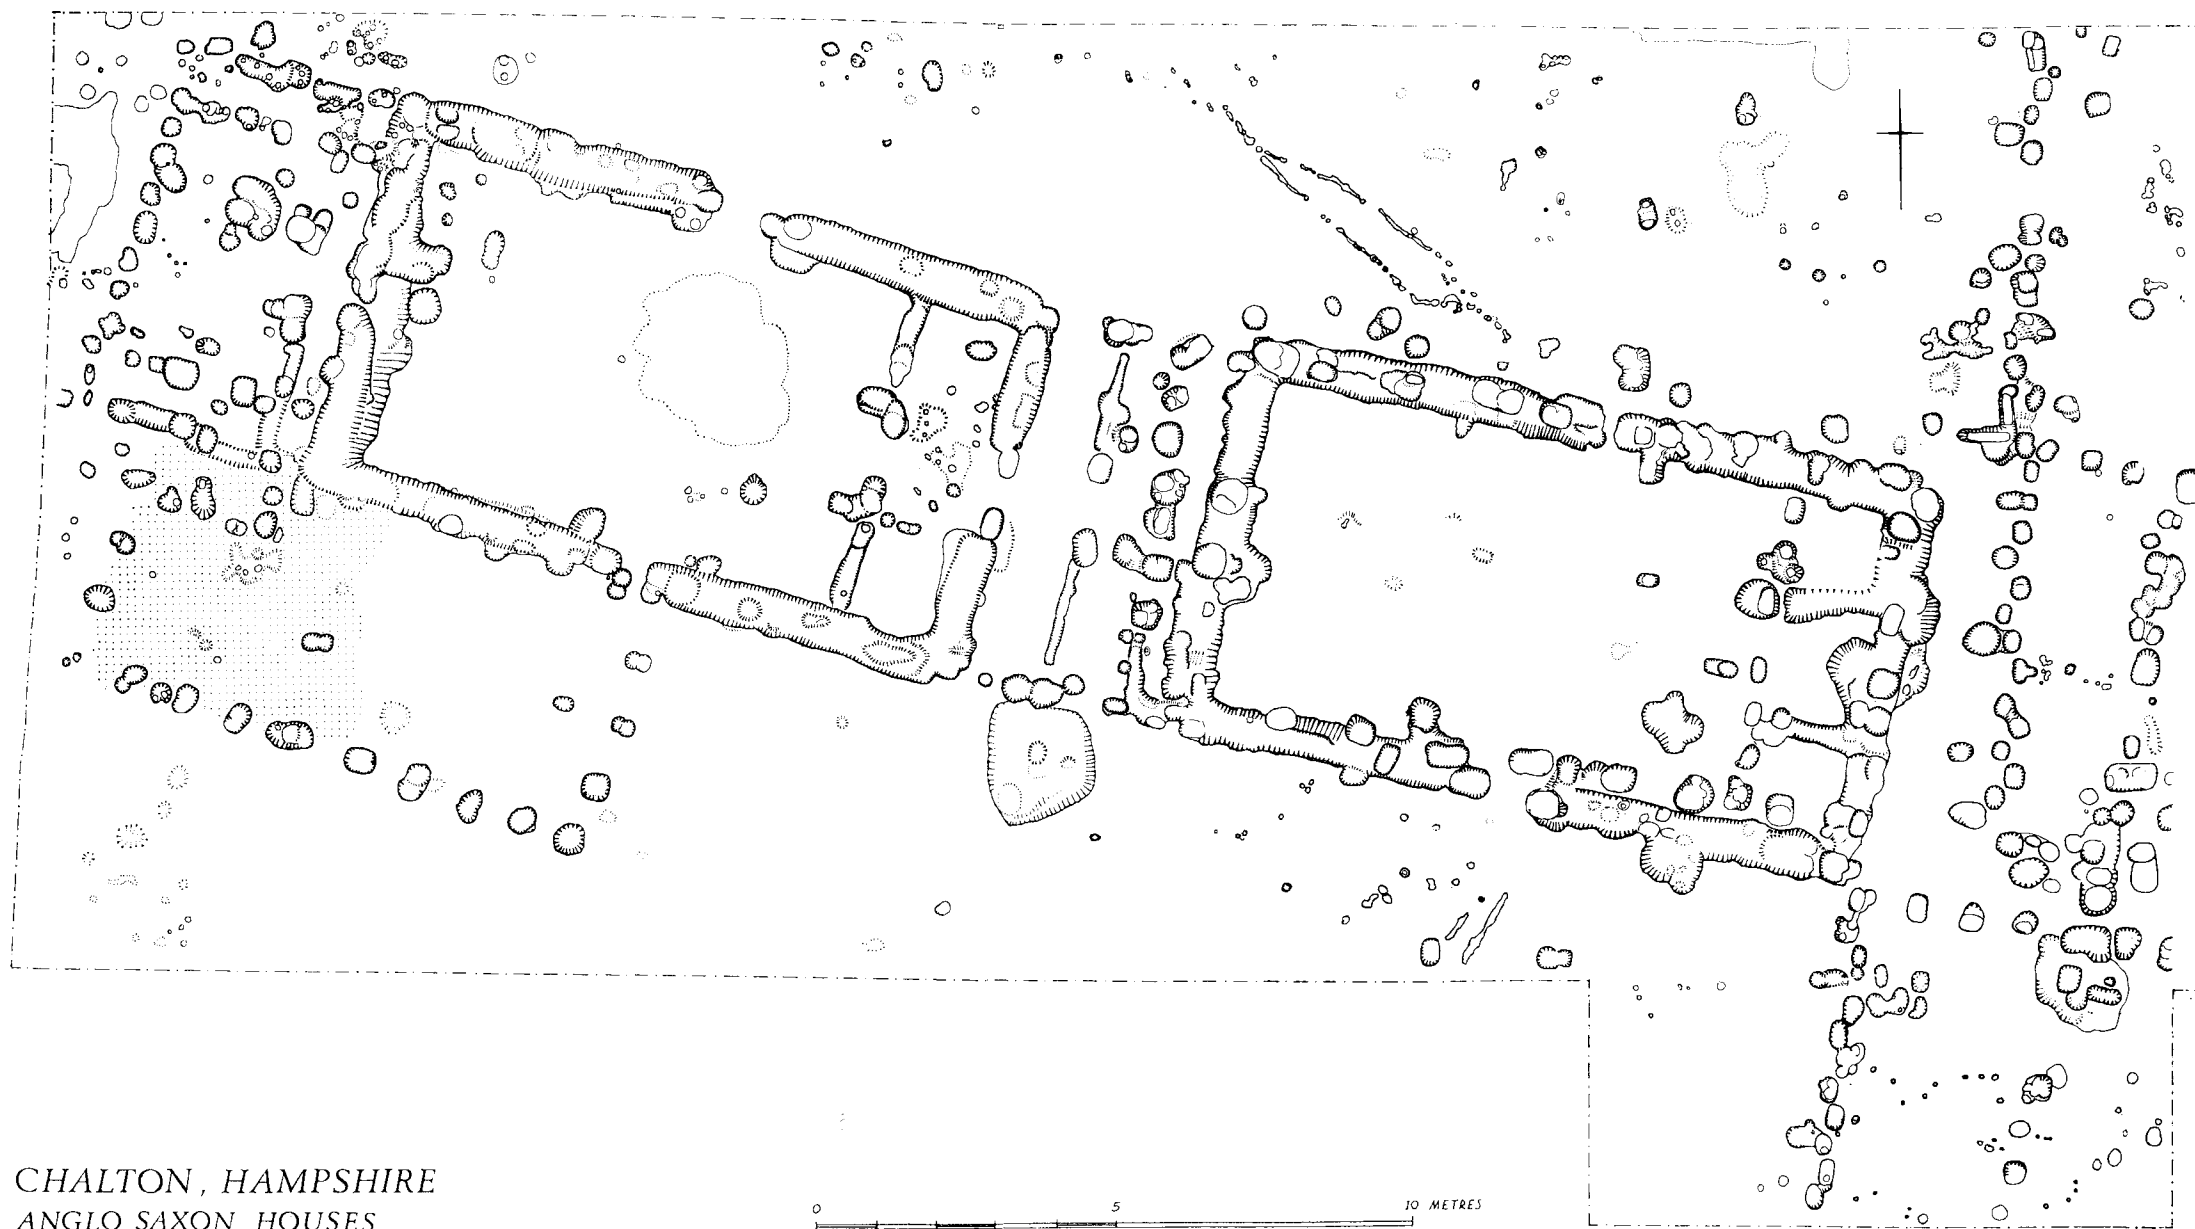
CHALTON, HAMPSHIRE
ANGLO SAXON HOUSES

FIG. 9
 PLAN OF THE EXCAVATION AT CHURCH DOWN, CHALTON, HANTS (p. 16)
 showing post-in-trench buildings (A1 and A2, pp. 17, 19 f.), post-and-trench building (A3, p. 20), fences
 (A4 and A5, p. 20), and various post-hole structures (B1-4 and C1, p. 21 f.)
 For interpretation of this composite plan, compare the outlines of the individual buildings in FIG. 12.

After initial clearing two main structures, A1 and A2, were immediately apparent. Both were represented by continuous trenches, and were large rectangular structures with opposing doors in the middle of the long sides, an end door, and a wall dividing the interior in the proportion 1/5 to 4/5. The two nearly identical buildings were set end to end, some 3.50 m. (11½ ft.) apart, on slightly differing axes. To east and to west of A1 and A2 were complex groups of post-holes, clearly representing structures of two or more periods. It has been assumed that the structures most evident on initial clearance belonged to the latest period,

Building A1 (FIGS. 9-12, 14-15; PLS. I, A, II, B, V, A, VI, A). This was a large rectangular bipartite house, 11.40 by 6.30 m. ($37\frac{1}{4}$ by $20\frac{1}{2}$ ft.), measured from centre-lines of the walls, with opposed doorways set in the middle of the long sides, and a door in the middle of the W. end. The walls were defined by trenches some 70 cm. ($2\frac{3}{4}$ ft.) wide, varying in depth from 10 to c. 50 cm. (4 to c. 20 in.). The trenches had extremely variable contents, in the main medium brown soil with some chalk and flints. There were, however, occasional concentrations of flints, or of chalk, or both, suggesting packing around timber elements formerly present in the trench. In some places, often within the packing, were patches of very dark soil, occasionally associated with charcoal, and sometimes with very powdery grey chalk, perhaps partly burnt (FIG. 10). Within the building a number of oval post-holes ran across it some 2 m. ($6\frac{1}{2}$ ft.) from the E. end. Two shallow, narrow, flat-bottomed trenches ran from this wall to meet the end wall. This arrangement cut off one-fifth of the interior, and subdivided it into three small rooms some 2 m. square. It is not clear whether there was a door in the middle of the end wall, though by analogy with A2 this seems possible. The doors seem to have been some 0.80 m. (2 ft. 7 in.) wide, and to have had lintels in the wall line with the door hung on a post set within the building. There was no clear indication of a hearth, though a worn hollow in the NE. corner of the main room may indicate its position. The wall-trenches had in places cut through the filling of earlier post-holes, most of which proved to be elements of structure B1 (FIG. 12 and PL. VI, A; p. 21).

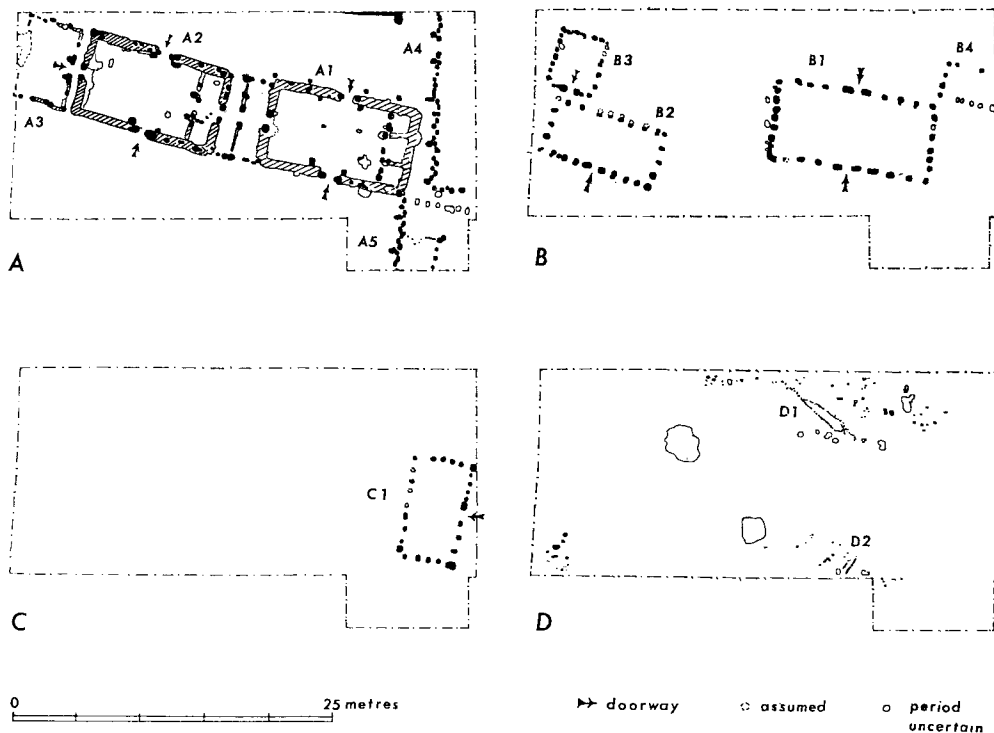
FIG. 12
CHURCH DOWN, CHALTON, HANTS

Interpretation-drawings showing the various buildings that can be recognized (pp. 17, 19 ff.)

Building A₃ (FIGS. 9, 12; PL. III, A). This was a small rectangular building west of A₂ with its side wall facing the end wall of A₂. It was 6.25 m. (20½ ft.) long. Its width was difficult to establish, as the line of the fourth wall was uncertain. Though the width was probably 4 m. (13 ft. 1½ in.), it is at least possible that the fourth wall lies outside the limits of the excavation, or that it has been completely destroyed since it would have been shallow and denudation has been severe in this area. Building A₃ had a door in the middle of its E. side, flanked by post-holes. This door seems to have hung on a post on the inner angle of the S. side of the doorway, and the doorway faced the apparent doorway at the W. end of A₂. The wall-construction of A₃ was related to, but differed in an interesting way from, that of A₂. Individual post-holes were clear, but between them there were shallow trenches which, in adjacent stretches, were not always in good alignment. The construction implied must be one of individual structural posts with post-to-post infilling, perhaps of wattle hurdles, or of panels with subsidiary uprights set into sill-beams, or conceivably of thick planks or beams slotted into the uprights.

Buildings A₄ and A₅ (FIGS. 9, 12, 13; PL. IV, B). East of A₁ was a maze of post-holes clearly representing several phases of occupation. Their interpretation must await further excavation, but at least one phase presumably belongs to period A. The most likely candidates are the oval post-holes set *c.* 25 cm. (10 in.) apart in two staggered rows. Associated with these were others, usually oval, set at 3 m. (9 ft. 10 in.) intervals slightly to one side of the main line. The interpretation of this arrangement seems to require close-set split trunks, presumably with flat sides facing inwards, and with planks or saplings dropped in between to form a continuous fence (FIG. 13). The more widely-spaced posts to one side of the fence presumably represent strainers. Miss Jane Holdsworth has kindly drawn our attention to the fine illustration of such a fence in MS. Cotton Julius;² similar fences are known in later contexts in Germany. Another such fence, A₅, seems to be related to the corner of structure A₁, and may provisionally be designated Building A₅.

Building B2 (FIGS. 9, 12; PL. IV, A). Building A2 was also preceded by a substantial building constructed on individual post-holes. It was not, however, quite on the same site. The W. part of the S. wall of A2 cut away refilled post-holes representing the N. wall of B2. Even so it was possible to reconstruct the layout of B2, a structure some 8·80 by 4·50 m. (28 ft. 10 in. by 14 ft. 9 in.) with gables of five somewhat insubstantial posts, and in some cases small double posts. The side walls (including corner-posts) were of ten posts, and particularly substantial post-holes flanked a door in the middle of the S. side. A similar door may have existed in the N. side, but it has been too much damaged by A2 for this to be certain. The SW. corner-post of B2 seemed curiously insubstantial, and it can hardly have had a main structural function.

Building B4 (FIG. 12; PL. IV, B). The maze of post-holes east of A1 represents at least two structures in addition to the fences described above (A4 and A5, p. 20). One of these presumably belongs to period B, and represents a post-built structure, standing in the main outside the excavated area.

Features D1 and D2 (FIG. 12; PL. VI, B). A number of shallow, narrow gullies and fissures in the chalk ran athwart the alignment of the various buildings described above. Some contained pockets of soil which seemed to represent stake-holes. Though many of these features seemed suspiciously to be associated with rotting chalk, it was not clear which was cause and which effect. They are, therefore, recorded here without interpretation, which will doubtless be possible after more extensive excavation. In addition a number of shallow depressions full of small, weathered pieces of chalk were found. One contained crumbs of pottery, almost certainly of the middle or late bronze age. They are most likely to have been tree-holes.
