Boars Tye Barn, Silver End, Rivenhall, Essex.

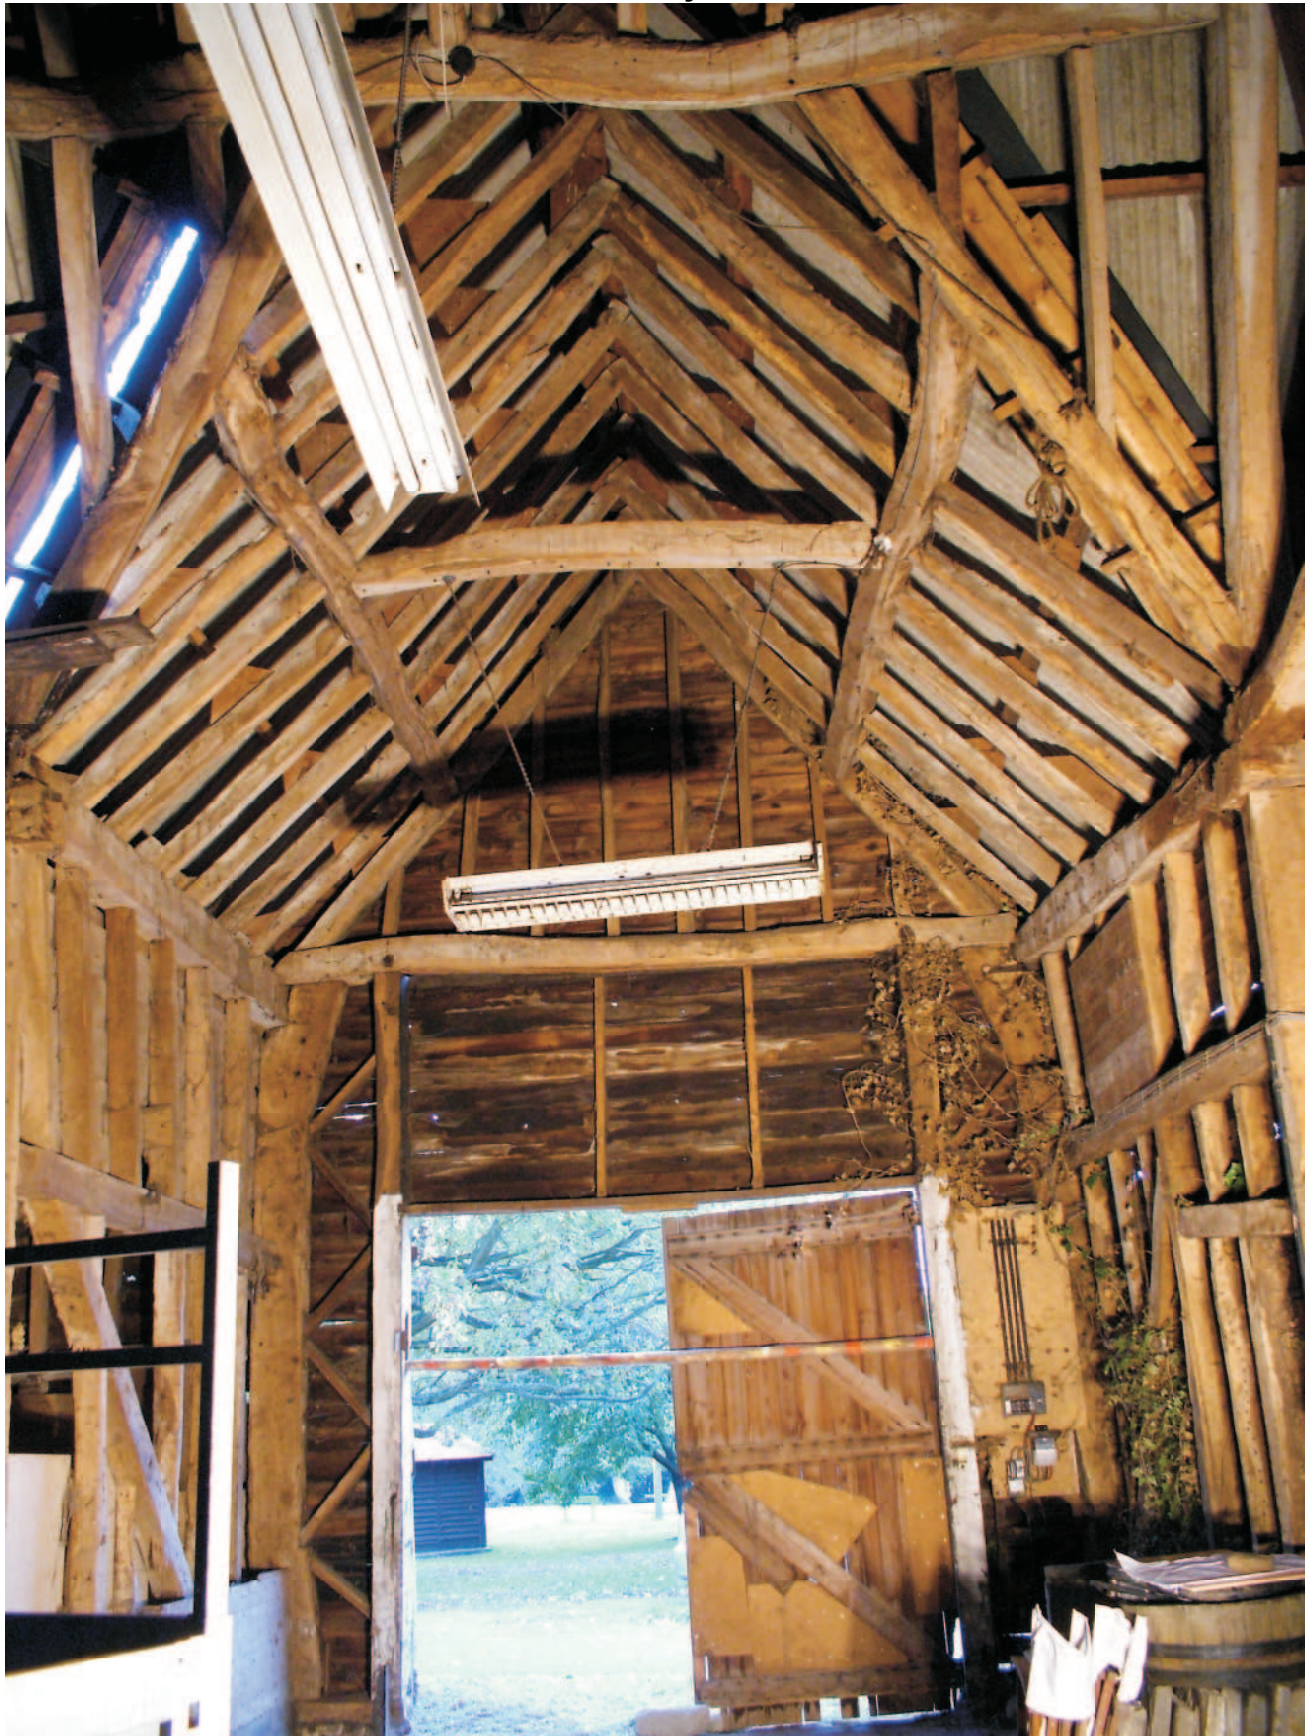
View into midstrey with lean-to at the left. Note the same framing as the main body of the barn. The wall to the right is all original with a door cut in to the inner side of the post supporting the primary brace and the studs are fitted by the use of long mortises. That to the left has had repairs to the wallplate which is a continuation of the tiebeam this time the midrail goes from post to post with the primary brace from under midrail to sill. A door opening with drop in board slots is cut into the frame, shown by the empty mortise of a removed stud. This was the entry to the lean-to which must have been a granary with boards slots to restrict entry. The heavily jowled door posts have positions for door pintles and at the lower end a bottom jowl slotted for boards. Part way up the posts are slotted mortises for a drop in tiebar across the opening. The present doorway is narrower and lower than the original.
