Boars Tye Barn, Silver End, Rivenhall, Essex.

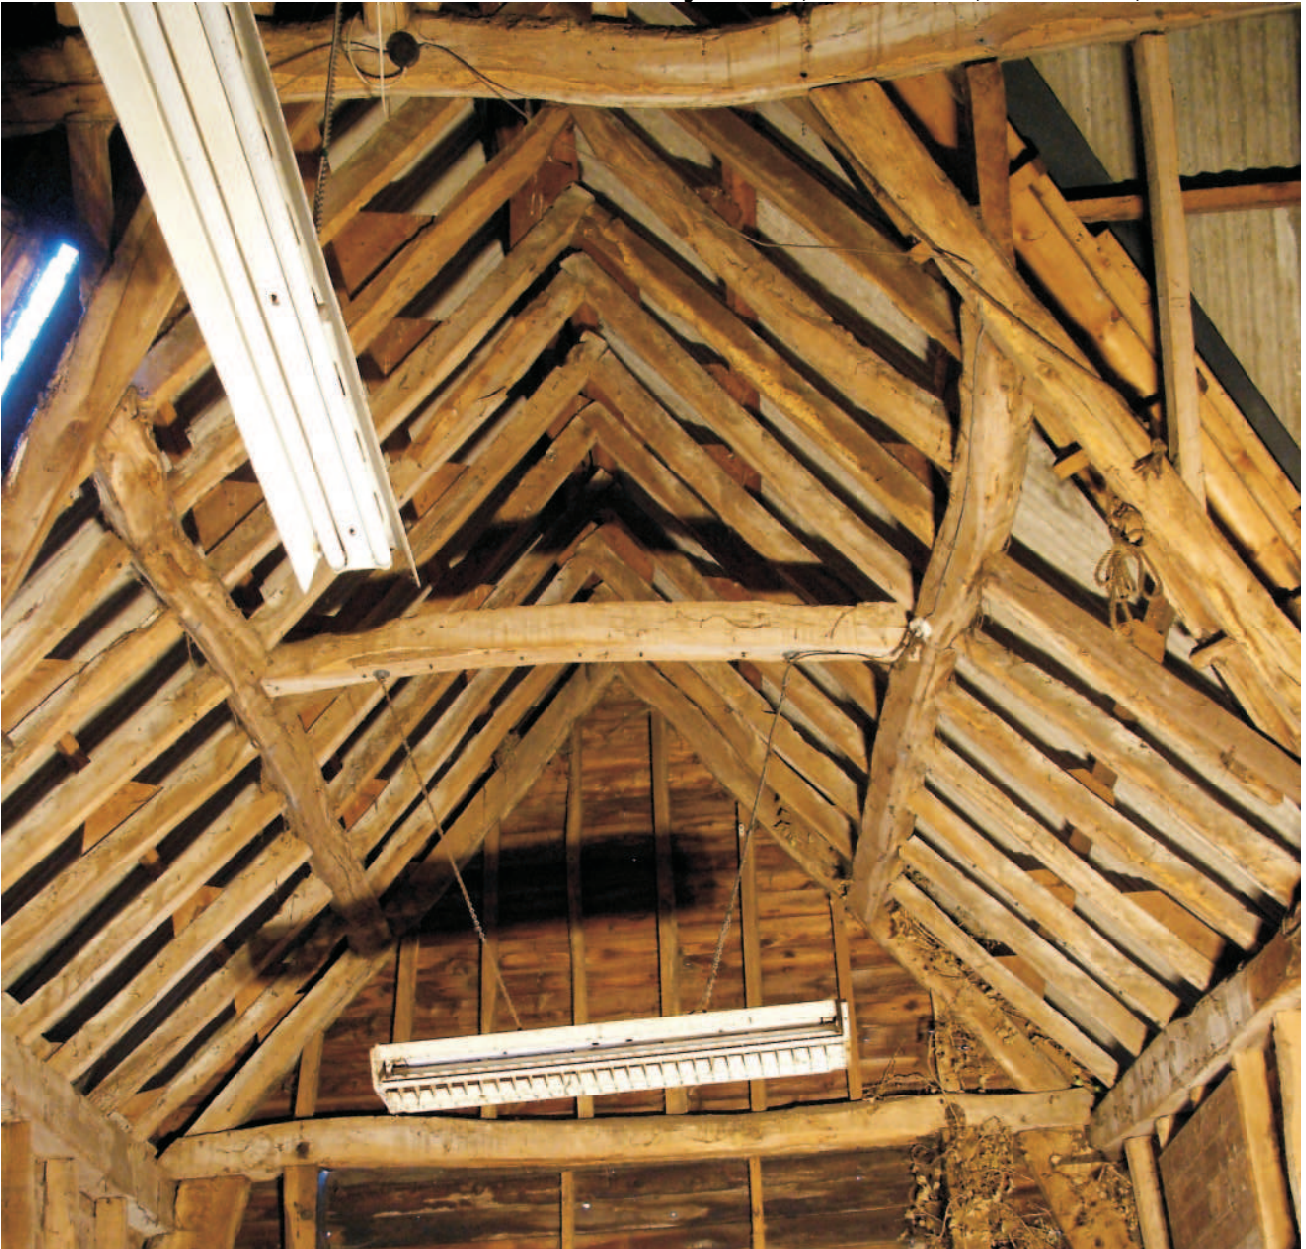
View into mid-strey roof, built a single bay unit with purlins framed front and rear and birds mouth collar between. Purlins converted from one tree sawn through the centre. These again suggest possible coppice growth pattern.

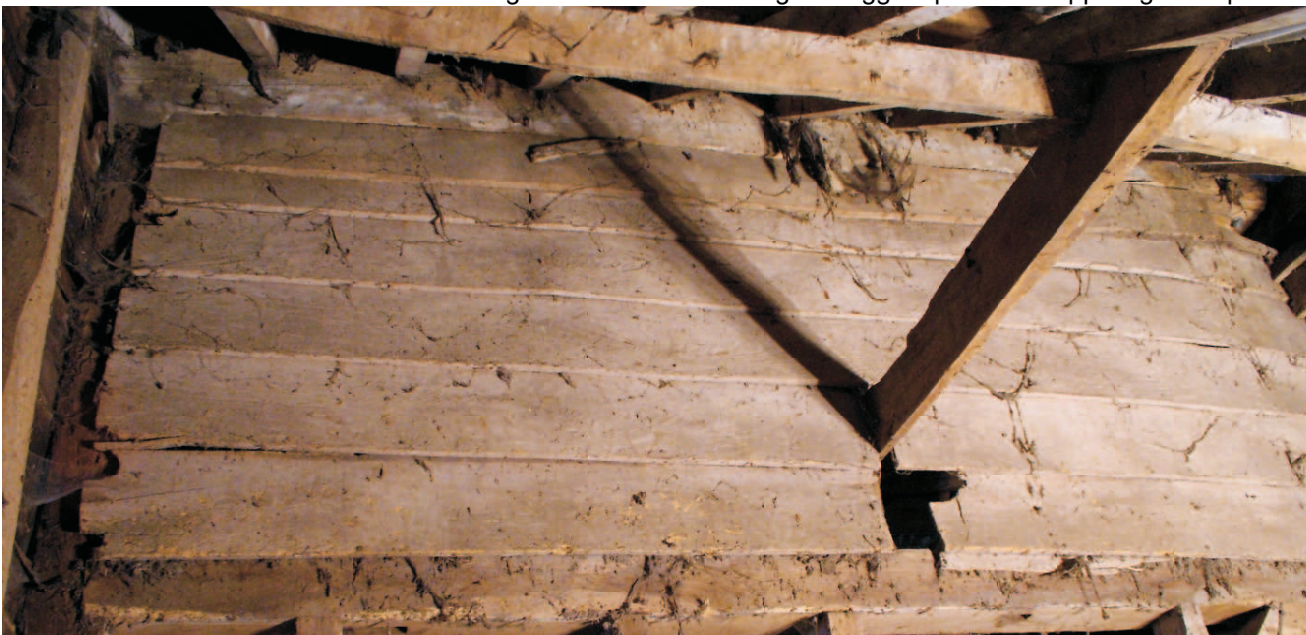
Possible original elm weatherboarding trapped by the lean-to roof. Still in good condition.
