Ansell Road Gasworks, Saltisford, Warwick

Archaeological Excavation
&
Watching Brief

CAP Report No.325

Date: **August 2004 & December 2004 - March 2005**

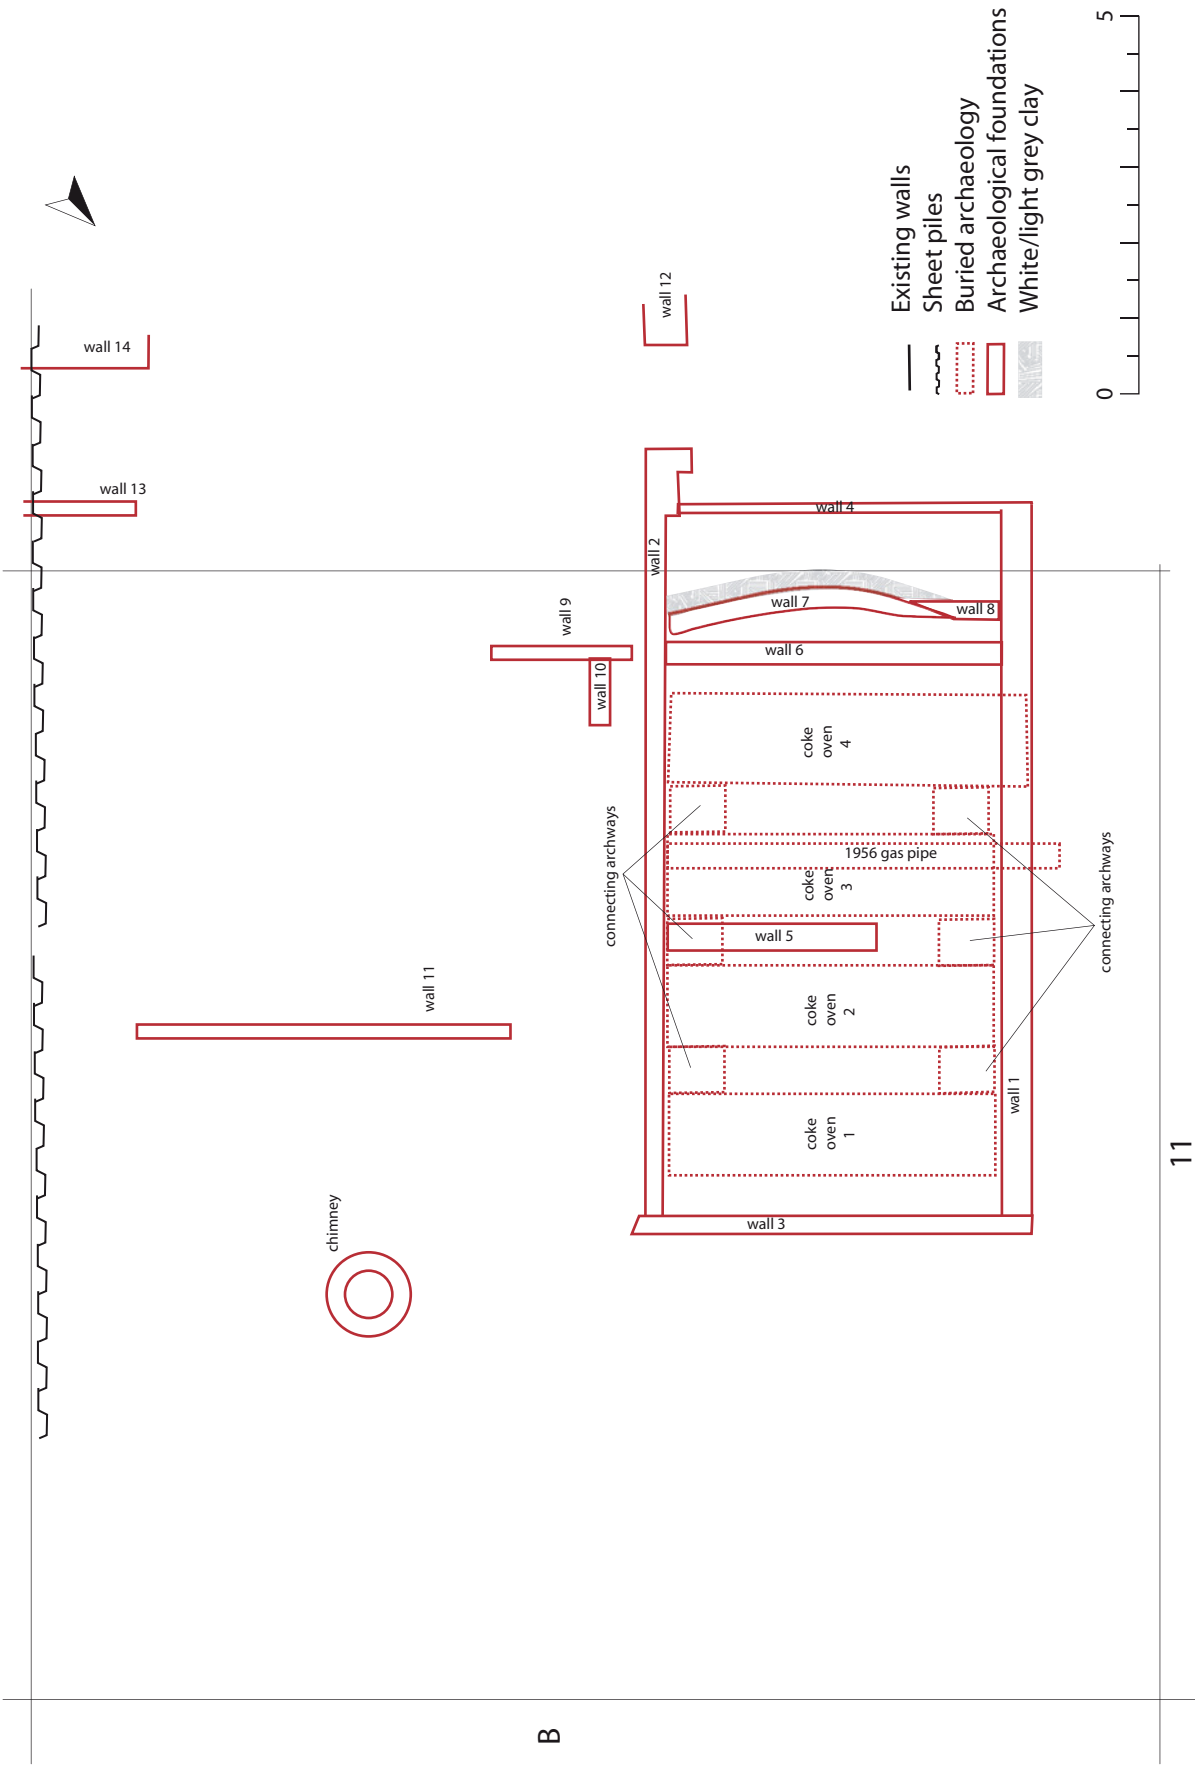
Figure11: Grid 11B showing archaeology

The layout of the remains can be seen on (fig 11) which shows a rectangle arranged roughly north-south along its length. The building is therefore on the same alignment as the surviving 1822 gasholder building and fits within the floor plan of the coal sheds noted on the 1851 Public Health Map (Figs 4&7).

The main concentration of surviving structures measured 19.35m in length and 9.91m in width. The first indication of their presence was not noted until a depth of 1.2m beneath the present surface had been removed. After that point, their remains continued to a further 2.2m before ending in a brick floor (plate 23).

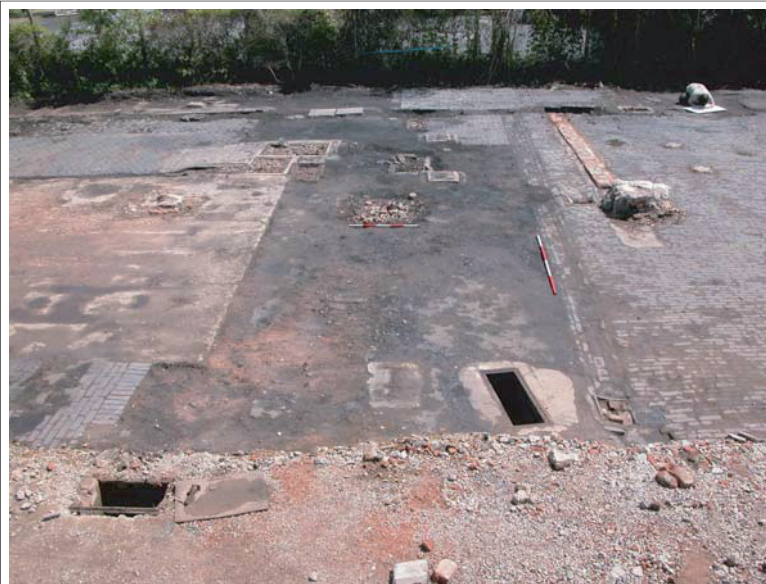
Owing to the recent nature of the archaeology in question deposits of archaeological interest were very close to the surface. The main deposits were floor layers either made up of interlocking bricks from the 19th century buildings or concrete floors from the 20th century buildings (plate 2).

Plate 02: Site overview showing flooring expanses,
scale 1 x 2m

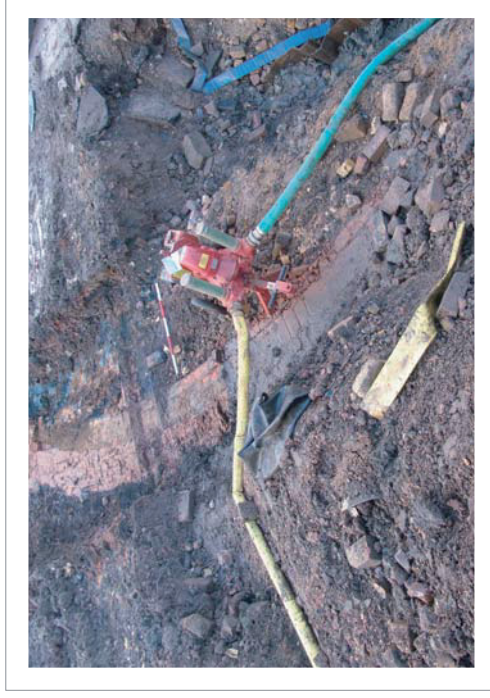
Plate 10: Gasholder rim (9A)

In (plate 10) the rim of the holder and its construction pattern can be clearly seen. The brick pattern of construction was length-ways on the inside and offset at 90° on the outside. The pattern was alternated with each course.

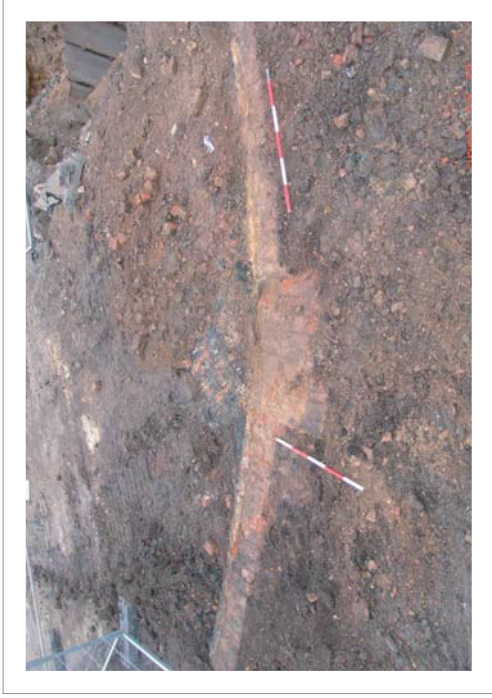
Plate 11: Gasholder rim buttress (9A)

Along the outer rim of the gasholder, brick buttresses could be found as shown in (plate 11). These buttresses measured 1m by 0.4m and had two iron rods imbedded vertically within their structure.

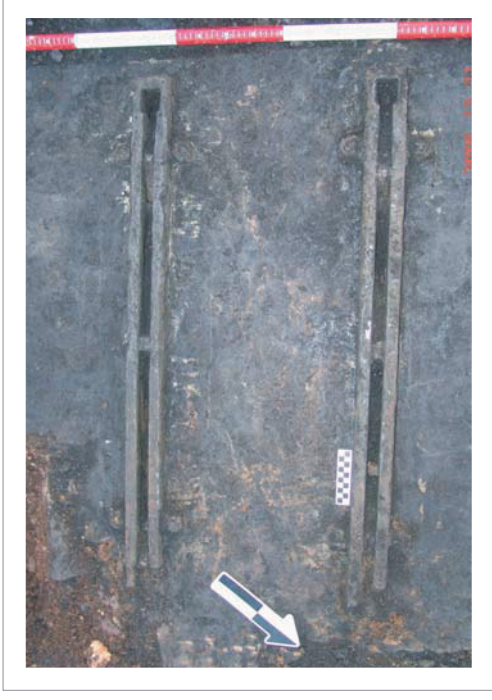
The north-east end of both rails had been broken off which suggests that they continued in that direction. The south-east ends of the rails had rectangular insets which may have held a stop mechanism at this the terminal end of the track.

Plate 12: Tramway section (9A)

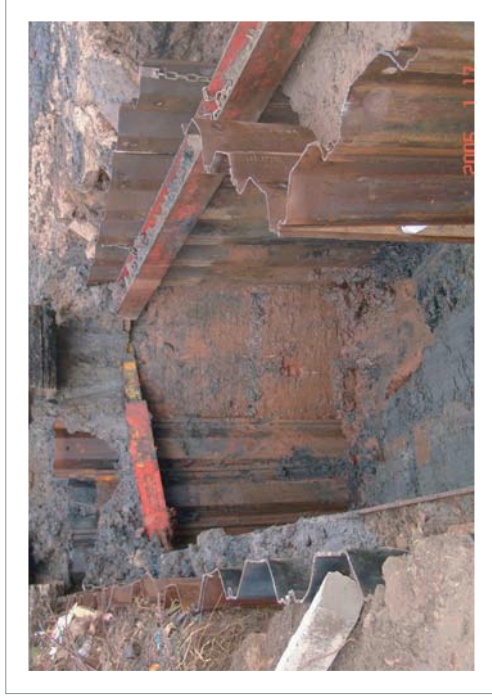
Plate 13: Gasholder outer wall (9E)

Plate 13 shows part of the outer wall of the structure between the piles. The inside of the gasholder, with an internal diameter of 25.46m, can be seen in (plate 14) showing a view south across the site.

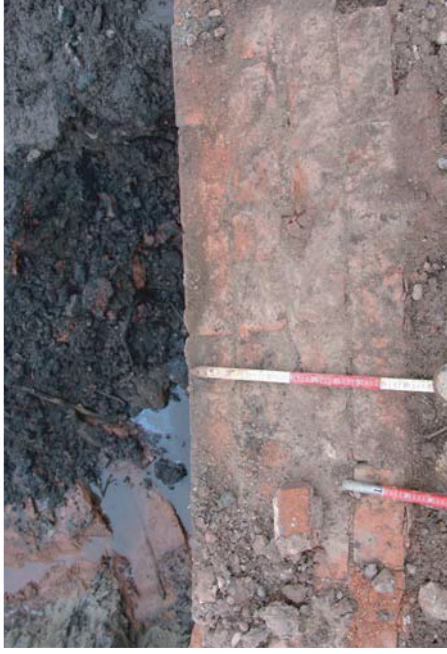
Plate 15: Gasholder rim (9E)

The construction detail of the gasholder can be seen in (plate 15). The brickwork at this level having been laid lengthways at a width of two bricks thick, 0.45m. The brick size was width $4\frac{3}{8}$ ", height $2\frac{7}{8}$ ", length 9".

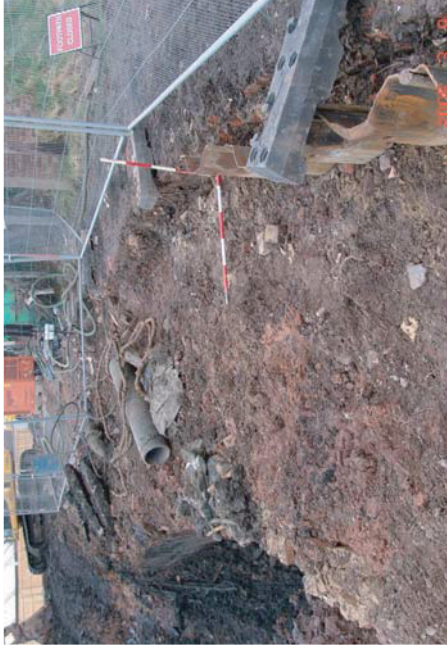
Plate 16: Double gasholder rims (9E)

It was not possible to date the main remains to any of the building phases mentioned above, however, a second phase, possibly earlier, partially exists in the extreme north-east of 8D and 9E. Plate 16 shows the view north-east adjacent to the east rim of the main gasholder. At the right of the photograph can be seen a low curved wall. Projecting the wall as a full circle, reveals a smaller gasholder with a diameter of 25.37m, around a centre offset to the north-east of that of the larger gasholder. Its depth remains unknown at this time.

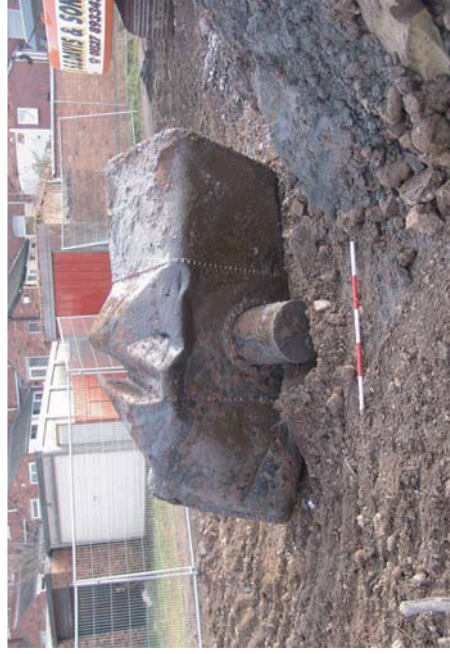
Plate 17: Liquor tank (9E)

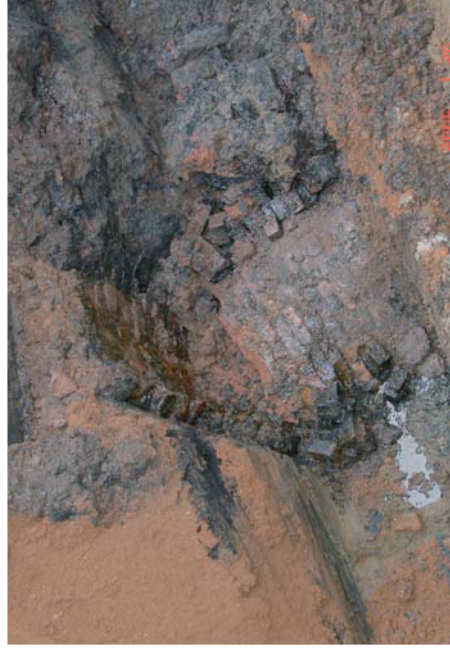
Plate 18: well (9E)

Plate 18 shows the well in situ at the bottom of the barrier trench. The north-west edge of the well was still standing and the dome of bricks in front of it was part of the west edge, dislodged by the excavator bucket.

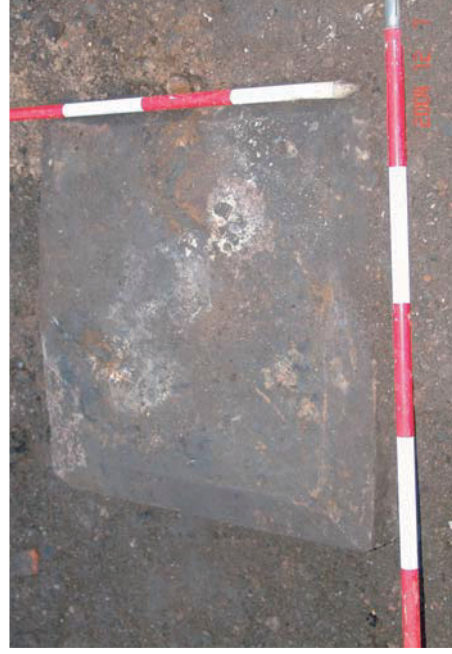
Plate 21: Concrete base(11A)

Only two small features were noted in grid square 11A. They consisted of a pair of concrete bases approximately 0.7m by 0.75m by 0.6m deep. The top edge of the bases had bevelled edges and mould marks could be detected on the side suggesting that they were probably modern factory manufacture (plate 21).

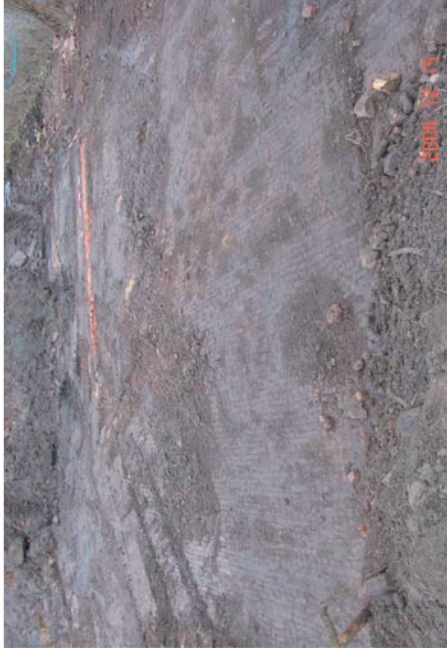
Plate 27: wall base 11 (11B)

Wall base 11 (plate 27) was one of the few surface features above the courtyard to be found at the site. Its length was 5m with a width of 0.23m but unfortunately it had no associated features to help with its interpretation. It is however, probable that it related to one of the later buildings at the site.

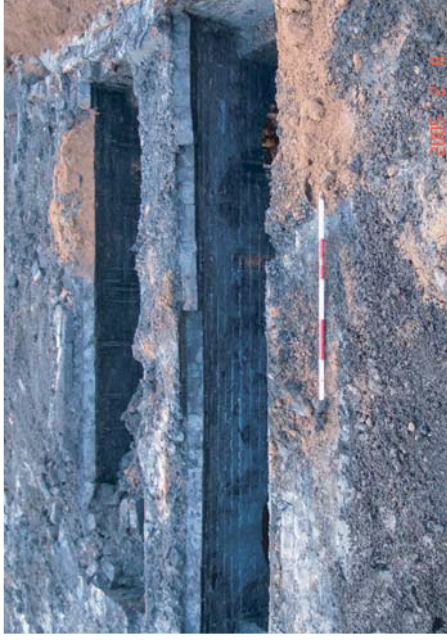
Plate 28: Brick chambers (11B)

The most structurally complete features at the site were found beneath the level of wall bases 1 – 10. The remains consisted of four arched chambers, 4.3m long, approximately 1.3m wide and 1.7m high. The chambers were entirely of brick construction. Plate 28 shows a view of chambers 1 & 2 with the arched roofs removed. Chambers 1 & 2 were intact whilst 3 & 4 were missing their arches and had been filled in with rubble. Chamber 3 had a cast iron pipe running through it which was linked to an old gas main with a junction fitting dated 1955 (plate 29). This could point to a date of when modifications were done to the chamber building, which involved demolishing some of the sub-surface levels. Chamber 4 was also full of rubble and missing its arched roof.

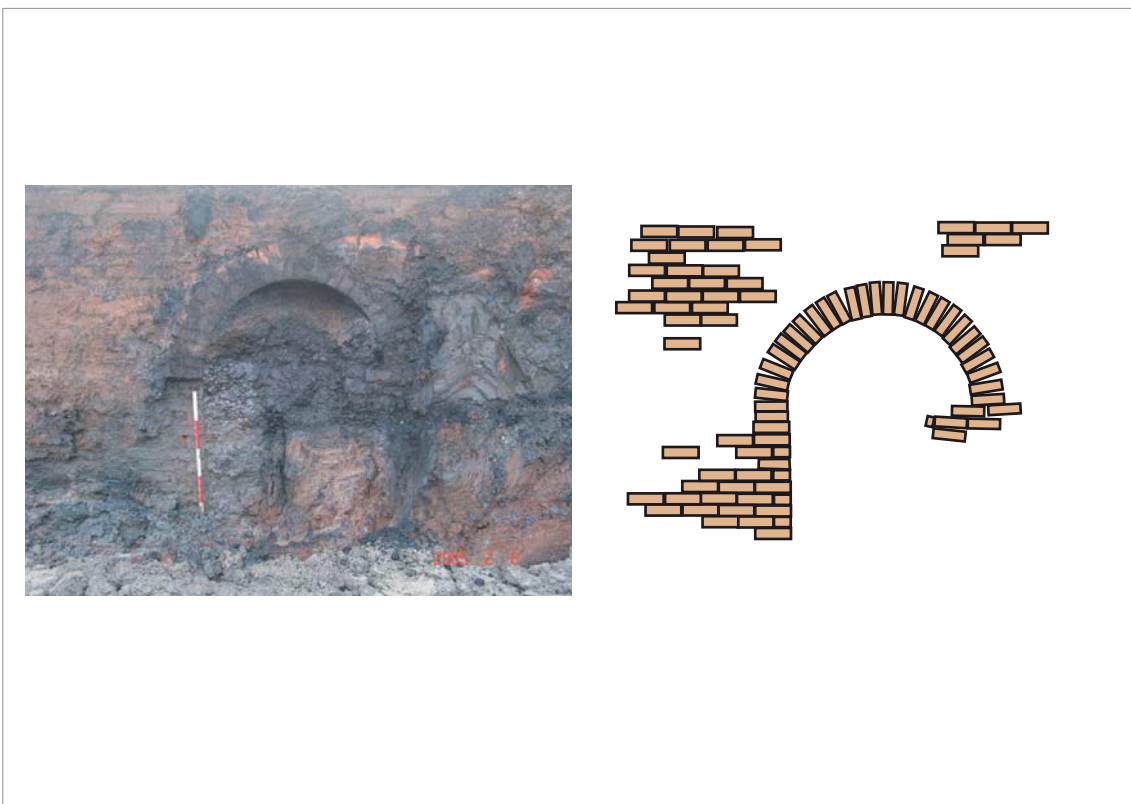
Plate 33: West portal to brick chamber 4 and schematic illustration

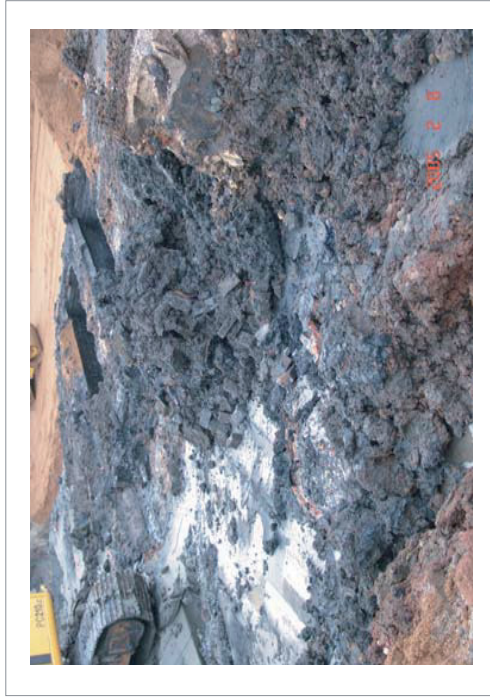
Unfortunately adverse weather conditions, contamination and site instability prevented any further information to be obtained about this feature. The interpretation of the feature as a chimney associated to the arched brick chambers was inferred from its proximity to the latter.

Plate 36: Chimney base (11B)

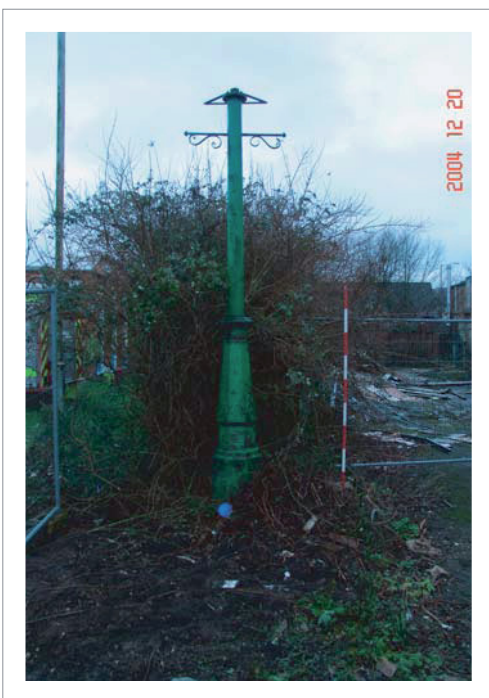
Plate 47: Cast Iron lamppost (12C)
