THE FOLLY, PARK FARM,  
RISBY, EAST YORKSHIRE

ARCHITECTURAL AND  
WILDLIFE SURVEY

Report no: 2011/395.R01  
Version: Final  
Date: September 2011  
Authors: Ed Dennison & Shaun Richardson

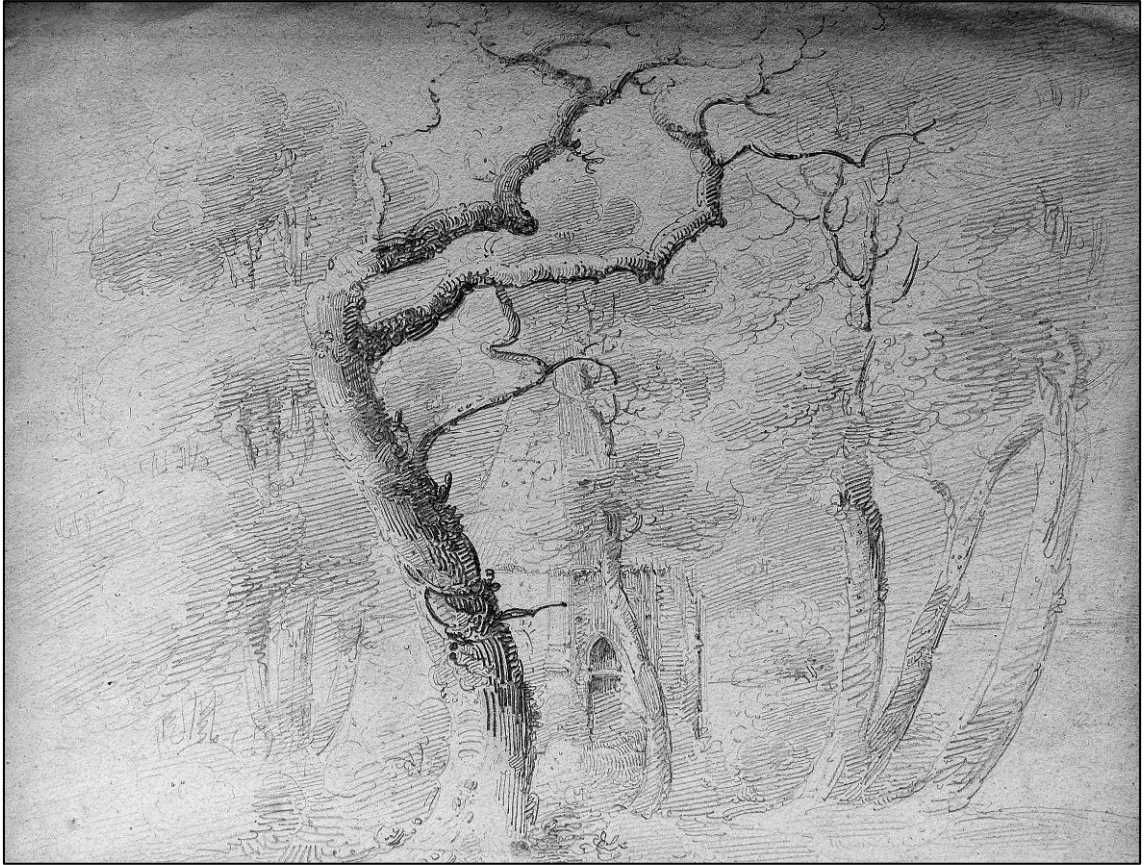
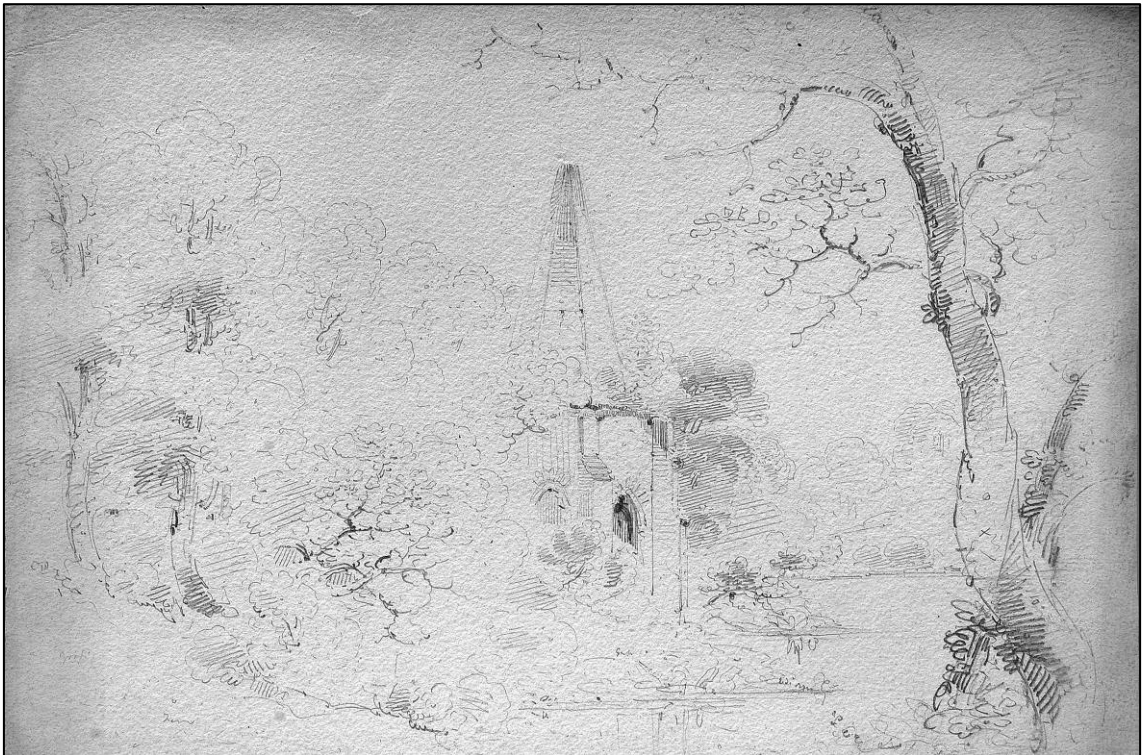
PROJECT		RISBY FOLLY	
TITLE		1817 SKETCHES	
SCALE	NTS	DATE	SEPT 2011
EDAS		FIGURE	3

Top: YORAG 2005/588/38.  
Bottom: YORAG 2005/588/8.

- 2.9 The two signed drawings, held at York Art Gallery, are dated 1817 and, although they are an extremely valuable resource in understanding the folly, their interpretation is not straightforward. One drawing has a tree in the centre, and appears to look west/north-west from an elevated position to the east of the folly; the lake is visible on the right side of the drawing (YORAG/2005/588/38) (see figure 3 top). The estate earthwork survey undertaken in conjunction with the folly survey, revealed a possible location for this elevated position, a linear round-ended mound some 10m south-east of the folly. The folly is visible in the drawing, and two of its buttresses can be seen flanking an arched opening. Above, or perhaps slightly beyond the folly, a tapering, pyramidal structure rises upwards; it is not obviously part of the folly, although the angles of the structure do line up approximately with the corners of the folly as indicated by the buttresses. The second drawing shows the folly more clearly (YORAG/2005/588/38) (see figure 3 bottom). Again, the viewpoint appears to have been from a location to the south-east or east of the folly; the lake is visible to the right of the folly, while water in the foreground to the front of the structure probably represents the inlet shown here on the 1840 tithe map (see below). Again, two buttresses are visible, together with two arched openings. The same tapering pyramidal structure is shown above the folly, but in this drawing, it appears to sit more squarely on the folly itself, with the angles again lining up with the buttresses. In both of these drawings the folly appears to be unused.

- 2.11 As has already been noted, Nicholson's 1817 drawings raise several problems of interpretation, largely revolving around the nature of the tapering, pyramidal structure. In the first drawing, the structure is badly drawn, and is not clearly associated with the folly (see figure 3 top). This has led to suggestions that it may in fact be an attempt by an artist to depict an obelisk sited somewhere to the south-west of the folly (David Neave, *pers. comm.*). There is indeed a natural promontory some 30m to the south-west, but for an obelisk to be aligned directly behind it, and if the depiction of the lake on the Risby tithe map is accurate, the artist would have to have been positioned on the lake itself. This could be explained by artistic licence but more significantly, on the second drawing, the pyramidal structure appears far too wide to be an obelisk. However, on the second drawing, it sits far more comfortably above the folly than beyond it, and it resembles a spire-like roof, which would have complemented the ecclesiastical design of the folly itself. It may be that the spire was designed to project above the surrounding trees, and perhaps even to be visible from the house. If a spire was present, then it would be

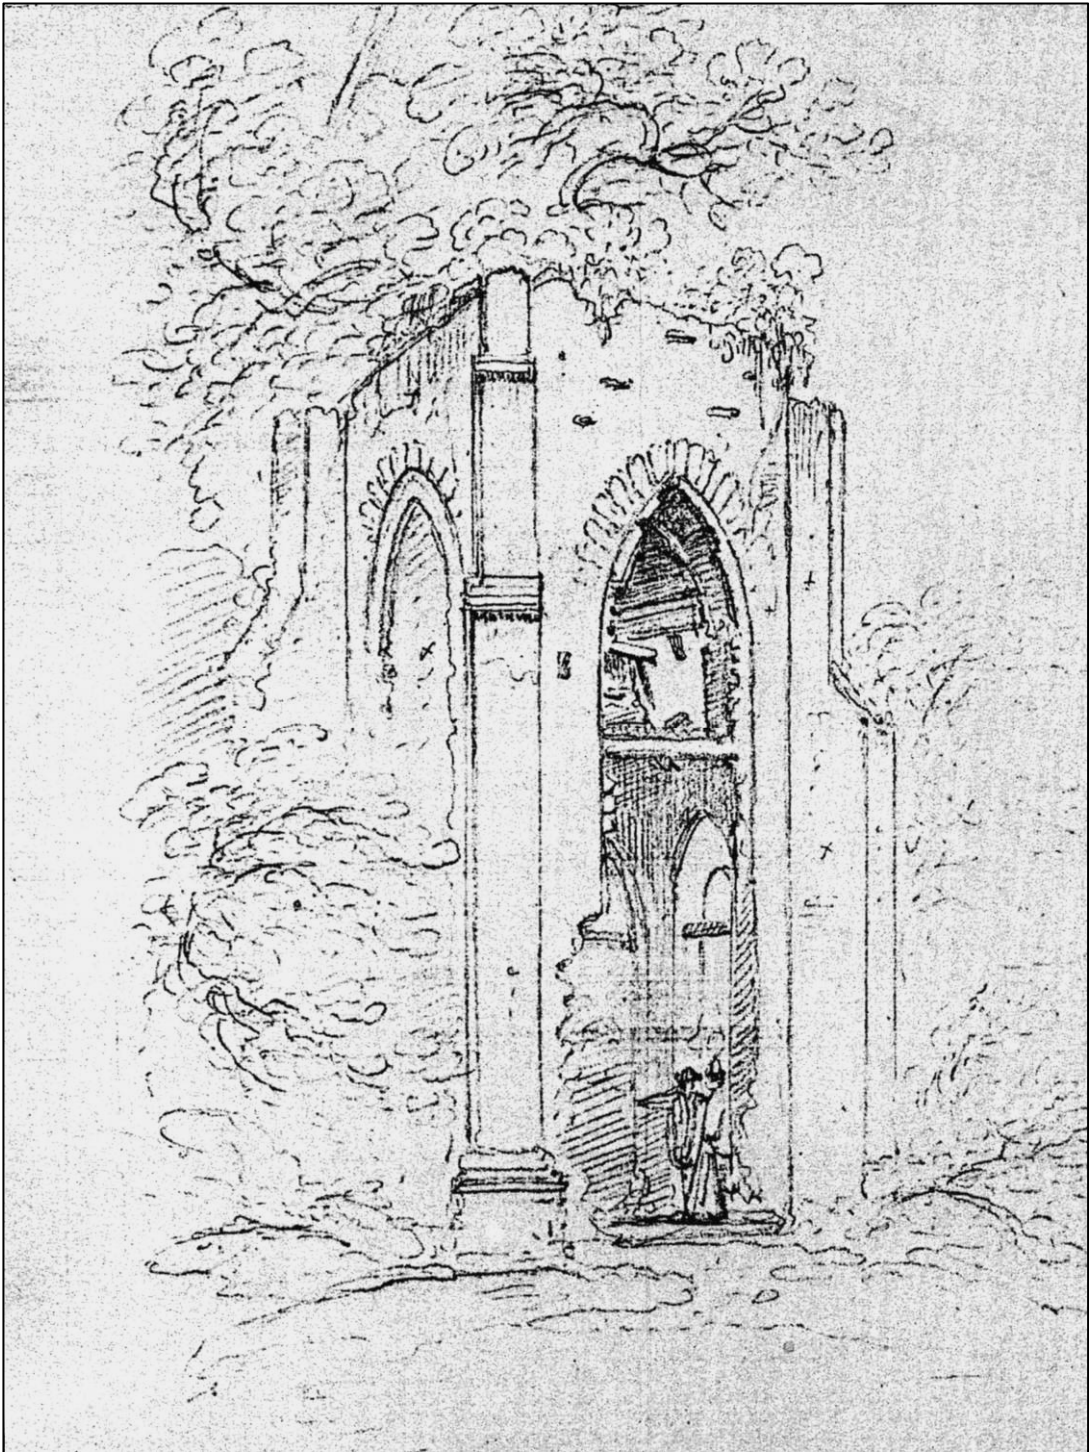
PROJECT	RISBY FOLLY	
TITLE	NICHOLSON'S UNDATED SKETCH	
SCALE	NTS	DATE SEPT 2011
	EDAS	FIGURE 4

Drawing of Risby folly by George Nicholson  
(undated) (from Neave & Waterson 1988, 52).

- 2.10 The third drawing (reproduced in Neave and Waterson 1988, 52) is undated but also attributed to Nicholson, gives a closer view of the building than either of the former pair (see figure 4). Here, the folly is clearly disused and indeed largely derelict; it is entitled 'Ruins in Risby Park, Yorkshire'. The viewpoint again appears to be from the south-east, and three buttresses are shown, together with two arched openings. The foremost arched opening has what appears to be a transom surviving below the level of the arch springing, and perhaps the fragmentary remains of a frame above this. Similar transoms can be seen in the two arched openings on the opposite side of the folly. Perhaps most significantly, no indication is given of the tapering, pyramidal structure shown on the other two drawings. Despite strenuous research, the location and source of this picture has not been located.

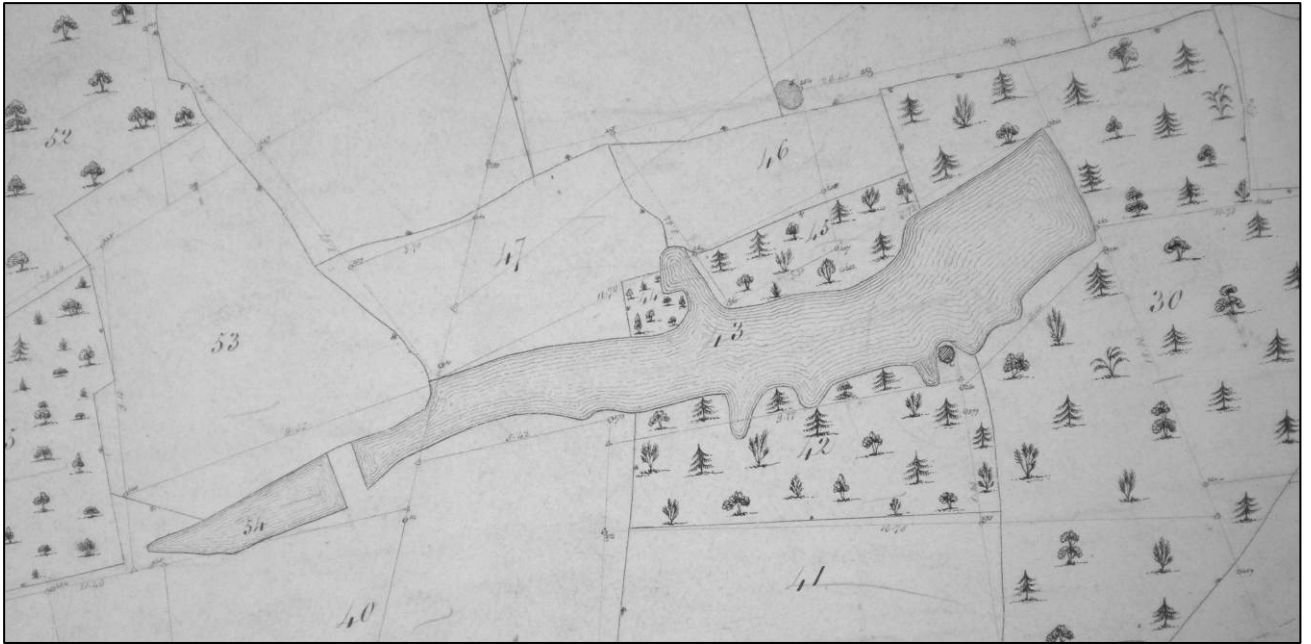
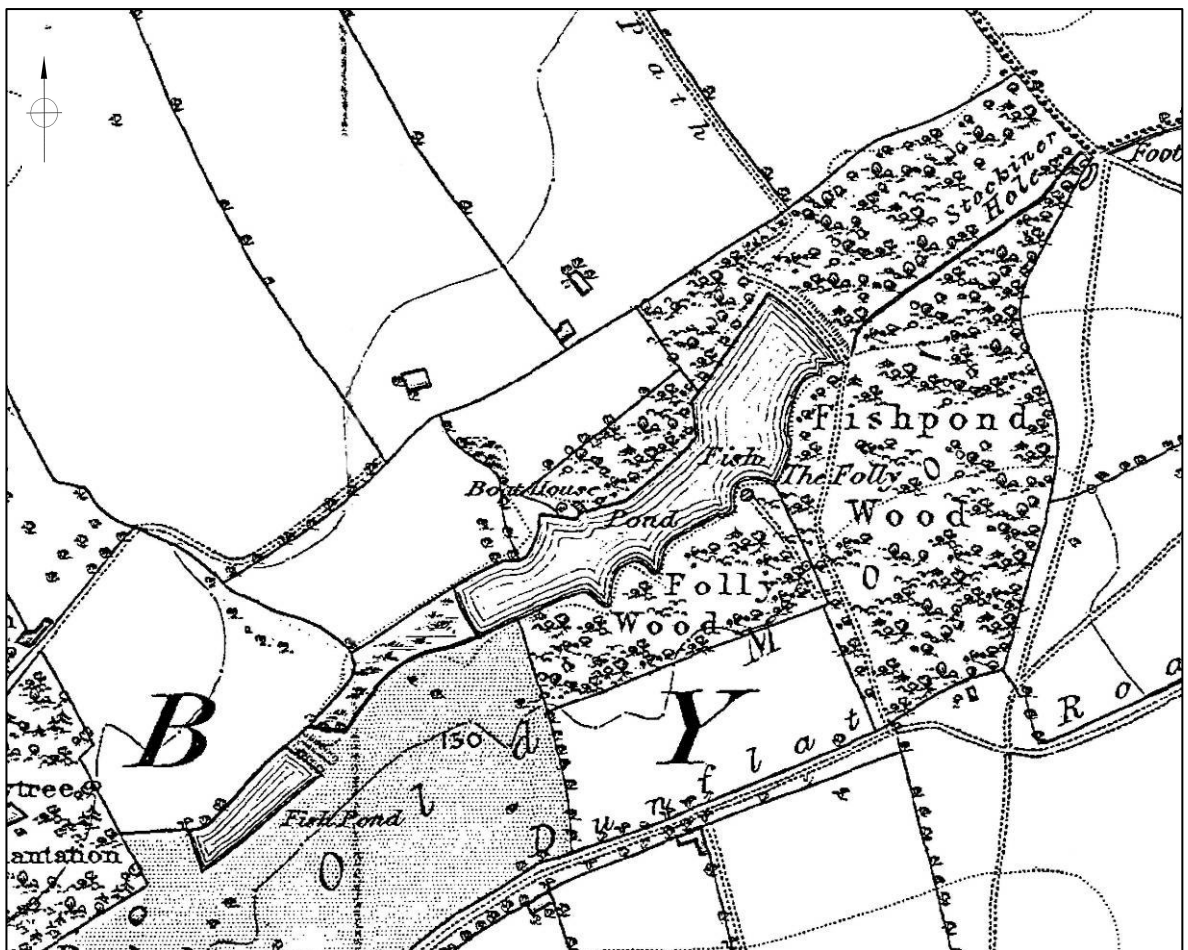
PROJECT	RISBY FOLLY	
TITLE	MAPS OF 1840 AND 1855	
SCALE	NTS	DATE SEPT 2011
EDAS	FIGURE 5

Top: Section of 1840 Risby Tithe Map (TNA IR 30/41/155).

Bottom: Section of Ordnance Survey 1855 1st edition 6" map (sheet 255).

- 2.13 The first known detailed depiction of the lake and folly comes on the 1840 Risby tithe map (TNA IR 30/41/155) (see figure 5 top). The north-east/south-west orientated lake, and the associated smaller body of water to the west, are shown occupying the same areas as in 1827 and 1834; the main lake is c.360m long, somewhat short of the mile and half originally planned. However, more significantly, the more accurate map depicts a number of projections on the north and south sides of the lake running into the surrounding woodland - the 'flow up among the groves' referred to by Young in 1771. Comparison with the detailed estate earthwork and walkover surveys shows that some of these 'flows' survive as earthworks and/or the lower end of natural gullies. For them to be water-filled as shown in 1840, the water level in the lake would have to have been much higher and wider than the existing dam at the east end would allow, and again earthwork survey has revealed evidence that the dam may once have stood as much as c.2m higher. This means that the folly would have projected into the lake on a round-ended promontory, as depicted in 1840, and not been set back as it is now (compare figure 5 top with figure 2). The tithe map provides little further information about the folly itself, but does provide a more correct plan form, as opposed to that given on the earlier, less detailed, maps.

- 2.14 The 1855 1st edition Ordnance Survey 6" to 1 mile map (surveyed 1851-52) shows the outline of the large lake and the folly, very much as they were in 1840, although it is noticeable that the extremities of the lake, particularly the western end, were beginning to silt up (see figure 5 bottom). This map also shows that the main outflow from the lake was along a leat at the south end of the eastern dam. A 'Boat House' is shown towards the west end of the north side of the lake, which does not appear in 1840, and a trackway runs through Folly Wood to the south side of the folly itself. The strip of now silted land dividing the lake from the smaller body of water to the west appears slightly wider than in 1840 and a linear bank or earthwork runs across it, parallel to the long sides. This is likely to be the remains of a dam, which had become isolated as the water level in the lake had begun to fall. The smaller body of water to the west appears to have been widened at the west end since 1840, and is labelled as a 'Fish Pond', as is the main lake itself.

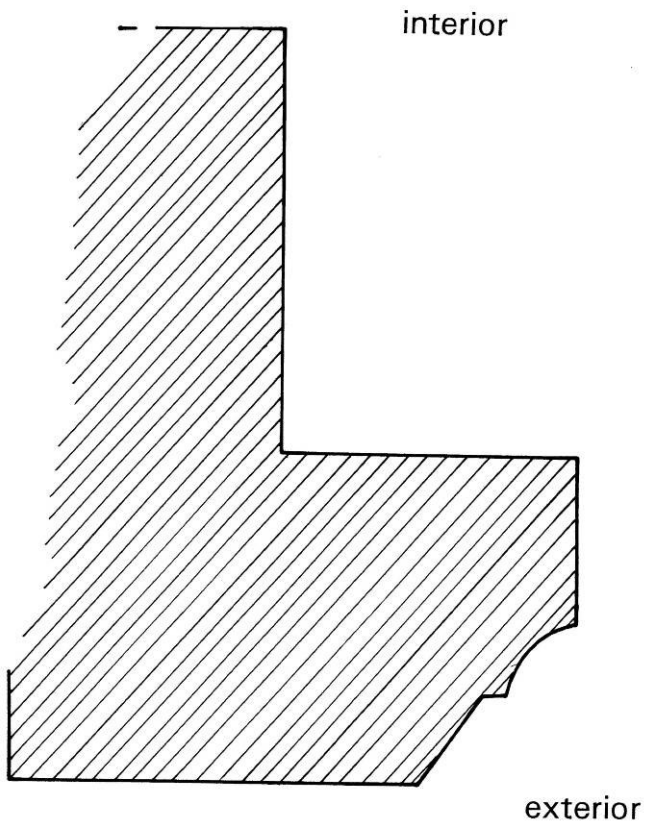
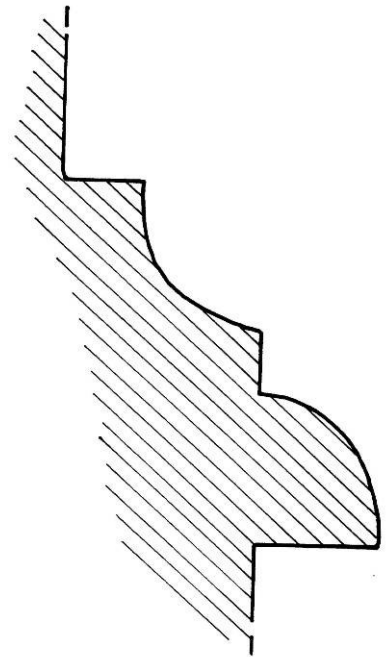
PROJECT		RISBY FOLLY	
TITLE		MOULDINGS	
SCALE	AS SHOWN	DATE	SEPT 2011
EDAS		FIGURE	9

Typical window/door  
moulding to Side C

Typical moulded  
stone/brick plinth

survive, the jambs have a hollow chamfered and chamfered moulding externally (see figure 9). The splayed sides of the openings suggest that internal shutters were once present.

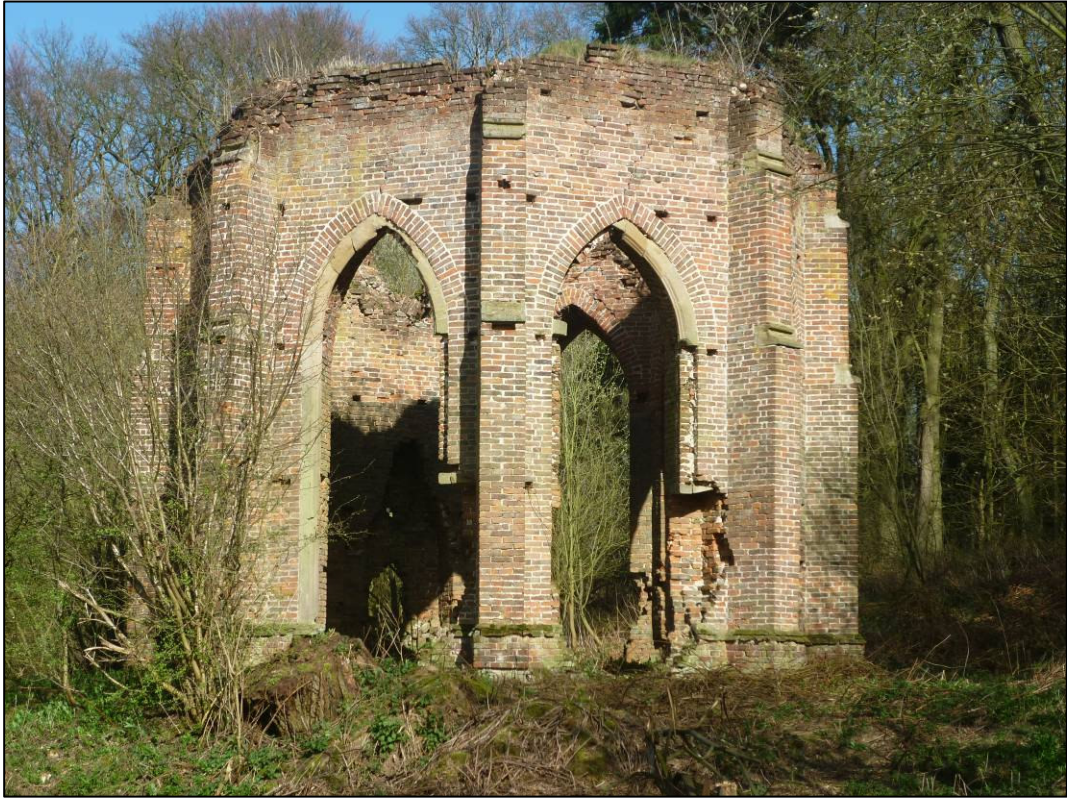
Plate 1: General view of west side of folly (Sides G and F), looking NE (photo 1/629).

- 3.2 The folly is an octagonal structure, and the internal and external faces of each side of the octagon are generally very similar (see plate 1). In order to aid clarity of description therefore, each side of the folly has been assigned a unique letter identifier (A, B etc), starting with the north side which contains a fireplace, and proceeding in a clockwise direction. Unless otherwise noted, the terms used to describe surviving or former timber or roof structures are taken from Alcock *et al* (1996) and Campbell (2000). Where possible, specific architectural terms used in the text are as defined by Curl (1977). Finally, in the following text, the term 'modern' is used to denote features or phasing dating to after c.1945.

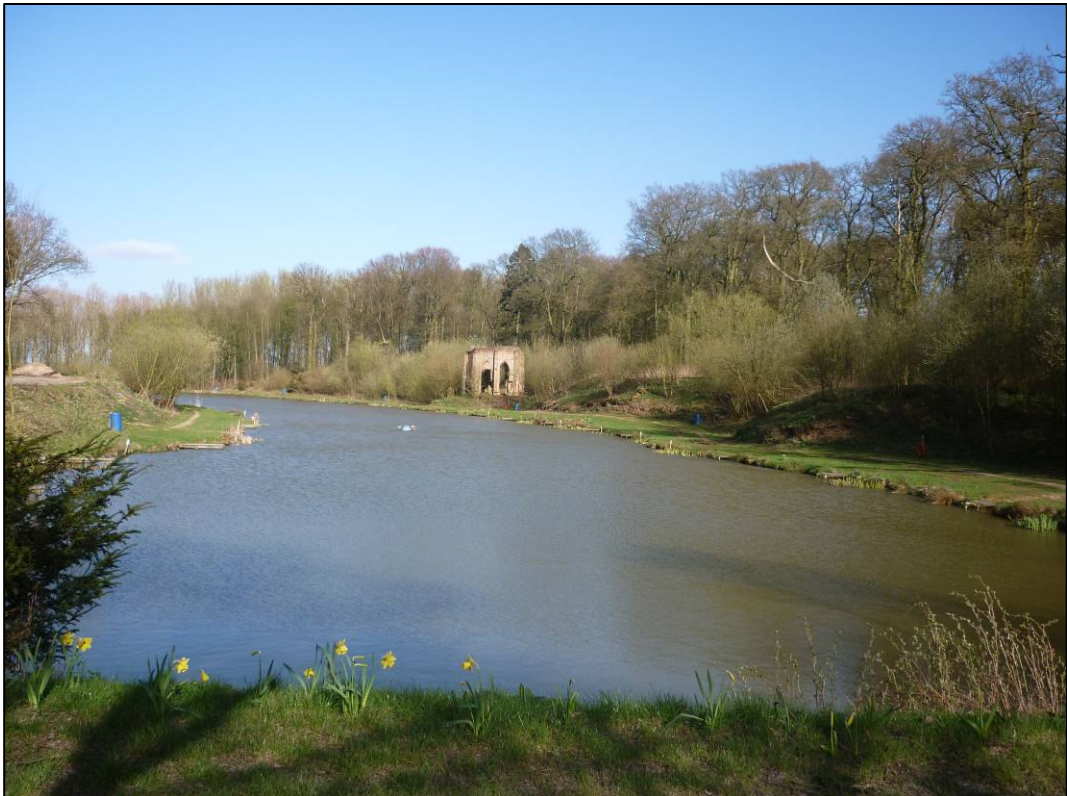
Plate 2: View to folly across lake, looking E (photo 1/633).

- 3.4 The folly is now set back some 8m-9m from the edge of the lake, and stands on a small sub-circular promontory, c.10m across (see plate 2). The sides of the c.2m high promontory are very steeply scarped, especially the western edge. Although the latter partly results from the works carried out to the lake in 2001, it also partly reflects the original arrangement, as three steps made of handmade red brick survive within the bank.

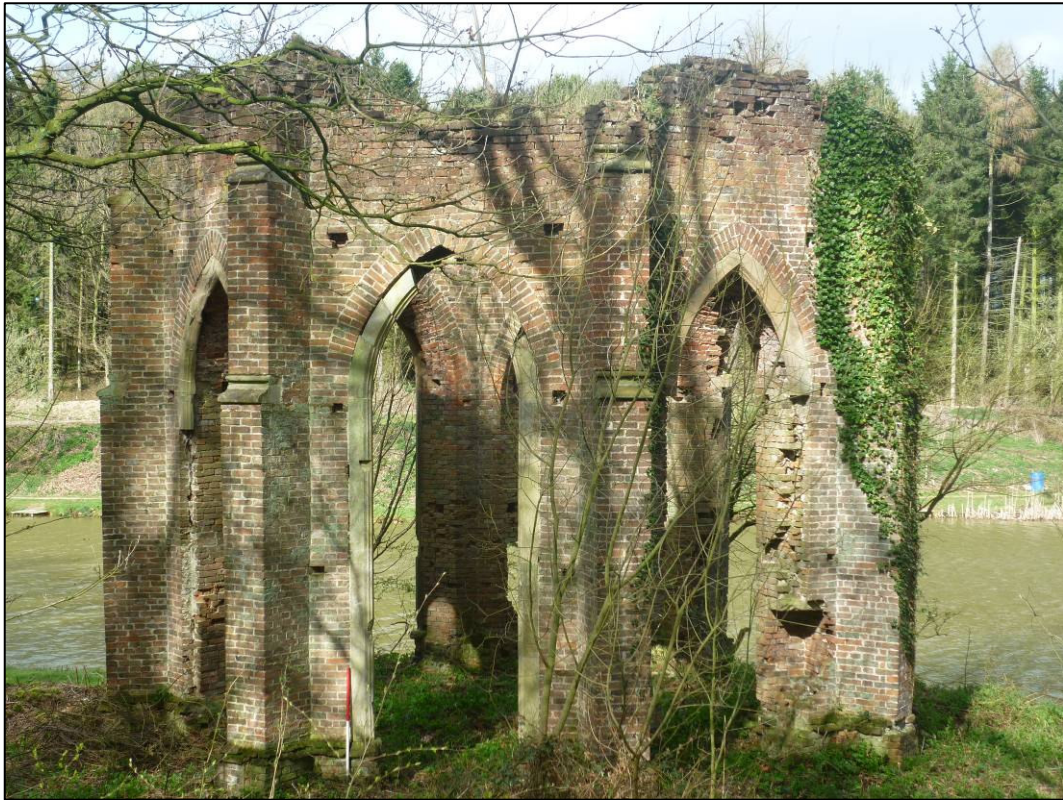
Plate 3: General view of east side of folly (Side C in centre), looking W (photo 1/619).

- 3.11 It is not altogether certain what form the base of the openings took. The brickwork at the base of nearly all of the openings has been cut back, making interpretation of the remains difficult. Perhaps the best preserved example of the base of an opening remains within Side D [1/656]. Here, the surviving brickwork suggests that the base of the opening may have reduced to 0.50m wide, and perhaps run right across the opening. If this were the case, then it may have formed the base for a window, perhaps with a window seat fitted internally. Scarring might also suggest that the sill of any such window opening was set about 0.50m above the existing ground surface, although again, it is difficult to be certain. However, in the opening on Side E, there is perhaps evidence that the base brickwork has 'proper' sides, and did not run all the way across the opening. Many of the openings are surrounded externally by a regular pattern of small square recesses reminiscent of putlog holes (see plates 1 and 3).

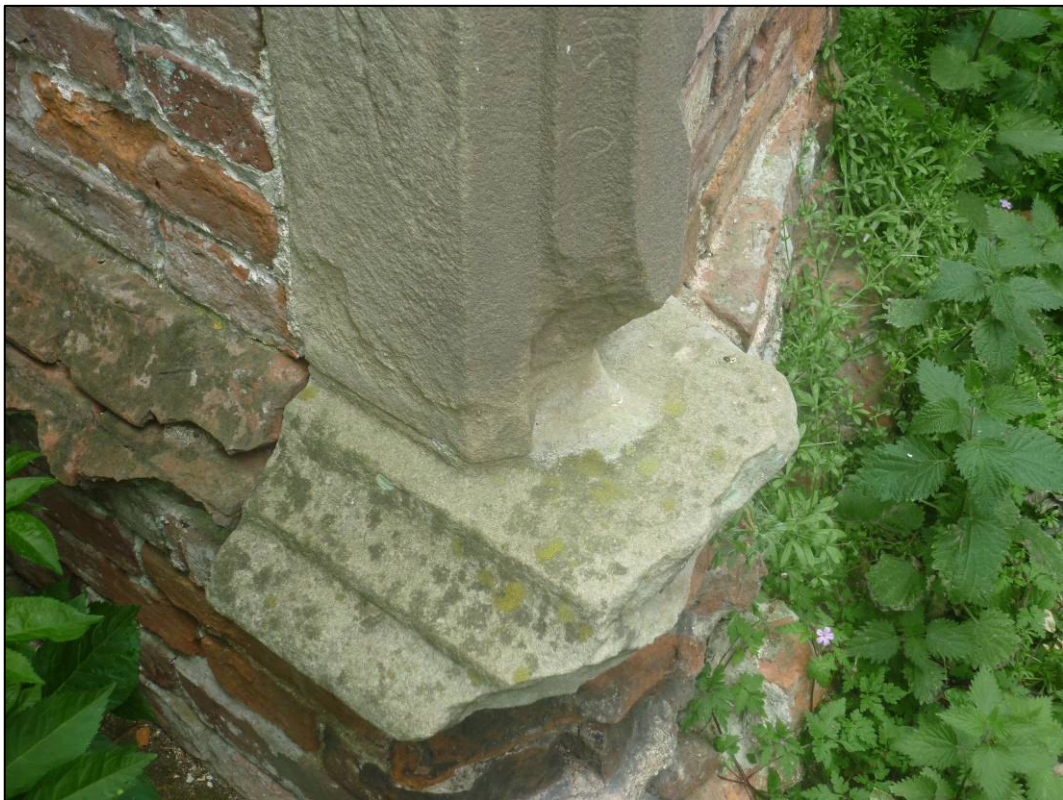
Plate 4: Typical brick and limestone moulding to plinth, base of Side C (photo 3/377).

- 3.10 All eight external sides of the folly, and the diagonal buttresses, rise from a moulded brick plinth; depending on the height of the adjacent ground, up to three offsets are visible below the plinth. The uppermost stage of the plinth comprises bricks with both concave and convex mouldings (see figure 9). Where they have survived, the bases of the limestone jambs of the openings have the same moulding as the brick plinth [1/649 and 3/377] (see plate 4); the moulded limestone continues all the way across the base of the exterior of Side A.

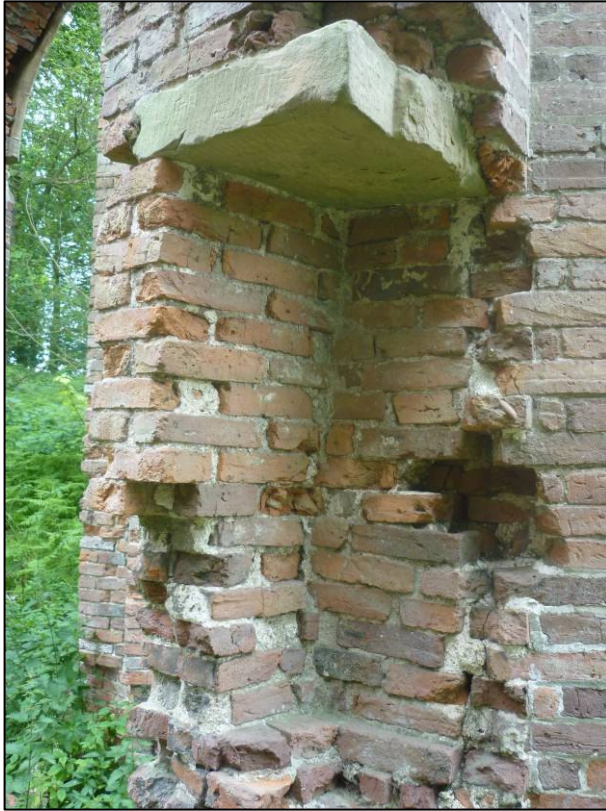
Plate 5: Recess to north side of Side D, looking NE (photo 3/378).

- 3.12 Matters are further complicated by the recesses which are incorporated into the sides of the openings. These are all of approximately the same form; the bases of the majority are set c.1m above the existing ground surface, and they have a total height of c.1m, with a stone lintel. The exceptions are in Sides E and F, where the recesses are set between 1.20m-2.15m above ground level; the underside of the lintel recess to Side E also has a slightly sloping, rather than a flat profile. The sides of the recesses, where they survive, are generally neatly constructed [3/378]; they average 0.40m wide, being slightly greater in depth (see plate 5). The recesses were all once internal, set just behind whatever filled the openings. They are not evenly distributed around the openings, although there is a pattern to their distribution. Sides B and H, flanking the internal fireplace (Side A), have recesses on both sides of the openings, whereas Sides D, E, F and G have the recesses on one side only (albeit all to the same side), and Side C is without recesses.

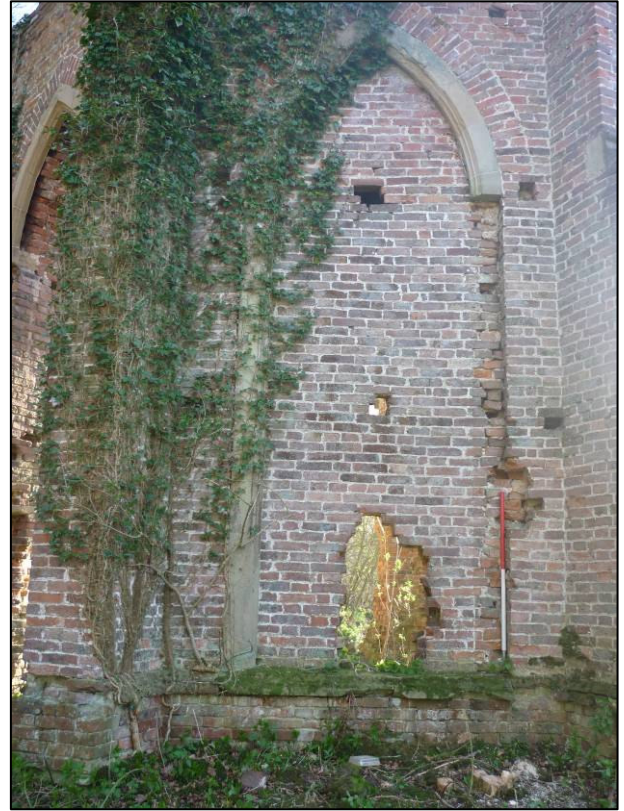
Plate 6: Exterior of Side A, looking S (photo 1/634).

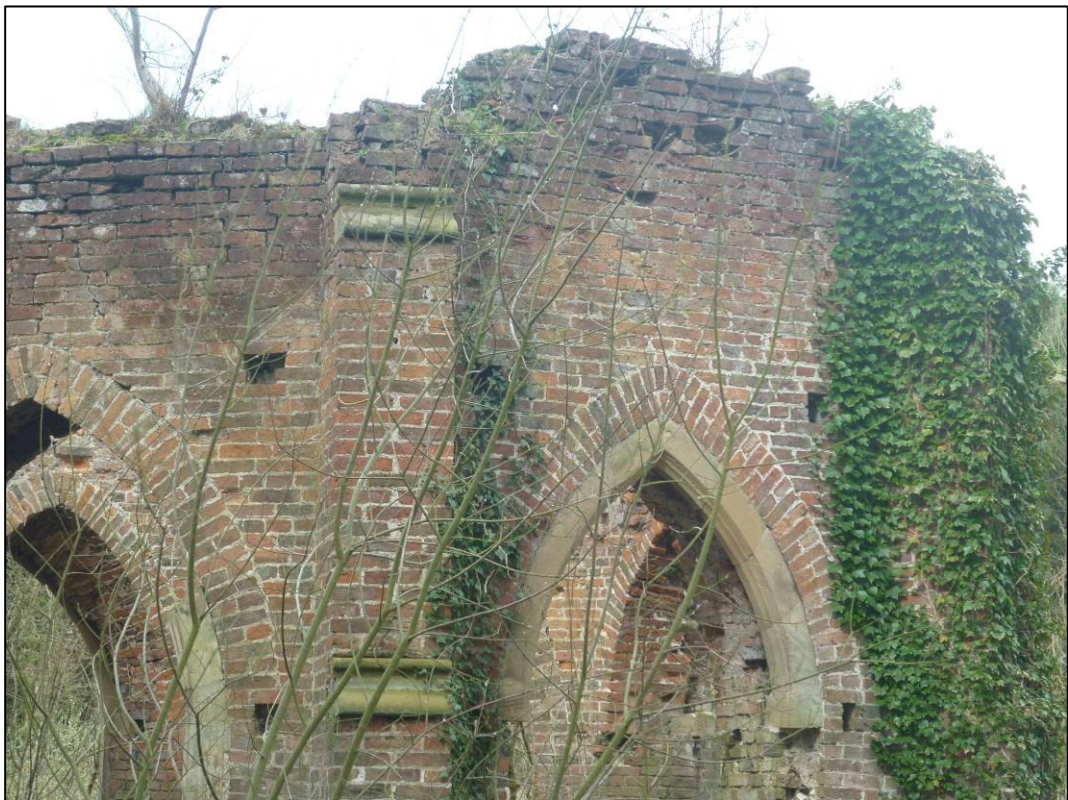
Plate 7: Upper levels of folly, Side F to right, looking NE (photo 1/629).

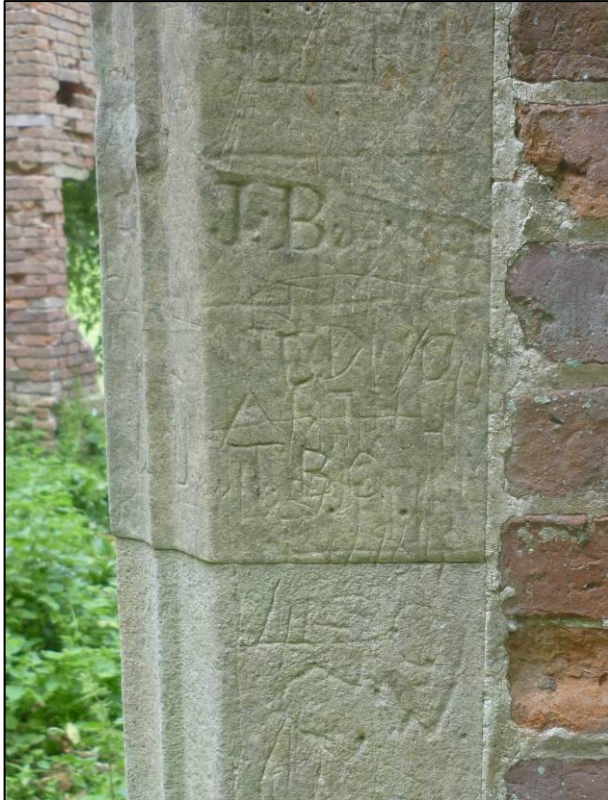
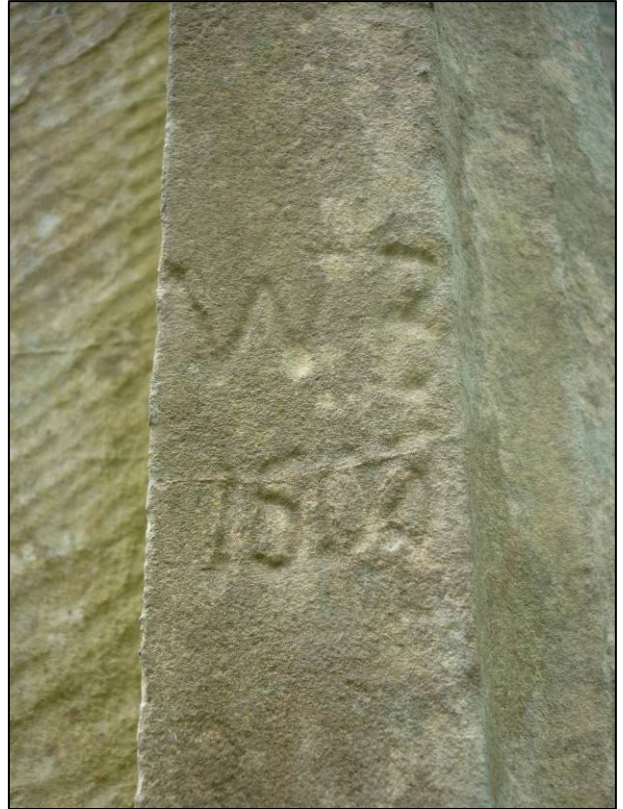
Plate 8: Graffiti on external north jamb of Side C (photo 3/373).

Plate 9: Graffiti in external north jamb of Side C (photo 3/374).

- 3.17 A small amount of historic graffiti survives on the folly, principally on the stone jambs of the opening in Side C. On the north jamb, there are numerous names and initials [1/624, 1/625, 1/627, 1/651, 3/373 and 3/376], including what appears to be 'W B 1808' [1/650 and 3/374] (see plates 8 and 9). There is further graffiti to the opening on Side F, including the inscription '1922 J G' [1/628]. New graffiti is continuing to appear on the folly, even some during the time that the survey took place ('Andy and Jake 2011') [3/375].

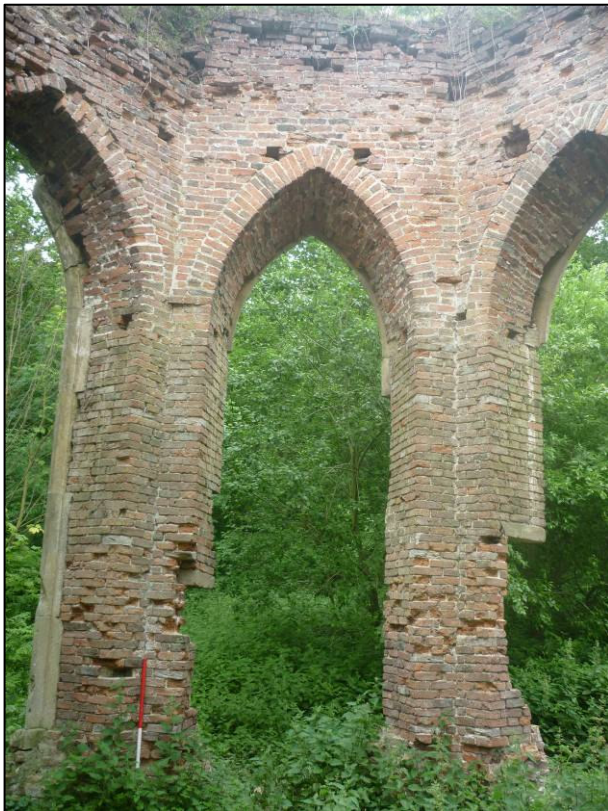
Plate 10: Interior of Side D, looking SE (photo 3/363).

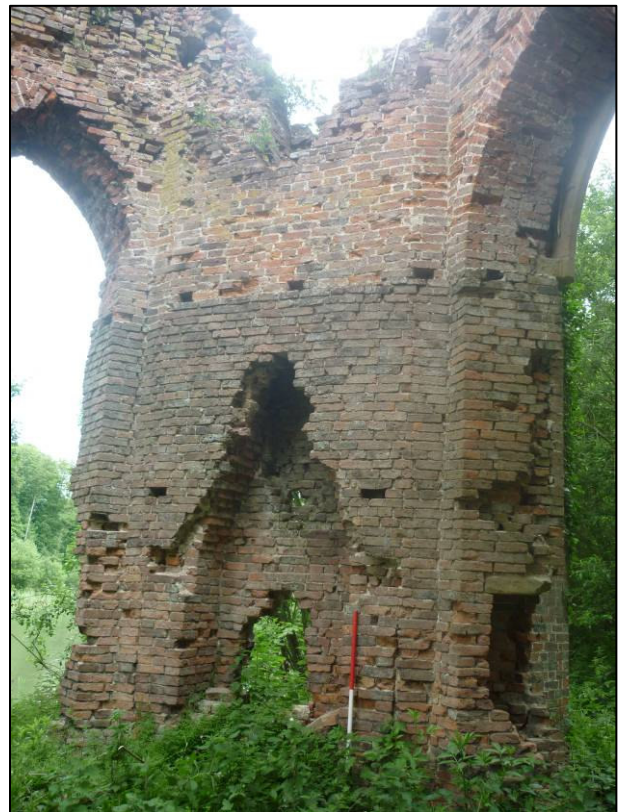
Plate 11: Interior of Side A with fireplace, looking N (photo 3/360).

fireplace changes at the same height as that around the rest of the structure, and so the fireplace might perhaps have been conceived as a change of plan during the original construction period, rather than being inserted at some later date; the change of colour in the brickwork is more prominent in this face due to the greater amount of visible brickwork. The head of the fireplace opening has been removed, but surviving scarring suggest that it may have had a pointed arch, echoing those of the much taller openings in the other seven sides of the folly. The flue can be seen to rise through the thickness of the wall. The fireplace opening may be flanked by two small recesses set c.2m above ground level, with a possible row of three further recesses at a higher level.
