FORMER GROSMONT IRONWORKS,
GROSMONT, NORTH YORKSHIRE
PHASE 1 ARCHAEOLOGICAL SURVEY

PHASE 1 ARCHAEOLOGICAL SURVEY

Report no: 2007/303.R01
Version: Final
Date: July 2007
Author: Shaun Richardson & Ed Dennison

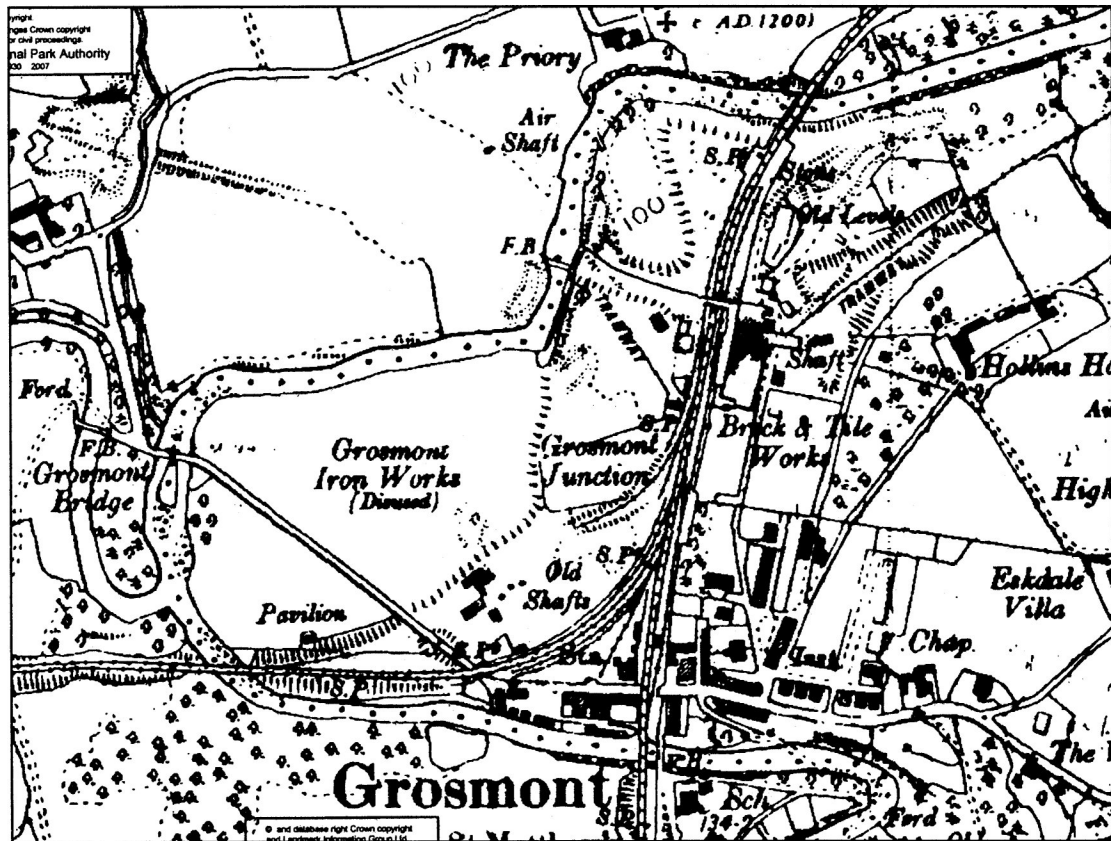
PROJECT		GROSMONT IRONWORKS	
TITLE			
HISTORIC ORDNANCE SURVEY MAPS			
SCALE		DATE	
NTS		JUL 2007	
EDAS		FIGURE	
		5

- 2.33 As well as having interest in ironstone mining, Arthur Gladstone must also have undertaken slag re-processing himself, as in 1913 both Gladstone and Company and Wm Schofield and Son are listed as slag merchants at Grosmont (Kelly & Co 1913, 108). As well as being crushed for roadstone, some of the slag was later used to manufacture slag wool as a fire-proof packing for boilers (Counsell 1981, 31). The 1913 Ordnance Survey 25” map (see figure 5a) shows significant changes to have taken place since 1893, particularly in the area of former slag tipping to the north of the ironworks. Virtually the only remnant of the ironworks surviving at this date was the boiler house chimney (marked as “Chy”). Although three “Old Shafts” are shown, these are in the wrong place to be the blast furnace bases, and so may perhaps relate to the former calcining kilns. The L-shaped range shown to the north-west of the chimney had been reduced in size slightly since 1893, but several new buildings had been erected to its north, adjacent to the north-east/south-west railway siding crossing the site. A siding leading from these new buildings into the area of slag tips to the north had been re-established, and the pattern of the tips themselves had changed since 1893 as a result of the extraction of slag for processing. The site is similarly depicted on the Ordnance Survey 1916 6” map.

- 2.35 Extraction of slag probably finally ceased some time around the Second World War, almost certainly because all economically viable supplies had been exhausted. The 1952 Ordnance Survey 6" map shows many of the structures on the former ironworks site to be unchanged since 1913 but, apart from a very small remainder, all slag heaps between the works and the river Esk had disappeared, as had the very large tip on the north side. Almost the last relic of the ironworks to be removed was the very tall boiler house chimney, which was not demolished until 1957, and by 1969, Joy was able to describe the former ironworks site as a "grass grown area" (Joy 1969, 57-58).

- a) OS 1913 25" map sheet 45/4
- b) OS 1952 6" map sheet 45NE

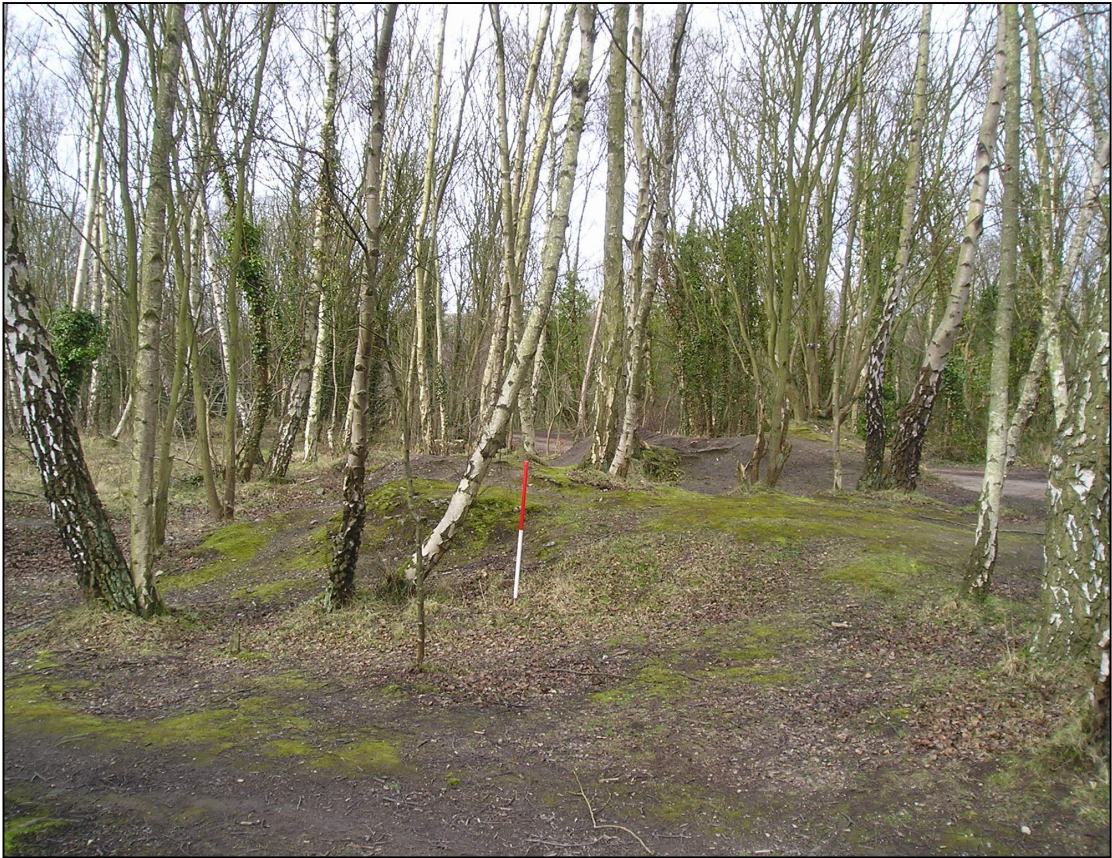
Plate 5: Furnace base (Site 7), looking NW.

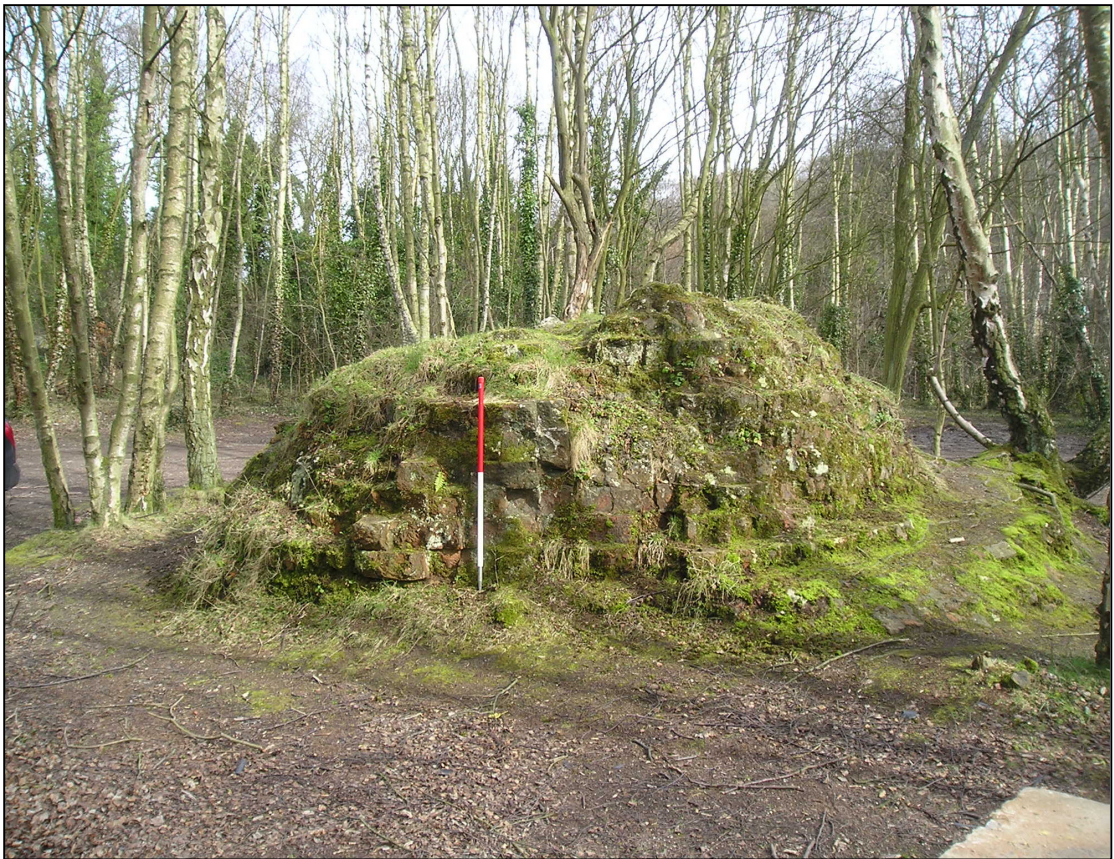
- 4.6 As has been previously noted, almost nothing remains above ground of the Grosmont ironworks. The main visible elements are the remnants of the lower part of the third and latest furnace (**Site 8**) and the tramway bridge to the north (**Site 20**) which brought iron ore from the mines located near Priory Farm. However, it is likely that the remains of all three of the blast furnace bases survive below the present NYMNPA car-park; the 1863 description of the works describes their substantial nature and depth, together with associated flues and pipes.

Plate 6: Furnace base (Site 8), looking NE.

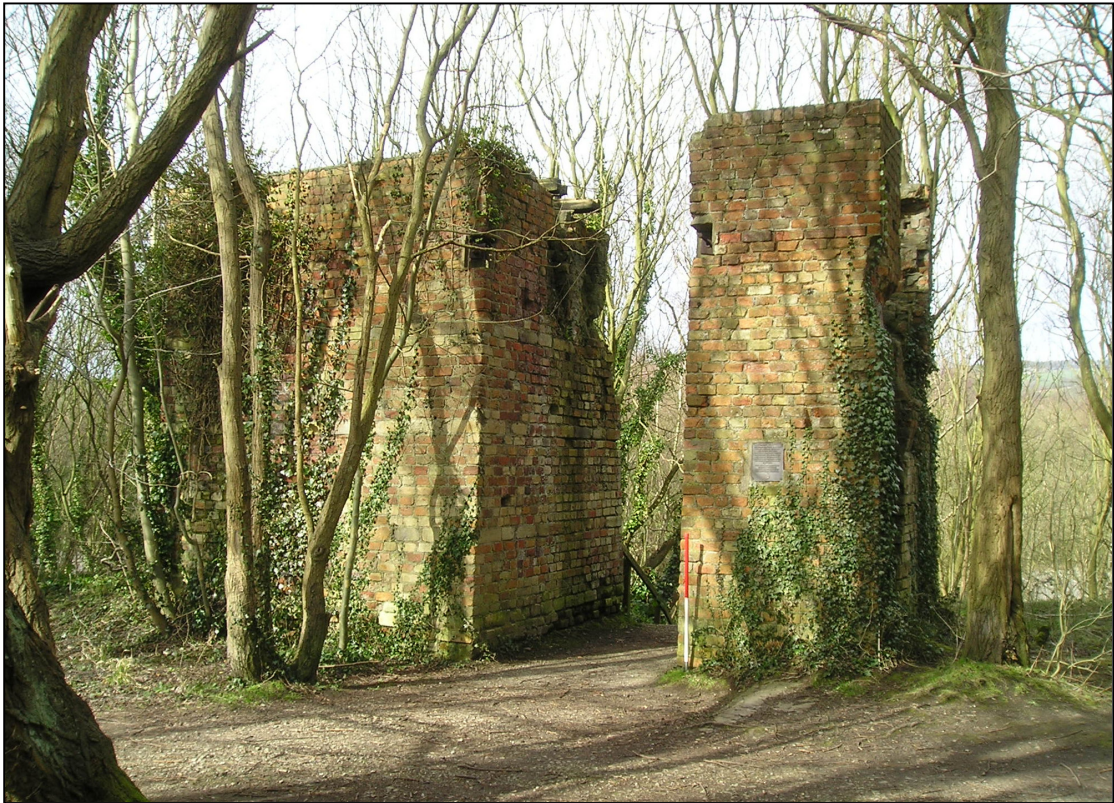
- 3.14 The ruined structure comprises two substantial brick pillars, rising to a maximum height of 4.40m (see plate 7 and figure 7). Both are rectangular in plan, the east pillar being slightly smaller than the west, but both have battered north and south faces and both are built of handmade reddish-brown and yellow bricks, incorporating bands of large refractory bricks. The east pillar has been subject to more alteration than the west, including a large irregularly-shaped area of repair or alteration, crudely carried out in re-used refractory bricks to the east face. To one side of the repair, a sub-oval "shaft" has been cut down through the body of the pillar. The shaft is c.0.60m deep and open to the east side, sloping downwards at a slight angle from north to south. There also appear to be the remains of a circular shaft in the east face. It is difficult to determine exactly how the shaft was cut into the brickwork; it has the appearance of being worn away in several stages by rubbing or friction, but this is not clear. The gap between the two pillars was once crossed by several beams or girders, the uppermost of which was a later insertion, and which bears the date "1927" above its former east end. The ground falls away very sharply to the north of the pillars, with the gap between the two now forming a footpath. A number of features are visible in plan only in the immediate area of the pillars, including concrete bases/beds and ruined structures of machine-made brick.

Plate 7: Remains of hoist / lift (Site 2), looking NW.

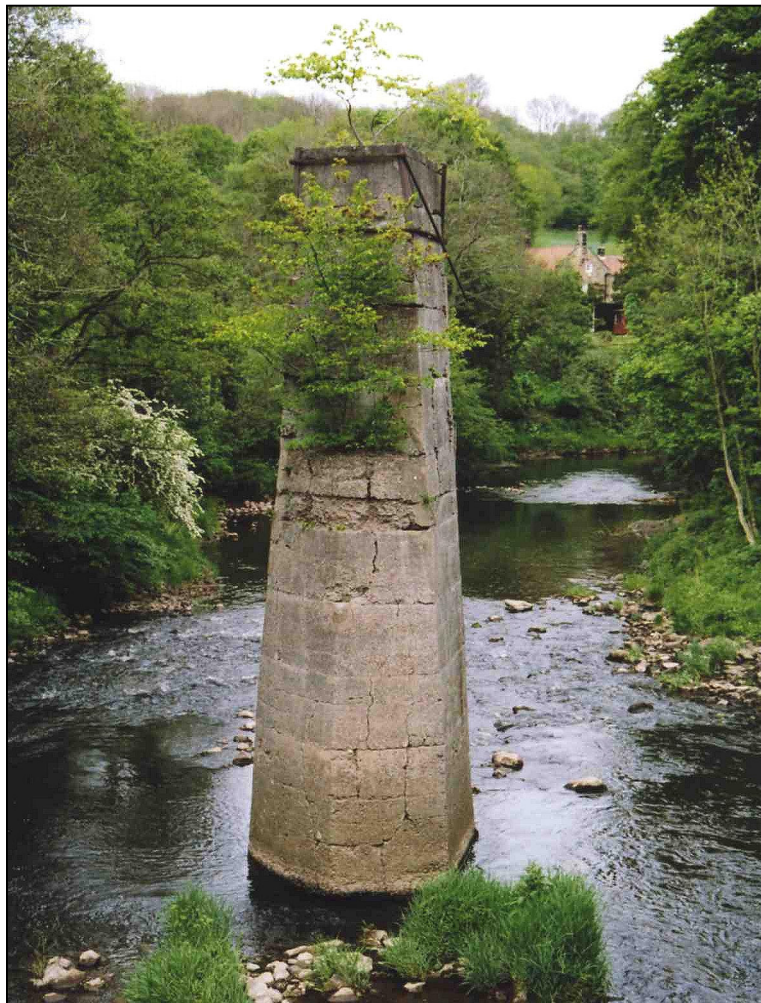
Plate 8: Bridge pier (part of Site 19), looking N.

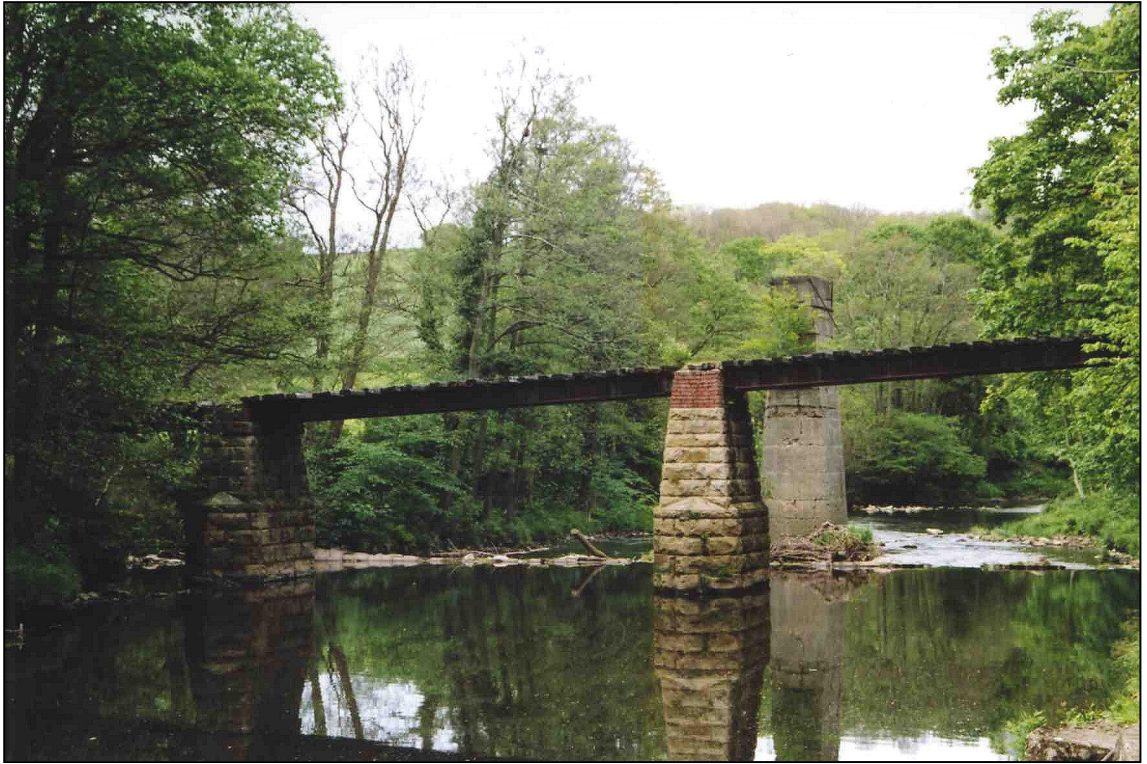
Plate 9: Tramway bridge (part of Site 20), looking N.

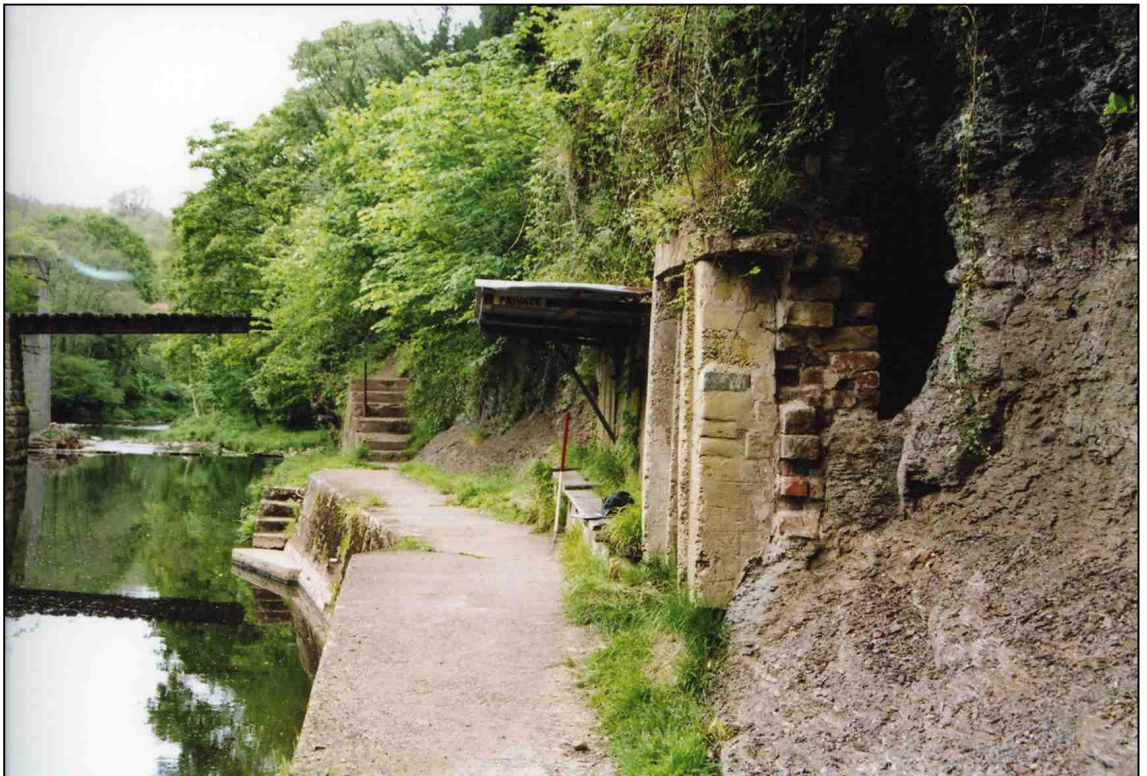
Plate 10: Wharf and related structures (Site 22), looking NE.
