Facit Chimney, Facit Quarry, Whitworth

A Photographic Building Survey

By J.M. Trippier Archaeological and Surveying Consultancy

September 2008

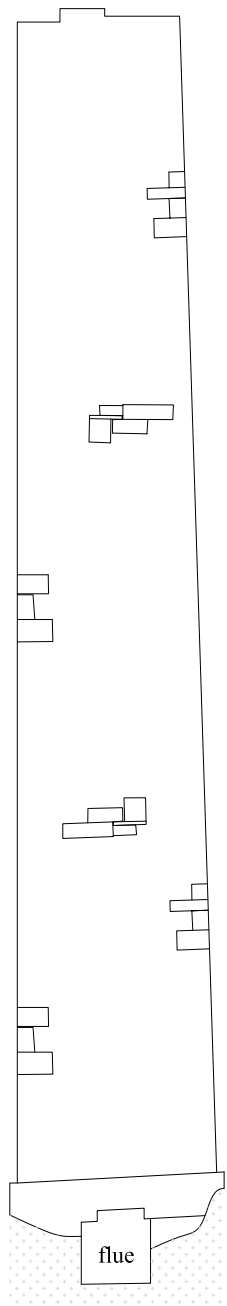
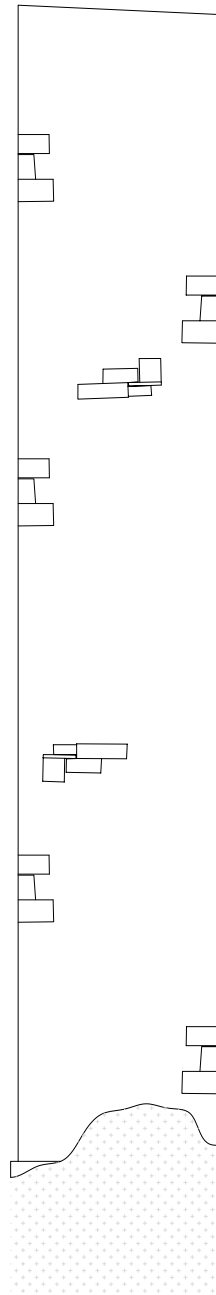
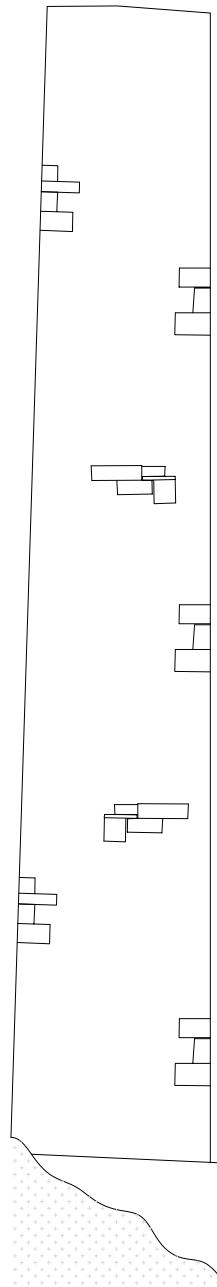
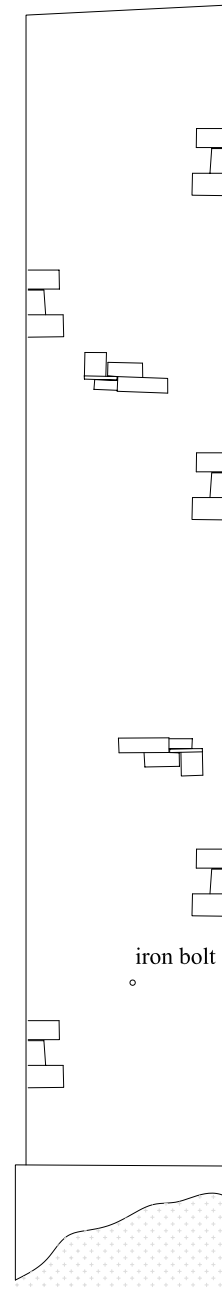
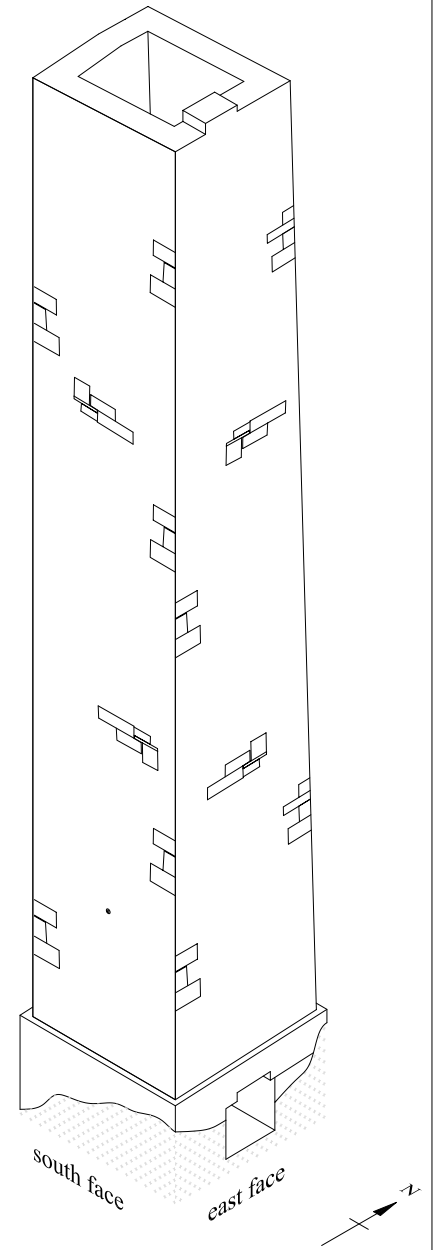
Fig. 5: Elevation Drawings

where the open flue could be seen (see **Plate 5**) and the height given is from the base of this flue. The plan size of 2m square also relates to the plinth. It is apparent that the chimney itself is slightly smaller at 1.8m square where it joins the plinth. Furthermore whilst the east and west faces are perpendicular it is apparent that the south and north ones slope in slightly so that the width of the east and west faces narrow to 1.5m at the top of the chimney. The walls of the chimney are estimated to be 200mm thick at the top (see **Fig.5**).

east face

north face

west face

south face

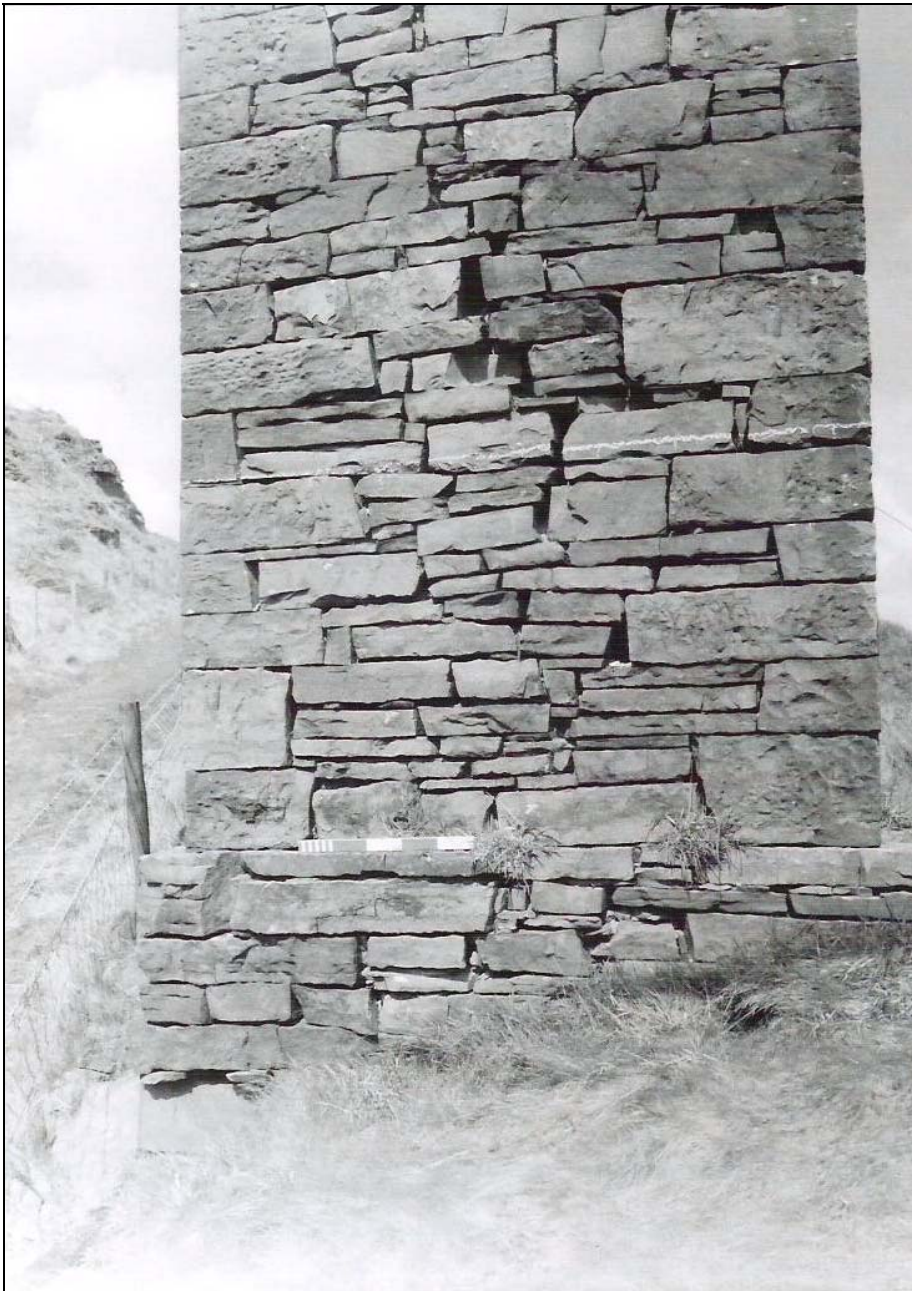
Plate 2: Plinth at Base of South Elevation

- 5.2 The chimney is constructed of random roughly coursed millstone grit with undressed quoinstones at each corner (see **Plate 2**). It is bonded with lime mortar although in places on the surface 'black ash' mortar is also visible. This is especially prevalent about 1 ½ m above the plinth on the west face. But its concentration in one or two places suggests that it may have been a pointing operation rather than a means of finishing the original work. Generally the lime mortar is very badly degraded to the extent that the initial impression is of dry-stone construction. There are also quite large cavities in the stonework (see **Plates 3 & 6** for some of the more extreme examples). These suggest that there may have been some movement in the chimney since its construction. A diagonal jagged crack towards the base of the west face also suggests some settlement (see **Plate 12**). It is also obvious that the top metre or so of the chimney is now leaning out where the stonework has become loose and need resetting. This is especially noticeable on the north and west elevations (**Plates 7 & 11**). A substantial number of stones have become dislodged round the top of the chimney (**Plate 4**) but there is nothing to indicate that this was ever capped in any way which may explain its vulnerability.

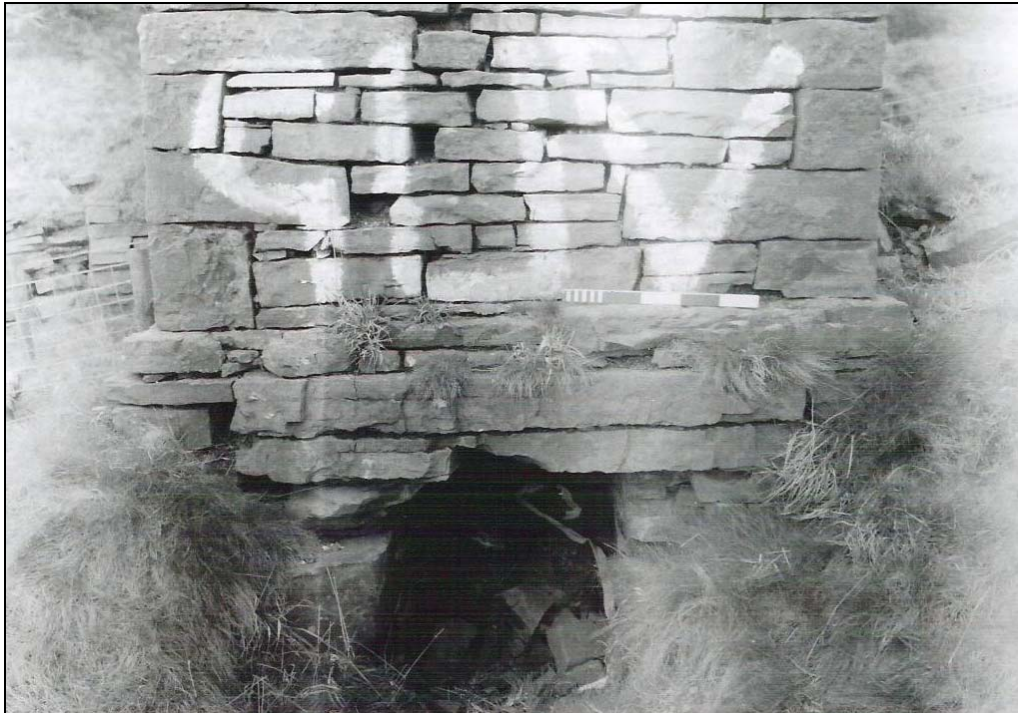
Plate 5: Flue at Base of East Elevation

- 5.1 The chimney stands slightly more than 11.3m high and has a maximum external floor plan of 2m square. It was not possible to arrive at an exact height because the stone plinth which forms the base of the chimney is now hidden somewhat by the surrounding earth and stone banking for the adjacent incline (see para. 3.1 above). The base of the chimney was most visible on the east side

For safety the open flue at the base of the east elevation should have a steel of zinc coated grille fixed over it to prevent unauthorised ingress. It is understood that Groundwork's architect will produce a suitable design.
