# DEFENCE AREA 53

## ATWICK

### 1. **Area details:**

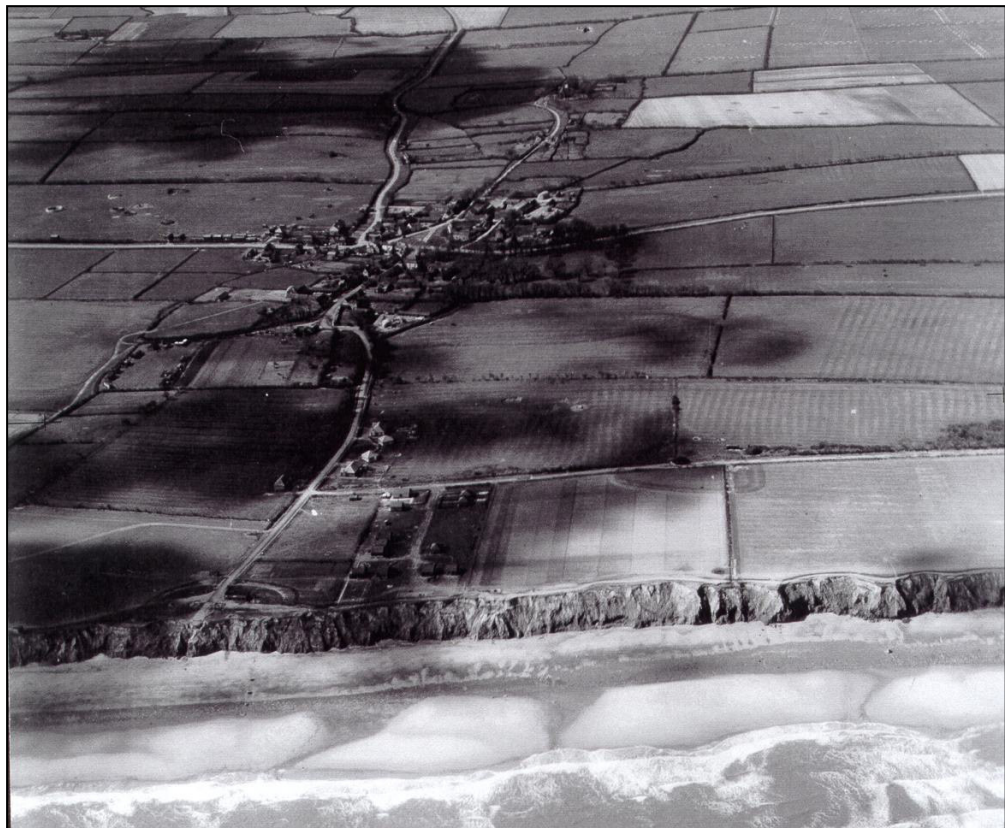
*Fig. 1 - Oblique air photograph taken in 1941 showing the cliffs and defended coastline east of the village of Atwick.*

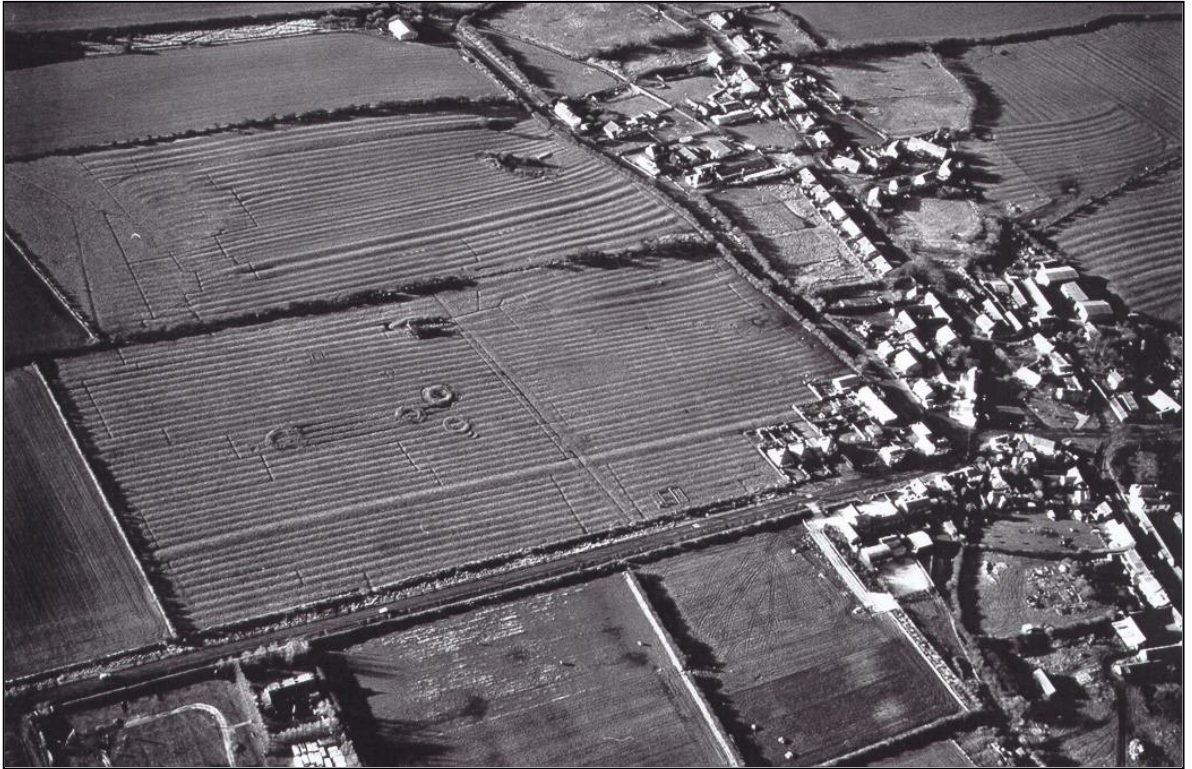
Circular earthworks in a field to the south of Atwick that show in air photographs of 1941 probably indicate the presence of a heavy anti-aircraft battery. At a later date in the war, a further heavy anti-aircraft battery, with four gun emplacements and an accompanying accommodation camp, was established on the site of the current caravan park. This may have been positioned here as part of the anti-Diver operations of 1944/45.

*Fig. 4 - Earthworks from a possible anti-aircraft battery (established early in 1941) still visible in fields south of Atwick in 1995.*

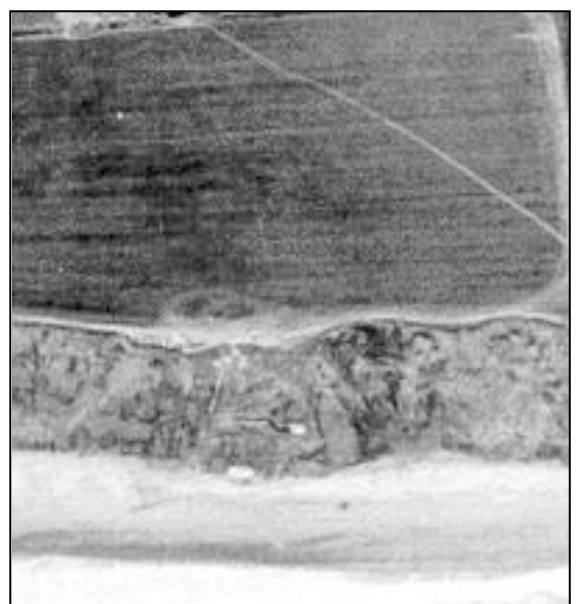
<sup>6</sup> Oblique air photographs show slit trenches dug in the cliffs above the pillboxes [see Fig. 6 ].

*Fig. 6 (right) - Beach front pillbox, UORN 13124, with a slit trench in the cliff face above it - detail from a July 1940 air photograph.*

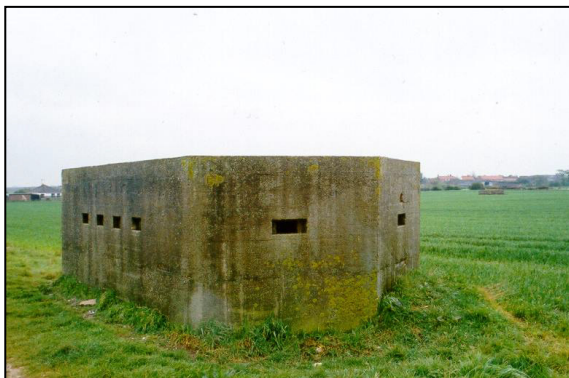
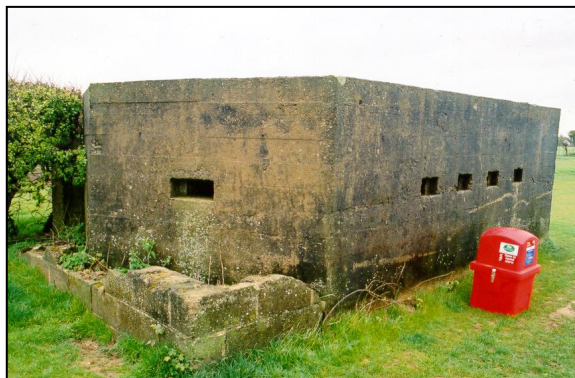
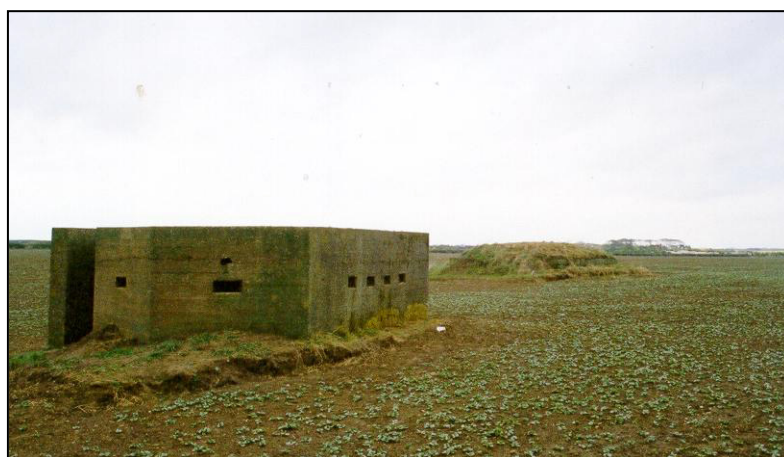
Owing to cliff erosion, all the pillboxes in the first line on the beach have been destroyed.<sup>12</sup> However, many of the second line pillboxes do survive, and these are of a particular local variant type that can be found as well further to the north [see Defence Area 52 - Speeton]. The type is of a hexagonal lozenge shape, and is characterised by four small embrasures side by side in the main forward face and by an attached loop-holed blast wall.

*Figs. 7, 8, 9 - Examples of the principal local type of infantry pillbox: from the top (clockwise), UORNs 13121, 13123, and 13194.*

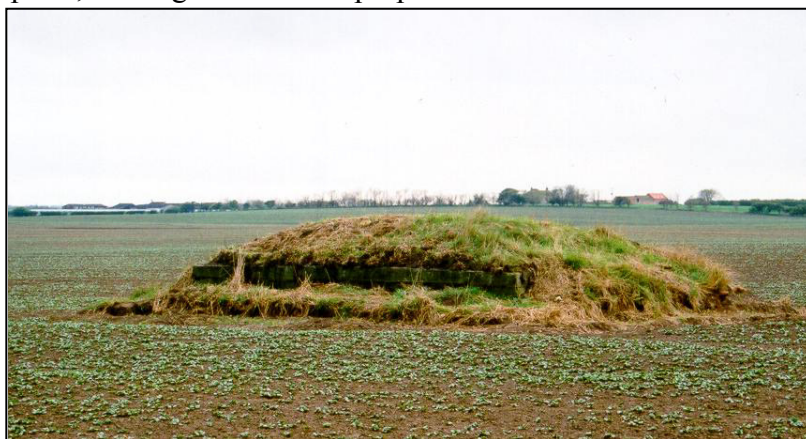
Two semi-buried structures [UORNs 13122 and 13195] may have been command posts, although their exact purpose and function is not clear.

*Fig. 10 - UORN 13195: sunken command post, looking from a distance like a prehistoric round barrow.*

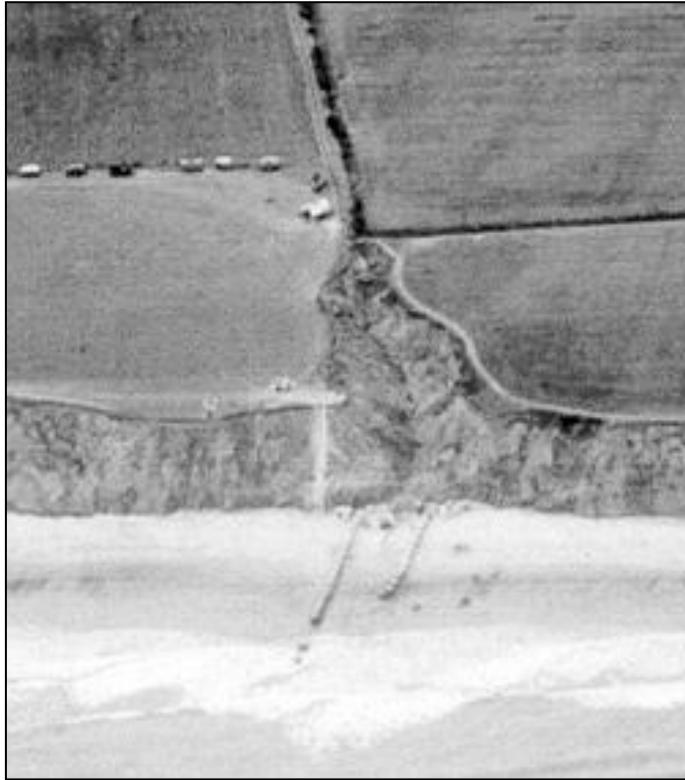
At Atwick Gap, protection of this natural exit between the cliffs from the beach was provided by parallel line of anti-tank cubes running from the shore to the sea that were designed to prevent armoured vehicles traversing the beach. Only a few heavily eroded blocks remain today.

*Fig. 11 - Parallel lines of anti-tank cubes running towards the sea at Atwick Gap can be seen in this detail from an oblique air photograph of July 1940. They were designed to prevent enemy armoured vehicles from traversing the beach to gain access to this exit through the cliffs.*

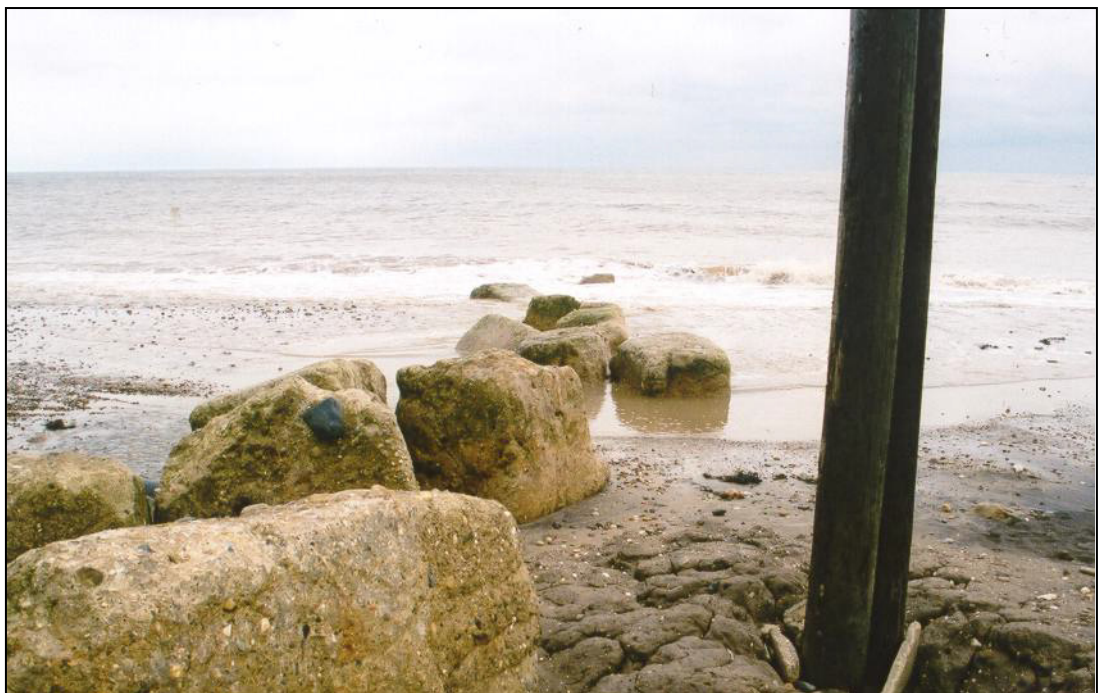
*Fig. 12 - UORN 13211: all that remains of the Atwick Gap anti-tank blocks today.*

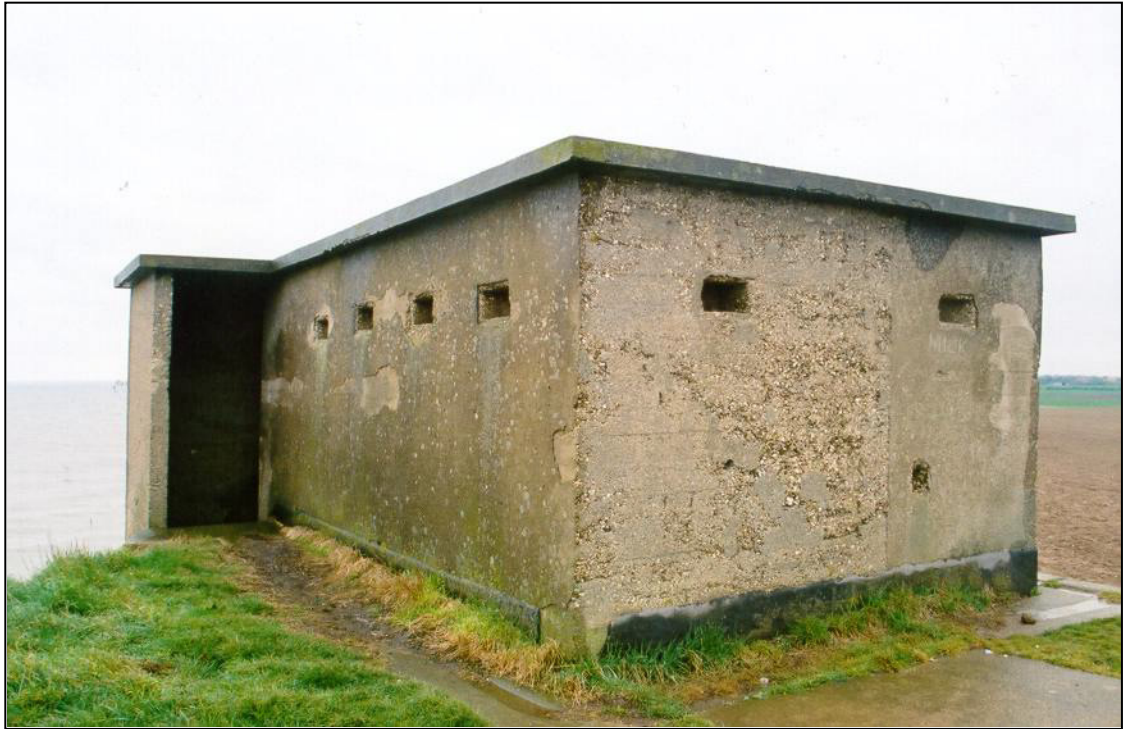
At Moor Hill at the north of the defence area piles of concrete and brick rubble indicate where at least two defence structures have been destroyed in recent years. Close by, a large loopholed observation post [UORN 13117], with unusual internal features that are hard to interpret, now hangs perilously over the eroding cliff. It is unlikely to survive for many months more, and represents a public danger that should be shut off with warning notices.

*Fig. 13 - UORN 13117: unusual defended observation post, whose exact function is not known. Part now projects over the eroding cliff and little could be done to prevent its inevitable fall.*

The observation post [UORN 13117], which is in immediate danger of being lost to the sea, is an unusual structure whose precise purpose is uncertain. The building should be recorded as fully as possible while this is still possible.

1. That the surviving anti-invasion defence works in the Atwick area be considered of national importance. They enable the defence of this section of the coast of the East Riding of Yorkshire to be interpreted, and provide evidence of the articulation of the defence and the inter-relationship of its functionally different components. Such interpretation is assisted by the documentary evidence provided in this report of defence structures that were built as part of the overall strategy but which have now been removed.
2. That the probable command posts, UORNs 13122 and 13195, be examined and recorded in detail to confirm their identity and function.
3. That the probable observation post, UORN 13117, be recorded before it is destroyed by cliff erosion.

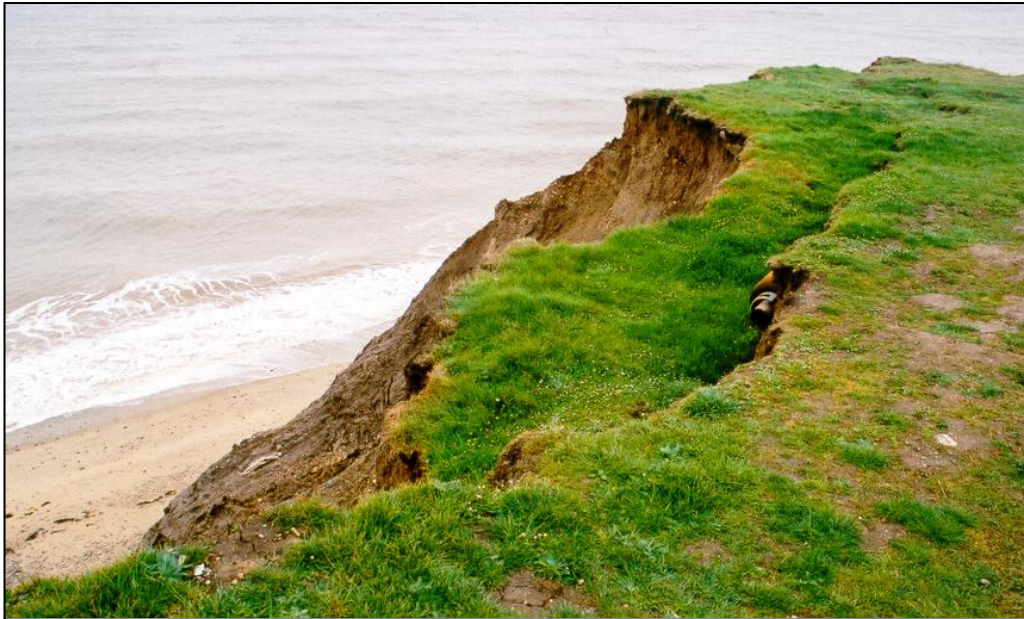
The principal changing feature of the landscape of the Atwick defence area is the steady erosion of the cliffs by the sea. Comparison with Second World War air photographs indicates that some twenty-five metres of cliff top land have been lost to the sea in the course of the last sixty years. This gradual erosion continues to threaten the cliff top defence works, and structures currently a hundred metres or so from the cliff edge [e.g. UORNs 13194 and 13195] will steadily become endangered. The observation post, UORN 13117, is already undermined and could fall at any time. Some caravans in the park near the cliff edge appear to be precariously situated.

*Fig. 14 - Continuous cliff erosion since the Second World War has removed many defence structures and endangers others.*

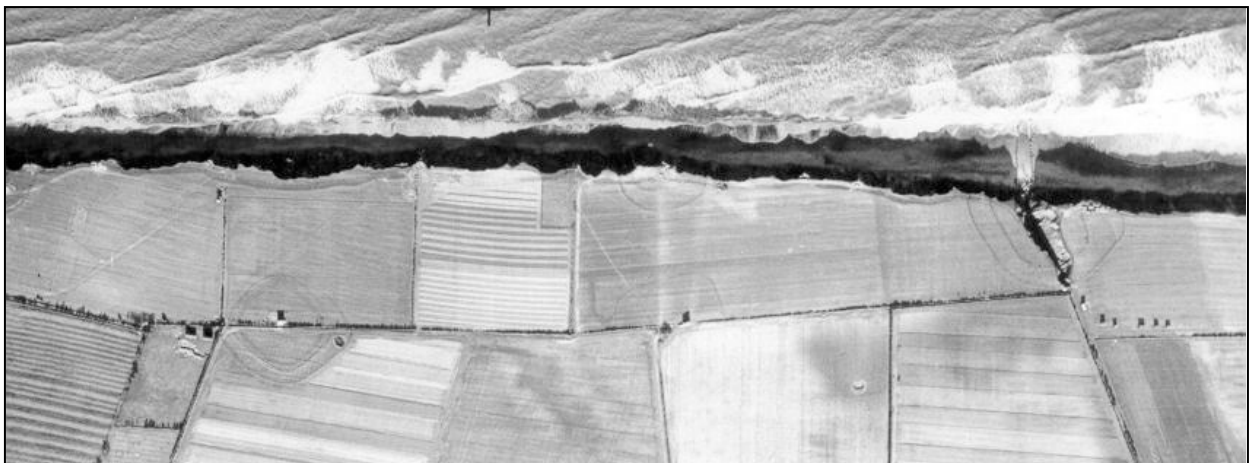
A feature of the study of Second World War air photographs of this area are the number of apparent crop marks they show that might be interpreted as single or double-ditched enclosures. As all of these correspond to the known positions of defence works, it is likely that they, in fact, show perimeter barbed-wire defences rather than buried ditches of an earlier period, although the clarity and extent of these marks is unusual.

*Fig. 15 - Portion of a 1941 air photograph showing three sets of apparent crop marks of enclosures. The markings, in fact, are almost certainly the lines of barbed wire perimeter defences at these positions.*
