DEFENCE AREA 56

WINTERTON-ON-SEA

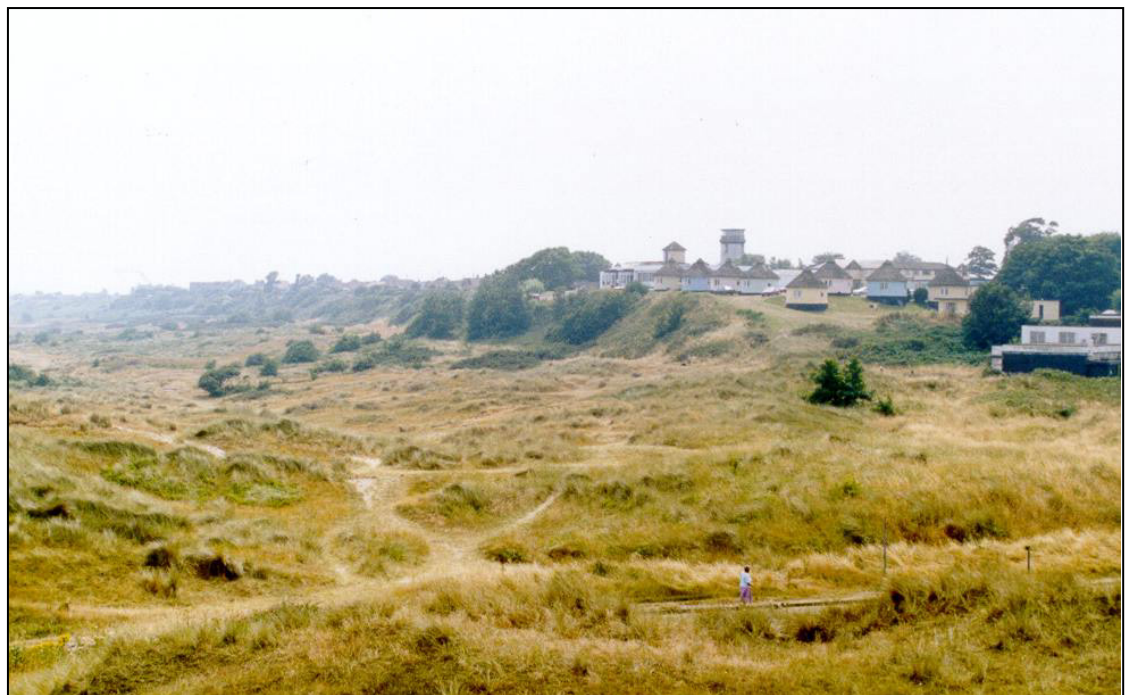
Fig. 1 - Winterton Dunes, looking south-west across Beach Road towards the bluffs topped by holiday homes and the Old Lighthouse. The latter was the Observation Post of Winterton Battery, which in 1940/41 was flanked by pillboxes and spigot mortar emplacements.

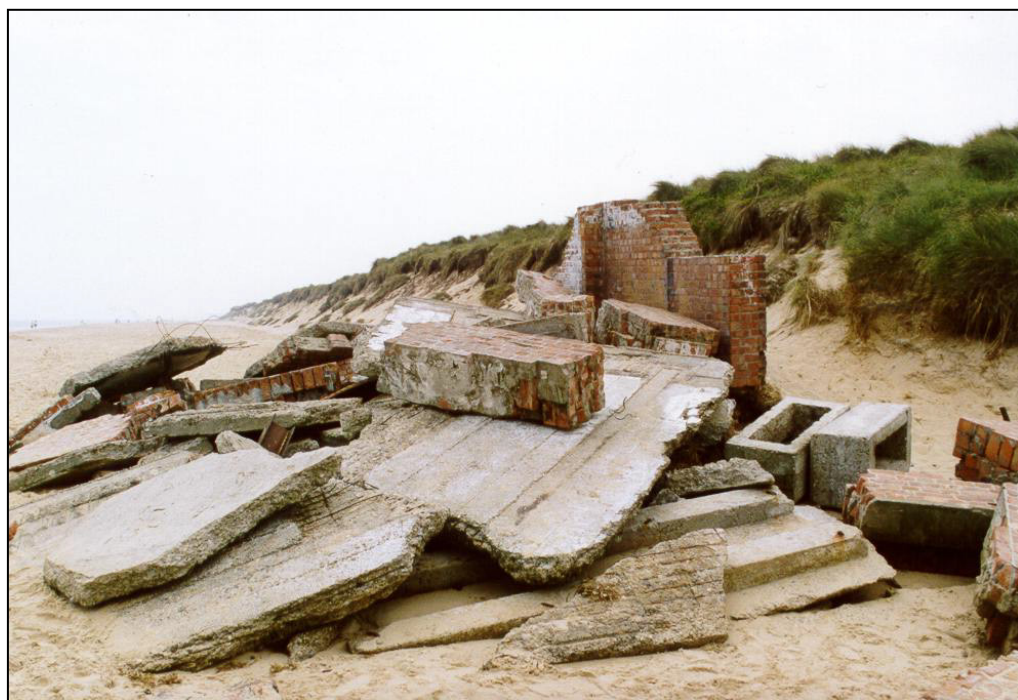
Of the concentration of defence works at Winterton, only a few survive today. Yet, what survives is of major importance. Some remaining buildings of Winterton Battery alongside the old lighthouse, itself the battery observation post, look out across the sand dunes beneath where in 1940/41 there were minefields, pillboxes, spigot mortar emplacements, and, at the edge of the sea, the battery's searchlights (CASLs). The debris from at least one of these is now piled at the head of the beach.

Fig. 4 - UORN 15958: the remains of one of the CASLs (Coast Artillery Searchlights) of Winterton Battery. This debris should be cleared away as it is ugly and a danger to holidaymakers.

2. That the debris of the coastal searchlight from Winterton Battery [UORN 15958] be cleared away. The structure has been destroyed, and there is no value in the remains. They represent a safety hazard to holidaymakers.

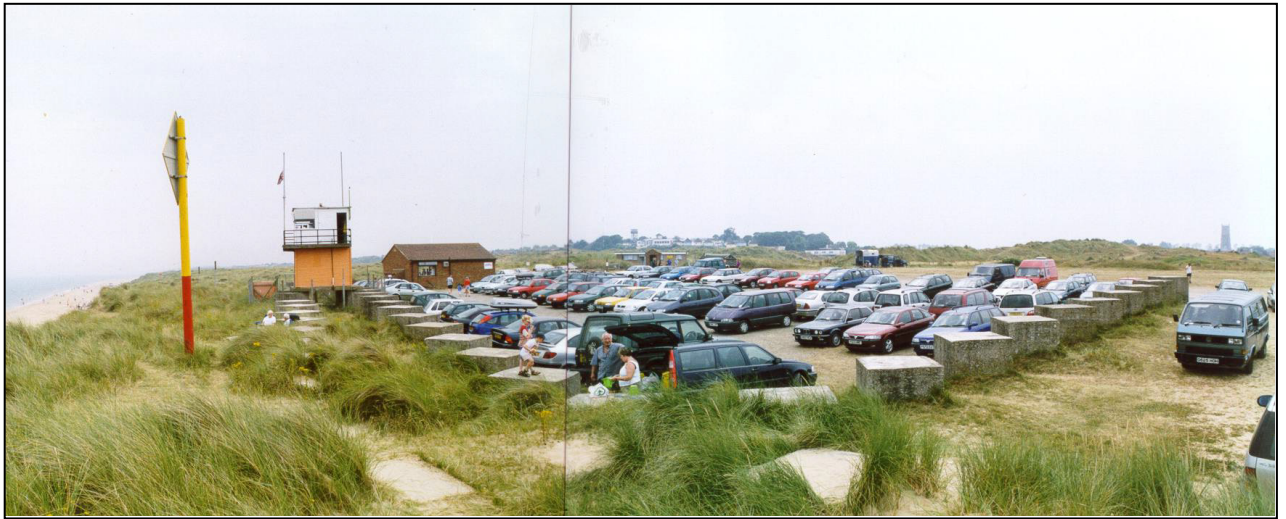
the remains of a once massive anti-tank barrier designed to block the Winterton Gap itself from an enemy landing.

Fig. 5 - UORN 9102: the lines of anti-tank blocks, now the site of the beach car park. The coastguard lookout hut is set on stilts resting on the blocks. Many blocks are now buried deep in the sand, and, to the left of the picture, they have tumbled onto the beach.

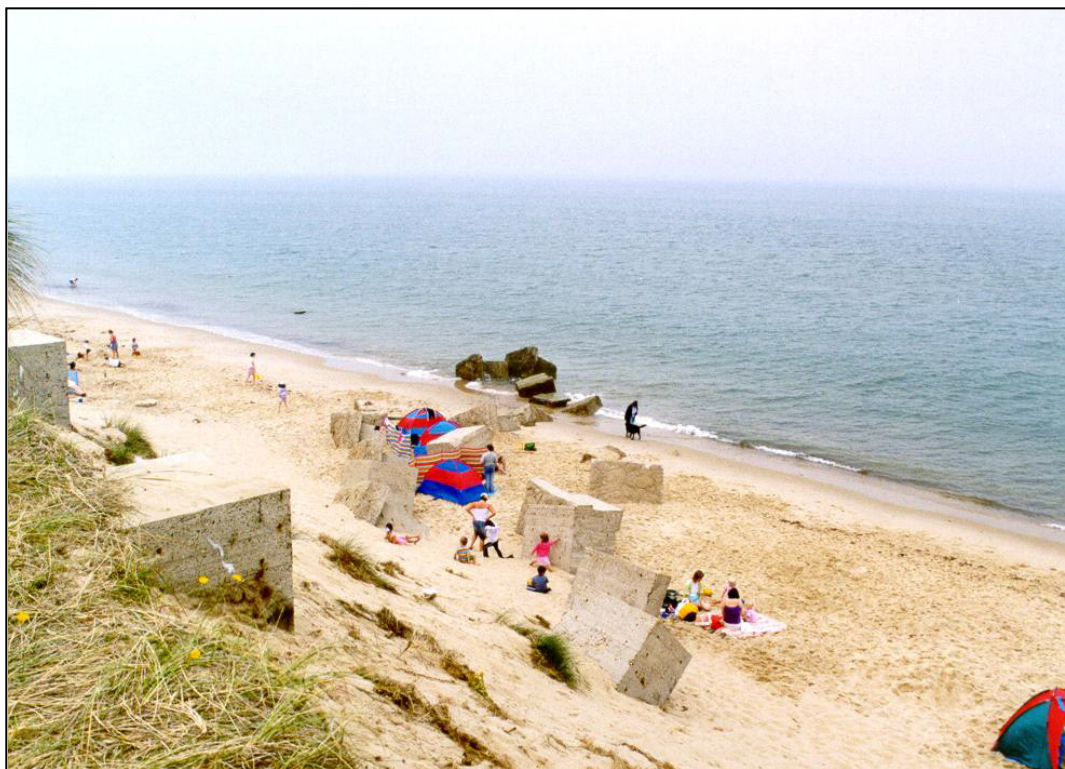
Fig. 6 - UORN 9102: anti-tank cubes toppled down the eroded sand dunes. At the time of the Second World War, the sea's edge was some 20 metres further out. A pillbox, and lines of barbed wire and tubular scaffolding, once stood where there is now open water.

As already stated, the most significant change in the landscape of this defence area lies in the degree of coastal erosion that has taken place in the last sixty years. Aerial photographs show that the lines of anti-tank blocks [UORN 9102] remained little affected by erosion until the end of the 1960s. There was then a relatively fast deterioration that resulted in almost the entire length of the northern arm disappearing by 1981, some blocks being washed away but others apparently buried by sand. The erosion is undoubtedly continuing, although perhaps slowed down, and before long the entire northern arm will have been displaced, with the remaining parts of the structure also threatened.

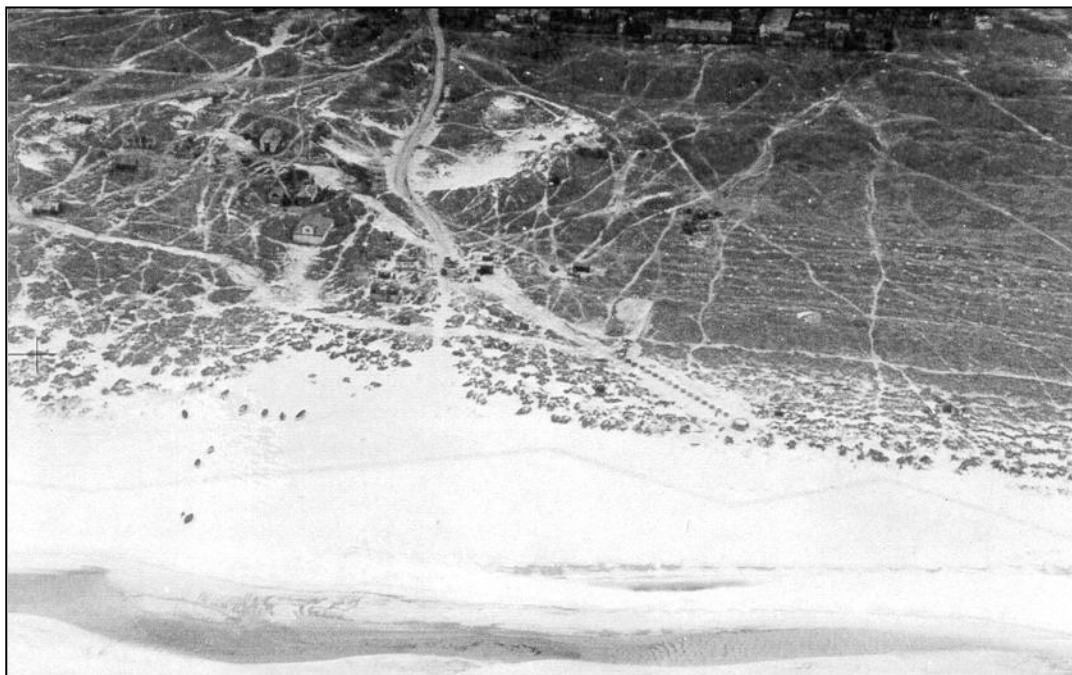
The anti-tank blocks that form UORN 9102 can first be seen in an aerial photograph of 16 August 1940. Then, they were only a single row of what was to become the northern arm of a double line of blocks, with a pillbox at the sea end. A short spur of blocks connected with this line (later the east end of the later western arm).

Fig. 7 - Aerial photograph taken on 16 August 1940, showing the first line of anti-tank blocks to be built. A pillbox is at the end nearest the sea, and a zig-zag line of barbed wire runs at the head of the beach. Behind, various structures can be seen within the sand dunes.

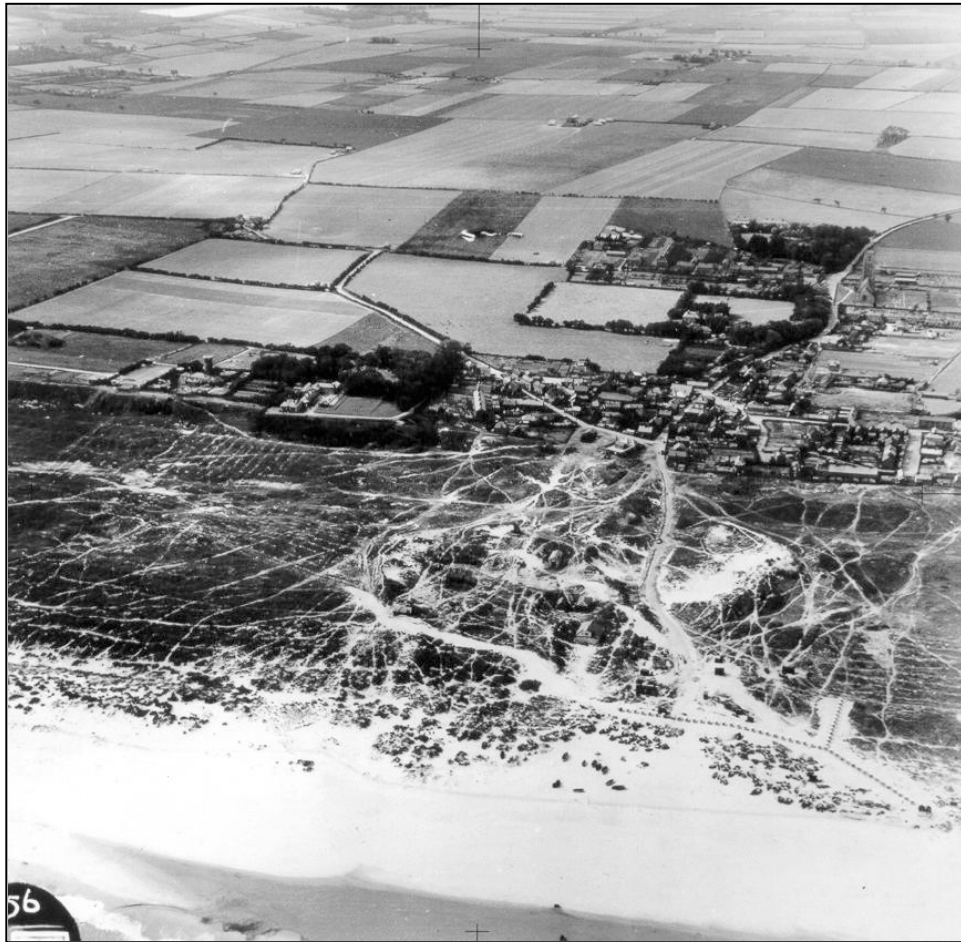
By 19 September, the anti-tank blocks were much further developed. The full extent of the eventual double-lined structure had been built, with its single connecting western arm. More additions were evidently considered necessary for a second north-south line was built alongside the first (probably in September 1941). It is possible that this work was carried out because the first blocks had sunk into the sand negating their value as an anti-tank obstacle.⁶

Fig. 8 - The single lines of anti-tank blocks as further developed by 19 Sept. 1940 .

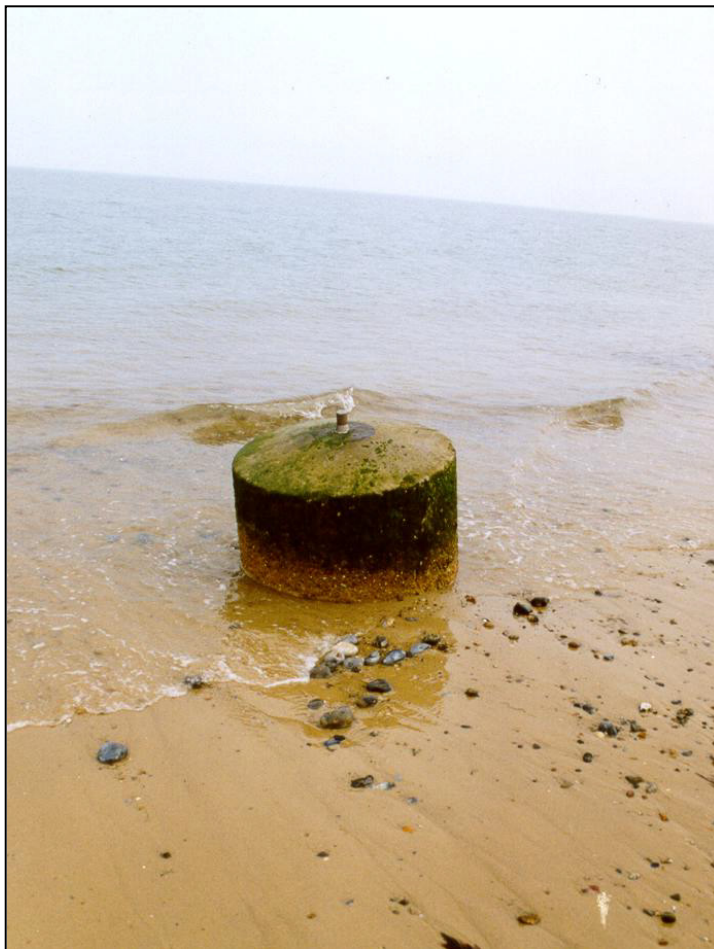
Two spigot mortar pedestals, from emplacements built possibly late in 1941, now stand on the beach near the tumbled anti-tank cubes. These were presumably built at the edge of the sand dunes, and have now been displaced to the edge of the sea, being entirely covered at high tide. Two other spigot mortar pedestals lie to the south, and show the particular deployment of this weapon for coastal defence by Eastern Command.

Fig. 11 - UORN 9101: spigot mortar pedestal emerging from the sea.
