# DEFENCE AREA 63

## DUNSTER BEACH

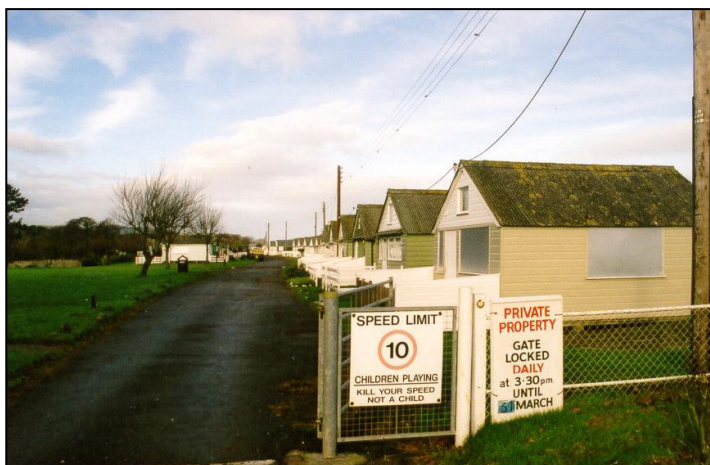
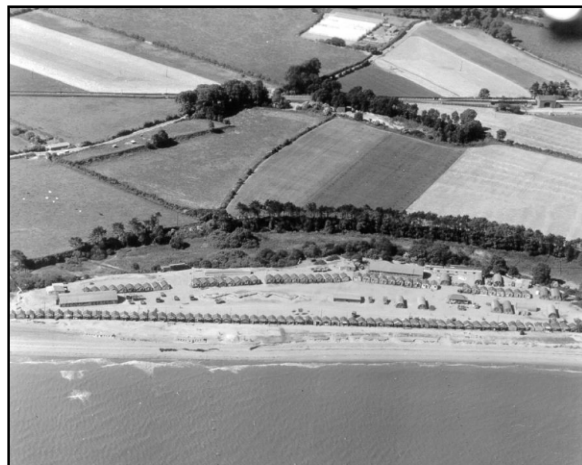
*Figs. 1 and 2 - Dunster holiday village at the western edge of the defence area is on the site of a former Second World War army camp (right).*

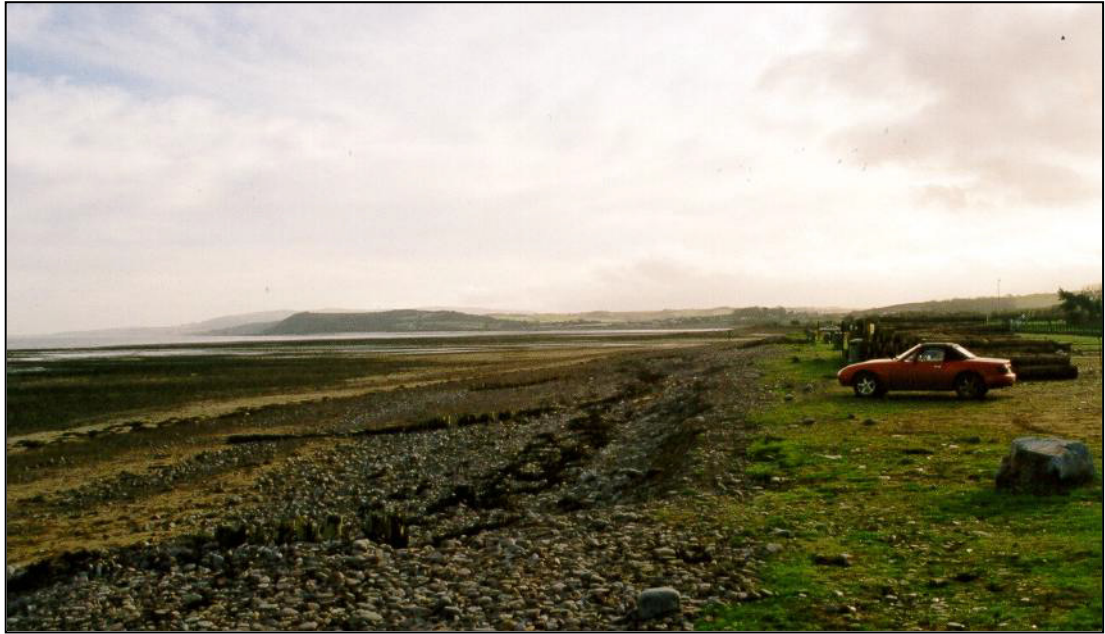
*Fig. 3 - Dunster Beach looking east. The flat shingle and sand expanses of the beach made it particularly vulnerable to a German seaborne landing.*

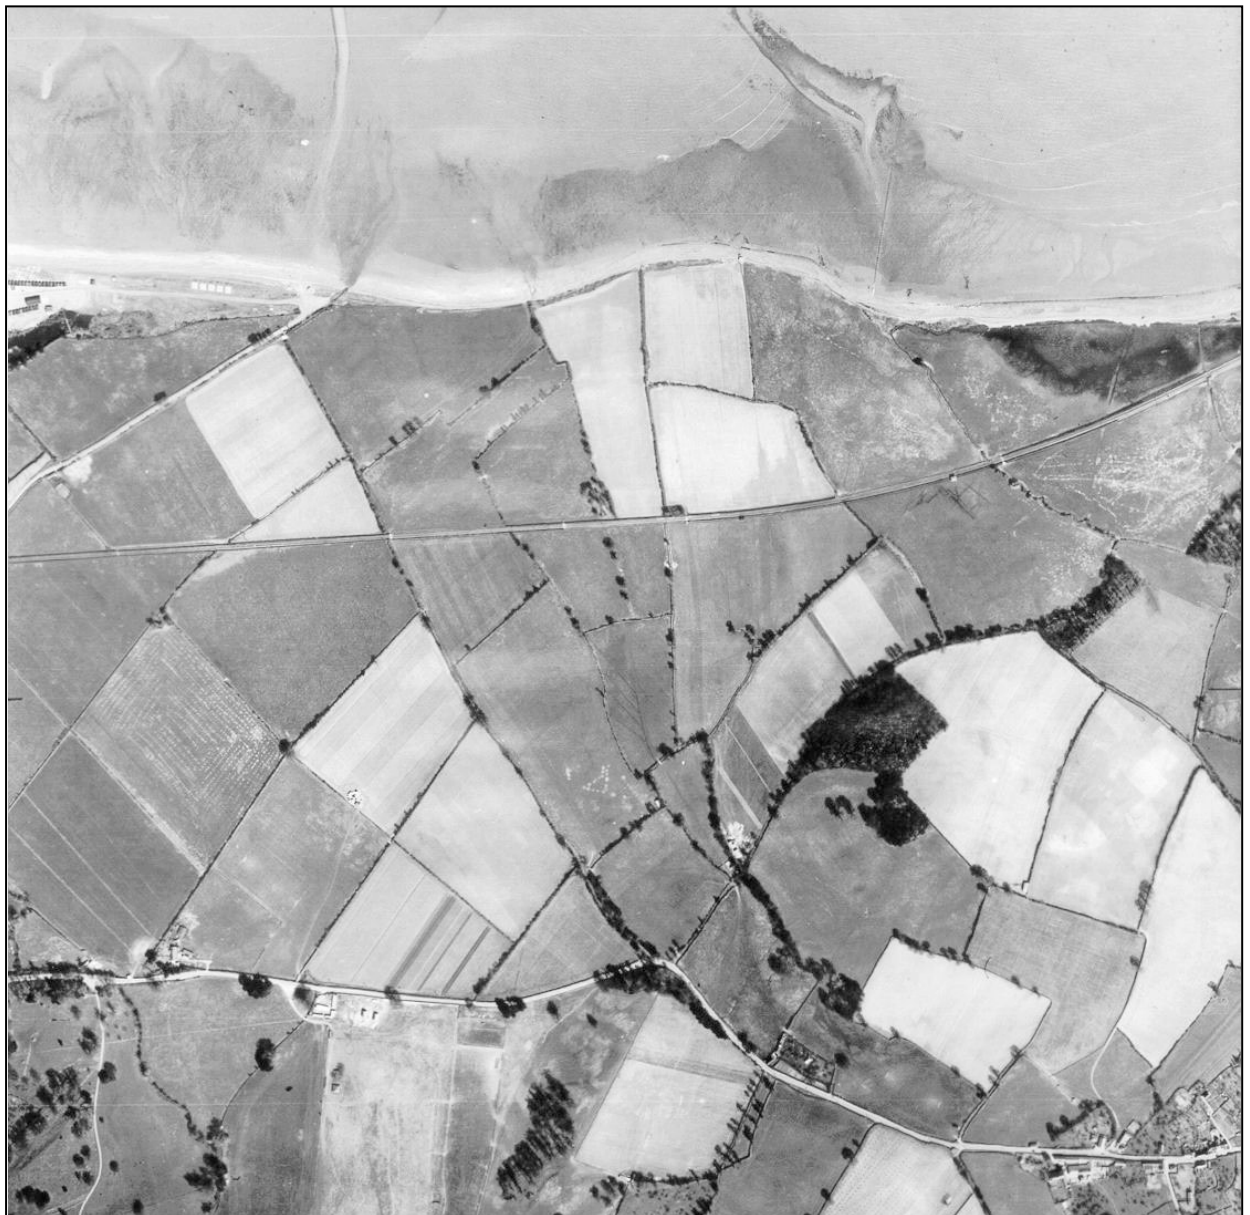
*Fig. 4 - The coastline of the Dunster Beach defence area in an air photograph taken in 1947. The army camp is at the extreme left. Defence works can be seen along the line of the beach and against the railway line to the rear.*

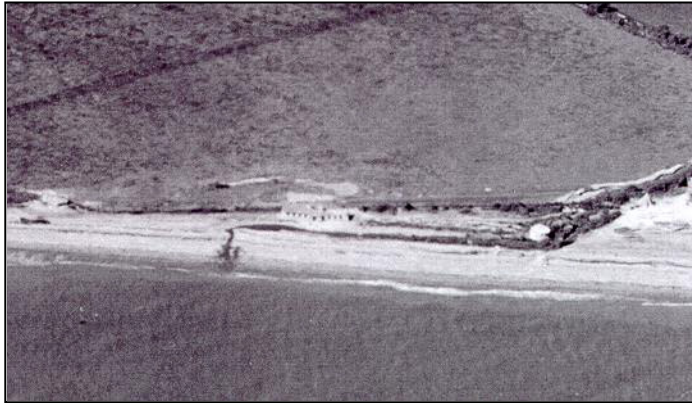
along the beach at the high water mark, and air photographs show amongst them an unusual type of structure that is probably a concrete section post. This takes the form of a rectangular pillbox with two wings, each with four forward-facing embrasures, the central core of the pillbox being unroofed, possibly for anti-aircraft fire, and with a single embrasure. Six of these structures have been plotted from air photographs within the area. None survive today, although it is possible that a length of curving wall near to Sea Lane End may have been part of one. Section posts were normally earthworks, but other hardened examples exist [see, for example, Defence Area 33 - Greatham Creek].

*Fig. 5 - Detail from an air photograph, showing, at the centre, one of the 'section posts' unique to the North Somerset coast.*

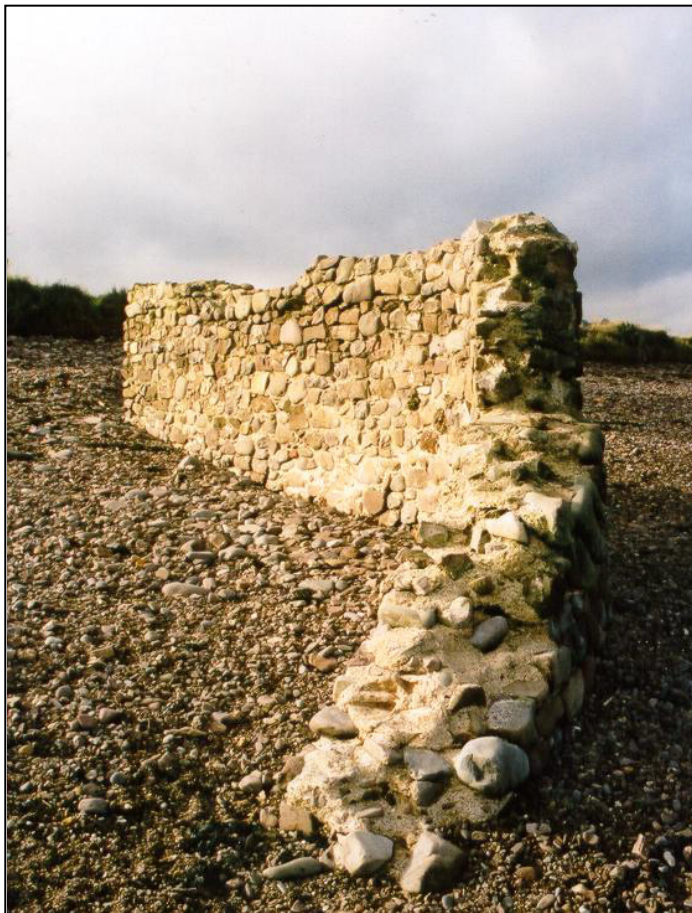
*Fig. 6 - UORN 16436: fragment of curving wall that possible formed part of one of the unusual 'section post' defence structures.*

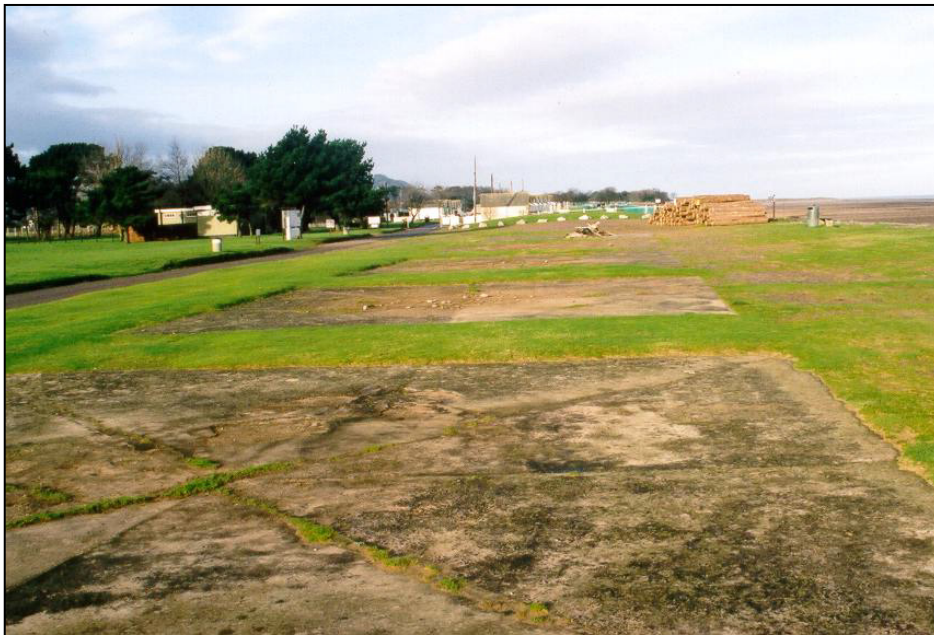
The condition of the surviving defence works varies between a few chunks of rubble washed by the sea on the foreshore to some very fine examples of pillboxes to be found on the railway line and amongst the fields behind. Additionally, at the Dunster beach car park can be seen the concrete slabs on which the beach defence battery's guns were positioned [UORN 3008].

*Fig. 7 - UORN 3008: concrete slabs where a beach defence battery was positioned.*

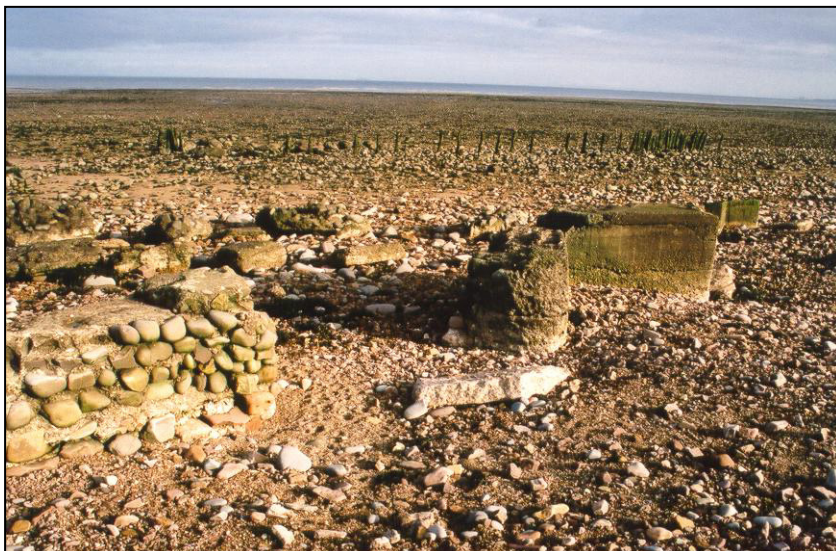
*Fig. 8 - UORN 16370: remains of a pillbox or section post on Dunster Beach.*

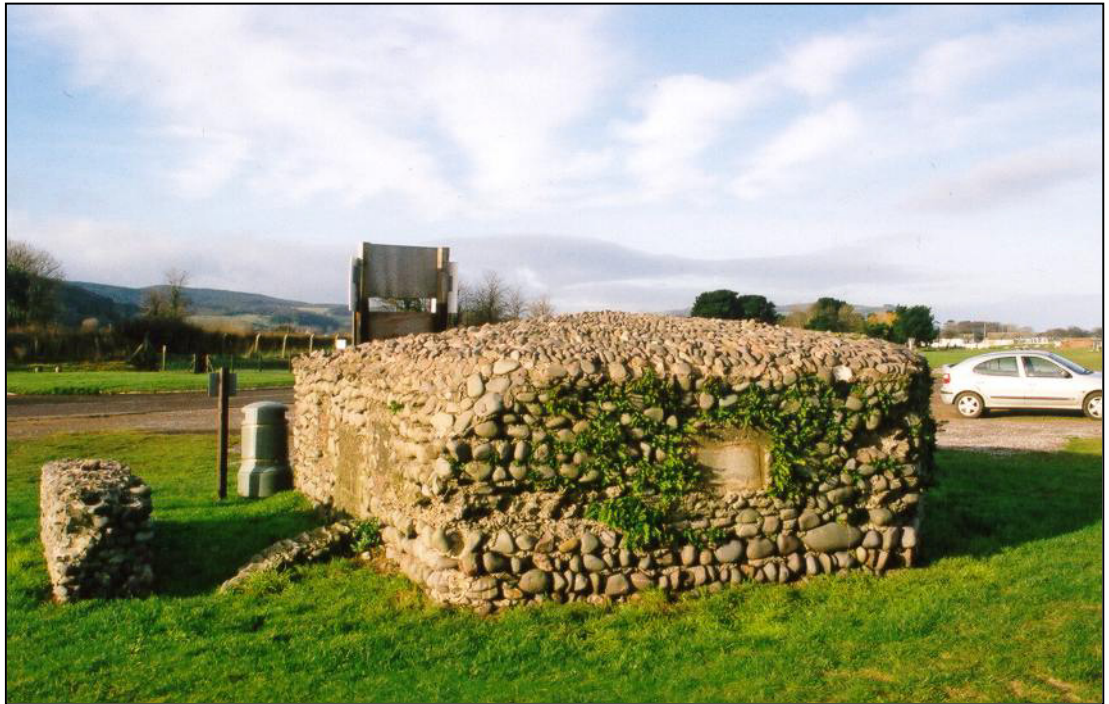
The most accessible pillbox to the general public is that to be found close to the entry of the Dunster Beach car park [UORN 3024], used today to affix a variety of signage. This is an excellent example that illustrates the use of beach pebbles as camouflage.

*Fig. 9 - UORN 3024: variant of a type 24 pillbox with a detached blast wall. Embrasures and doorway are now blocked. The use of beach pebbles as exterior camouflage cladding is remarkable.*

4. That consideration be given to erecting an information board within the Dunster Beach car park, probably alongside pillbox, UORN 3024, that would provide information on the Second World War defence of Dunster Beach. Such information should include reference to the continuity of the defence along Blue Anchor Bay as a whole.

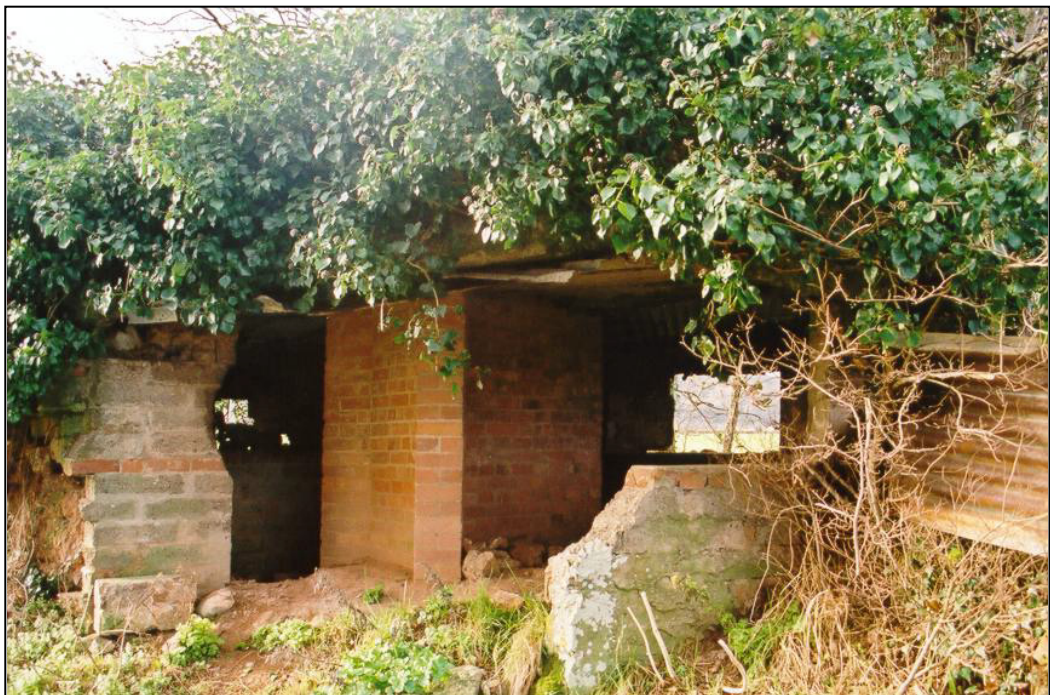
At Sea Lane End a pillbox survives in a broken state [UORN 1563], and its remains should be consolidated or otherwise it is likely to be removed as a public danger. East of the drainage canal (constructed in the early 1960s), however, pillboxes can be found in conditions varying from fair to excellent.

*Fig. 10 - UORN 1563: remains of a type 24 pillbox, instructive in showing the method of construction and the different building materials.*

2. That the remains of pillbox, UORN 1563, which is in a ruinous condition, be consolidated to prevent their further deterioration and to eliminate a possible danger to visitors.

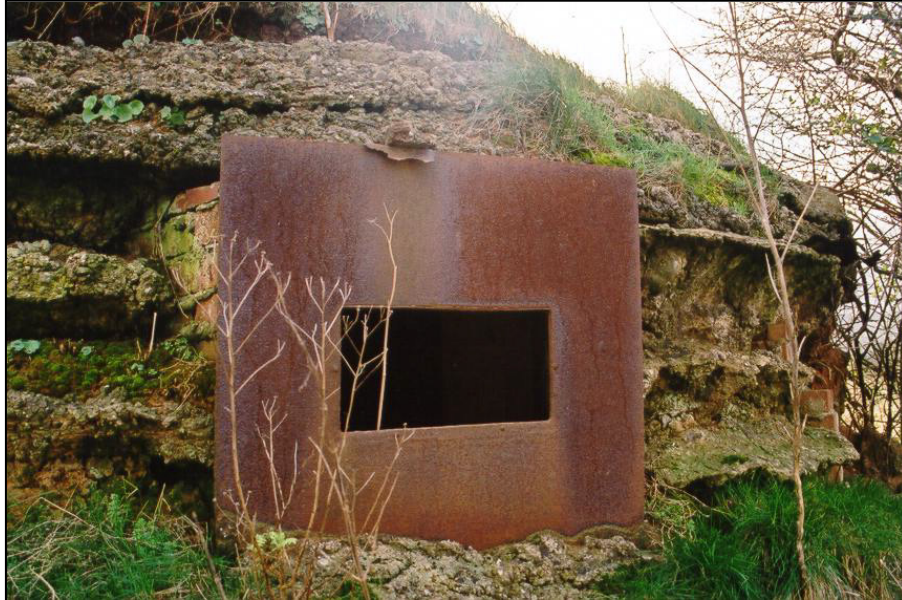
UORN 424 is a variant hexagonal-shaped pillbox that now looks rounded owing to weathering. It retains its steel embrasure surrounds. Today, it stands in the middle of a field, whereas originally it was positioned in a hedgerow at the corner junction of three fields.

*Fig. 11 - UORN 424: a steel embrasure surround is still in place on this pillbox.*

3. That consideration be given, in a possible initiative with Somerset County Council and the local authority, to establishing a 'pillbox walk' along Dunster Beach and its immediate hinterland. It might be possible to organise with landowners access to pillboxes, UORNs 424, 426, and 431, for the purpose of this walk, otherwise these structures could only be viewed from a distance. As they are important surviving defence works, with features encountered rarely and worthy of public inspection, it is hoped that some form of access could be organised.

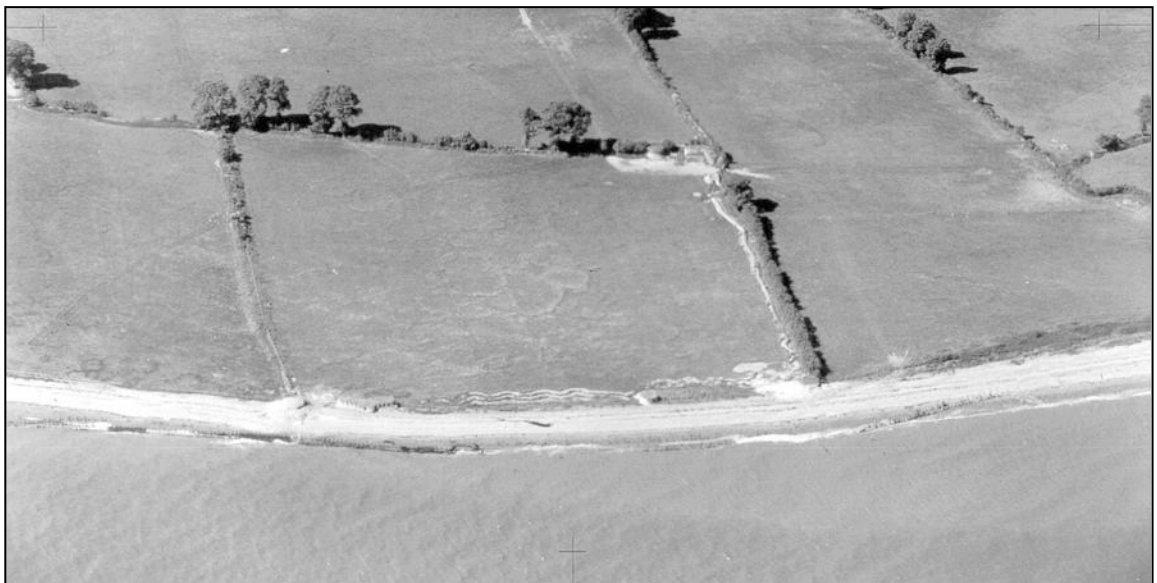
*Fig. 12 - The position of pillbox, UORN 424, can be seen in the right centre of this oblique air photograph. Slit trenches run along the hedgerow to the beach where there are pillboxes, further trenches, and a section post.*

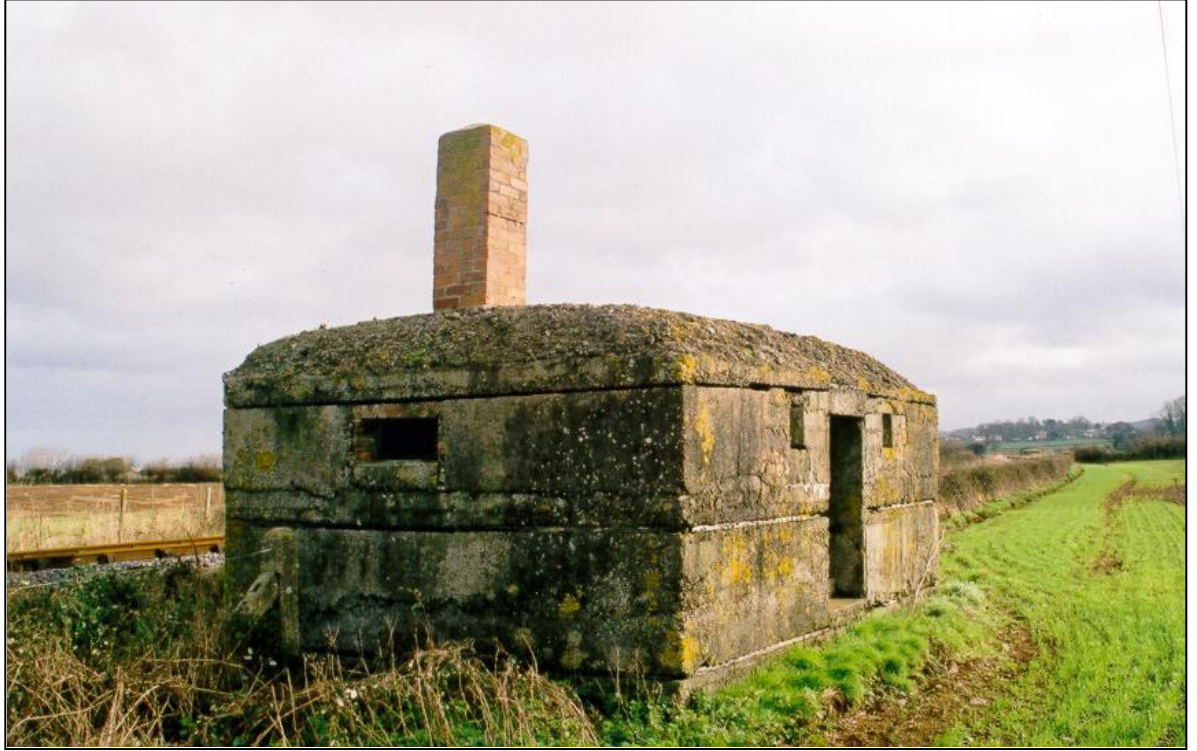
Close to UORN 424, on the south side of the railway line, is pillbox, UORN 426, which was camouflaged as a signal cabin. A brick chimney still rises from the concrete roof. Further down the railway line is another pillbox [UORN 431], which is in excellent condition with steel visors still in place. Behind this, on rising ground is the brick-shuttered pillbox, UORN 432, inaccessible on private land but appearing from a distance to be in good condition. The turrets of Dunster Castle overlook it. A further pillbox built on the railway embankment stands further to the east near the crossing of the line by a public footpath [UORN 16303]. The pillbox has an unusual entrance way made from curving corrugated iron.

*Fig. 13 - UORN 426: pillbox by the railway line that was disguised as a signal cabin. It once had a false pitched roof of which the chimney stack survives.*

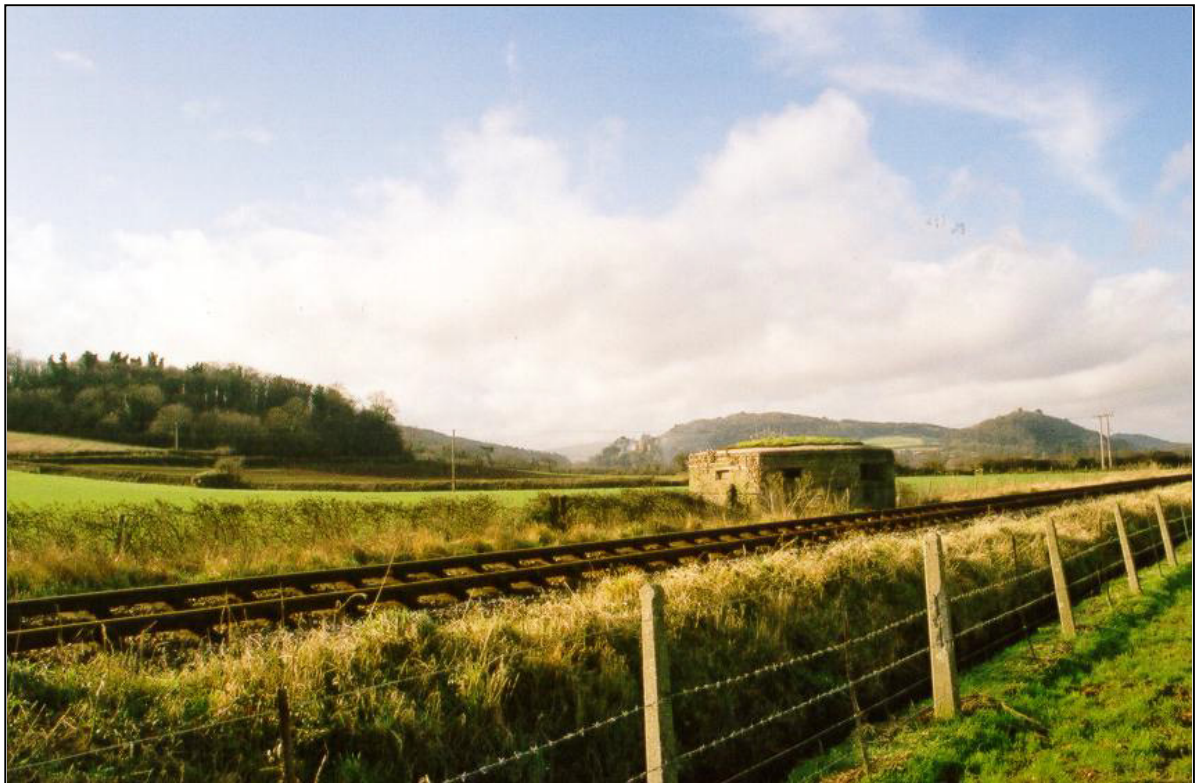
*Fig. 14 - Pillbox, UORN 431, with UORN 432 beyond. Dunster Castle is in the centre of the line of hills.*
