**THE EVIDENCE FOR CHANGES
TO FARM BUILDINGS ON THE
DEVONSHIRE ESTATE IN THE
PARISH OF AULT HUCKNALL,
DERBYSHIRE, DURING THE
MID-LATE 19TH CENTURY**

by
Richard Sheppard

TPA Project Code: HEF.1
December 2008

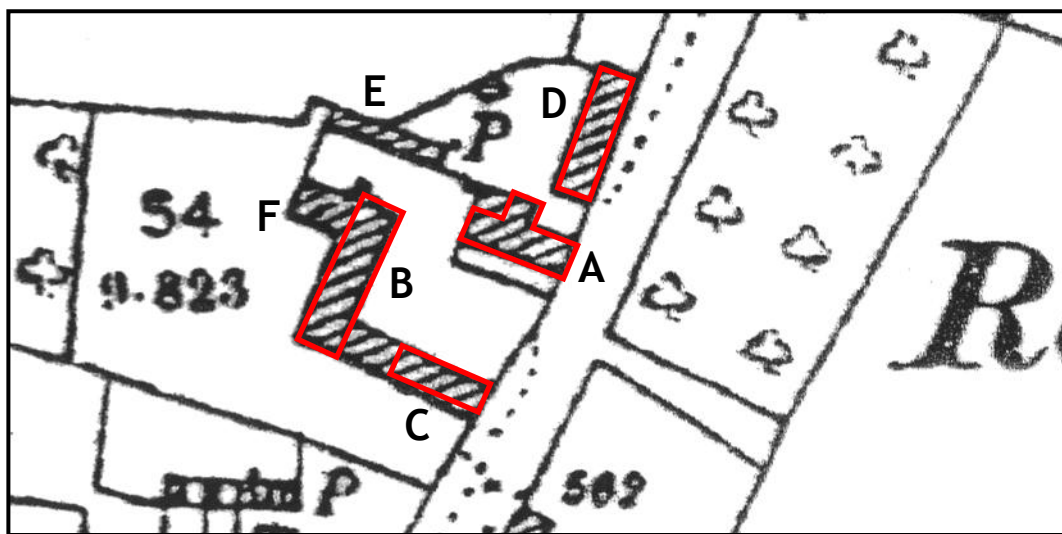
Fig. 7 Plan of Pear Tree Farm in c.1900, with buildings present on the 1838 tithe award plan overlain in red outline. Scale 1:1,000.

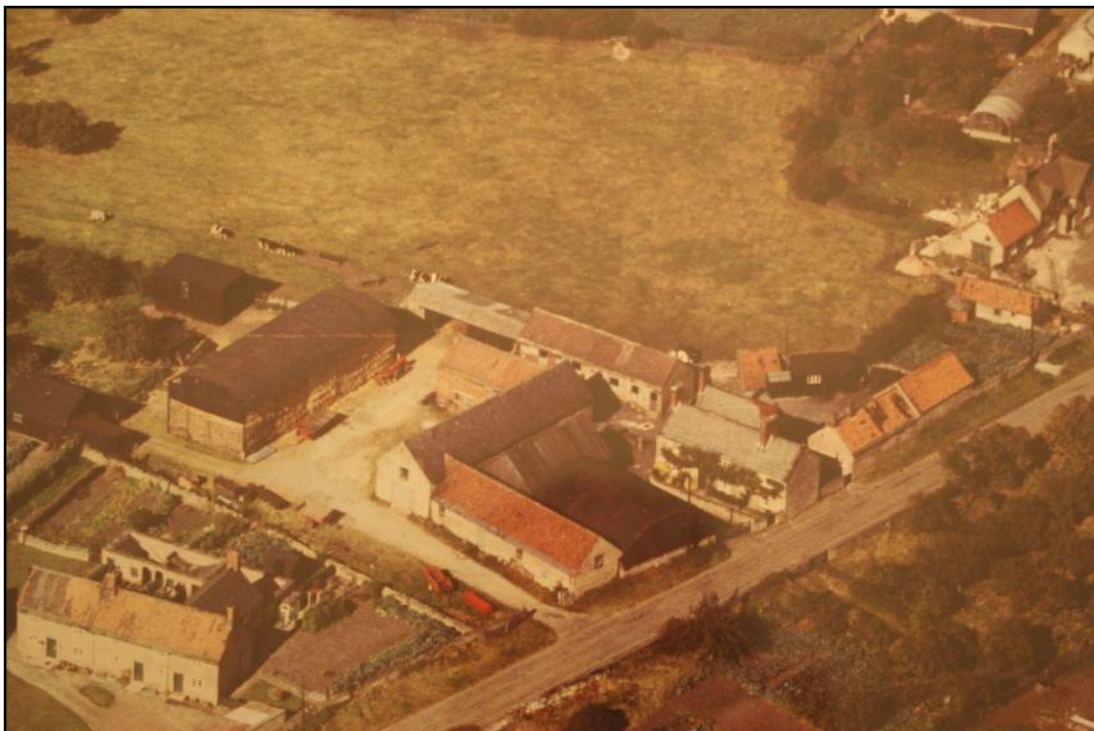
Plate 1 Aerial view of Pea Tree Farm, Rowthorne taken in the 1970s when it was still a working farm

An aerial photograph shows 20th century sheds covering most of the yard and barns to the west, all since removed (Plate 1). Now privately owned former farm, divided between about four owners. A pre-renovation drawing by Latham Architects shows that the barn's east elevation has been much altered despite its present original-looking appearance (Fig. 6).

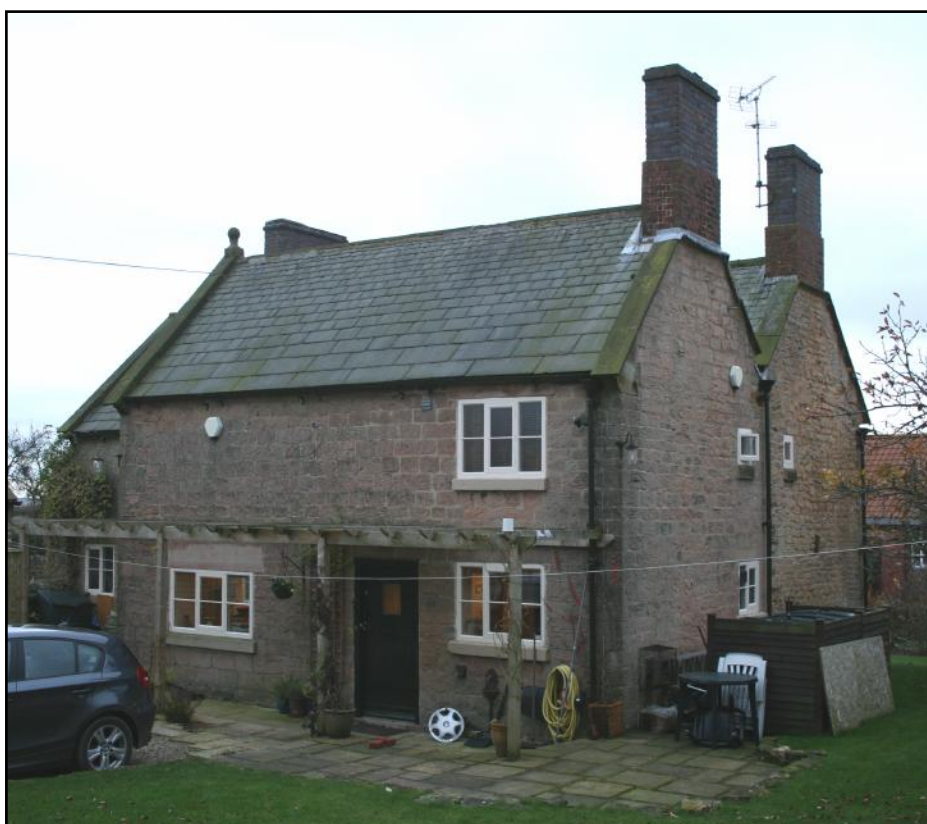
Plate 2: North, rear kitchen part of the listed former farmhouse of Pear Tree Farm, Rowthorne, showing the double gable roof-line and similar brick end stacks.

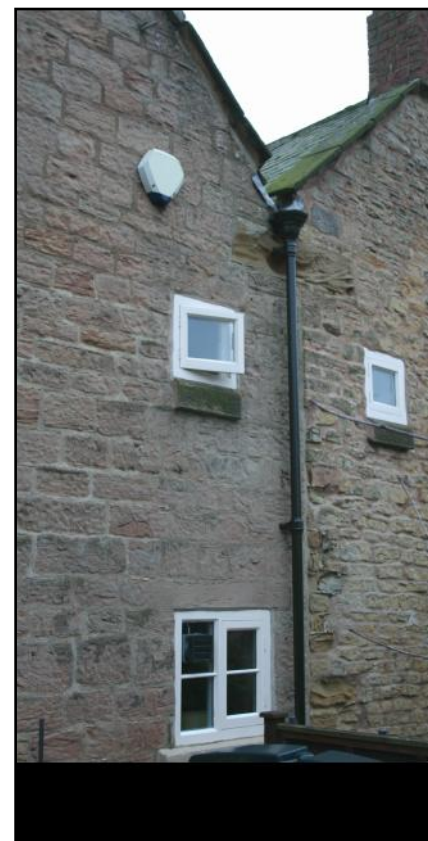
Plate 3: Distinct differences in the stonework showing on the west side of the building.

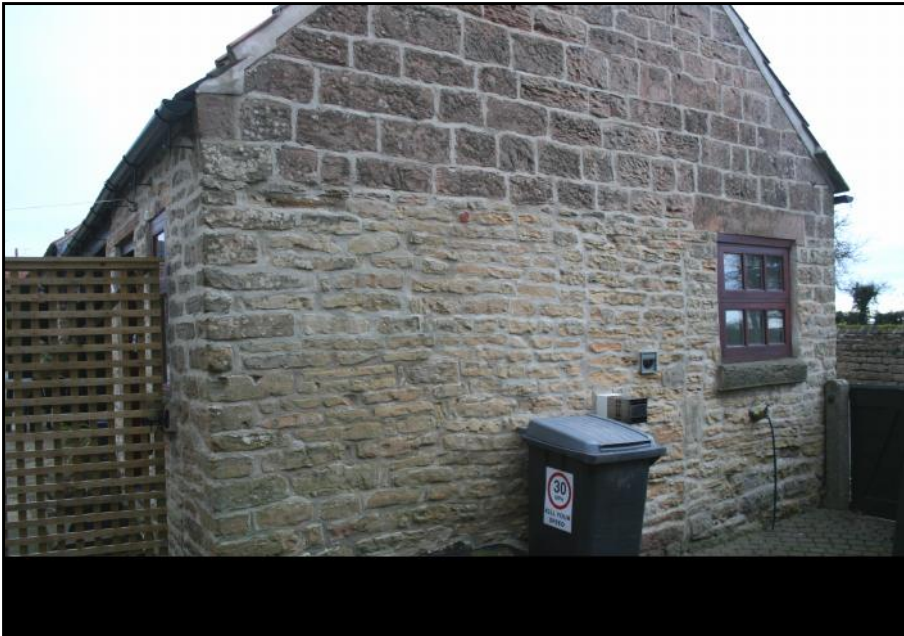
Plate 4: The south end of Structure D at Pear Tree Farm, Rowthorne, showing a blocked doorway in possibly 18th century masonry and a rebuilt gable end.

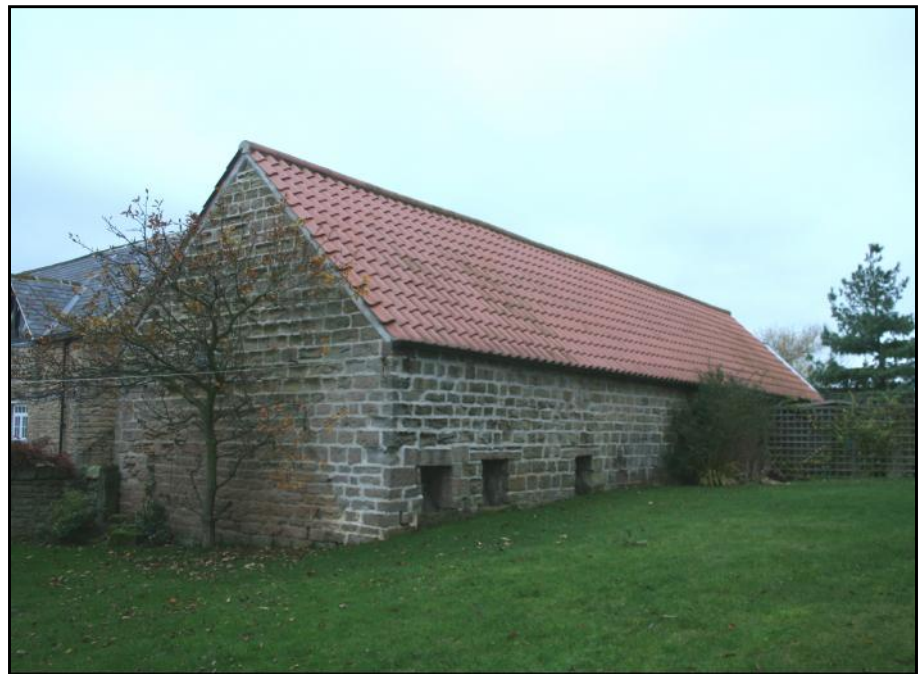
Plate 5: North side of Structure E at Pear Tree Farm, showing pig feeders and a mid-19th century style of masonry,

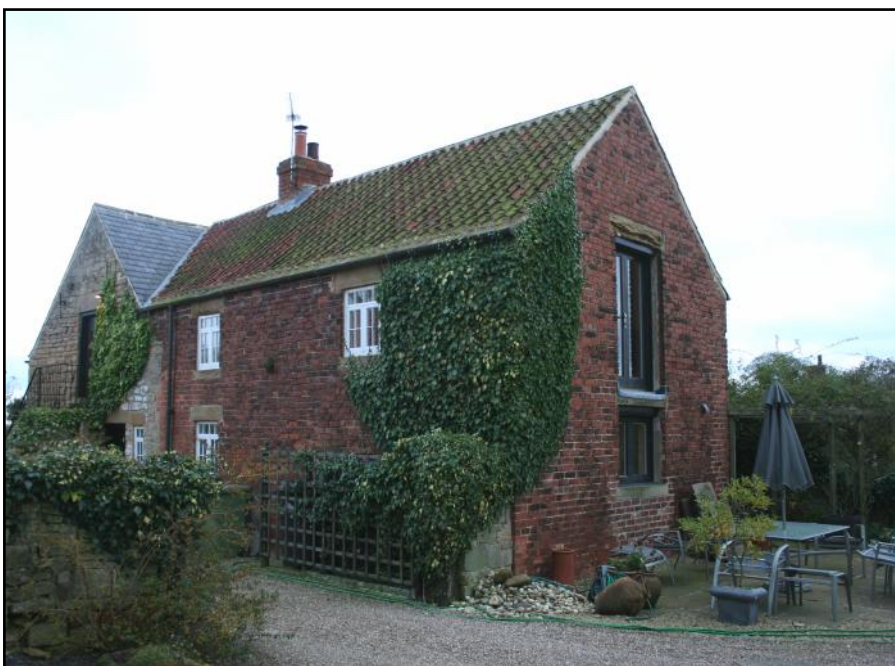
Plate 6: Mainly brick-built Structure F at Pear Tree Farm, a late 19th century stable addition to the barn (showing to left).

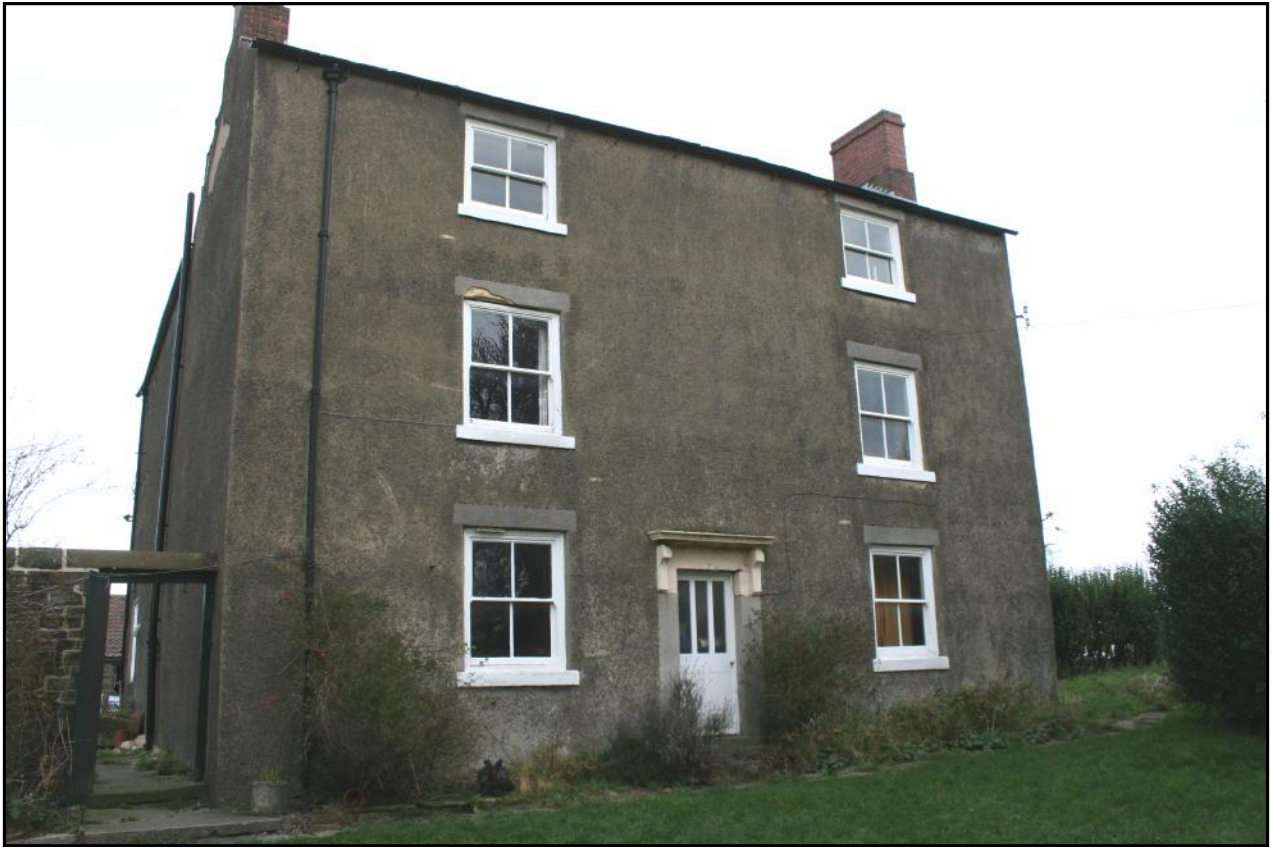
Plate 7: South wing of the farmhouse at High House Farm, Timber Lane, this part probably largely rebuilt in 1859-60 at the cost of about £280.

The greater sum of about £280 a decade earlier was probably spent on the rebuilding of the south wing of the farmhouse over a period covering two years' accounts. The variety of materials and tradesmen employed would be explained by this. There is no mention of digging out foundations because existing foundation trenches would have been reused.

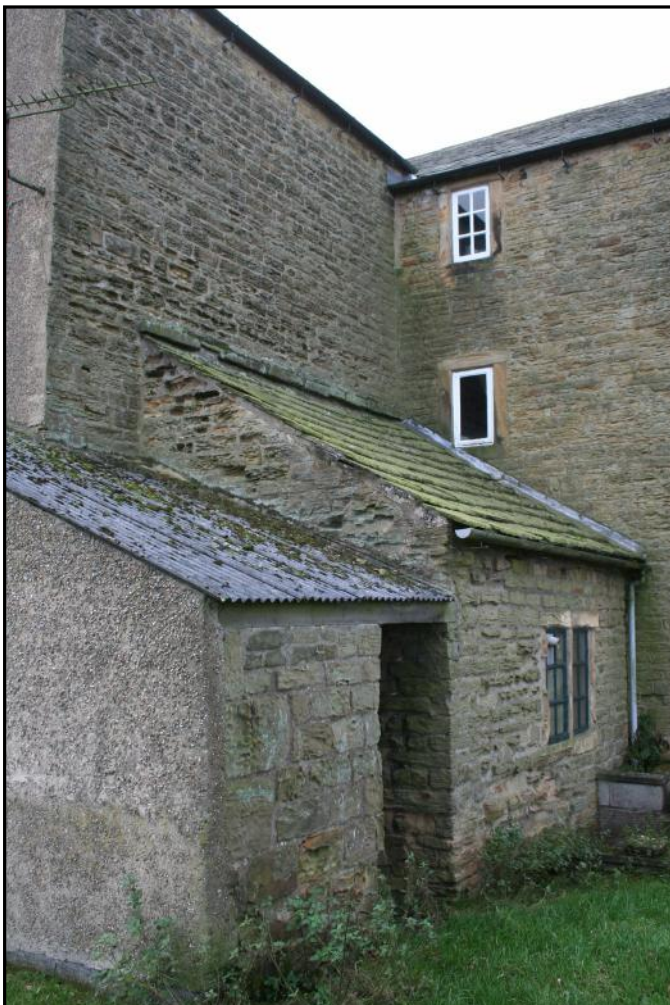
Plate 8: Thin-coursed 18th century stonework showing at the join of the west and south wings of the L-shaped building. The original dairy is the lean-to in the middle.

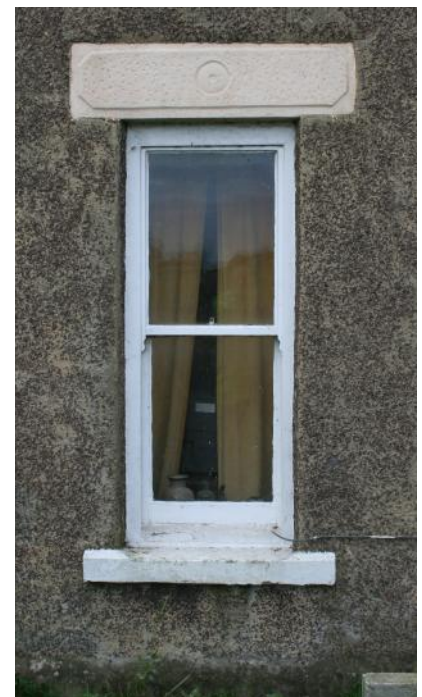
Plate 9: Victorian ornamental window lintel at the east end of the south wing.

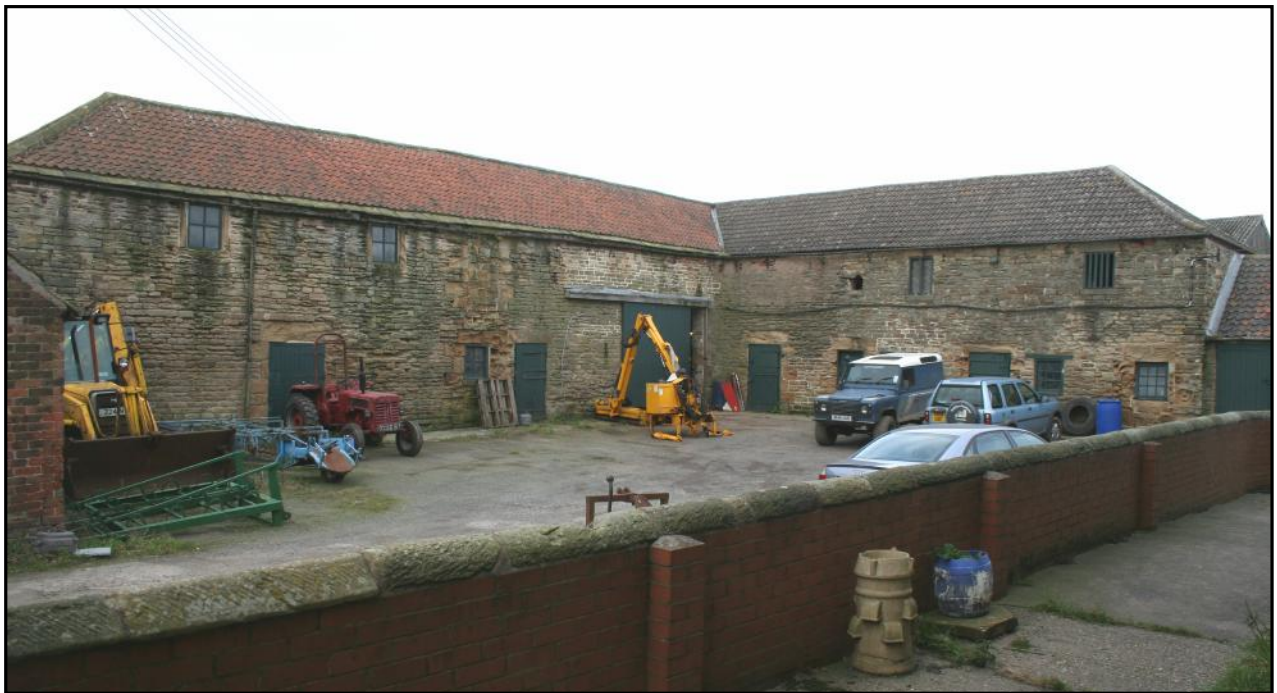
Plate 10: The continuous west and north ranges at High House Farm, probably of 18th century origin, but with much evidence of infilled doorways, differing window styles, stonework patching and replacement, and re-roofing.

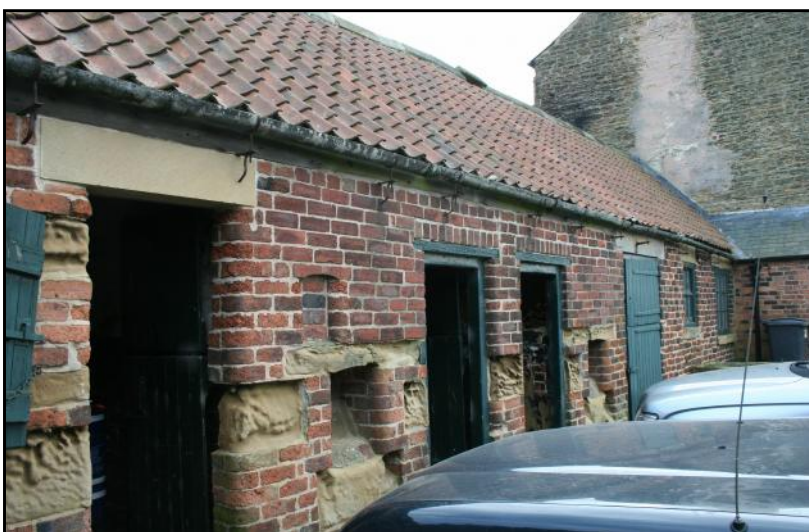
Plate 11: East range built in brick in c.1875 and including a loosebox, piggery and wash-house.

J: East range: Brick-built in 1870s to include a loosebox (north end), two sections for pigs and a wash-house. South end subsequently altered and reduced to house the dairy.

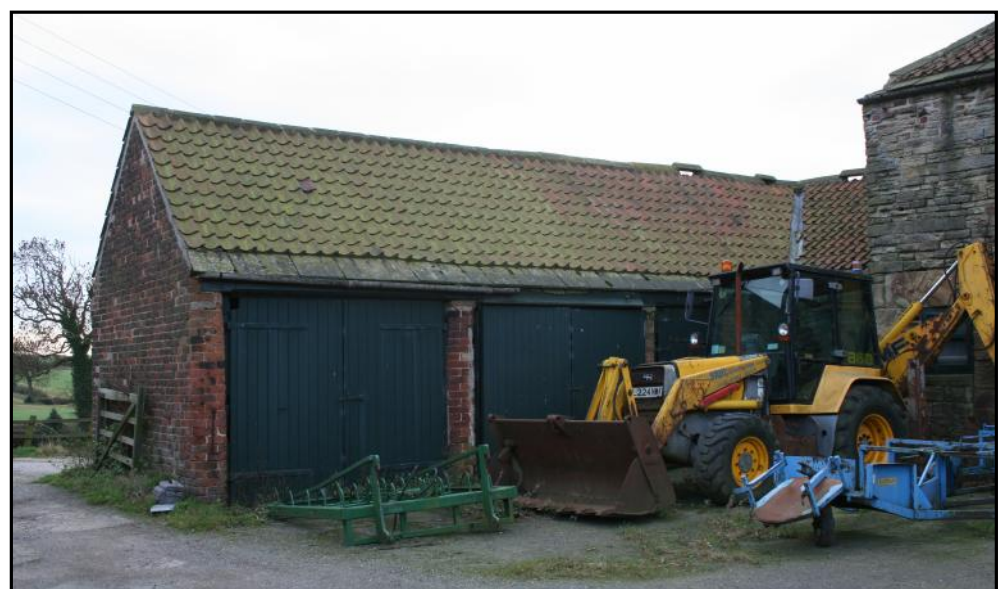
Plate 12: Former 'open shed with brick pillars' built at some point between 1855-77.

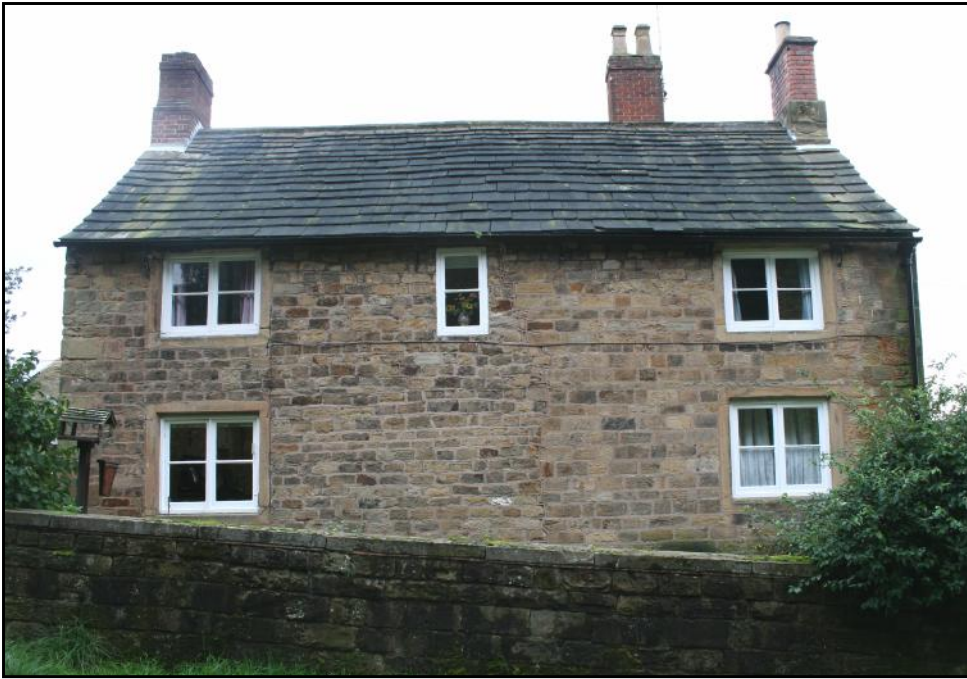
Plate 13: Street frontage of the original 18th century part of the farmhouse at Stainsby Farm. The off-centre entrance doorway has been lost during re-facing.

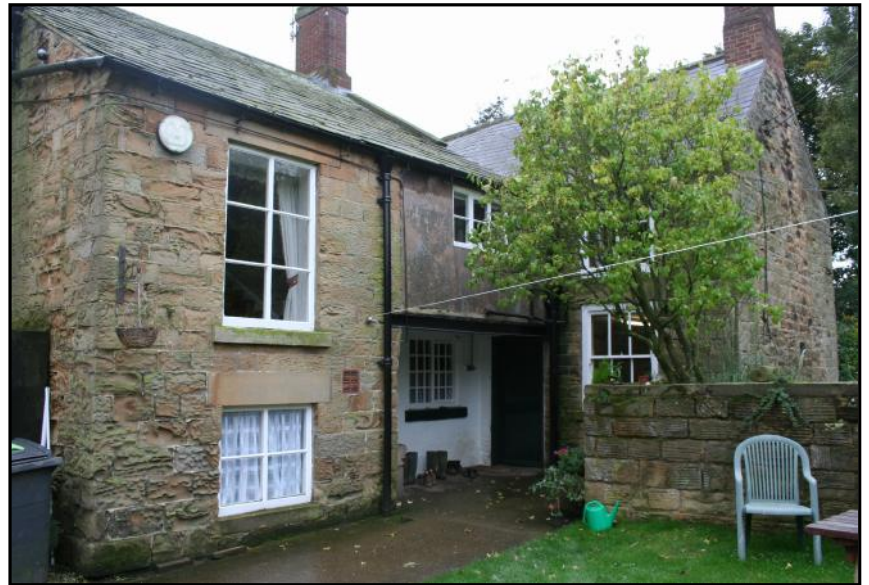
Plate 14: The back of the farmhouse, showing the older part to right and the central projecting part of the 19th century extension to the left. The middle part shows a later bedroom addition.

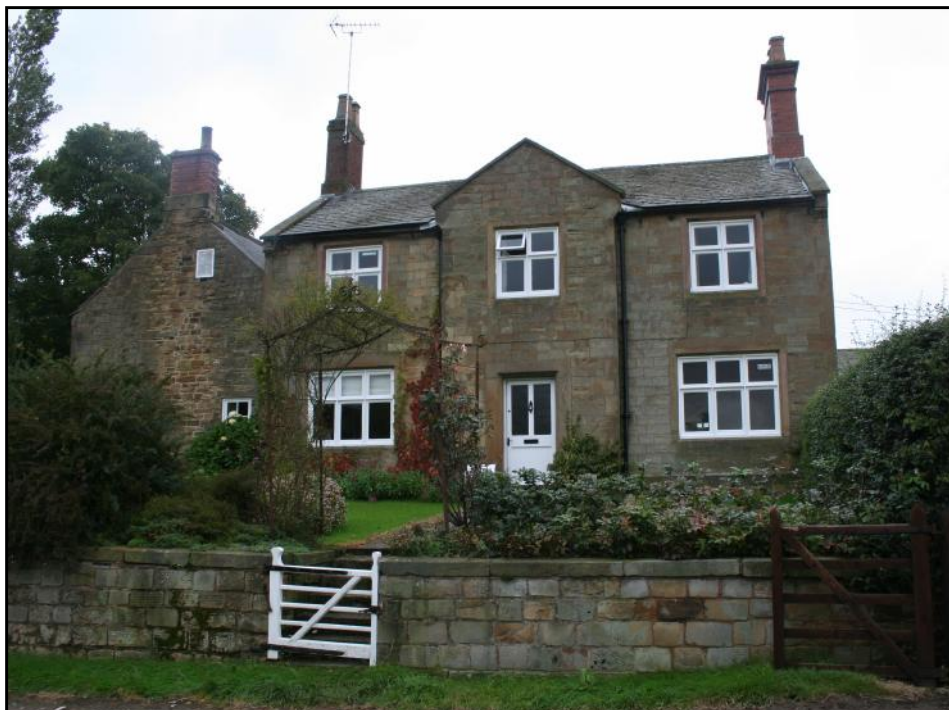
Plate 15: The south frontage of the part of the farmhouse at Stainsby Farm built in c.1848.

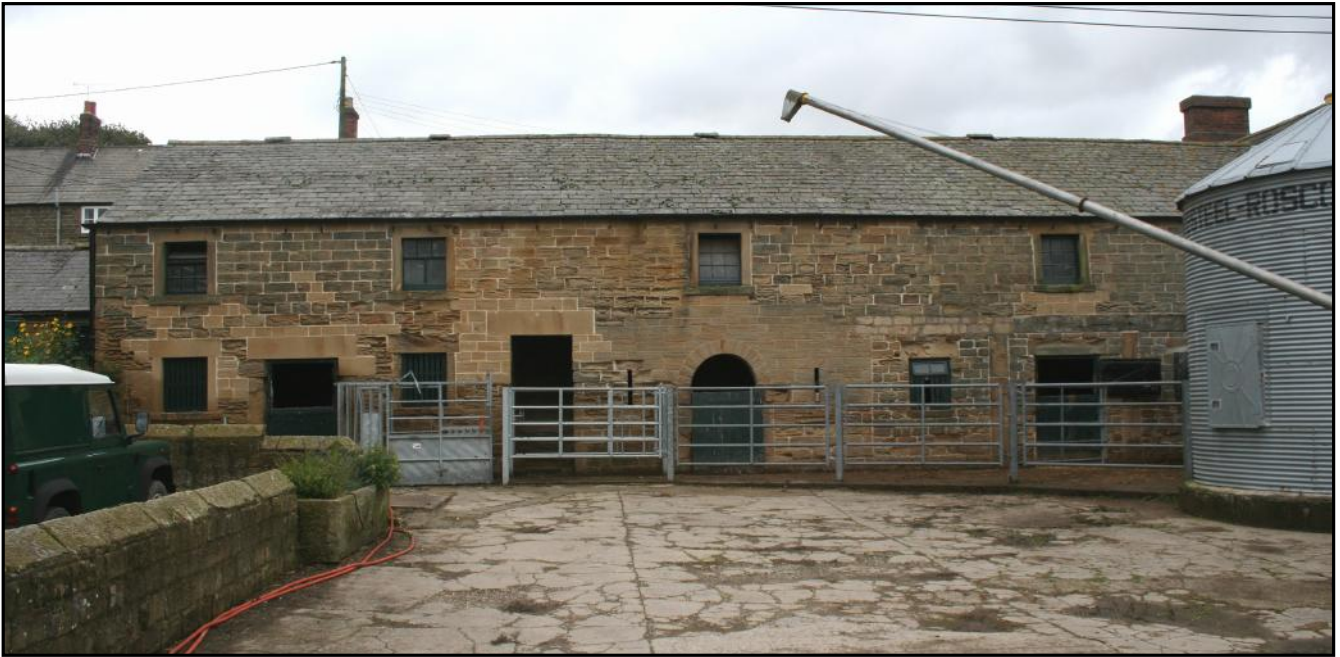
Plate 16: South elevation of the multi-purpose north range (B) at Stainsby Farm, Stainsby, with much evidence of alterations and modern replacement of eroded stonework.

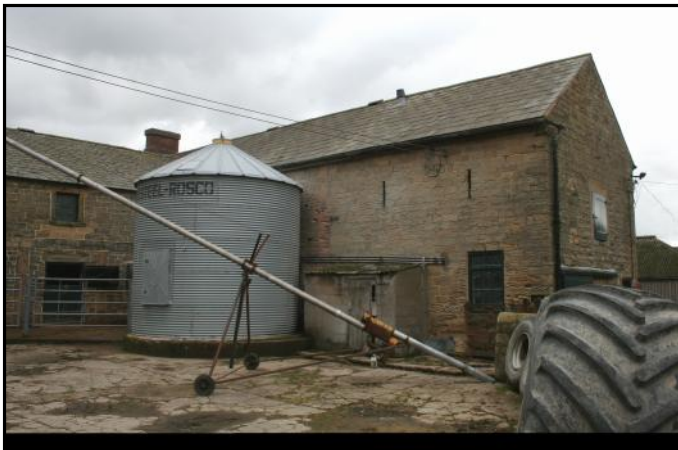
Plate 17: West elevation of the east barn range (C), with a high rounded arch showing behind the tank.

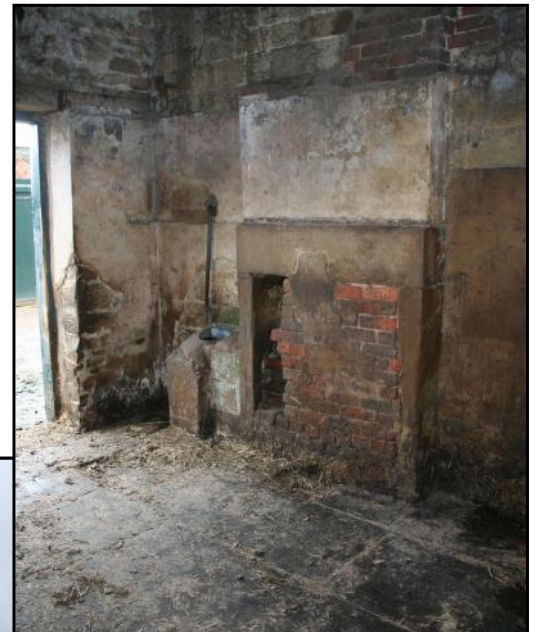
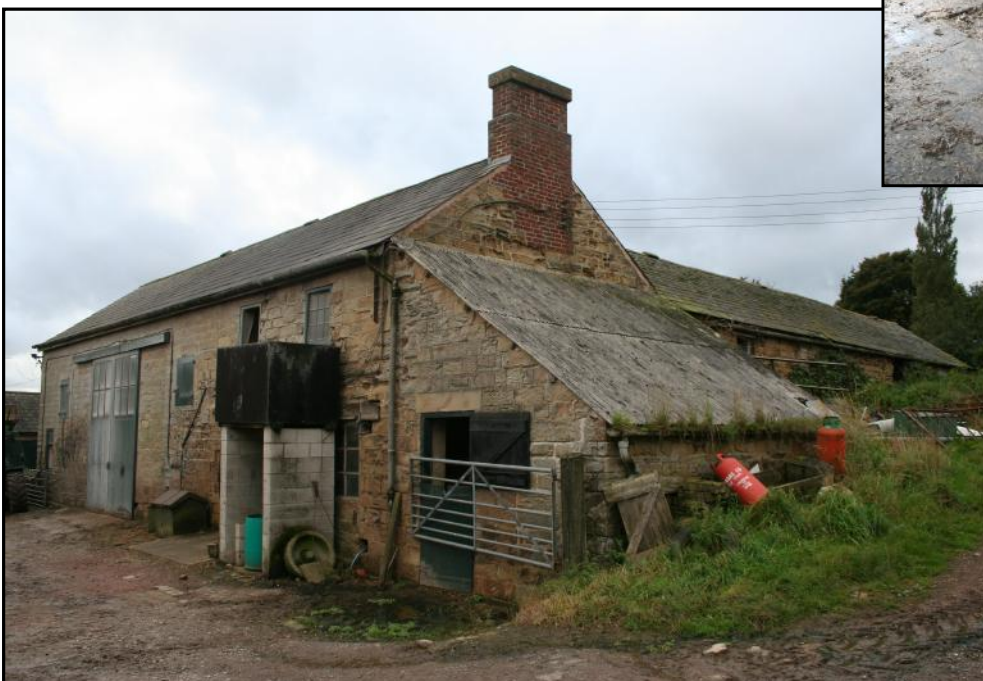
Plates 18 and 19: The east side of the barn with a lean-to that had been part of a labourer's cottage. Above: a remaining fireplace and slabbed floor within it.

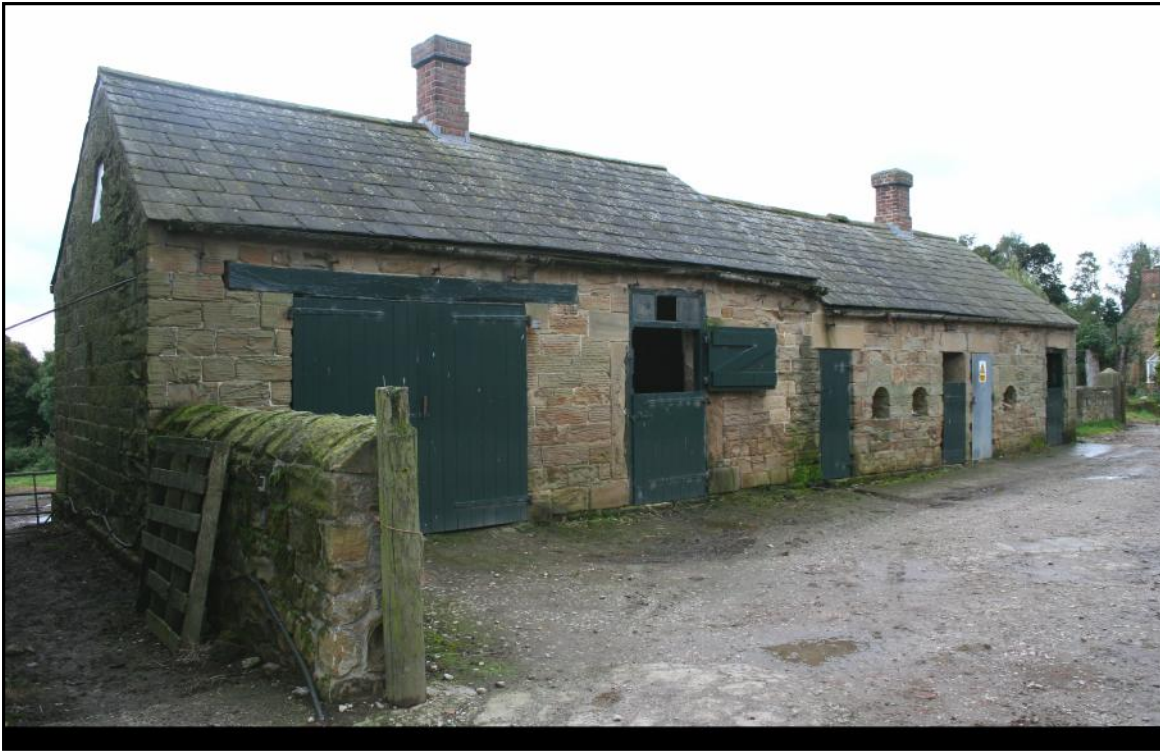
Plate 20: The mid-19th century single-storey south range (F) at Stainsby Farm, a combined gig house, stable, piggeries and wash-house at Stainsby Farm.

F: South range. This is another multi-purpose range south of the farmhouse. This too is stone-built with brick stacks. It consisted of two parts: a bigger gig house and stable loosebox, and a smaller and narrower piggery and probable wash-house at the west end.

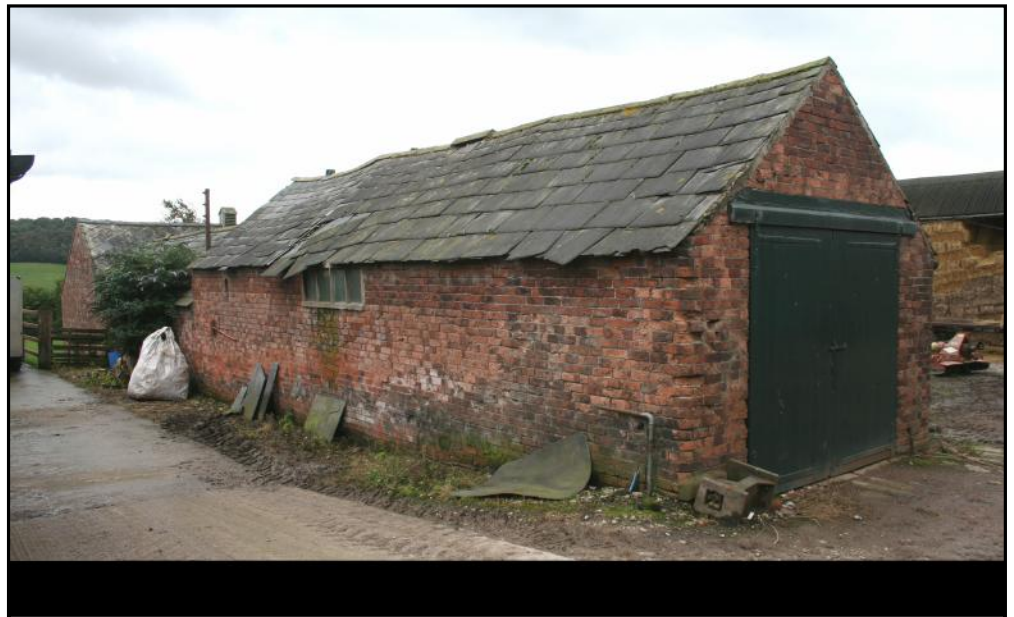
Plate 21: View of the L-shaped east ranges (G) at Stainsby Farm, built in brick in the mid 19th century. These included a turnip house, stables, an open shed and a hen roost.

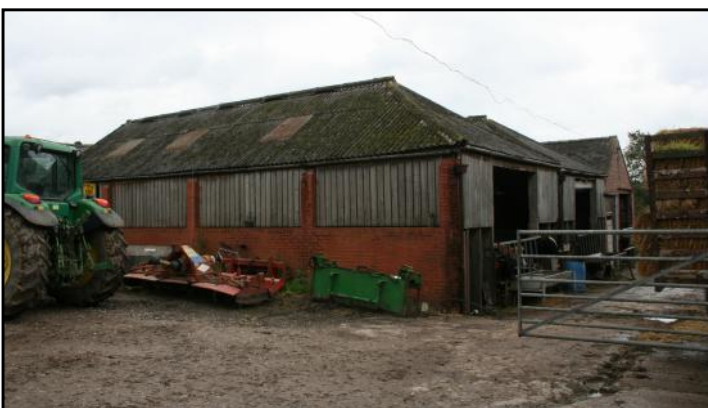
Plate 22: Early 20th century brick-built cowsheds (H) built beside the earlier brick east ranges.

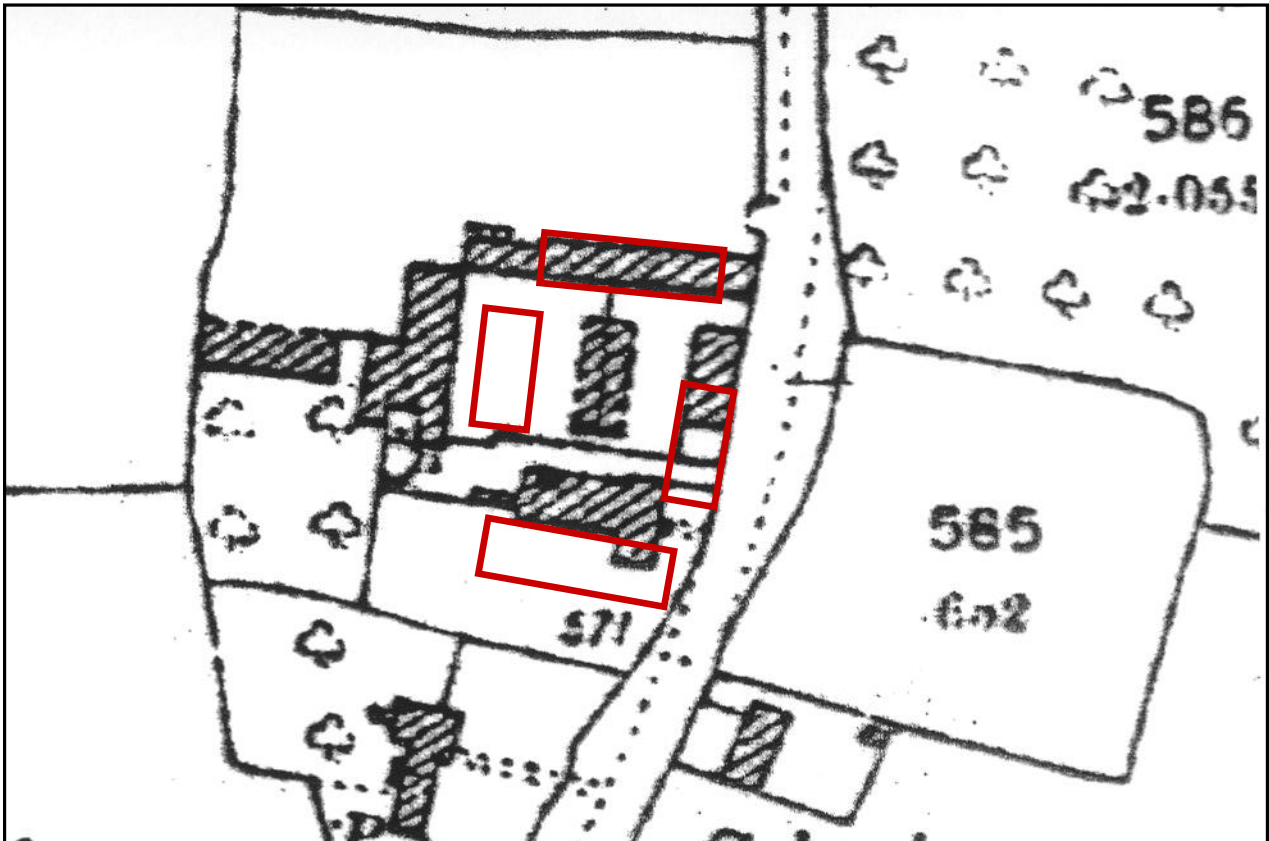
Fig. 14 Plan of Top Farm, Rowthorne as shown on the 2nd Edition 25 inch (1:2,500) scale Ordnance Survey map of about 1900, with buildings shown on the 1838 tithe award map overlain in red. Scale 1:1,000.

- Only one of the other three farm buildings still remains for certain. The north building was the barn, to which a stable with chamber over was added at the west end (see Plate) and a cartshed at the east end. It is built of smallish squared blocks and has vertical ventilators still largely open on the south side. A date-stone of 1694 was recovered from within the barn and is now displayed in the gable wall of the cartshed. A smaller stone building on the west side of the square might possibly be the earlier building but if so, the tithe map is distorted. The east building was replaced but may be on the original footprint, as may be most of the farmhouse.

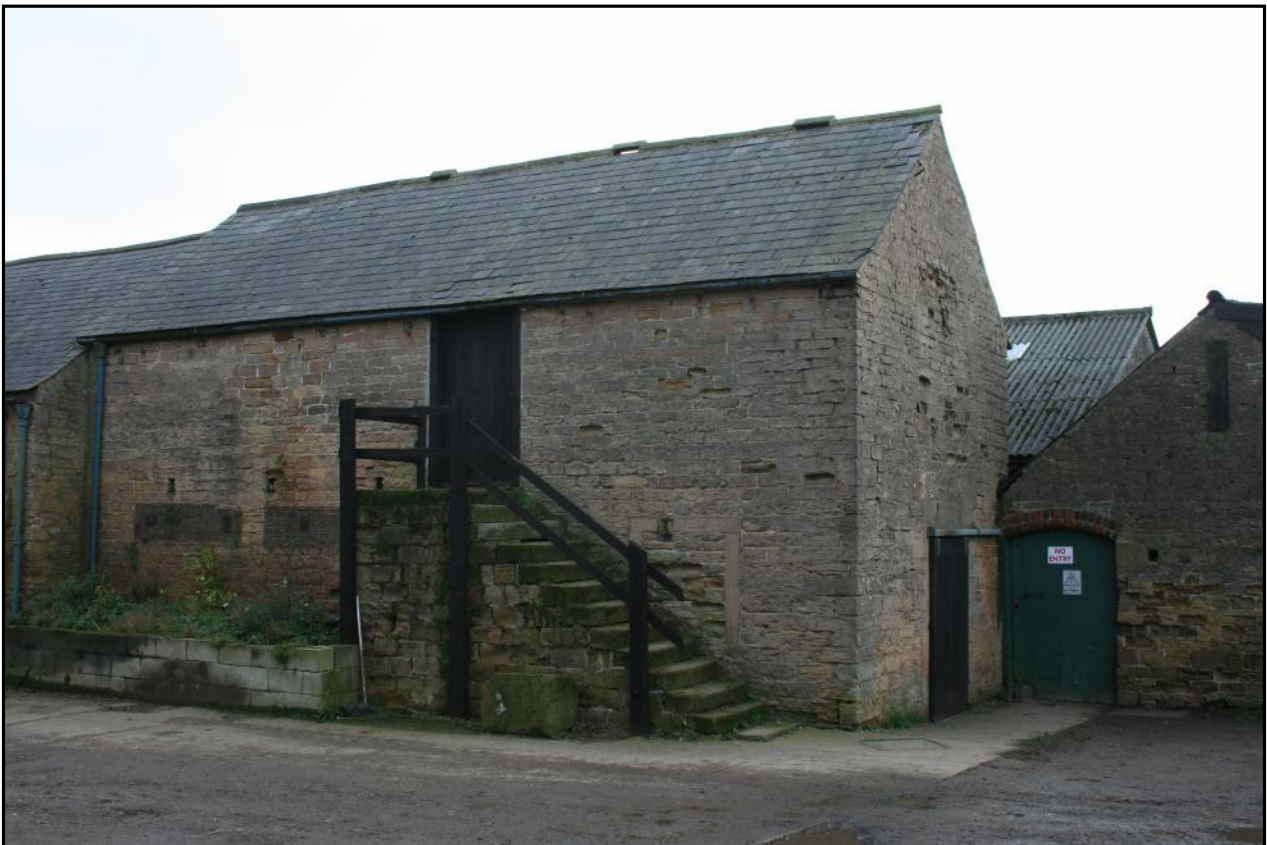
Plate 23: Building (stable with chamber over) added to the west end of the old barn at Top Farm, Rowthorne, probably in 1862.

- There are only two figures for spending on Fisher's, Rowthorne: the sums of £609 spent in 1862 and £112 a year later. The former was listed merely as paid to G. Vallance for additions to the farmhouse and farm buildings, with nothing itemized. These extensions of existing buildings are reflected in the increased lengths of buildings in the 1877 account. The lack of mention of the existing farmhouse suggests that it was rebuilt somewhere between 1838-55 and extended at the back later in 1862.

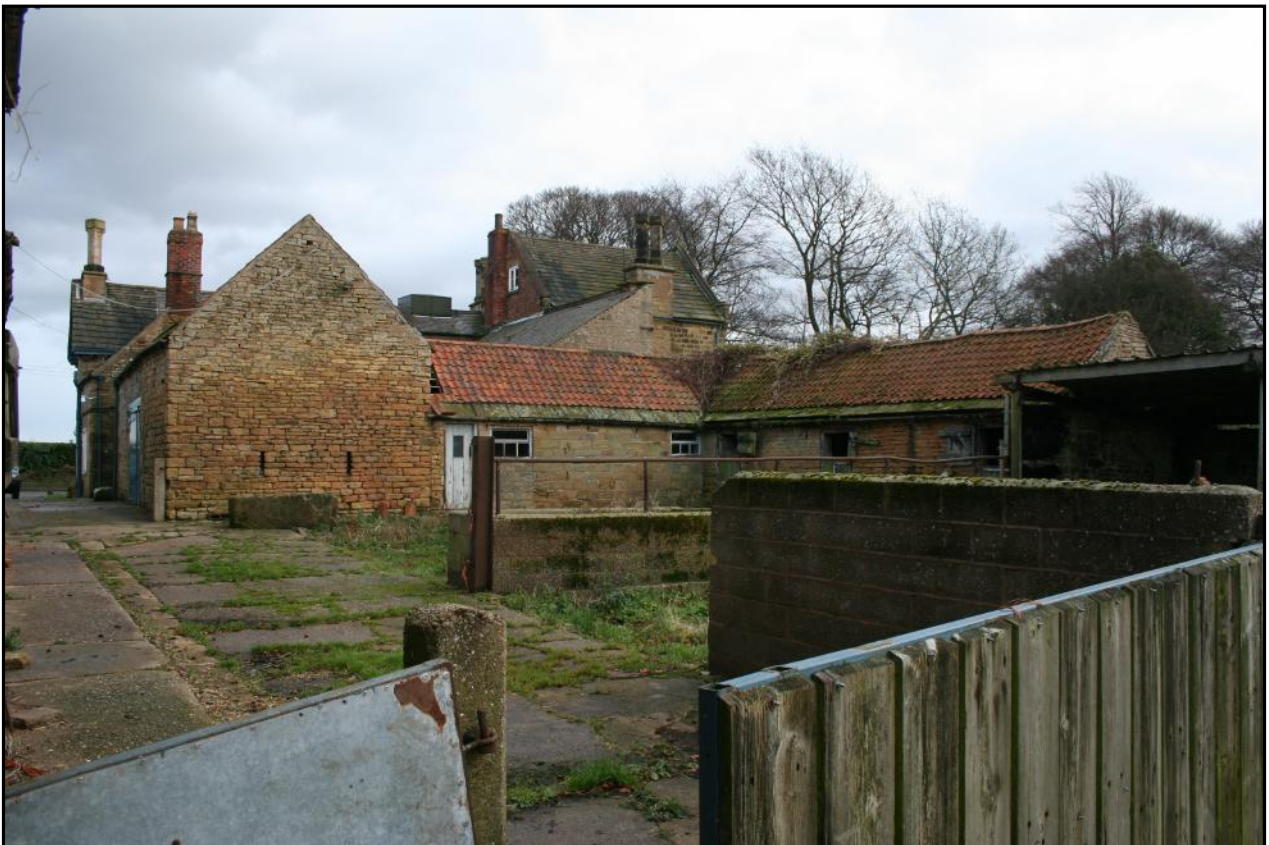
Plate 24: Buildings, now mainly disused, to the west of the large former farmhouse known as The Hall (showing in background) at Hall Farm, Rowthorne.

- The various farm buildings close to the Hall are now disused and some can be classed as ‘at risk.’ The Hall has been vacated and the Chatsworth is thought to be intending to refurbish it and sub-divide it into two saleable properties. The fate of the farm buildings is unclear.

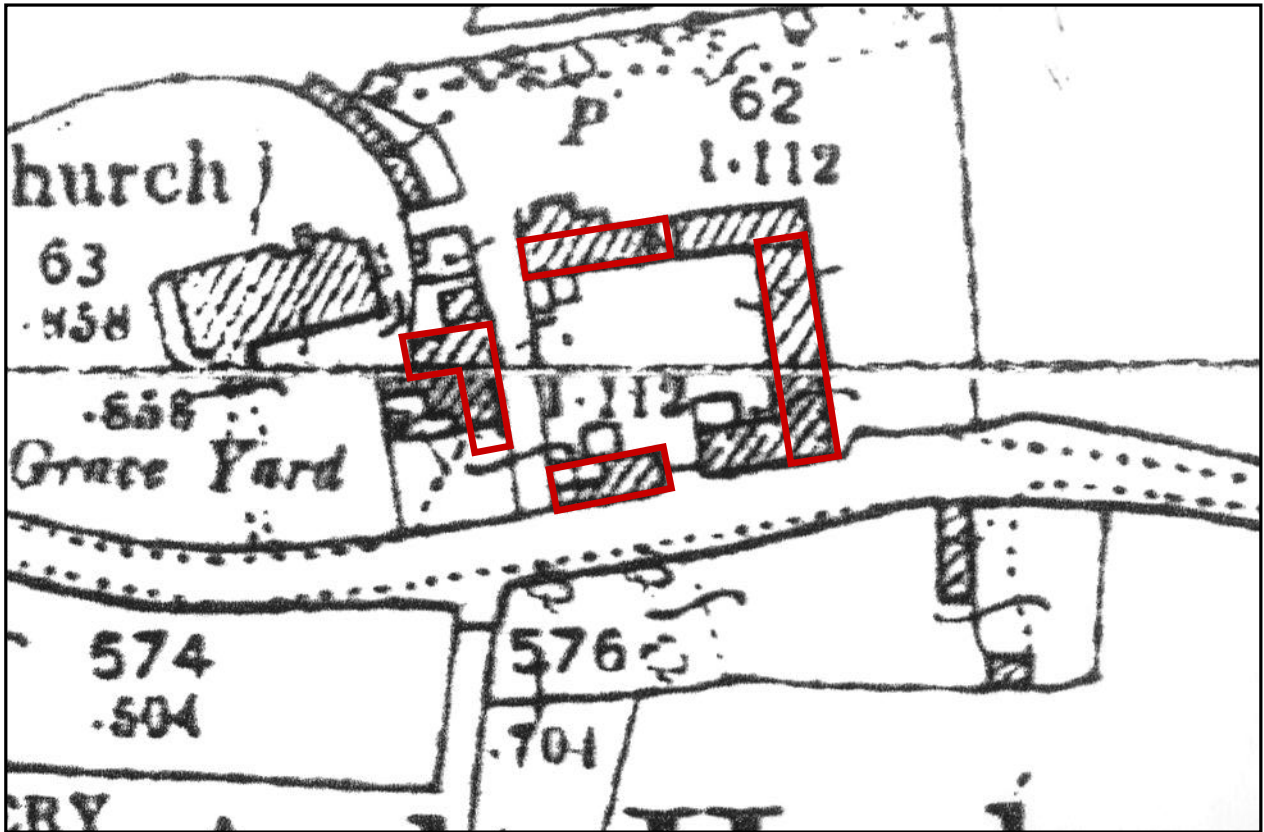
Fig. 16 Plan of Ault Hucknall Farm, as shown on the 2nd Edition 25 inch (1:2,500) scale Ordnance Survey map of about 1900, with buildings shown on the 1838 tithe award map overlain in red. Scale 1:1,000.

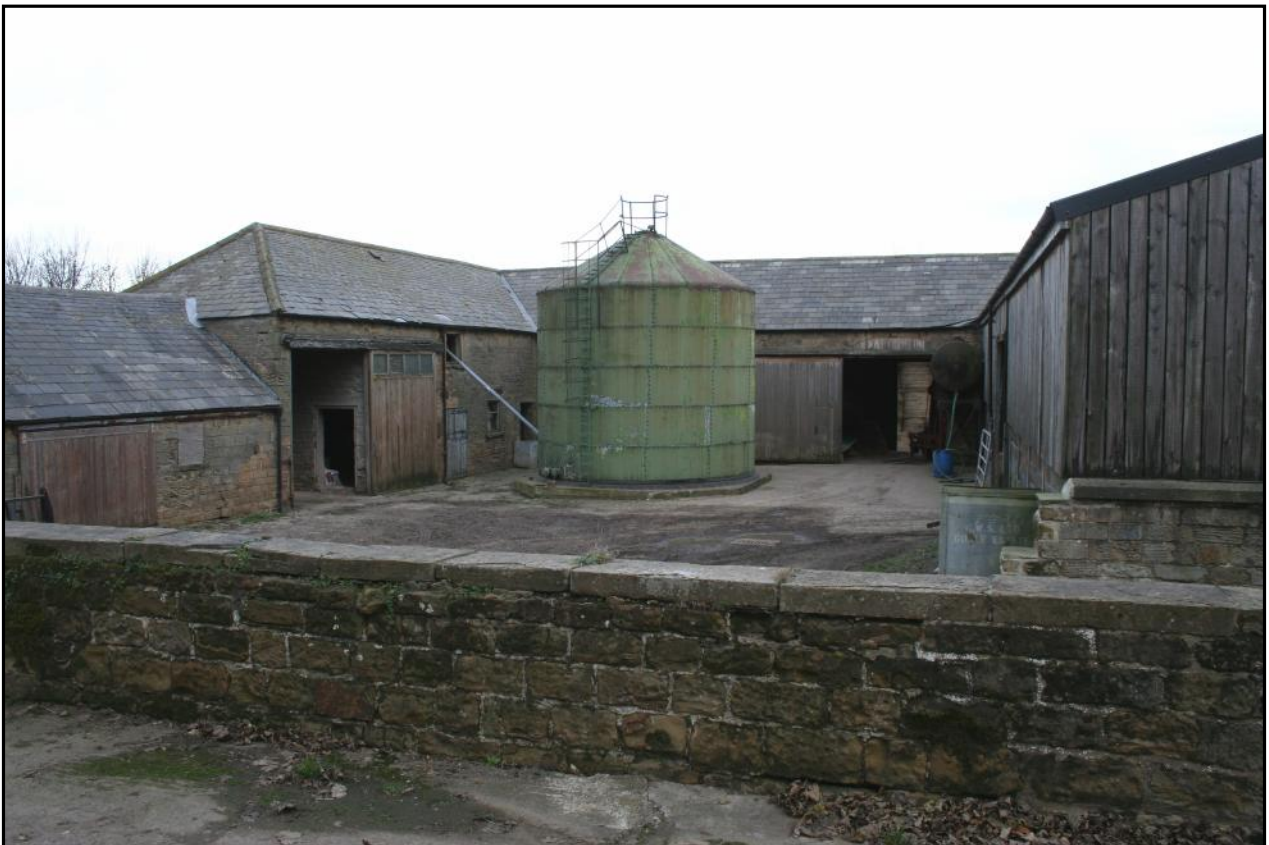
Plate 25: Buildings facing the courtyard at Ault Hucknall Farm, with the oldest building showing to the left and the possibly improved barn showing to right of the tank.

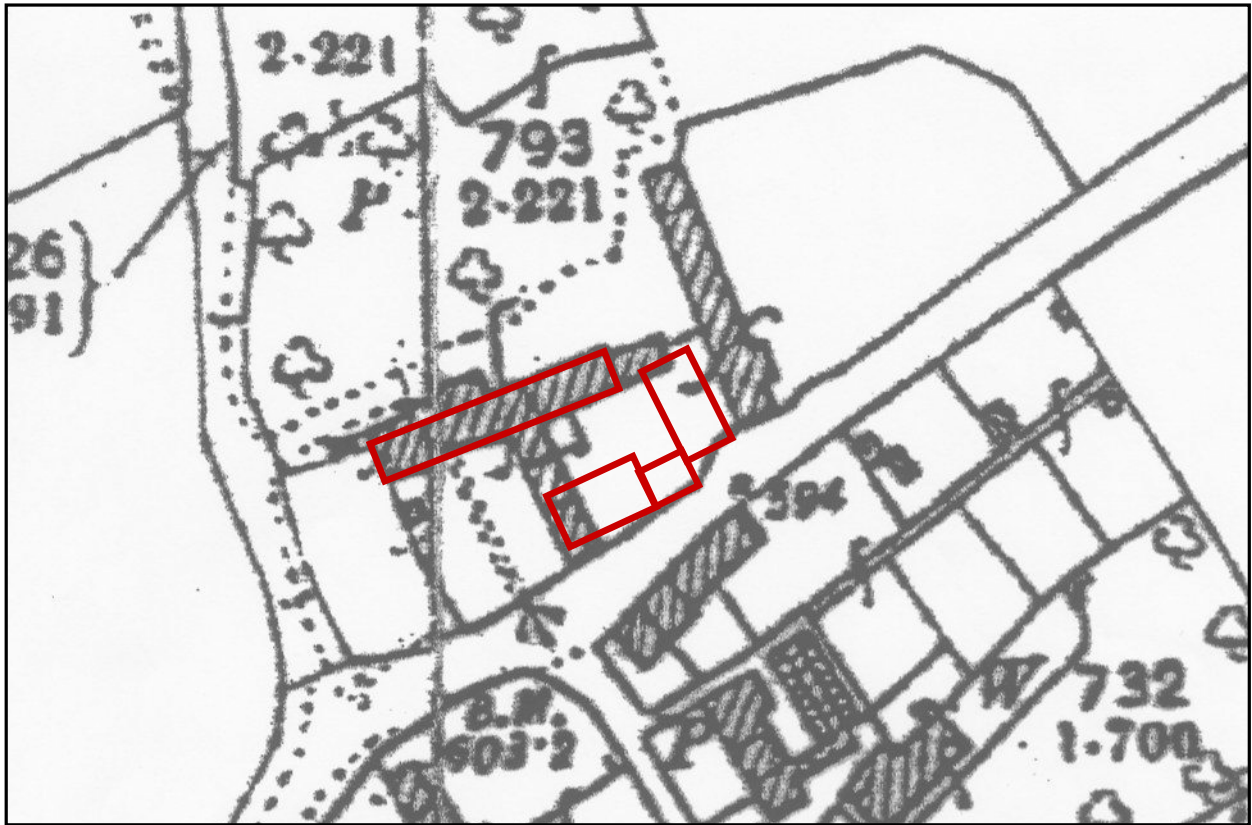
Fig. 17 Plan of Yew Tree Farm, Hardstoft, as shown on the 2nd Edition 25 inch (1:2,500) scale Ordnance Survey map of about 1900, with buildings shown on the 1838 tithe award map overlain in red. Scale 1:1,000.
