**THE EVIDENCE FOR CHANGES
TO FARM BUILDINGS ON THE
DEVONSHIRE ESTATE IN THE
PARISH OF AULT HUCKNALL,
DERBYSHIRE, DURING THE
MID-LATE 19TH CENTURY**

by
Richard Sheppard

TPA Project Code: HEF.1
December 2008

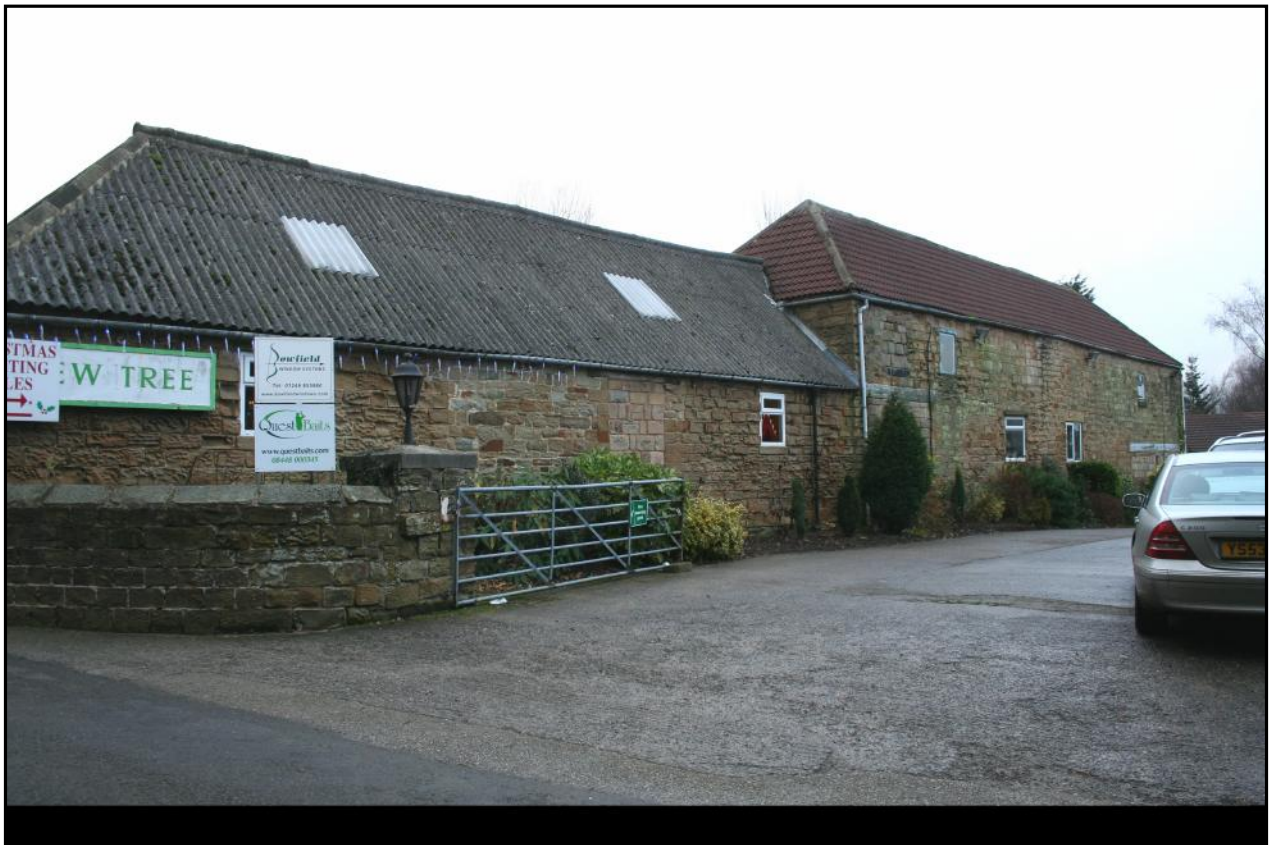
Plate 26: The east range built at Yew Tree Farm, Hardstoft, between 1870-74, with cowhouses to left and the barn to right.

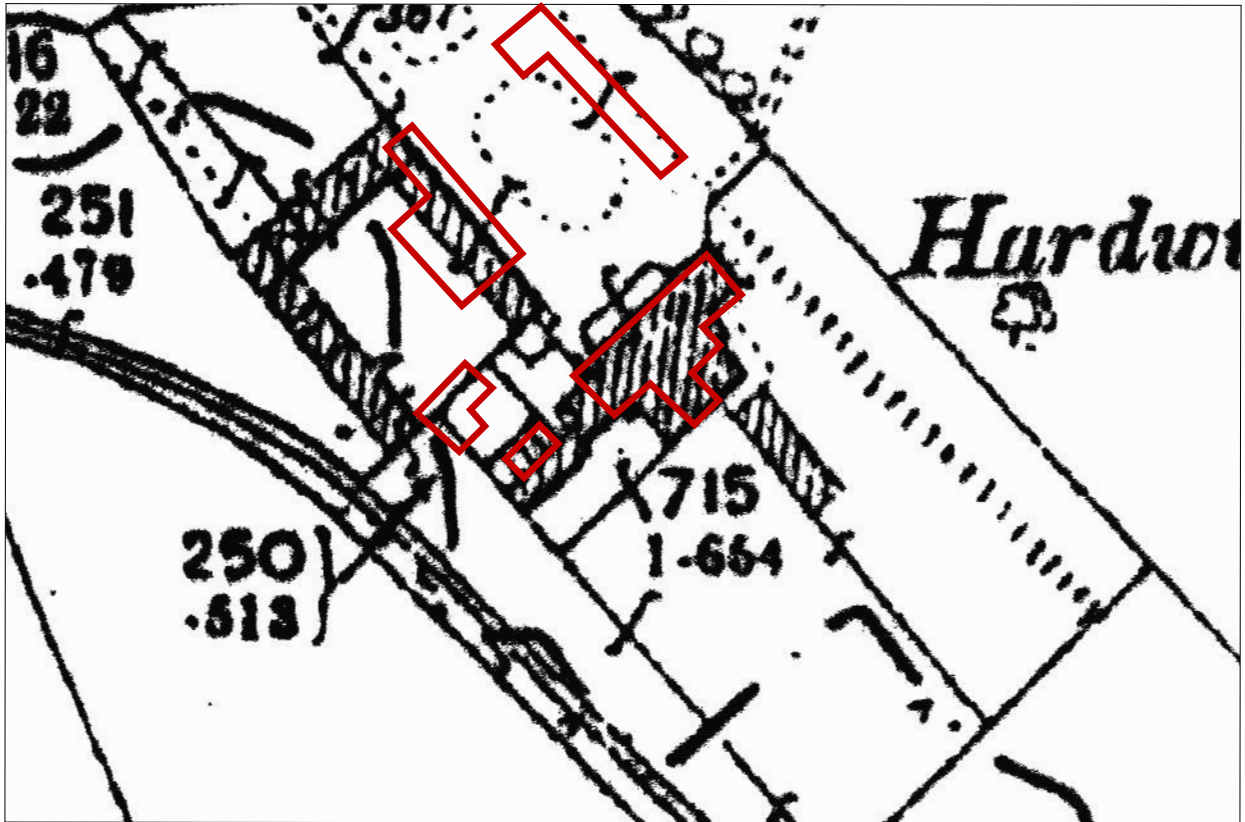
Fig. 18 Plan of Hardwick Inn, as shown on the 2nd Edition 25 inch (1:2,500) scale Ordnance Survey map of about 1900, with buildings shown on the 1838 tithe award map overlain in red. Scale 1:1,000.

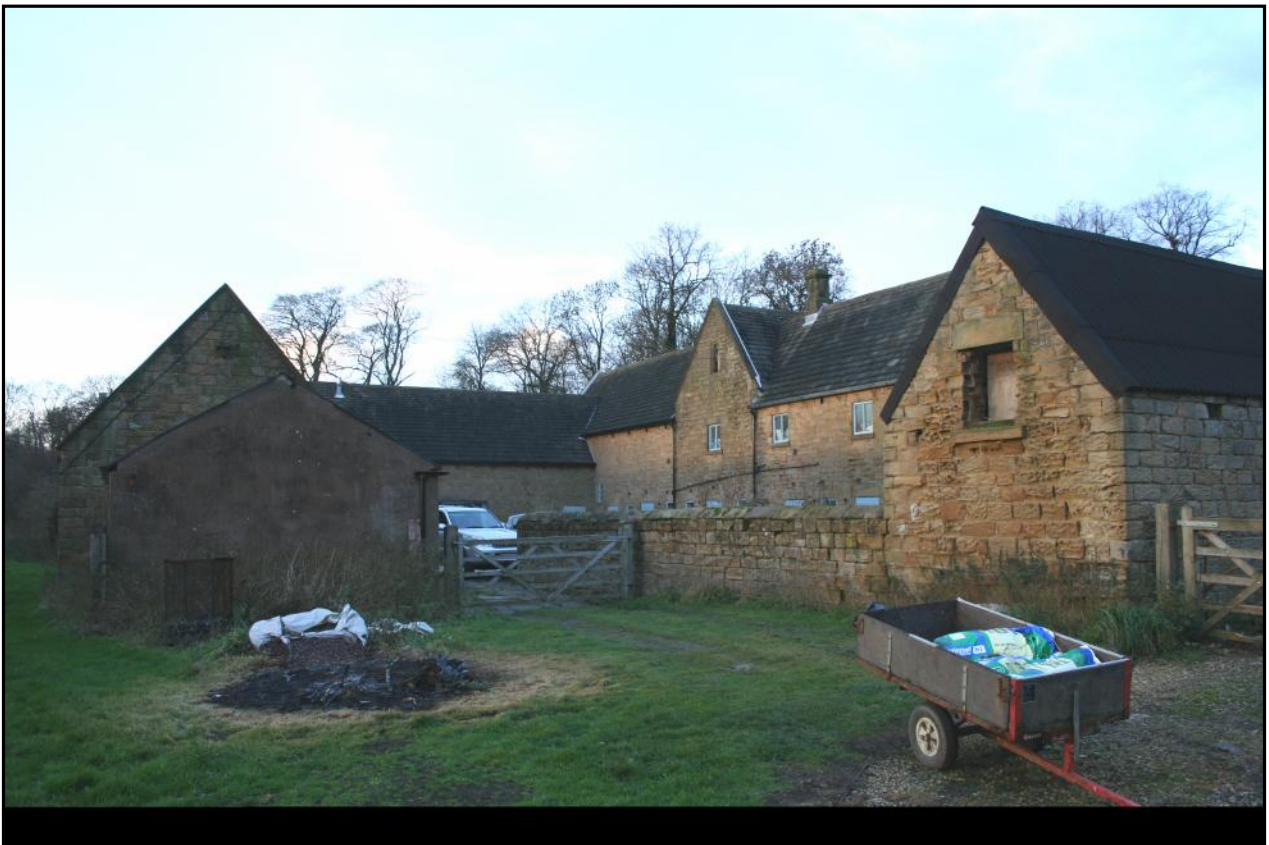
Plate 27: View from the south looking towards the farm buildings erected at Hardwick Inn between 1857-60.

- The relatively high expenditure, better standard of the materials used and the ornamental exterior of the farmstead (its yard facing away from the road) all reflect the status of the site on the main approach into Hardwick Park, where important visitors will have become aware of the Inn and its outbuildings.

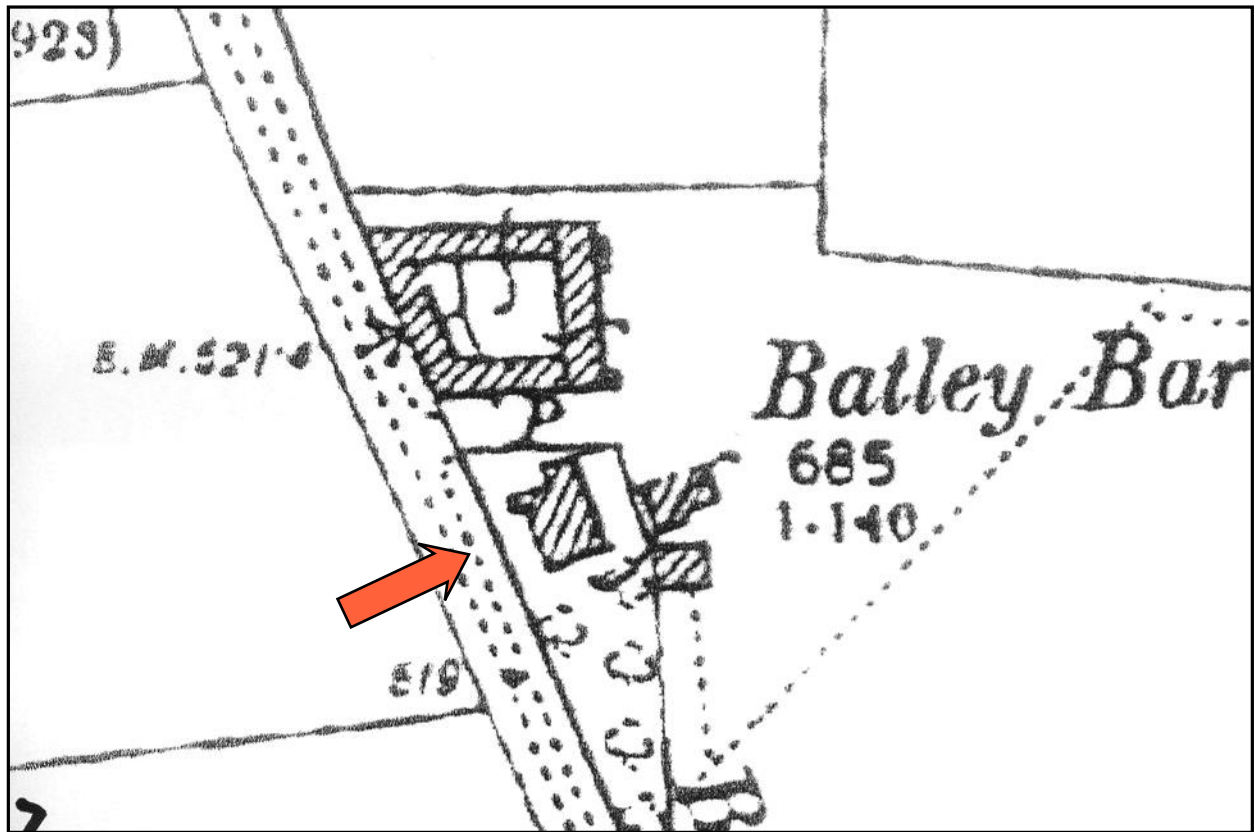
Fig. 19 Plan of Batley Barn / Farm, south-east of Rowthorne, as shown on the 2nd Edition 25 inch (1:2,500) scale Ordnance Survey map of about 1900, with the added cottages (here adapted into a farmhouse) highlighted. Scale 1:1,000.

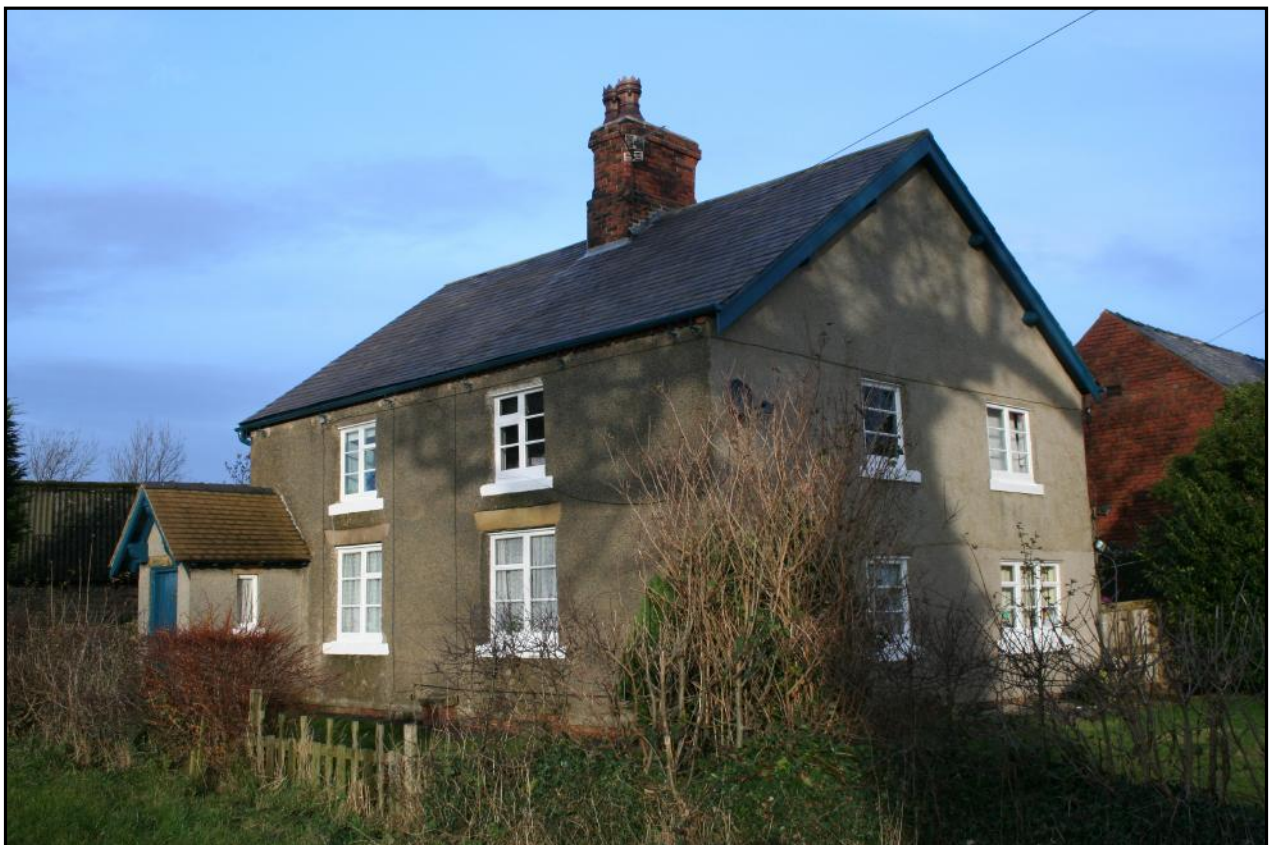
Plate 28: View of the former cottages built near existing farm buildings at Batley Barn / Farm, in 1878. To the far right there is a larger window where a side entry used to be. The building had become a single farmhouse before 1900.

- In 1878 paired labourers' cottages were built for £273 just south of the farm complex, each entered through porches at the side. A brick-built cartshed with granary was also built before 1900. However, by then Batley was probably being used as a separate farm, despite still being called Batley Barn, with the cottages combined into a single house. The entrance on the east side was filled in and replaced by a window. It was certainly listed as a separate farm in 1910 when its land holding made it one of the largest farms in the parish.
