Keigwins, Mousehole

(Keigwin and Little Keigwin and their relationship to adjacent and associated buildings including the Old Standard)

January 2007

A Report for the
Victoria County History, England's Past for Everyone project

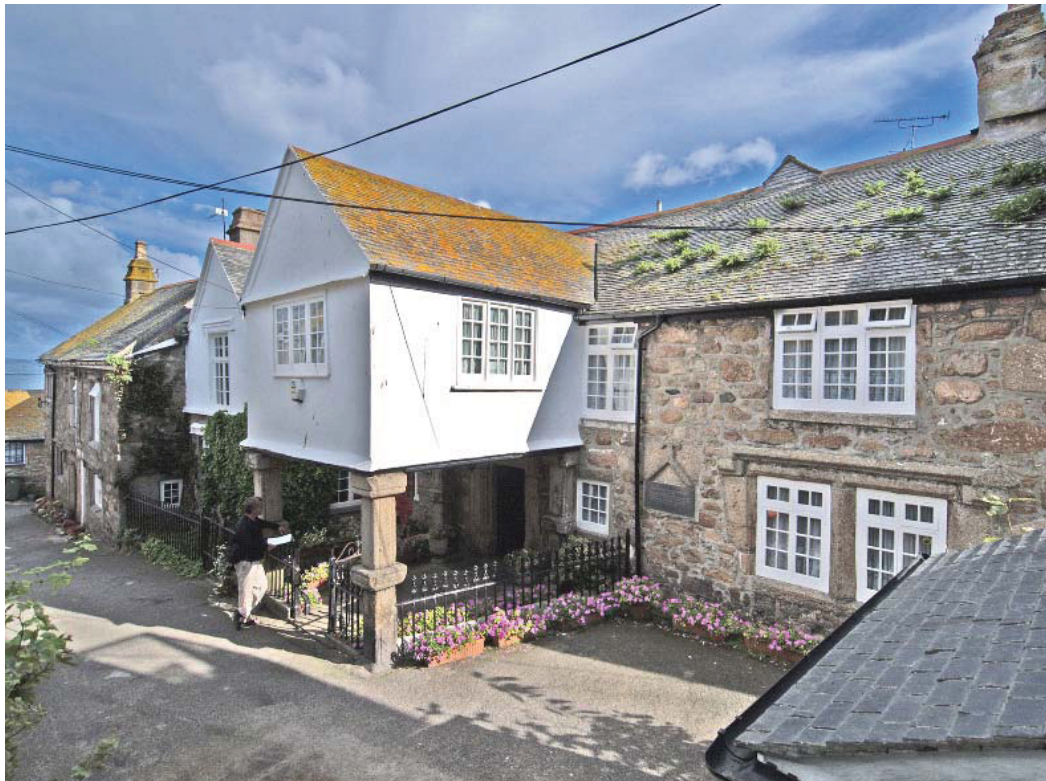
1. Keigwin with Little Keigwin and the Old Standard far left

The roof was largely re-slatted in the mid 20th century with scantle slate. There is an original dressed granite chimney stack over each gable end (photo 1), interestingly of a less refined design to those of the Old Standard (photo 2).

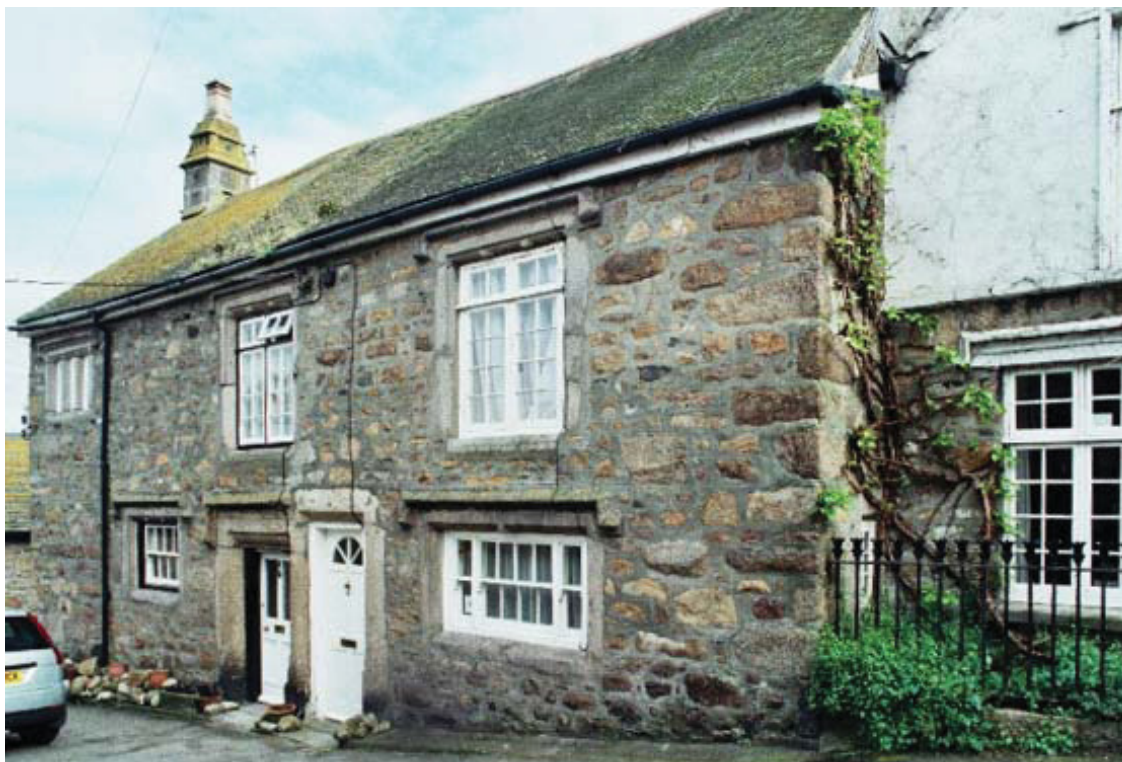
2. The Old Standard

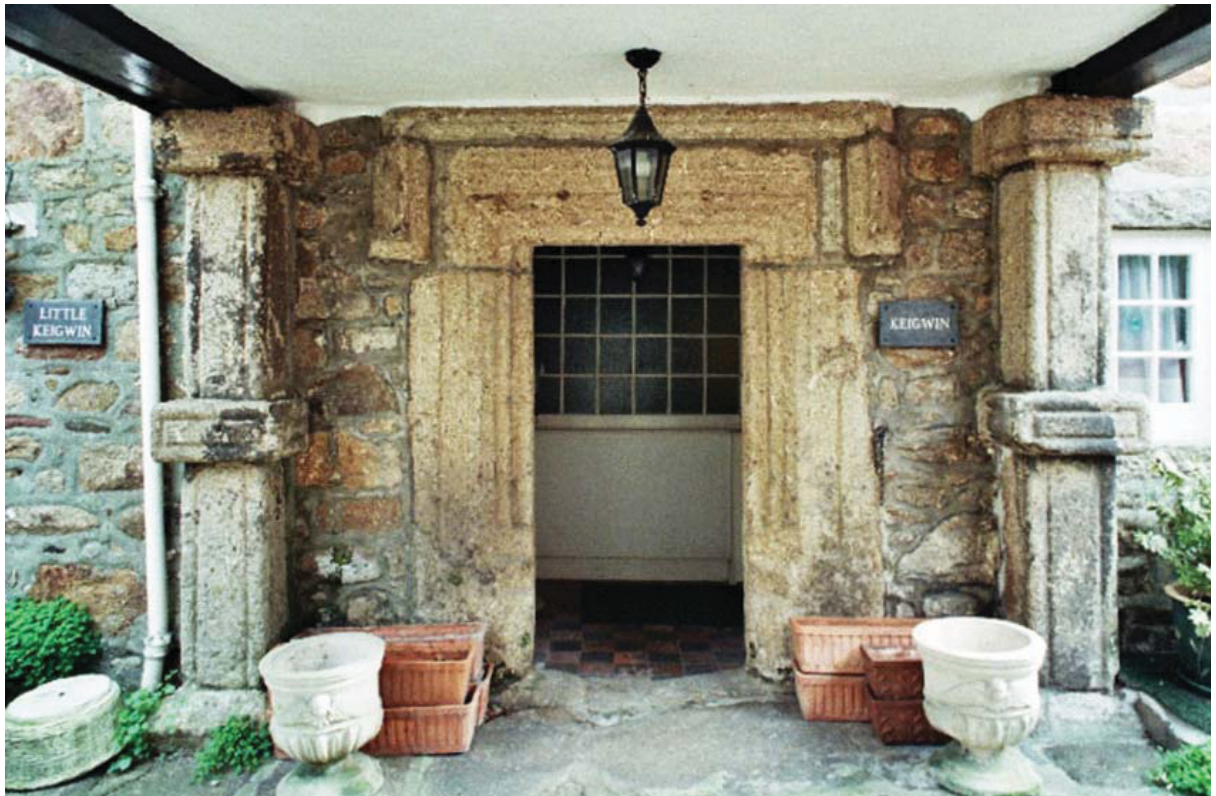
3. Keigwin: moulded granite front doorway and flanking columns of late porch

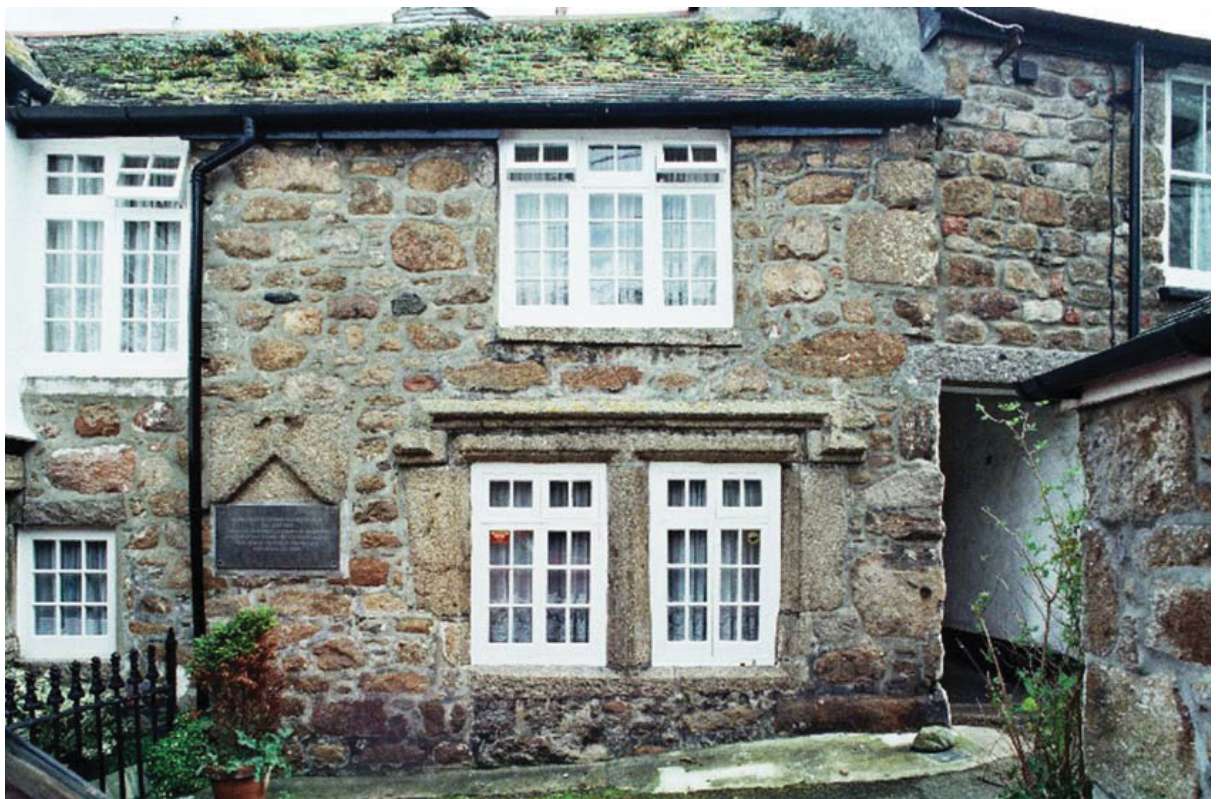
4. Keigwin: restored hall window and reset gable coping of former lateral stack

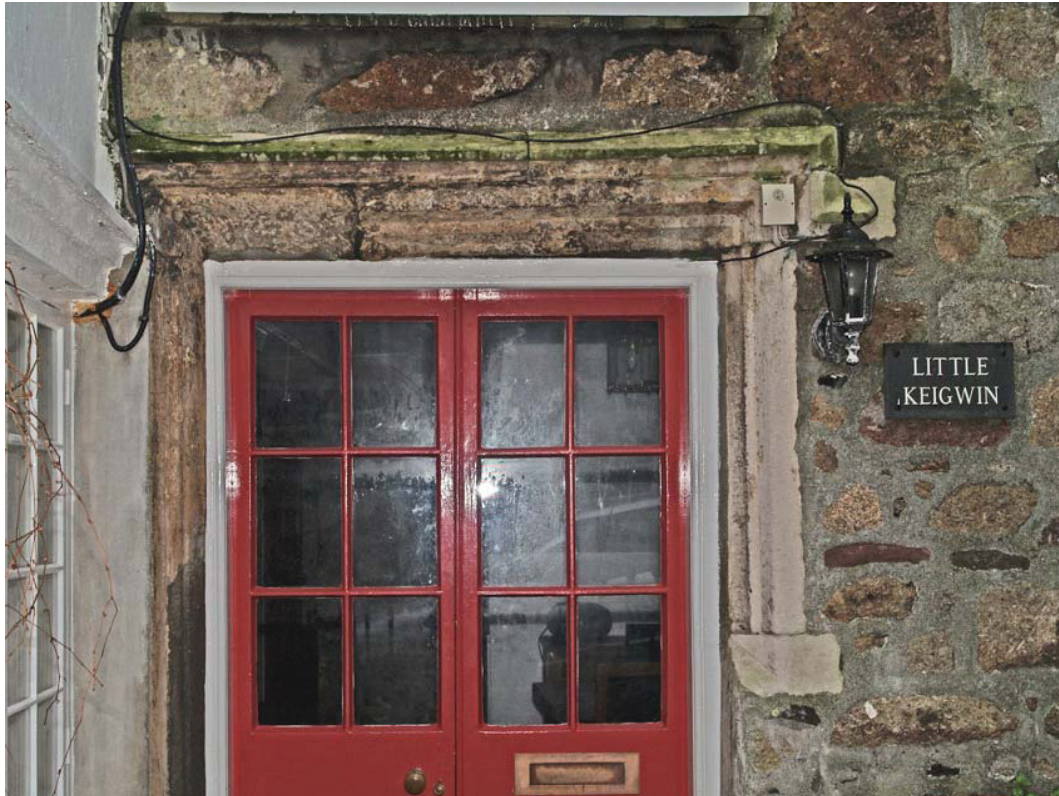
5. Little Keigwin: lintel and jamb remains of freestone 3-light mullioned window

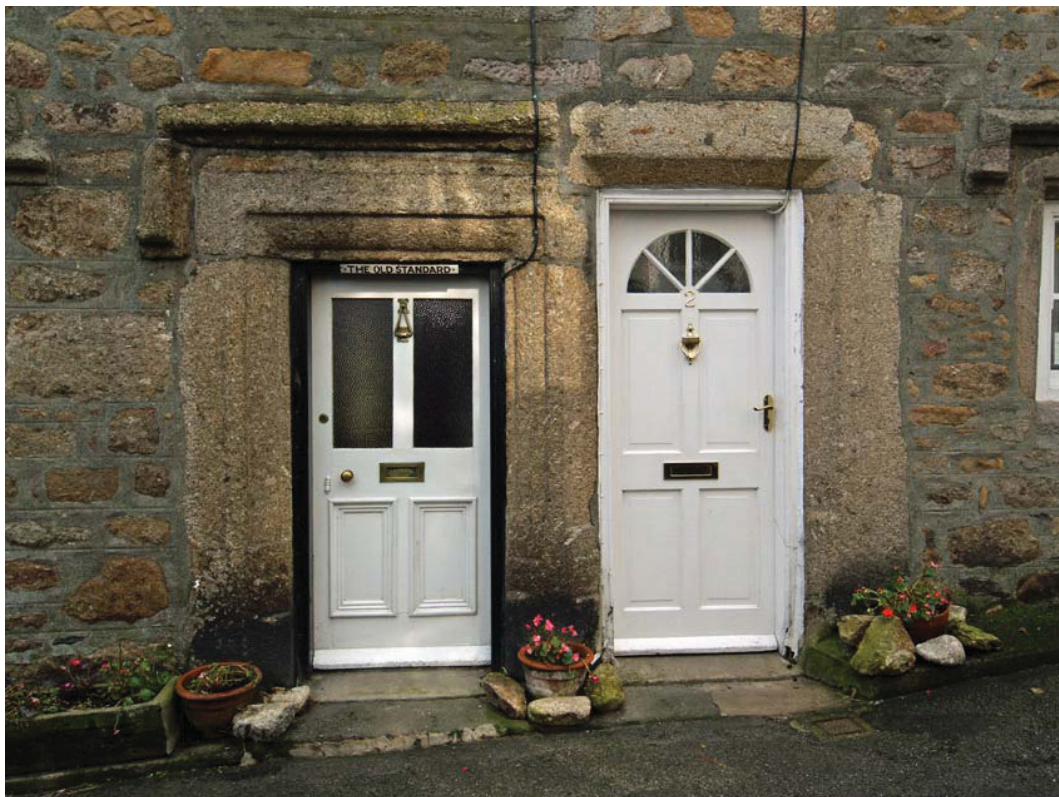
6. The Old Standard: original doorway (left) and later doorway of reused material

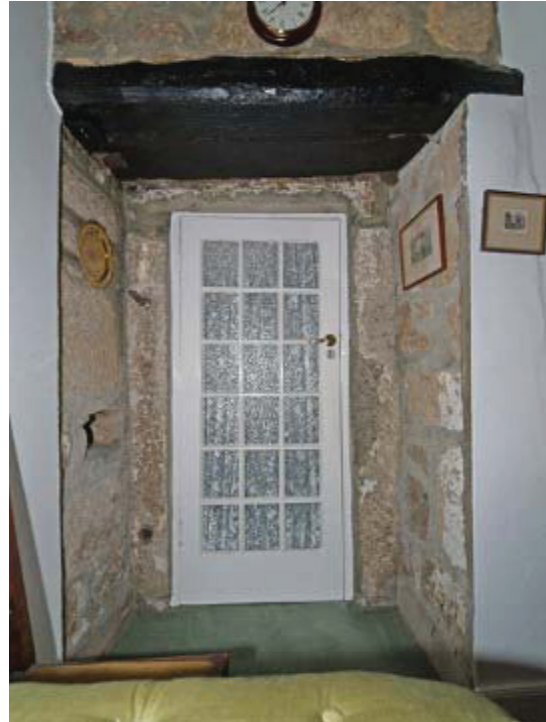
8. Keigwin: interior of rear doorway

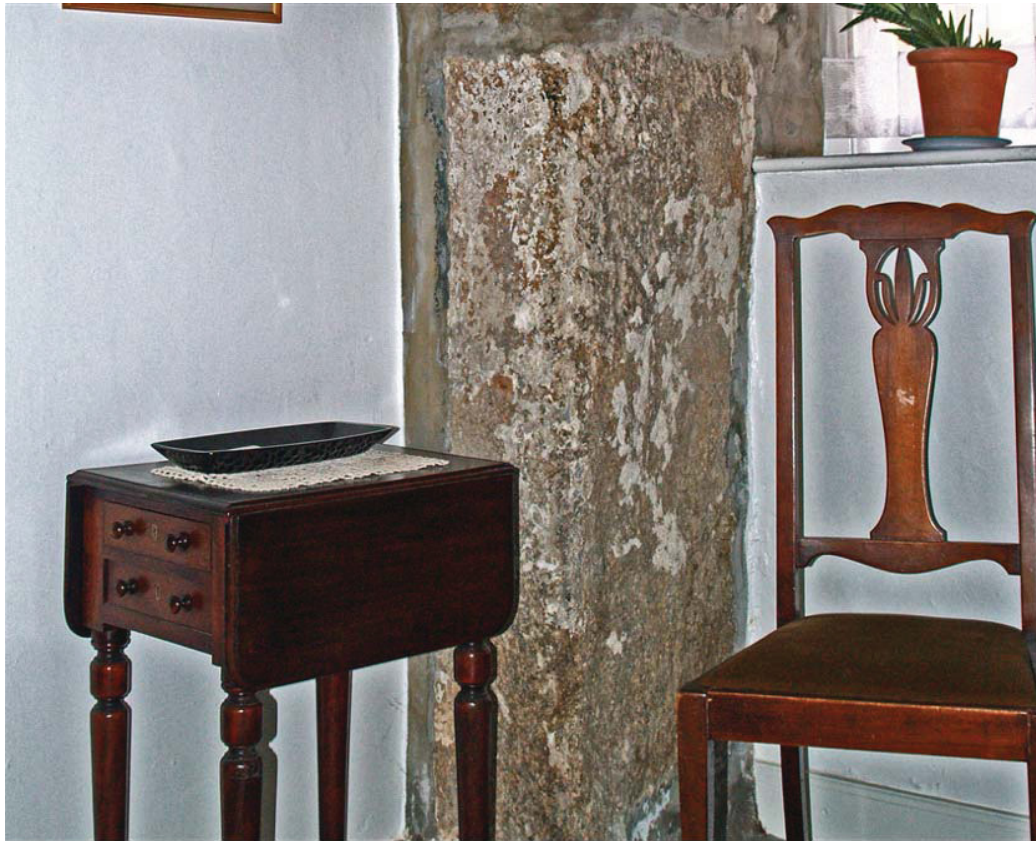
11. Keigwin: chamfered jamb of hall fireplace

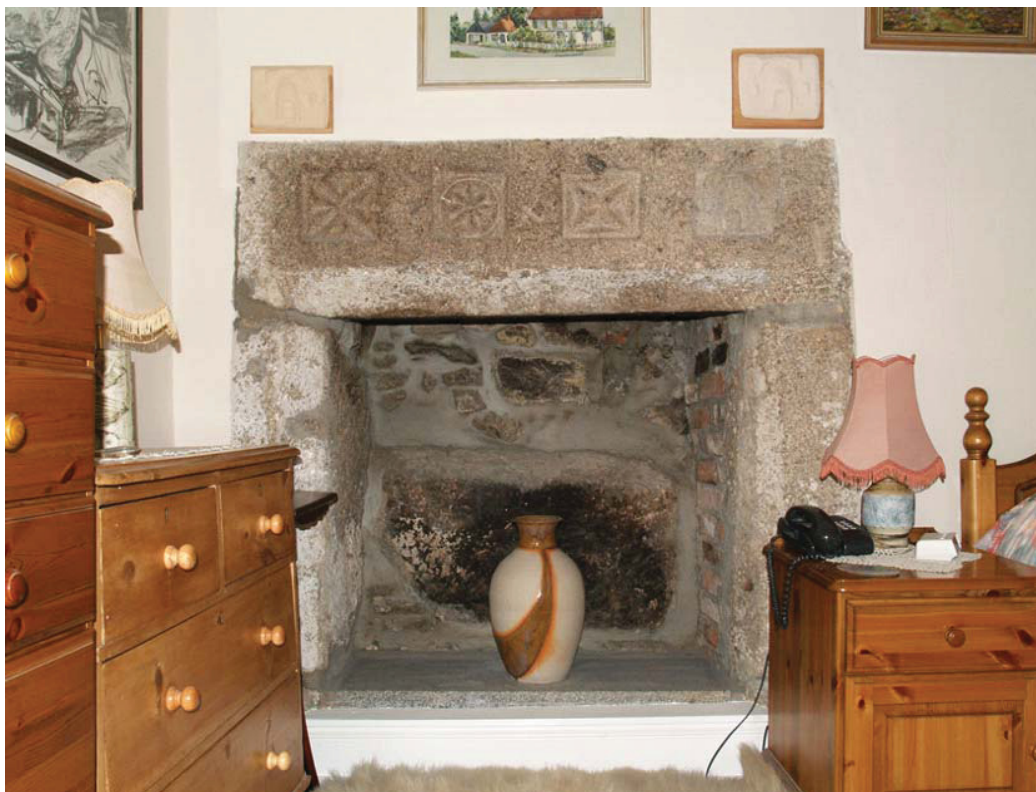
12. Keigwin: fireplace with carved motifs, in chamber above hall: the Keigwin rebus is shown in a plaster cast

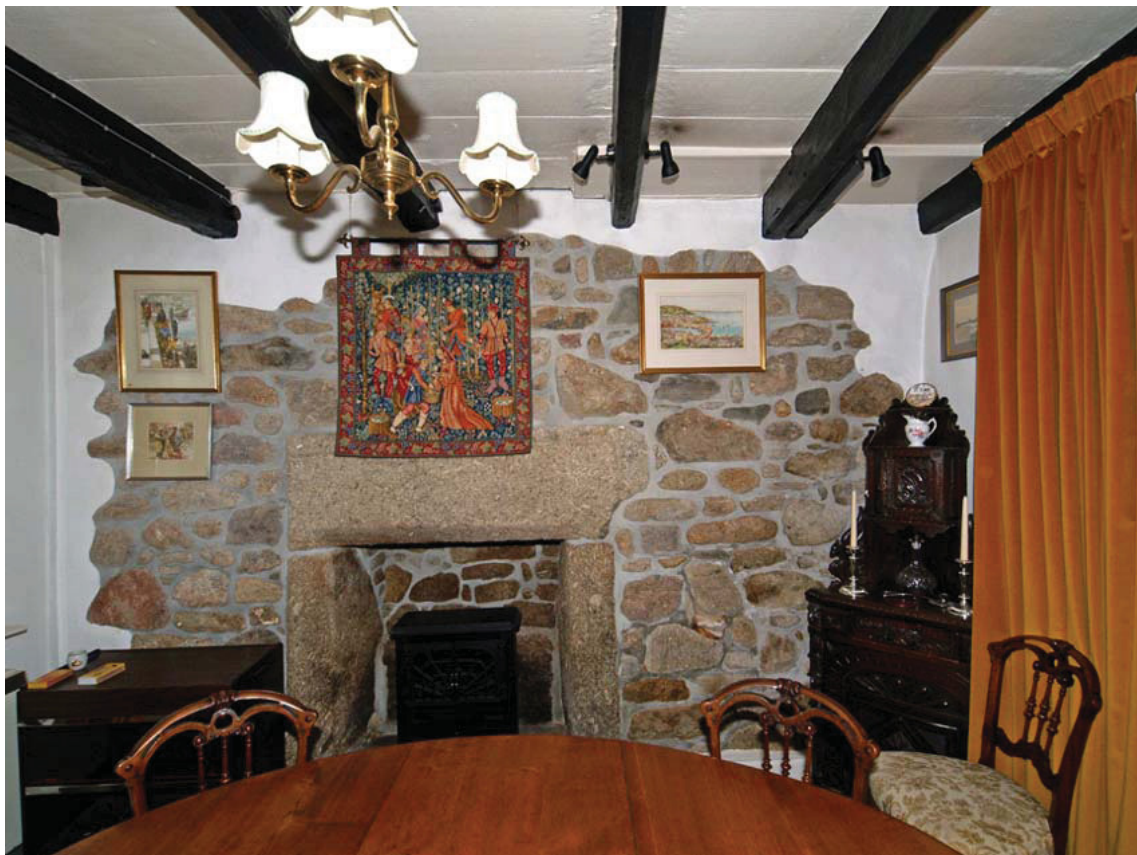
14. Keigwin: original parlour fireplace and ceiling with original chamfered joists

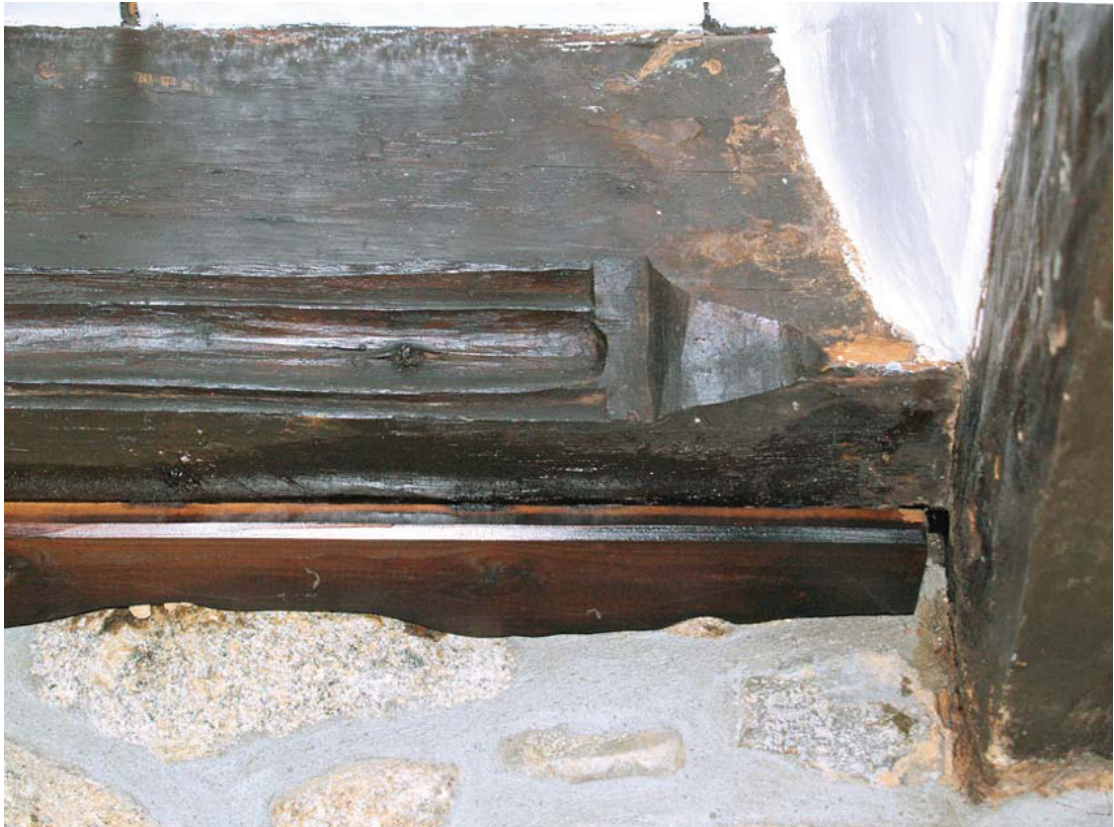
15. Keigwin: hall ceiling detail with moulded joist and stop

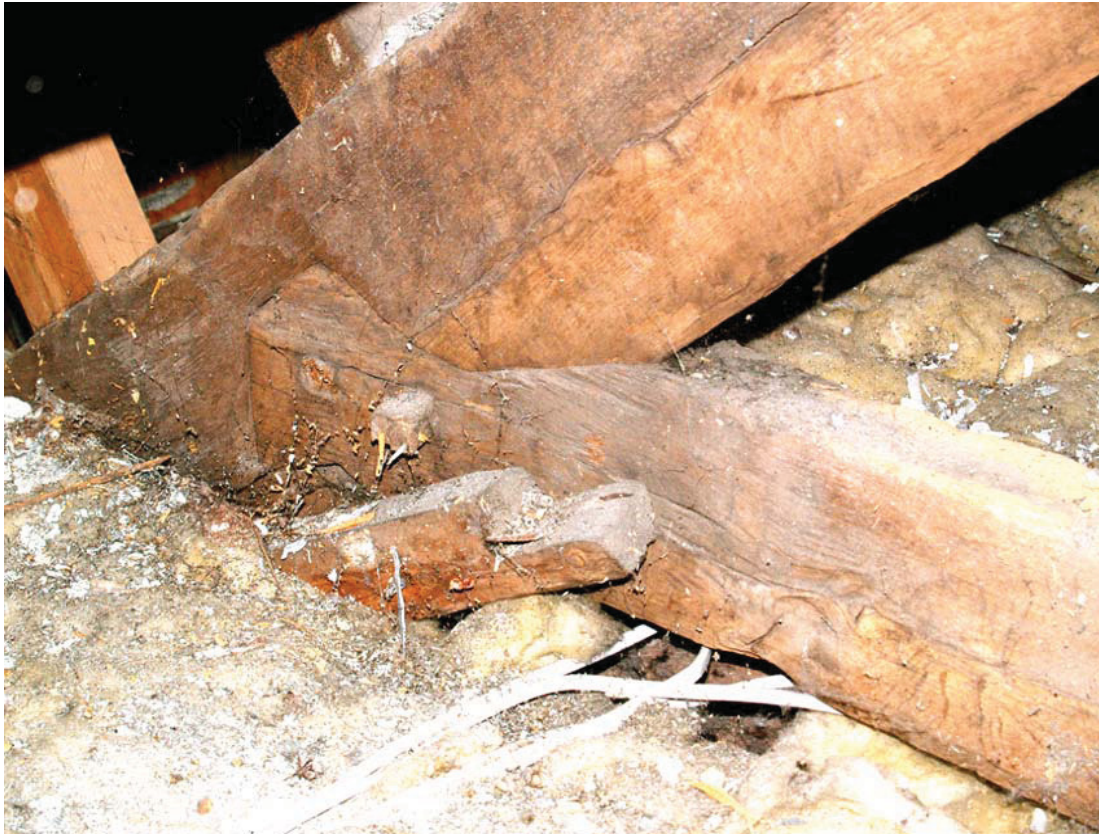
17. Keigwin: front roof structure with detail of collar joint and evidence for former barrel ceiling

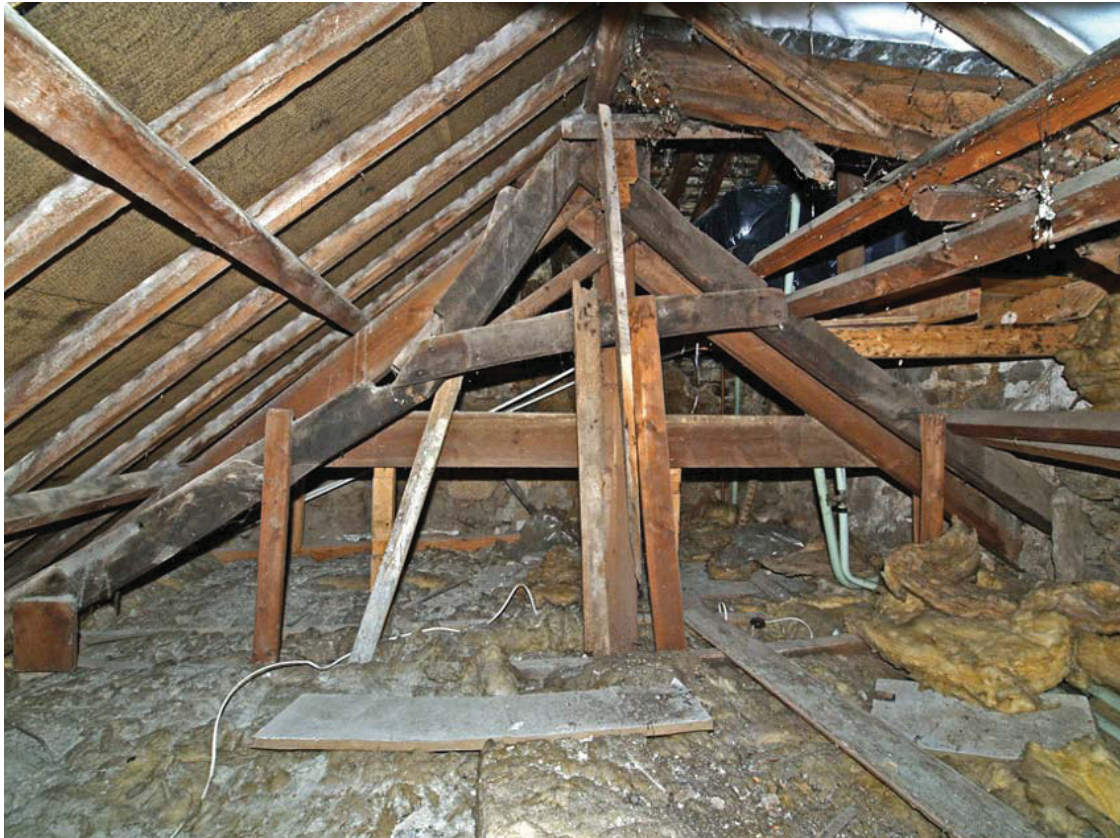
19. Keigwin: roof over rear range; original smoke-blackened truss at west end

The roof of the Keigwin kitchen wing (photos 19 and 20) has two phases of construction, both with similar carpentry detail to the front building range. However, the 2-bay (1 smoke-blackened truss) west end of this wing has one tier of collar joints whereas the 2.5-bay east end has three original trusses, each with two tiers of collar joints, perhaps a precautionary constructional detail stimulated by failure of the west truss that now has a broken rafter to its south side. There are three chimney breasts projecting within the roof space, the one to the north-west serving the parlour and chamber above, the one to the south-west corner serving the fireplace(s) in the west wall of the rear range and the one in the south-east corner relating to the attached house to the south (No 8 Wesley Square).

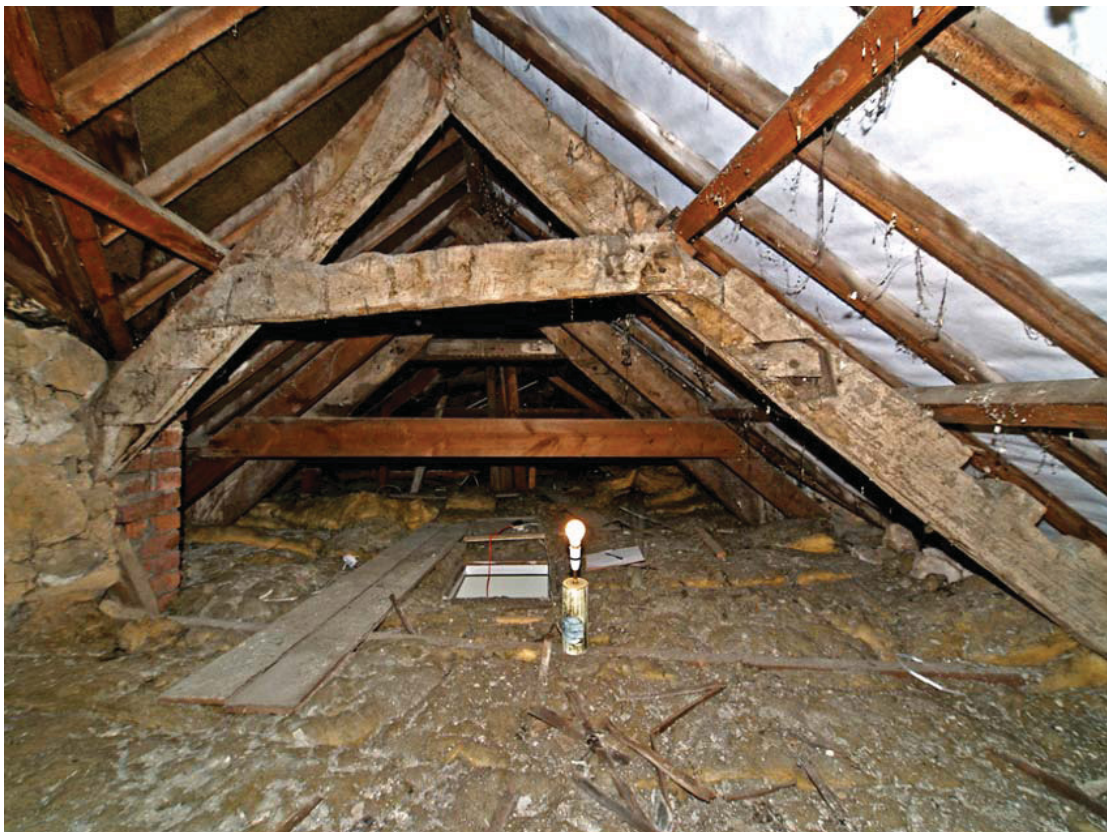
20. Keigwin: roof over east extension to rear range originally with for 2 tiers of collars

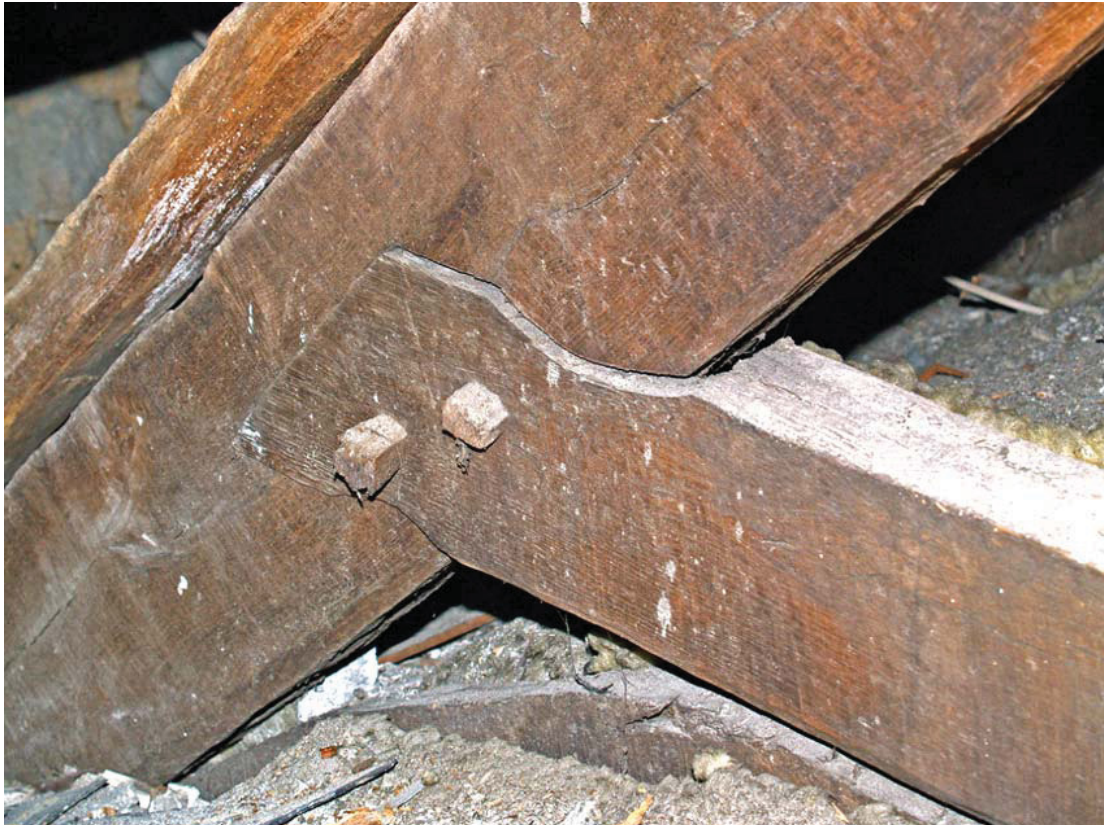
21. Little Keigwin: front roof structure detail of collar joint and brace supporting barrel ceiling

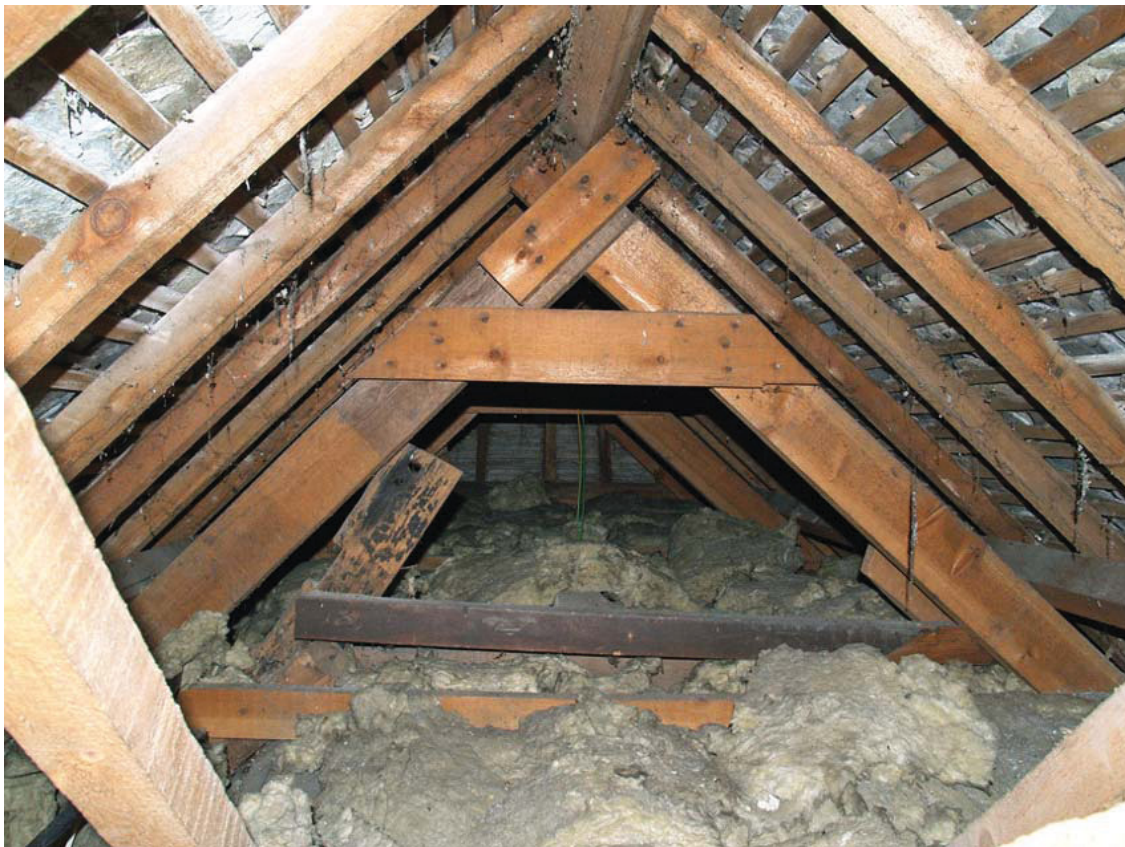
22. Little Keigwin: steep-pitched original truss over front wing under later roof structure

The small projecting front wing of Little Keigwin has the sawn-off remains of two original steeply-pitched trusses but has otherwise been replaced.

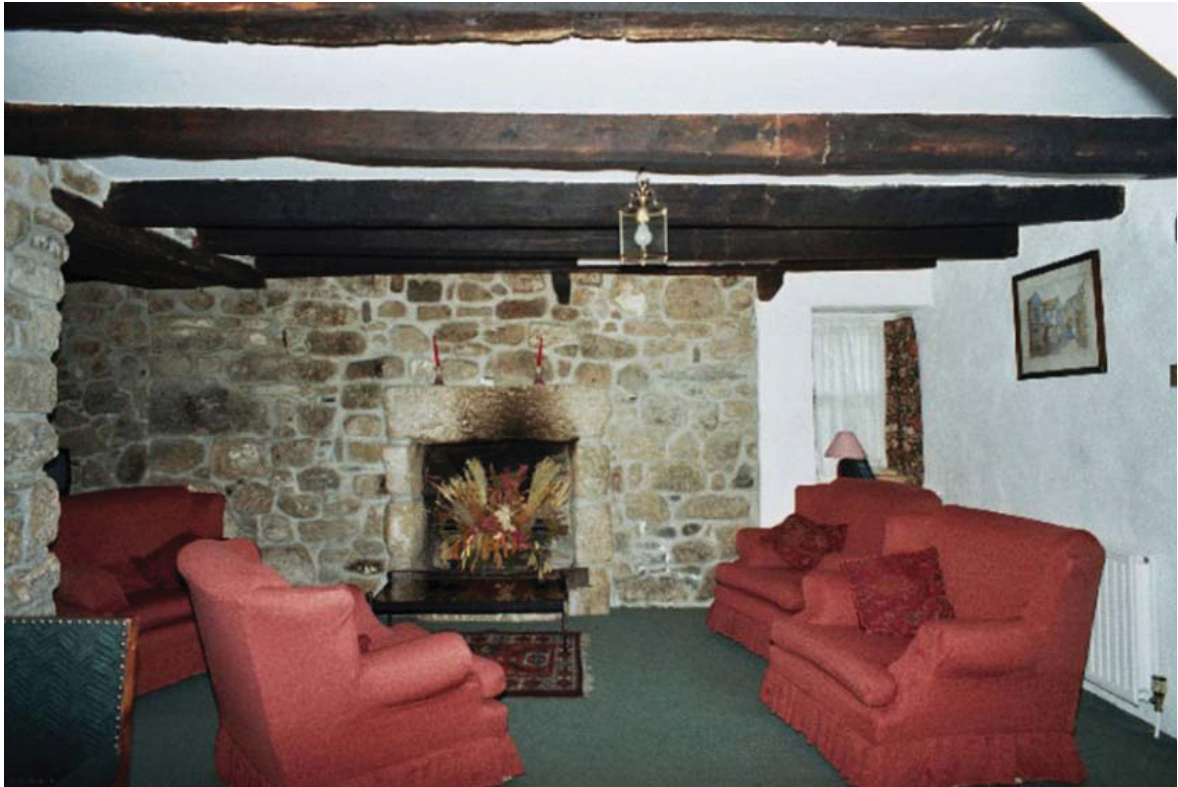
23. Little Keigwin: main front room with later inserted fireplace (note chamfered joists)

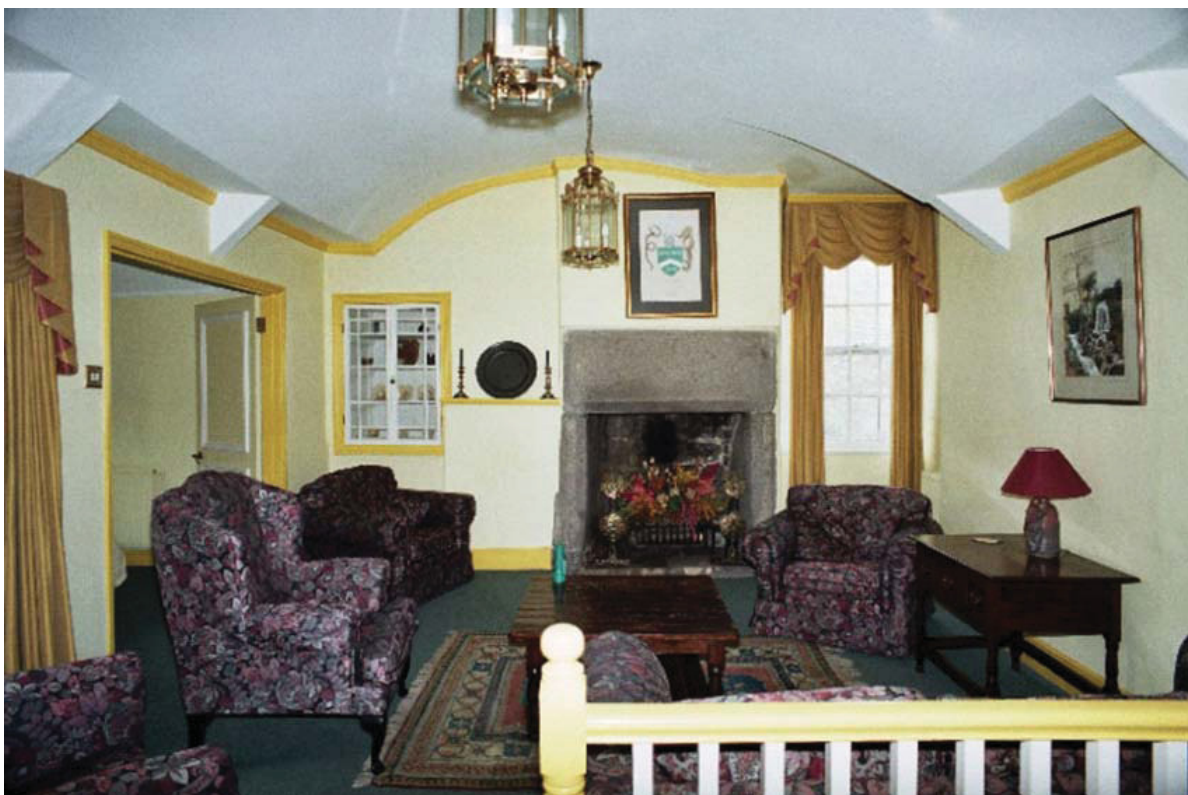
24. Little Keigwin: principal chamber with chamfered fireplace and plaster barrel ceiling

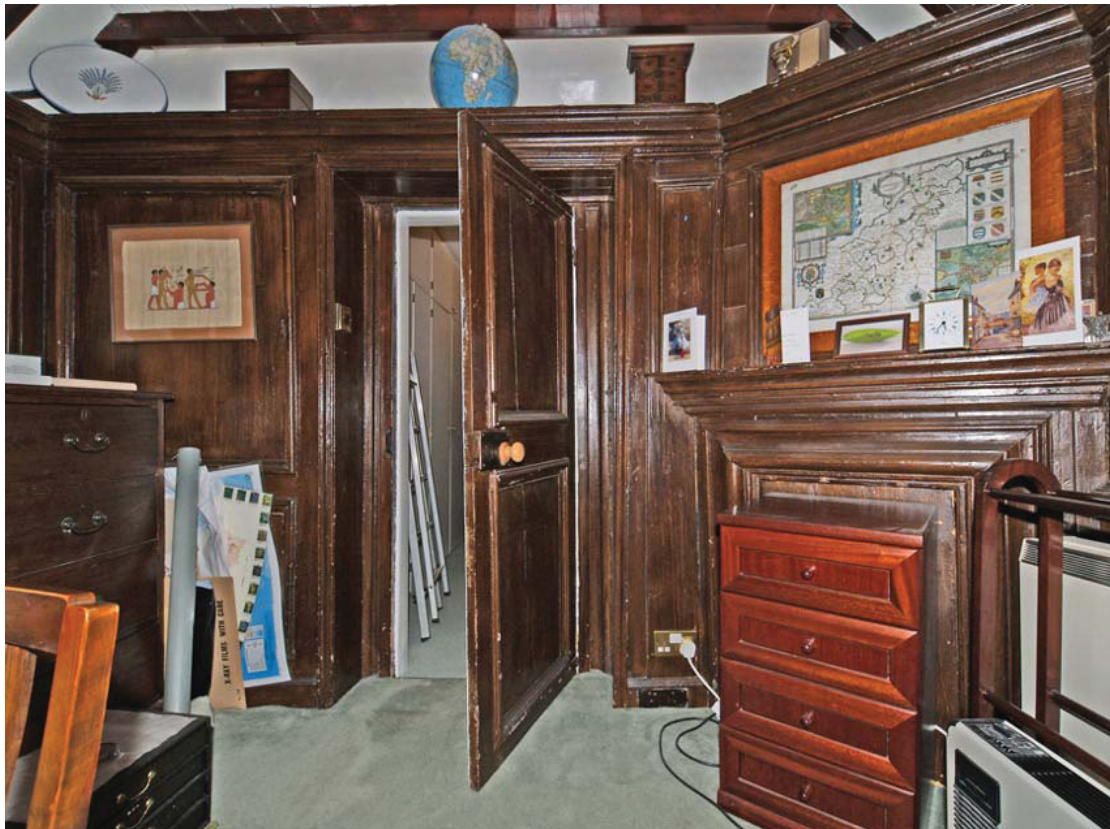
25. Keigwin: bolection-moulded panelled room over porch

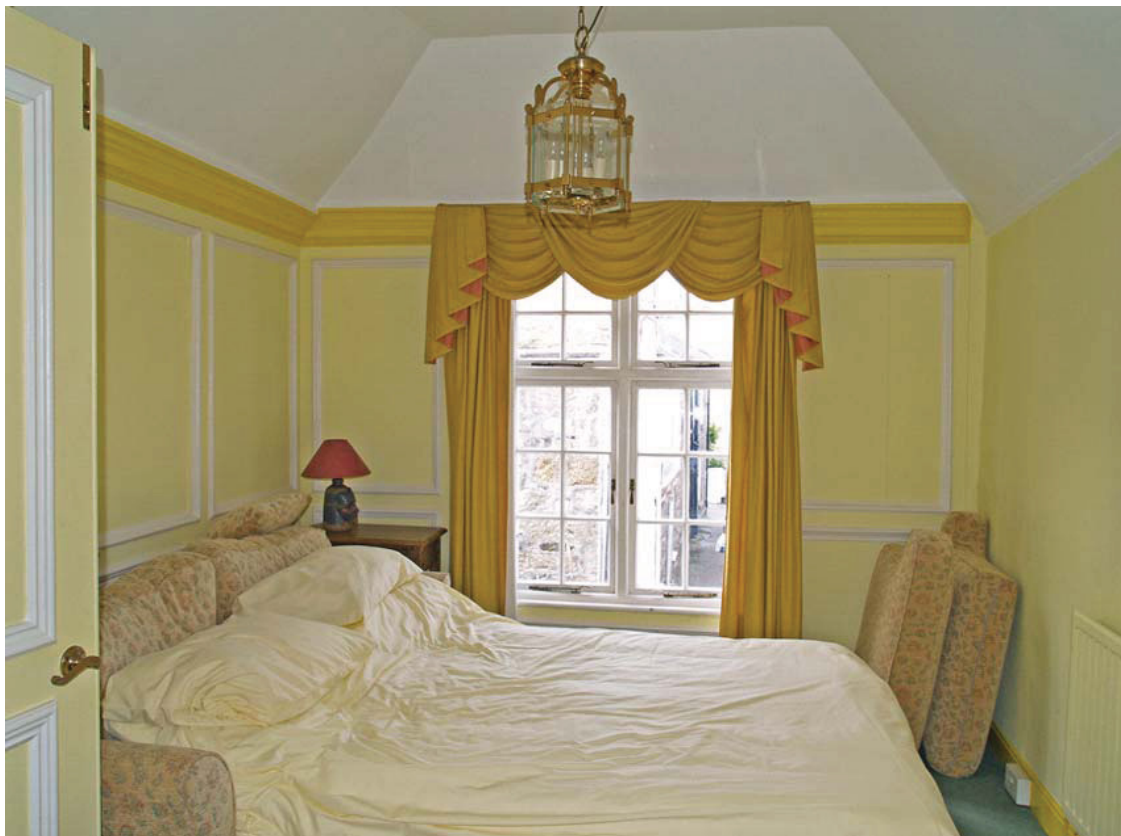
26. Little Keigwin: Bolection-moulded panelled room over front wing

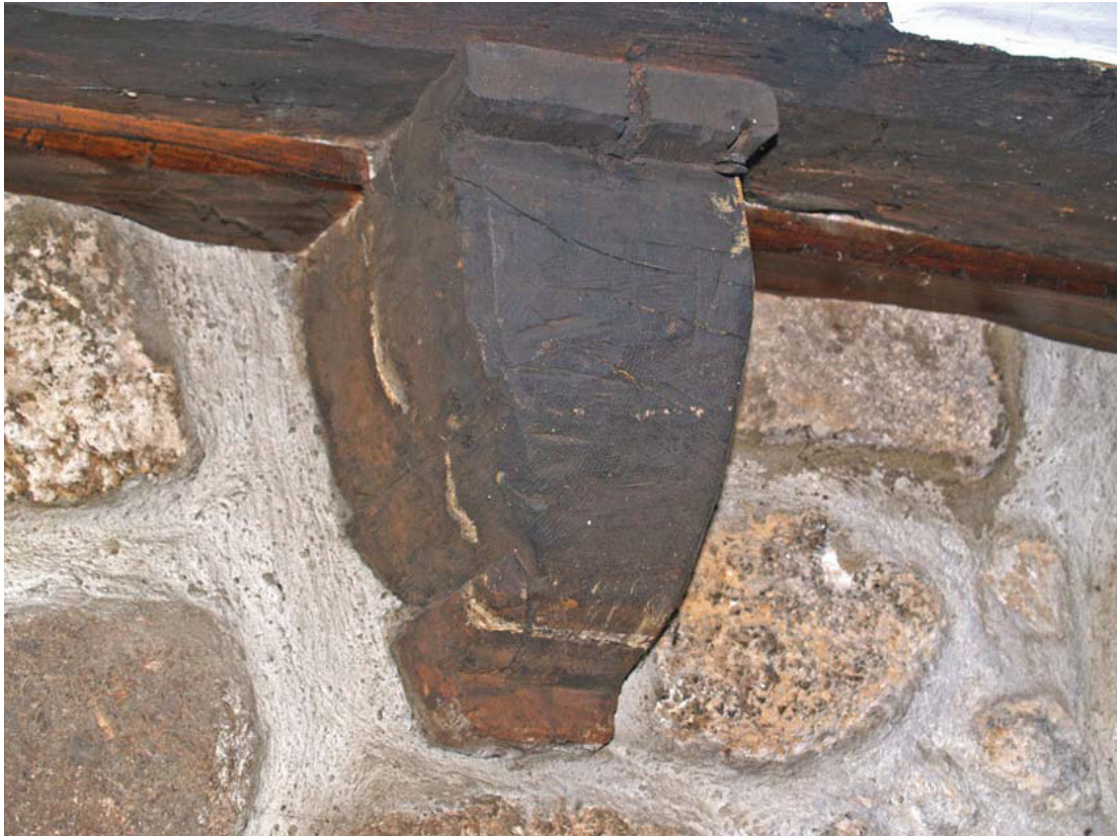
27. Little Keigwin: principal ground-floor room, moulded corbel under 1st-floor fireplace

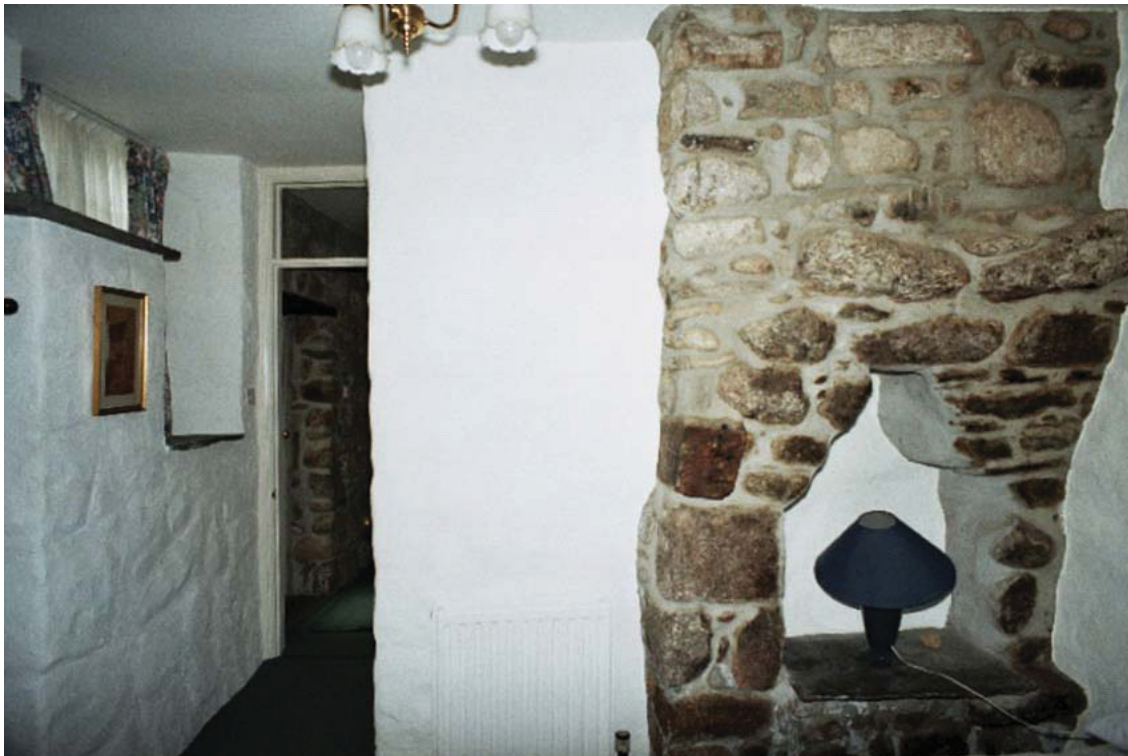
28. Little Keigwin: 18th century oven inserted to 17th century fireplace since mostly removed

remains of a 17th century fireplace (photo 28) in its rear room. The front projecting wing of Little Keigwin is probably early 18th century based on the surviving panelling (photo 26) in its upper chamber. These phases are summarised in Figure 1.

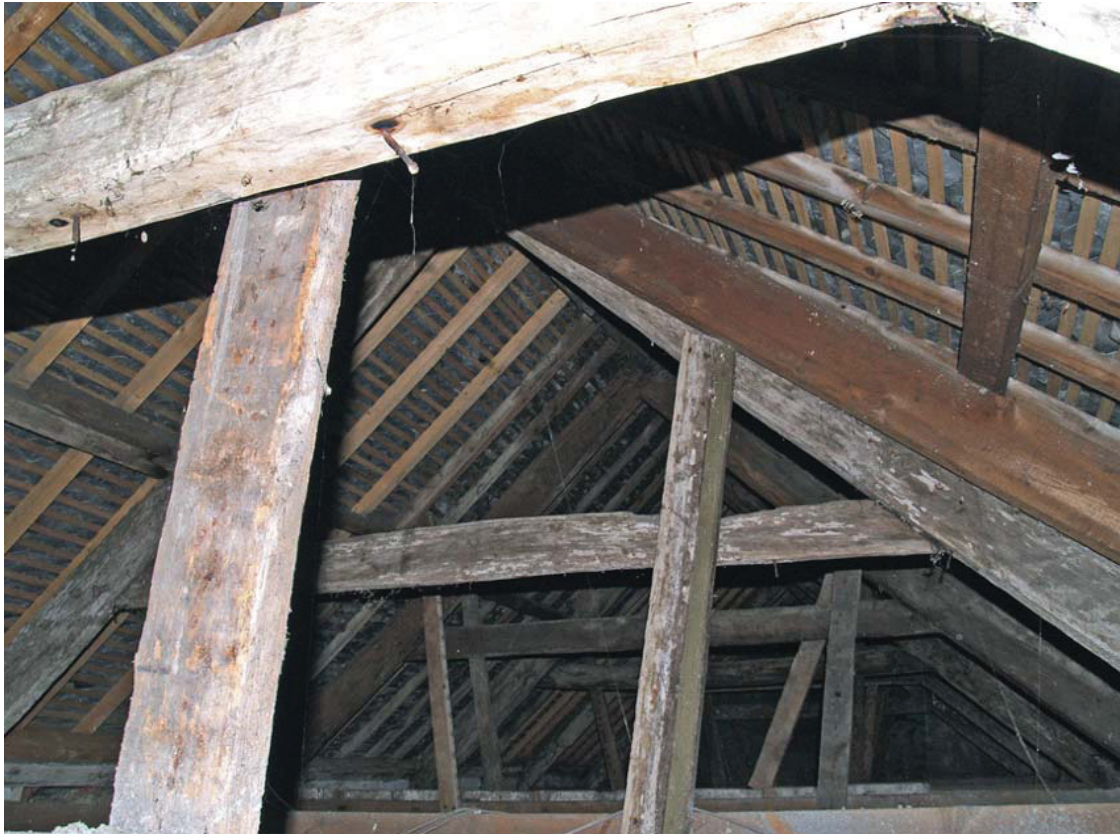
31. Old Standard: original 7-bay roof structure over front range (note lime-wash)

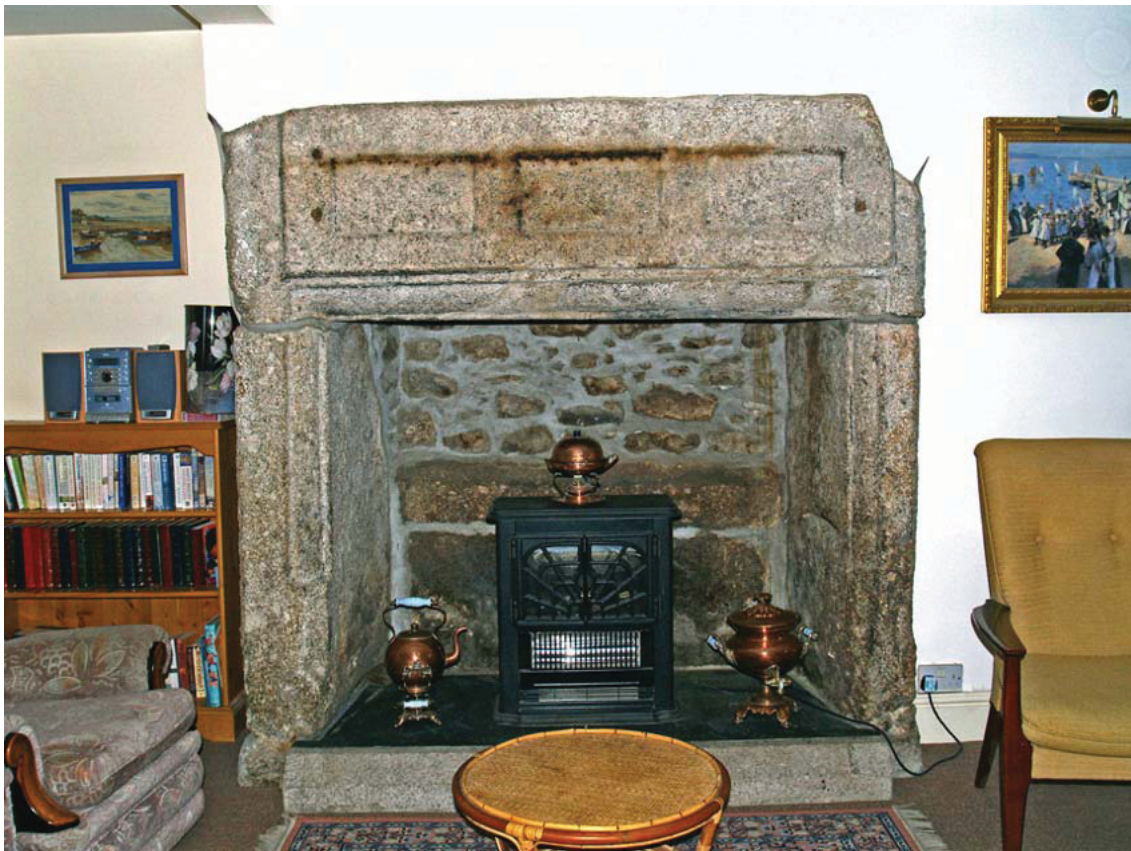
32. Old Standard: moulded granite hall fireplace with panelled lintel, at west gable end

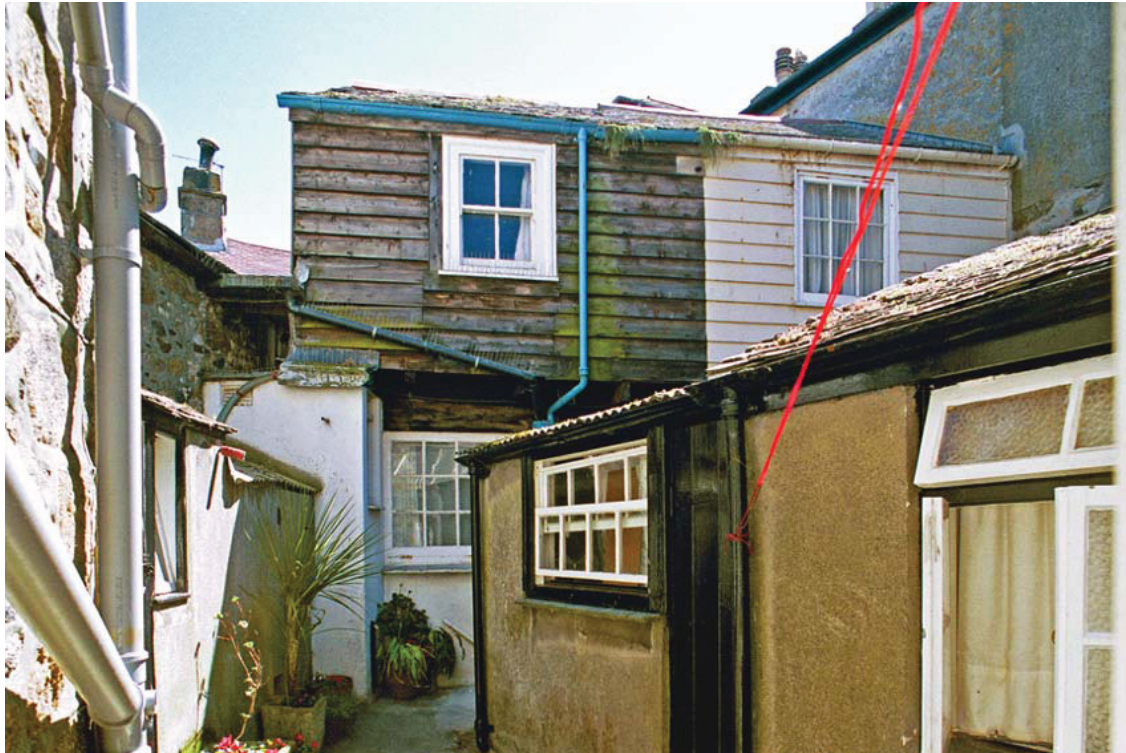
33. Old Standard: 19th century fish cellar range at rear

An overhanging shelf (photo 34) in the rear range (photo 33) of the Old Standard is a good example of the type of beam shelf used to lodge the beam ends used during the pilchard pressing that was once the staple industry in Mousehole, and is an indication of the later 19th century decline in the status of the complex.
