Keigwins, Mousehole

(Keigwin and Little Keigwin and their relationship to adjacent and associated buildings including the Old Standard)

January 2007

A Report for the
Victoria County History, England's Past for Everyone project

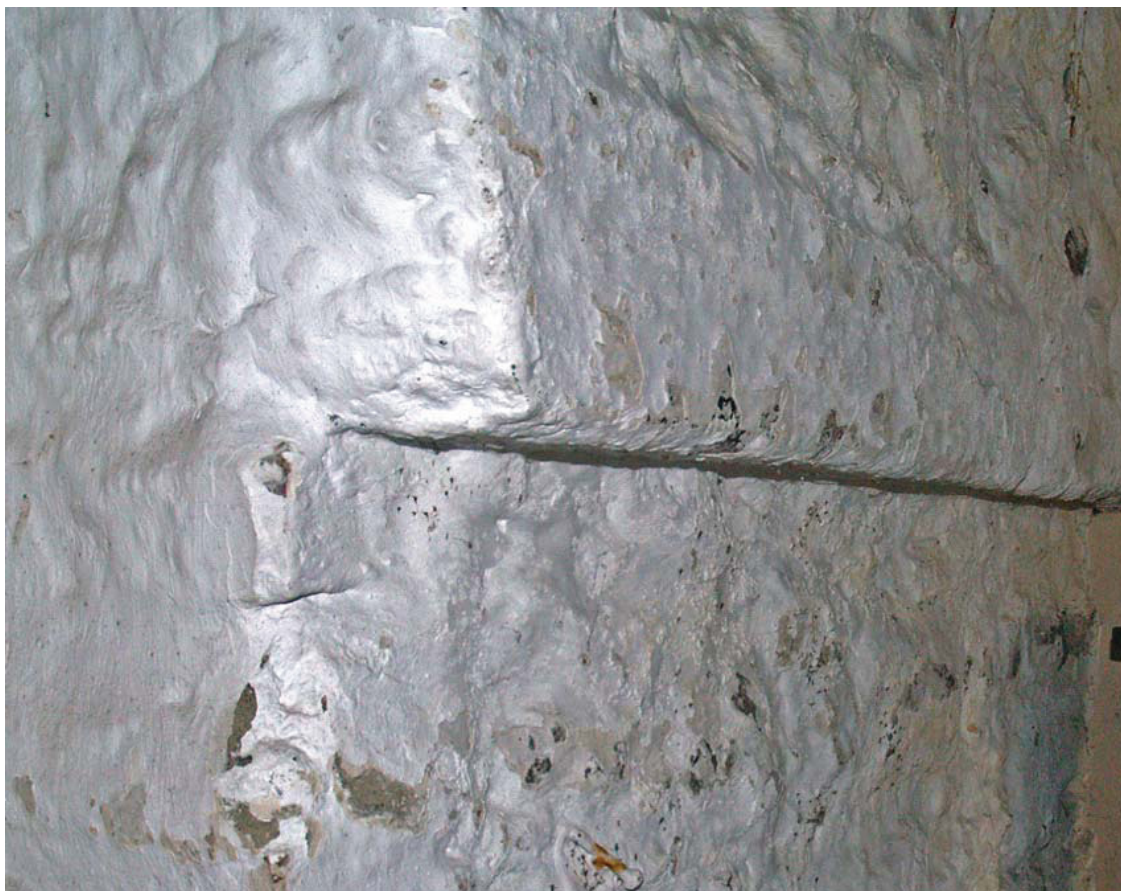
34. Old Standard: corbelled beam shelf for pilchard-pressing floor

An overhanging shelf (photo 34) in the rear range (photo 33) of the Old Standard is a good example of the type of beam shelf used to lodge the beam ends used during the pilchard pressing that was once the staple industry in Mousehole, and is an indication of the later 19th century decline in the status of the complex.
