Archaeological Watching Brief
Meigle Churchyard
Ardler Road, Meigle
PERTH AND KINROSS

ME03

**ARCHAEOLOGICAL WATCHING BRIEF
MEIGLE CHURCHYARD
ARDLER ROAD, MEIGLE**

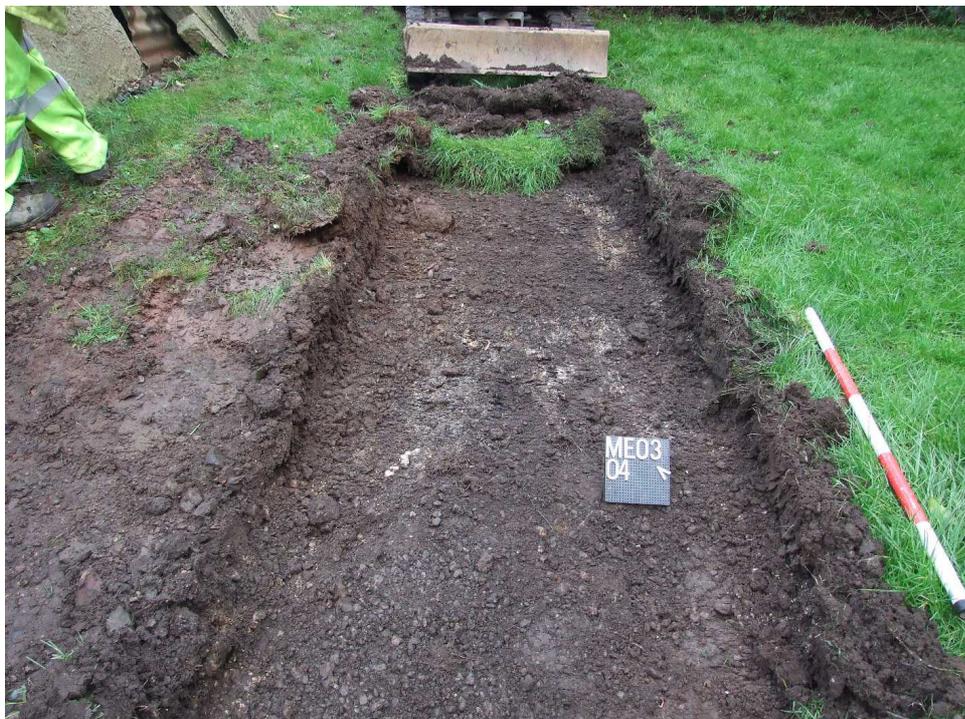
In the area to the NW of the museum excavation revealed that below the turf and topsoil (01) was a deposit of gravel (02) which was considered to be the makeup for the former footpath or perhaps just the former general yard surface at this location. At the SW end of the excavation what was considered to be subsoil (03) was observed in patches below the gravel. Other components of the gravel makeup (02) included light grey ash (04).

Gravel with ash 04 below turf

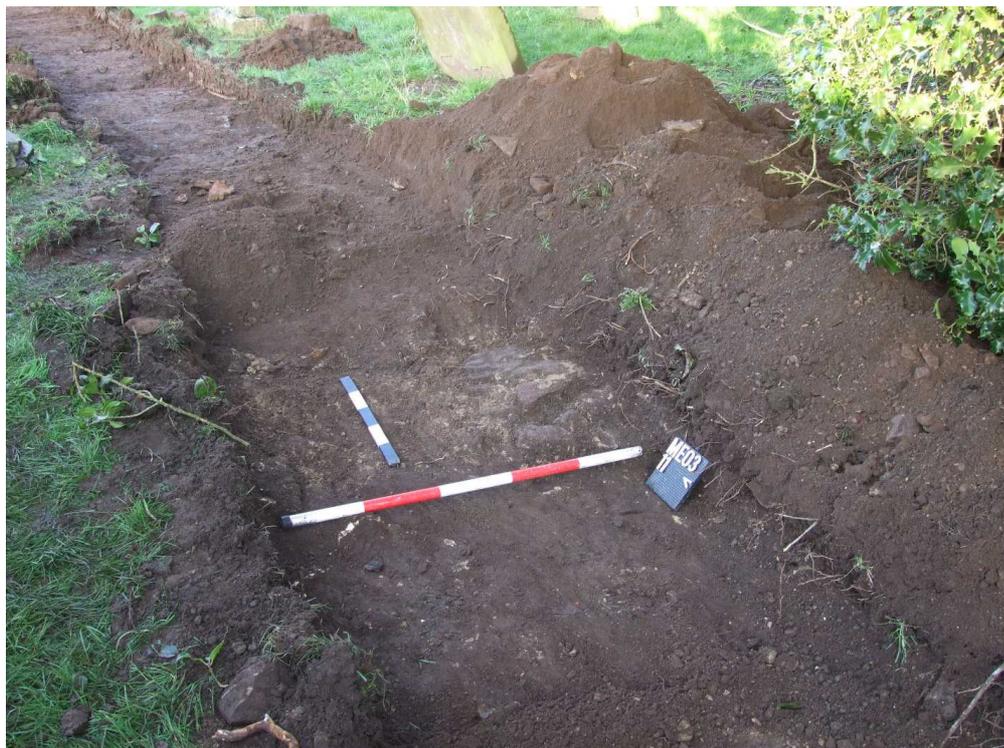
At a distance of 14.60m from the S end of the pathway a deposit, small-medium sized stone fragments and mortar (05) were observed which were considered to be the upper deposit or demolition spread over the demolished graveyard wall (11). Below (05) were some larger mortared stones (11) forming the fabric of the base of the former graveyard wall. Wall remains (11) were formed by one large irregular shaped flat stone with smaller stones or packing on either side, measuring 0.60m wide. The wall remains were only cleaned and not fully excavated and were more evident on the E side of the trench.

Former graveyard wall (11)

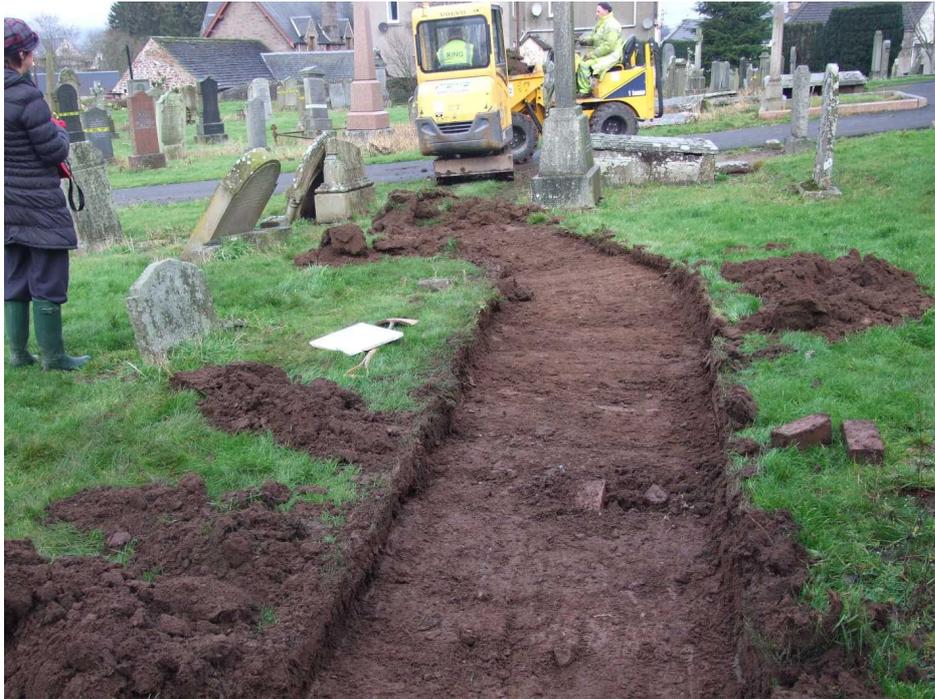
On the N side of wall remains (11) was the graveyard. Here, below the turf, the soil forming the base of the new pathway was a mid brown silty loam with occasional stone fragment inclusions (09). The former gravel pathway (02) as seen the on the S side of wall (11) was not observed here.

Working in graveyard area showing base of topsoil (09)

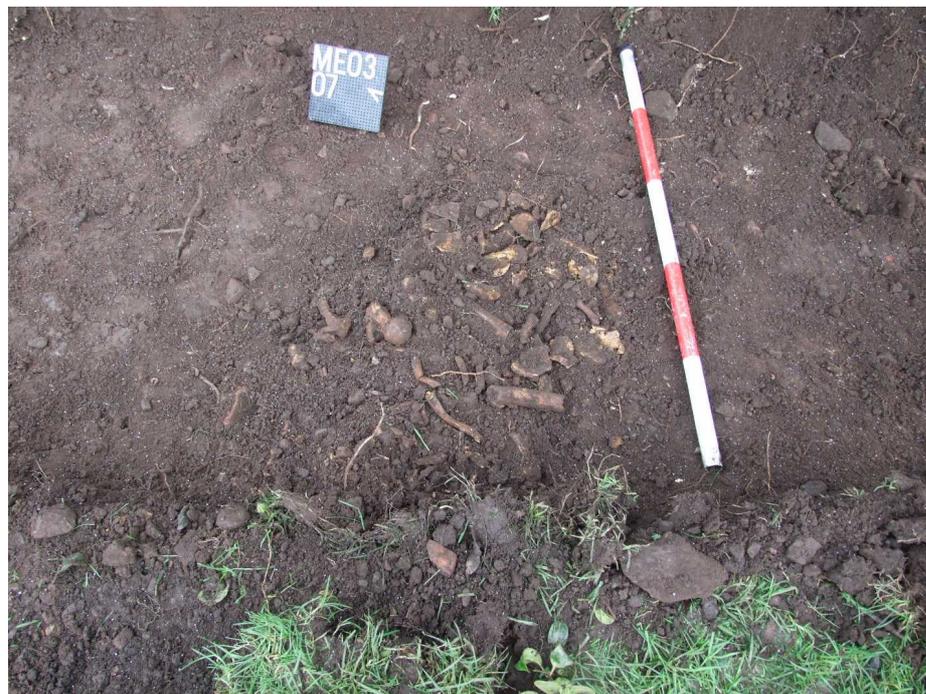
At 1m to the N of the former graveyard wall (11) a deposit of disarticulated human bone (07) was found in a shallow pit (08). The bone was mixed in with sandy silt loam (06) and the top of the bone deposit was only 0.10m below the surface.

Disarticulated human bones (07) when first found

The bone deposit measured c. 0.80 x 0.75m and was 0.25-0.30m deep. It extended below W edge of trench. Since the bones were so close to the surface, they had to be removed for the construction of the new pathway and reburied. It was considered best to rebury the bones below their original position. The bones were removed for reburial and were seen to be from many individuals.

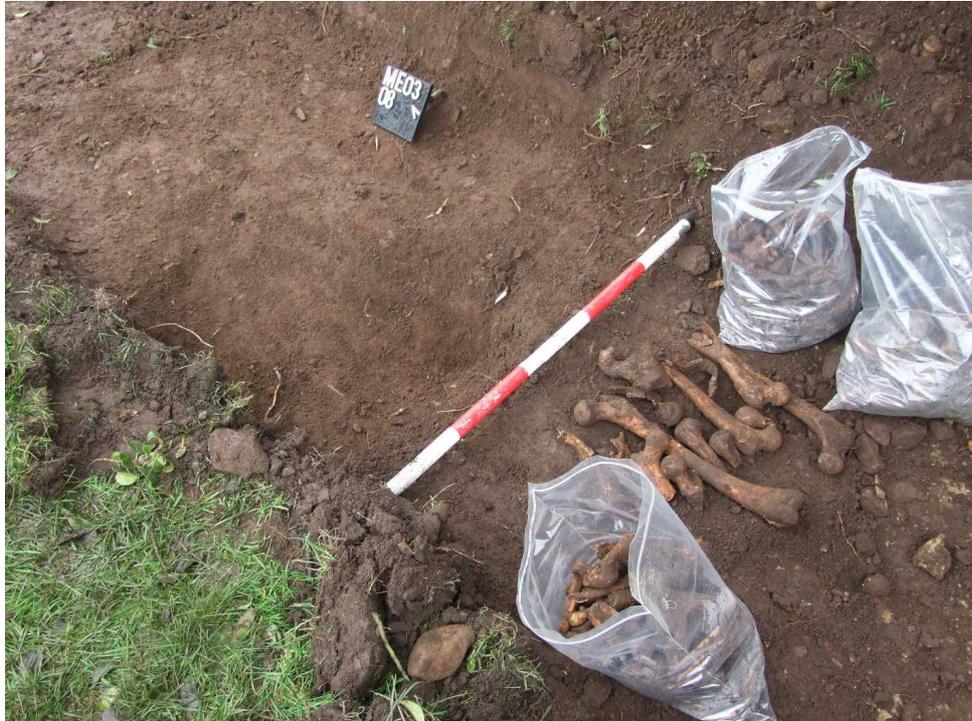
Disarticulated human bones removed, showing pit (08) that contained the bones

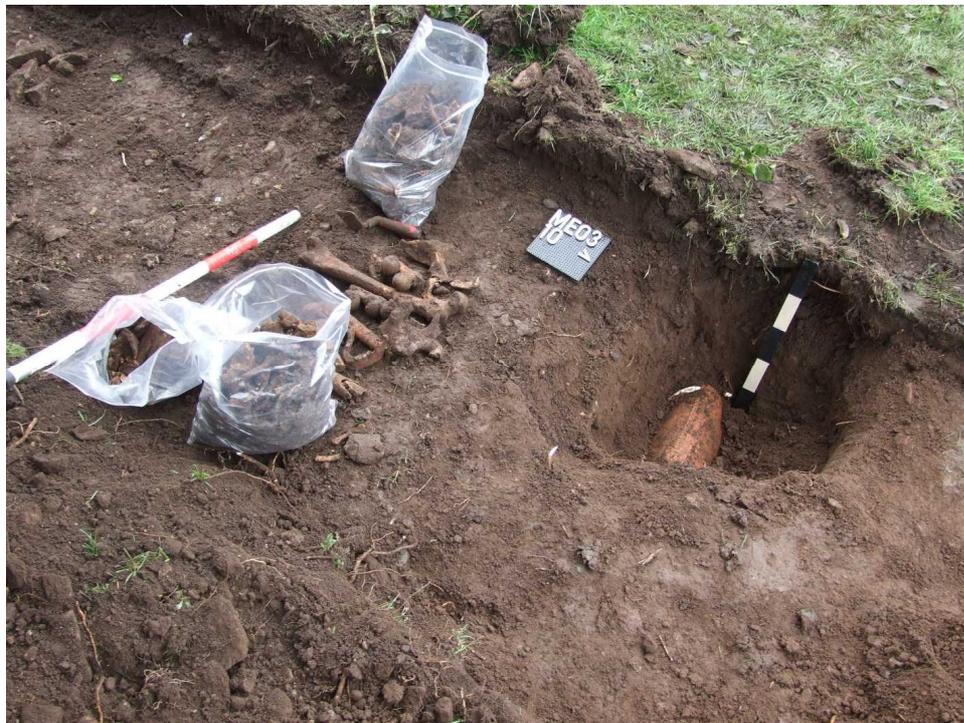
Ceramic drain (10)

When a pit for reburial was carefully being excavated through graveyard soil a red ceramic field drain (10) was found at a depth of 0.40m below the site surface. The ceramic drain had a diameter of 0.17m and was an early horseshoe type set over a slate sole (early to mid 19th C). It was apparent that the bones had been collected from burials disturbed by the insertion of the field drain and then reburied in the backfill over the field drain. The bones were reburied on the S side of the field drain in a pit measuring 0.60 X 0.60m and 0.60m deep. The pit bottom was 0.60m below site surface and the top of bones was 0.40m below the site surface. Most of the pit was excavated into the backfill for the field drain and nothing of archaeological significance was found in this deposit.

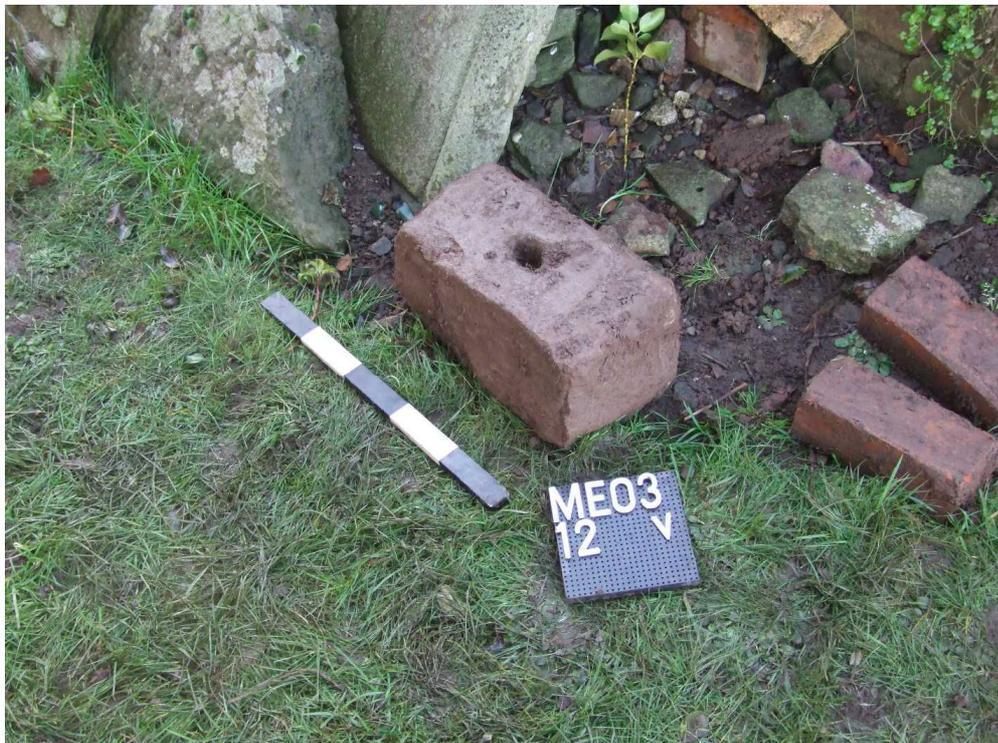
Stone (12) placed by wall along with bricks (14)

Further to the N beyond the bone deposit, nothing of archaeological significance was found. However, of interest were a rectangular stone with a circular hole in one long side (12), possibly part of a grave surround, two hand made bricks (14), that once supported a headstone base, and two fragments of worked stone (15) that appeared to be parts of the base for a modern headstone. These finds were all considered to be modern and were collected and placed up against the graveyard wall on the W side of the new pathway at the N end beside the corner where the wall returns to the S.

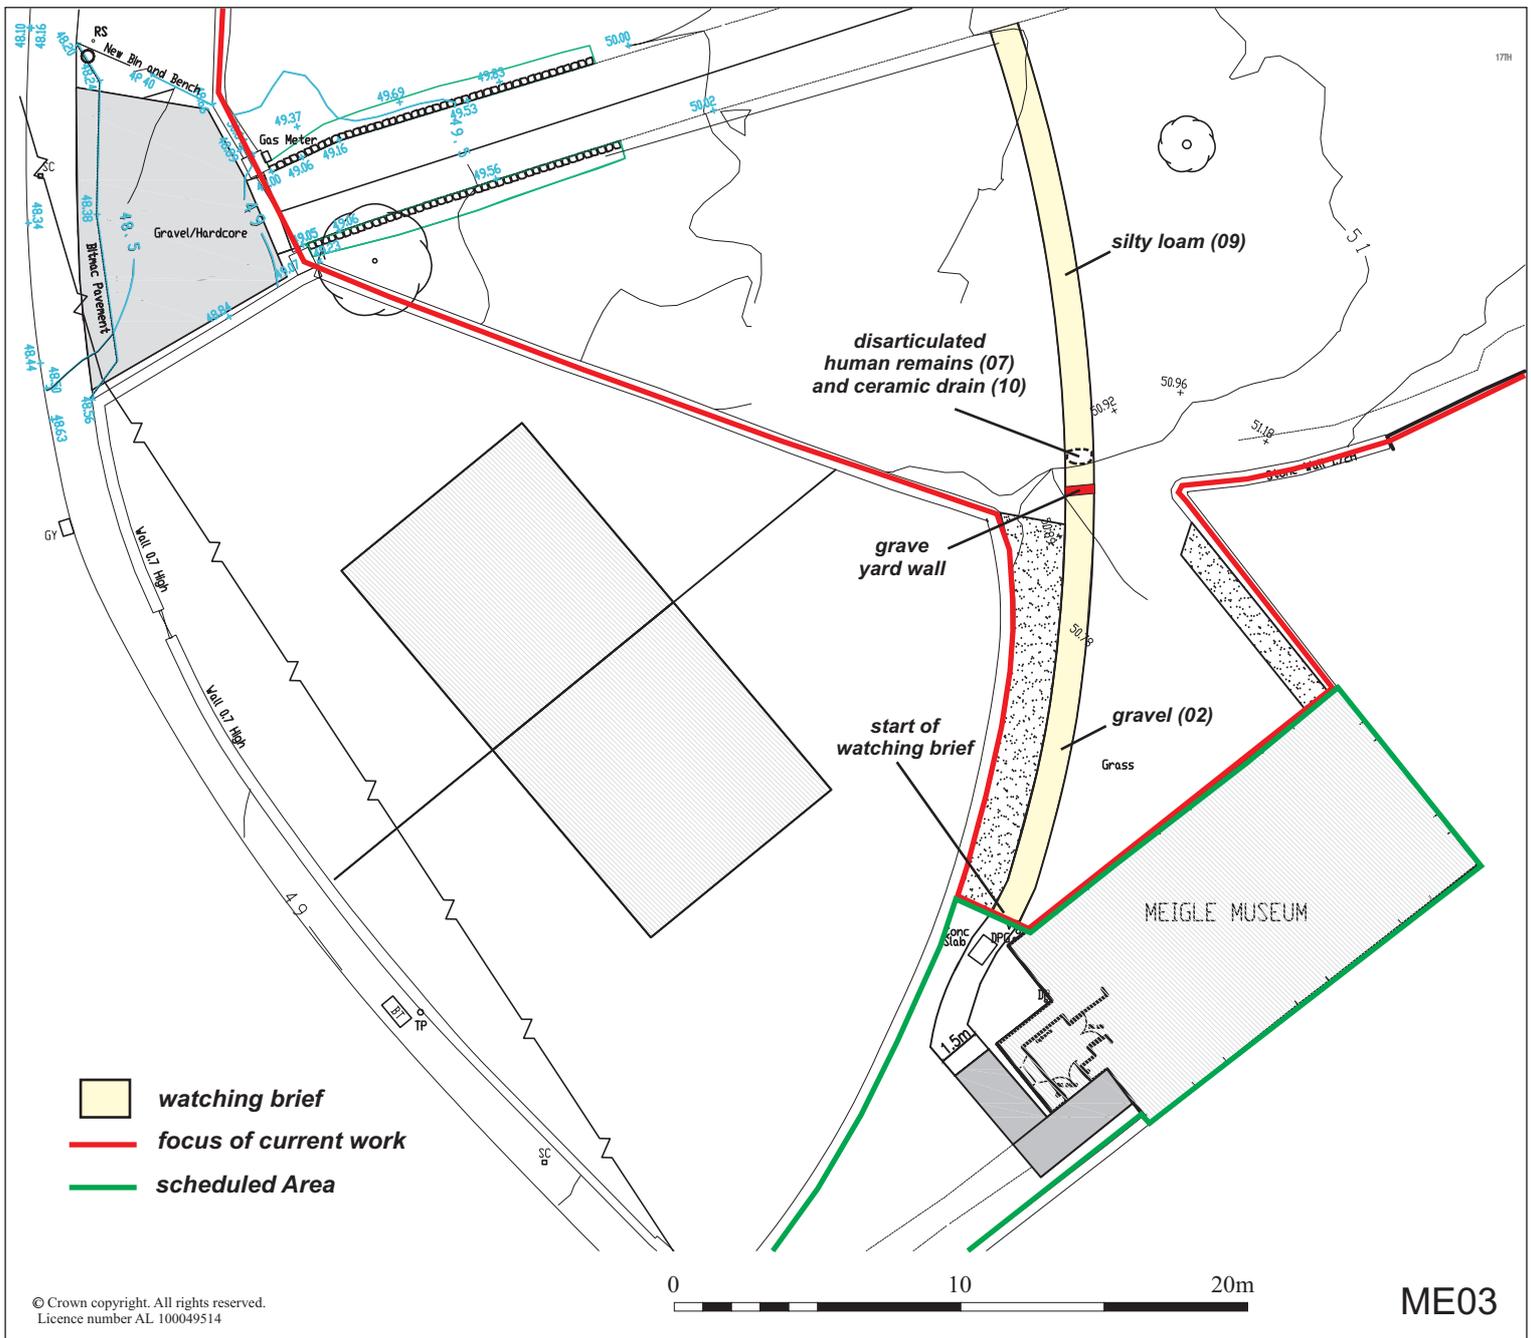
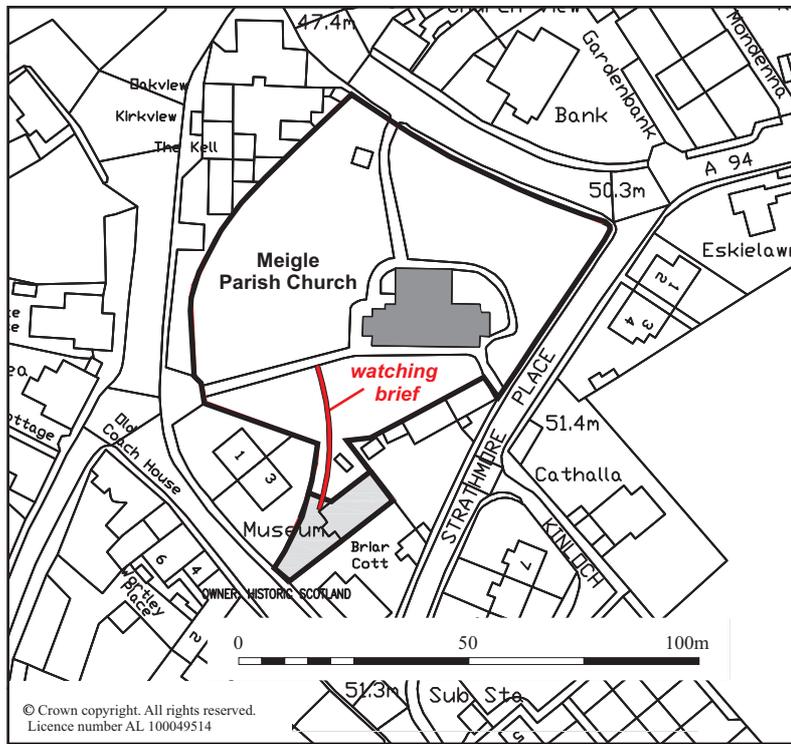
Illus 2
Location
of Watching Brief

The proposed disabled access pathway is located between the NW side of the Museum and the W path to the church. The S part of the new access is within an area on the NW side of the museum (former school), which is outside of the burial ground, while the N part is within the burial ground.

The original division between the graveyard and the school ground had been the graveyard boundary wall. Part of the wall was subsequently removed, creating a gap of 6m wide which accommodated a narrow footpath between the school and the church. According to OS map evidence this work was carried out sometime between 1893 and 1903.
