Archaeological Monitoring
Keithick Mills
Near Coupar Angus
PERTH AND KINROSS

CG08

**ARCHAEOLOGICAL MONITORING
AT KEITHICK MILLS
NEAR
COUPAR ANGUS
CG08**

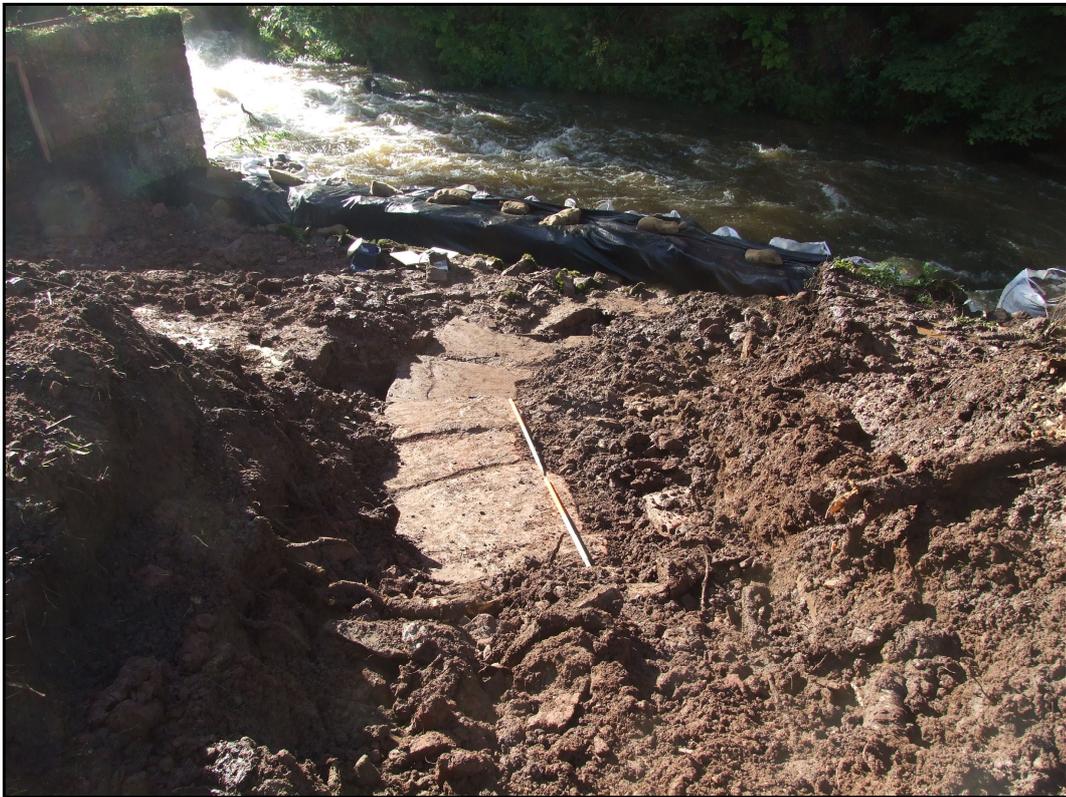
Culvert (08)

Nearby, a group of stone culverts were exposed to the NW of the pump house. These comprised parallel drystone walls (c. 0.45m high) built on platforms cut into the bedrock and covered by non-uniform flat sandstone slabs. Three distinct sections of culverts were identified and given separate context numbers. To the E (09) extended uphill towards the mouth of the lade but was truncated by modern activity. Joined to this was (08) which extended up into the bank towards the nearby mill building. Where these two culverts joined (07) ran SW downhill to join the burn.

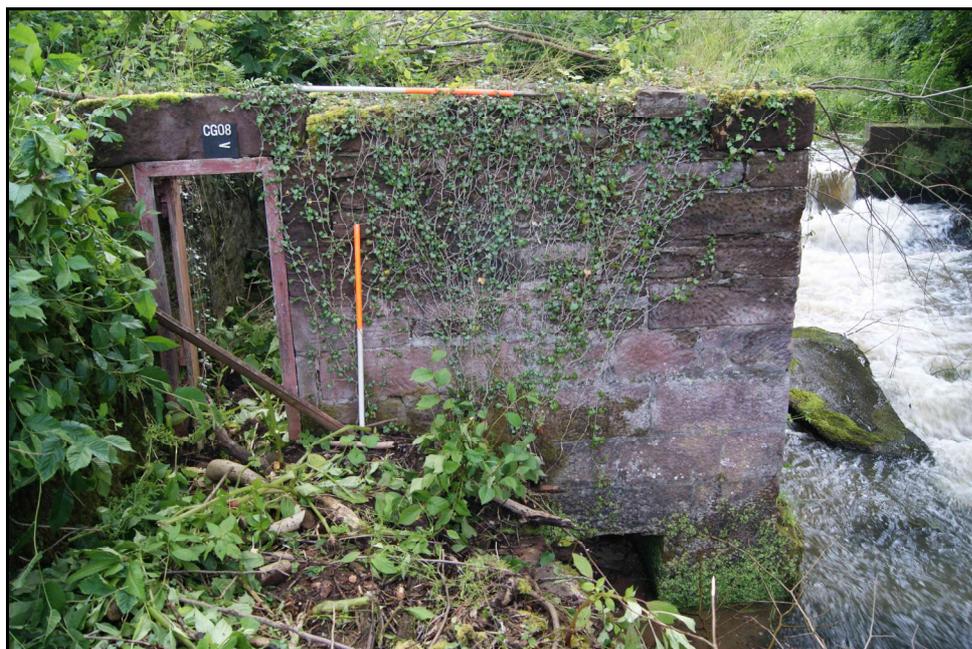
The building (24) is roofless and roughly 3.5m square, with walls constructed from lime mortared, tooled red sandstone blocks, presumably local. The S half of the building has been constructed out over the main burn with the S wall foundations constructed in the water.

W elevation of the Pump House

This building dates to the second half of the 19th century (confirmed by map evidence) and seems to have been constructed as a pump house to supply water to the nearby Mill buildings, or possibly Keithick House. The waterwheel would have been fed by the large mill pond which once lay behind the large weir across the burn. The pipe feeding the waterwheel would have been located low down in the weir to provide water under pressure. During the excavation of the trench for the archimedes' screw the NW corner of the pump house was accidentally demolished.

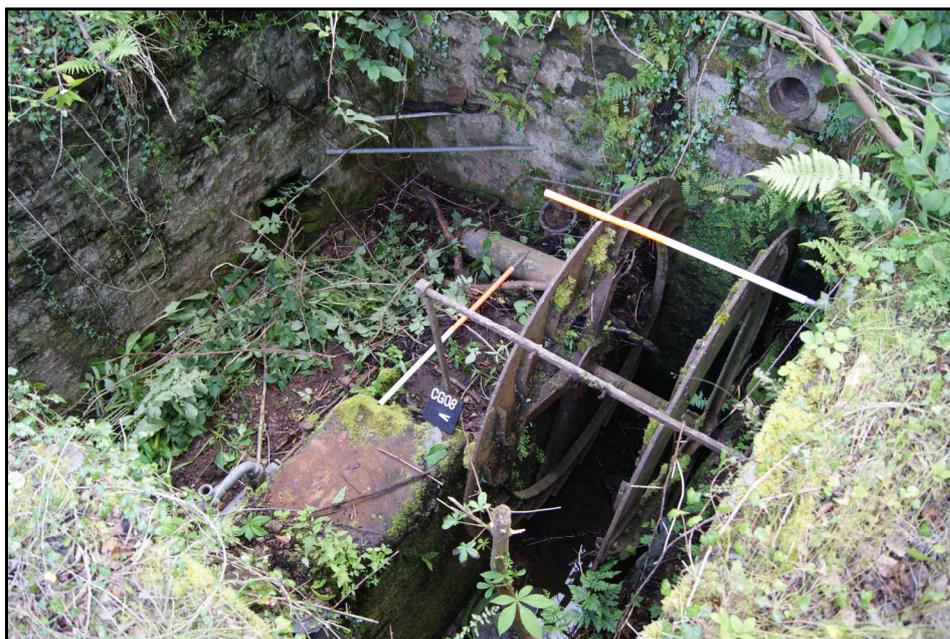
The interior of the building is divided in two, the S half comprising a pit descending down to the level of the burn, over which a cast iron waterwheel is suspended. A hole low down in the W wall would have let water out into the burn from this pit. The axle of the waterwheel connects to pivots, one in the S wall and another on a low sandstone wall running E-W across the centre of the building. The axle is connected to a reciprocating piston which is part of a water pump. Just above the waterwheel in the E wall is a pipe which would have supplied the water. The N half of the building is essentially a flat maintenance platform accessed via a narrow door in the W wall. The water pipe from the pump appeared to exit through a small hole near the wall foundation to the S of the doorway.

Interior of the Pump House

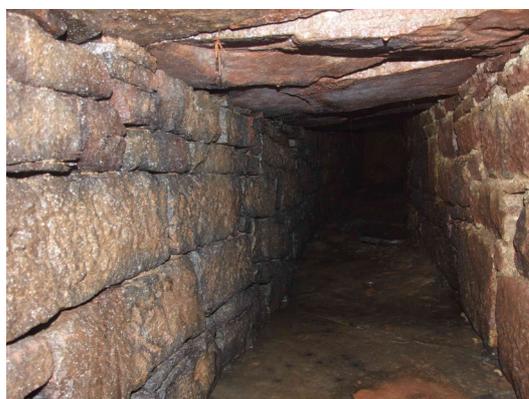
Looking up Culvert (07)

The quality of the masonry suggests a 19th century date, though there was nothing to conclusively date the structures. It seems likely that the branch (09) acted as an overflow channel for the lade, while (08) was probably used to drain outflow from the nearby mill building.

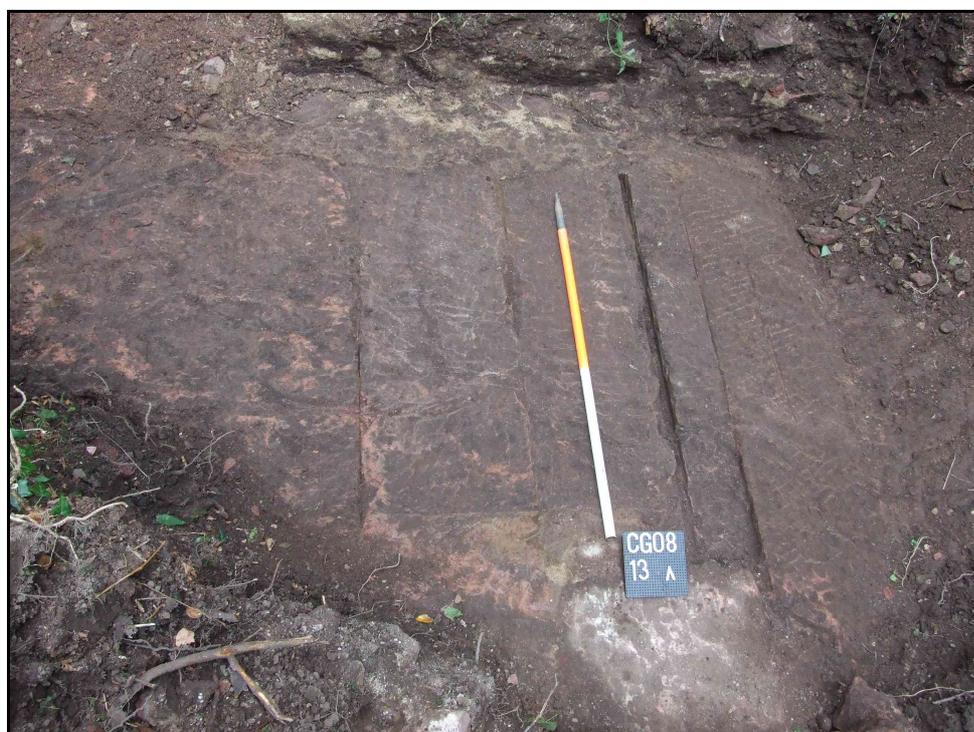
There are several features of interest around the lade entrance; the most important being remains showing where a sluice was located (13). These comprise flat sandstone slabs mortared into position with mortared surfaces on either side. Between two of the stones is a slot, the location of a sluice gate.

Remains relating to a sluice at the entrance to the lade (13)

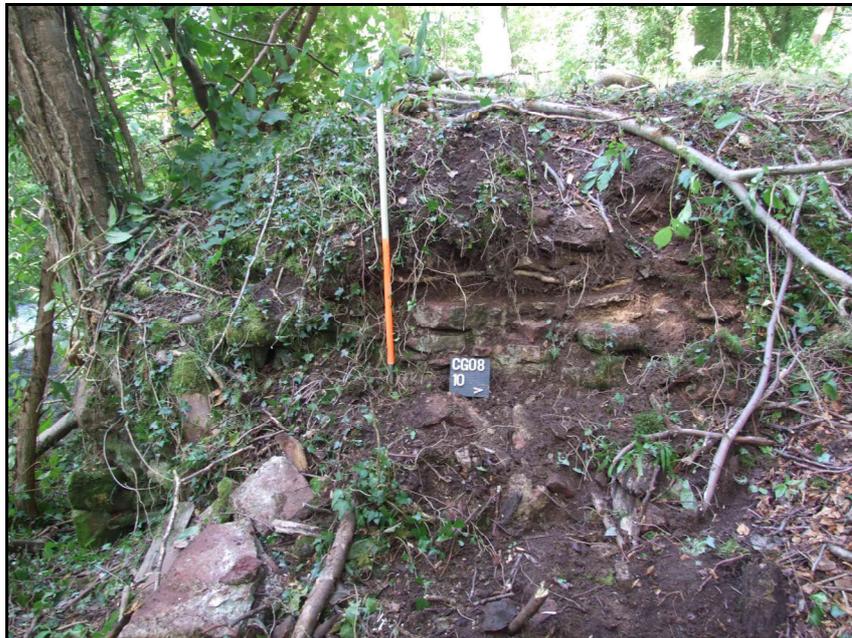
To the S of this sluice, a revetting wall (10) extends from the entrance of the lade across to the burn and along its N bank. This wall would have been built to protect the lade entrance and the N bank of the burn from erosion. Opposite and running parallel to the E face of this wall was another shorter section of revetting wall (11).

Wall (10)

Together the two walls probably formed an overflow channel which would have been required when the lade sluice was closed. The steepness of the bank between the two walls suggests there was also possibly once a weir here (12) to keep the water level high at the entrance to the lade. Along the N side of the lade by the sluice was another

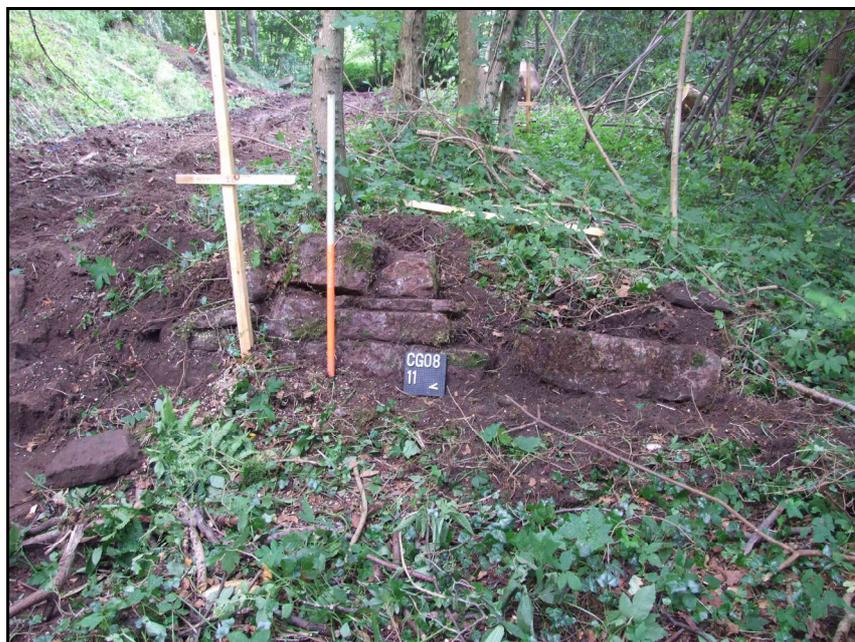
Wall (11) opposite (10)

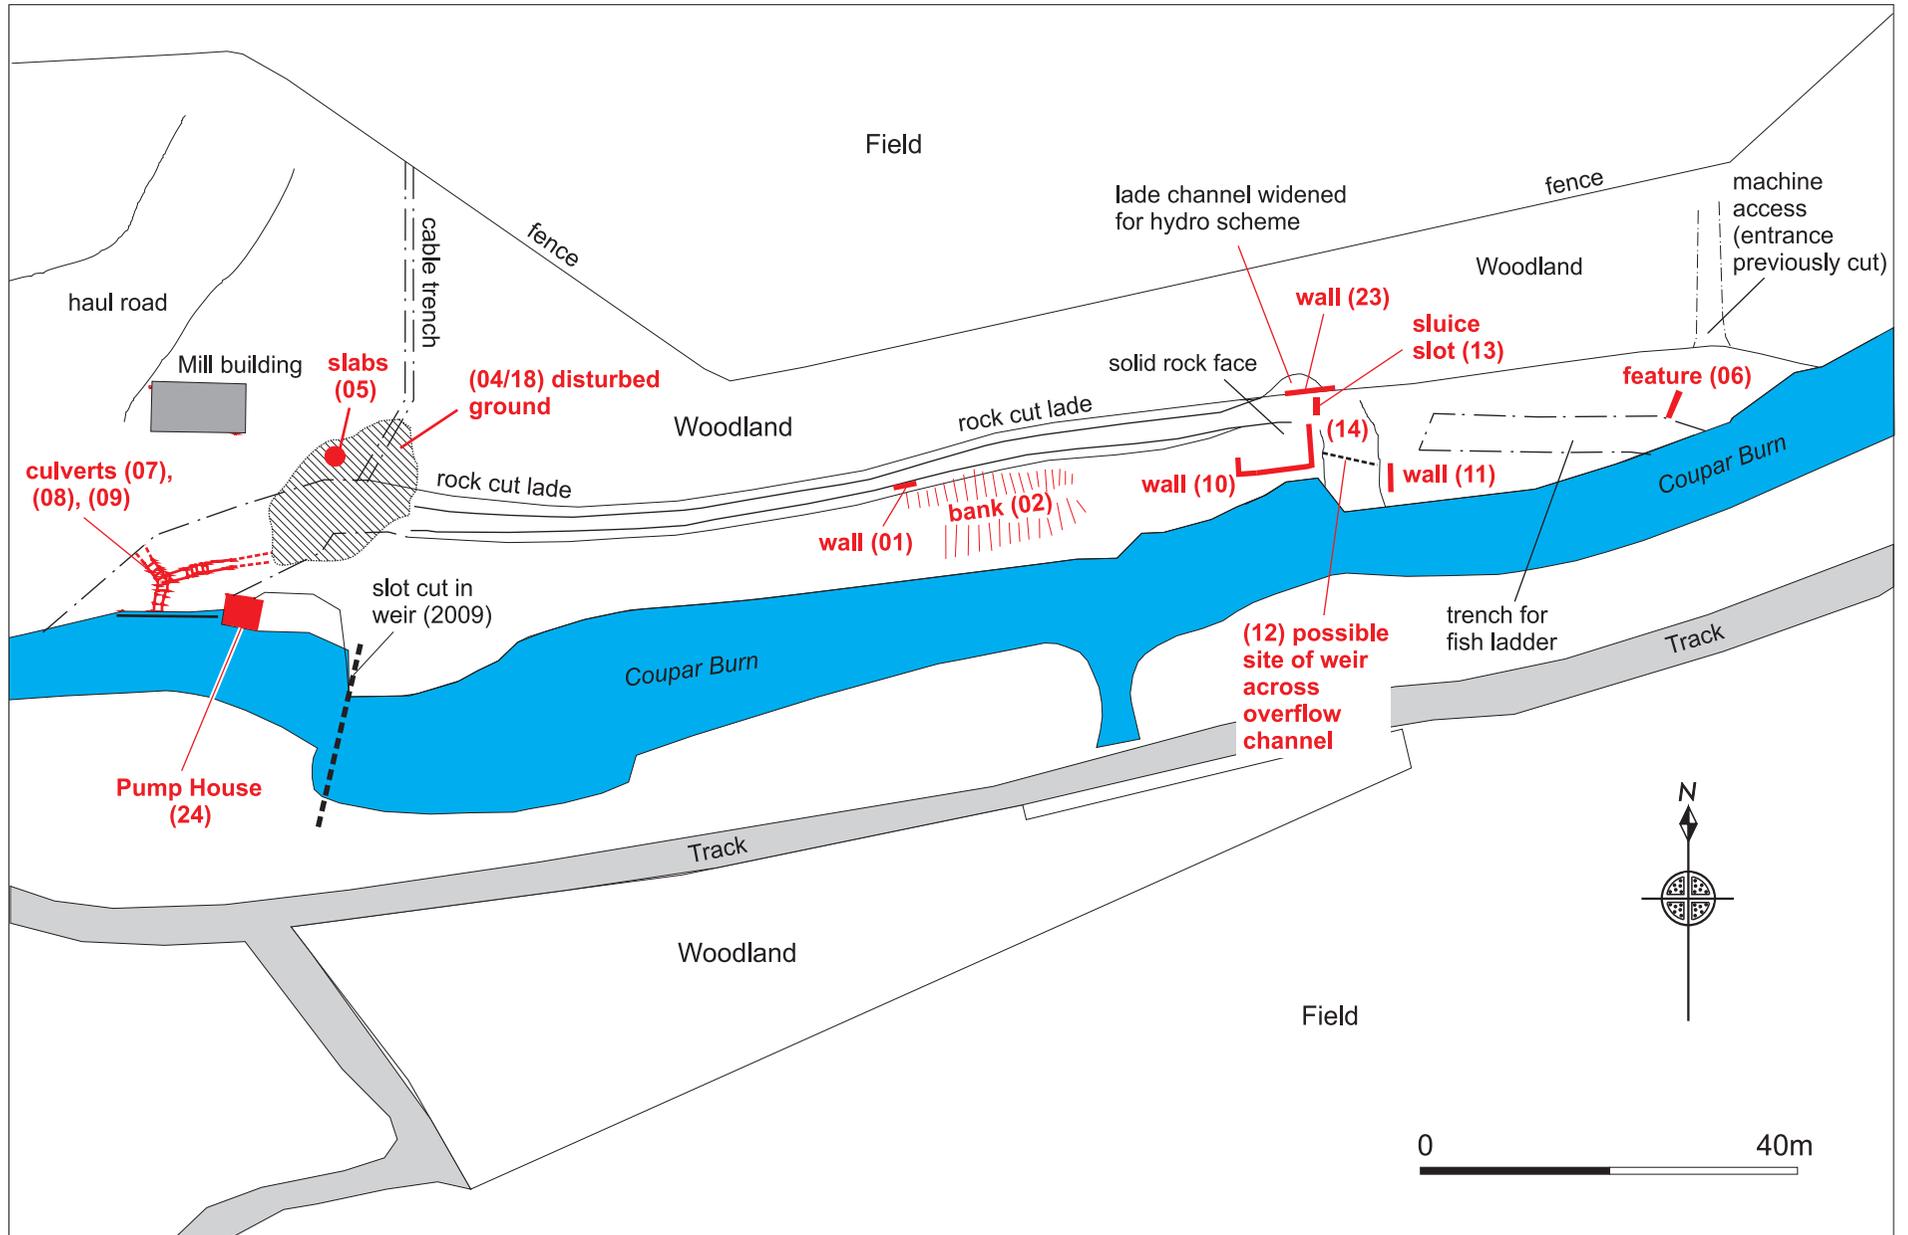
Illus 2

Overall plan of Archaeological Features along the Hydroelectric Scheme
